Our Ref: DH/31106/01

**Re: Cavendish House, Manchester - Timber Inspection**

## REPORT TIMBER INSPECTION

CAVENDISH HOUSE  
MANCHESTER

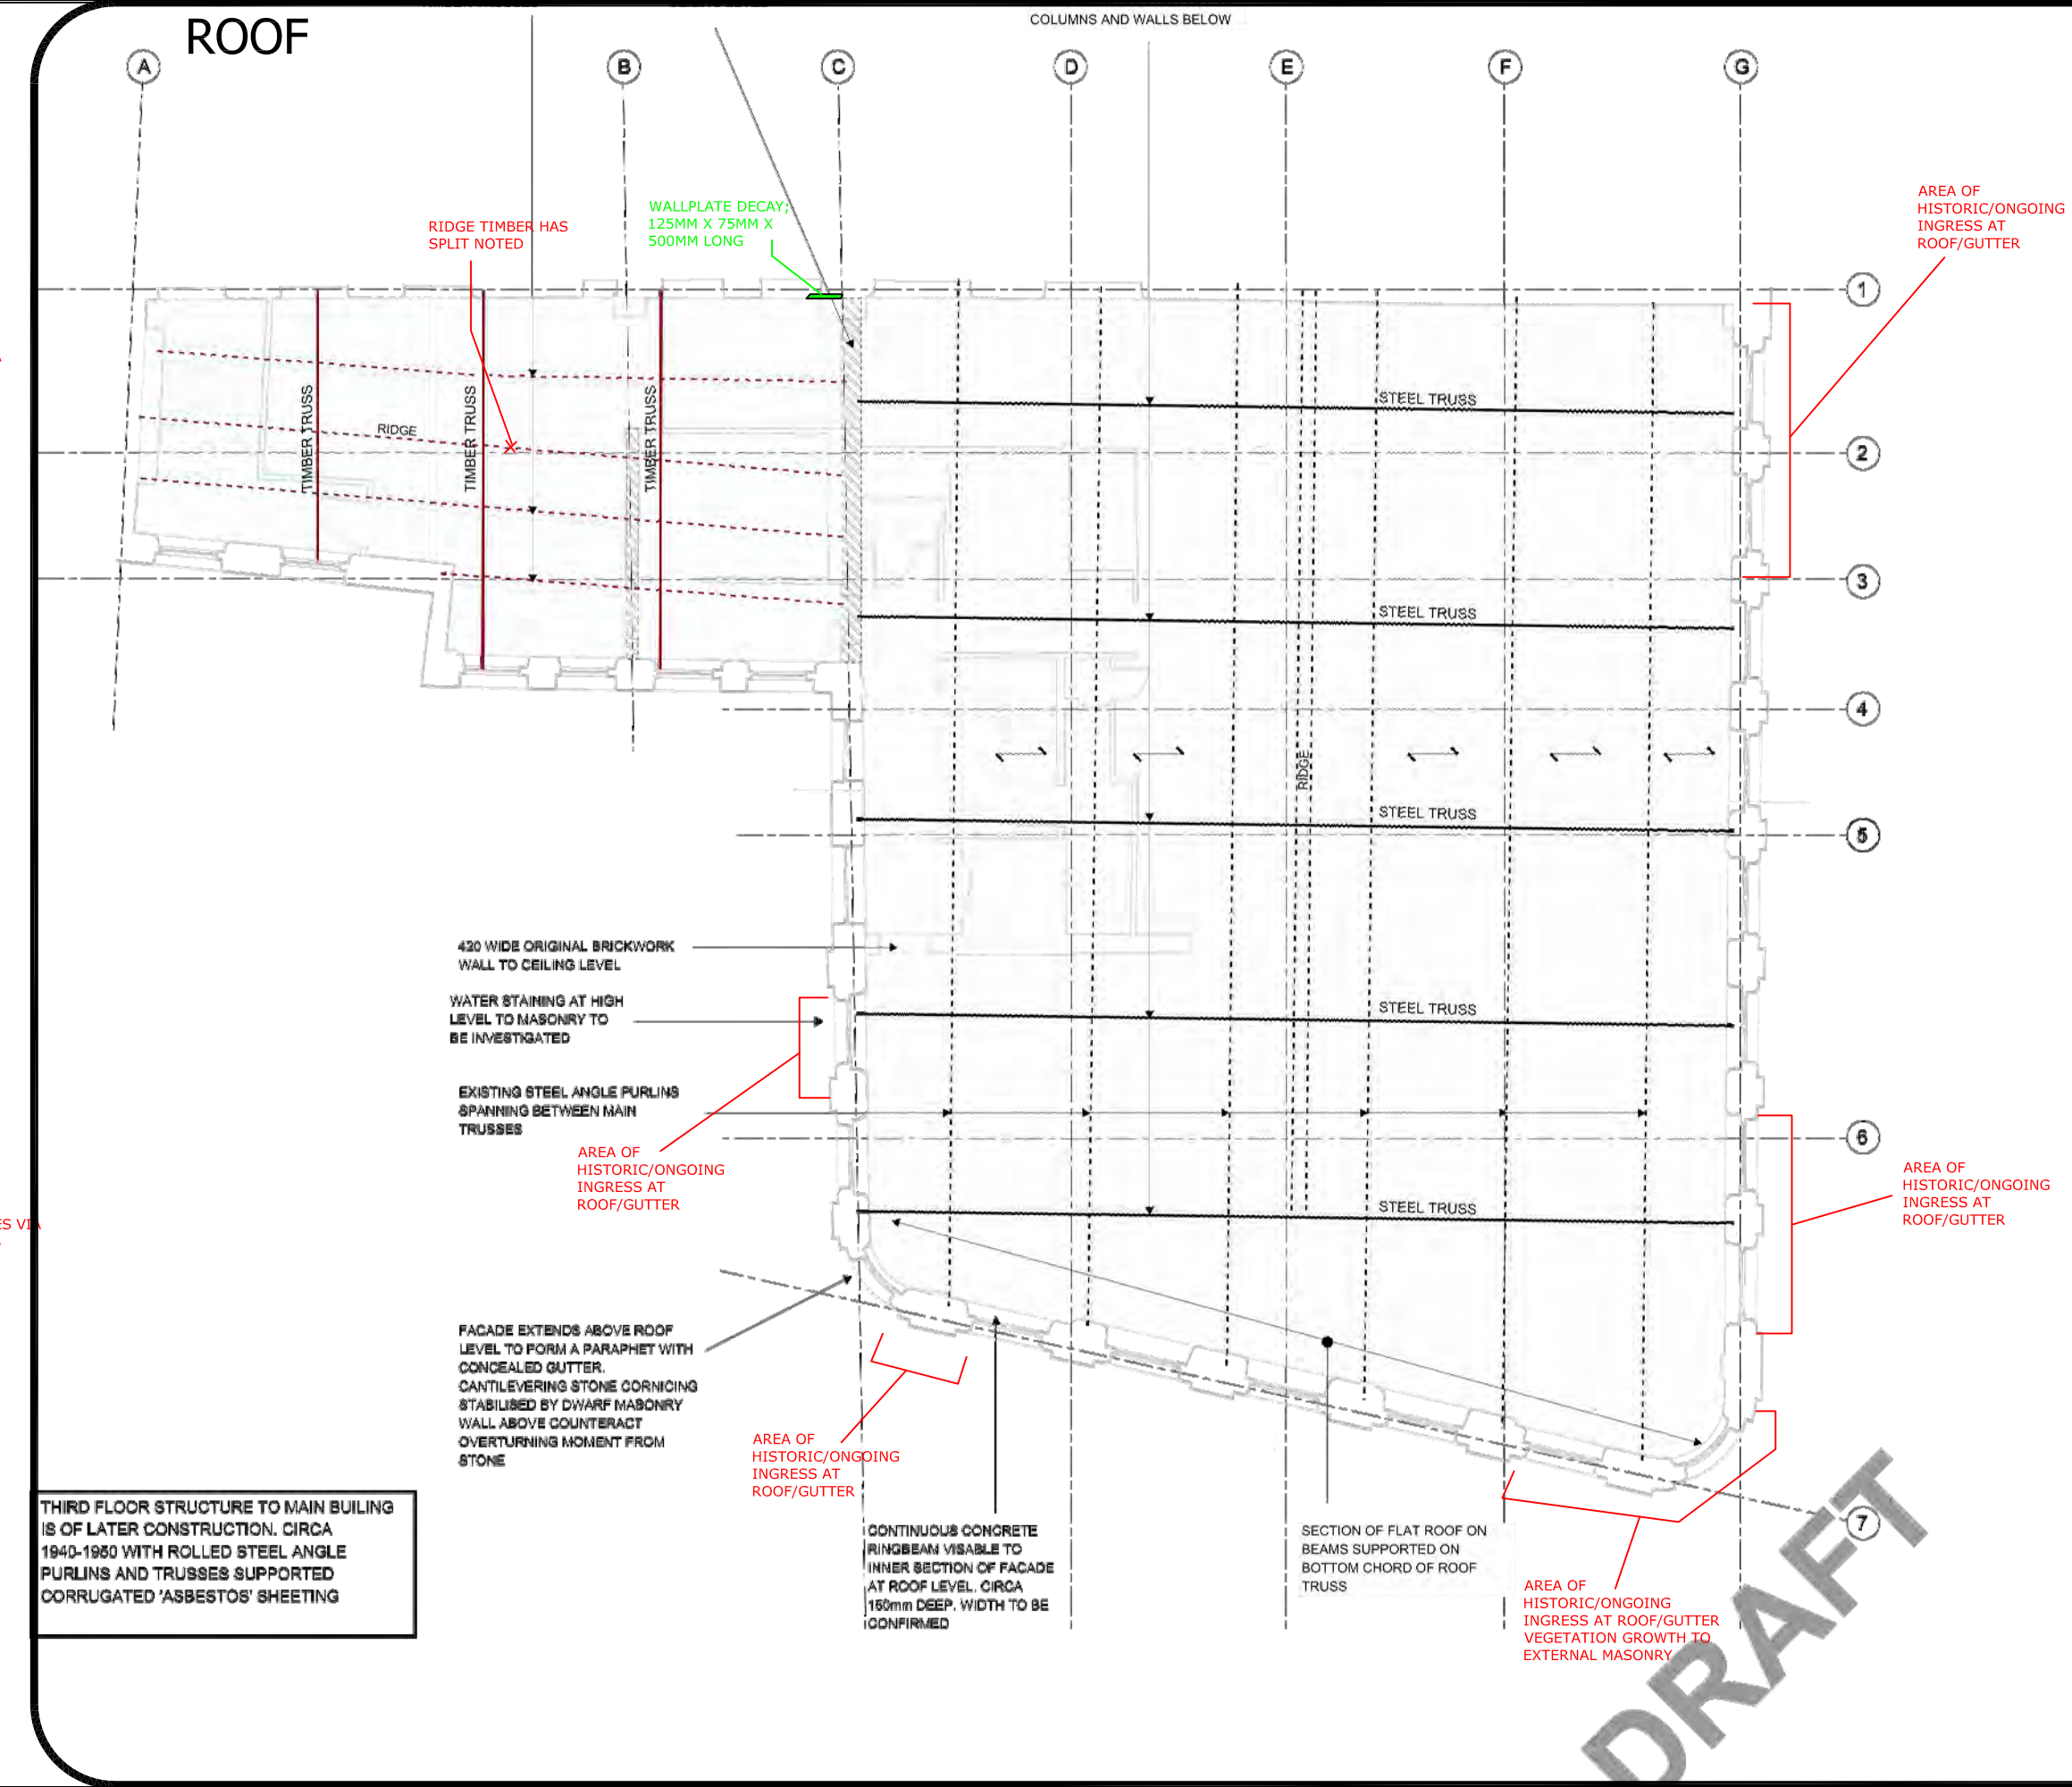
ROOF

RIDGE TIMBER HAS  
SPLIT NOTED

WALLPLATE DECAY;  
125MM X 75MM X  
500MM LONG

We did not identify decay to  
bearing end of Truss  
members in all x3no.  
Trusses

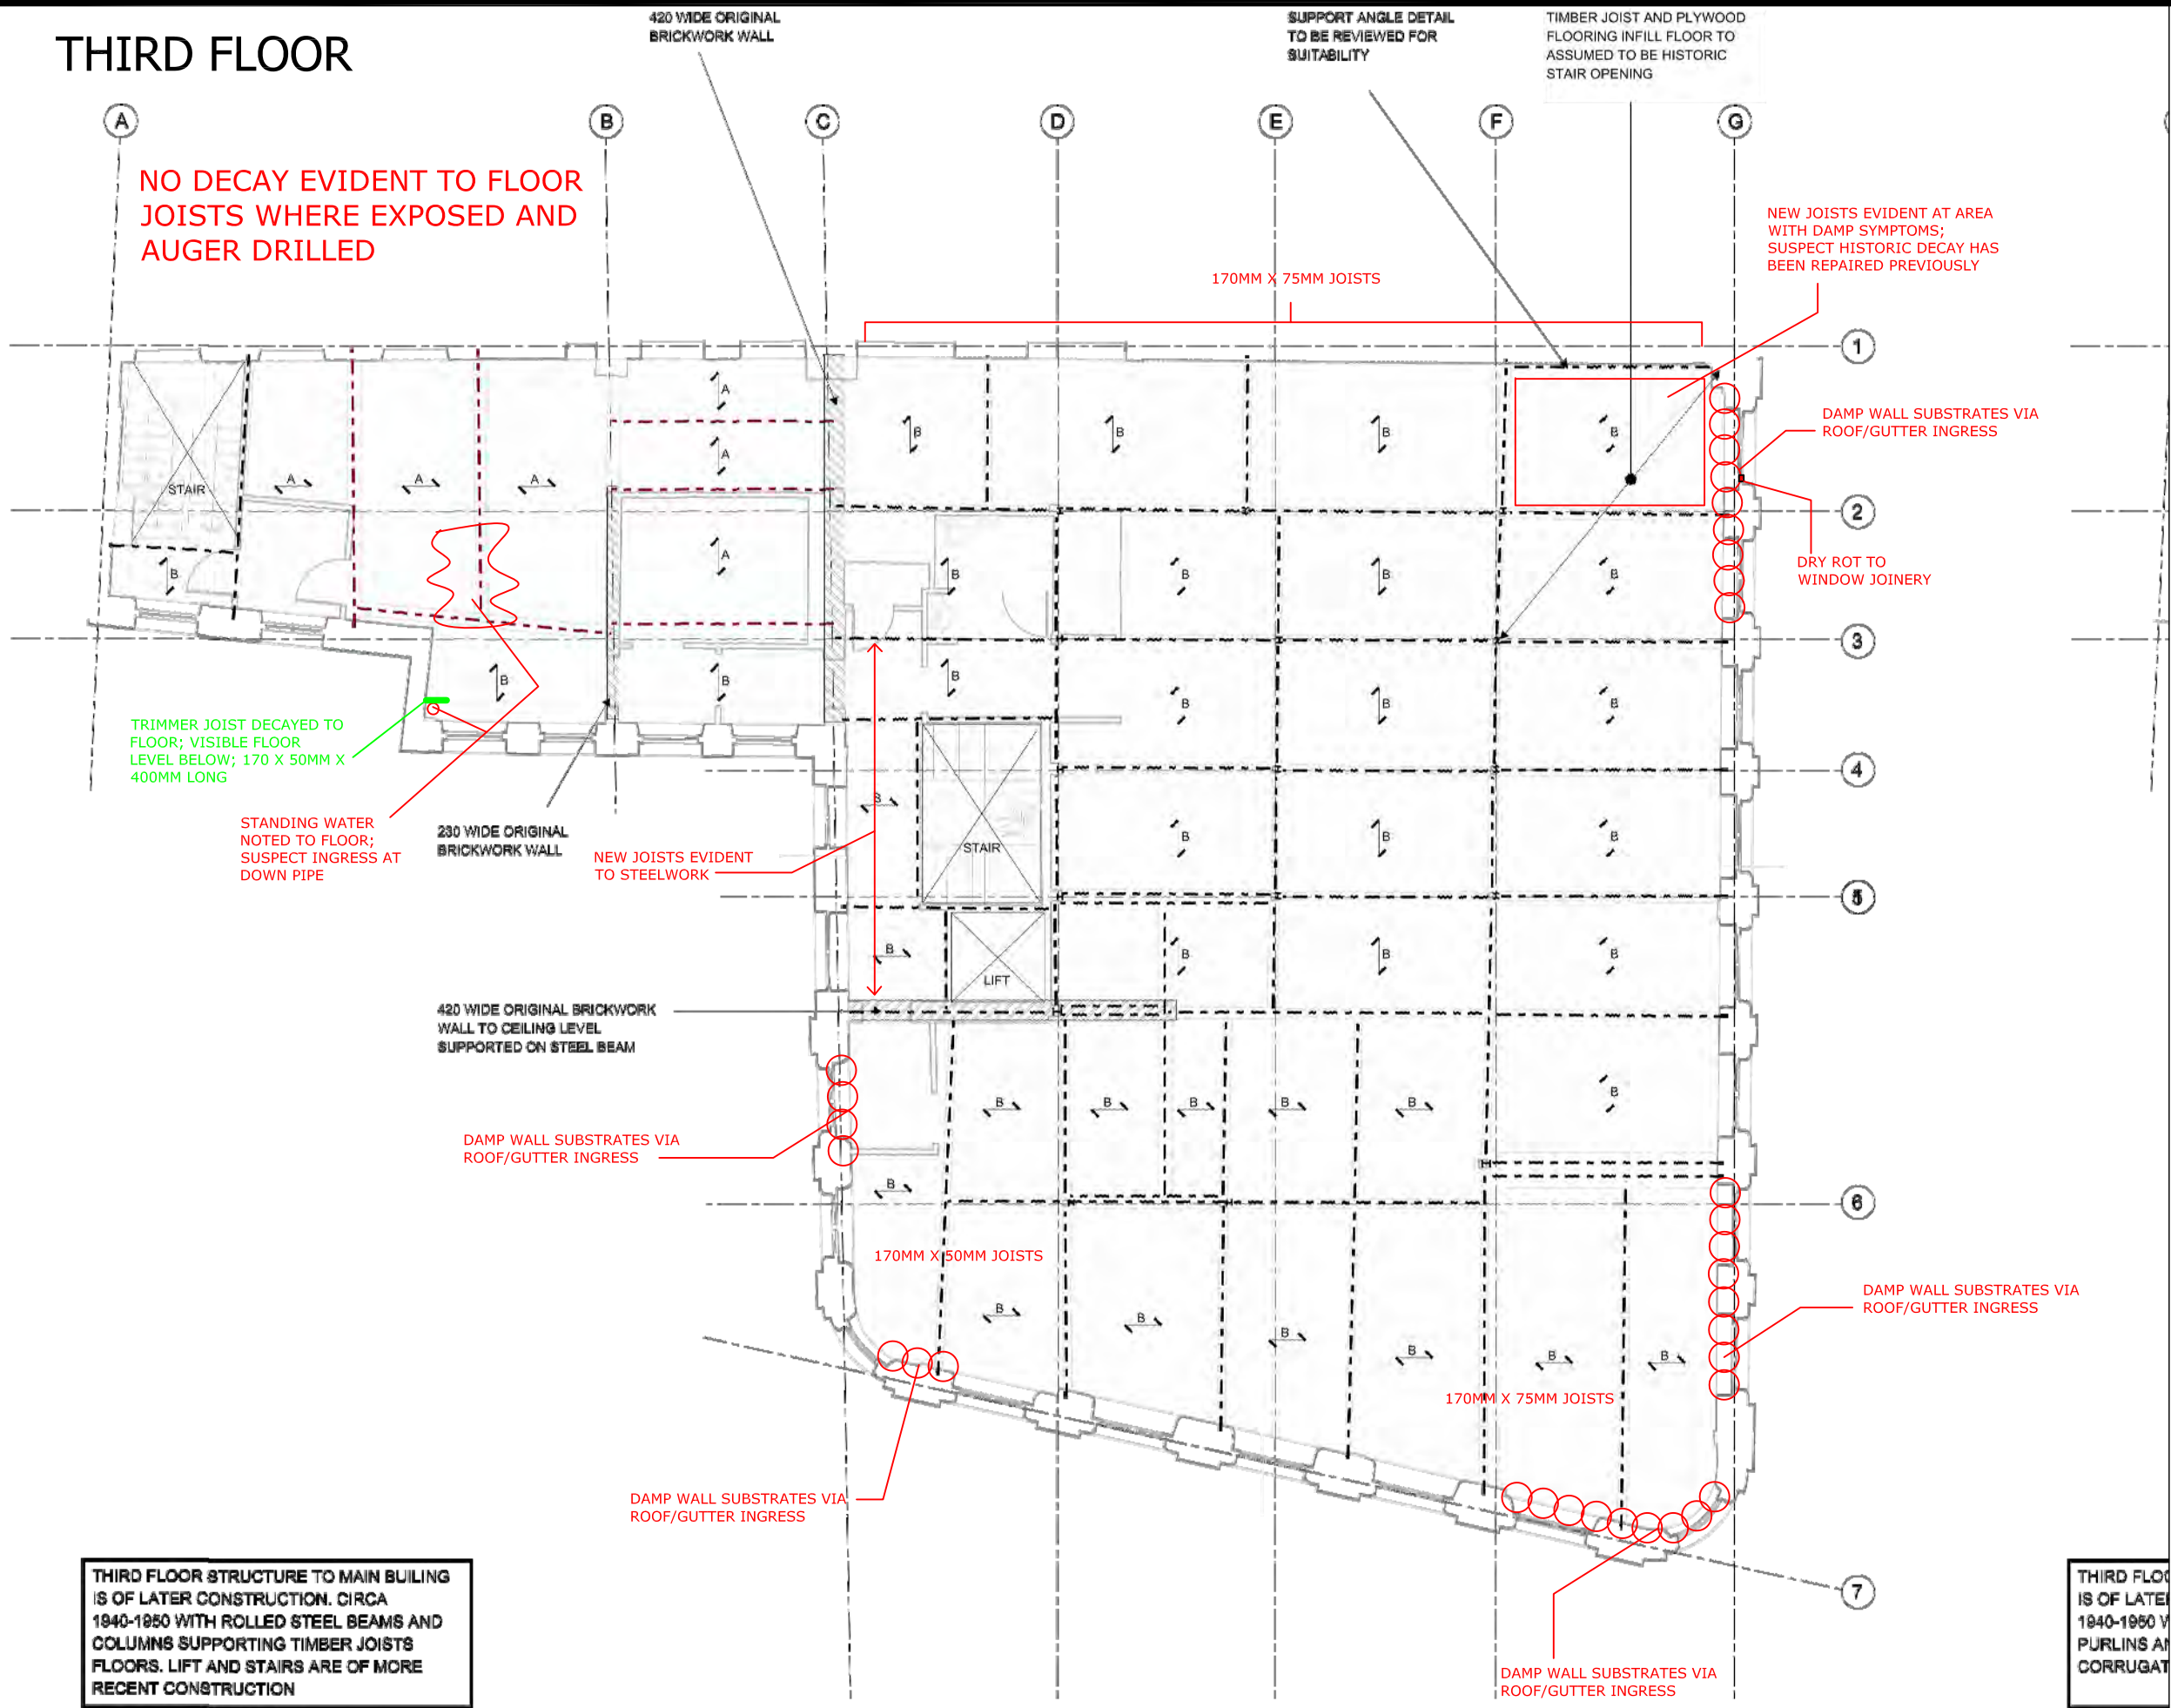
THIRD FLOOR

4.1.2 If structural alteration is required to timbers for the wider scheme, this report makes no allowance for unknown structural alterations at this stage. Window decay is also not included in Trace works at this stage (third floor window has dry rot).

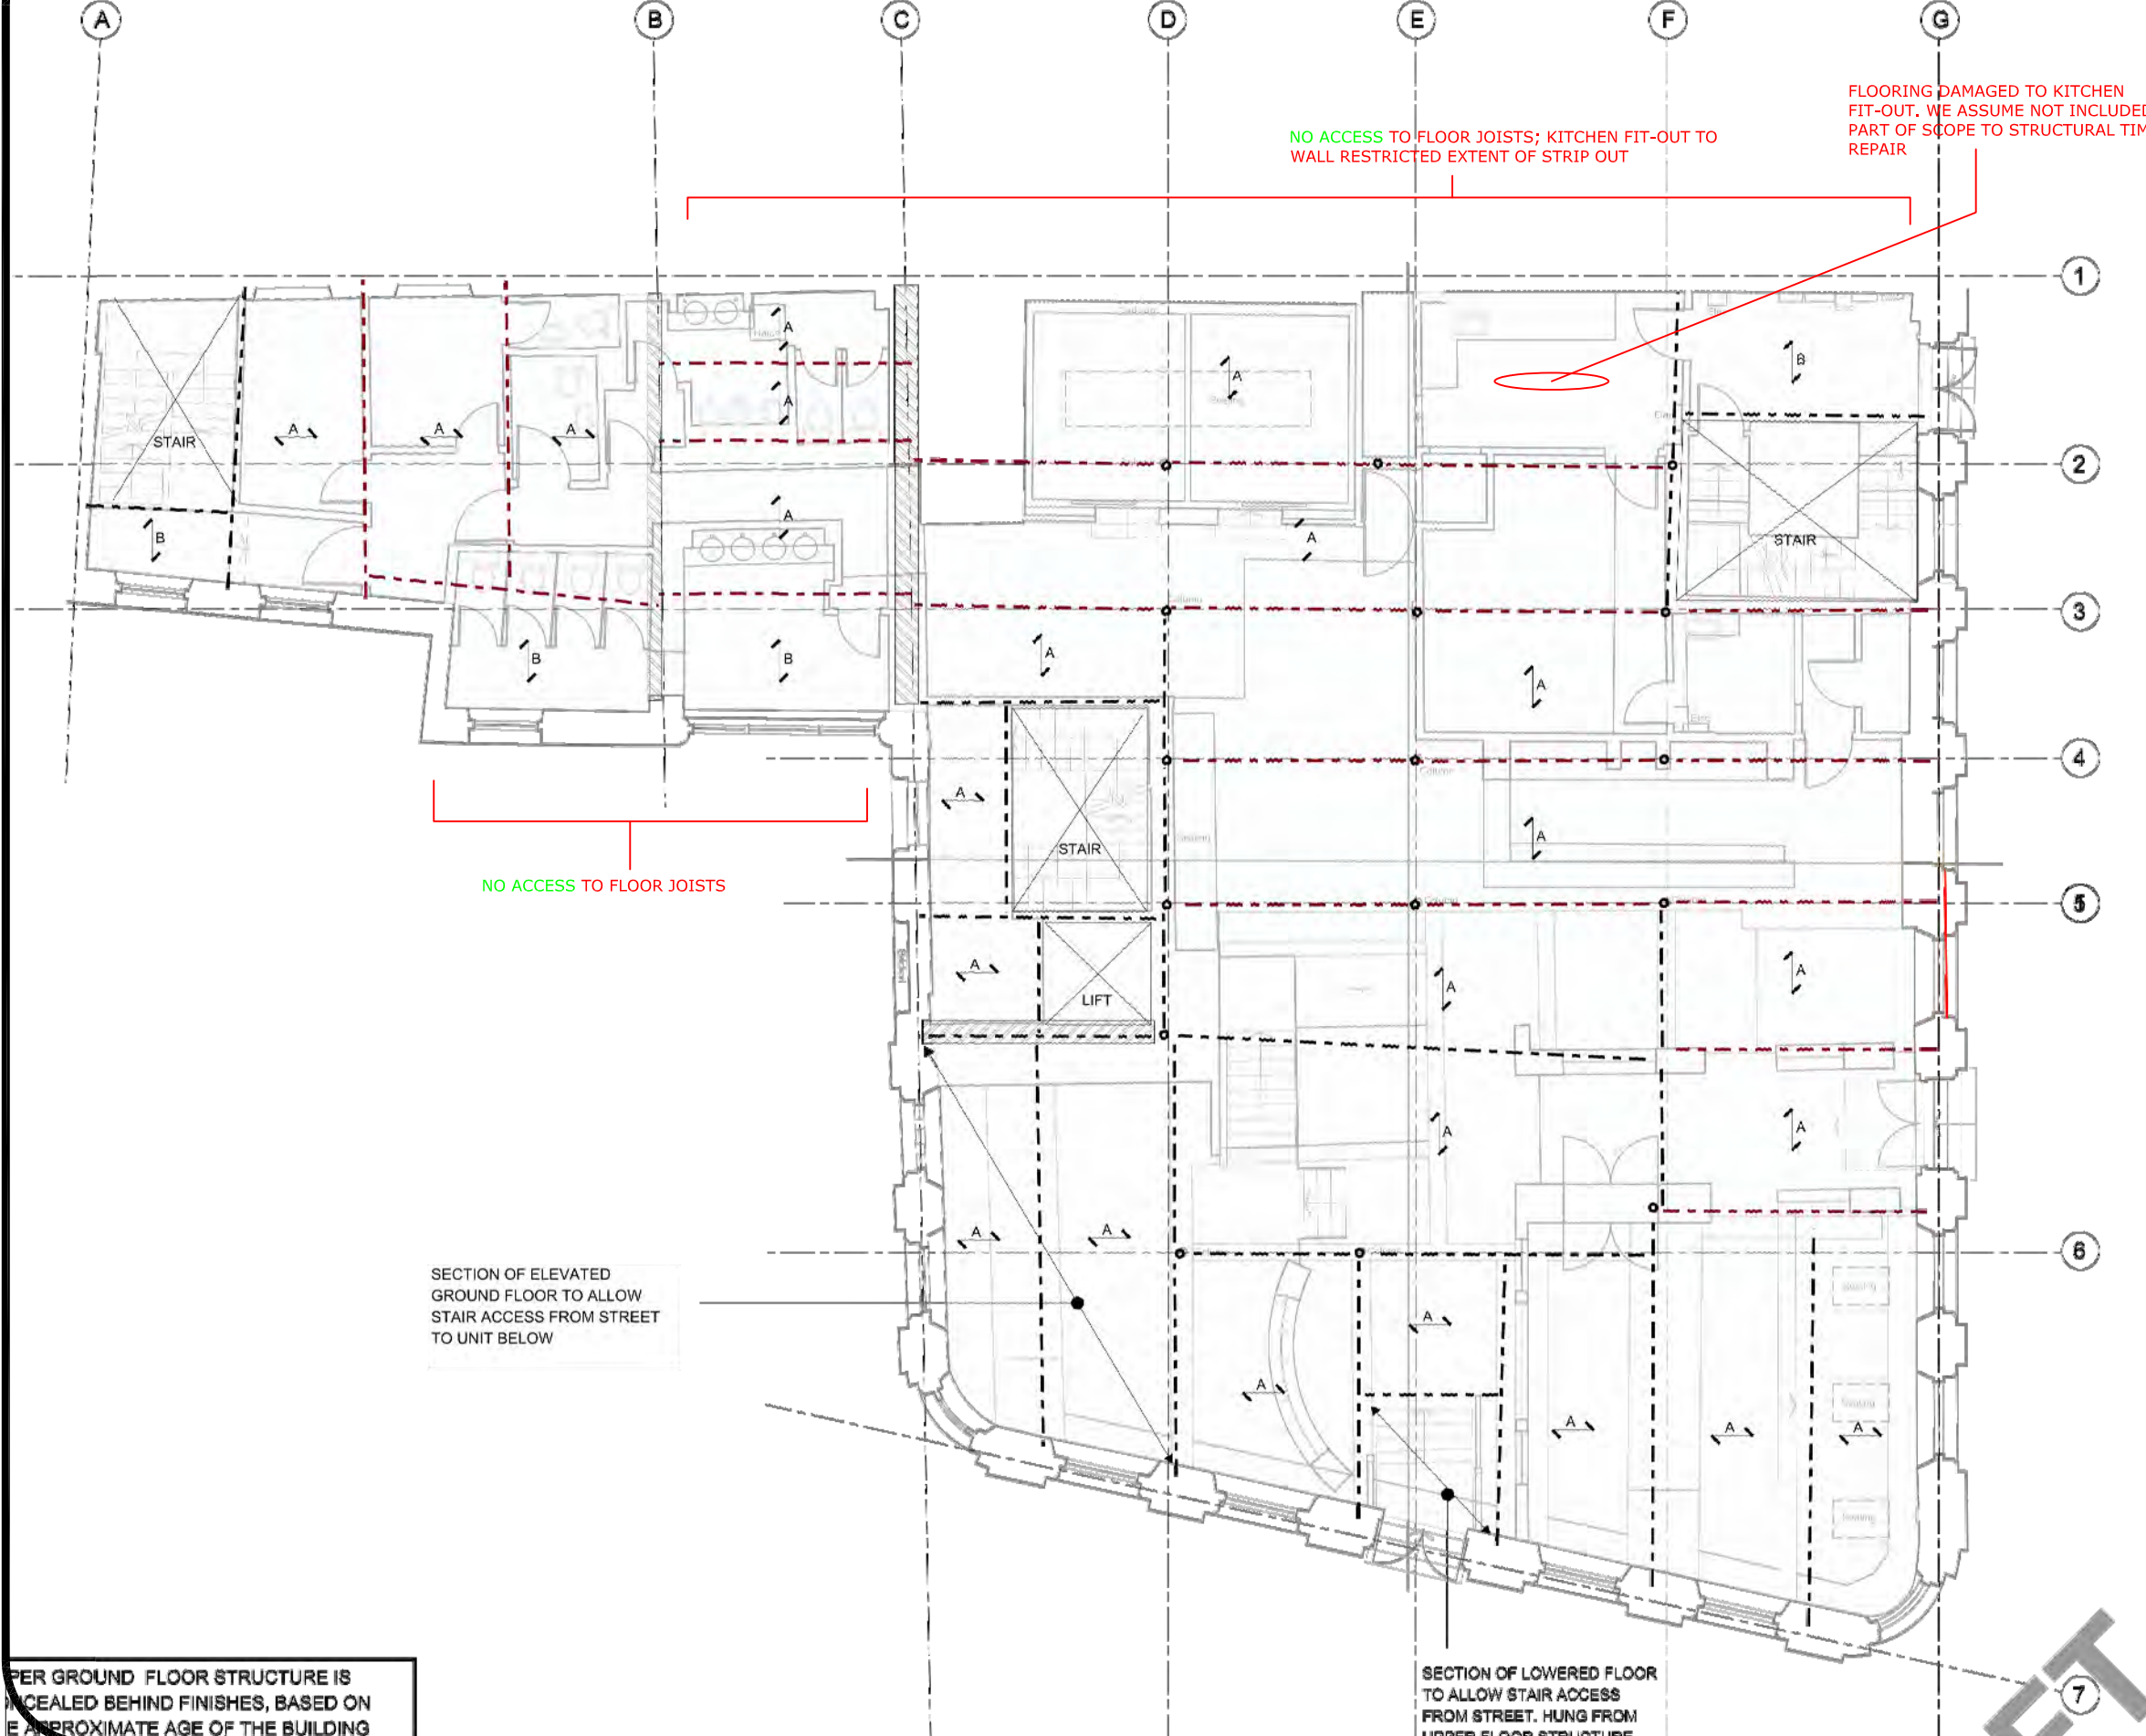
UPPER GROUND FLOOR

SECTION OF LOWERED FLOOR TO ALLOW STAIR ACCESS FROM STREET, HUNG FROM UPPER FLOOR STRUCTURE

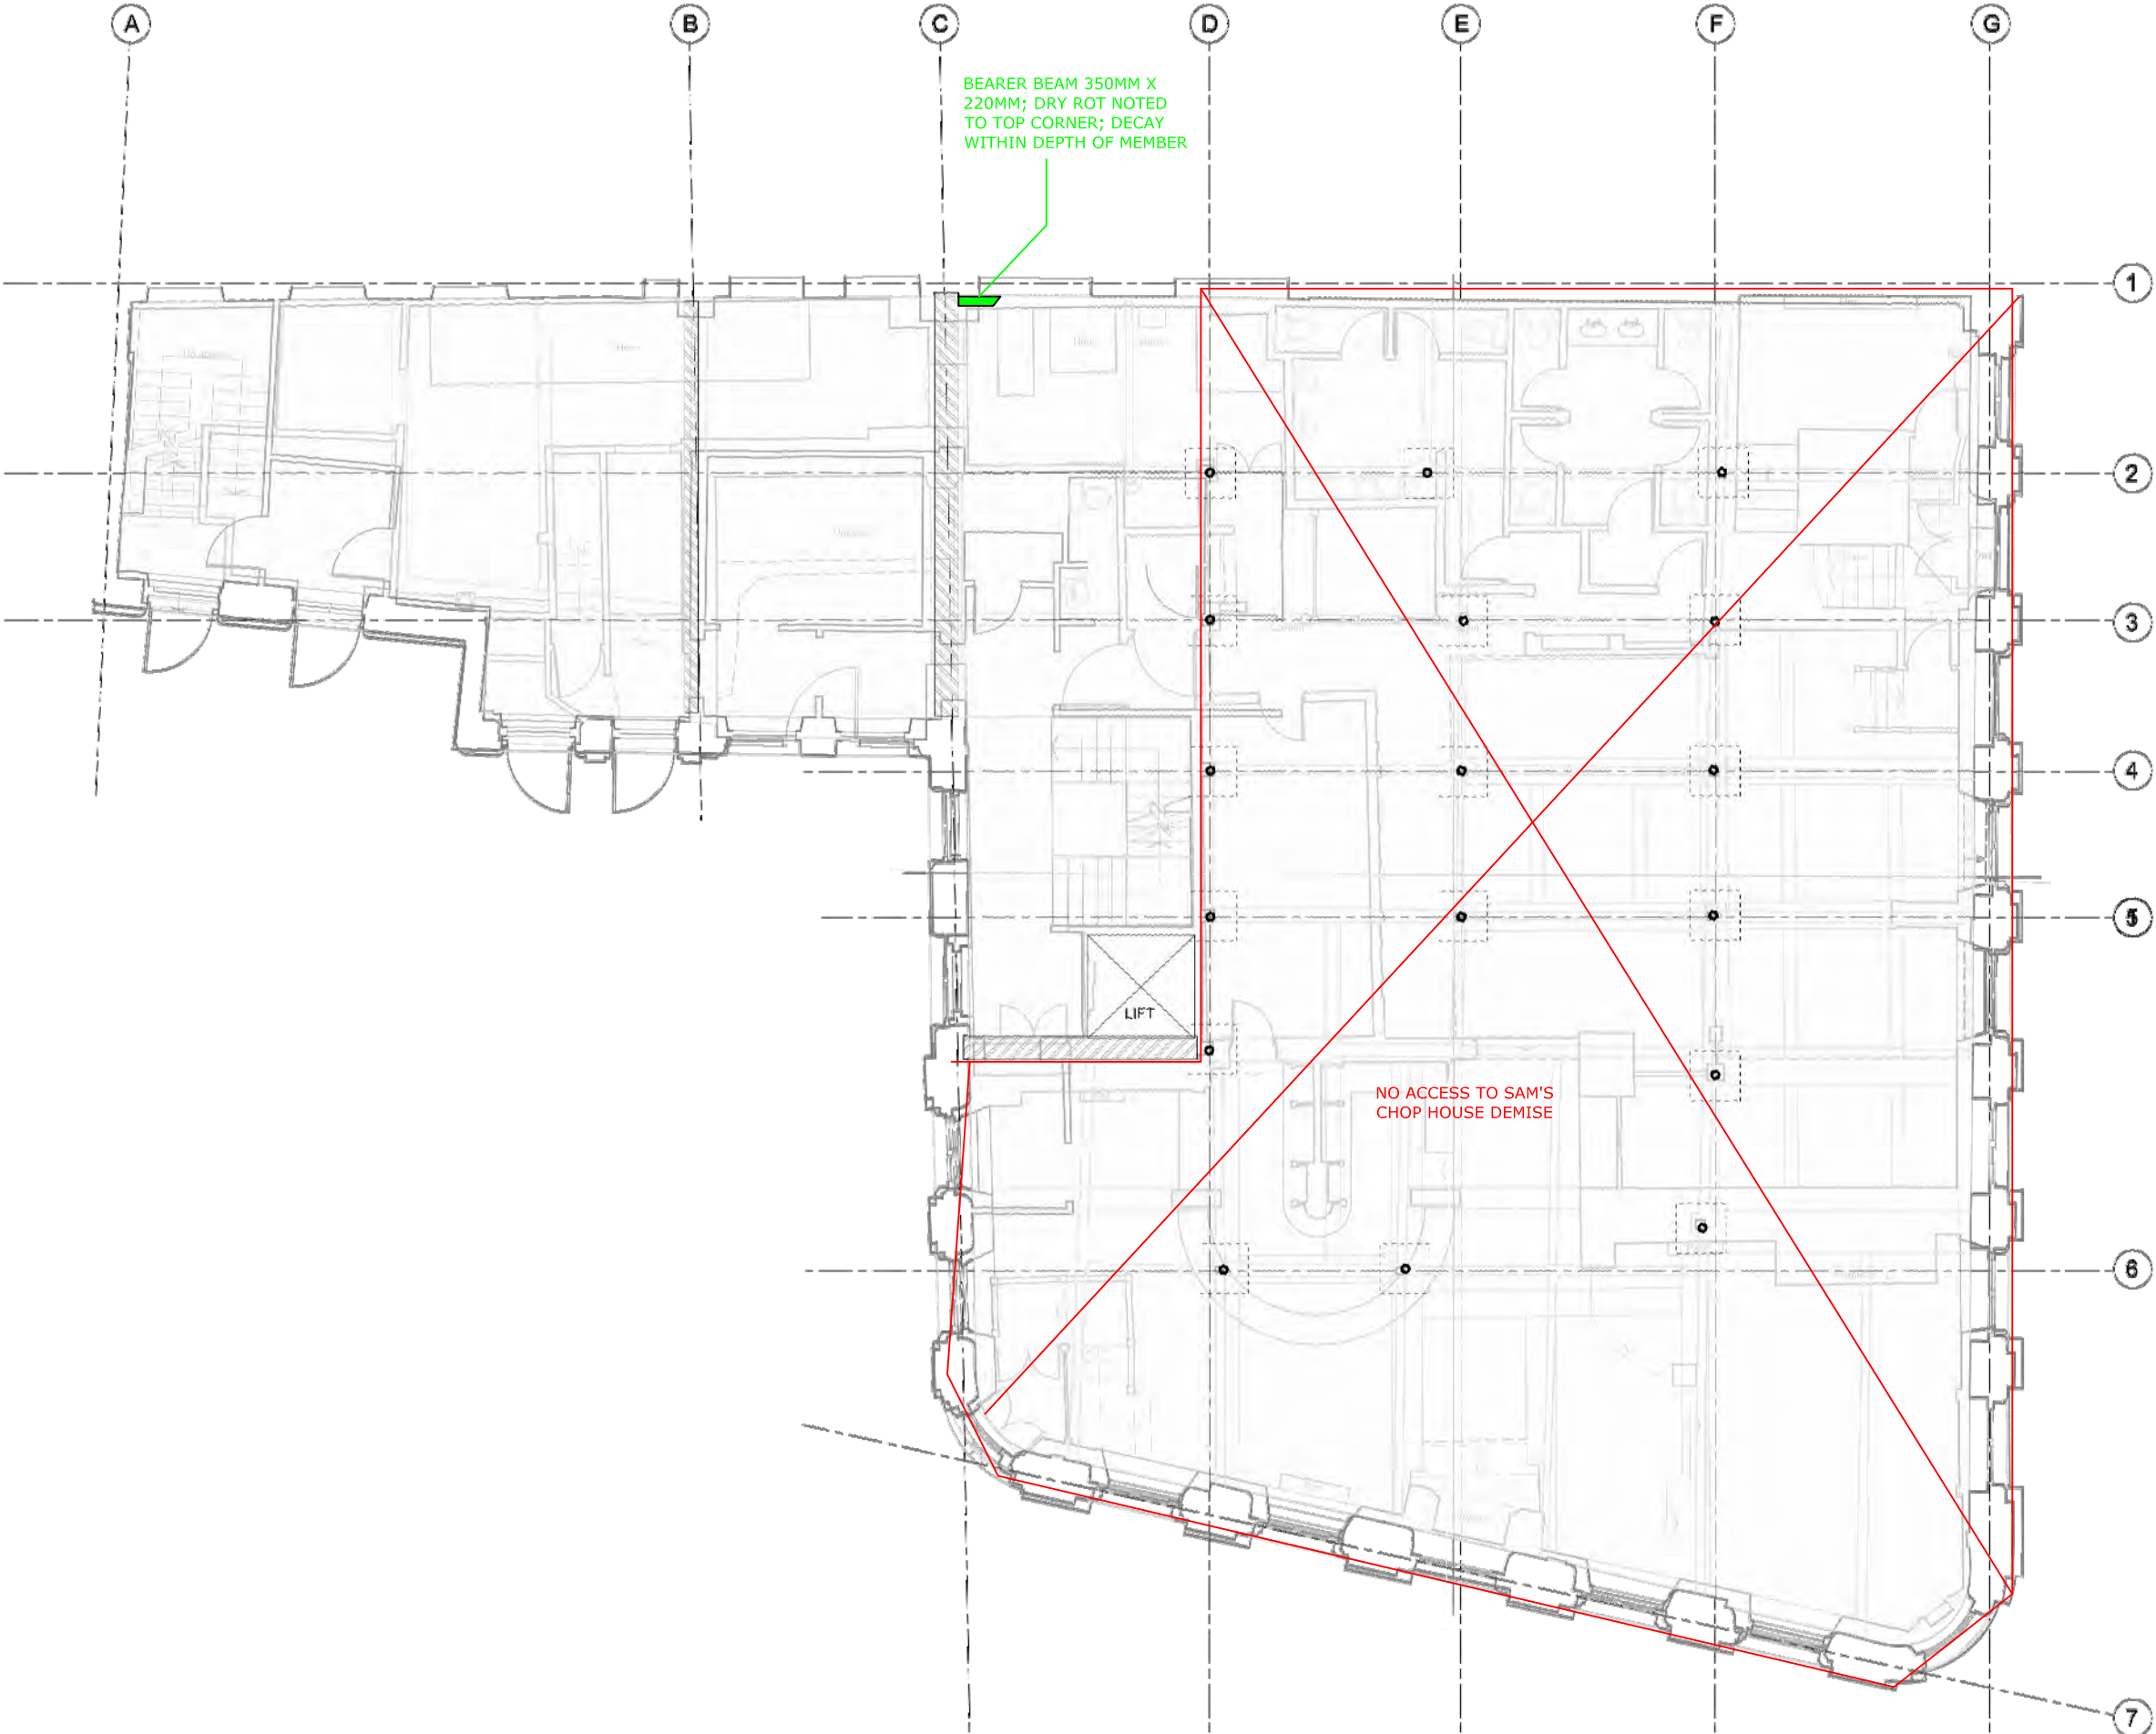
LOWER GROUND FLOOR

The areas highlighted in green show areas that still have decay/timber repairs, but generally these are localised repairs and more significant areas of replacement have been completed historically, which follow the pattern of damp/ingress down the building.

The most significant area with remaining decay is located to 2nd floor joists (front corner) and more minor issues in terms of timber repair around the internal downpipes.

Ingress is ongoing with standing water to upper floors and this is through to be via the internal downpipes as we did not see any moisture staining to the pitched roof soffits in the locality.

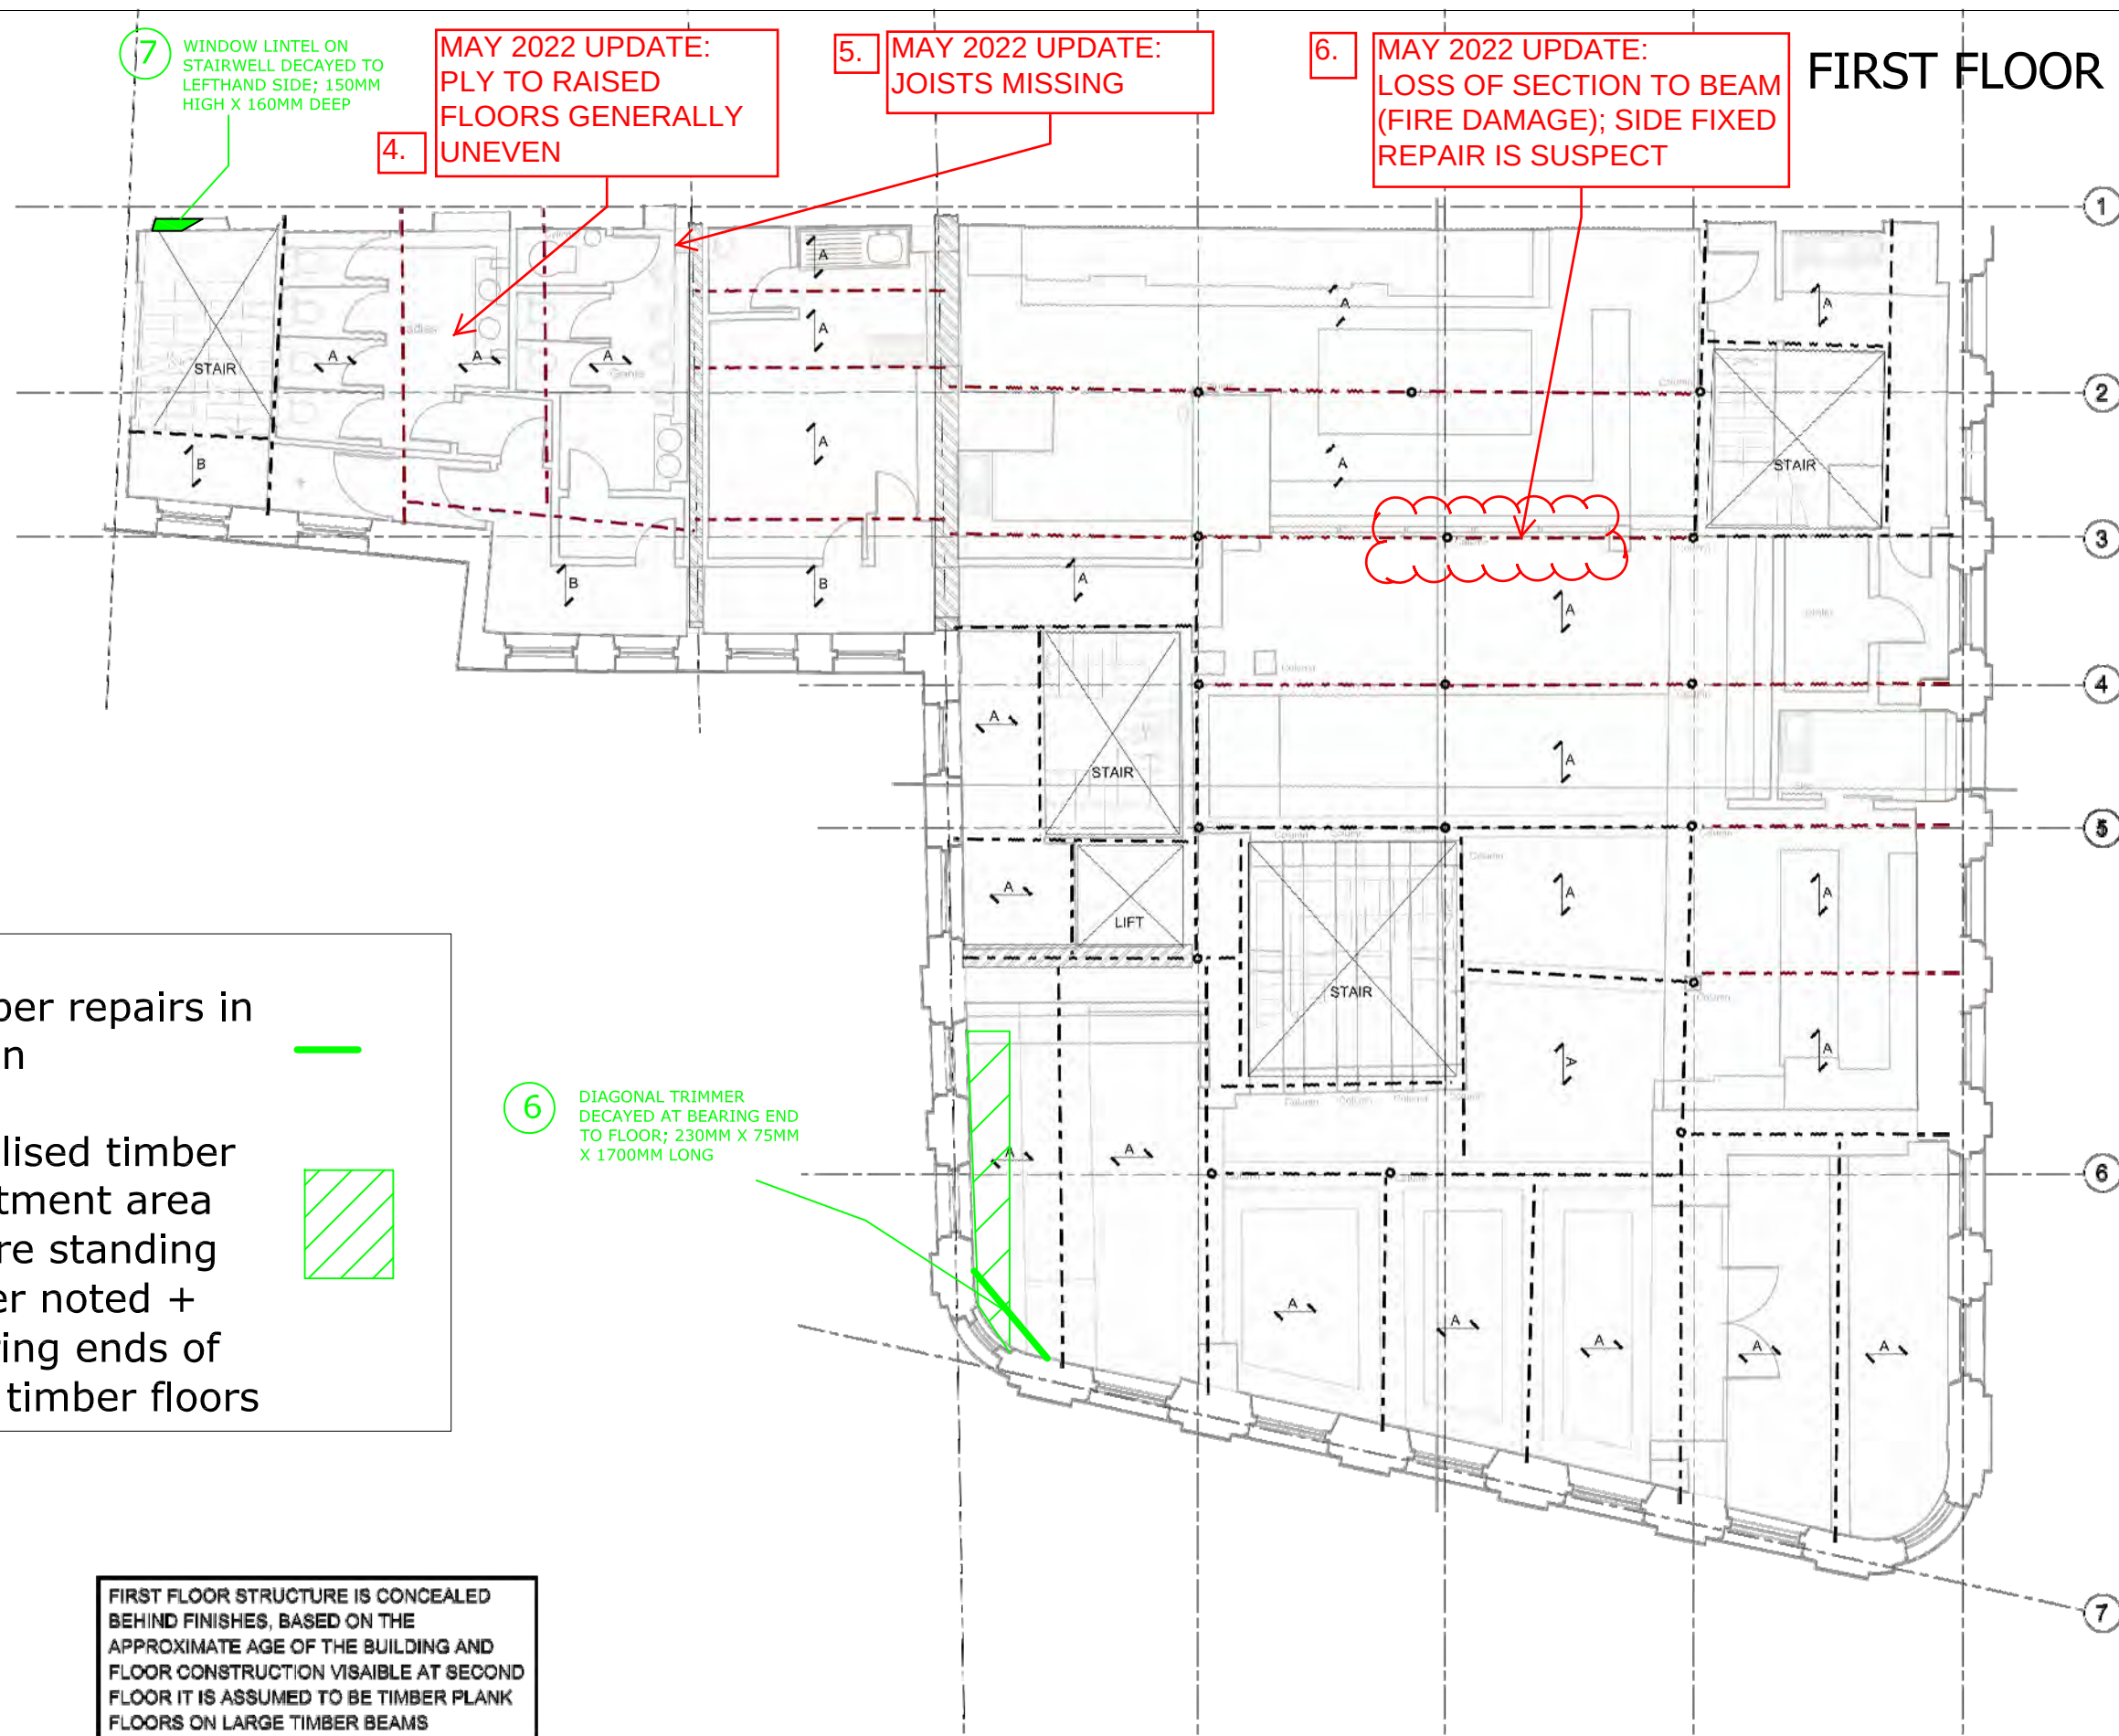
FIRST FLOOR STRUCTURE IS CONCEALED BEHIND FINISHES. BASED ON THE APPROXIMATE AGE OF THE BUILDING AND FLOOR CONSTRUCTION VISIBLE AT SECOND FLOOR IT IS ASSUMED TO BE TIMBER PLANK FLOORS ON LARGE TIMBER BEAMS

Localised timber treatment area where standing water noted + bearing ends of new timber floors

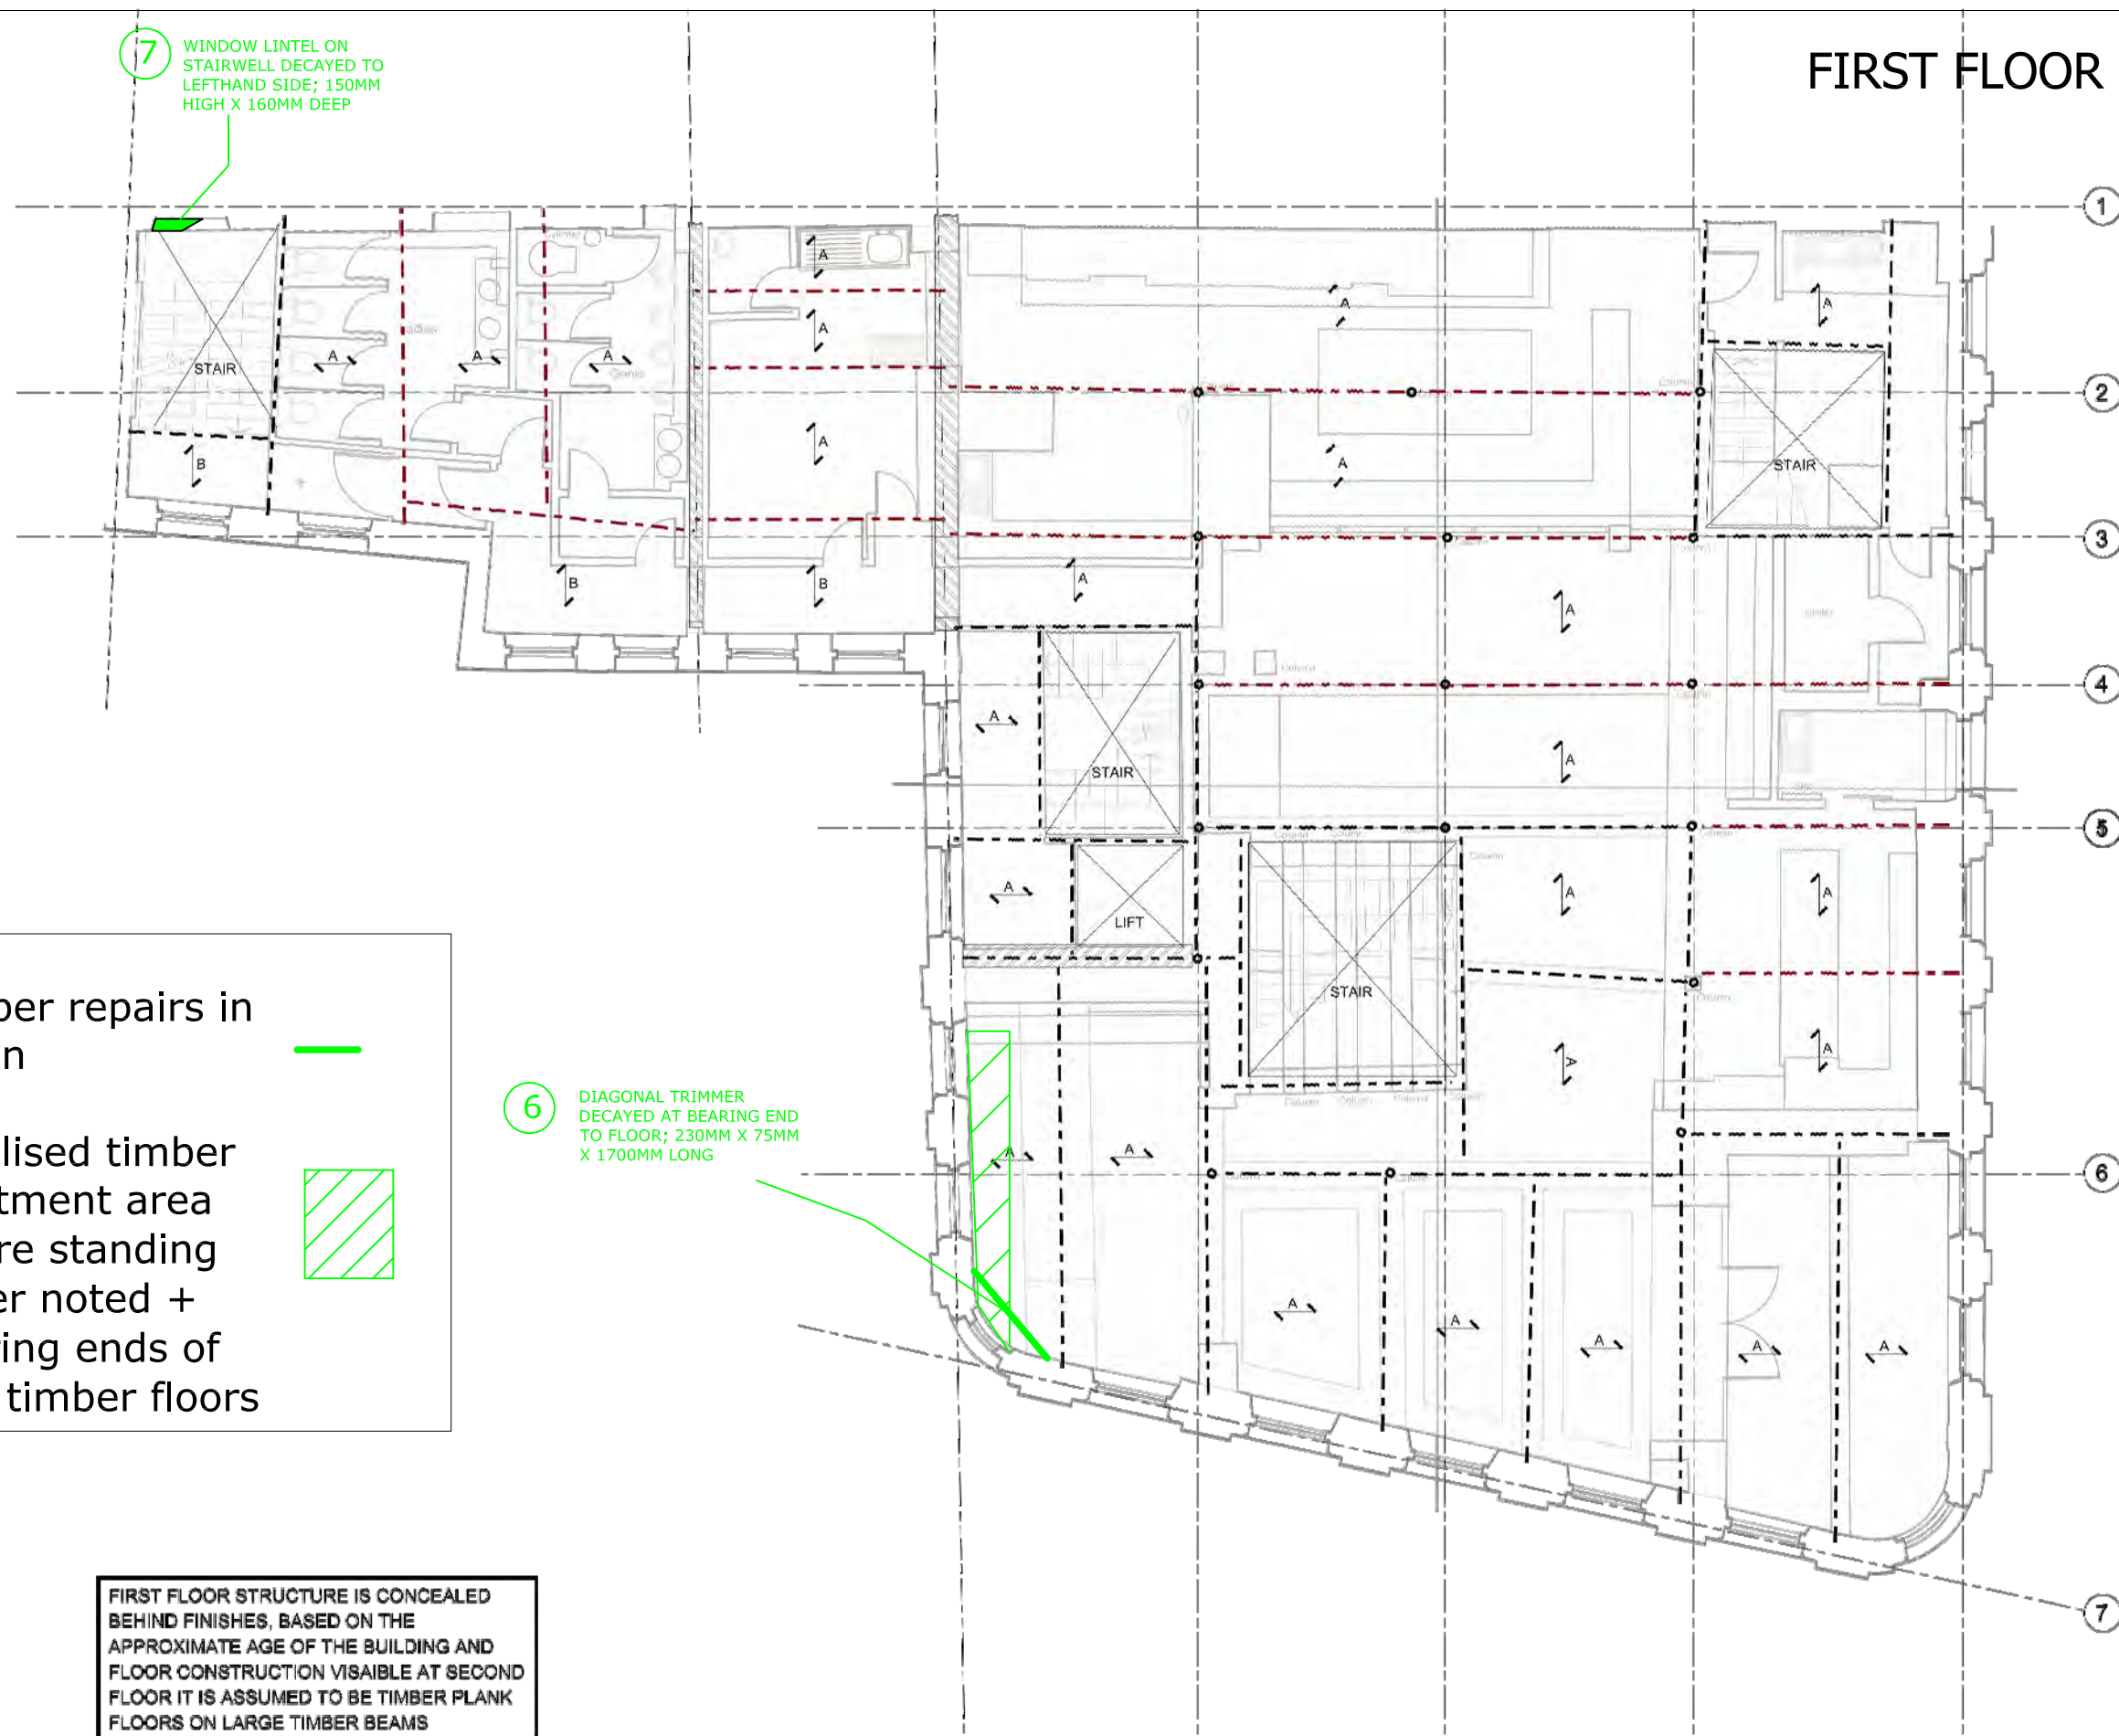
FIRST FLOOR STRUCTURE IS CONCEALED BEHIND FINISHES. BASED ON THE APPROXIMATE AGE OF THE BUILDING AND FLOOR CONSTRUCTION VISIBLE AT SECOND FLOOR IT IS ASSUMED TO BE TIMBER PLANK FLOORS ON LARGE TIMBER BEAMS

Localised timber treatment area where standing water noted + bearing ends of new timber floors
