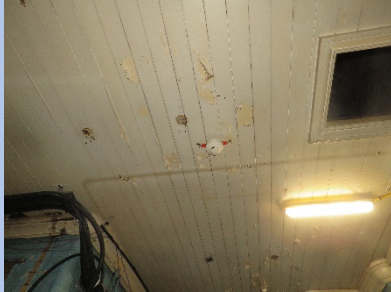
| Room Ref. | Element | Description / Item | Condition | Action | Photographs | | |
|---|---|---|---|---|---|---|---|
| | Ceiling | Timber boards, painted and not painted. | Fair | <ul style="list-style-type: none"> <li>Remove flaking paint.</li> <li>Existing Timber boarding and steel encasement repaired and painted with intumescent paint NBS:Z12/213. All holes to be infilled and redundant services removed. Infill all holes following removals.</li> </ul> | | | |
