**HBL ASSOCIATES LTD**  
**VISUAL STRUCTURAL INSPECTION REPORT**

**BRIDGEWATER HOUSE**  
**CHESTER ROAD**  
**MANCHESTER**  
**M15 4AX**

**WATCH THIS SPACE (Jembrana) Ltd.**

**HBL Ref: 9757**

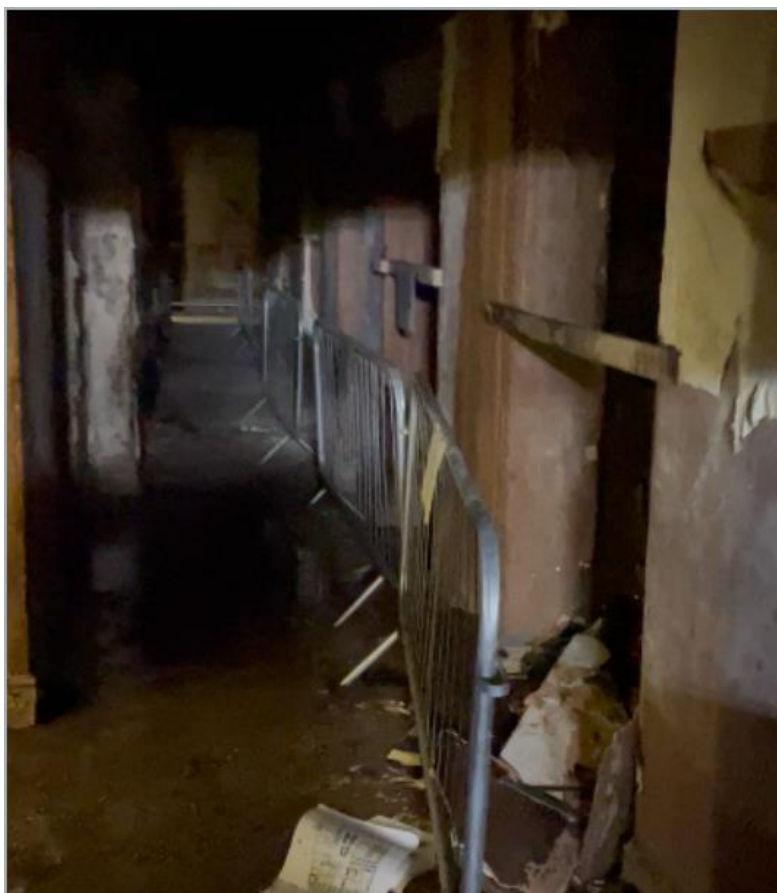
Photo 2A

- 4.71. Access into all rooms was prohibited due to the collapse of the ceilings. Limited observations were made from the main corridor doorways. No observations could be made in Rooms 0.11, 0.12 & 0.13.
- 4.72. There was standing water on the floor for the length of the main corridor. See Photo 2A.
- 4.73. The floor joists over Room 0.17 had collapsed. See Photo 2B.
- 4.74. The steel filler joists supporting the barrel-vaulted masonry first-floor appeared to be in an advanced state of corrosion over Room 0.16. See Photo 2C
- 4.75. The ceiling had collapsed throughout Room 0.09. See Photo 2D.
- 4.76. The steel filler joists supporting the barrel-vaulted masonry first-floor appeared to be in an advanced state of corrosion over Room 0.15. See Photo 2E

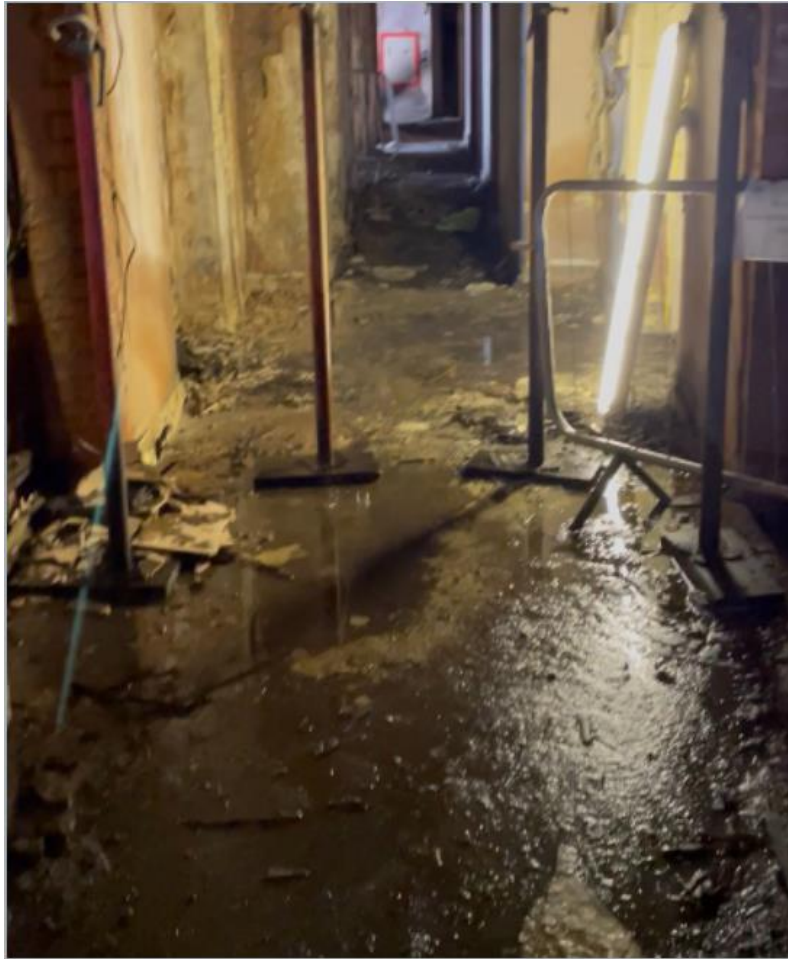
Photo 2H

4.86. There was free standing water for the length of the main corridor and water was pouring through the roof sheeting. See Photo 2H.

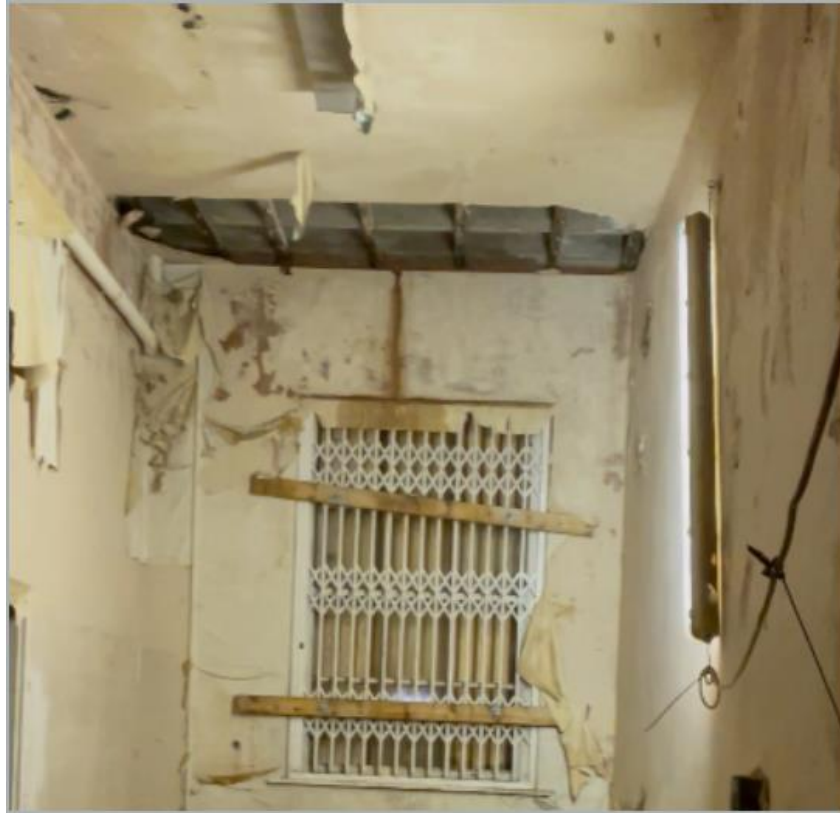
Photo 3A

4.89. An area of ceiling boards had collapsed in Room 0.07. See Photo 3A.

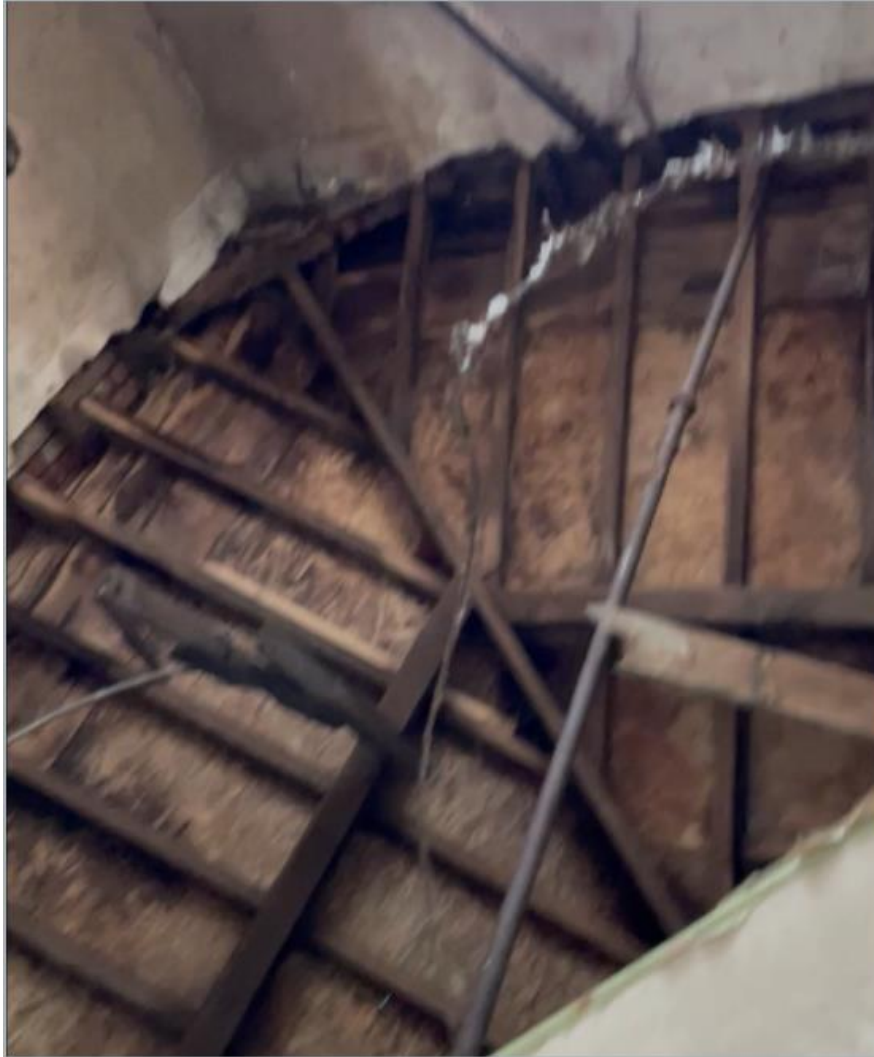
Photo 4A

4.100. The whole of the ceiling had collapsed in Room 0.24. See Photo 4A.

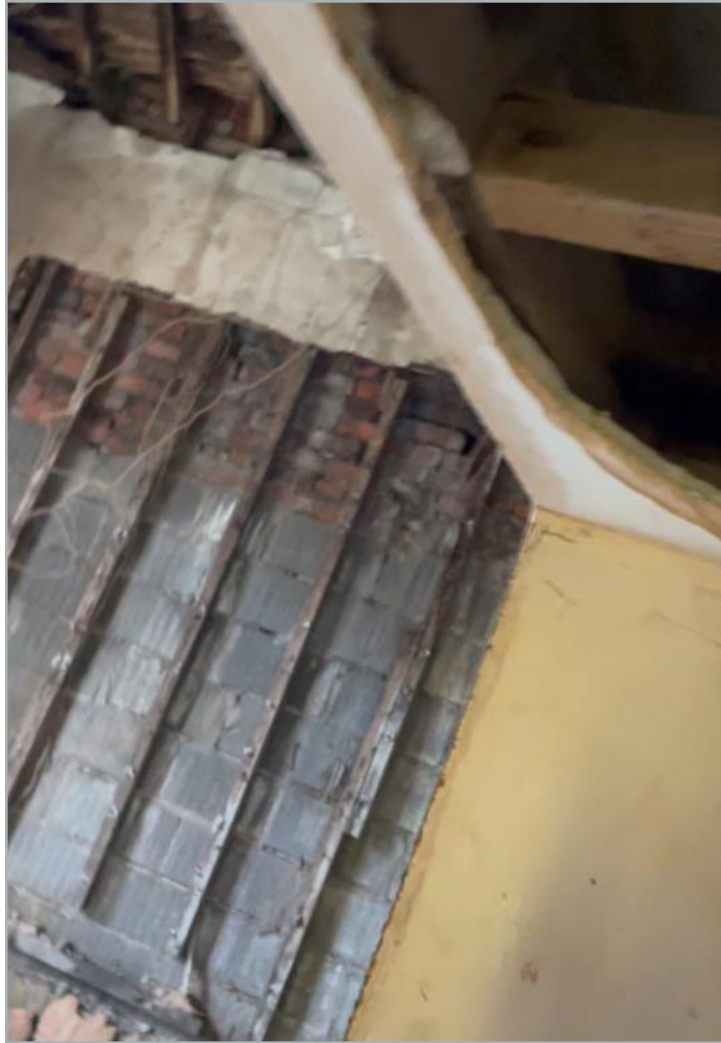
Photo 4B

4.101. A large section of plasterboards had collapsed from the timber (liner) wall in Room 0.24. See Photo 4B.
