## THE OLD STATIONMASTER'S HOUSE LIVERPOOL ROAD RAILWAYS STATION, MANCHESTER

### GRADE I CONDITION INSPECTION REPORT

For the Landmark Trust  
Date of primary Inspection 21<sup>st</sup> Oct 2021  
Weather: Dry and warm. Heavy rain the previous day  
Inspection status: First by this Architect

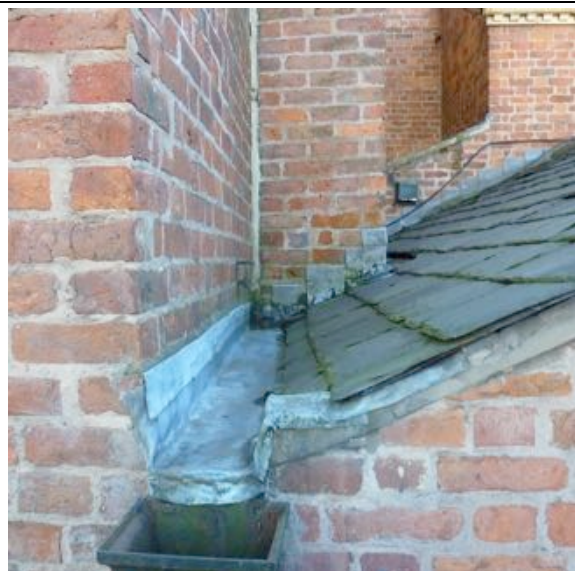
General view of the end of the flat lead gutter at the east side. The end drip into the hopper is too short and has been quite mangled, probably by attempted theft. The chimney stack projecting forward means the gutter has to drain around it.

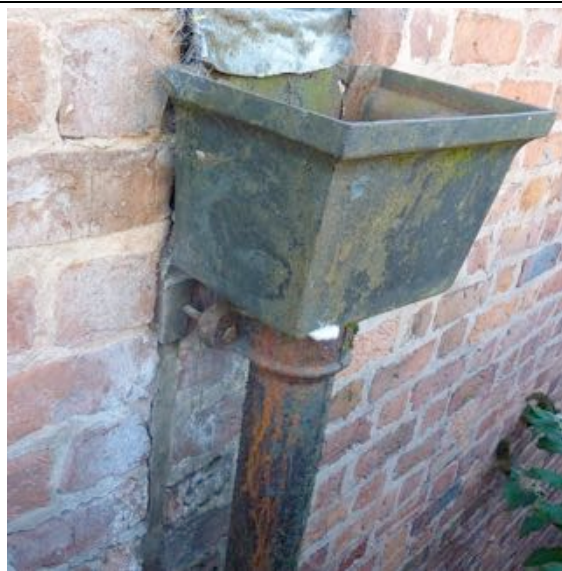
Fixings to the hopper under the outlet coming away, paintwork in poor order.

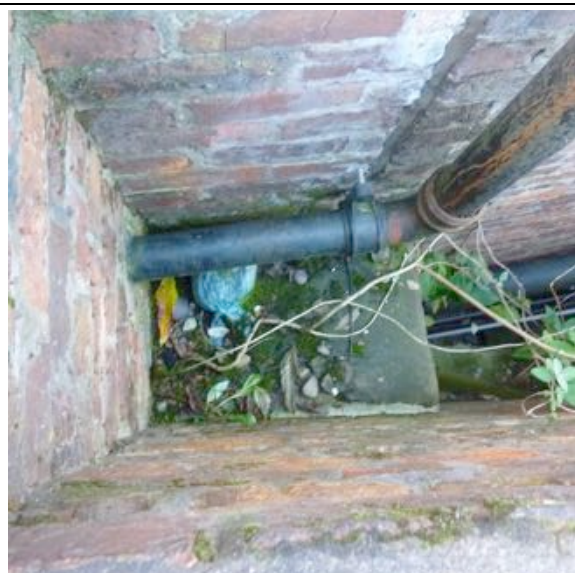
Pipe under the hopper goes through the wall onto the platform where it looks like it connects onto a section of asbestos pipe?

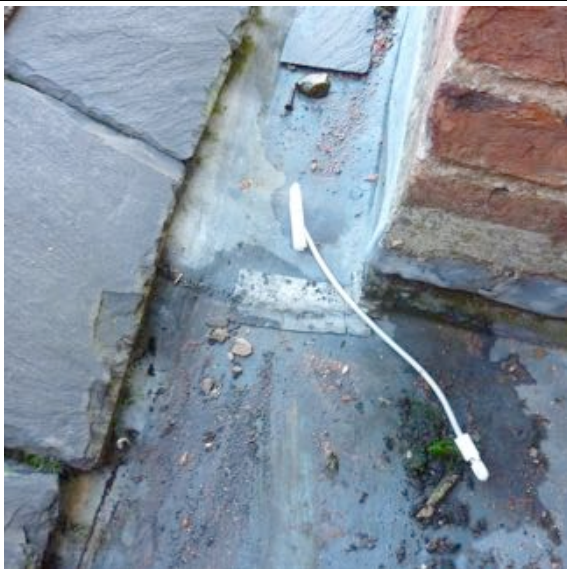
Where the gutter narrows past the stack, it was originally a simple butt joint and weld. This has broken down in the past and been patched with a strip of flashband. There are stained ceilings internally that must predate this patching. This patch looks quite damaged now.

| <p>Lead flat valley to the east pitch has an awkward 'pinch point' to the south of the chimney stack. There should be a step here but instead there is just a welded butt joint that looks to have failed. It is patched with flashband.</p> | <p>The joint adjacent is welded to a large single sheet of lead that has started to develop work-hardened ridges due to expansion and contraction. These will develop into splits.</p> |

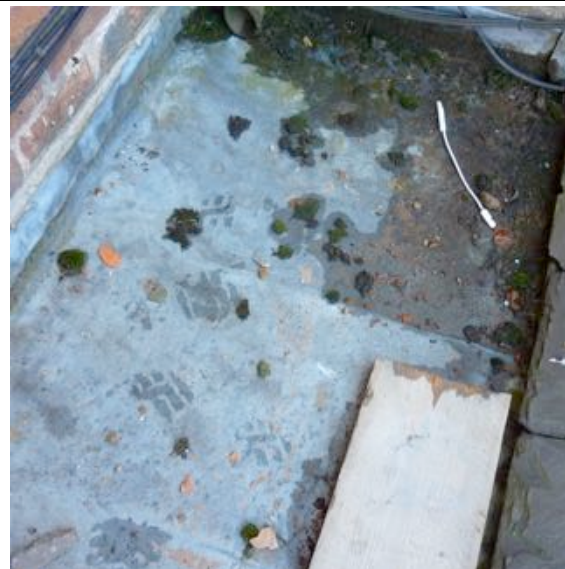
The back gutter area beyond the stack of the outshot roof has a relatively wide section of gutter, which is formed of a single piece of lead. This has to narrow down to only around 8 inches wide as it passes the stack. The large sheet of lead has prominent ridges in two locations, suggesting that it has been suffering from expansion and contraction, and cracking will develop along the line of those ridges in the future. There is some very old-looking lead flashing at the abutment with the station wall. This has various splits and punctures due to its age.

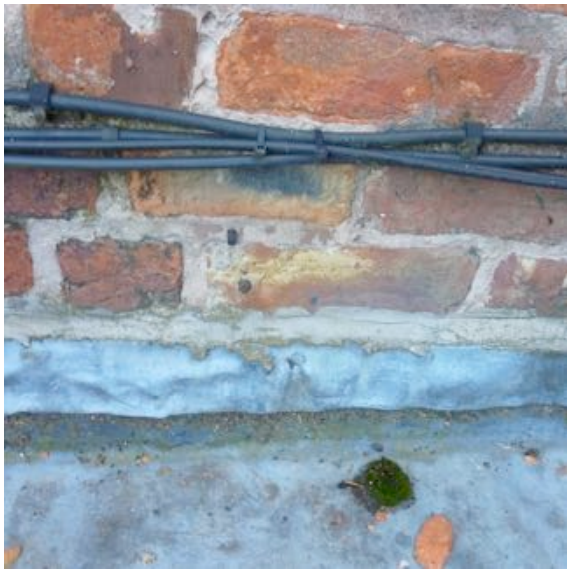
| <p>Minimal sized flashing to the lead flat. This is split in several locations.</p> | |

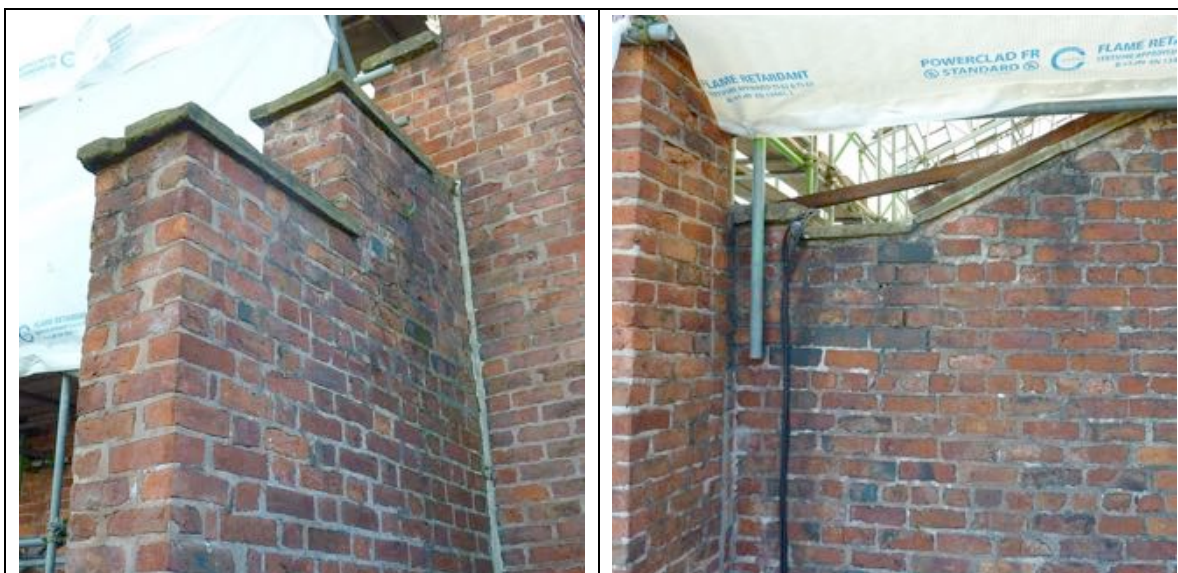
At the part wall of the house and the station itself there are some tall areas of wall that will be difficult to maintain. The responsibility for future maintenance should be established.

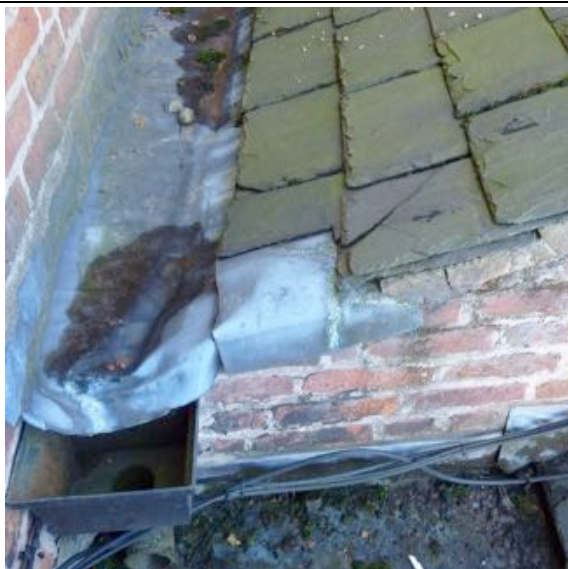
The lead back gutter is in fair order, not too wide a sheet but quite butchered at the end. It has possibly been damaged by lead theft. Good overhang on the remains of the drip to the hopper.

| <p>General view of the roof over the toilet. Vent stack for the entire building comes through the roof.</p> | <p>Detail view of the end of the flat gutter. It may have been subject to attempted theft resulting in broken slates and cracked mortar.</p> |

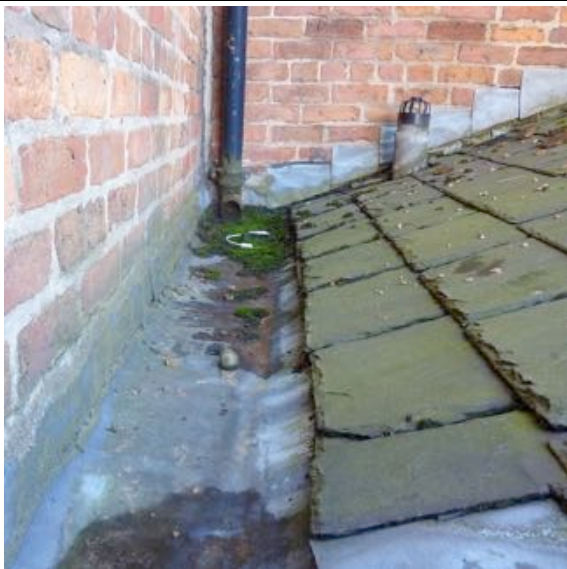
| <p>The flat gutter has a definite tilt back towards the roof resulting in moss building up at the edge of the slates. The lead flat probably sits on top of the masonry of the old external wall with the station wall butted up alongside to the East.</p> | <p>Pipe coming down from the upper roof into the gutter.</p> |

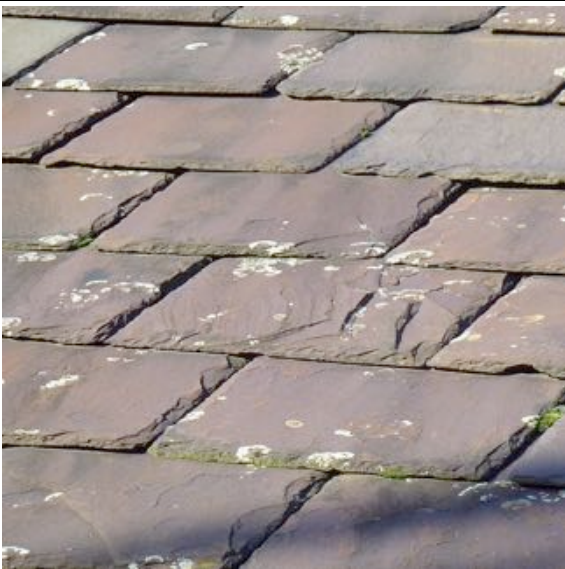
A couple of individual slates look like they might be suffering from age delamination as there are suffering light surface shaling. The roof has been re-slatted in recent decades so these may be poor quality second hand replacements.

| <p>General view of the west part of the roof</p> | <p>Very thick slates used on the west part of the roof. Some possible surface delamination noted.</p> |

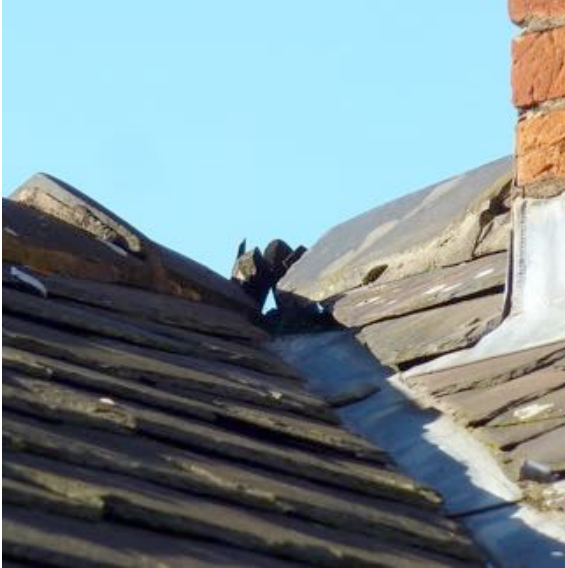
We can see the back of the timber rolls at the apex of the west facing fan roof. This will be covered morte in the following entries but it can be clearly seen that the lead capping is missing.

| <p>Lead valley seems in fair order</p> | <p>The apex of the valley is missing the capping piece and the exposed timber rolls look very weather beaten. There is no significant leak internally at this point though.</p> |

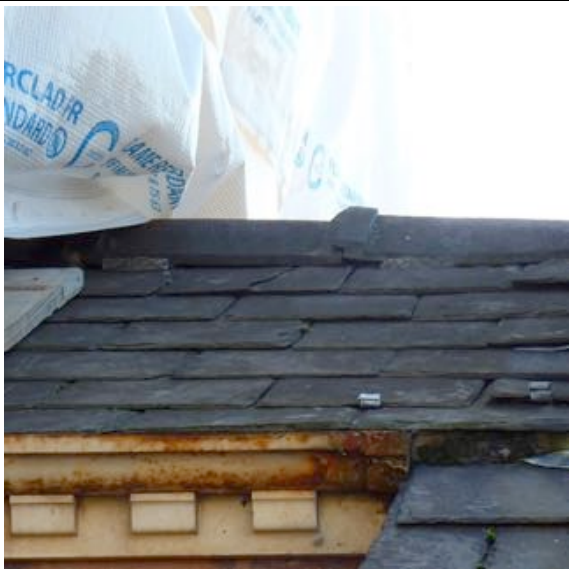
Ridges seem fair, though missing a fair amount of their bedding mortar, particularly at the east end of the north facing pitch where the scaffold has come over from the station house repairs.

| <p>Tile ridge at the east end (by scaffold) missing mortar</p> | <p>General view of the rooflight. The ridge line can be seen to crown behind the chimney and this would seem to be on the line of the internal spine wall.</p> |

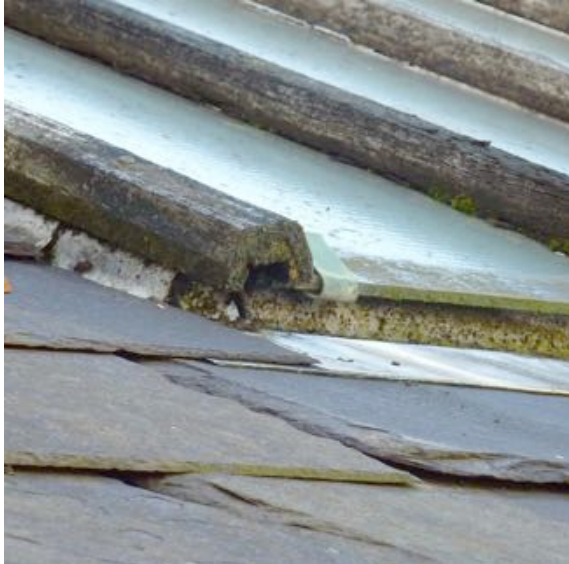
- The timber roof light over the stairs is currently functional but the components are looking extremely weather-beaten and may be on the edge of failure. One sheet of glass is cracked.

| <p>Detail of the condition of the rooflight timbers</p> | <p>Detail of the condition of the rooflight timber and lead</p> |

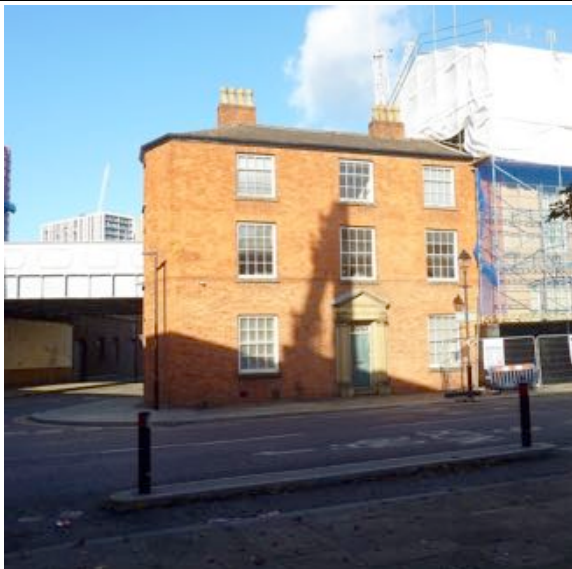
| <p>General view of the roof (and the building) from the south. The gutter has to drain by going all the way around the corner to the north west corner where there is a 75mm pipe connected by an offset. This must be at regular risk of blockage.</p> | <p>Evidence of long term leaks or over-topping of the gutter at the west end of the gutter.</p> |

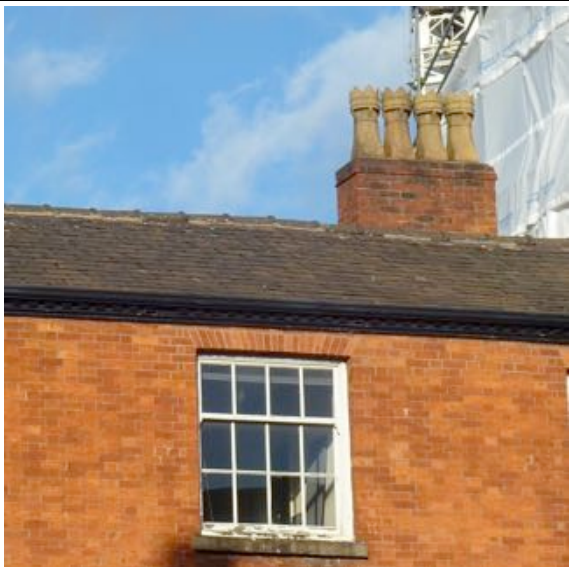
| <p>Crowning of the ridge line over the internal cross wall</p> | <p>Mortar loss to the ridge tiles. The chimney stacks seem in reasonable condition. Some face loss of bricks on the north side.</p> |

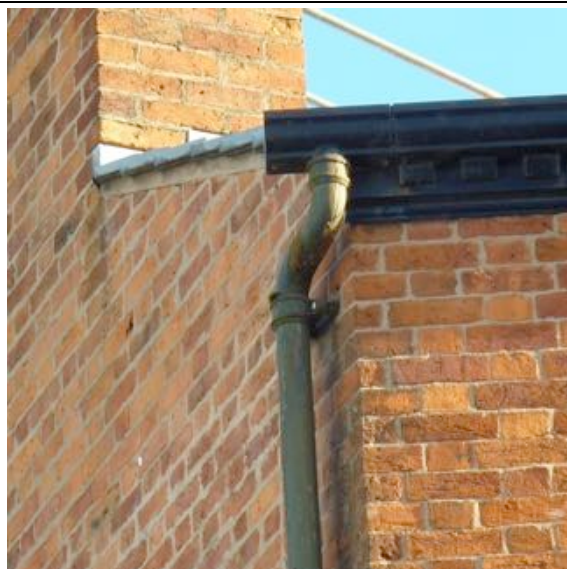
View of the downpipe which has to take all of the water from the south and west roof pitches. The rust would suggest this is often blocked and overflowing.

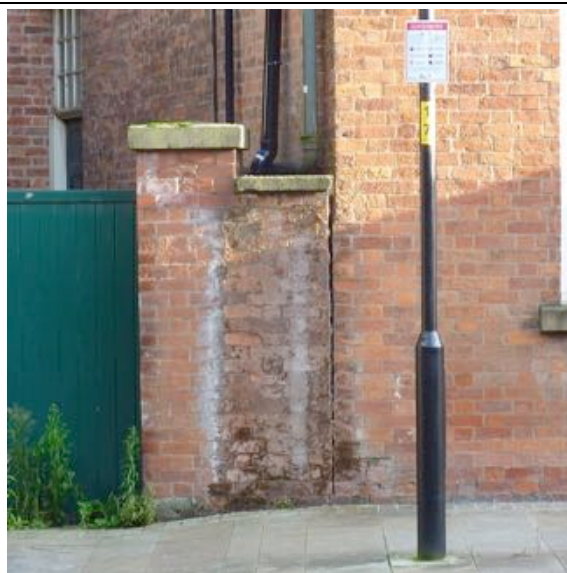
The damp staining to the boundary wall at low level may be where the over-topping rainwater pipe drops its water.

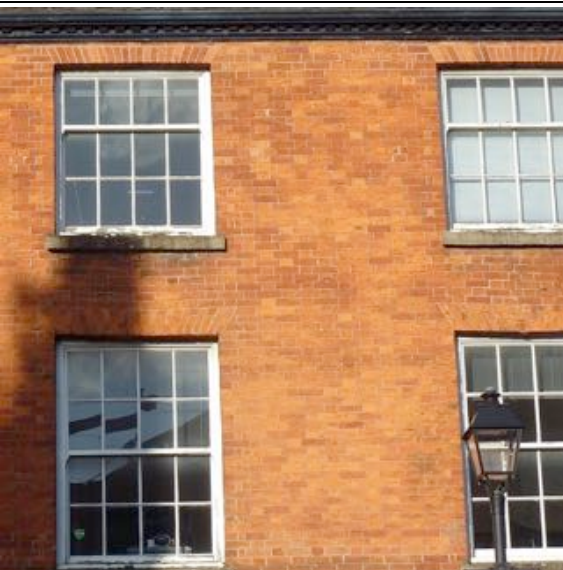
| <p>General view of the south elevation from the east. The section of wall below the first floor window cills</p> | <p>Slumping of the panel of brickwork under the two second floor windows at the centre and east/</p> |

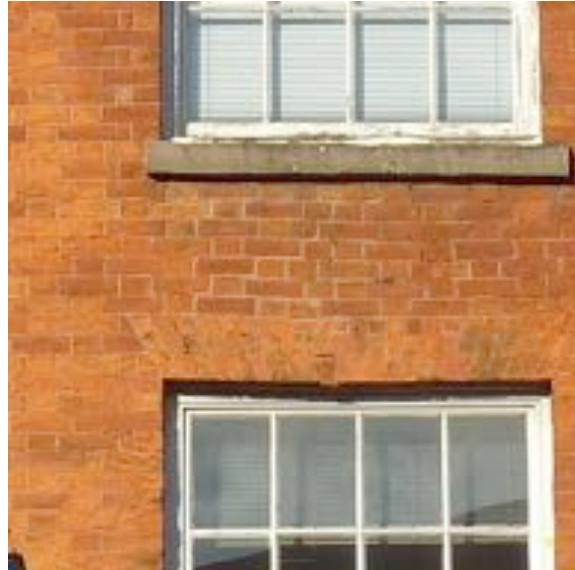
Detail of slumping panel of brickwork. This currently looks stable but there is one voussoir that has slipped

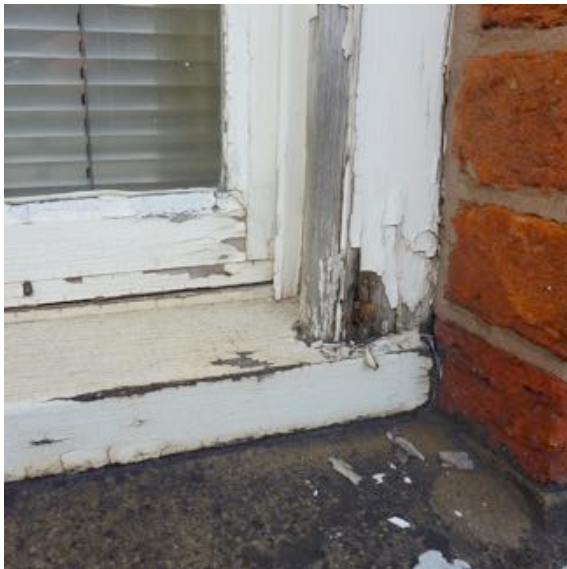
Typical condition of the ground floor windows. The rot damage is mainly limited to the softwood fascia board of the sash boxes. The cills are oak.

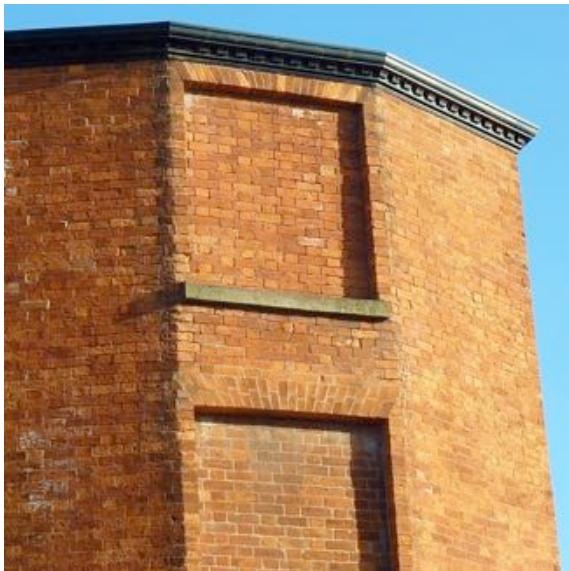
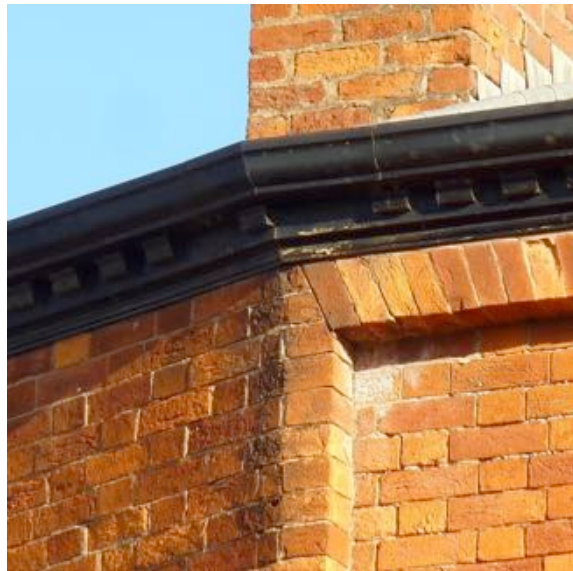
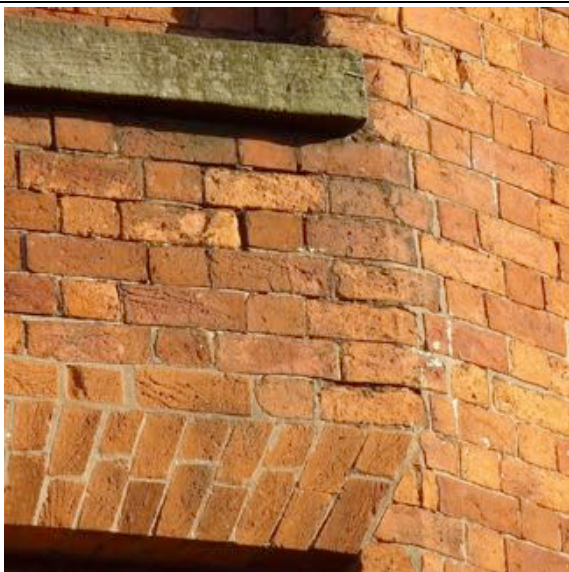
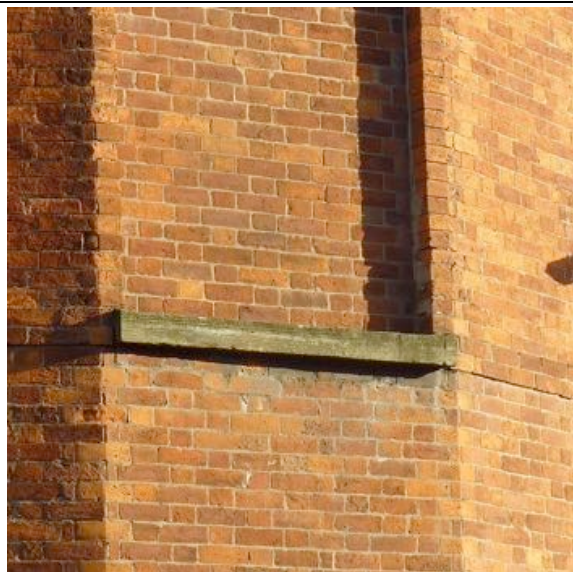
Detailed view of the brickwork to the facet areas. Widespread washing out of the mortar to the upper areas.

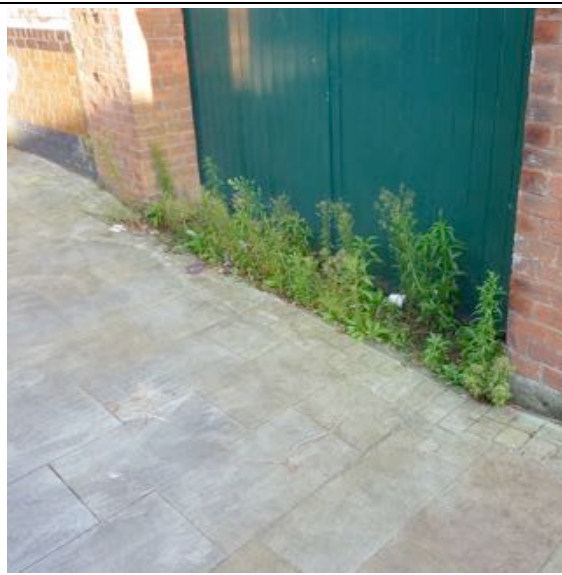
The re-laid street paving is around 50mm up from the level of the historic back yard which is unhelpful especially as the plan was for this to be the way in for wheelchairs. The slot is trapping soil and debris.

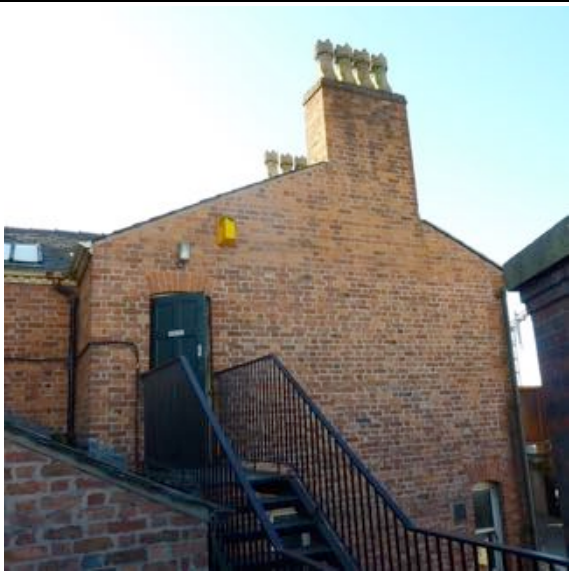
| General view of the upper part of the main building gable . It may be that part of this has been rebuilt | Evidence of the side elevation being built later than the front elevation and 'block bonded' |

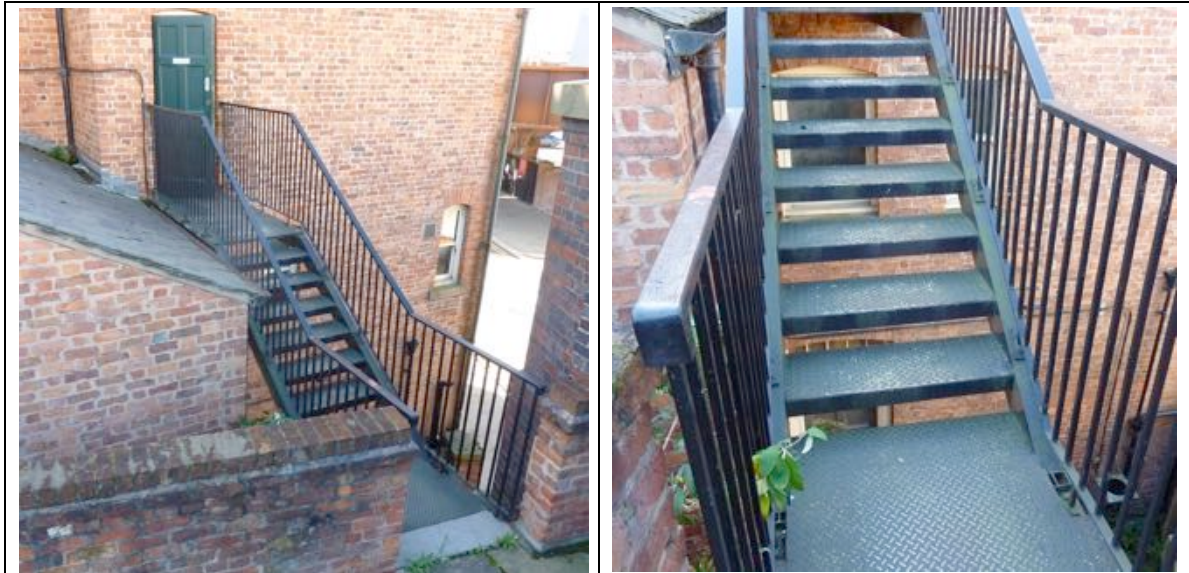
The steelwork gantry is quite heavily corroded but still looks like there is plenty of redundancy in the structure. All capable of refurbishment. No signs of brick cracking at the beam seatings, but this cannot be ruled out in the future

General vies of the steel platform access bridge. This needs a general repaint.

| Cond'n | Action | Item | Cost |
|---|---|---|---|
| <b>M</b> | <b>8</b> | Monitor the wall connection of the steel bridge in case cracking develops in the bricks. | <b>(Z)</b> |

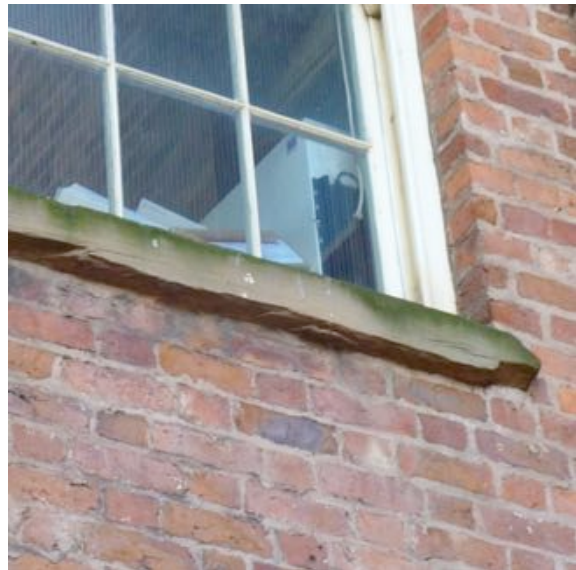
Window cill at the upper level of the north extension is showing signs of de-lamination

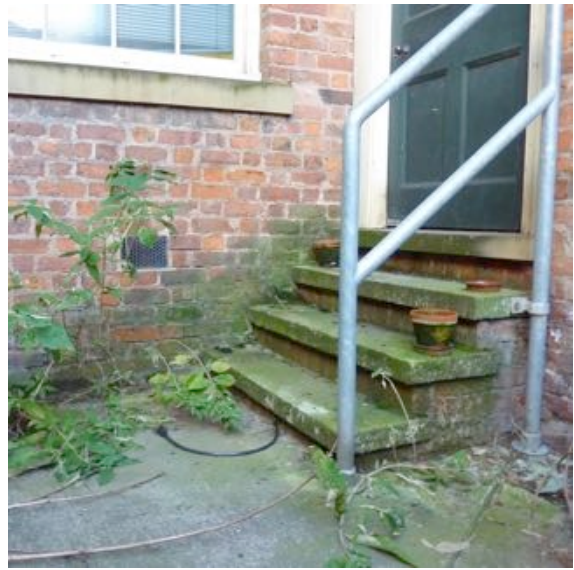
The steps up to the back door are very steep

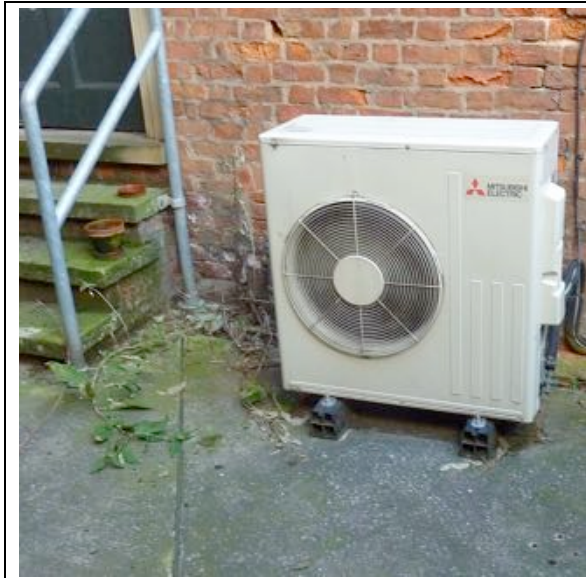
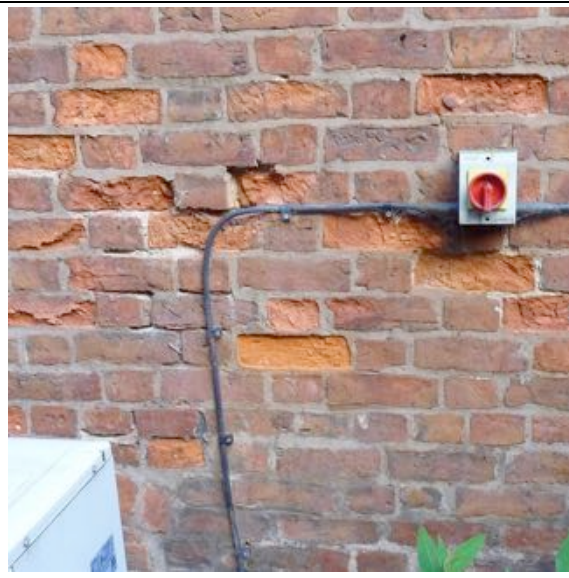
Localised face loss to the brickwork behind the air con unit. Face loss is not really a problem elsewhere so could this be related?

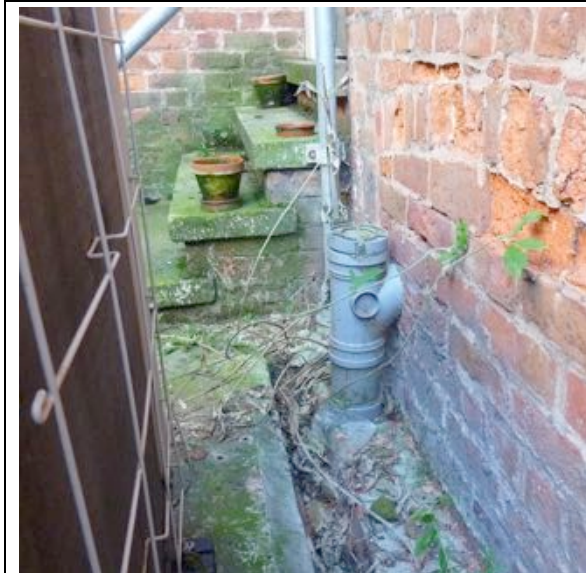
The main WC drain coming out of the wall by the steps.

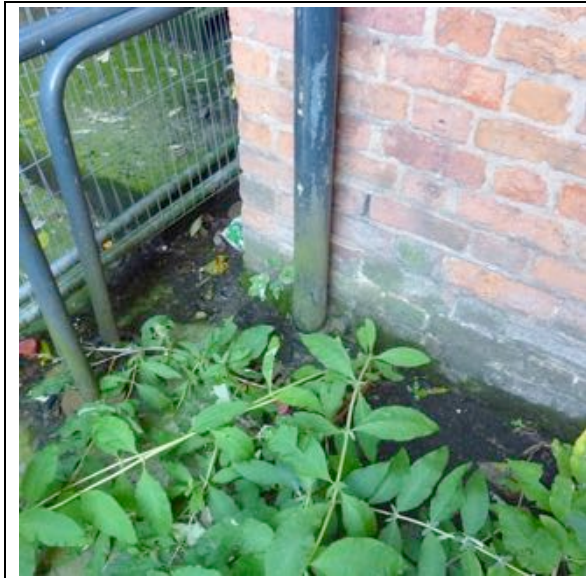
Drain gulley to the rainwater pipe serving the extension roof is blocked with debris and plant growth.

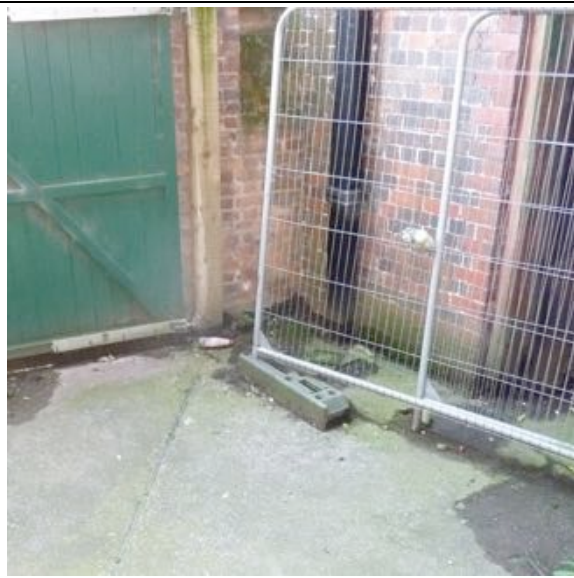
At the NW corner of the yard is a large pipe carrying rainwater from the upper level of the bridge. There is no actual drain gulley at this point and water must flood the yard and seep down past the drain cover.

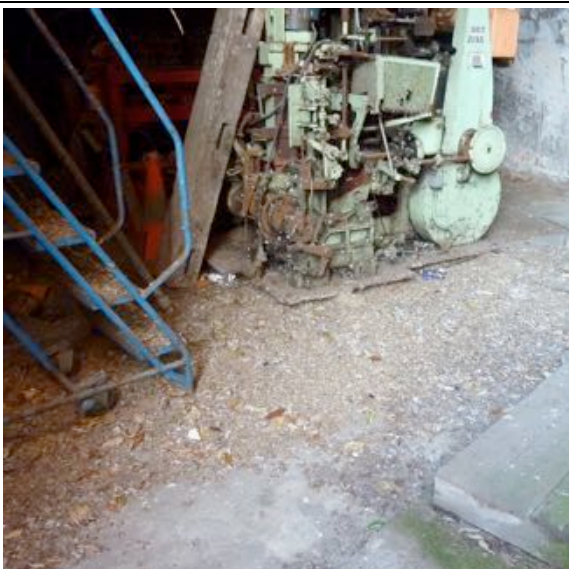
The arch is very heavily occupied by pigeons who have created a real mess. If the space was to be used as car parking or access this may be a significant problem as they will deposit mess all over the cars. There may also be some raptors using the space, because there are bird carcasses too and ripped up feathers.

| Large drain pipe that drains the upper platform area attached to the north wall of the extension | High levels of pigeon waste in the railway arch. |

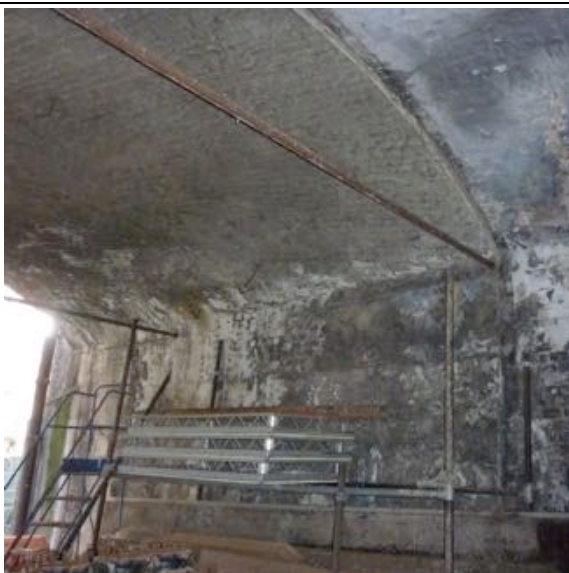
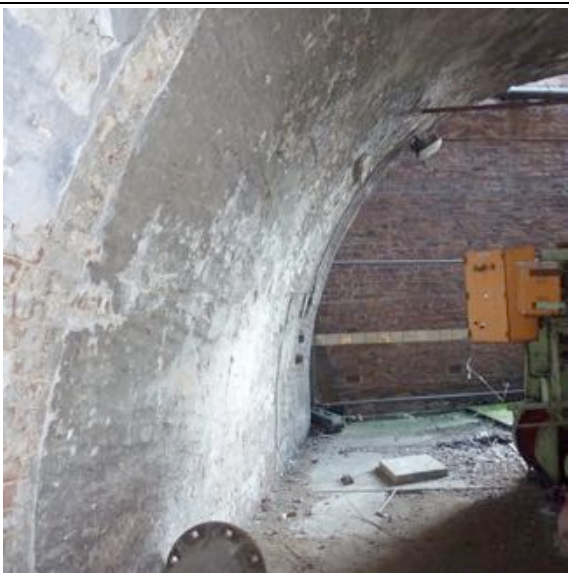
| General views of the railway arch interior. | |

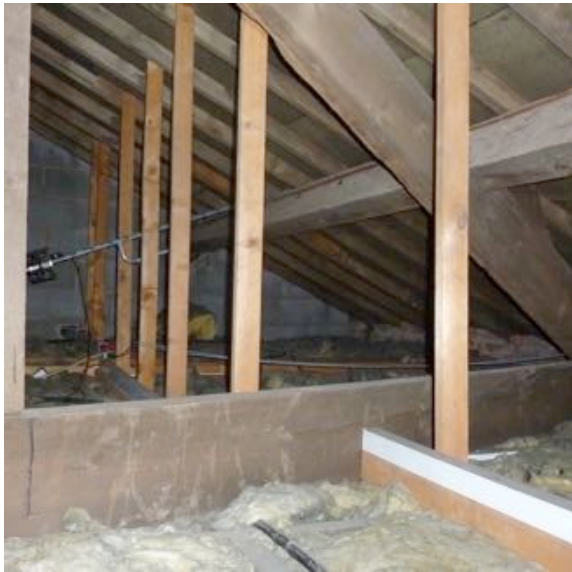
| <p>General view looking east towards the blockwork partition. New timber ceiling hangers on the C/L of the room</p> | <p>View of the apex on the truss and the hip rafters. Some old staining but it does look currently dry. There is daylight seen but the lap of the felt seems to keep water out.</p> |

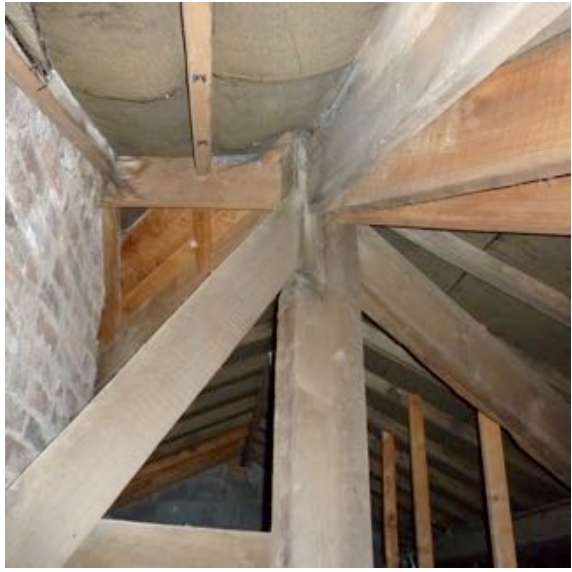
At the apex of the truss some daylight can be seen and this must correspond to where the lead capping is missing. The truss itself does not seem to be damp or excessively stained so it may be that the lap of the felt is sufficient to not let water penetrate.

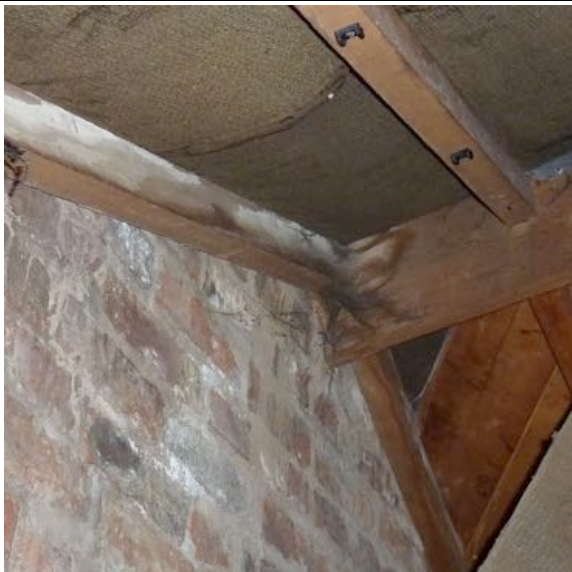
By contrast, the end of the ridge board adjacent to the stack looks stained as if there is water penetrating at the flashing to the base of the stack. There is a bucket set below it but it currently is dry. Water may penetrate when the wind blows in certain directions. The flashing needs to be checked and repaired if required.

| <p>Possible occasional leak at the back gutter of the chimney stack.</p> | |

| Cond'n | Action | Item | Cost |
|---|---|---|---|
| <b>F</b> | <b>1</b> | Check whether there is a defect in the flashing at the west of the stack and repair if necessary. | <b>(M)</b> |

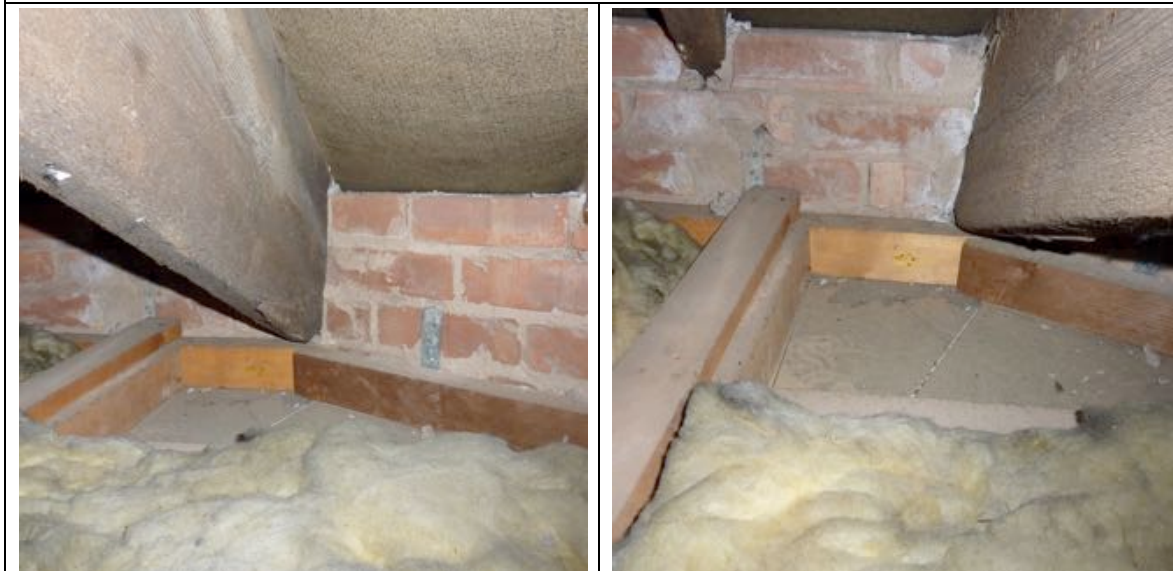
Further shots of the brickwork and plasterboard at the eaves of the faceted roof. This is all bone dry.

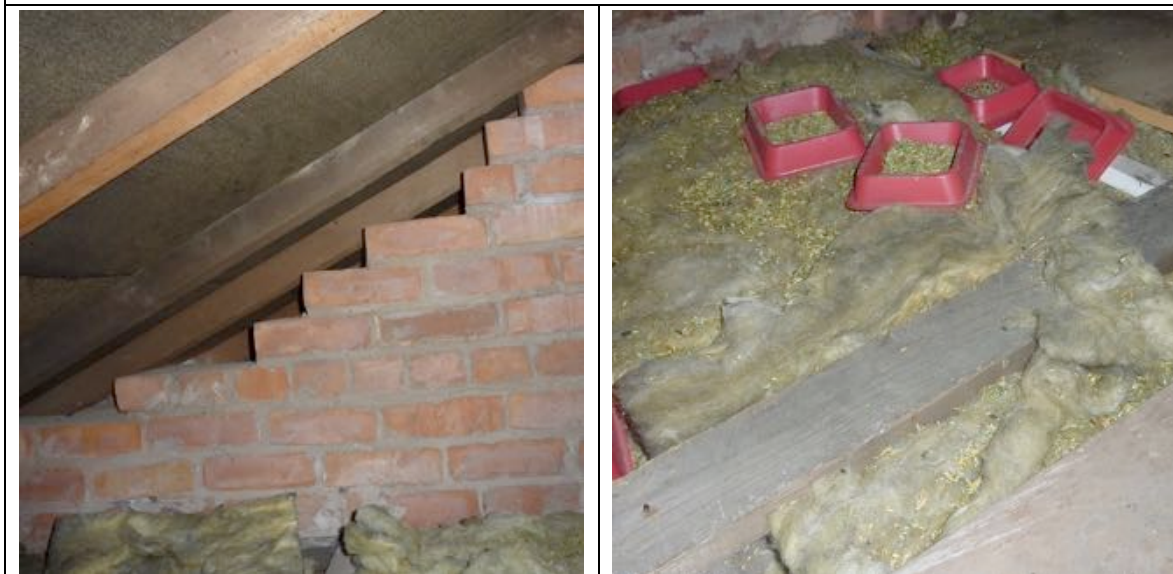
| The partition wall between this roofspace and the next one to the north has been built up in modern times but it does not go high enough to act as a fire barrier. This may as well be built right up. | Poison bait on top of the insulation but we saw no evidence of mouse or rat droppings. This may be an issue if evidence of bats was mistaken for an unprotected species. |

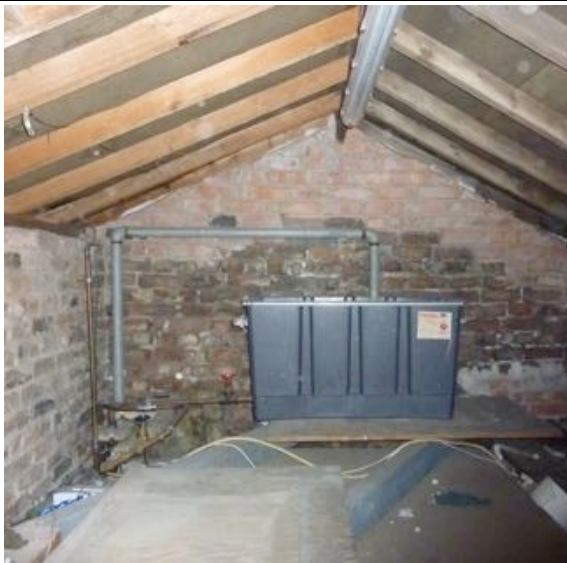
| <p>General view looking east. The water tank is currently empty. It may be an pressure overflow catcher</p> | <p>Steel beams set into brickwork. All looks relatively recent.</p> |

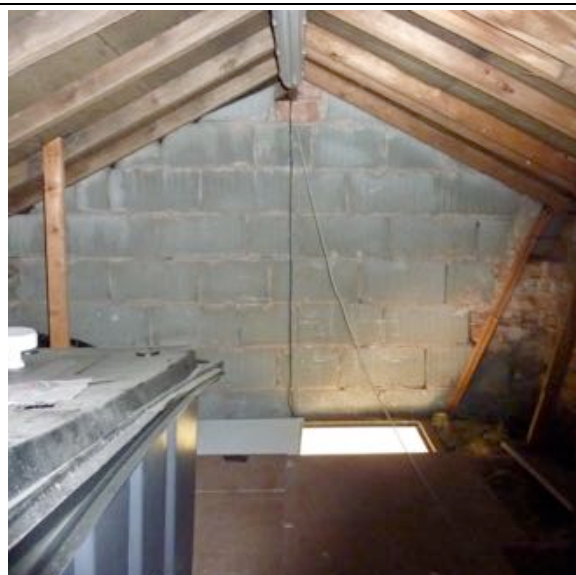
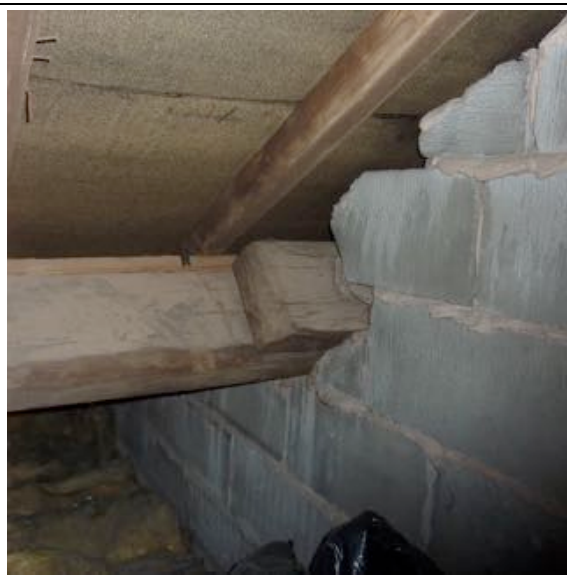
General view looking west to blockwork partitions. South purlins supported by blockwork wall, would this once have been a timber truss?

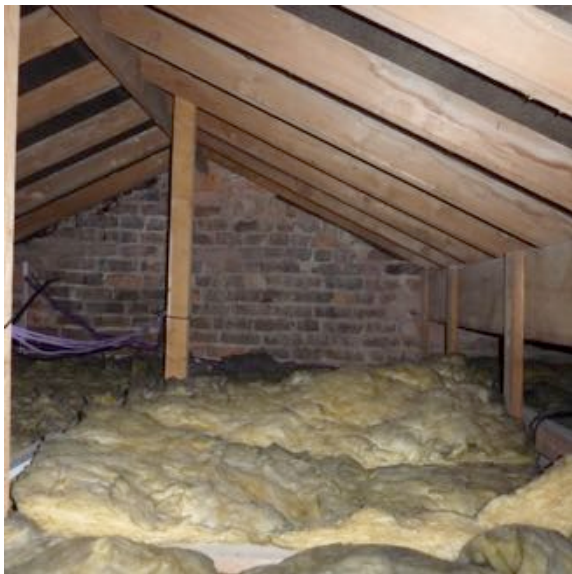
| <p>General view looking South. All of the timbers look to be fairly modern</p> | <p>View to the North East corner showing some ragging and breakdown of the roofing felt. This may have been damaged during an attempted theft of the lead to the flat gutter.</p> |

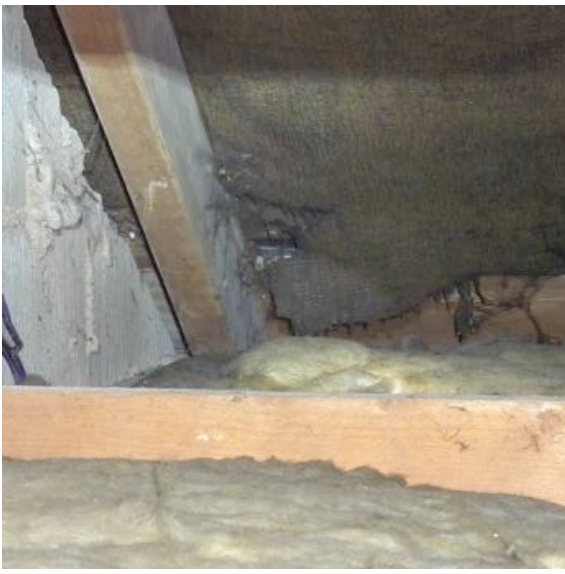
Looking to the north east corner we can see that there is a fair amount of ragging to the underslating felt at the north end. Possibly some stolen slates or damaged slates at corners let UV light in which has degraded the felt? No particular signs of any leaks internally.

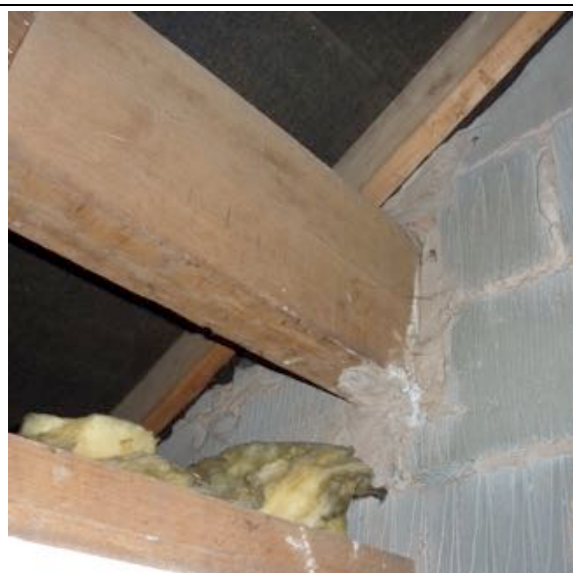
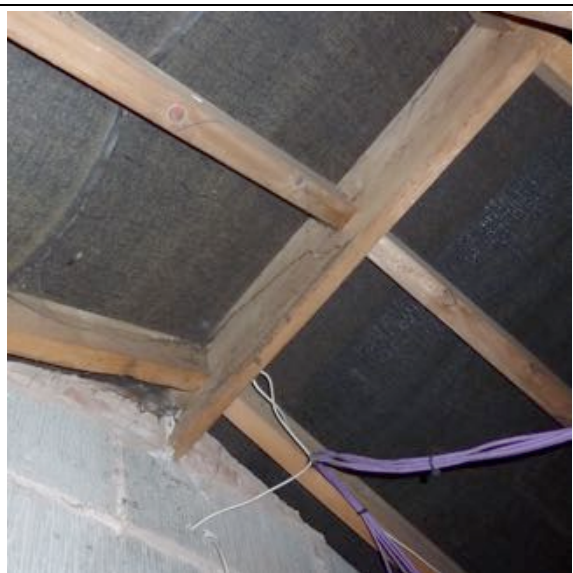
General views of the North wall. This all looks to be a fully new construction.

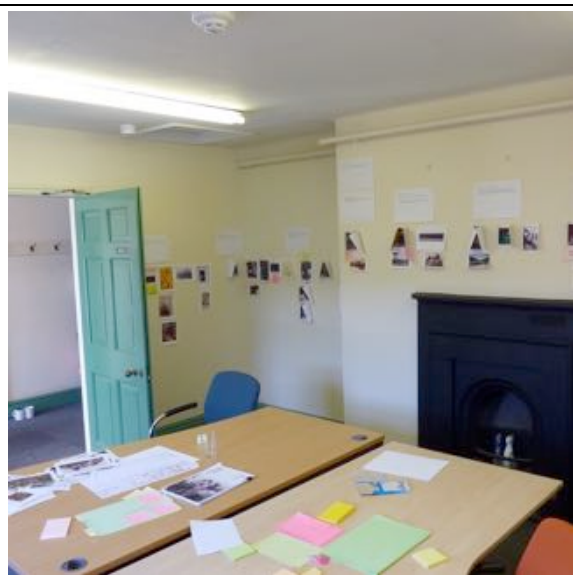
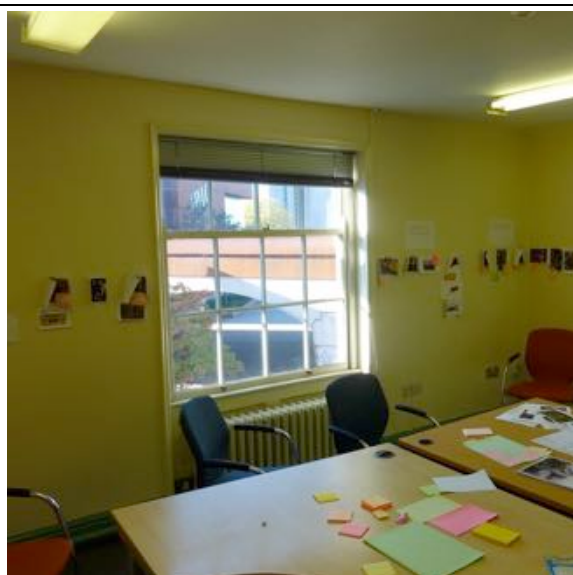
General views of the interior finishes. Generally the whole building is finished in this way (with a few exceptions)

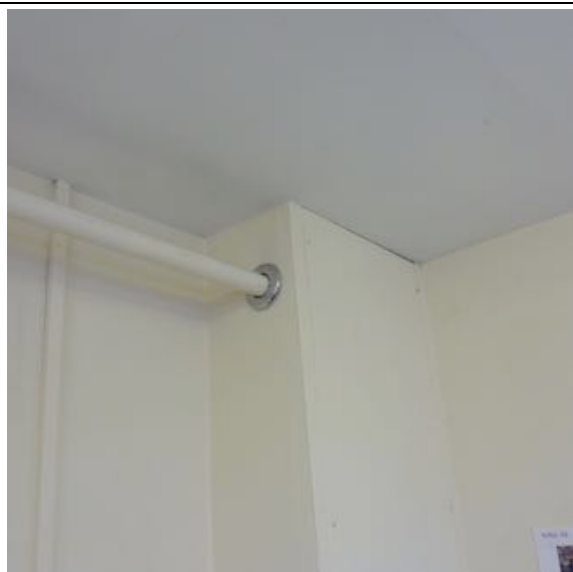
Pipe boxing in the room corner runs the height of the building from the basement. This will feed the tank in the room above.

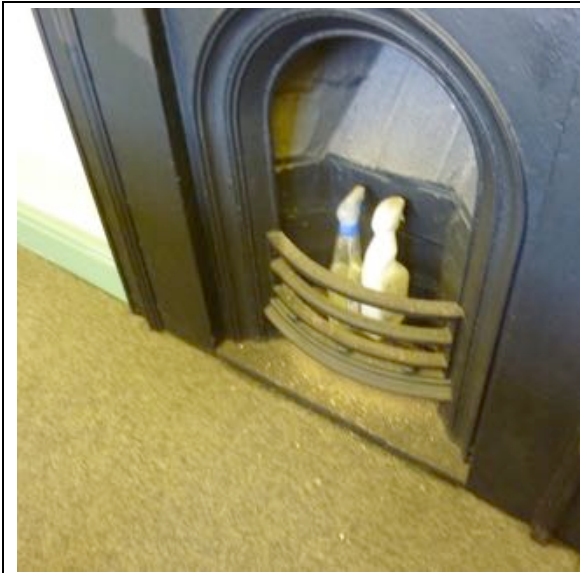
Dust in the fireplace shows this is an open flue.

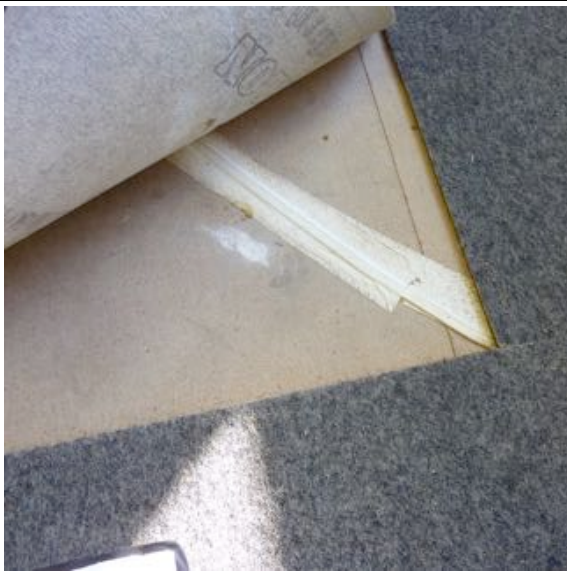
| <p>Chipboard flooring common to all areas.</p> | <p>In the lobby, crack to the lightweight partition wall and running over the ceiling.</p> |

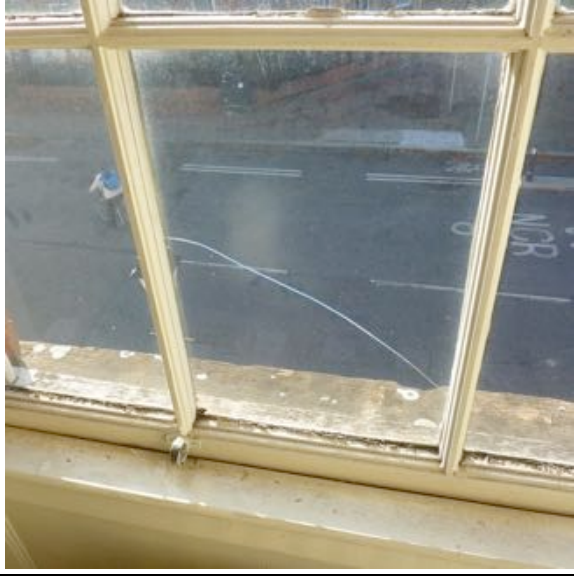
| <p>The partition to the staircase has a fire door and georgian wired glass but is the flat painted panel fire rated?</p> | <p>Cracked pane of glass to the lobby window.</p> |
