## THE OLD STATIONMASTER'S HOUSE LIVERPOOL ROAD RAILWAYS STATION, MANCHESTER

### GRADE I CONDITION INSPECTION REPORT

For the Landmark Trust  
Date of primary Inspection 21<sup>st</sup> Oct 2021  
Weather: Dry and warm. Heavy rain the previous day  
Inspection status: First by this Architect

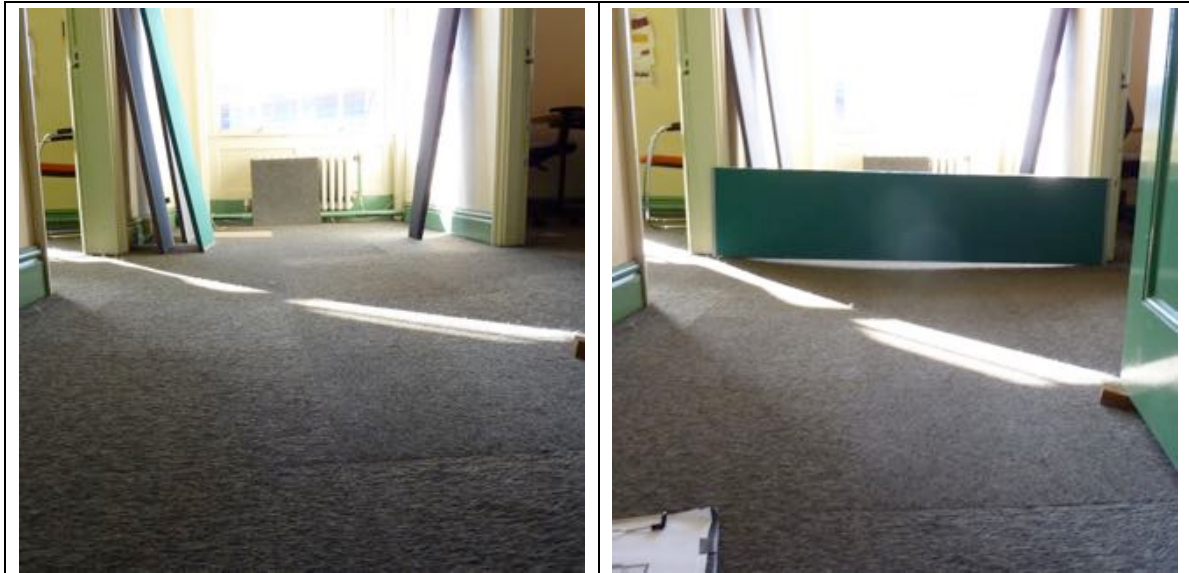
The floor of the lobby is distorted by 25mm over a short distance.

| Cond'n | Action | Item | Cost |
|---|---|---|---|
| <b>F</b> | <b>2</b> | Investigate the cause of distortion in the lobby floor and devise a method of strengthening and correct the slump. | <b>(M)</b> |

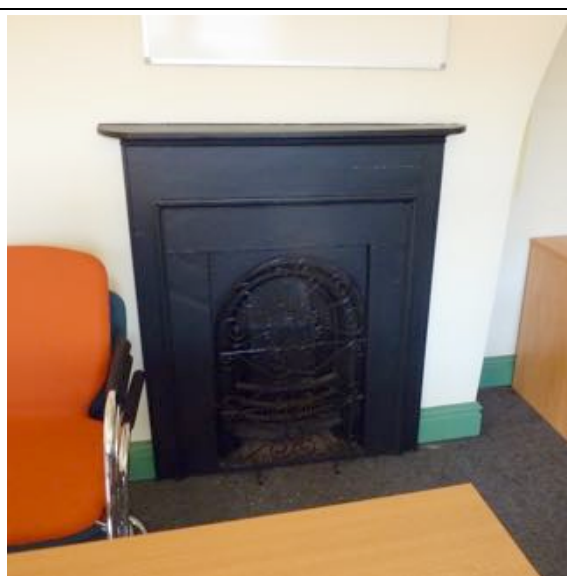
Fireplace has dust in the grate so must still be an open flue.

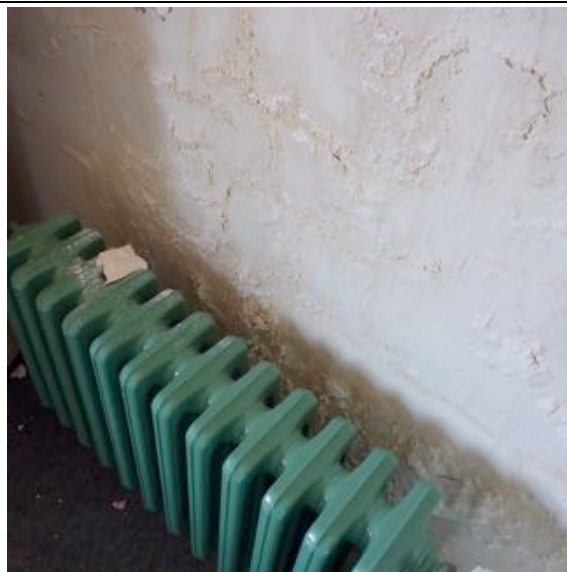
Salting particularly bad above the radiator as this will be force dried. This will also coincide with the height of the window cill to the blanked window on the outside.

| Cond'n | Action | Item | Cost |
|---|---|---|---|
| <b>P</b> | <b>4</b> | Cut back the salt damaged plaster to the west wall of SM202 and SM101 and renew in lime plaster. This to be done after the external issues are dealt with. | <b>(M)</b> |

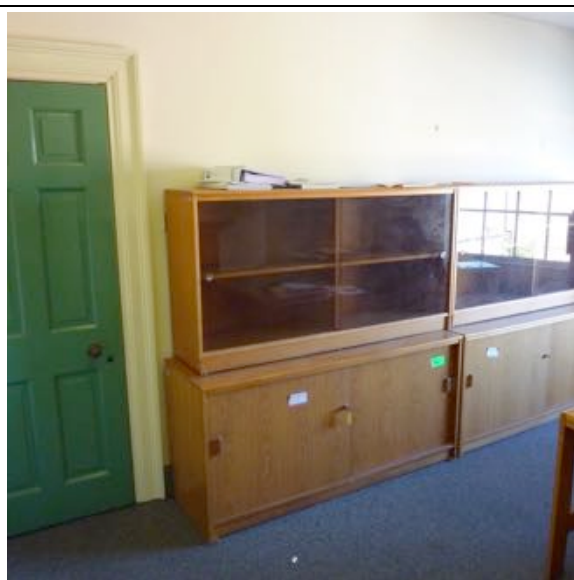
These cabinets would have imposed quite a load on the floor when full. No signs of any issues though.

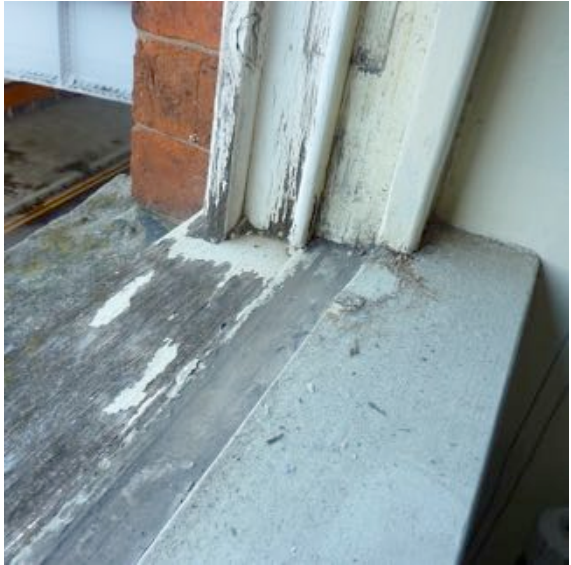
| <p>Weather beaten but sound window cill</p> | <p>Replacement sash cord in purple will be hard to paint out.</p> |

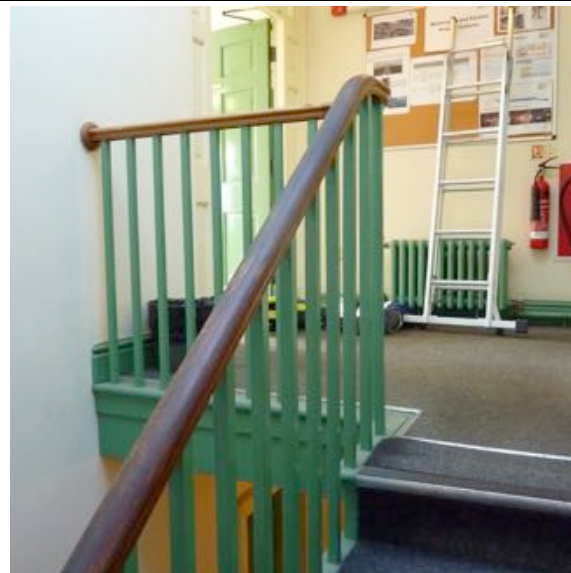
| <p>General view of the upper landing and rooflight.</p> | <p>The handrail at the top landing is less than 1100mm so it does not meet current regulations. It is also a little wobbly so might not withstand a drunken person grabbing for it.</p> |

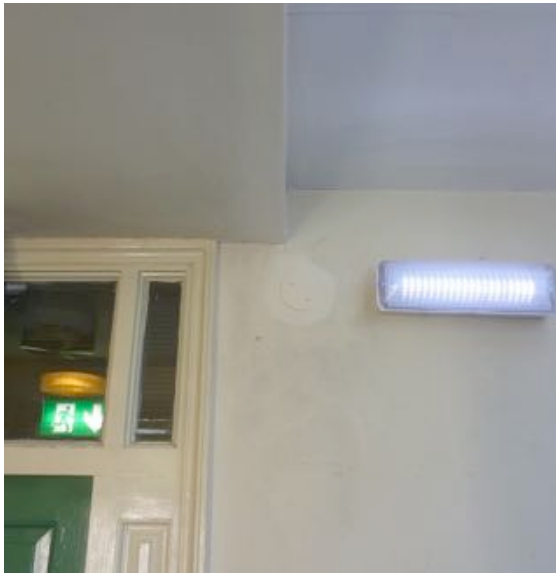
On the staircase landing there is no significant cracking noted in the south wall but on the north, there is some noticeable cracking just adjacent to the door link out to the station. Going through into the lobby beyond, there is quite a substantial crack over the outer door, which would be continuous with the same zone. There is no cracking in the ceiling to join those two lines up.

| <p>Fine cracking where the flat ceiling of the landing meets the north wall.</p> | <p>This cracking adjacent extends into the outer lobby area to the north where it is more prominent.</p> |

| Cond'n | Action | Item | Cost |
|---|---|---|---|
| <b>F</b> | <b>2</b> | Investigate the cause of cracking to the wall around the platform access door and devise a method of tying in. There is also cracking in the landing below this which should be looked at too. | <b>(S)</b> |

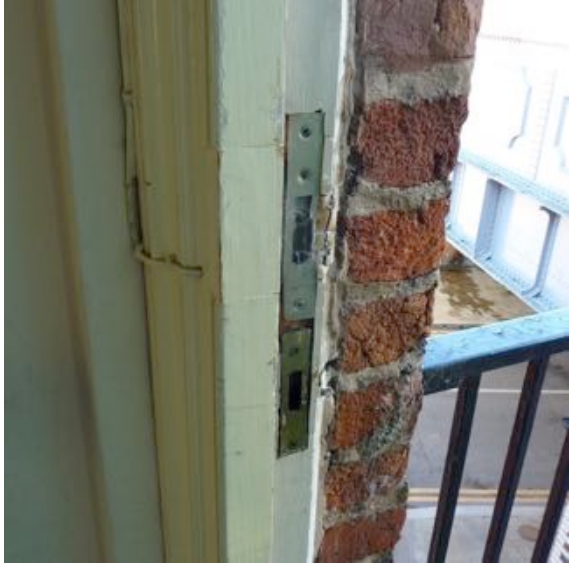
Externally, it looks like the door has had some attempted break-ins, or has just been damaged due to rough handling, this will need repair.

| <p>Damage to the door frame to the door out to the platform bridge might indicate a past break in?</p> | <p>Door mat to the door to the bridge slumped creating a trip hazard</p> |

| Cond'n | Action | Item | Cost |
|---|---|---|---|
| <b>F</b> | <b>5</b> | Repair the door and frame out to the railway platform where it has been damaged by intruders. | <b>(S)</b> |

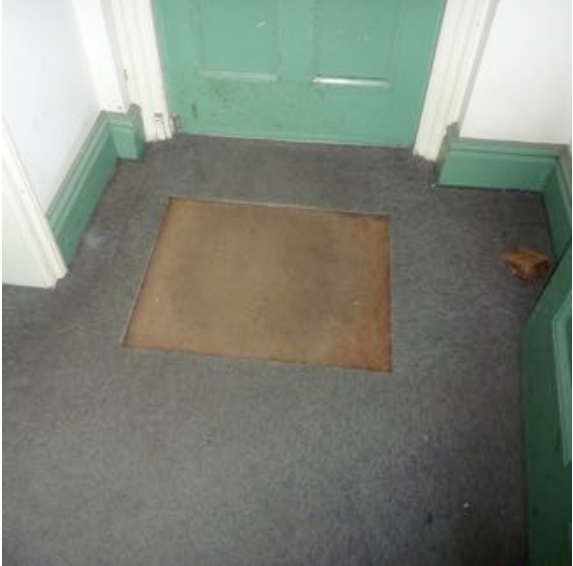
The floor is chipboard, but has a dropped section for a mat. The mat has slumped, creating a trip hazard. Under the mat is chipboard again, so it does not look like they have over-boarded on original planking.

| Cond'n | Action | Item | Cost |
|---|---|---|---|
| <b>G</b> | <b>1</b> | Level up the entrance mat to the back door to take out the potential trip hazard. | <b>(S)</b> |

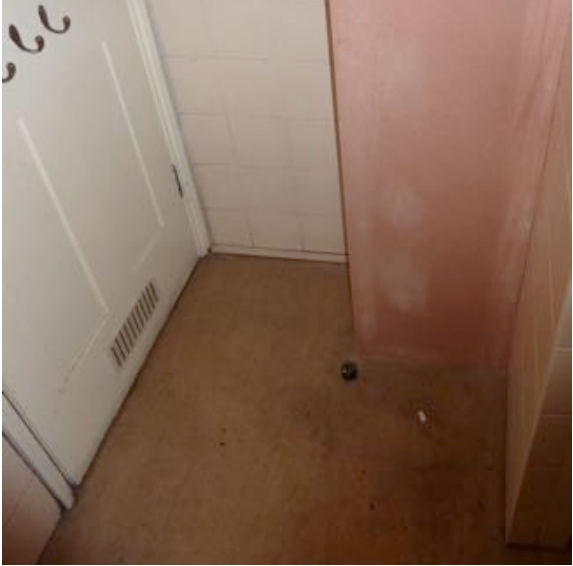
| <p>General view of the interior of the landing toilet.</p> | <p>Door swing massively constricted by the boxing out of the extract fan.</p> |

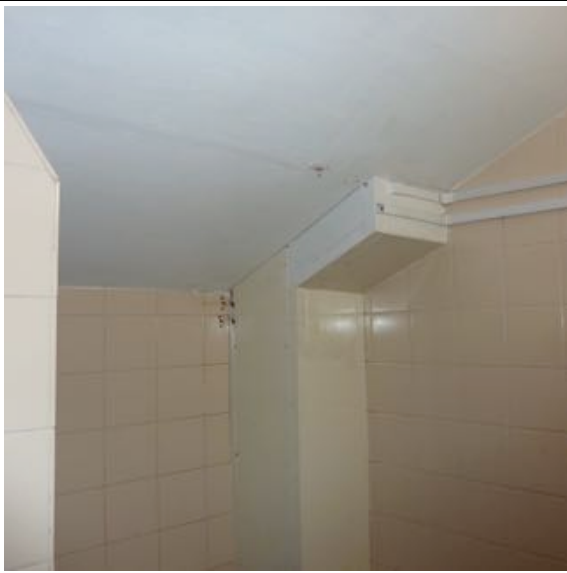
| <p>Boxing out of the ceiling for the soil vent pipe. No signs of any leaks around this.</p> | <p>The old shower head. You would have had to be very short to use this.</p> |

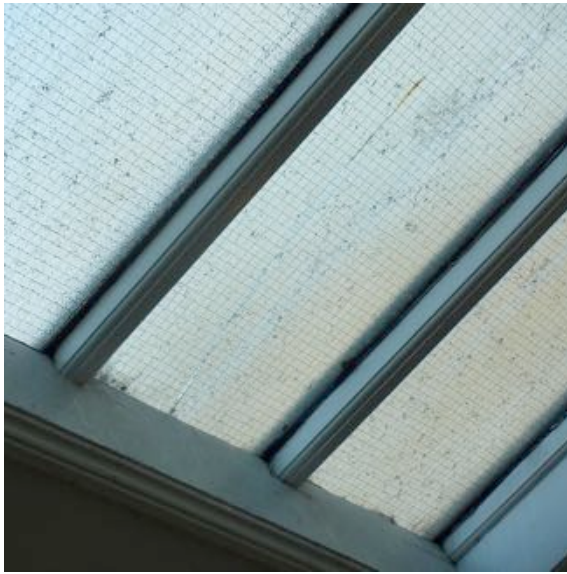
The timber roof light seems in quite good order on the inside and does not look to be particularly old. There looks to be some form of gasketing to the glass. We note externally that the timber cover strips have perished so leaks may develop more in the future. It was noted that one of the panes of Georgian wired glass is cracked but it doesn't seem to be leaking. We have already recommended that this rooflight be replaced.

| <p>Cracked pane of georgian wired glass to the roof light. No actual signs of any leaks, we presume there is a mastic tape under the glass</p> | <p>General view of the staircase treads and ballusters.</p> |

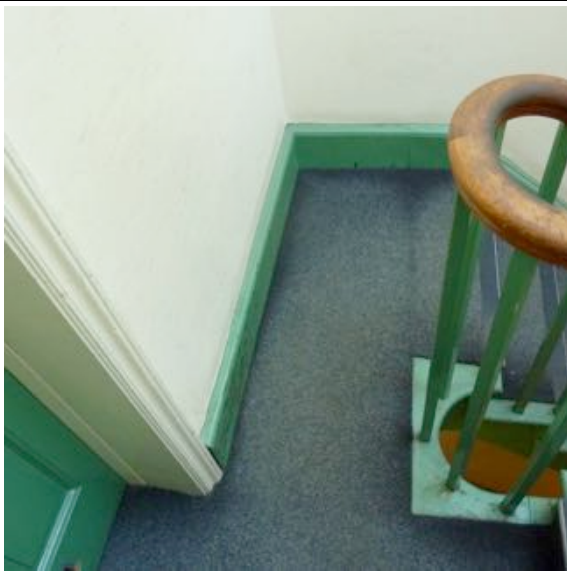
| <p>The landing wall by the WC only has a small clearance to the handrail. The balusters are greater than 100mm apart at the landings.</p> | <p>Cracking to the soffit of the stair plasterwork under the landing shown in the photo adjacent.</p> |

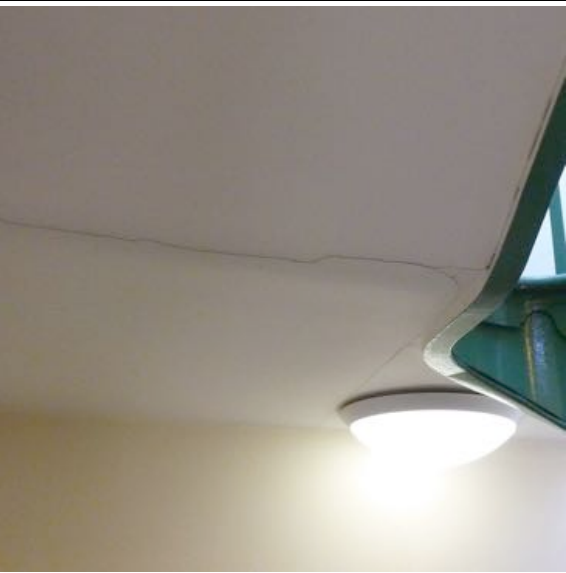
It is noted when viewed from the floor below that the plaster soffit under the north end of the mid landing is cracked although there was no spring in the structure at that point.

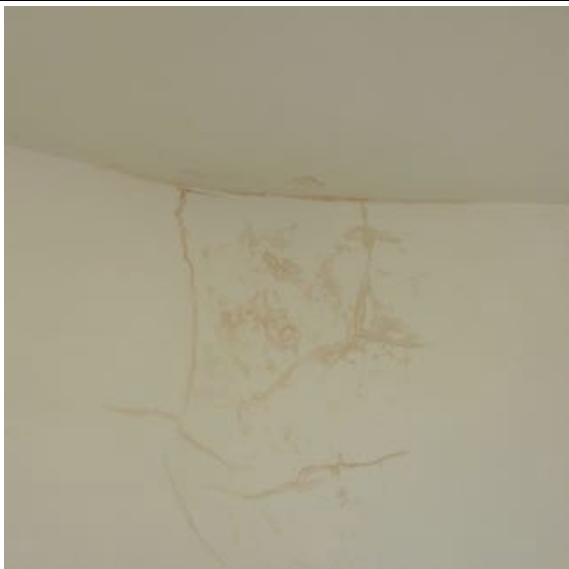
The west wall like in the room above, has been affected by water penetration, causing blowing of the plaster. There is also a fairly substantial crack in the plaster at what would be the outside corner between the central flat facet and the south angle section. There is a horizontal line extending out from the bottom of the crack across the wall, which roughly corresponds to the height of the other windows on the south wall, so both these cracks may be a dislocation of a section of masonry infill to an old window?

| <p>Old damp staining to the top of the wall and the edge of the ceiling on the West wall.</p> | <p>The wall did feel slightly damp behind the radiator. Is water sitting on the cill externally and tracking in?</p> |

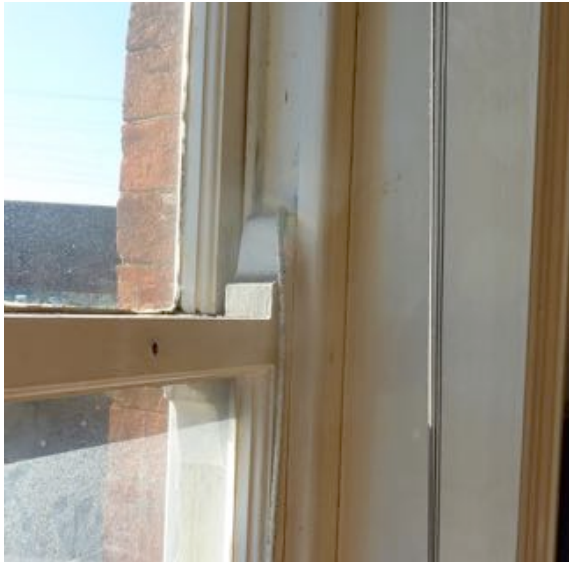
| <p>Snapped sash cord</p> | <p>The fireplaces to this room are fake and the hearth is blocked up. There is a vent to the chimney breast to the west fireplace so the flue may still be open behind?</p> |

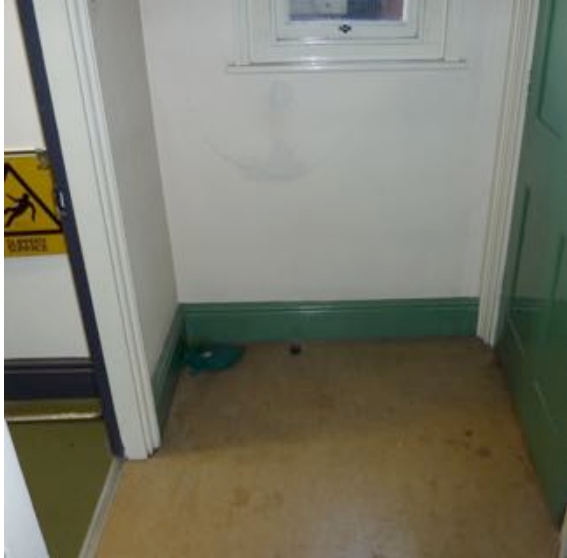
| <p>Grubby lino to the floor of the outer vestibule.</p> | <p>The doors to the inner rooms are thinner and not fire doors. Are these originals? The brass number tags are an interesting 'British Rail' style feature, should they be retained.</p> |

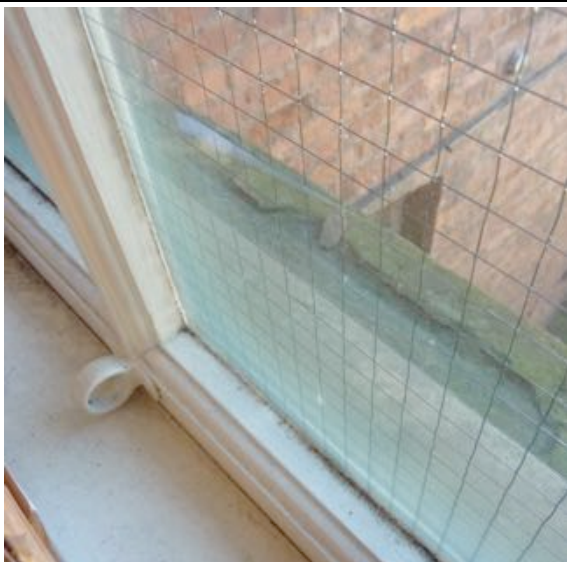
| <p>The external stone cill is quite de-laminated. Note the georgian wider glass to these rear windows.</p> | <p>Good quality 'hob grate' fire place. The flue is walled up though.</p> |

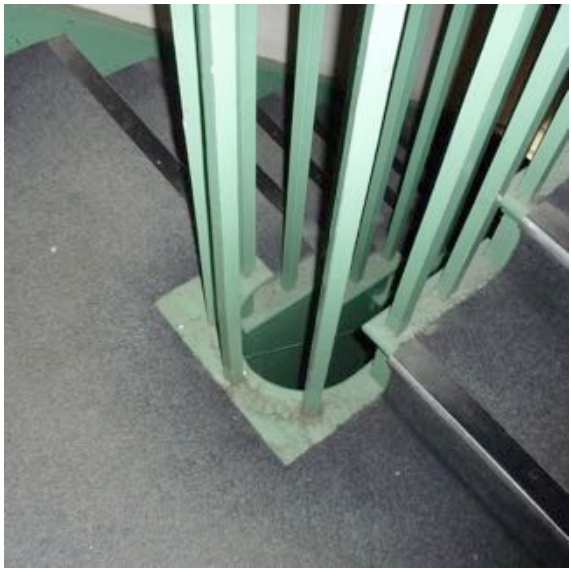
| There is a wider gap between the mid landing handrail and the wall, but not by much. | Possible use of asbestos containing Marley floor tiles. |

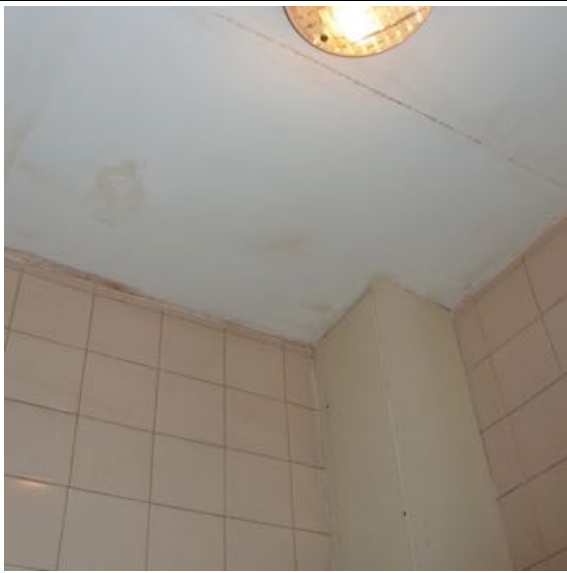
| <p>Staining to the WC ceiling must date from when the shower was in use.</p> | <p>The shower has long since been a functioning facility.</p> |

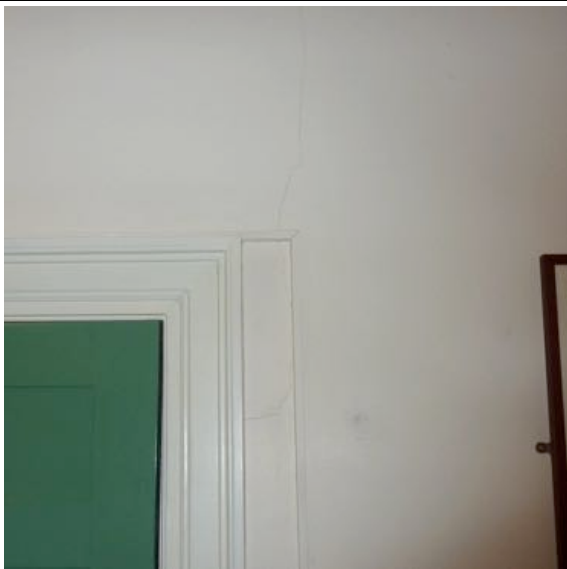
Fine movement cracking noted to run up from the north side of the door into the entrance lobby. Some fine cracking running diagonally up from the west jamb of the window as well.

| <p>Fine cracking running up from the door to the lobby</p> | <p>Metal grilles to the windows are quite tasteful.</p> |

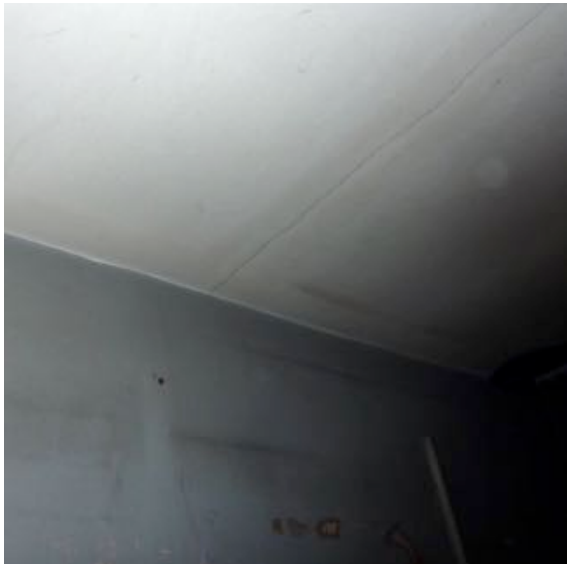
In the cupboard under the landing there is a crack in the west wall and this runs across the ceiling. Not sure what the ceiling is made of, it could potentially be made out of asbestos.

| <p>Crack in the ceiling of the room under the landing WC. Ceiling material feels quite hard, could it be asbestos?</p> | <p>The boxing out for the soil vent riser also carries a lot of cables.</p> |

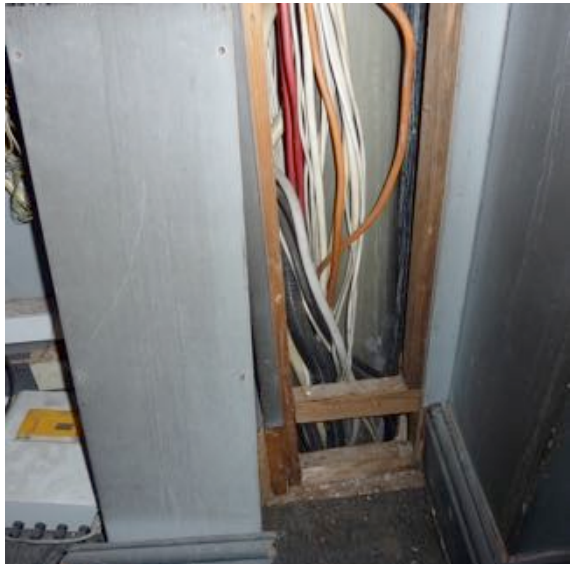
It is generally dry but in a knocked about condition. there is a boxing around the soil vent pipe which drops to the basement and has also been co-opted for use as the main wiring riser. Not a lot of space in there.

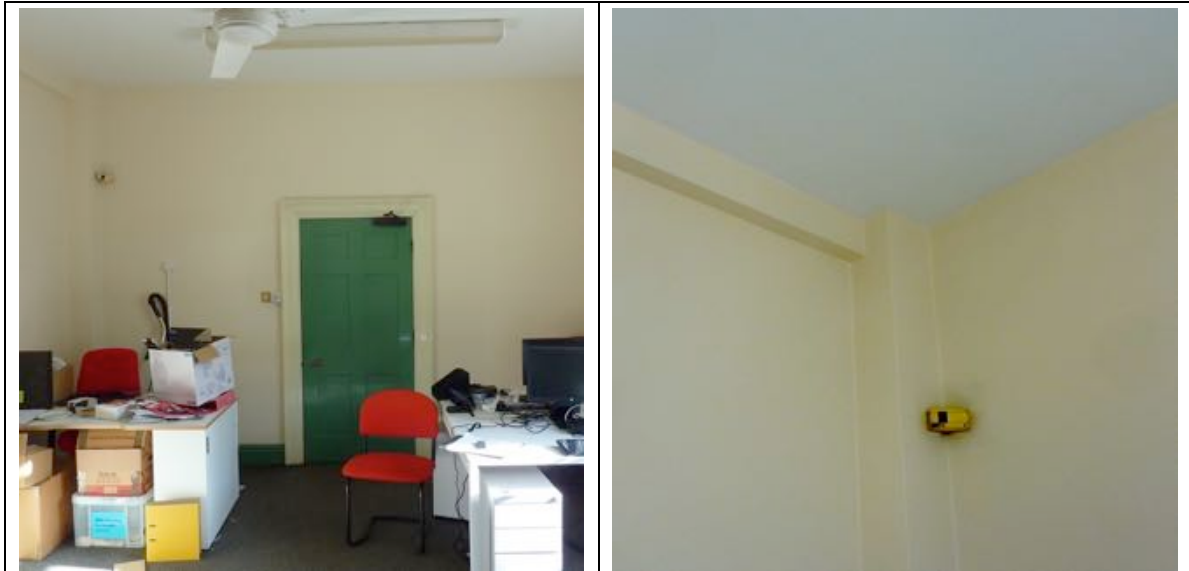
General view looking East. In the left corner is a nib and a beam along the ceiling. This may date from when this was open plan and used as a shop?

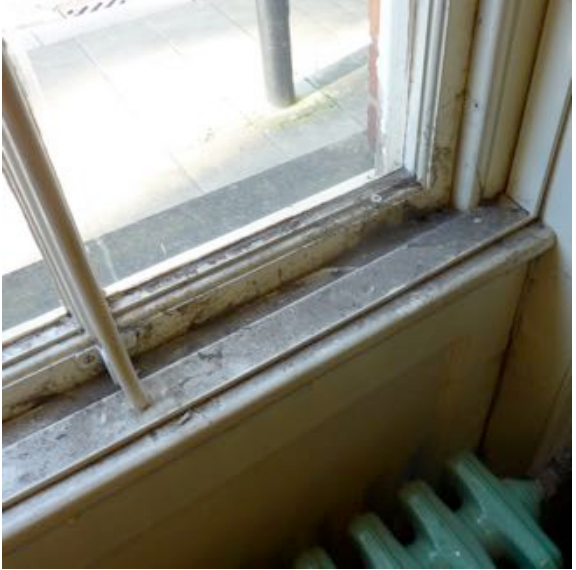
| <p>South window has a good quality security grille.</p> | <p>The west window frame is quite dirty. We know from the external survey that this sash is rotten at the corner.</p> |

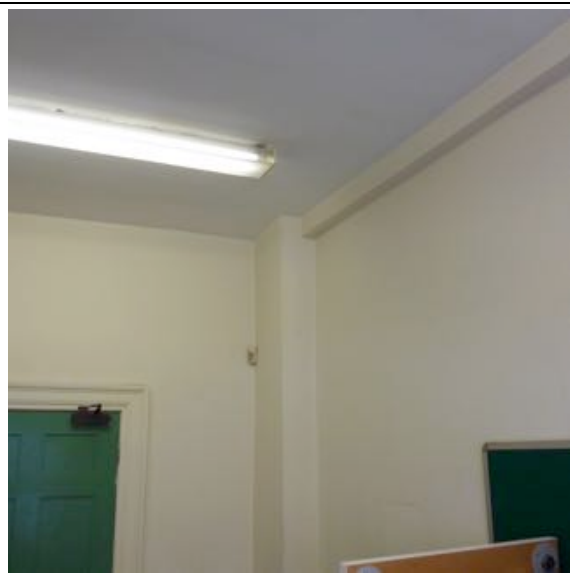
The same nib and beam noted to the room previous is in this space too

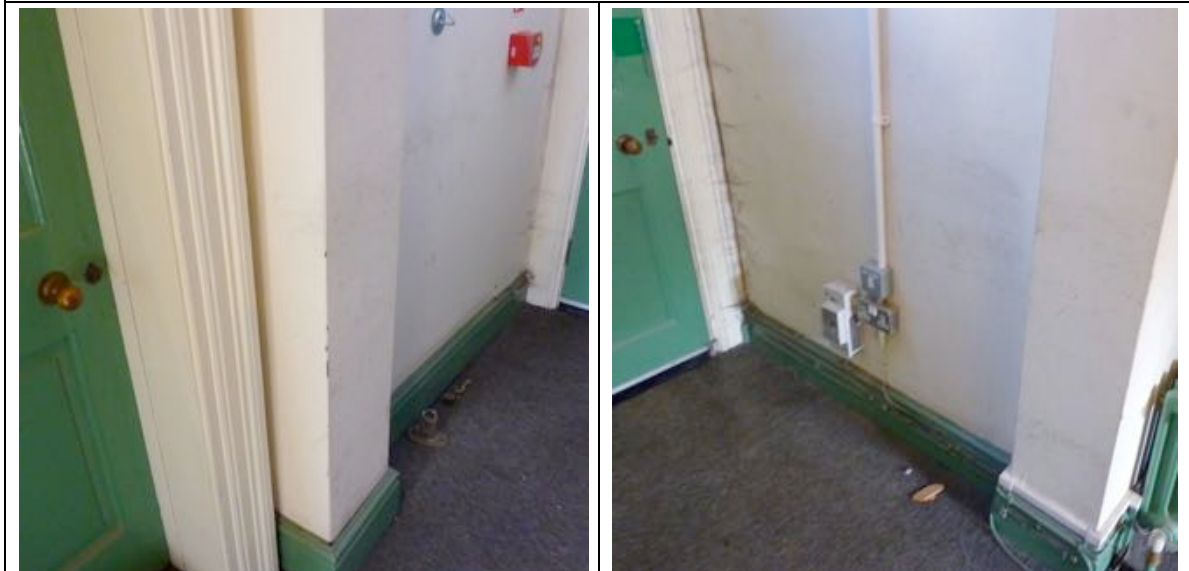
Quite a heavily trafficked area so lots of bumps and knocks to the wall plaster and skirtings.

| Cond'n | Action | Item | Cost |
|---|---|---|---|
| <b>F</b> | <b>4</b> | Make good to small areas of impact damage to the wall plaster and timber trims. | <b>(M)</b> |

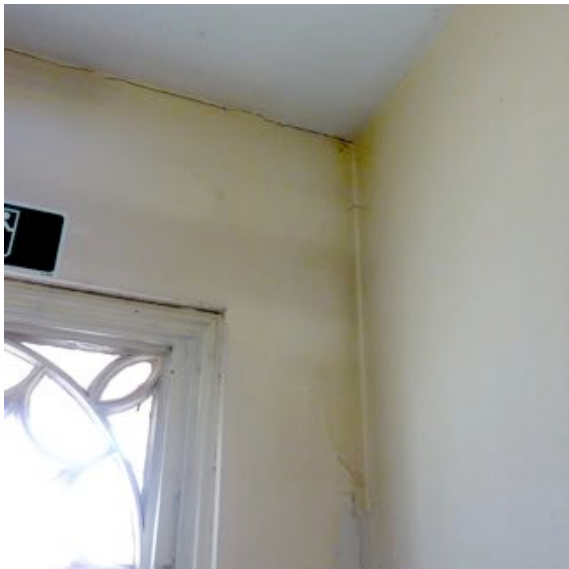
Various lines of fine vertical cracking noted on the east and west doors into the side rooms. These have been filled and have reopened but they do not seem to be particularly significant

| Cracking to the west wall over the door | Cracking to the east wall over the door |

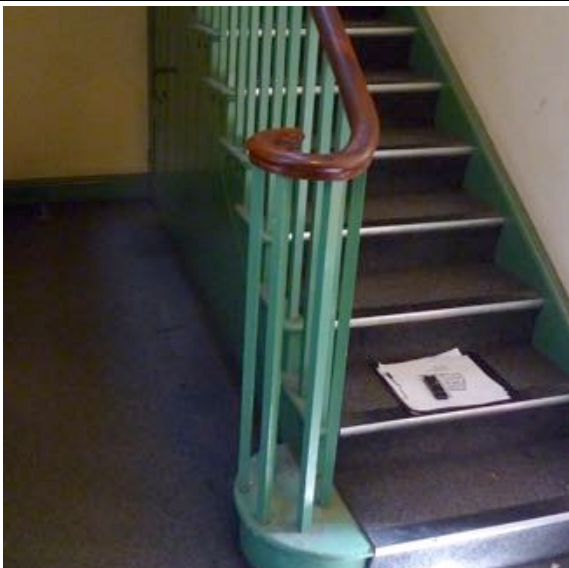
The masonry arch moving through to the back door has small diagonal cracking running out from one 45° on the east side.

| Cracking to the arch leading to the back door. | General view of the bottom of the staircase. The handrail is a little wobbly but not excessive. |

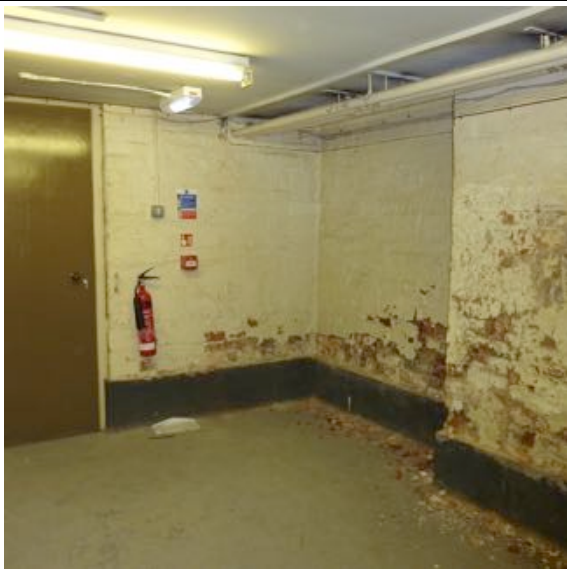
There has been substantial damage to the surface of the brickwork of all walls other than the south (which is encased in render). The bricks are heavily salt damaged and the fire skin has ruptured leaving them fractured and pocketed. There is a lot of scale and salt lying on the wall.

| <p>General view towards the NW. Extensive build up of salt and brick waste on the floor. The floor is concrete as is the skirting profile.</p> | <p>General view towards the SW, hard render to the south wall.</p> |

| Cond'n | Action | Item | Cost |
|---|---|---|---|
| <b>P</b> | <b>3</b> | Remove the remains of the acrylic wall paint and try to passivate the salt growth in the face of the brickwork. Cut out and replace bricks with severe face loss and consolidate with lime mortar. This comment applies to most of the basement rooms. | <b>(L)</b> |

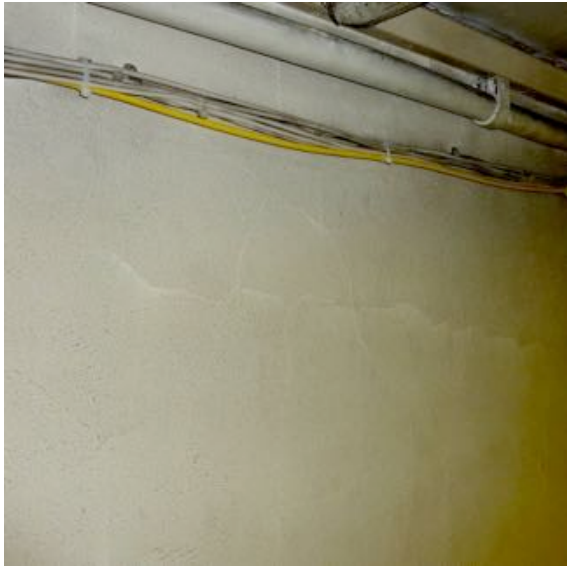
Floor is dry, no signs of any water penetration through the south rendering or up through the floor. The south rendering does have some fine cracking running through it, but is still hard bonded to the external wall.

| <p>Hard render to the south wall is cracked but still well bonded. No leaks.</p> | <p>Main fibre optic intake to the whole station complex comes in the south wall. This may be too expensive to move and may have to be maintained.</p> |

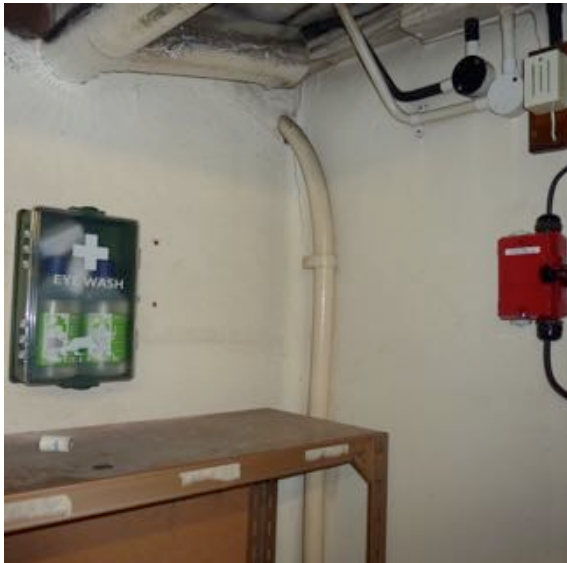
Cracking noted at the extreme south-east corner, possibly to do with where the cable has been brought through from the hallway and the brickwork removed. There is cracking in the hallway above this position.

| <p>Large electric feed cable comes though the wall from the lobby area. There is cracking in this location</p> | <p>Gas main comes in the west wall. The gas pipe heading to the left feeds into the main station building</p> |

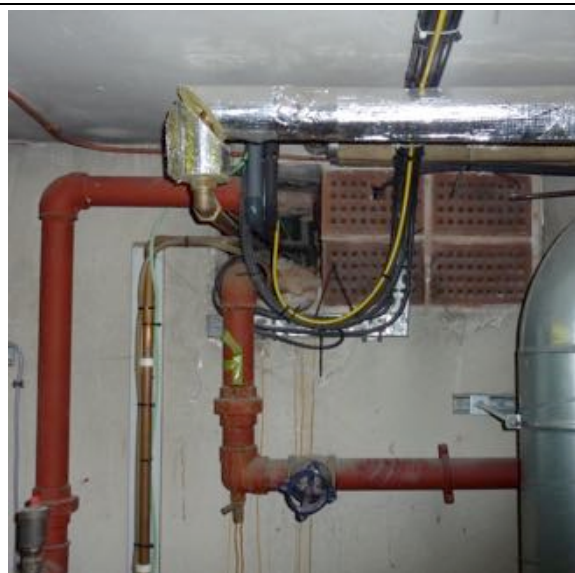
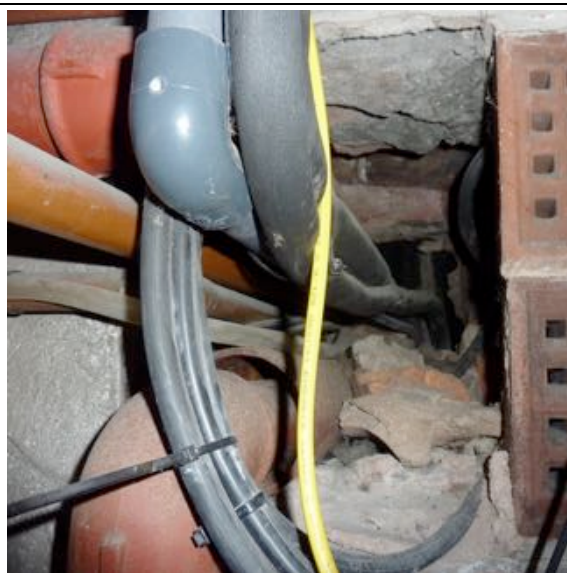
Various heating and drainage pipes crowd into one opening in the north wall. The void is not well sealed and vermin could enter the building on this route.

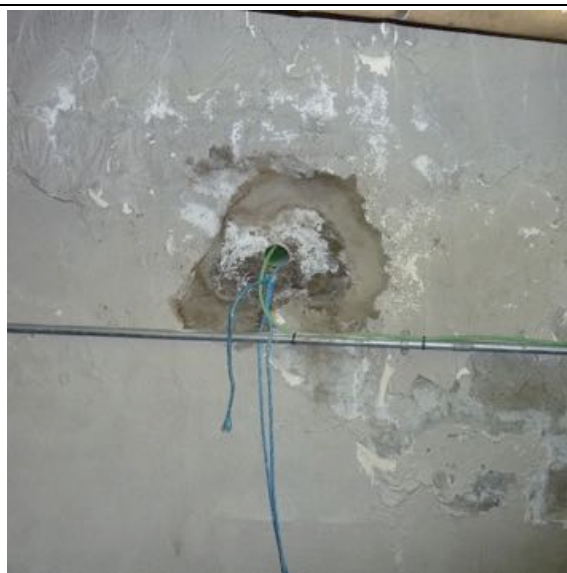
The bricks to the south spine wall are salted but do not have the extensive damage as other rooms.

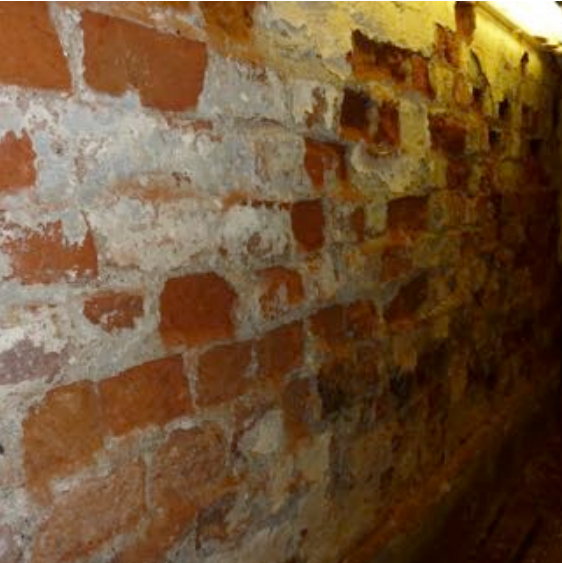
These brick walls have been faced with render, but, as with other areas, the extremely high levels of salt in the brickwork which de-bonded the render and it has burst out the face leaving it all looking quite a mess. All of this render needs to be removed and any bricks that look to be too weak will need to be replaced. These are very thin nibs so it may be better to just renew the whole construction from the floor up.

| <p>General view from the north looking back to the access corridor</p> | <p>Face loss to the brickwork of the central spine wall. This is thicker than the nibs so decay is less concerning.</p> |

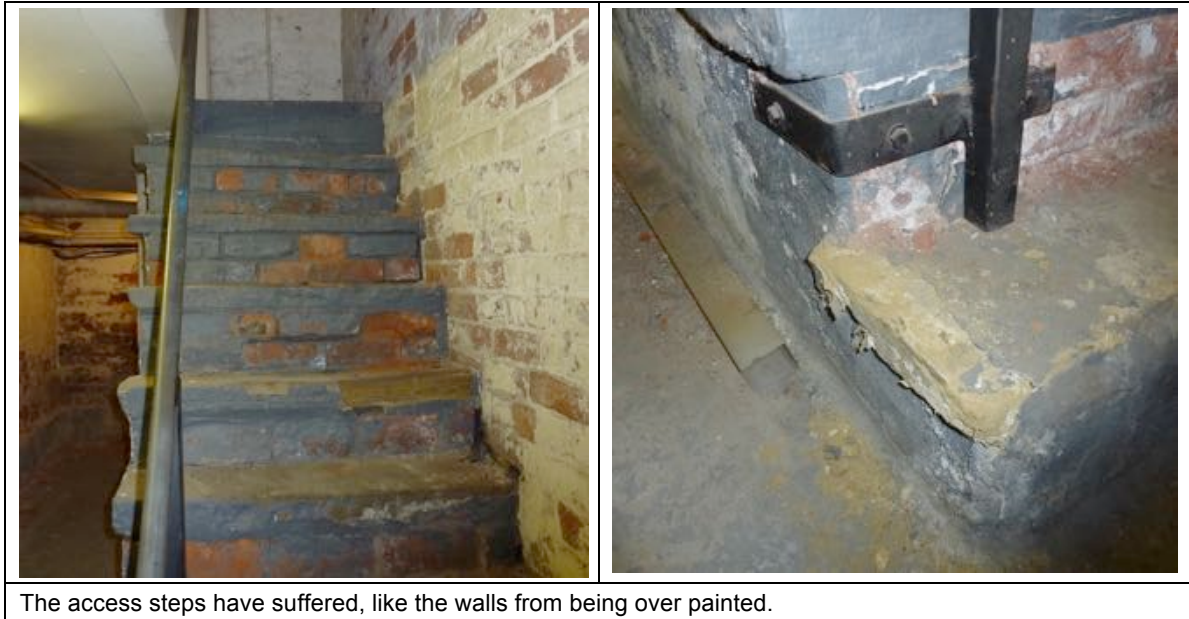
The access steps have suffered, like the walls from being over painted.

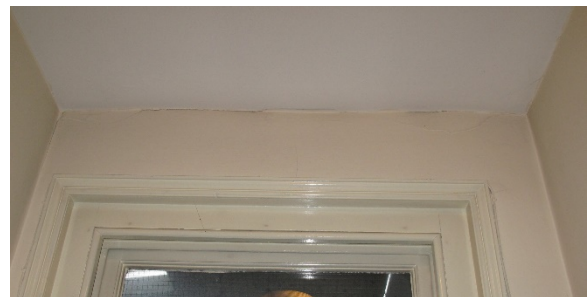
SECOND FLOOR REAR DOOR OPENING

Item 4.4 Upper Stair Hall and Landing WC “ Investigate the cause of cracking to the wall around the platform access door - - - and in the landing below”.

It is therefore probable that the cracking in the internal finishings near the rear openings are related to a minor differential effect from foundation level that the masonry is able to absorb without cracking. The stages of development of the building cannot be traced with any certainty as it seems there has been substantial rebuilding, but any changes may have an effect at foundation level where the walls most probably rest on river deposits of some type. Any leaking of water to ground could cause saturation leading to a loss of strength in cohesive and silty type material. Ensuring all the drains are out-falling into a

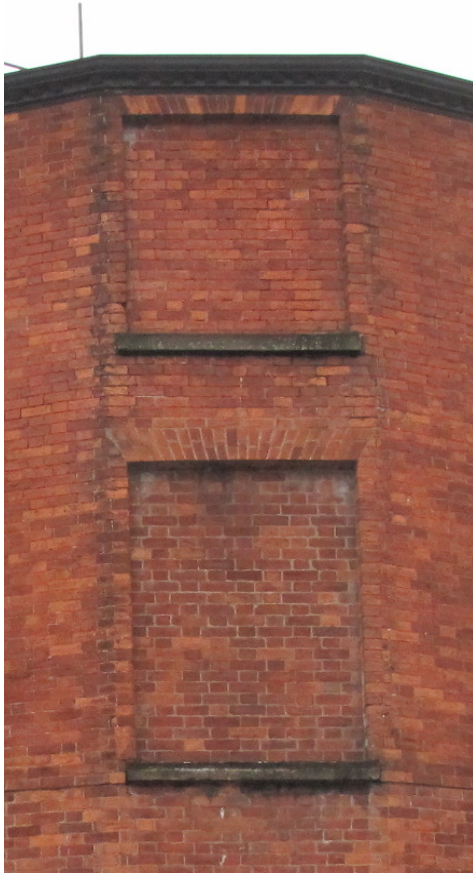
EXTERNAL VIEW

The visible cracks are in the finishings, not the masonry, but there is evidence portions of the wall have been increased in thickness at some time. At high level the roof valley terminates in this area. It has a 5.5 metre span on plan and almost 6 metre on the slope. A photograph of the valley appears on page 14 of the Wiles & Maguire Report. There are load-bearing walls at third points along the valley so it is reasonable to assume they would have been used to break the span in the substantially modern re-roofing exercise that included the rafters. main sewer and not to ground will minimise the risk of further foundation disturbance if this was involved. As can be seen in the photograph above, the north wing has been constructed at a different time, seeming to pre-date the rest of the building with a more industrial appearance founded on a barrel vaulted foundation. This may account for the disturbance, with the two portions reacting differently to variations in ground conditions or the foundation depths not being the same.
