# EXTENDED PHASE 1 HABITAT SURVEY & DAYTIME BAT SURVEY

ST GABRIEL'S, OXFORD PLACE,  
GREATER MANCHESTER

FEBRUARY 2022

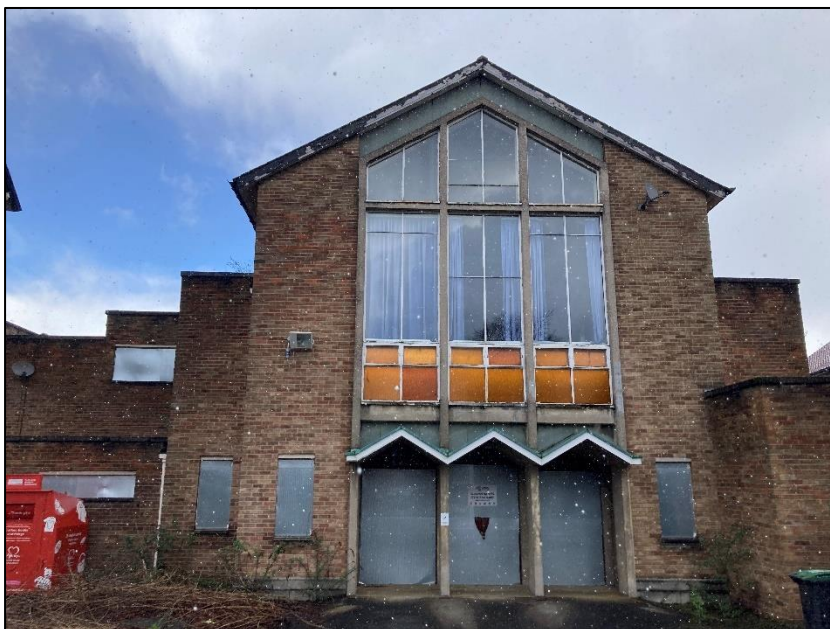
*Photograph 26 showing the front facing elevation of The Chapel*

- 3.19 The Chapel is adjacent to St Gabriel's Hall and comprises multiple interconnected buildings. The building is constructed from brick with pitched and flat roofs (see Photograph 26). The external brick walls are in good condition, with no missing bricks or mortar, and do not support suitable cavities for roosting bats (see Photograph 27). The windows and door frames are uPVC and are well-sealed. Some of the lower-floor windows are covered with sheet metal and are well-sealed.

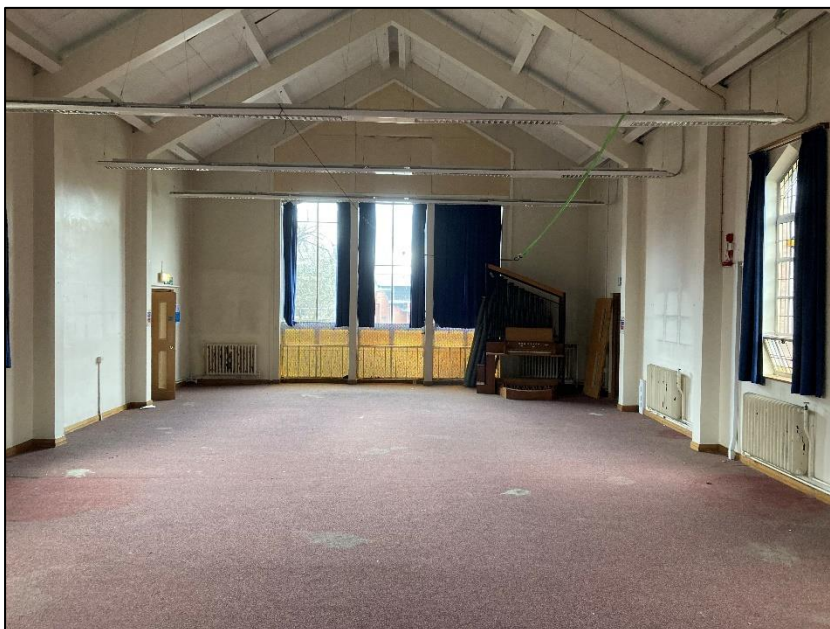
*Photograph 30 showing the internal space of the Chapel*

- 3.21 The building is currently not in use. The ground-floor and first-floor rooms are finished spaces that do not present suitable bat roosting habitat (see Photograph 30). The Chapel does not support a roof void (see Photograph 31). The wooden roof beams are visible, complete and intact with no cracks or crevices that could be used by bats for roosting. The underside of roof is lined with panels these are lie flush to the roof above and each other offering no potential access to the internal space.

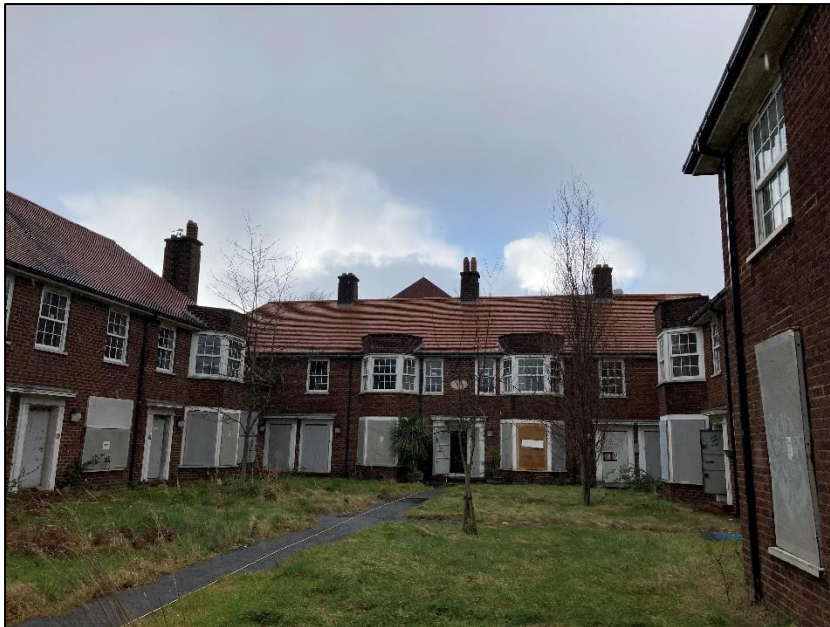
*Photograph 32 showing Woodthorpe Hall*

- 3.22 Woodthorpe Hall comprises a U-shaped building which were formerly used as apartments. The building is constructed from brick and features hipped roofs constructed from clay tiles. The external brick walls are in good condition, with no missing bricks or mortar, and do not support cavities that could be exploited by roosting bats (see Photographs 32 and 33). The brick chimney stacks are complete. The windows and door frames are uPVC and are well-sealed. The ground floor windows are covered with sheet metal or plyboards and are well-sealed.

- 4.8 Woodthorpe Hall is a two-storey brick-built building with a hipped roof covered with clay tiles. The building is in a good material condition with no external features that could be exploited by bats for roosting and no potential access points for bats to the internal spaces. The roof voids are fully accessible and appear to be well-sealed also. No evidence of bat activity was found within the building. Woodthorpe Hall is considered to offer **negligible potential** to support a bat roost.

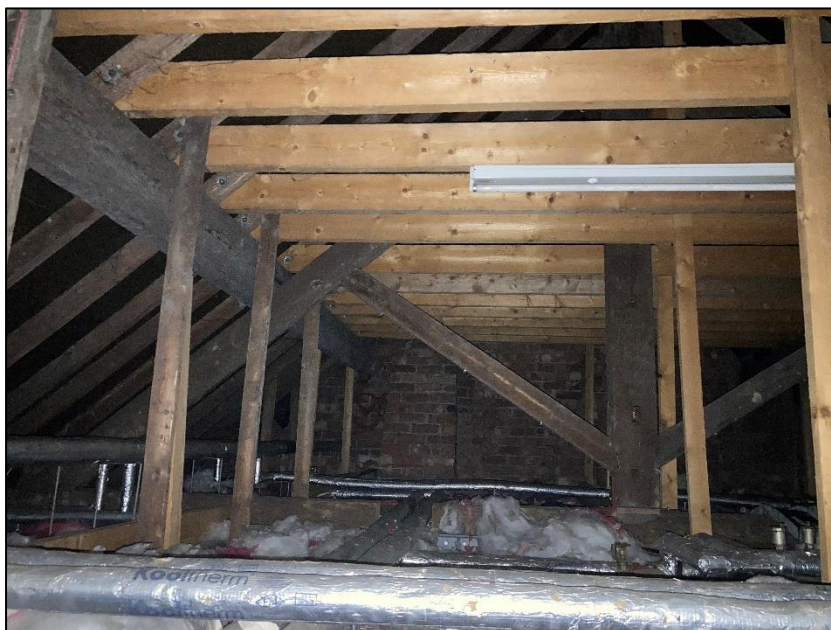
*Photograph 37 showing the roof void*

- 3.25 The building is not currently in use. The ground-floor and first-floor rooms are finished spaces which do not offer suitable bat roosting habitat. The building has multiple large and accessible roof voids which contain services. The spaces are cold and cobwebbed throughout (see Photograph 37). The roof voids have wooden roof joists, which are

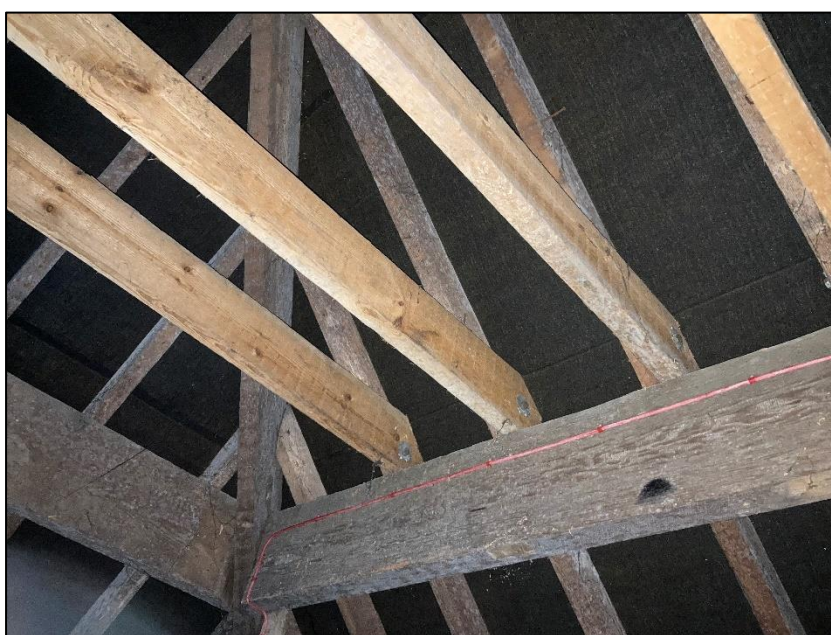
*Photograph 38 showing the roof joists*

without gaps or cracks for bats to use (see Photograph 38). The roof is lined throughout, and this is complete and lies flush to the roof above, with no significant tears or rips.

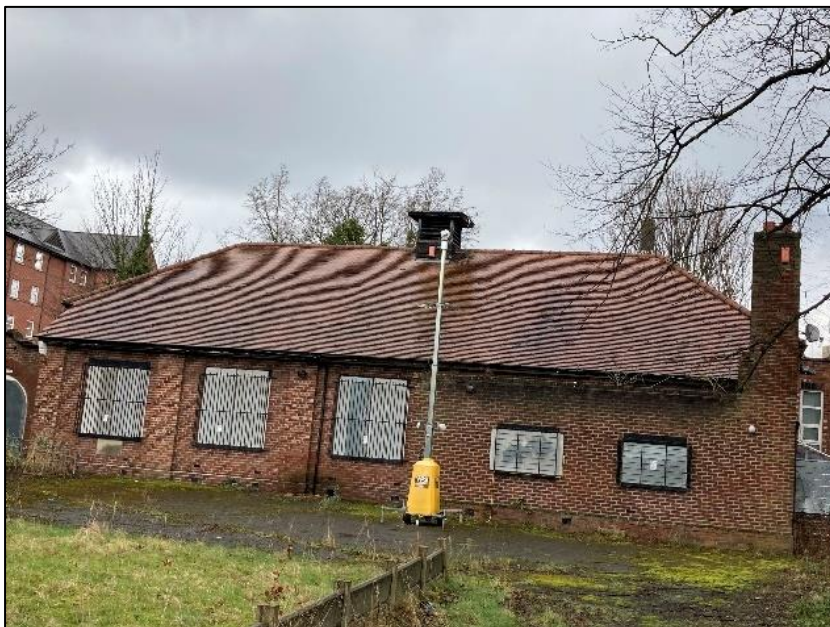
*Photograph 42 showing St David's Hall*

- 3.27 St David's Hall is located to the east of the site and is a former theatre building (see Photograph 42). The building is single-storey and constructed from brick with a hipped roof. The external brickwork is in good condition with no areas of recessed mortar or cracks. The brick chimney stack is complete. The windows are boarded over with sheet metal and are well-sealed.

- 4.9 St David's Hall is a double height single-storey brick. The building is generally in a good material condition with the only potential access point the decorative cupola on the roof. There is a concealed roof void above the main theatre below the cupola. St David's Hall is considered to offer **Low Potential** to support a bat roost. A minimum of one dusk emergence surveys should be conducted to determine if bats are gaining access to the roof void.
- 4.10 The trees on site were subject of a ground level assessment to search for features that could support roosting bats. No such features were found during the survey, the trees on site are considered to offer **negligible potential** to support a bat roost.

- **Bats** - A minimum of two dusk bat emergence surveys is recommended on St Gabriel's Hall. A minimum of one dusk bat emergence survey is recommended on St David's Hall. The surveys should be carried out between May-September, in suitable weather conditions. Should an active bat roost be found on the site, bat mitigation will be required, as well as a Natural England bat mitigation licence in order to carry out works on the bat roost. Mitigation could include a number of bat boxes, for example.

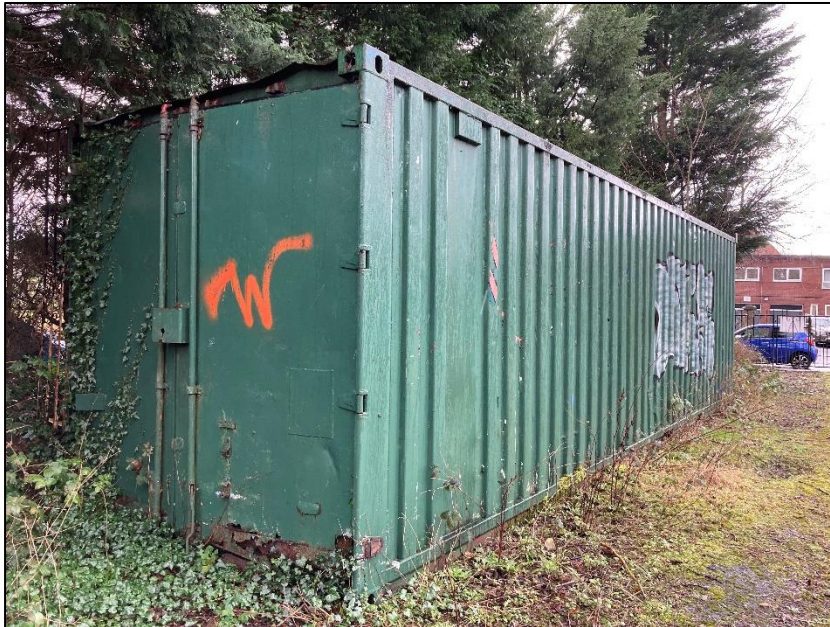
*Photograph 45 showing the shipping container*

- 3.30 A shipping container is located on the site (see Photograph 45). This is in good condition, well-sealed and does not present any suitable opportunities for roosting bats. A services building is present on the north of the site (see Photograph 46). This is a single storey brick-built structure with a flat roof. The windows and door have been sealed with sheet metal, and so there was no internal access. The building appears to be extremely well-sealed with no potential access points for bats, or external feature that could be used by bats for roosting.

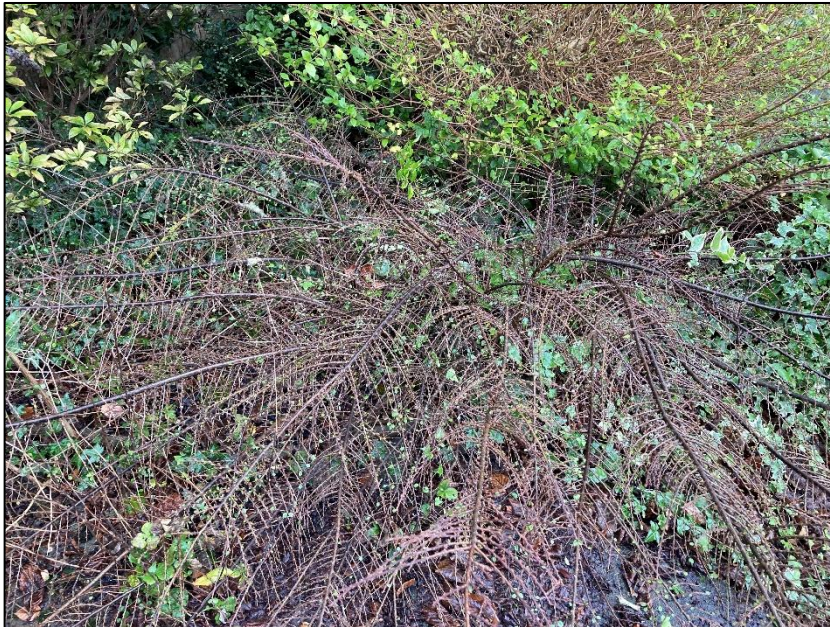
Photograph 48 showing the Wall Cotoneaster

- 3.36 Three invasive, non-native species as listed on Schedule 9 of The Wildlife & Countryside Act 1981 (as amended) are present on site. Wall Cotoneaster *Cotoneaster horizontalis* is present in an introduced shrub bed adjacent to the southern elevation of St Gabriel's Hall (see Photograph 48). Rhododendron *Rhododendron ponticum* is present in an introduced shrub bed along the southern boundary of the site (see Photograph 49). Montbretia *Crocasmia x crocosmiiflora* is present along the southern wall of Woodthorpe Hall (see Photograph 50).

5.4 Cotoneaster, Rhododendron and Montbretia are present on the site. These plants are invasive, non-native species and it is recommended they are eradicated from the site during site clearance works, using a suitable methodology for each species or managed on site as part of the landscaping.
