FLOYDCONSULT

Assessment of timber at

32-34 LAYSTALL STREET, M1 2JZ

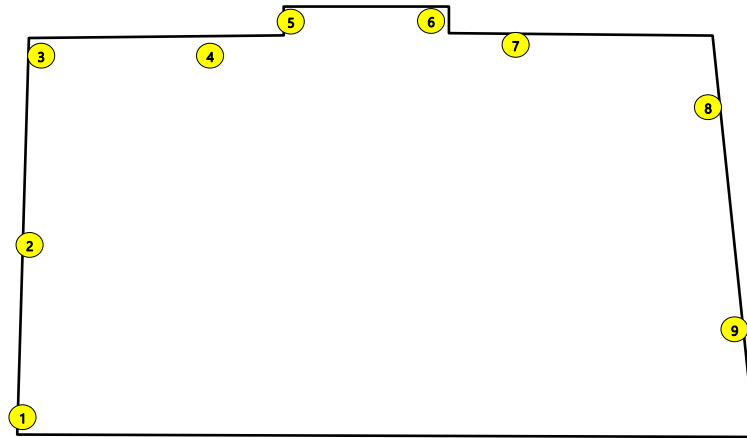
Roof

1  
The decking board and top and side of the embedded section of the joist in the corner have been wet up historically. The joist end has lost approximately 50% of its section in the bearing and would **benefit from some additional support such as a partner section.**

2  
The joist closest to the W wall has suffered from decay along its top edge where the sarking has also deteriorated. There is some movement in this joist, probably due more to the fact it has lost its connection and therefore stiffening effect with the sarking. **The entire joist would benefit from replacement when the sarking is replaced where it has decayed in contact with the W wall.**

3  
The joist has decayed in its N bearing. Again the sarking is decayed over the top of the joist **and it would probably benefit from complete replacement.**

4  
The joist arrowed is decayed in its bearing as is the lintel of the window below.

The end of the window frame is decayed in the corner as is the end of the trimmer beam which has lost approximately 50% of its section where it runs into the masonry (arrowed) **and would benefit from some additional support.**

5 joists are decayed in their bearings together with the window lintel (window right-hand side).

**The joists would benefit from additional support and the lintel requires replacement.**

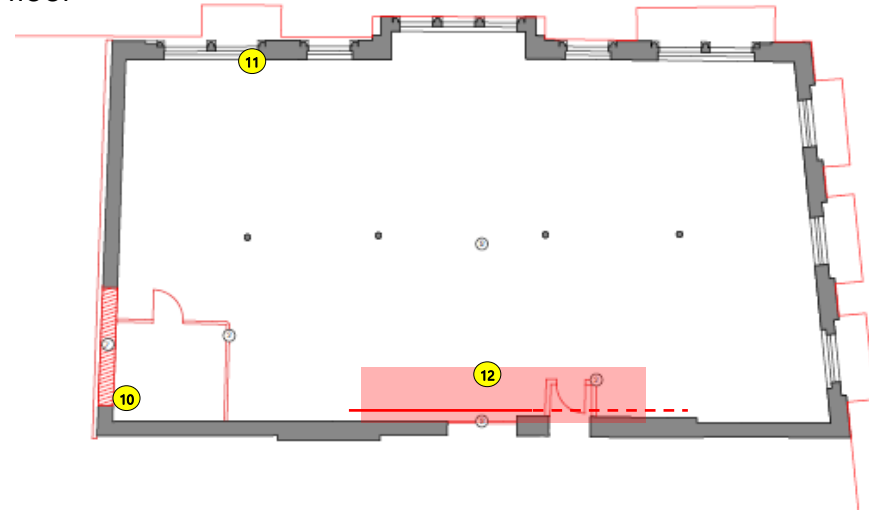
2<sup>nd</sup> floor

10  
Showing the underside of the second floor. **There is a possibility of some decay to 1 or 2 joist bearings in the W wall at this point and possibly to the floorboards also** (which were concealed from above).

11  
The lintel (which is probably 300 mm wide) is **decayed in its E bearing and will require replacement**.

12  
Water ingress (presumably from the opening at this point) has caused decay to the floor structure to the approximately extent shown on plan. **The solid line represents decay to the floor joist and floor boarding (extent of damage the floor boarding is represented by the shaded area). The dashed line represents possible damage to the joist adjacent to the wall which should be checked from below when the ceiling is repaired.**

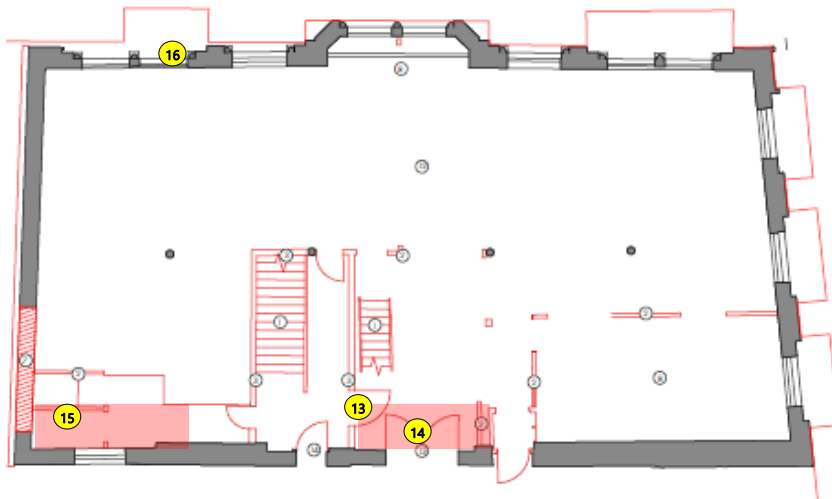
1<sup>st</sup> floor

13  
There is a stud and masonry partition laid on steel at mezzanine level. **Some exposure was made showing all the timber stud work to be decayed at least 1 m from the S wall.**

Close access was not possible from below. There is a continuation of the damage caused by the water ingress down through the building. Further exposure is required from below where the timber under boarding has decayed. **There is a possibility of 10 to 12 joists decayed in their bearings together with the floor boarding directly above. Exposure is required either from above or below to confirm.**

There are signs of an historic outbreak of dry rot to the underside of the first floor structure. The fungus is now dying back. However it would seem the joists bear into the S wall at this point and as such it is **possible that at least seven or eight joist ends might well be decayed in the bearings together with the floor boarding above. Exposure is needed at this point.**

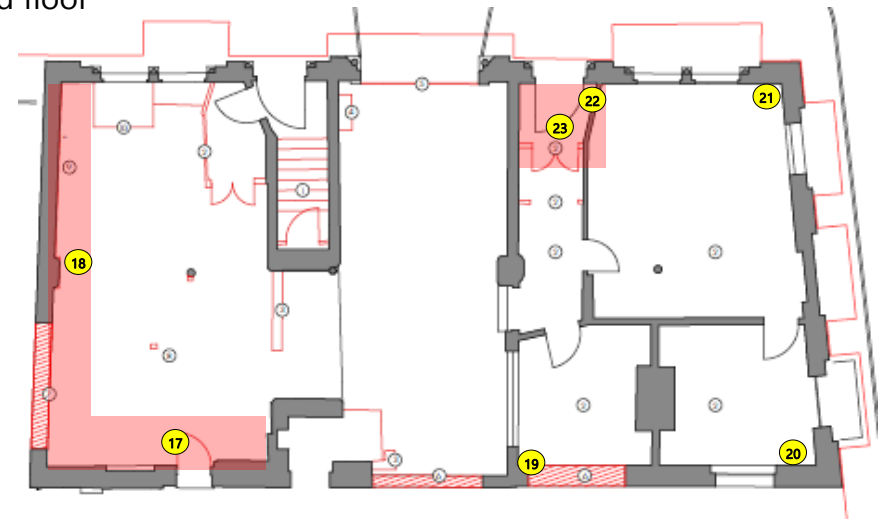
Ground floor

The underside of the suspended timber structure has been covered with corrugated iron. **Some of this was removed revealing joists decayed in their S bearings for all of the extent shown on plan.**

The joist adjacent to the W wall is decayed for pretty much the full extent of the elevation.

There are signs of rusting and the possibility of one or two joist bearings being decayed in this corner. **The corrugated iron needs to be stripped from the underside of the floor for a full inspection. The lintel arrowed is also decayed and requires replacement.**
