10 Minshull Street and 11 Bloom Street

**ADDITIONAL FEATURES**

PLANNING CONDITIONS RELEASE 11(a), (h), (r), (s)

Planning Permission 119374/FO/2018 – BOTH BUILDINGS

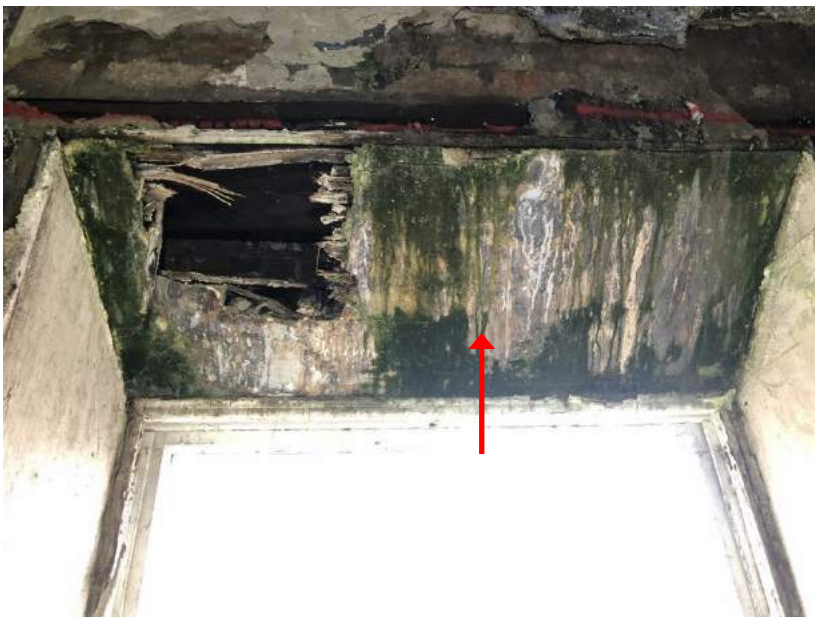
**Fig 2:**

Fourth Floor, MS-401; showing a typical example of the damp and decayed lath and lime plaster soffit over MS-4W06

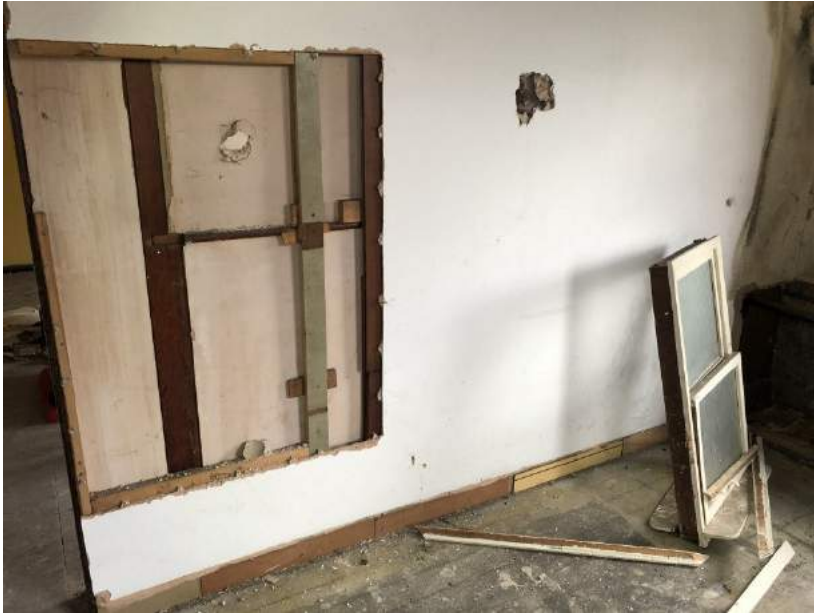
**Fig 3:**

Fourth Floor, MS-401; showing modern plasterboard lining to stud partition

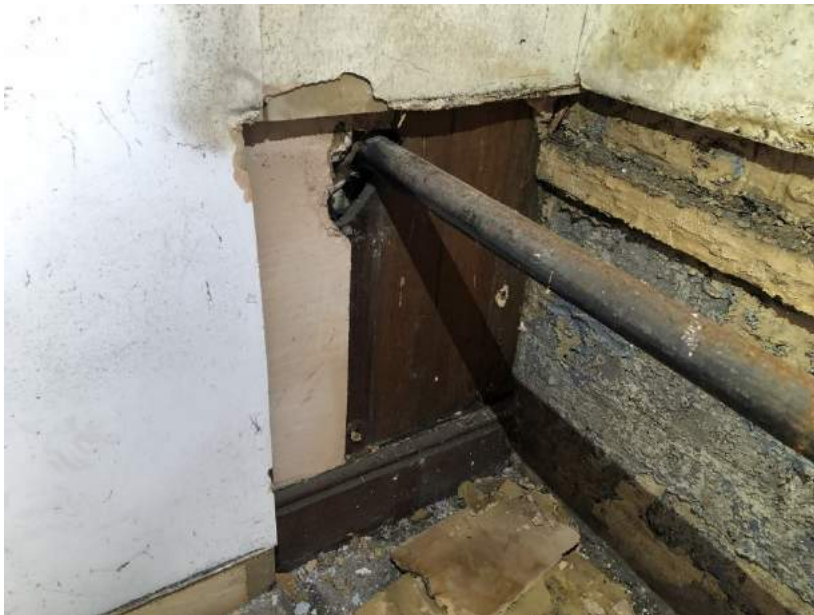
**Fig 4:**

Fourth Floor, MS-401; showing earlier vertical t&g panelling with a softwood skirting board behind. Timbers were damp and partially decayed in the area of ongoing water penetration

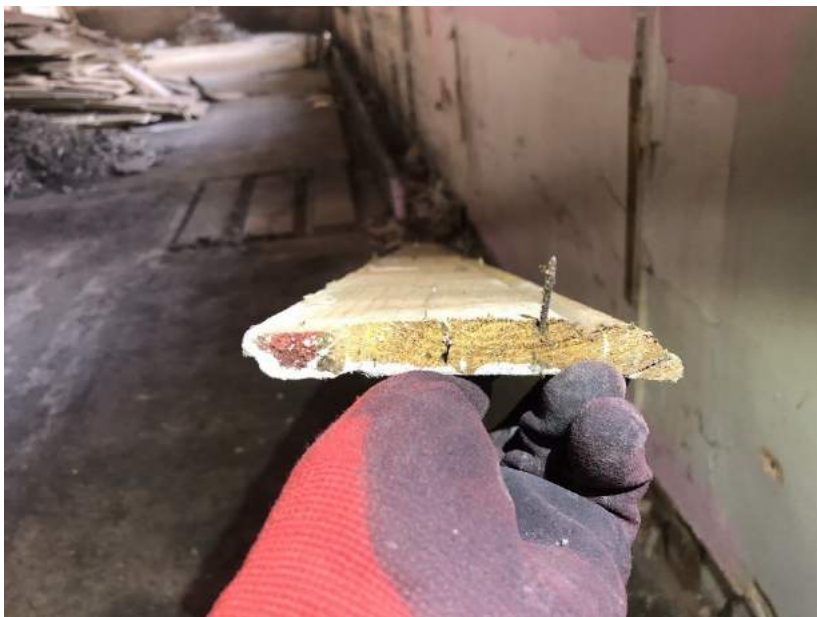
**Fig 8:**

Fourth Floor, MS-402; showing the profile of a removed section of softwood skirting board. This reversible/dual purpose moulding is of mid-late 20th century

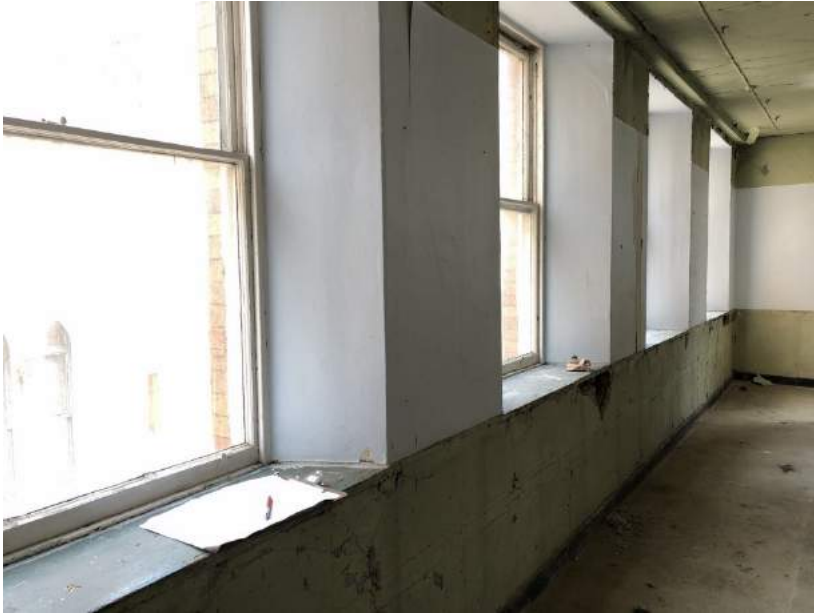
**Fig 25:**

Third Floor, MS-305-MS-308; showing early/original lime plaster to the external wall. Plaster was generally in fair condition with localised areas of debonding at low-level

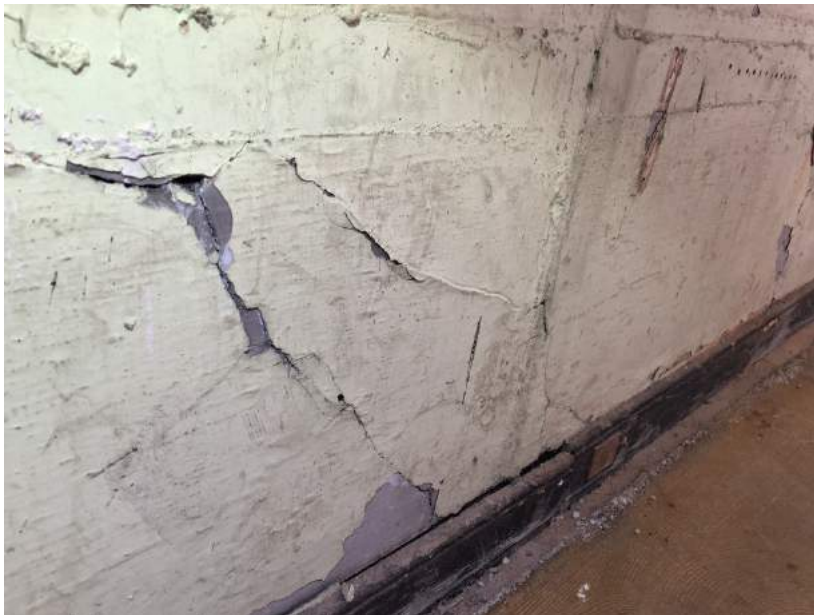
**Fig 26:**

Third Floor, MS-305-MS-308; showing a typical example of where the lime plaster had cracked and debonded from the brick substrate

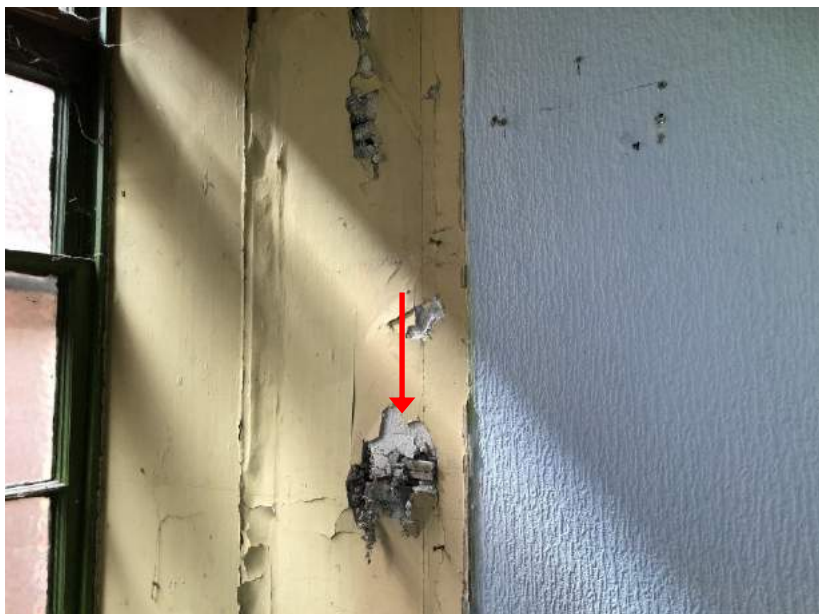
**Fig 49:**

Second Floor, MS-216; showing an area of lath and lime plaster used behind the cupboard of MS-218. The lath and plaster was damp and partially decayed where abutting the external wall

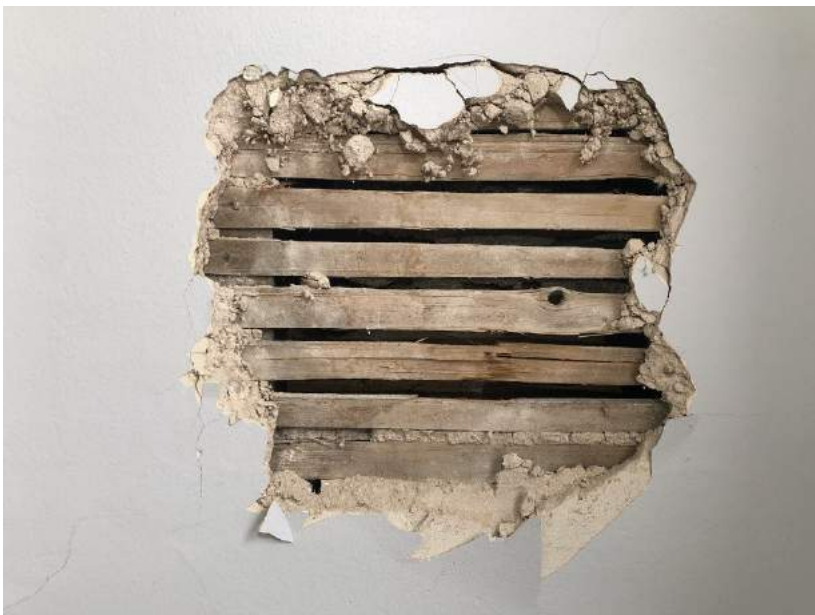
**Fig 58:**

First Floor, MS-101; showing a close-up of the lath and lime plaster finishes to the internal partition between MS-119

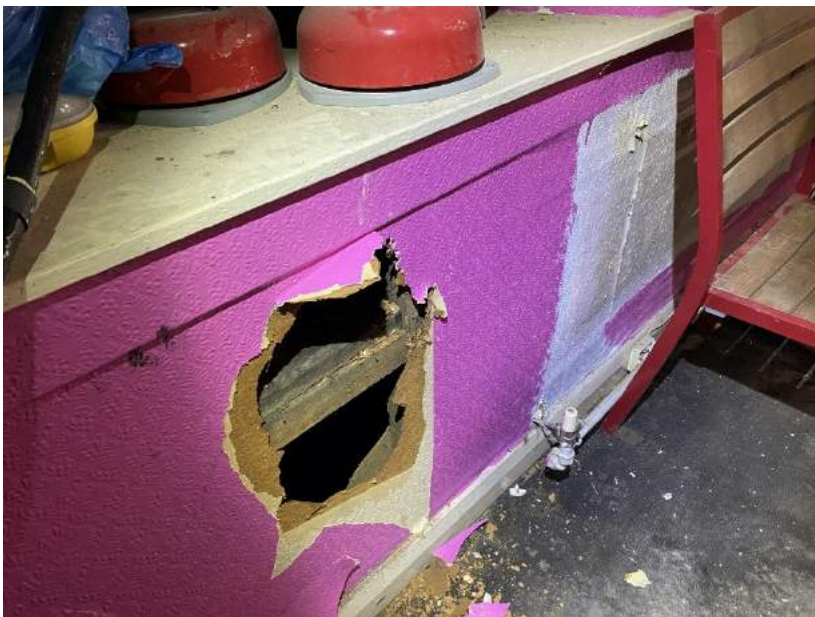
**Fig 76:**

Upper Ground Floor, MS-UG04;  
showing a close-up of the non-original  
fibreboard boxing at low-level

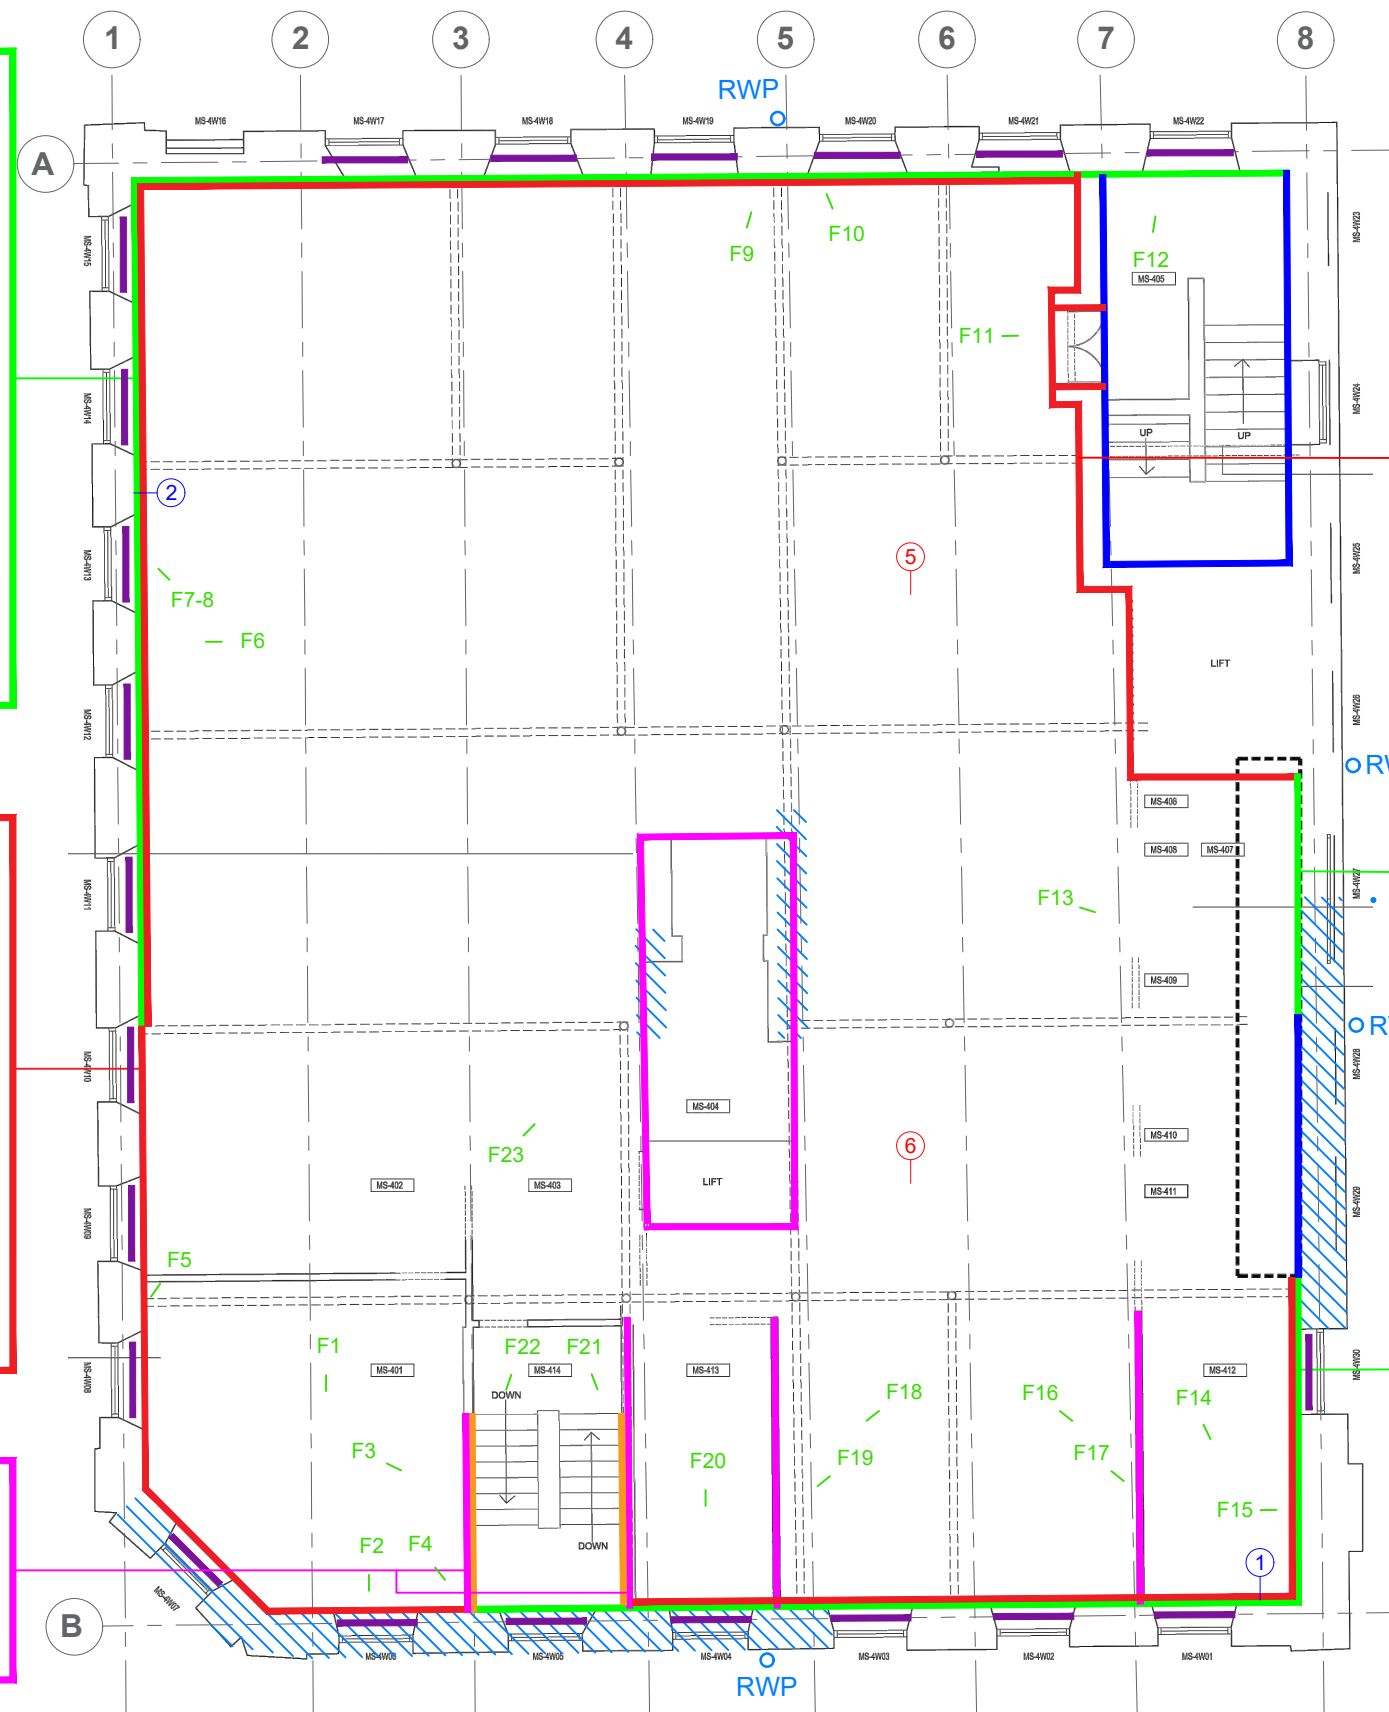
**Mindel House, Manchester - Fourth Floor**  
Plaster condition survey  
8 April 2021

Plaster condition: Lime plaster largely debonded and generally in poor condition. Lath and plaster partially decayed in localised areas

Plaster condition: Inadequate 'key' to the brick substrate and largely debonded

Plaster condition: Wet and largely debonded. Lath and plaster heavily decayed by wet rot in areas of water penetration

Timber condition: Timbers damp and partially decayed by wet rot against external wall

Plaster condition: Wet and largely debonded

Plaster condition: Good 'key' prepared to brick substrate and plaster generally well bonded but wet in areas of water penetration

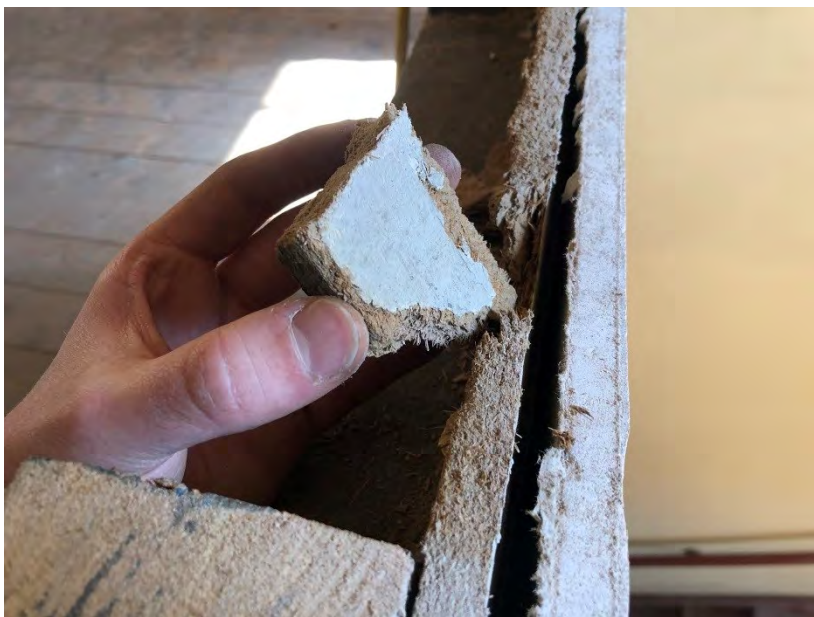
**Fig 3:**

Fourth floor, South staircase; showing softwood stud partitions lined with insulated fibreboard and plasterboard. This partition post-dates the fire

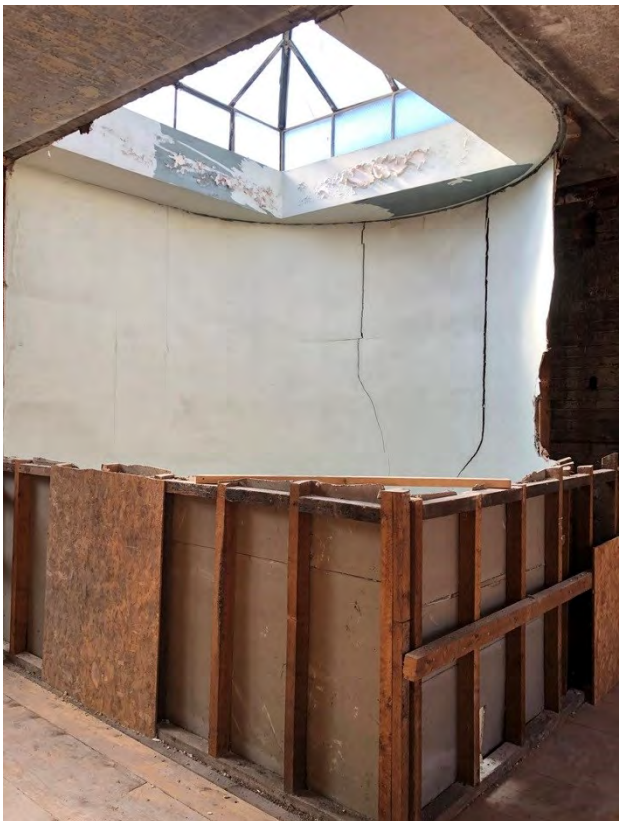
**Fig 5:**

Fourth floor, West staircase; showing the non-original softwood stud partition around the staircase that leads to the Fourth floor. Plasterboard had recently been removed

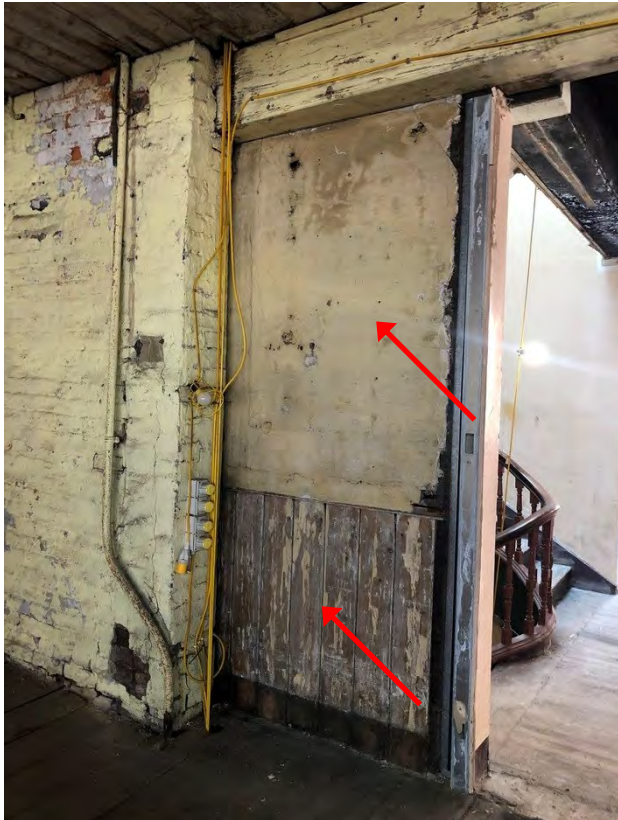
**Fig 22:**

Second floor, South staircase; showing a view inside the stud partition. Note lath and plaster had been applied to either side of the studwork

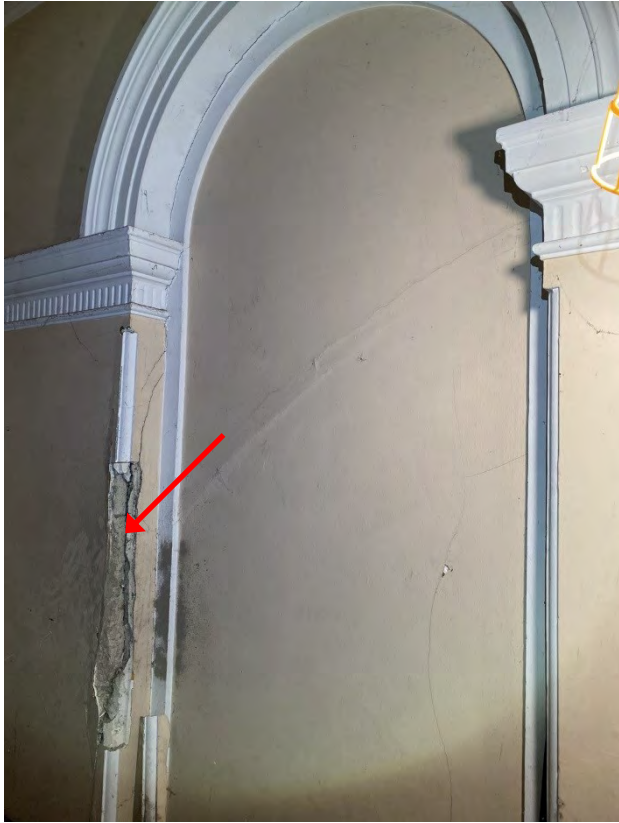
**Fig 57:**

Upper ground floor, West entrance lobby; showing lime plaster and decorative mouldings to the internal brick wall. Plaster was generally in fair condition but with localised mechanical damage

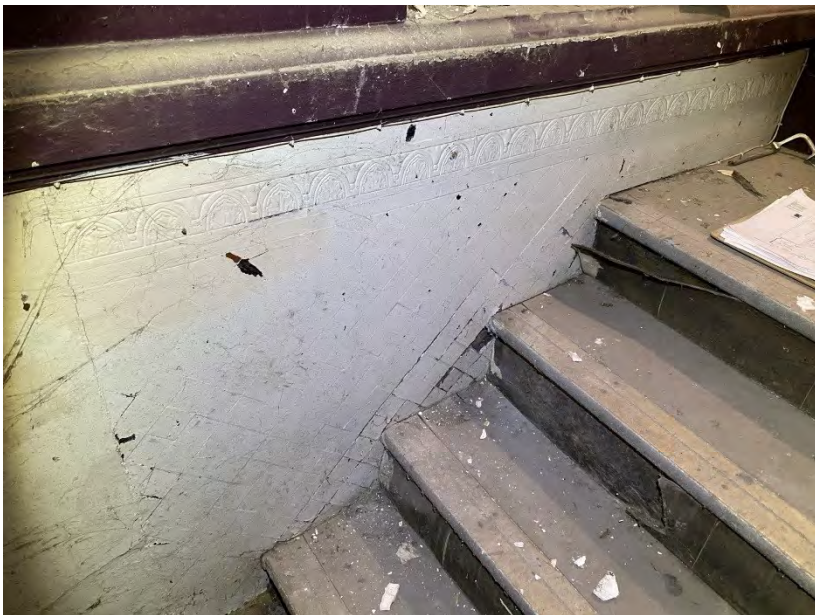
**Fig 58:**

Upper ground floor, West entrance lobby; showing painted glazed tiling at low level. A proportion of the tiles were loose and a small number were missing

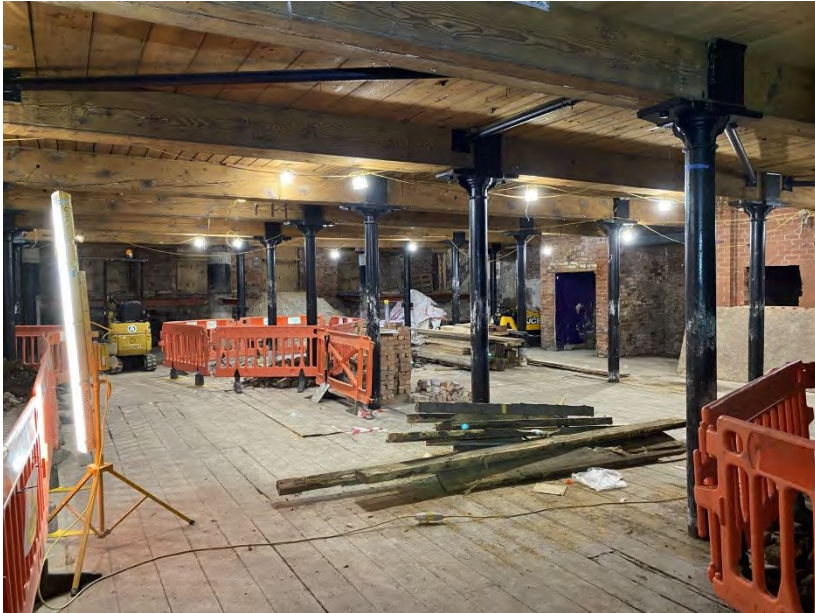
**Fig 59:**

Lower ground floor; showing a general view of the undecorated masonry

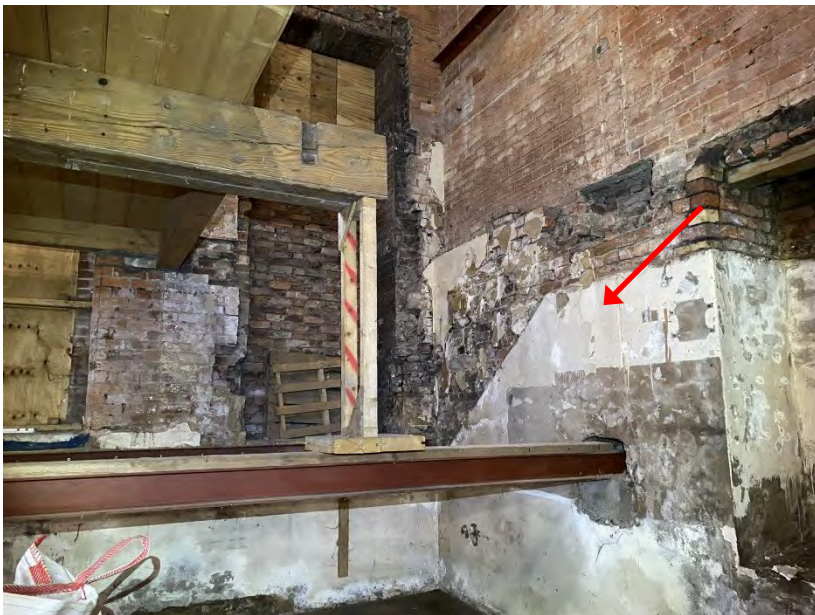
**Fig 60:**

Lower ground floor, South east corner; showing use of cementitious plaster tanking to the external walls. The plaster had largely debonded

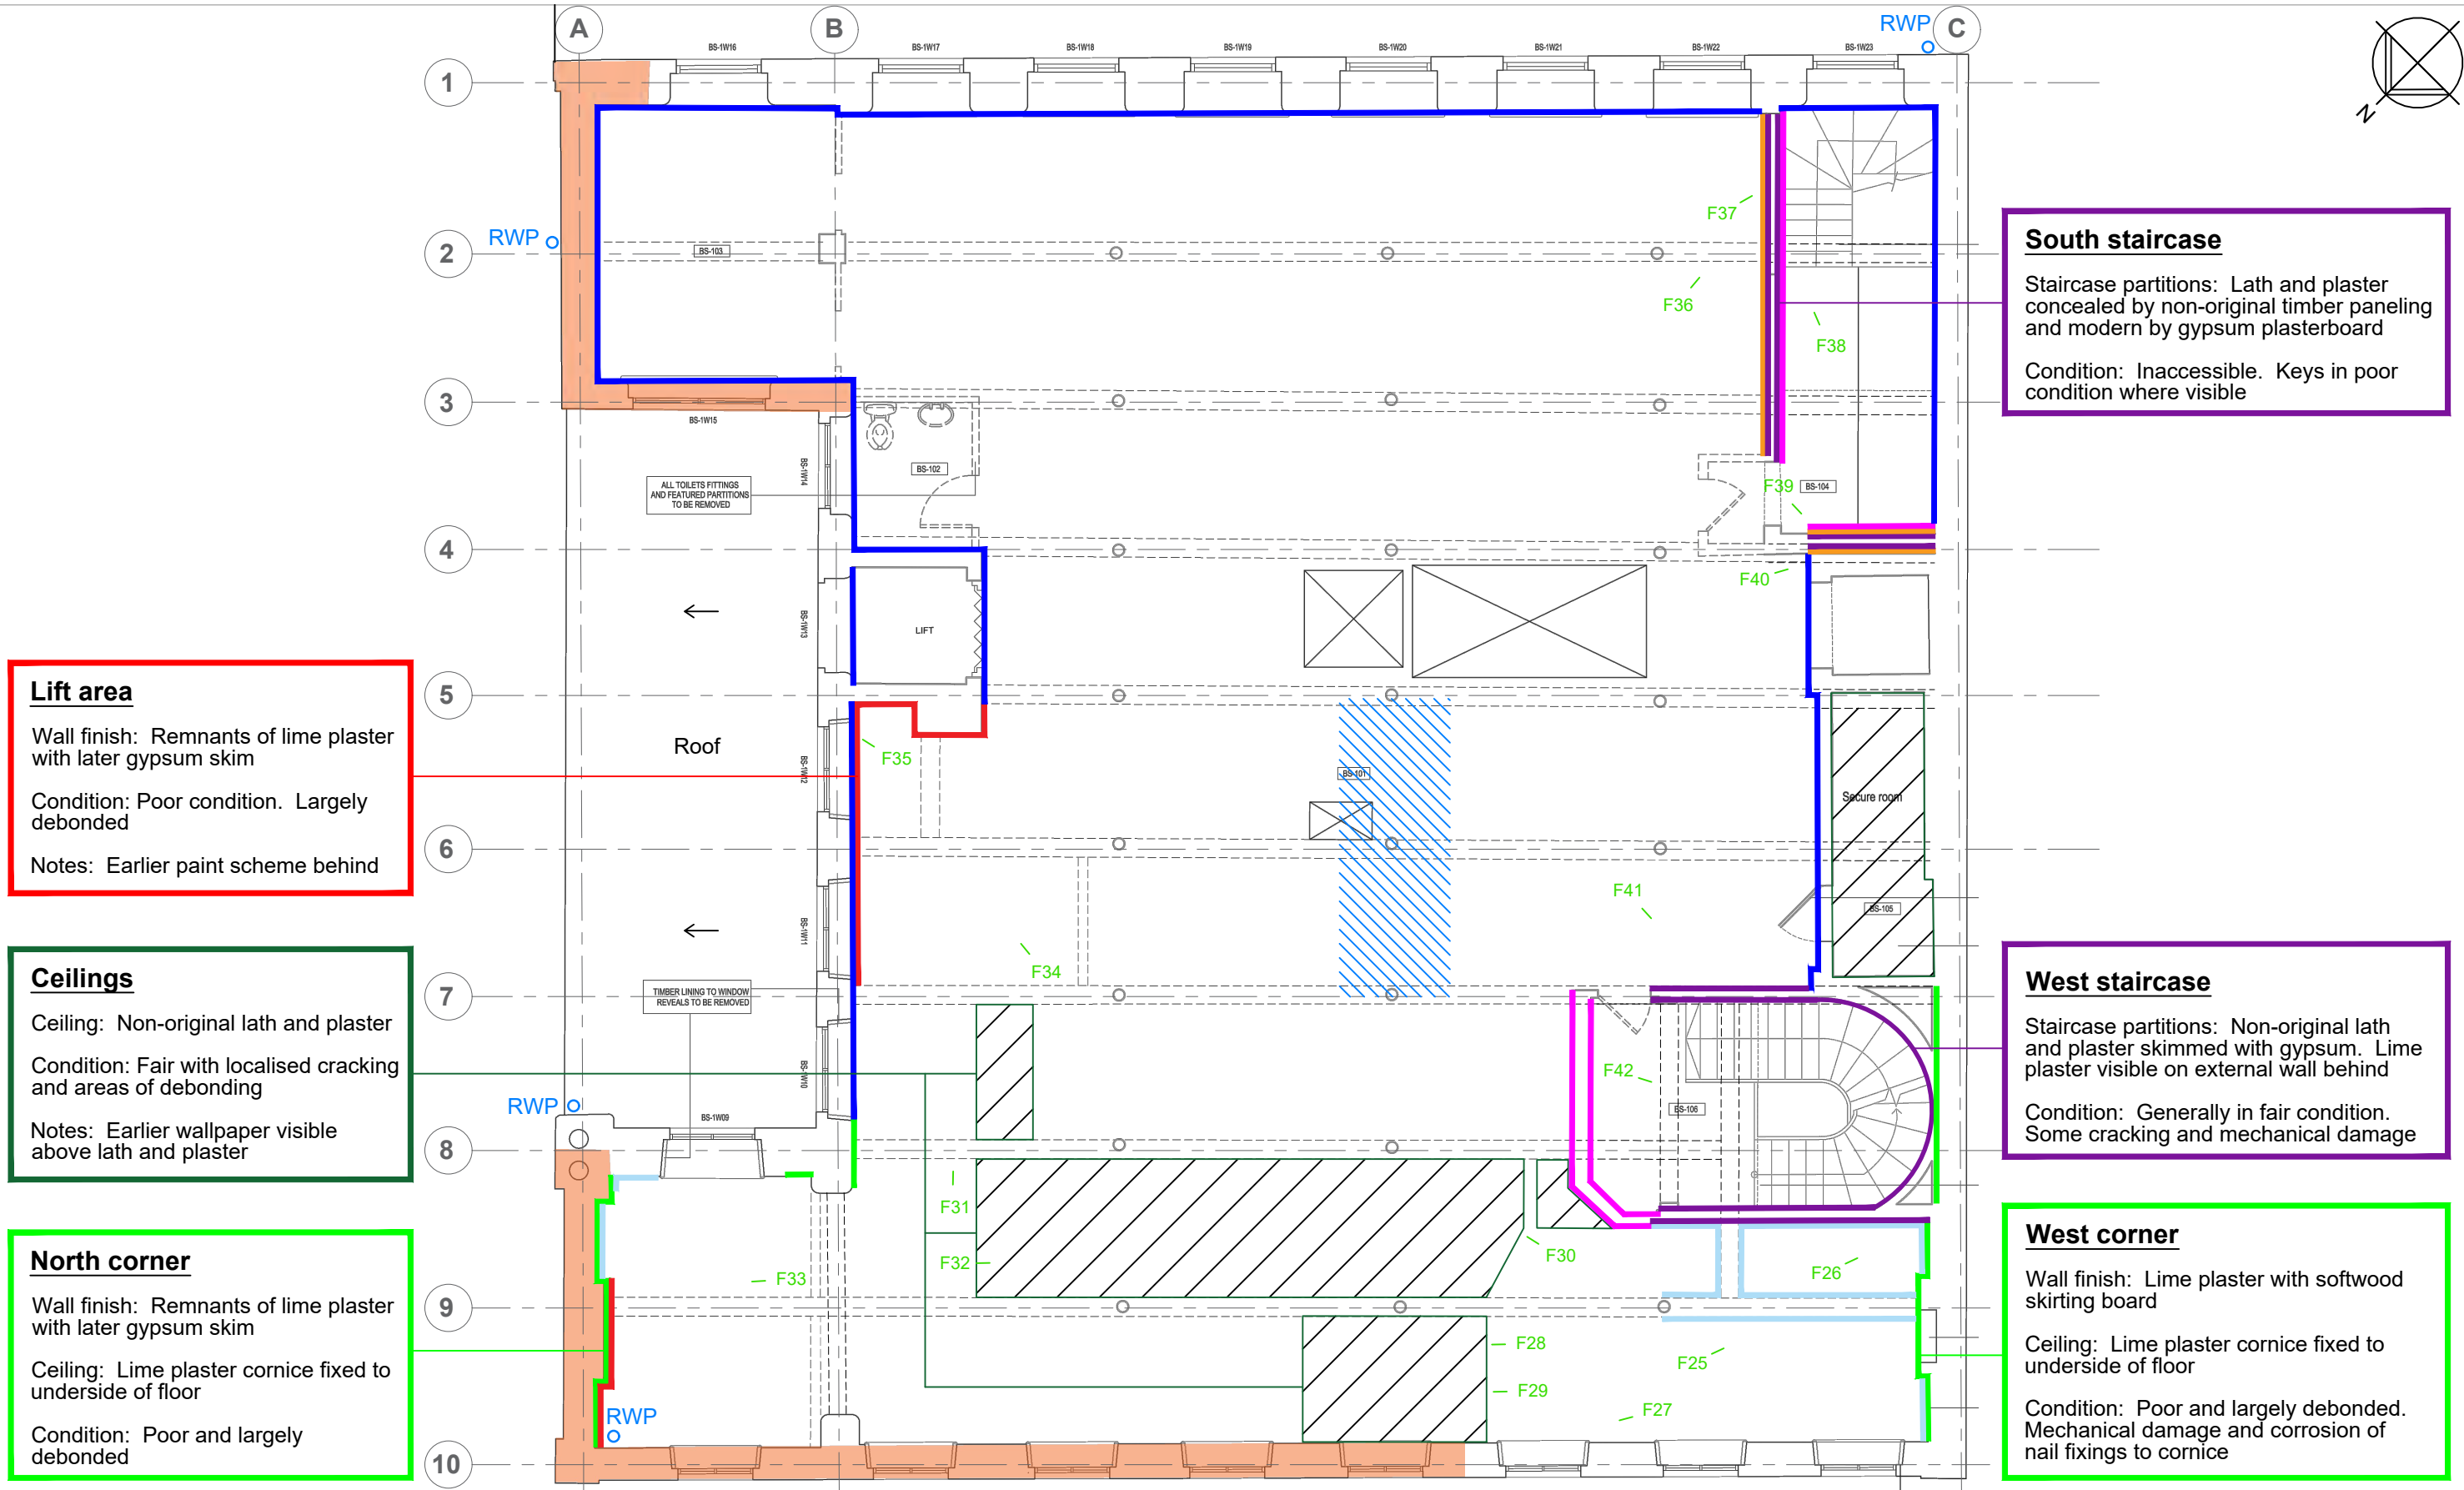
**Lift area**

Wall finish: Remnants of lime plaster with later gypsum skim

Condition: Poor condition. Largely debonded

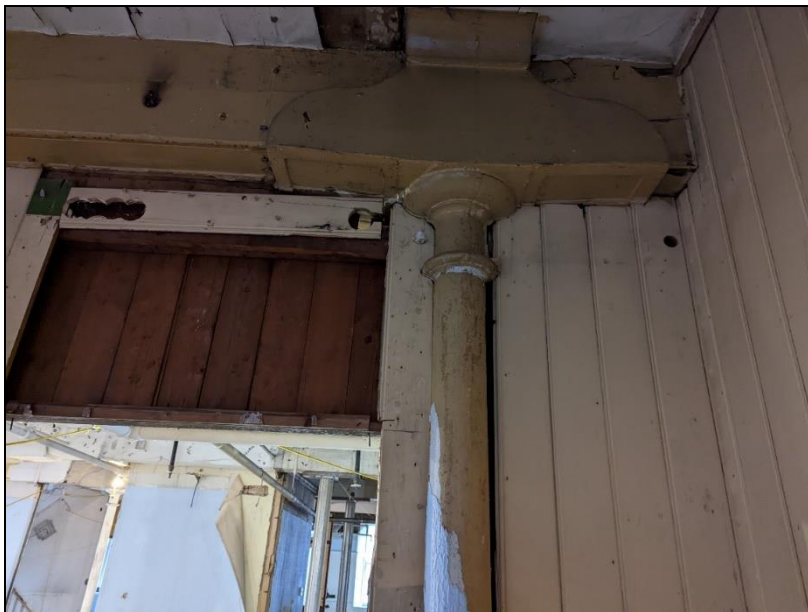
Panelling around stanchion

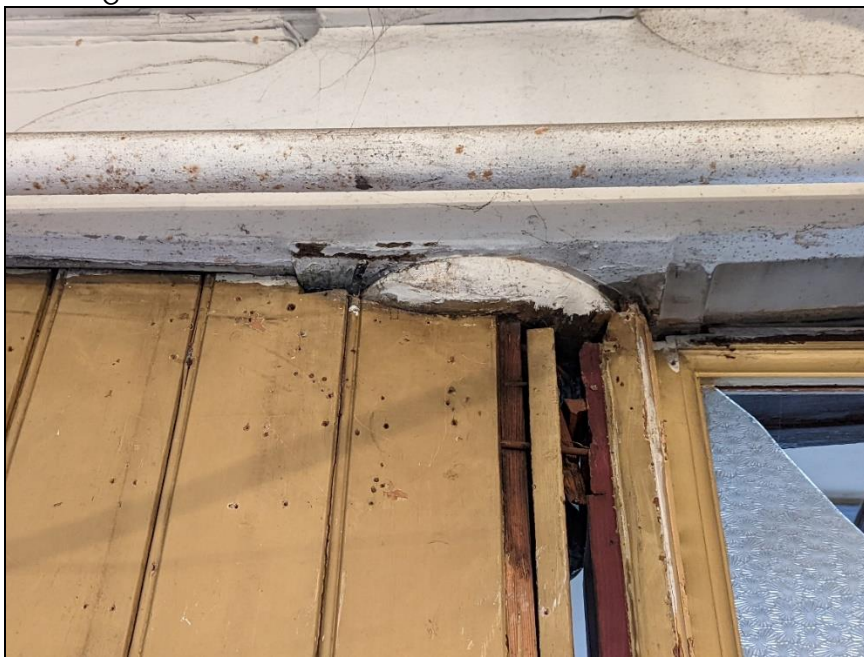
Crude panelling installation detail around stanchion

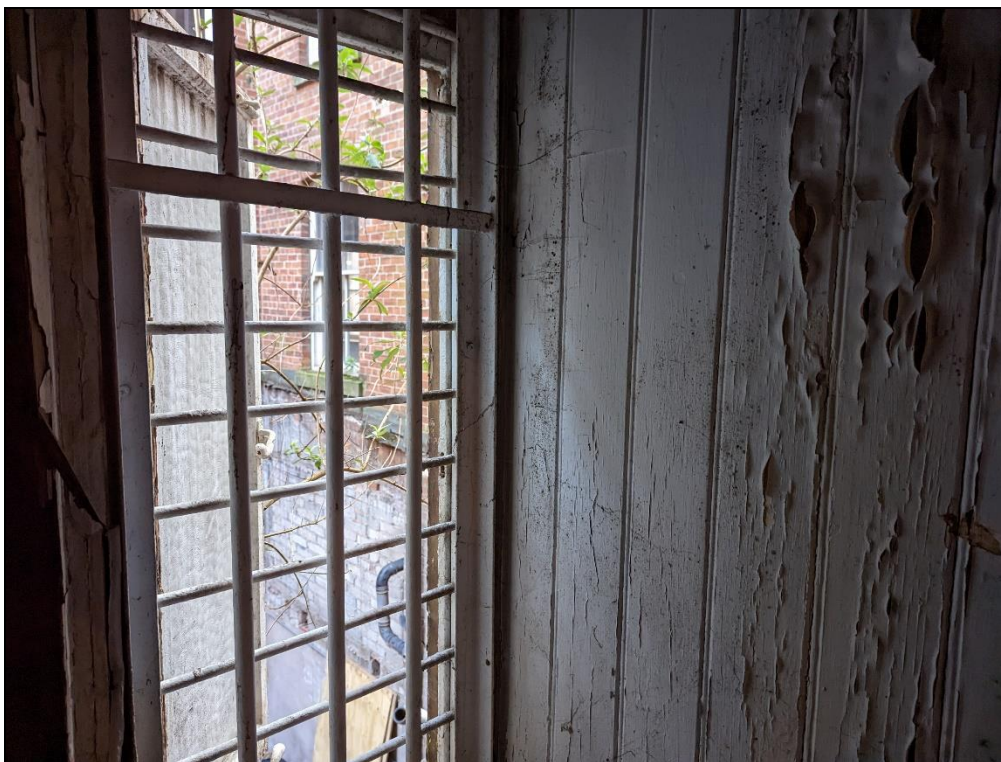
The timber panelling forming the toilets on the second floor butt up against the centre of the window, forming a timber mullion visible from the exterior and suggesting it as a later addition. The timber panelling on the fourth floor appears to be the same date, likely early – mid 20<sup>th</sup> century.

Panelling butting up to window in toilets

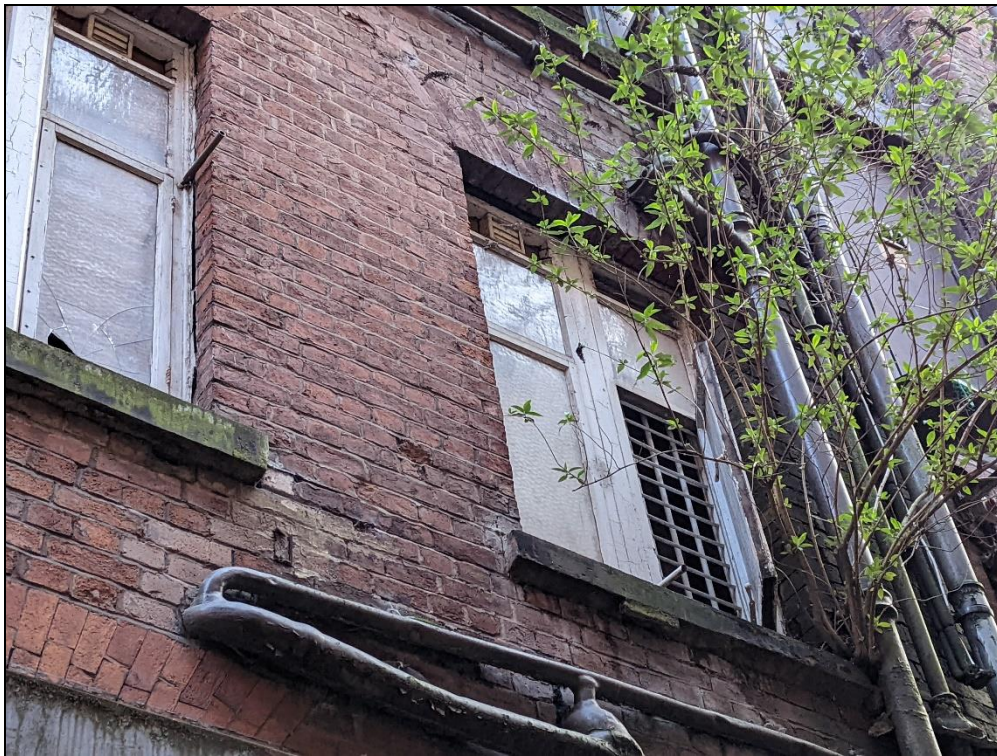
windows as viewed from outside showing inserted timber mullion in centre

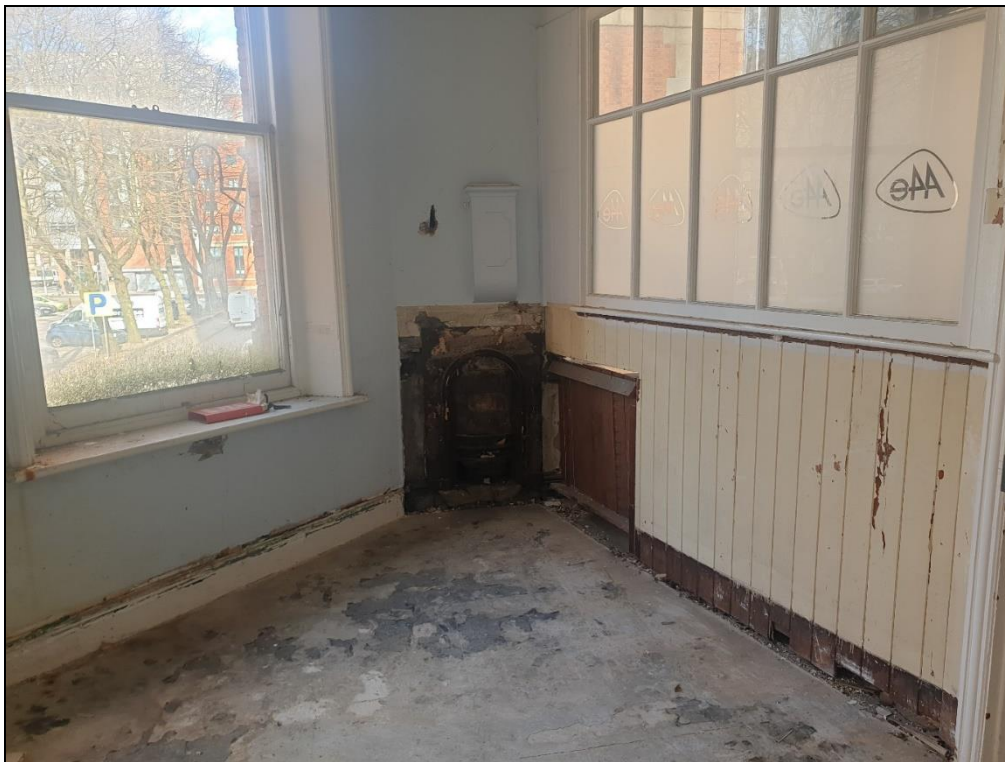
The timber office walling to the first floor has boards of the same width and butts up to the wall directly adjacent to a revealed fireplace. This suggests that the area was originally an office, although the proximity of the timber wall to the fireplace suggests it was inserted after the fireplace went out of use.

Timber panelling up to revealed fireplace floor

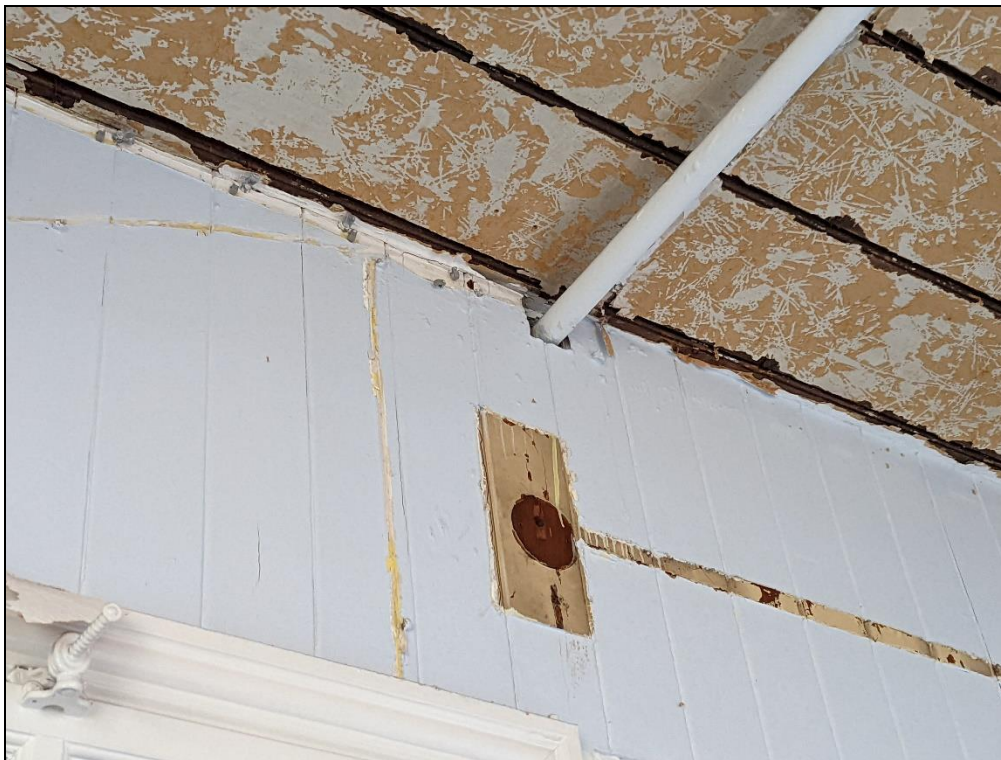
Timber panelling cut around sprinkler system

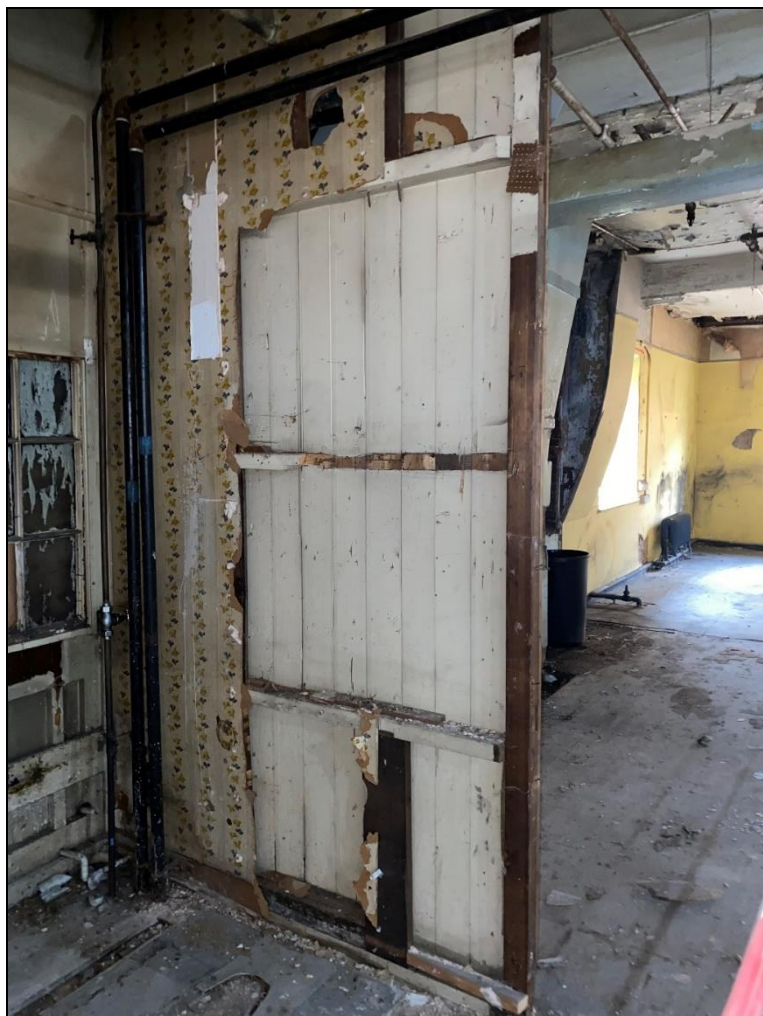
Timber partition / panelling at fourth floor.

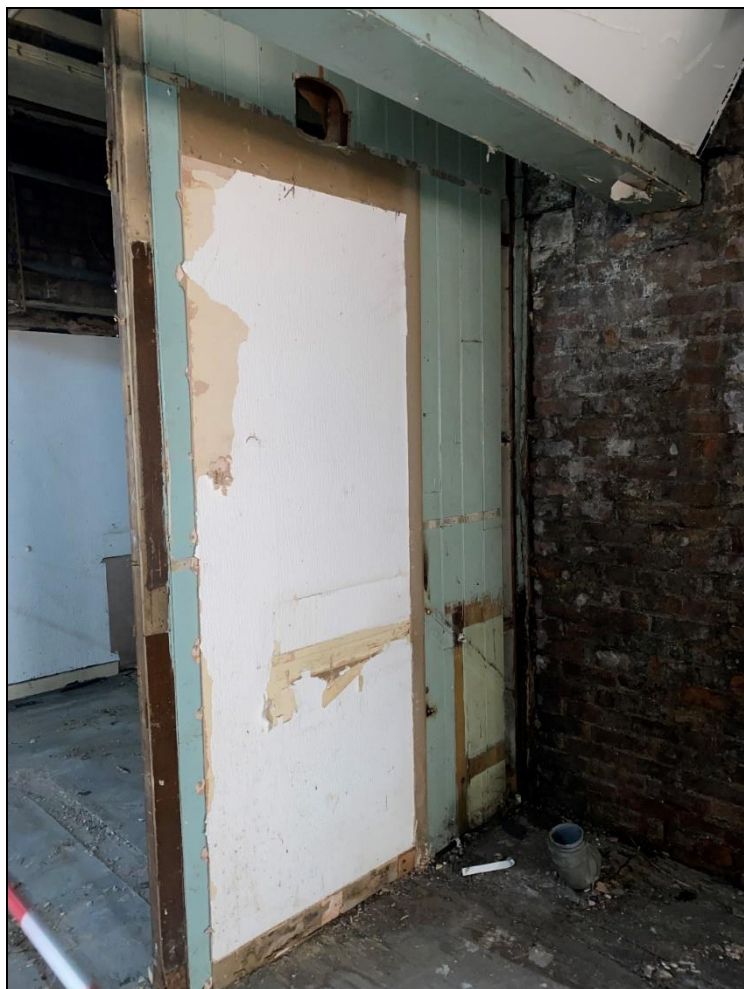
Timber partition / panelling at fourth floor.

The timber panelling around the modern lift appears to be modern and is wider than the rest of the panelling found throughout, suggesting it was added during a different period.

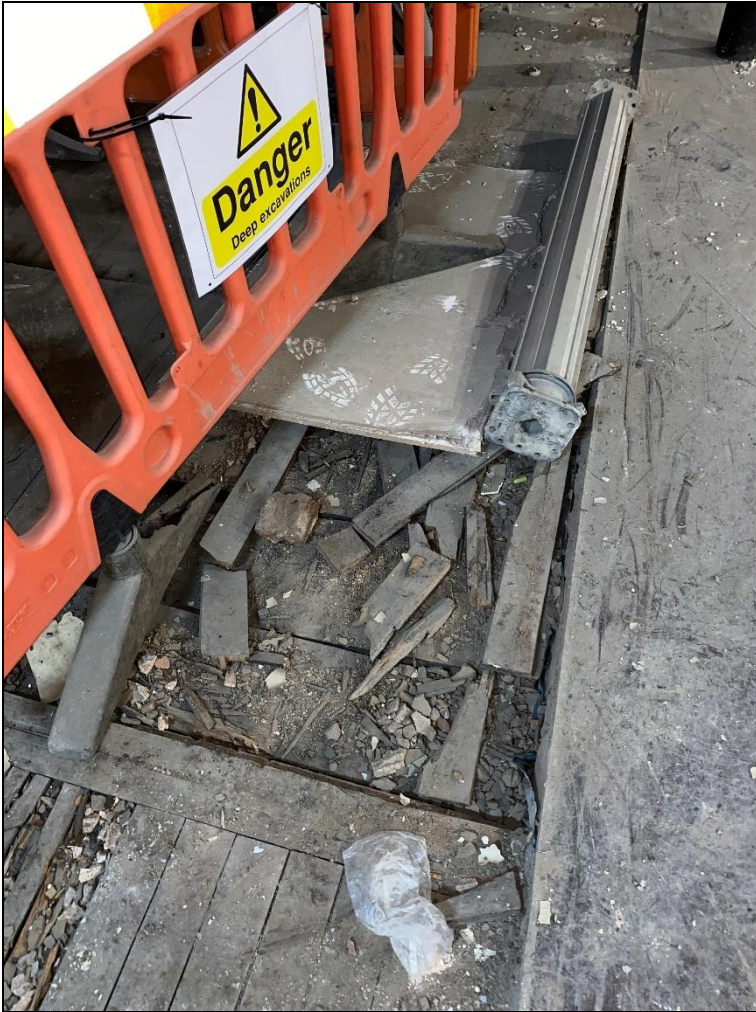
Timber flooring around the central lift shaft was observed and appears to comprise historic boards. Investigation by Hutton + Rostron has suggested that the boards are not thought to be original to this setting and may have been recycled from a late 19th Century warehouse or mill building.

Historic boards around the lift shaft at basement level.

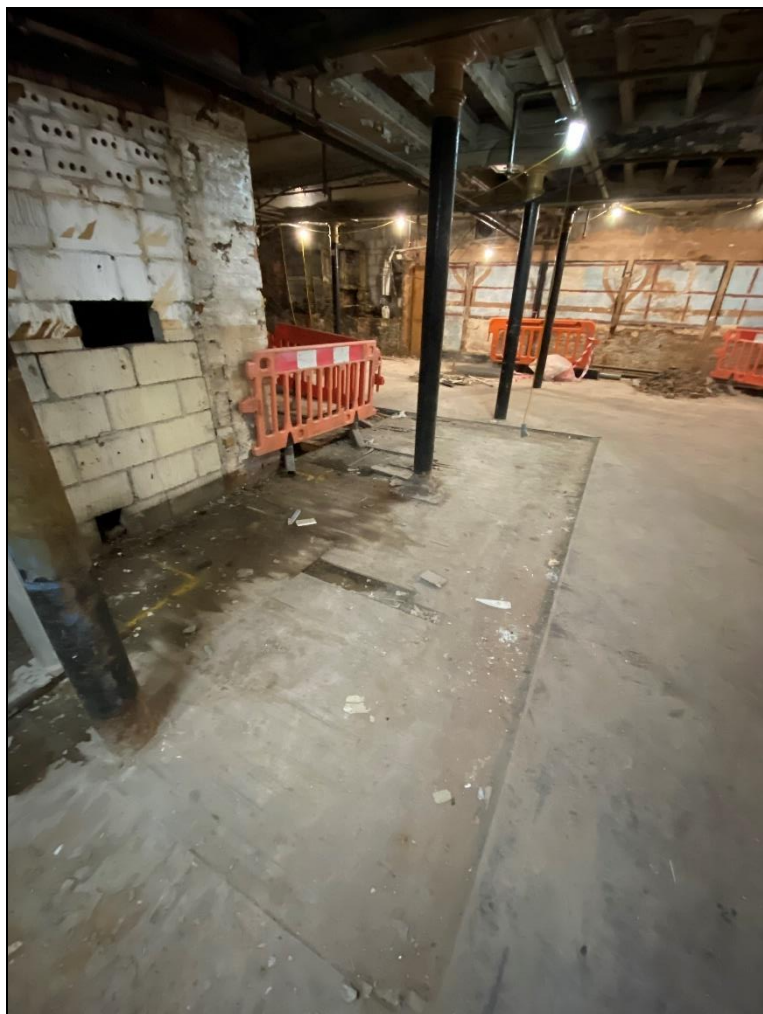
Historic boards around the lift shaft at basement level.
