10 Minshull Street and 11 Bloom Street

**ADDITIONAL FEATURES**

PLANNING CONDITIONS RELEASE 11(a), (h), (r), (s)

Planning Permission 119374/FO/2018 – BOTH BUILDINGS

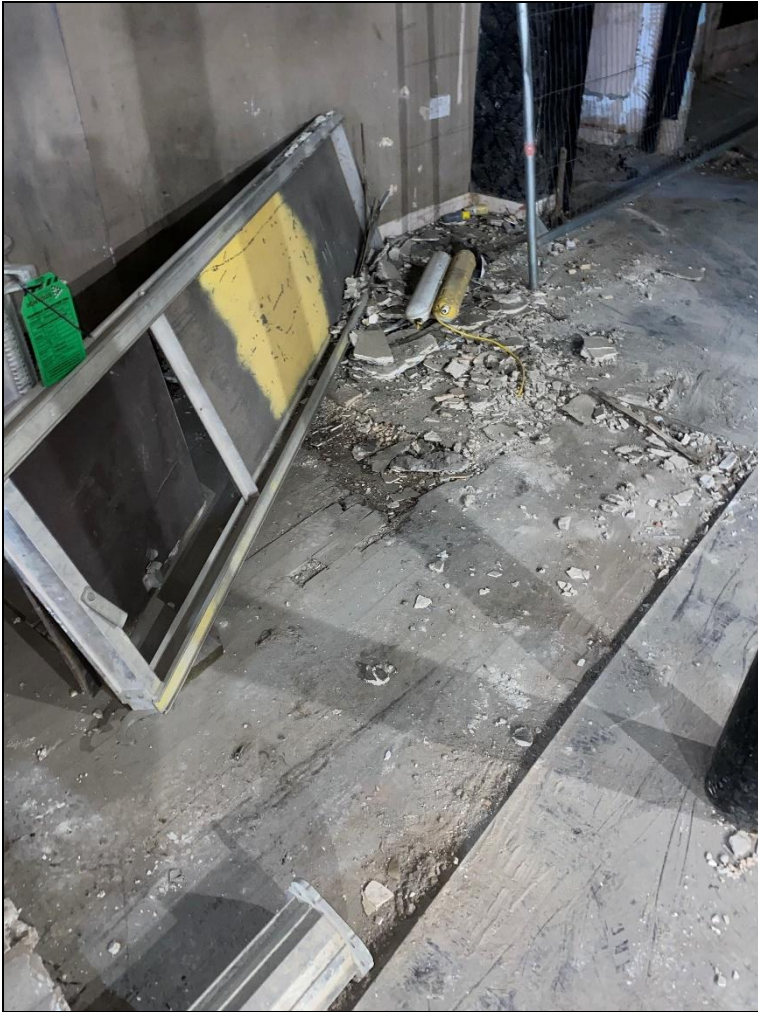
Historic boards around the lift shaft at basement level.

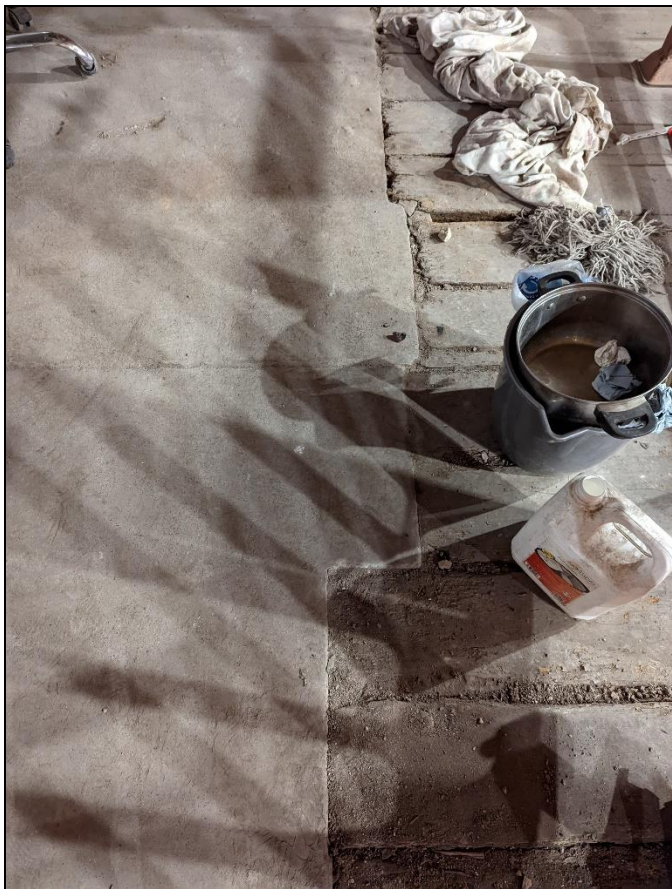
Line of concrete butting against timber boards evocative of flag stones

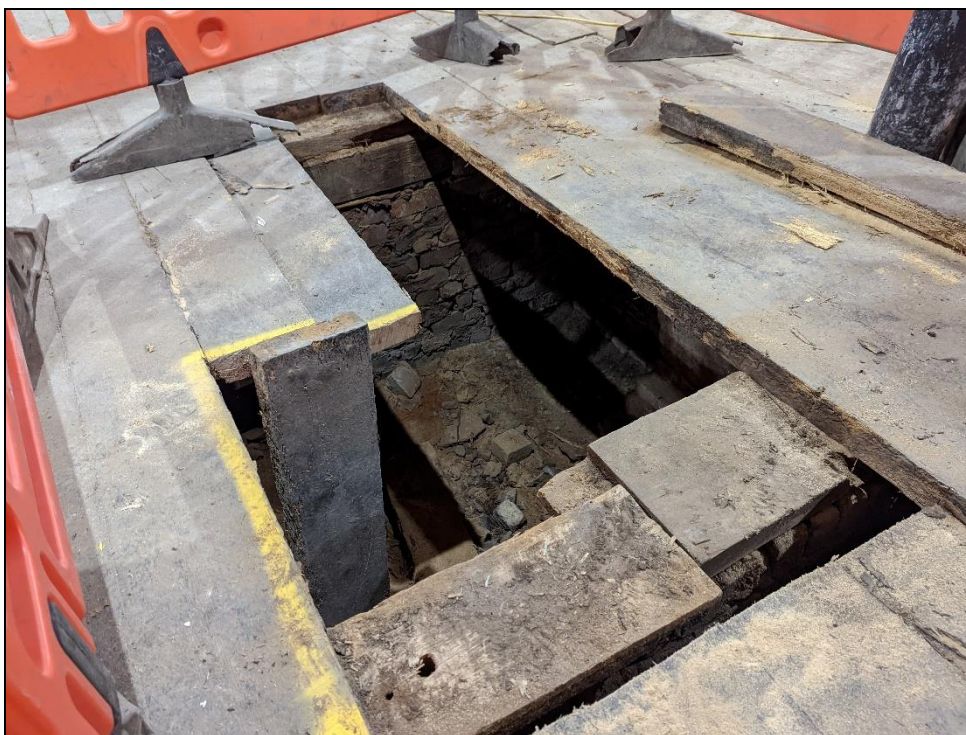
Boards supported on stone walls

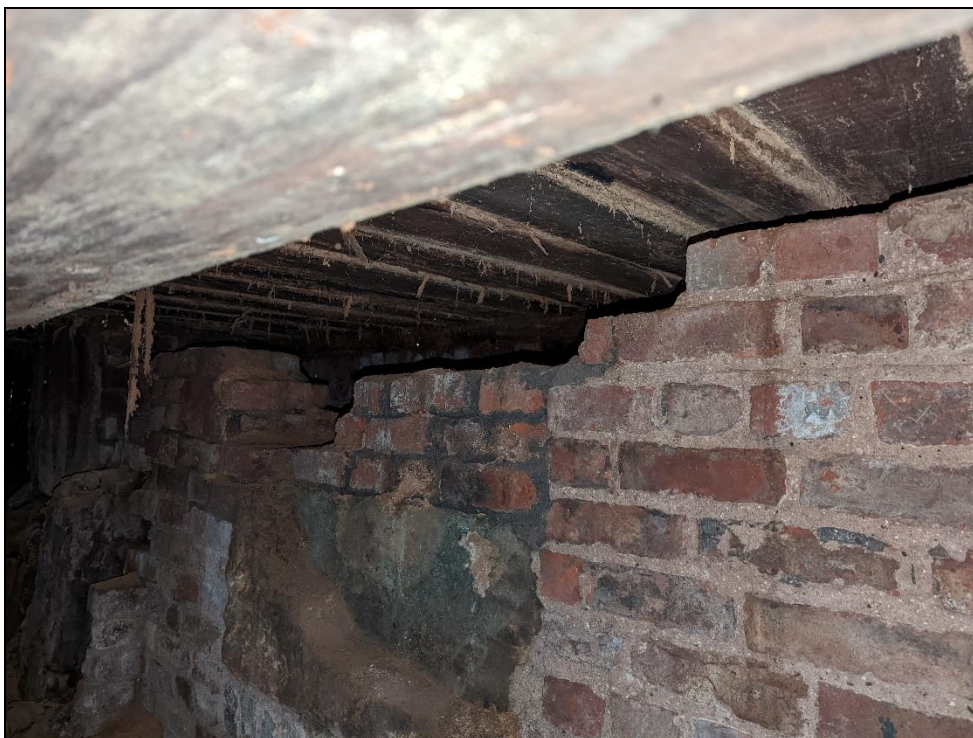
Brick wall supporting boards at junction with concrete, showing a pink lime mortar suggestive of 19<sup>th</sup> century construction

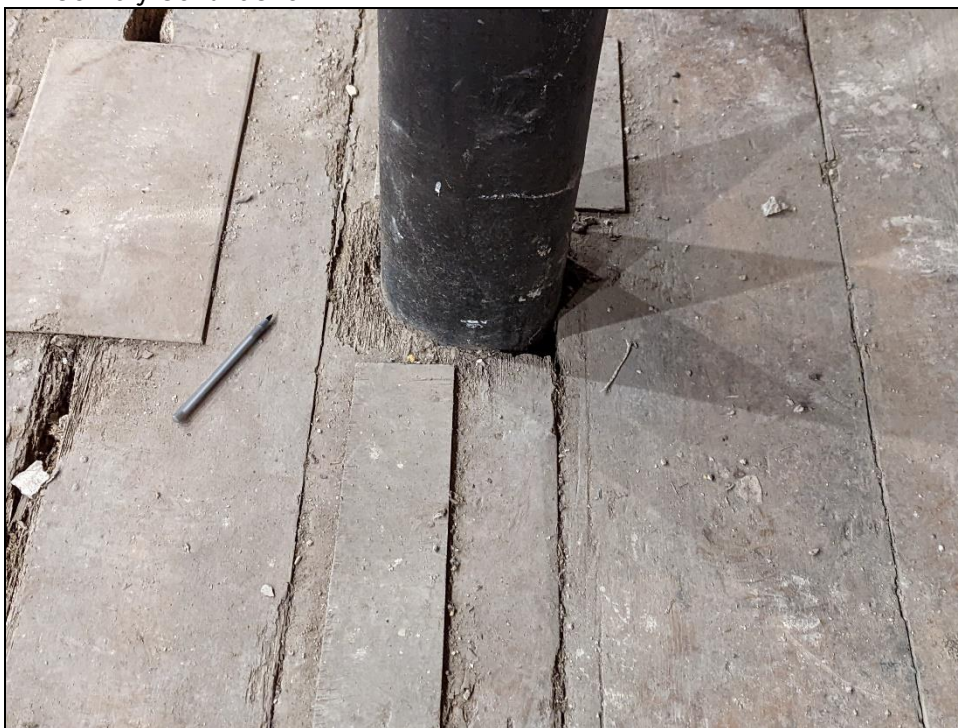
Floorboard finish around stanchion

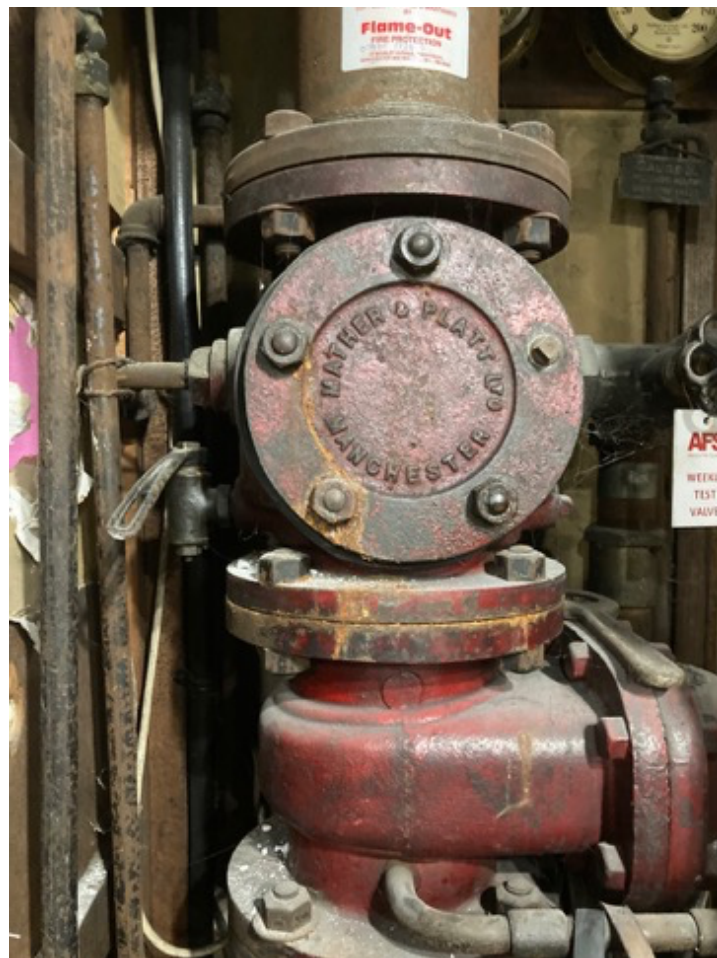
The sprinkler system in the Piccadilly Warehouse, as far as can be ascertained, was probably installed between in the years before the First World War. The main sprinkler valve marked 'Mather & Platt' was in production from 1890 until 1948. (Photo 1) Its alarm components almost certainly date from no earlier than 1910. However, many of the visible sprinkler heads date from the 1960/70's - possibly having been installed when alterations were undertaken when the building's use changed from warehousing to offices. The alterations undertaken included extensions to the water distribution pipework and relocation of sprinkler heads as well as new heads.

Photo 1: Detail of Sprinkler Alarm Valve

Despite the Mather & Platt nameplate, this is a Dowson Taylor 'Type A' alarm valve. Dowson Taylor merged with Mather & Platt in 1896.

While it would be possible to conserve and refurbish the valves and related components and individual sections of pipework for display these will almost certainly be in inappropriate areas or where parts of the new structure impact on their visibility. It's hard to see how the alarm valves in Photos 1 and 6 could be displayed *in situ* given their present locations.

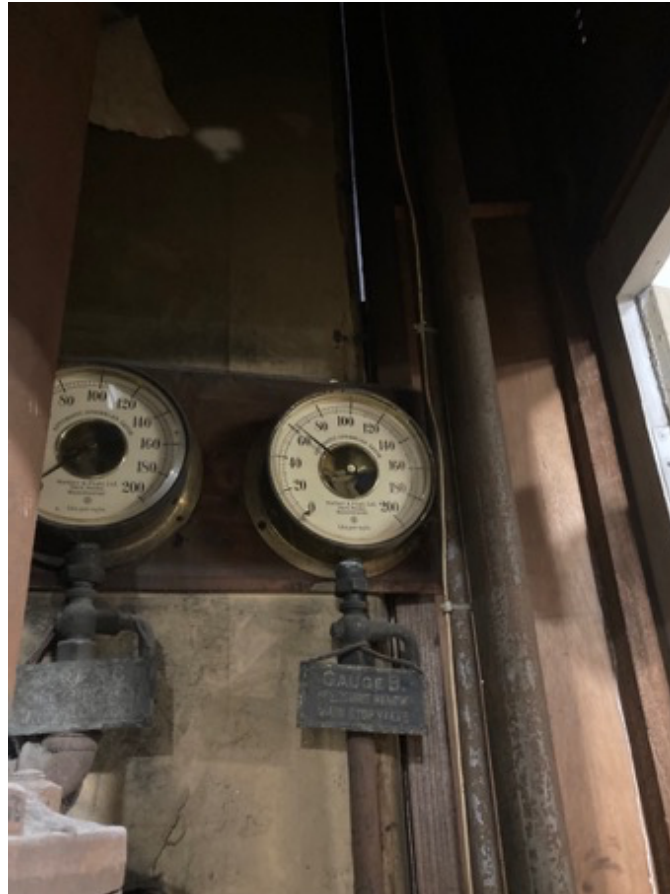
Other components of interest include the large pressure gauges (Photo 2) and the rotary alarm gongs. Photo 3A shows the interior of the building with the gongs painted in white. Photo 3B shows the exterior of the gongs in red – these are a common sight in urban areas in Lancashire and the NW. Photo 3C shows the detail of the sprinkler valve warning plate which is intended to assist the fire brigade when responding to a protected building. This would originally have been painted white with red lettering.

3. At the time of my visit, the pressure indications on the gauges suggested that the system upstream of the stop and alarm valves was pressurised at 3.5 Bar. This in itself presents a hazard to the construction process during the conversion of the building<sup>3</sup>.

Photo 2: Pressure Gauges

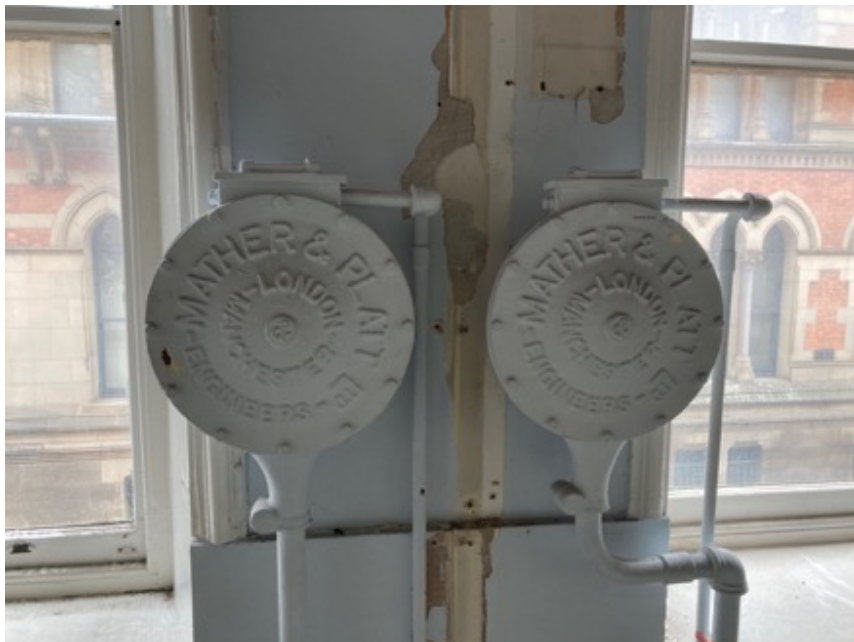
Photo 3A Interior of building showing rear of rotary alarm gongs

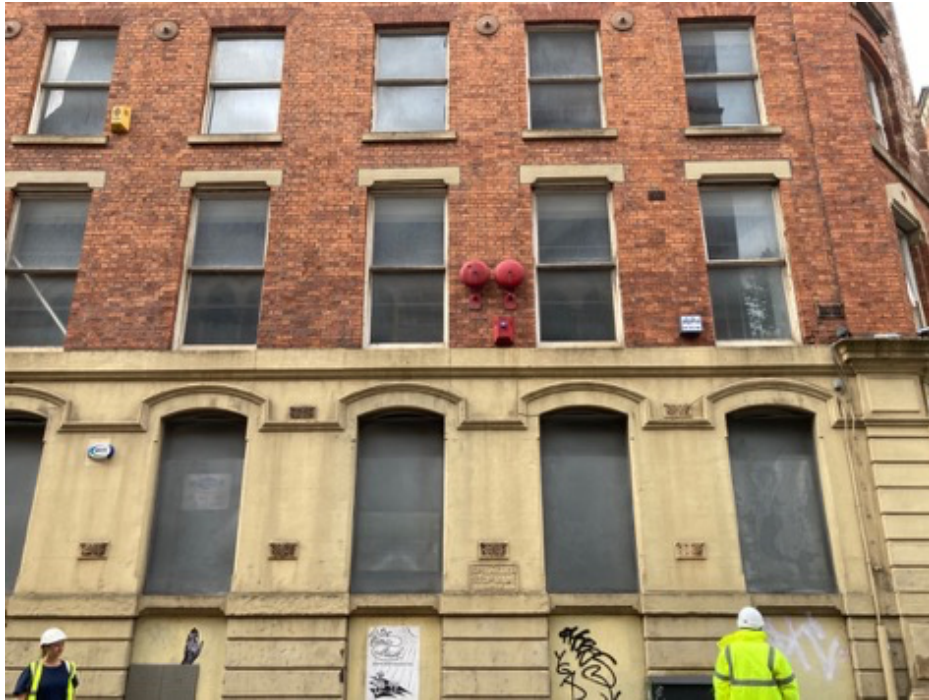
Photo 3B Exterior of building showing red painted rotary alarm gongs

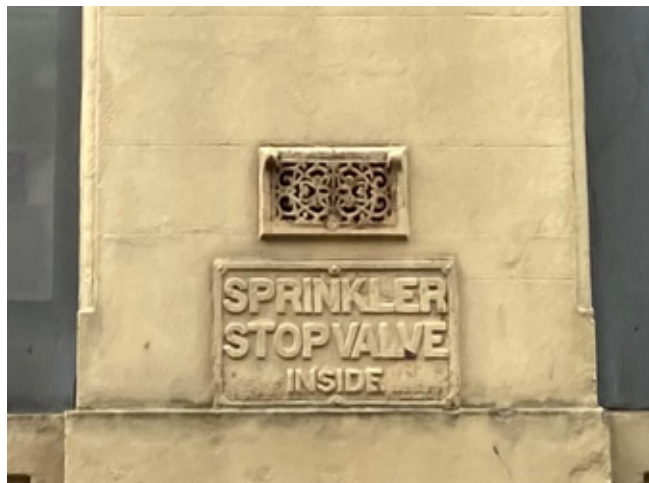
Photo 3C Sprinkler Marker Plate (directly below alarm gongs)

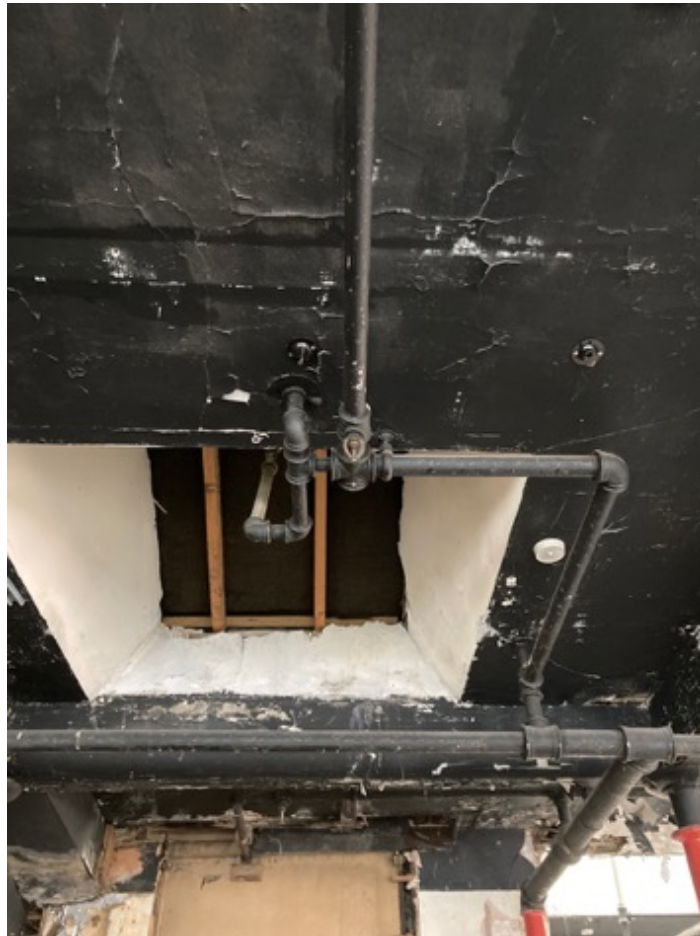
Much of the sprinkler pipework appears in poor condition with evidence of past leakage at the joints – not unusual in a pipe threaded system of this age. Perhaps the oldest part of the visible pipework is shown at Photo 4A. Photo 4B shows what may be the oldest sprinkler head in the building, possibly pre-WW1. For comparison, Photo 5 shows a relatively modern sprinkler head probably installed in the 1970's or later when the building's use changed. It will be possible to date the head precisely by close examination of the deflector or yoke which I was not able to do at the time of my visit.

Photo 4A: Old pipework and sprinkler head – certainly pre-WW2

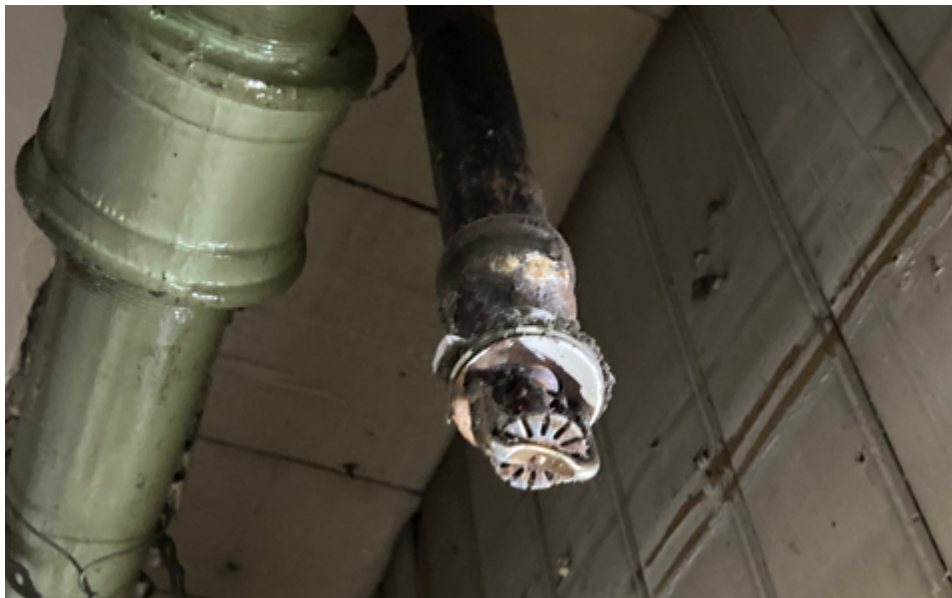
Photo 4B: Probably oldest visible sprinkler head  
Note external corrosion on range pipe above head

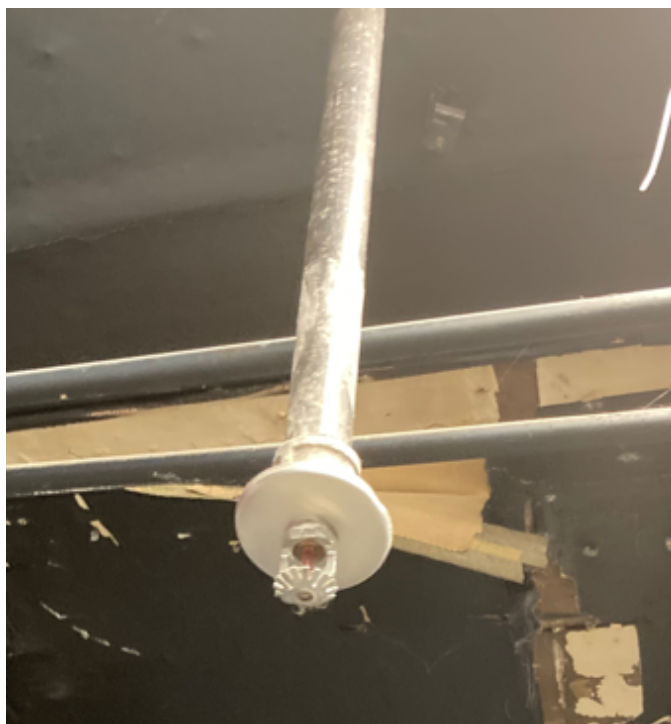
1. It should be recognised that although there has been a sprinkler system in the warehouse building for more than 100 years, it lacks significant authenticity and originality having been modified over the years to take account changes of use and the layout of the building. Much pipework and many sprinkler heads date from the 1970's. (Photo 5)

Photo 5: Modern sprinkler head and pipework
