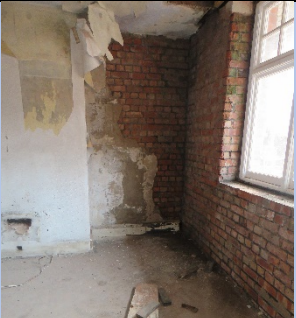
| Room Ref. | Element | Description / Item | Condition | Action | Photographs | | | |
|---|---|---|---|---|---|---|---|---|
| | Joinery | Skirting in situ. Picture rail. | | Proposed works <ul style="list-style-type: none"> <li>Timber skirting and picture rail to be removed.</li> </ul> | | | | |

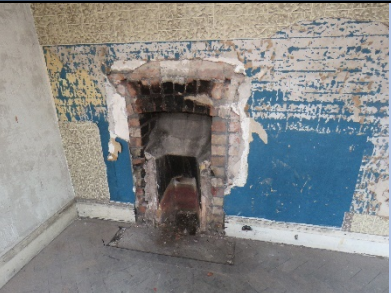
| Room Ref. | Element | Description / Item | Condition | Action | Photographs | | | |
|---|---|---|---|---|---|---|---|---|
| 222a-c | Walls | Plaster on brickwork with wallpaper finish. Hole to wall. | Fair | <ul style="list-style-type: none"> <li>De-nail walls.</li> <li>Infill area of wall to door opening with salvaged brickwork.</li> </ul> <hr/> Proposed works <ul style="list-style-type: none"> <li>Strip all walls back to masonry</li> <li>Provide insulated plasterboard (refer to wall type drawing) and secondary glazing (NBS:L10/580A) to east wall (LR).</li> <li>Provide stud partitions to form internal bathroom and lobby (222b&amp;c) as per drawing 2415.</li> <li>Provide acoustic plaster board to south party wall and to west corridor party wall as per drawing 2415.</li> <li>North (party) wall to remain as bare masonry, refer to drawing 2415.</li> </ul> | | | | 00<br>1 |

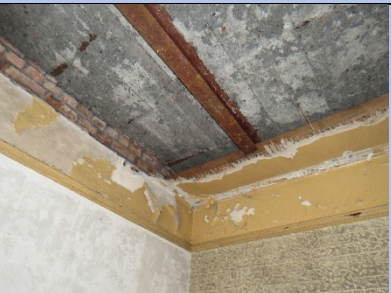
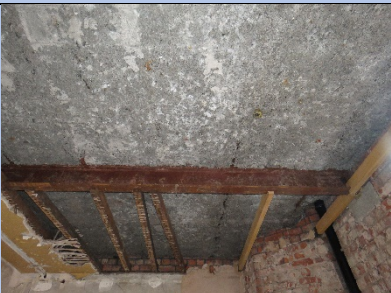
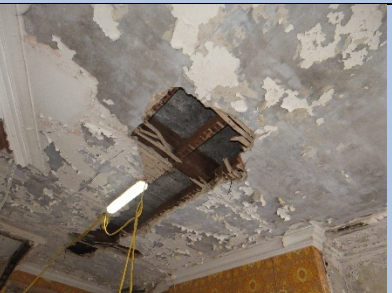
| Room Ref. | Element | Description / Item | Condition | Action | Photographs | | | |
|---|---|---|---|---|---|---|---|---|
| | Ceiling | Plaster on lath with paint finish. Areas of lost ceiling. Remnant of plaster cornice. | Poor | <ul style="list-style-type: none"> <li>Retain timbers from steel beams.</li> <li>Retain plaster cornice.</li> </ul> <hr/> Proposed works <ul style="list-style-type: none"> <li>Existing lath and plaster ceiling to be removed along with timber substrate</li> <li>Steel beams to be de-rusted and treated with intumescent paint per NBS:M61/120.</li> <li>Provide new plasterboard ceiling within the structural steel zone. Refer to drawing 2253.</li> </ul> | | | | |

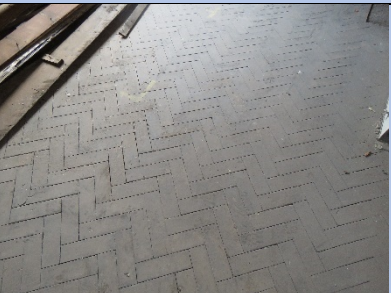
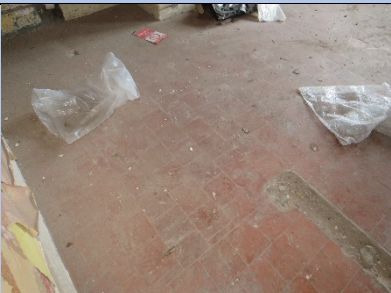
| Room Ref. | Element | Description / Item | Condition | Action | Photographs | | | |
|---|---|---|---|---|---|---|---|---|
| | Floor | Red quarry tile, wood block and glazed tile to hearth. | Good / fair | <ul style="list-style-type: none"> <li>Remove all debris.</li> <li>Clean red quarry tile and protect.</li> <li>Record quantity of wood block, lift and store on pallet in room.</li> </ul> <hr/> Proposed works <ul style="list-style-type: none"> <li>Floor to be levelled and prepared throughout with latex levelling screed or similar NBS:M10/120.</li> </ul> | | | | |

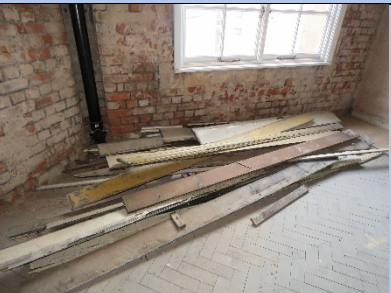
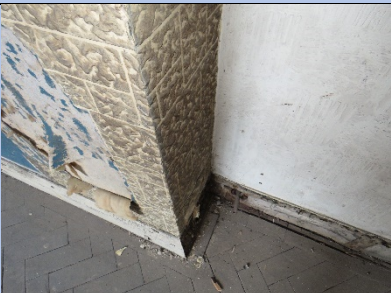
| Room Ref. | Element | Description / Item | Condition | Action | Photographs | | | |
|---|---|---|---|---|---|---|---|---|
| | Joinery | Skirting in situ. Pile of joinery. | | <hr/> Proposed works <ul style="list-style-type: none"> <li>Timber skirting and picture rail to be removed.</li> <li>Loose timber to be reused where possible otherwise scrapped.</li> </ul> | | | | |

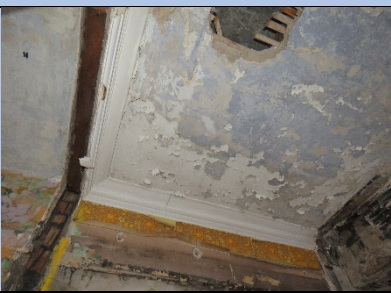
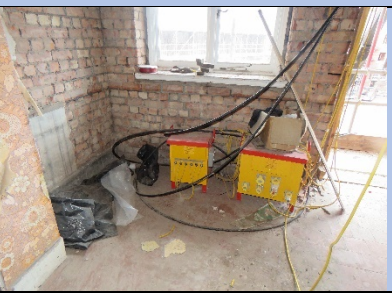
| Room Ref. | Element | Description / Item | Condition | Action | Photographs | | | |
|---|---|---|---|---|---|---|---|---|
| | Misc. | Redundant pipe and fixings. | | <ul style="list-style-type: none"> <li>Remove redundant pipe and fixings.</li> </ul> <hr/> Proposed works <ul style="list-style-type: none"> <li>Repair, clean fireplace insert.</li> </ul> | | | | |

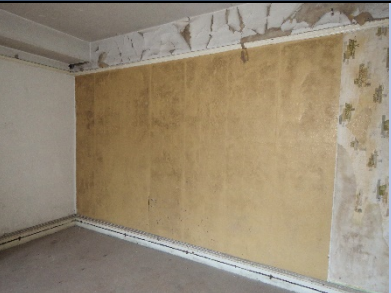
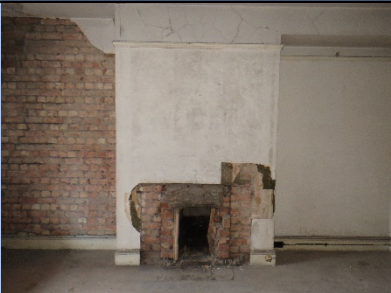
| Room Ref. | Element | Description / Item | Condition | Action | Photographs | | | |
|---|---|---|---|---|---|---|---|---|
| 224a-b | Walls | Plaster on brickwork with wallpaper finish. Hole to wall from old vent. Remnant of removed wall. | Fair | <ul style="list-style-type: none"> <li>De-nail walls.</li> <li>Remove remainder of now removed partition.</li> </ul> <hr/> Proposed works <ul style="list-style-type: none"> <li>Strip all walls back to masonry</li> <li>Provide insulated plasterboard (refer to wall type drawing 2415) and secondary glazing (NBS:L10/580A) to east wall 224a (LR).</li> <li>Provide stud partitions to form internal bathroom (224b) as per drawing 2415.</li> <li>Provide acoustic plaster board to opening in south party wall &amp; to west corridor party wall &amp; north party wall to 224a as per drawing 2415.</li> <li>South (party) wall to otherwise remain as bare masonry, refer to drawing 2415.</li> </ul> | | | | 00<br>1 |

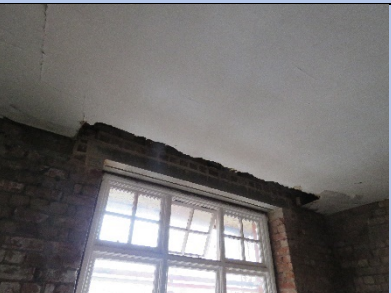
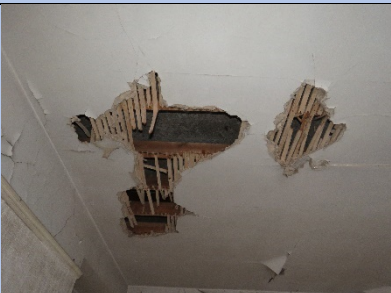
| Room Ref. | Element | Description / Item | Condition | Action | Photographs | | | |
|---|---|---|---|---|---|---|---|---|
| | Ceiling | Plaster on lath with paint finish. Areas of lost ceiling. Remnant of plaster cornice. | Poor | Proposed works <ul style="list-style-type: none"> <li>Existing lath and plaster ceiling to be removed along with timber substrate</li> <li>Steel beams to be de-rusted and treated with intumescent paint per NBS:M61/120.</li> <li>Provide new plasterboard ceiling within the structural steel zone. Refer to drawing 2253.</li> </ul> | | | | |

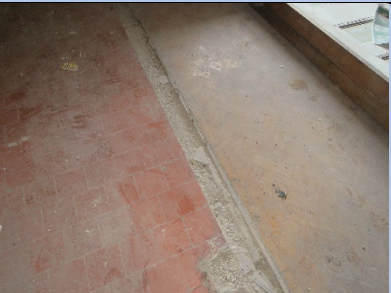
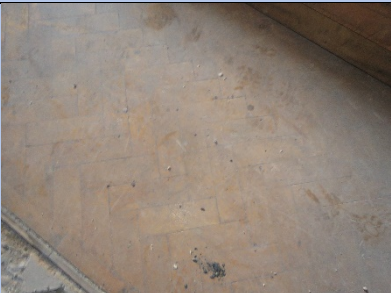
| Room Ref. | Element | Description / Item | Condition | Action | Photographs | | | |
|---|---|---|---|---|---|---|---|---|
| | Floor | Red quarry tile, wood block and glazed tile to hearth. | Good / fair | <ul style="list-style-type: none"> <li>Remove all debris.</li> <li>Clean red quarry tile and protect.</li> <li>Record quantity of wood block, lift and store on pallet in room.</li> <li>De-nail floor.</li> </ul> <hr/> Proposed works <ul style="list-style-type: none"> <li>Floor to be levelled and prepared throughout with latex levelling screed or similar NBS:M10/120.</li> </ul> | | | | |

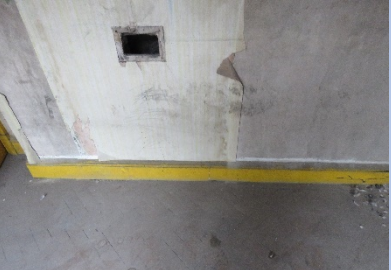
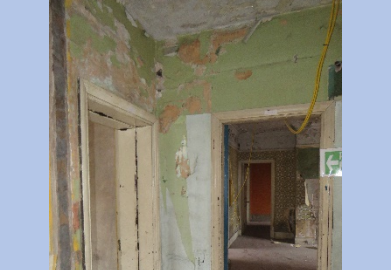
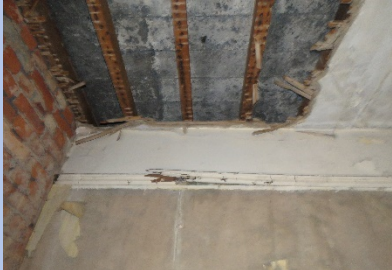
| Room Ref. | Element | Description / Item | Condition | Action | Photographs | | | |
|---|---|---|---|---|---|---|---|---|
| | Joinery | Skirting in situ. Pile of joinery. 3no doors. 2no. door architraves. | | Proposed works <ul style="list-style-type: none"> <li>Timber skirting and picture rail to be removed.</li> <li>Doors, frames, architraves to be set aside for reuse elsewhere.</li> <li>Loose timber to be reused where possible otherwise scrapped.</li> </ul> | | | | |

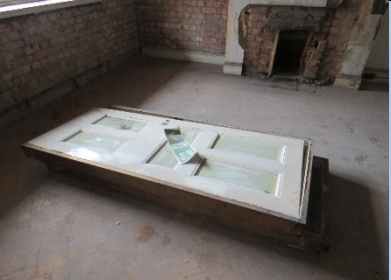
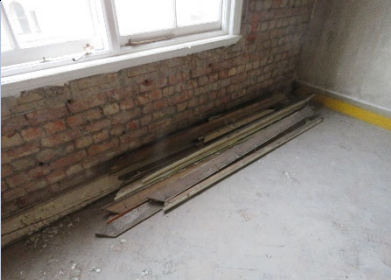
| Room Ref. | Element | Description / Item | Condition | Action | Photographs | | | |
|---|---|---|---|---|---|---|---|---|
| | Misc. | | | Proposed works <ul style="list-style-type: none"> <li>Repair, clean fireplace insert.</li> </ul> | | | | |

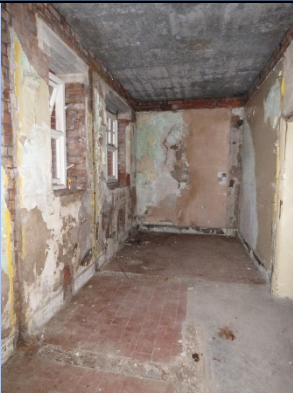
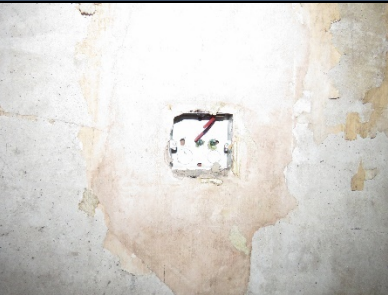
| Room Ref. | Element | Description / Item | Condition | Action | Photographs | | | |
|---|---|---|---|---|---|---|---|---|
| 229 – Lobby and Bed-room | Walls | Plaster on brickwork with wallpaper and paint finish. | Fair | <ul style="list-style-type: none"> <li>De-nail walls.</li> </ul> Proposed works <ul style="list-style-type: none"> <li>Strip all walls back to masonry</li> <li>Provide insulated plasterboard (refer to wall type drawing 2403) and secondary glazing (NBS:L10/580A) to east wall 229a (LR).</li> <li>Provide stud partitions to form internal bathroom (229b) and lobby (229) as per drawing 2403.</li> <li>Provide acoustic plaster board to south party wall of 229a and west party (corridor) wall as per drawing 2403.</li> <li>North (party) wall of 229a to remain as bare masonry, refer to drawing 2403.</li> </ul> | | | | 001 |

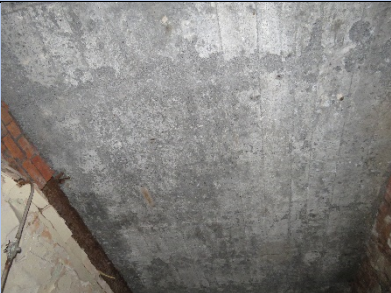
| Room Ref. | Element | Description / Item | Condition | Action | Photographs | | | |
|---|---|---|---|---|---|---|---|---|
| | Ceiling | Exposed concrete. | | Proposed works <ul style="list-style-type: none"> <li>Steel beams to be de-rusted and treated with intumescent paint per NBS:M61/120.</li> <li>Provide new plasterboard ceiling within the structural steel zone. Refer to drawing 2253.</li> </ul> | | | | |

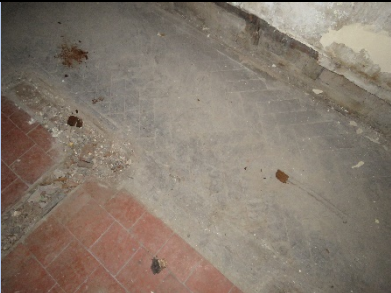
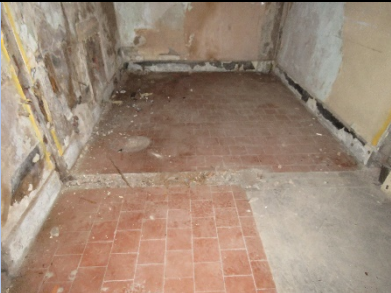
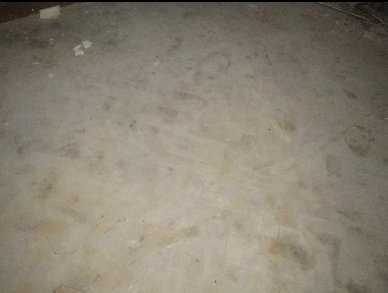
| Room Ref. | Element | Description / Item | Condition | Action | Photographs | | | |
|---|---|---|---|---|---|---|---|---|
| | Floor | Red quarry tile, wood block and glazed tile to hearth. | Good / fair | <ul style="list-style-type: none"> <li>Remove all debris.</li> <li>Clean red quarry tile and protect.</li> <li>Record quantity of wood block, lift and store on pallet in room.</li> </ul> Proposed works <ul style="list-style-type: none"> <li>Floor to be levelled and prepared throughout with latex levelling screed or similar NBS:M10/120.</li> </ul> | | | | |

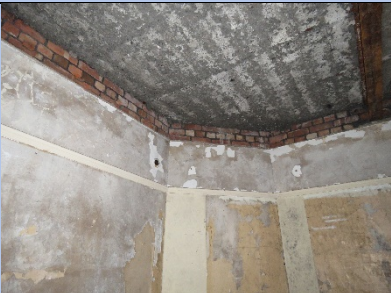
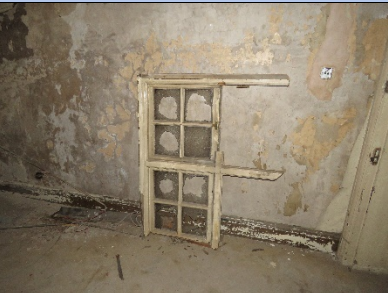
| Room Ref. | Element | Description / Item | Condition | Action | Photographs | | | |
|---|---|---|---|---|---|---|---|---|
| | Joinery | Skirting in situ. Door architrave. Picture rail. 2no doors and architraves. | | Proposed works <ul style="list-style-type: none"> <li>Timber skirting and picture rail to be removed.</li> <li>Doors, frames, architraves to be set aside for reuse elsewhere.</li> </ul> | | | | |

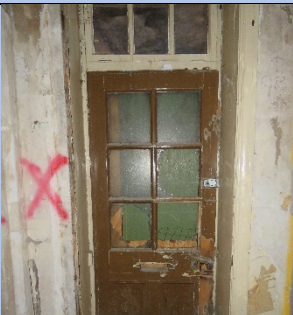
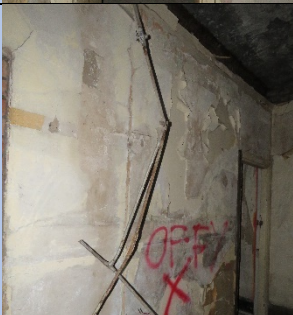
| Room Ref. | Element | Description / Item | Condition | Action | Photographs | | | |
|---|---|---|---|---|---|---|---|---|
| | Misc. | Redundant M&E conduit. | | <ul style="list-style-type: none"> <li>Remove conduit &amp; fill remaining hole in wall.</li> <li>Clean &amp; make good around existing fireplace opening.</li> </ul> | | | | |

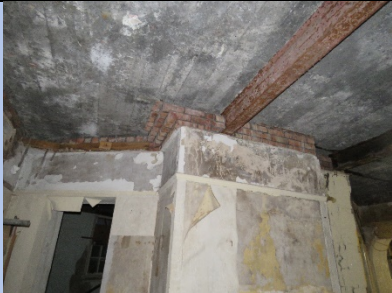
| Room Ref. | Element | Description / Item | Condition | Action | Photographs | | | |
|---|---|---|---|---|---|---|---|---|
| | Ceiling | Exposed concrete. | | Proposed works <ul style="list-style-type: none"> <li>Steel beams to be de-rusted and treated with intumescent paint per NBS:M61/120.</li> <li>Provide new plasterboard ceiling within the structural steel zone. Refer to drawing 2253.</li> </ul> | | | | |

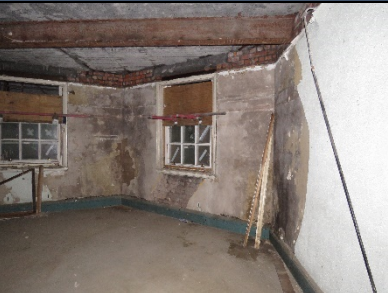
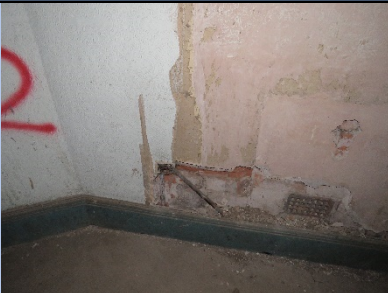
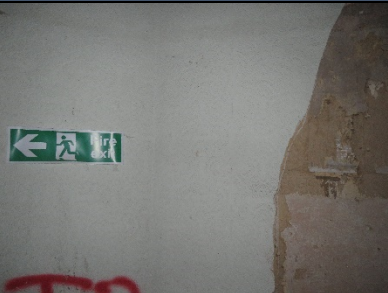
| Room Ref. | Element | Description / Item | Condition | Action | Photographs | | | |
|---|---|---|---|---|---|---|---|---|
| 230b, 230e | Walls | Plaster on brickwork with wallpaper finish. Vent to chimney. Holes to walls of now removed ceiling joists. | Fair | <ul style="list-style-type: none"> <li>De-nail walls.</li> </ul> <hr/> Proposed works <ul style="list-style-type: none"> <li>Strip all walls back to masonry</li> <li>Provide insulated plasterboard (refer to wall type drawing 2403) and secondary glazing (NBS:L10/580A) to east &amp; south walls (FFS/LR).</li> <li>Provide stud partitions to separate rooms from lobby 229 as per drawing 2403.</li> <li>North and west walls to remain as bare masonry, refer to drawing 2403.</li> </ul> | | | | 001 |

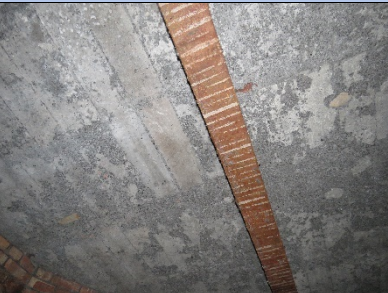
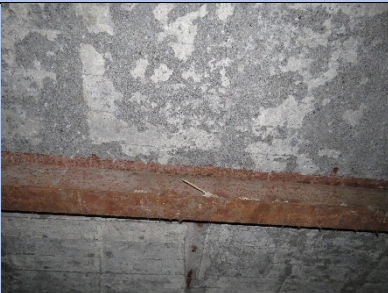
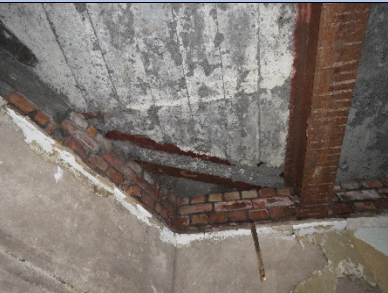
| Room Ref. | Element | Description / Item | Condition | Action | Photographs | | | |
|---|---|---|---|---|---|---|---|---|
| | Ceiling | Exposed concrete, area of friable concrete and exposed re-enforcement. Remnants of lath and plaster ceiling. | | <ul style="list-style-type: none"> <li>Curtins to inspect floor slab and specify repair, Unless covered by overall ceiling repair strategy.</li> <li>Remove remnants of lath and plaster ceiling.</li> </ul> <hr/> Proposed works <ul style="list-style-type: none"> <li>Steel beams to be de-rusted and treated with intumescent paint per NBS:M61/120.</li> <li>Provide new plasterboard ceiling within the structural steel zone. Refer to drawing 2253.</li> </ul> | | | | |

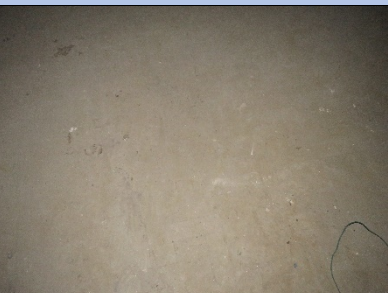
| Room Ref. | Element | Description / Item | Condition | Action | Photographs | | | |
|---|---|---|---|---|---|---|---|---|
| | Floor | Wood block. | Good / fair | <ul style="list-style-type: none"> <li>Remove all debris.</li> <li>Record quantity of wood block, lift and store on pallet in room.</li> </ul> <hr/> Proposed works <ul style="list-style-type: none"> <li>Floor to be levelled and prepared throughout with latex levelling screed or similar NBS:M10/120.</li> </ul> | | | | |

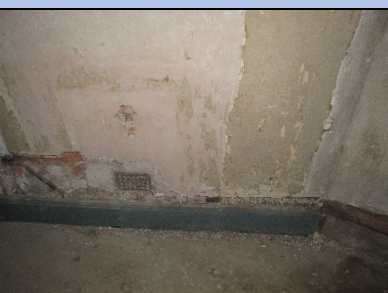
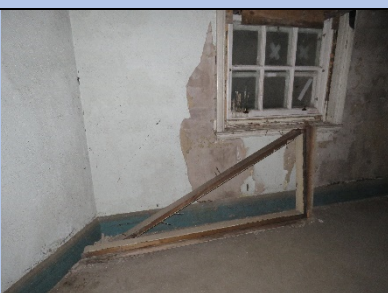
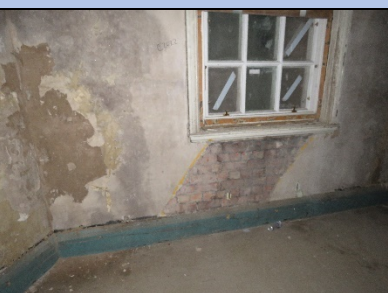
| Room Ref. | Element | Description / Item | Condition | Action | Photographs | | | |
|---|---|---|---|---|---|---|---|---|
| | Joinery | Skirting in situ. Door architrave. Door architraves. Door frame in room. | | Proposed works <ul style="list-style-type: none"> <li>Timber skirting and picture rail to be removed</li> <li>Doors, frames, architraves to be set aside for reuse elsewhere.</li> </ul> | | | | |

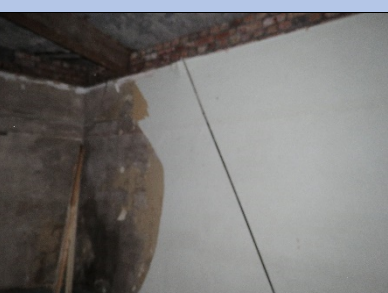
| Room Ref. | Element | Description / Item | Condition | Action | Photographs | | | |
|---|---|---|---|---|---|---|---|---|
| | Misc. | Redundant M&E cables and conduit. | | <ul style="list-style-type: none"> <li>Remove all redundant M&amp;E.</li> <li>Fill all holes left in walls following removal.</li> </ul> | | | | |

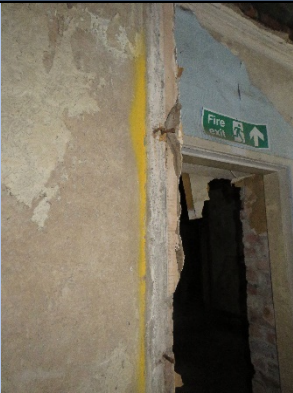
| Room Ref. | Element | Description / Item | Condition | Action | Photographs | | | |
|---|---|---|---|---|---|---|---|---|
| 230c, 230d (inc. stair-case) | Walls | Plaster on brickwork with wallpaper finish. | Fair | <ul style="list-style-type: none"> <li>Remove partition remnant and de-nail walls.</li> </ul> Proposed works <ul style="list-style-type: none"> <li>Strip all walls back to masonry</li> <li>Provide insulated plasterboard (refer to wall type drawing 2403) and secondary glazing (NBS:L10/580A) to south walls (FFS).</li> <li>Provide stud partitions to bathroom as per drawing 2403.</li> <li>Provide acoustic plasterboard wall to north and west wall of 230d as per drawing 2403.</li> <li>East walls to remain as bare masonry, refer to drawing 2403.</li> </ul> | | | | 001 |

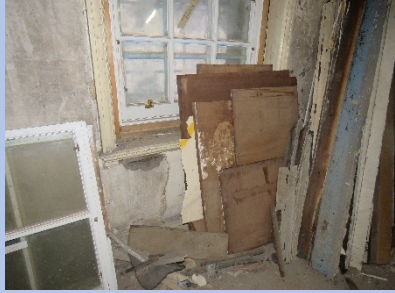
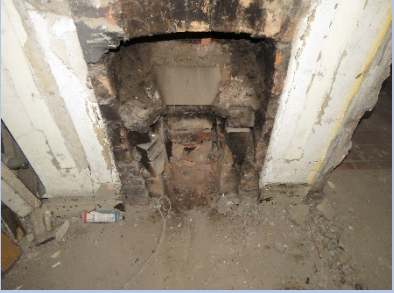
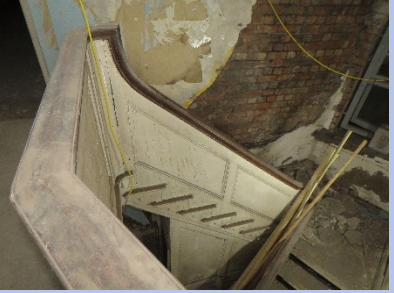
| Room Ref. | Element | Description / Item | Condition | Action | Photographs | | | |
|---|---|---|---|---|---|---|---|---|
| | Misc. | Misc. debris and construction waste. Radiator. Staircase and balustrade. M&E cables, conduit and pipe. | | <ul style="list-style-type: none"> <li>Remove all debris and construction waste.</li> <li>Remove all redundant M&amp;E &amp; fille holes left in walls.</li> <li>Retain staircase and balustrade elements for reuse elsewhere.</li> </ul> | | | | |
