### STRUCTURAL REPORT

#### CLAYTON HALL MANCHESTER

**Date:** February 2022

**Reference:** RGR/BBR/16076~srep rev 2

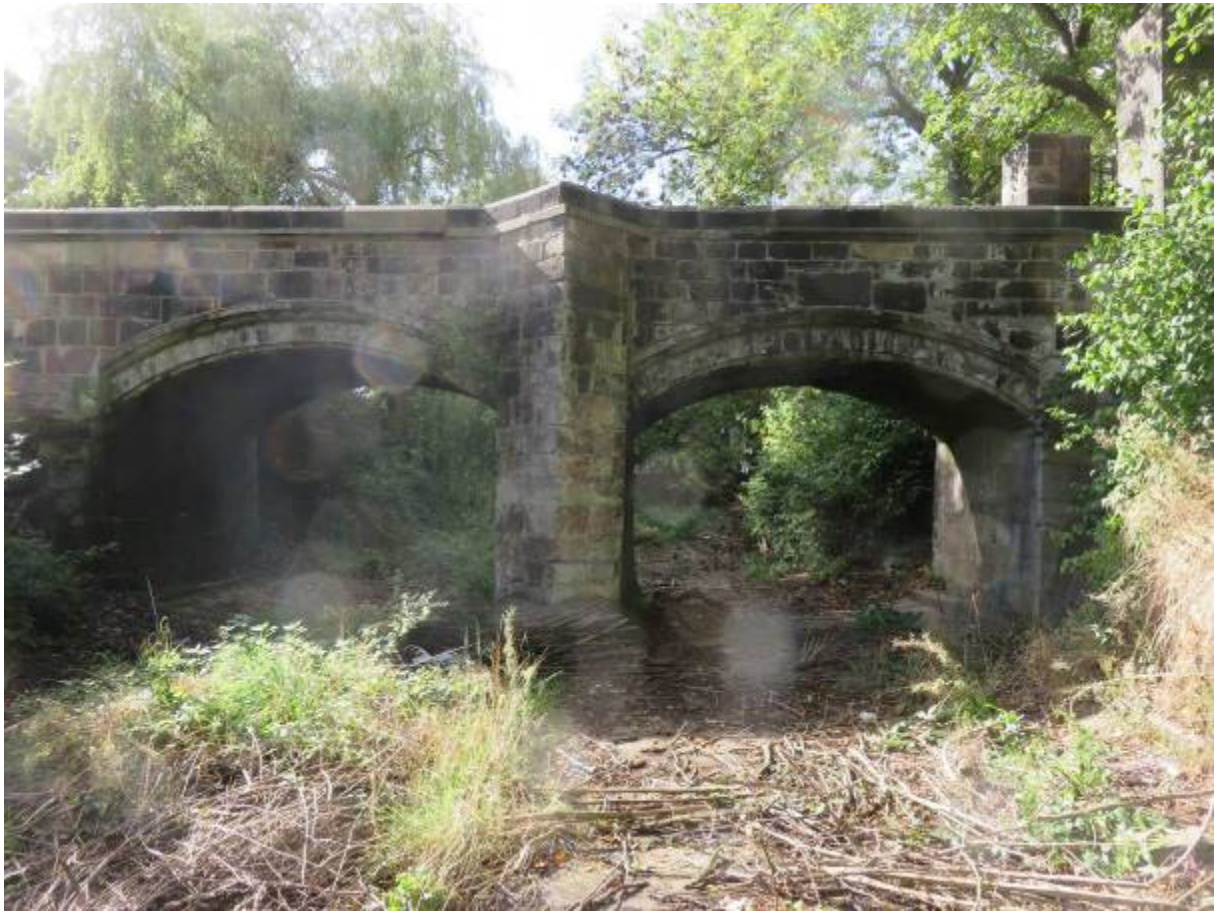
- 2.3 The bridge over the moat (see photograph 3) is separately listed Grade II, with the description as follows:

**Photograph 3: Bridge over moat to south of site**

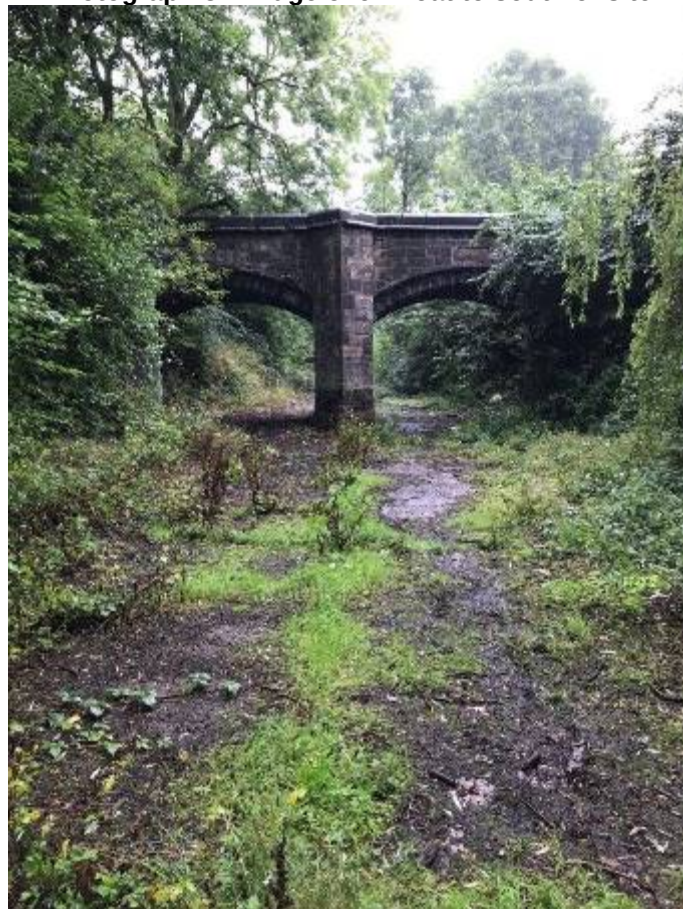
**Photograph 3A: Double arch masonry bridge across former moat**

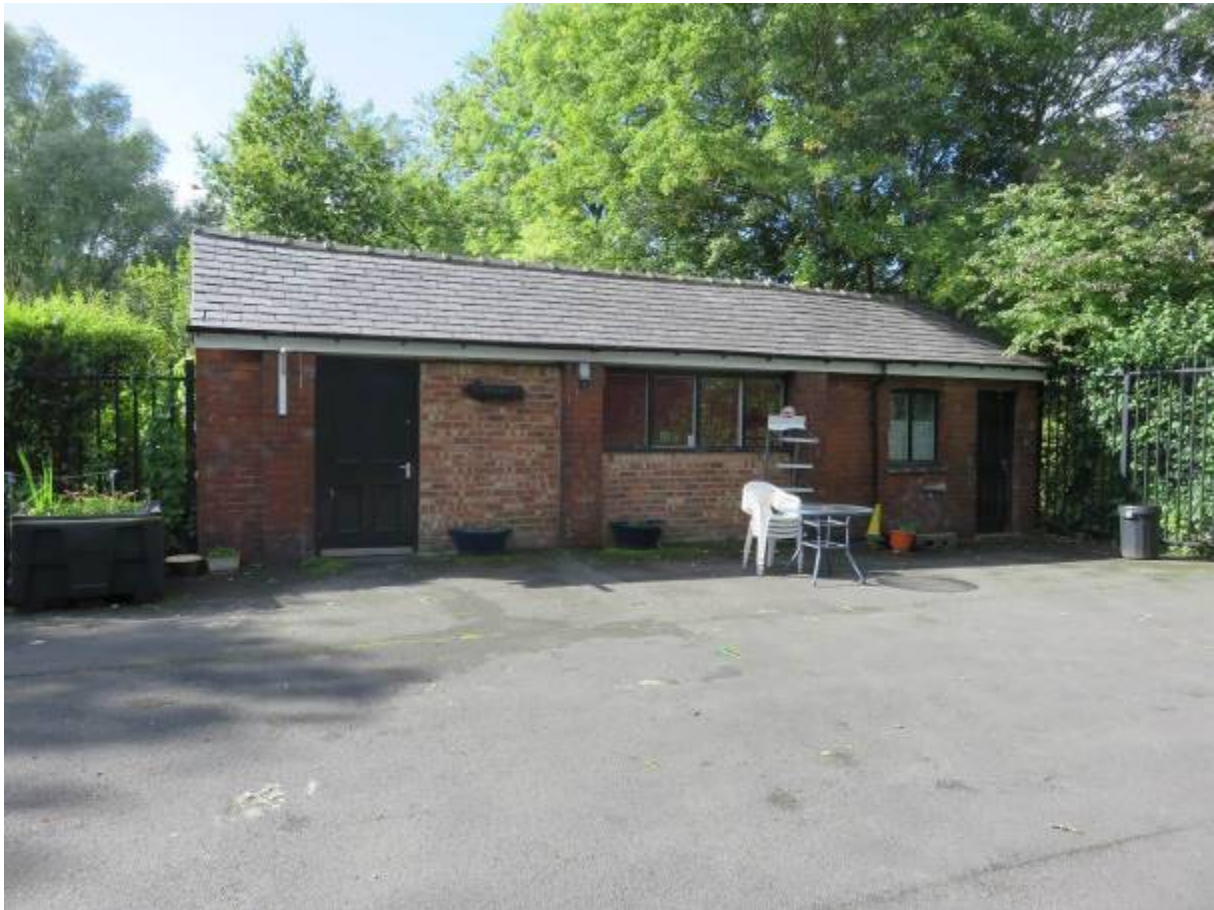
- 2.4 To the north of the moated site is a single storey range currently used as the kitchen/café (see photograph 4). This is of brick construction, and sits immediately to the south of the moat.
- 2.5 More detailed descriptions are included in the Architect's and Archaeologist's information.
- 2.6 It is understood through the meeting that took place on the morning of 17<sup>th</sup> August 2021, that in 2016, works took place to create a café area with a new bathroom formed at southern corner, in which new drainage was formed in relation to this, as well as appropriate repairs to the timber soleplate and framework in this locality at ground floor level.

Photograph 4: Single storey kitchen/café range

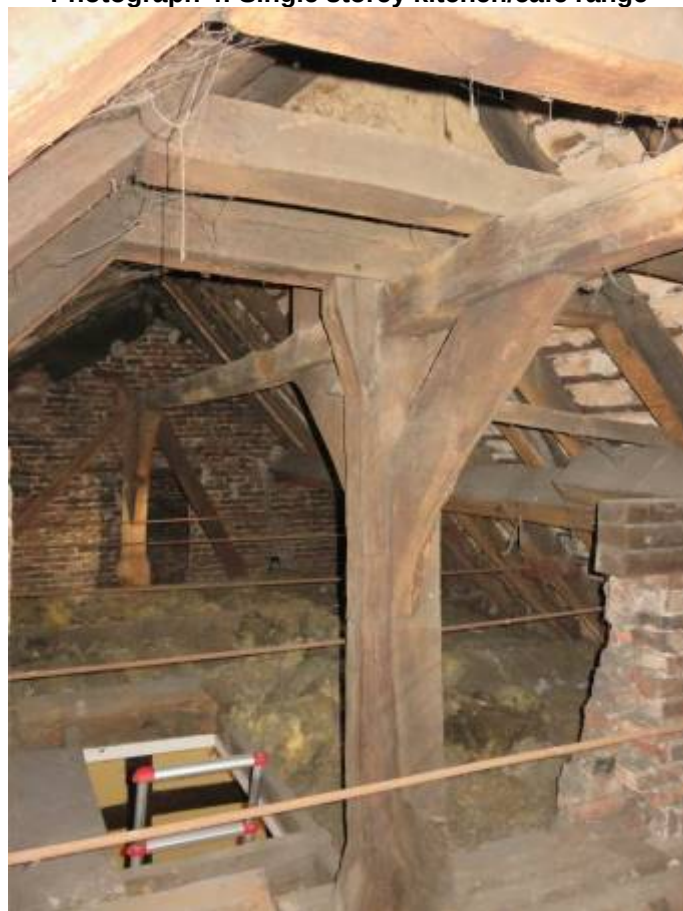
Photograph 5: Central crown post between north and south bay

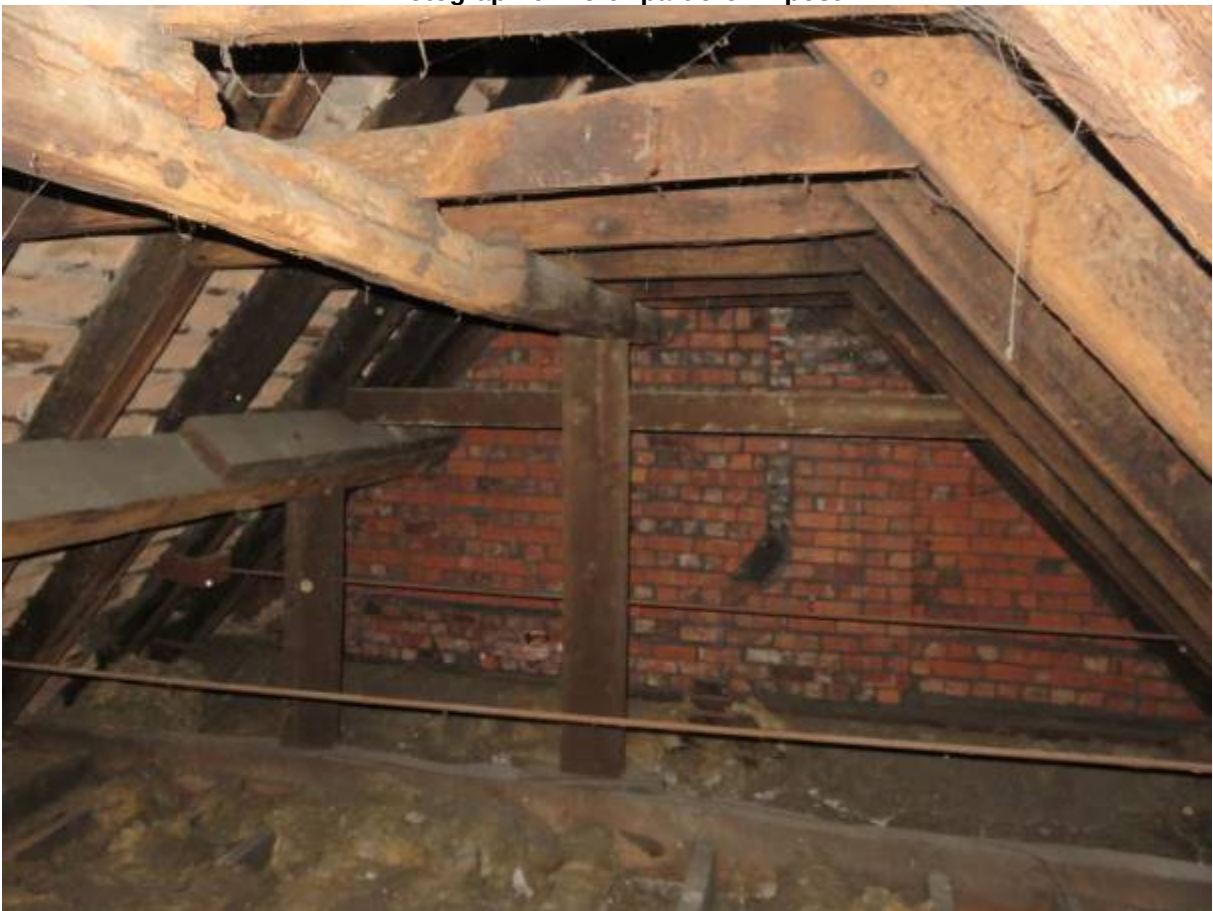
Photograph 7: South end of roof with brick gable

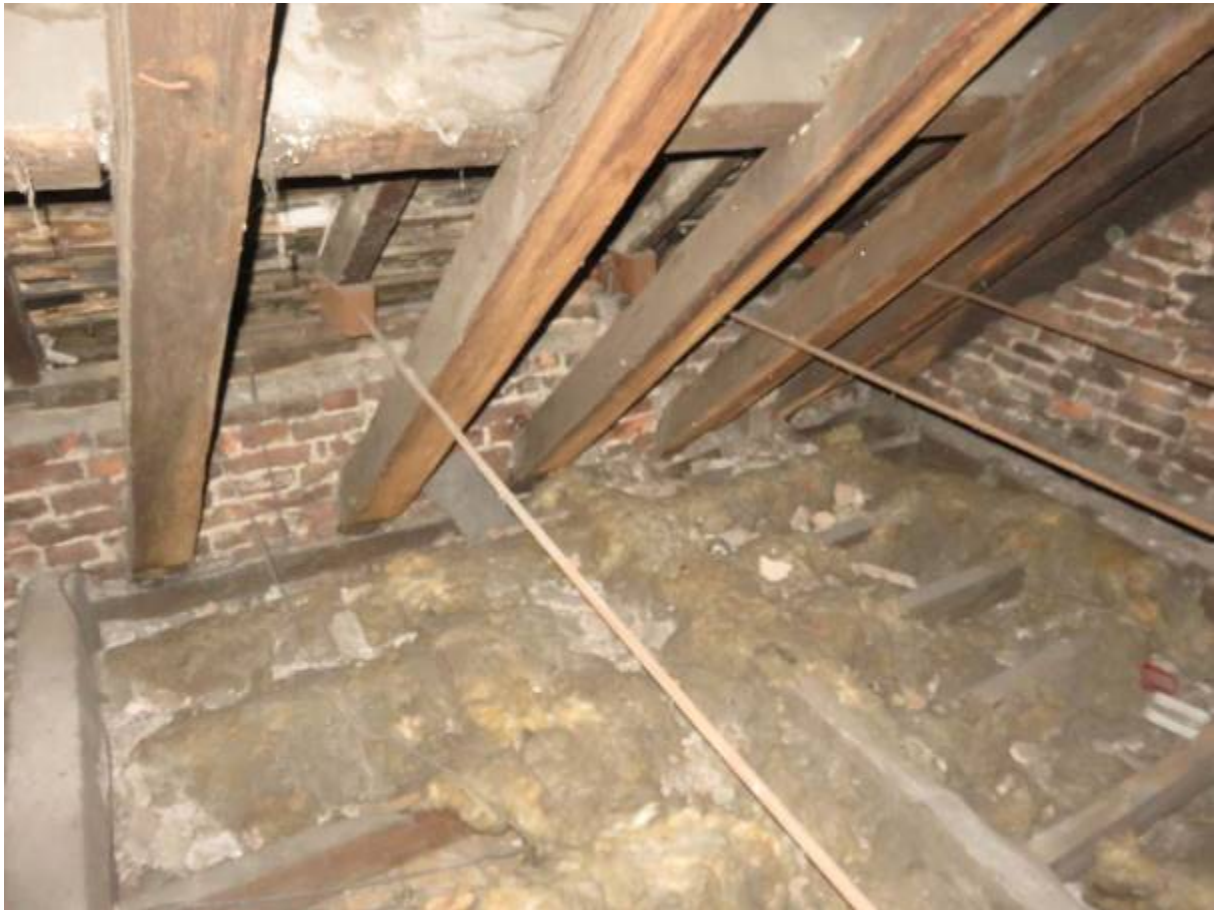
| 3.1.4 | With the adjoining corridor the eaves level to the west side has been raised with brickwork rising off the timber frame, and with a secondary set of rafters above the original to the south bay (see photograph 8). The introduced purlins support the common rafters and span between the brickwork to the gable ends and an added central truss, which is supported off brickwork, built up off the tie beam to the main truss which provides some additional stiffness. | The roof structure and its form have no changes since the previous survey. |

**Photograph 8: Eaves to west side raised with added brickwork and further rafters**

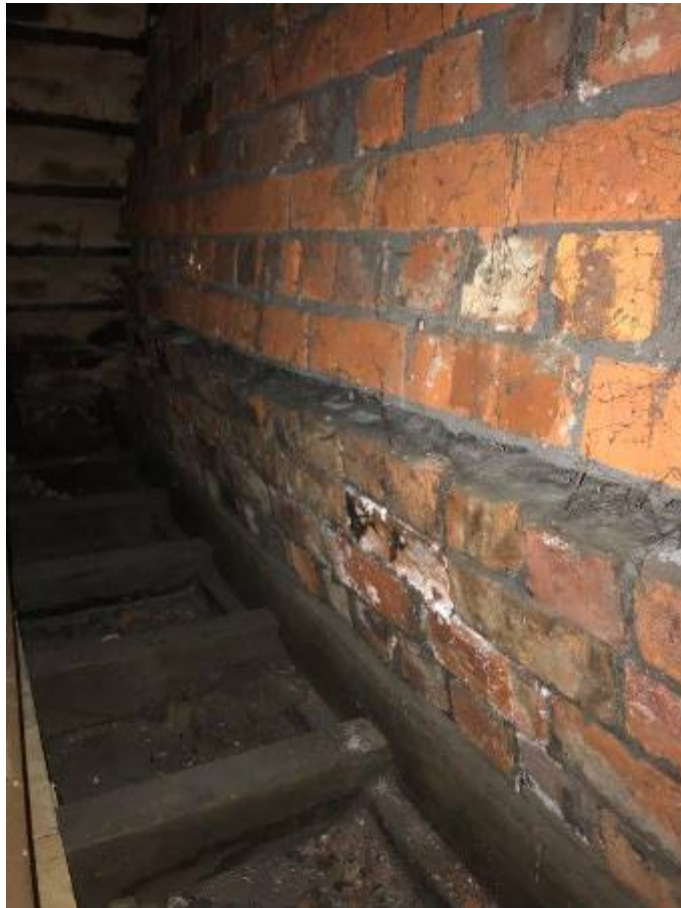
| 3.1.7 | To the south gable end there is a timber plate built into the brickwork to support the ceiling joists. The brickwork above this has rotated laterally inwards and there are areas of salt, perhaps suggesting moisture ingress. Three to four courses above the timber plate there is a horizontal crack which has opened up by 45mm approximately due to this action (see photograph 9). It has clearly been in this state for a considerable time, but warrants some attention. There is some racking of the roof including the trusses, but which appears historic. It is buttressed to the north direction by the northern range. | <p>This appears to have progressed as it has opened up to a further 5mm. It can be noted that this brickwork likely has never been properly supported by this timber plate as there is no contact between these materials even with the dropped masonry above and fits the conclusion of the ceiling being formed at a later date. It was likely envisioned that the headers of the brickwork would be able to stretch back and cantilever to pick up the brickwork above the timber, however with a limited wall thickness of 9" there is insufficient back span and the wall panel thins to 4" where the timber plate is present (see photographs 9A &amp; 9B).</p> <p>Externally this rotational movement is apparent, with more recent cracking patterns to the side of</p> |

Photograph 9A: Worsening of rotational movement to south gable

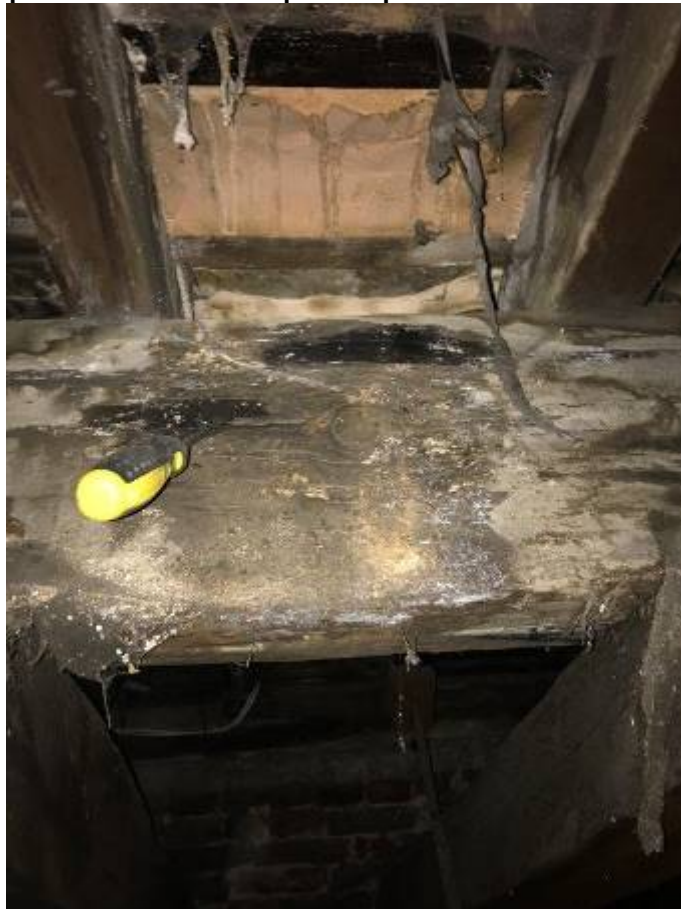
Photograph 12B: West flank at blind window with water ingress onto purlin

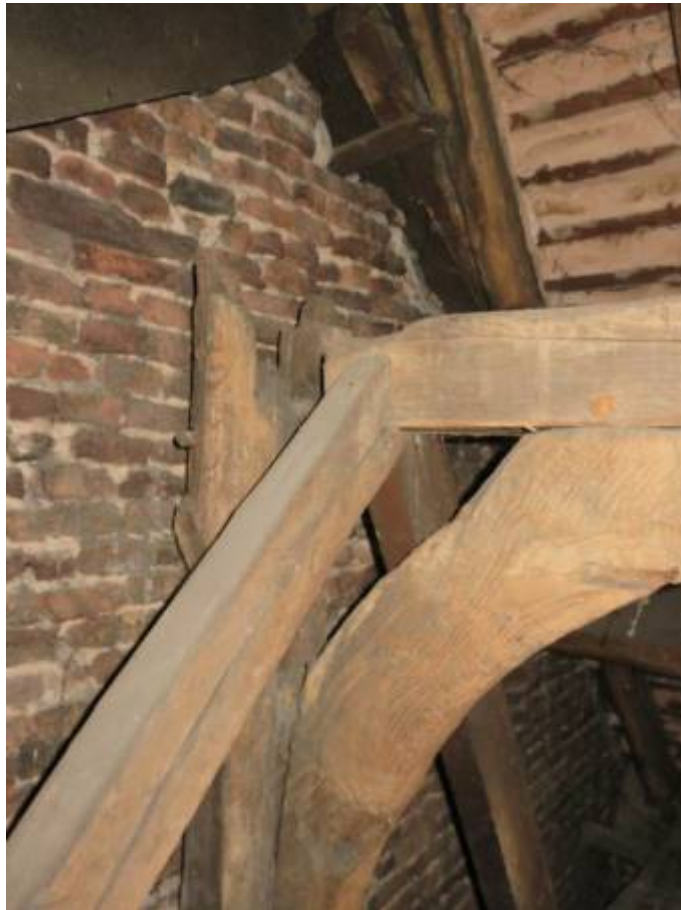
| 3.1.13 To the northern bay, the overall condition appears not unreasonable, but the collar purlin is no longer engaged with the half-crown post (see photograph 13), but with props having been introduced alongside. This member no longer supports collars, | The previously described arrangement is still present and no movement has taken place. |

**Photograph 13: Collar purlin no longer engaged with crown post but with added struts**

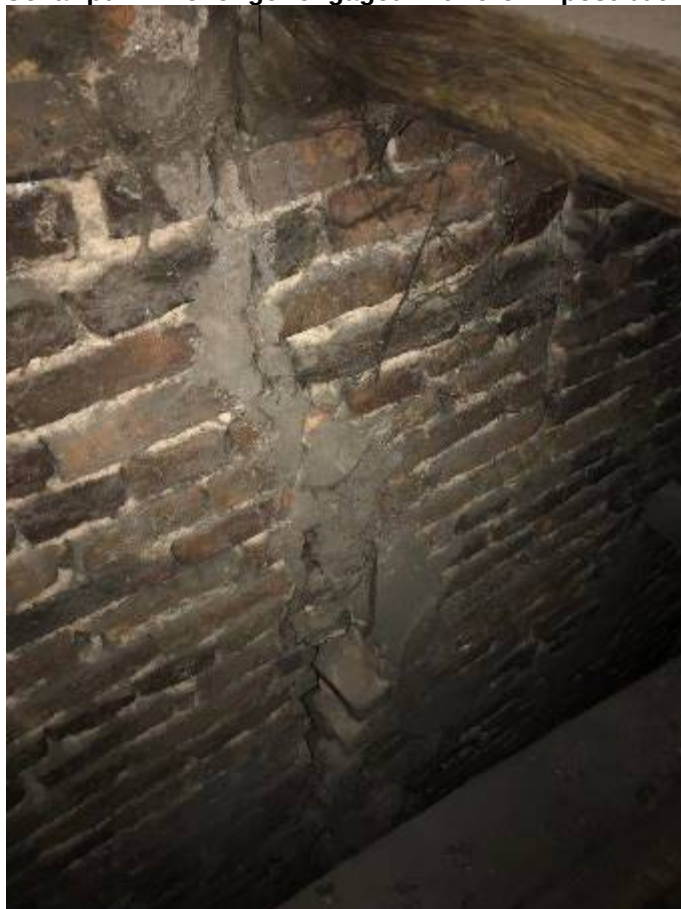
| 3.1.15 The in-built purlin ends should be micro-drilled, although appear sound and these to the north wall at not so much as risk, as this is the internal dividing wall between the north and south ranges. The roofs are at slightly different alignment and thus, there is some minor vulnerability to water ingress due to the abutment. Drilling has shown the purlins to be sound. | Purlin ends appear sound.<br><br>It can be noted when preceding toward the north range a void space is apparent between the 2No. sections of the hall allowing for services to run. To the brickwork construction to the south range, a historic fairly vertical crack is present and it can be noted that this movement is not current and not of concern (see photograph 13A). |

**Photograph 13A: Historic crack to end wall of south range**

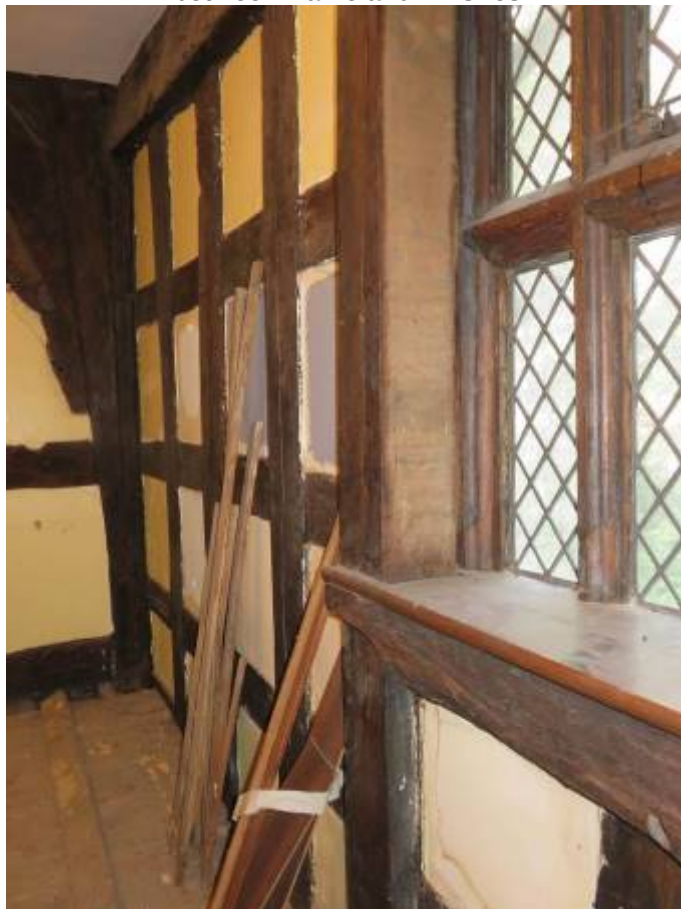
**Photograph 16: Post sitting proud of wall face and supporting cill**

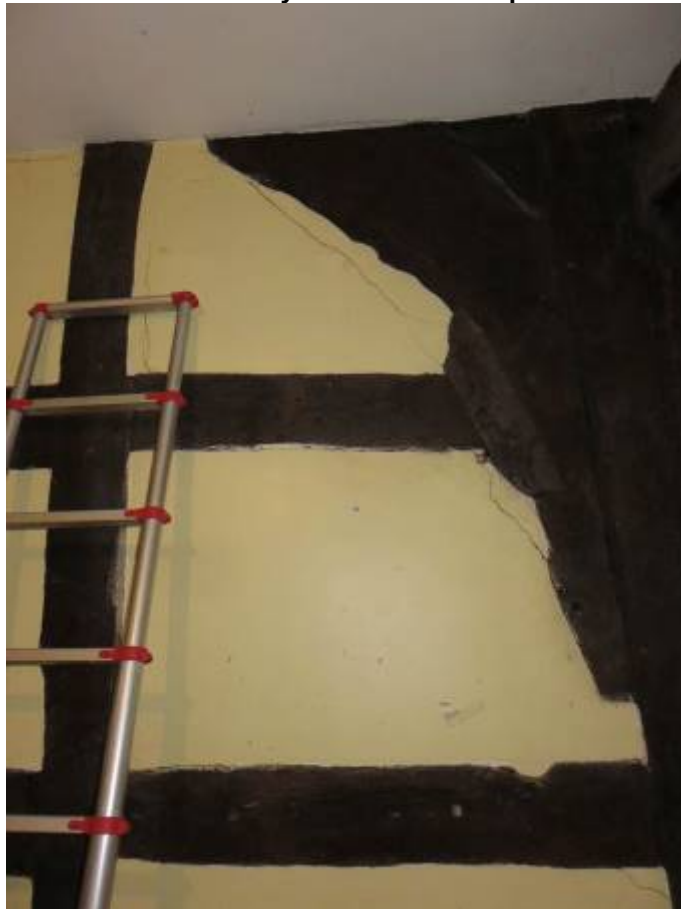
| | finishes and there is infill making good to the underside of the brace (see photograph 18). | |

Photograph 18: Minor cracking to assumed infill plaster main frame

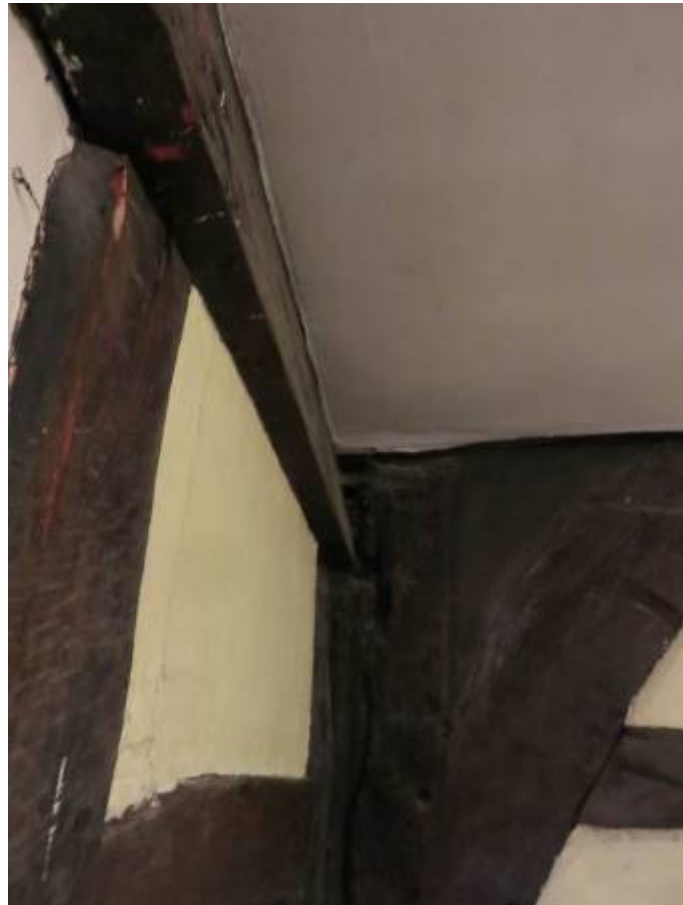
**Photograph 19: Rotation of western eaves plate to north bay**

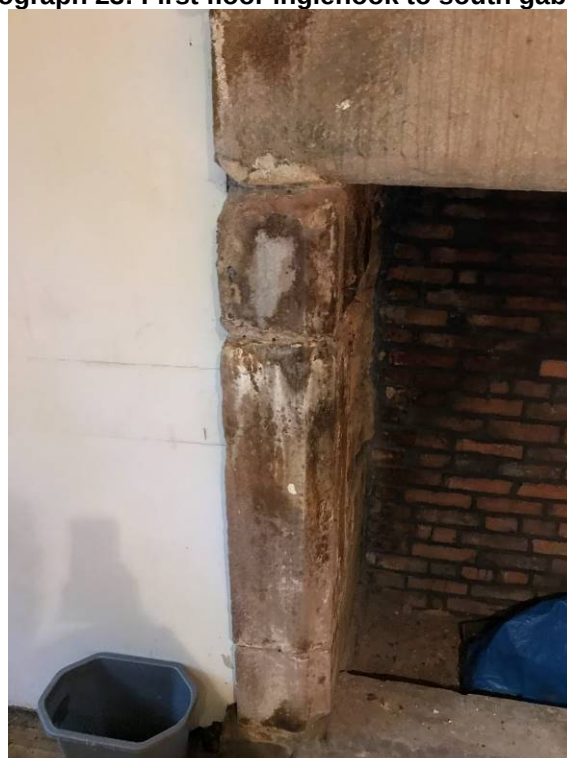
Photograph 23A: Increase of efflorescence and damp upon fireplace surround

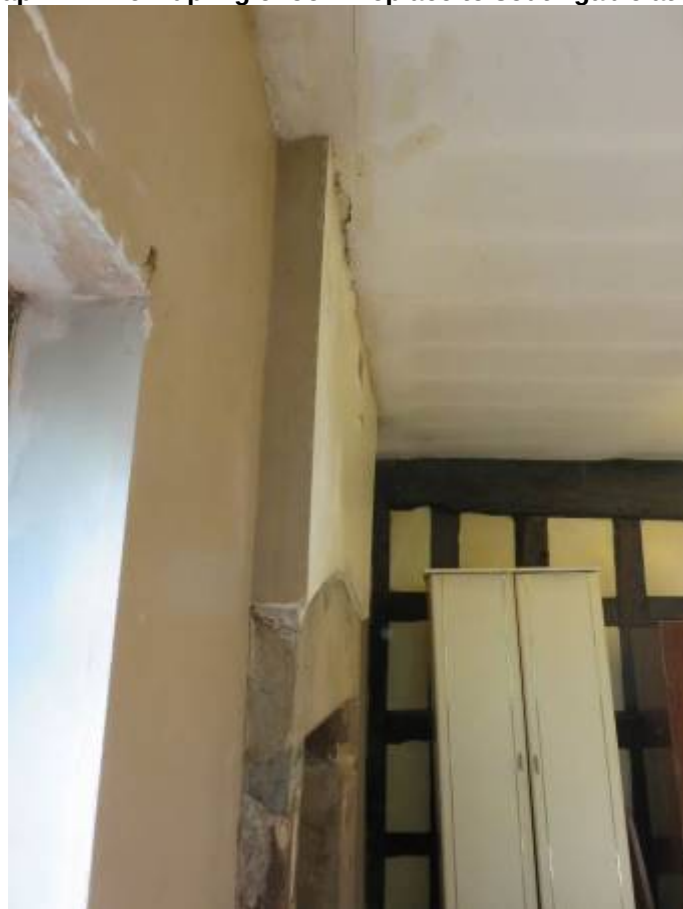
Photograph 25: Apparent minor movement to wall above fireplace

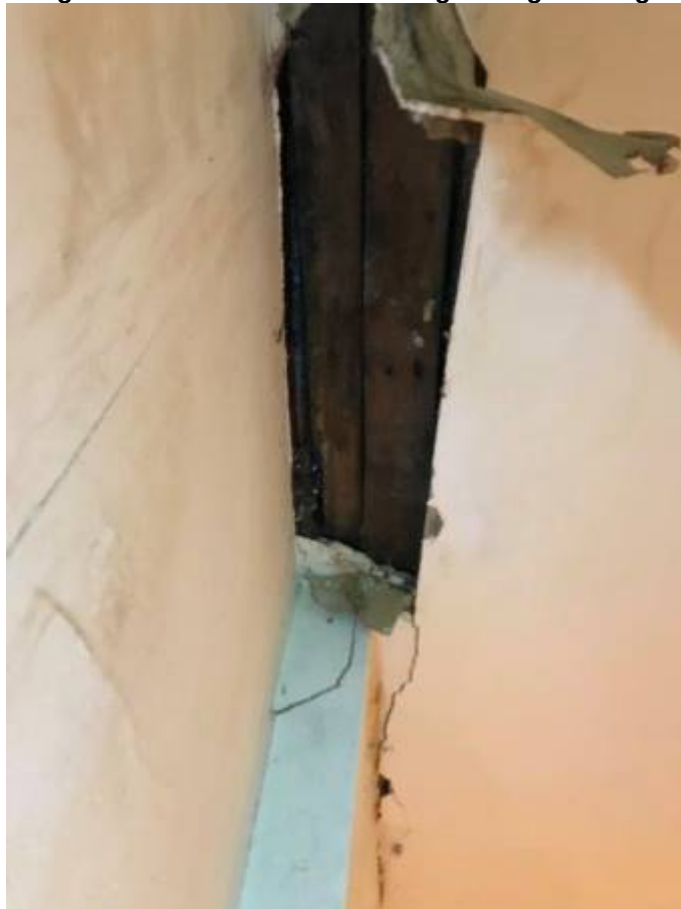
Photograph 25B: Cracking and loss of plaster at stack

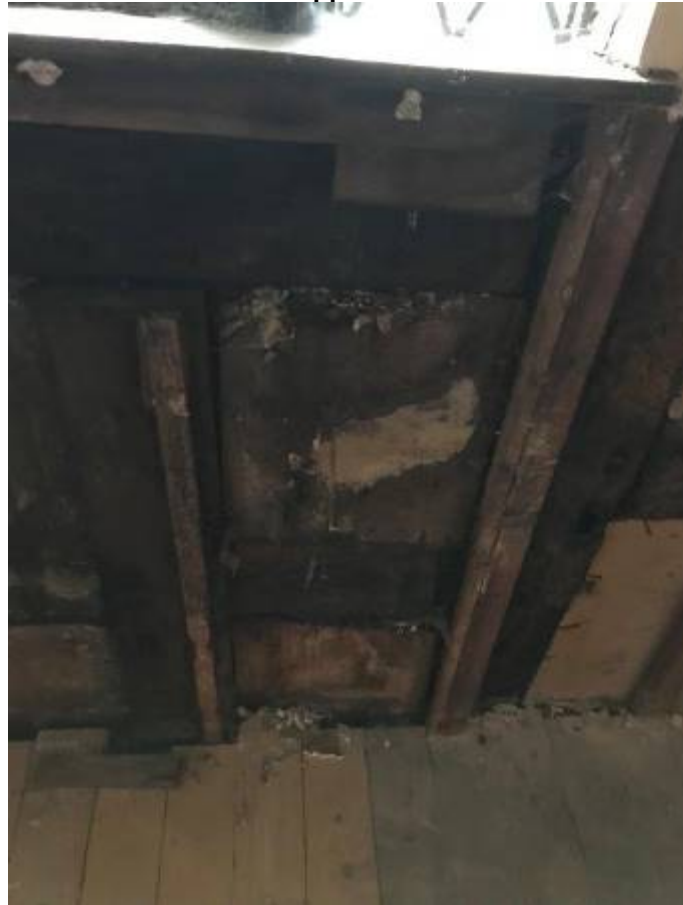
Photograph 28D: Water ingress of stripped back panelling with stair tower

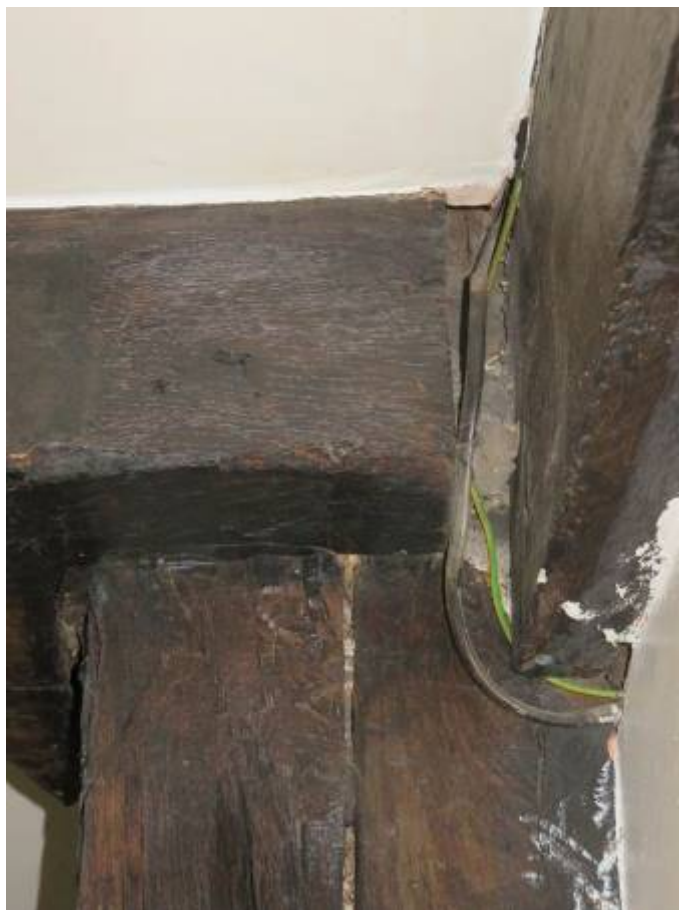
Photograph 30: Minor opening up between cross beam and first floor plate to northern bay

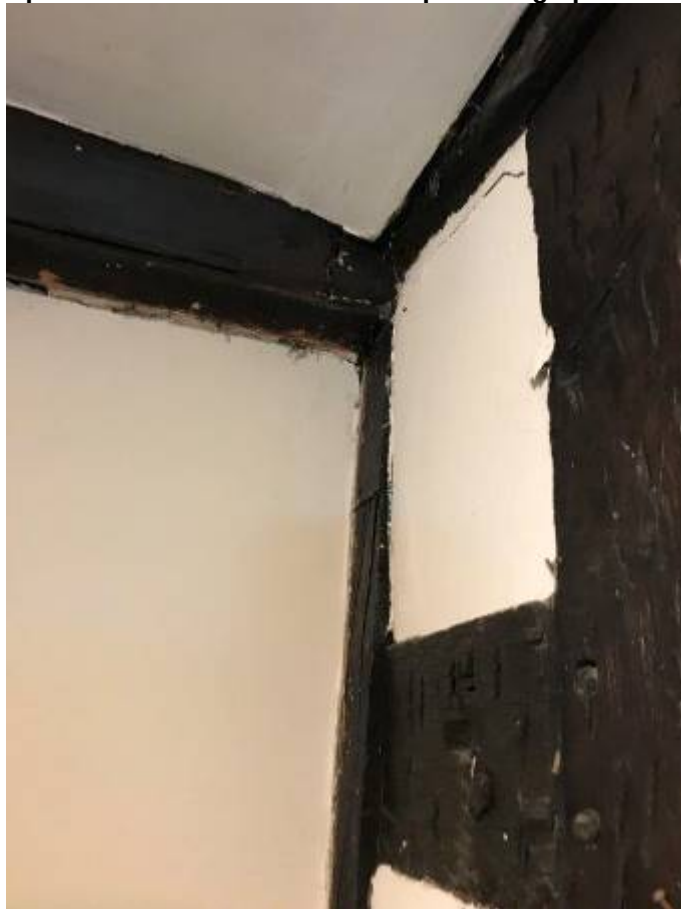
**Photograph 34C: South mid-rail to west frame connection indicating fracture to mid-rail and movement in adjacent finishes**

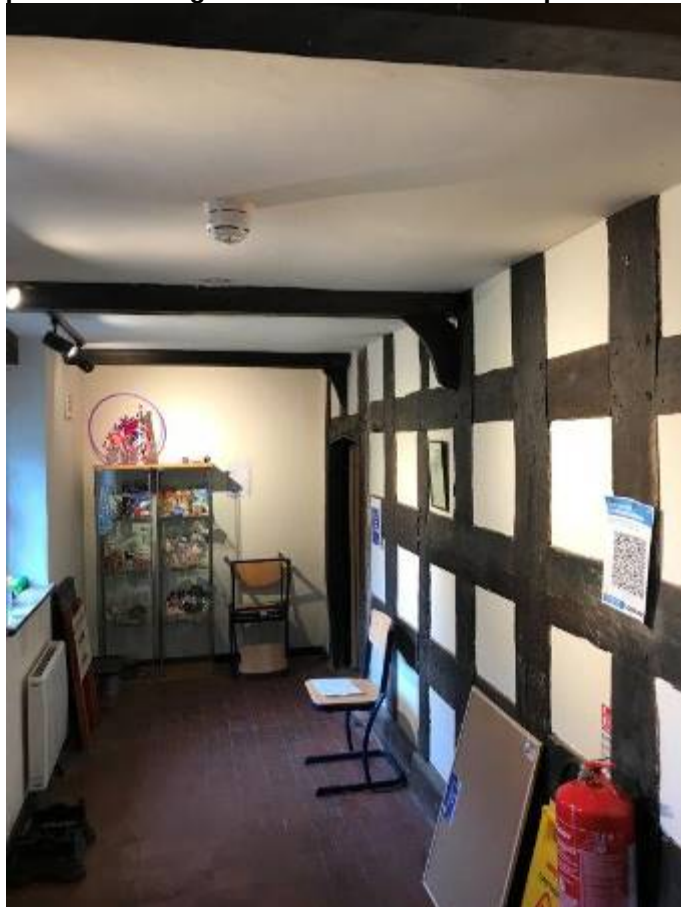
Photograph 35: Cracking to corridor of west wall at position of later infill

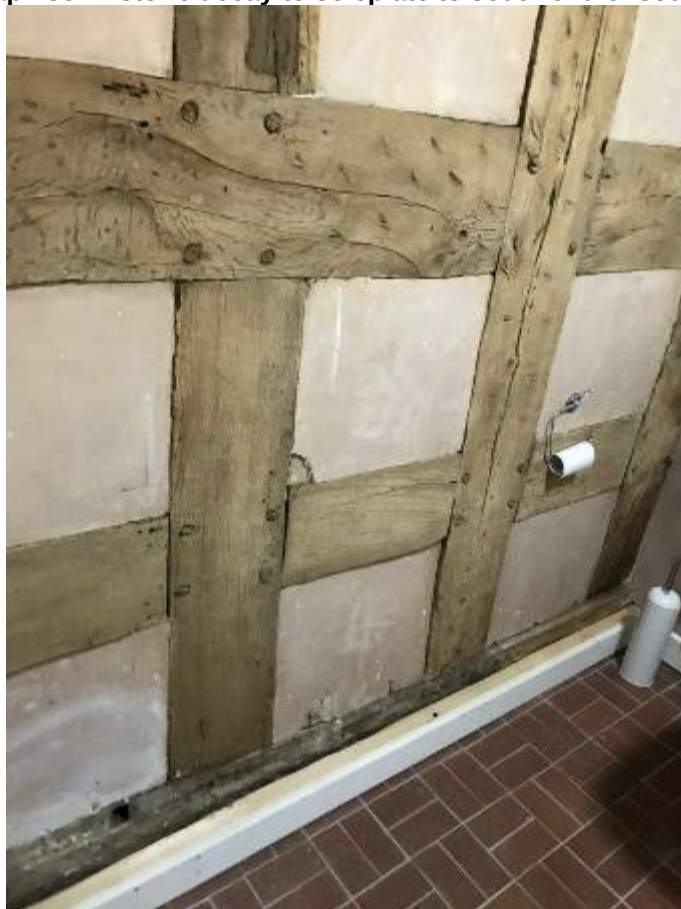
Photograph 36: Historic decay to soleplate to south end of southern bay

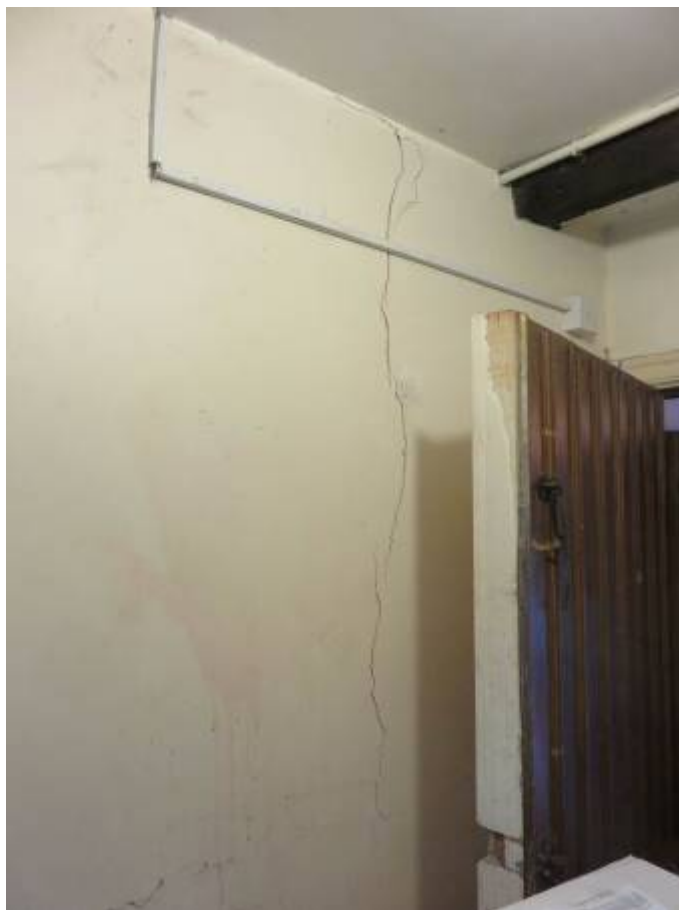
Photograph 37: West wall of WC at ground with crack at junction where stair tower abuts

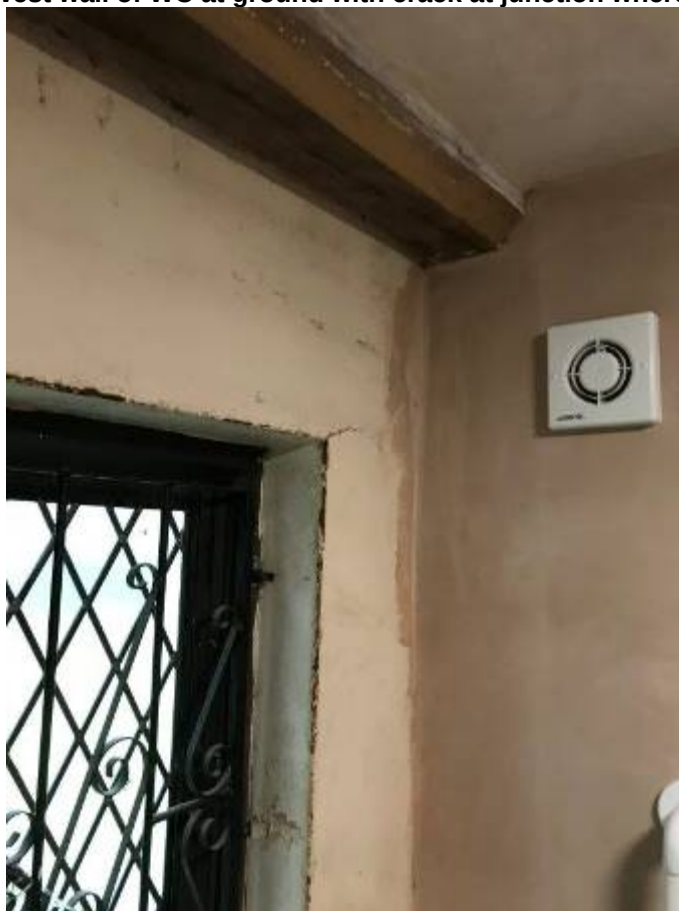
Photograph 37A: Cracking to west bearing of south window 1mm width

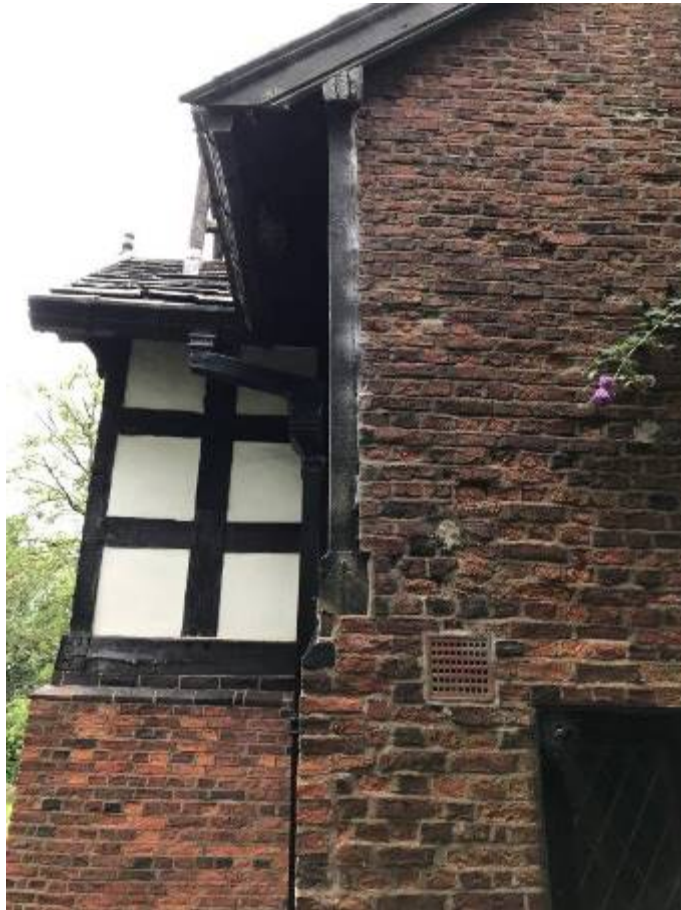
**Photograph 41A: Opening up between timber post and adjacent brickwork**

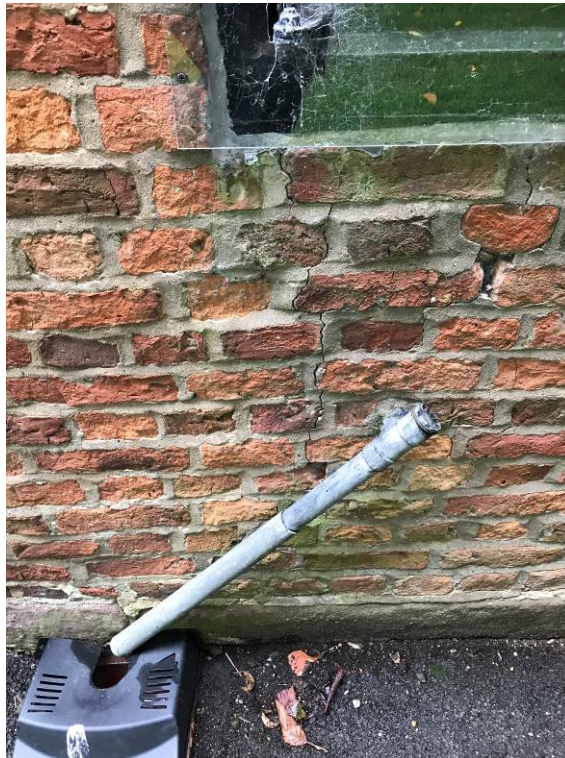
Photograph 42A: Active 1 – 2mm width cracking from sill level downwards

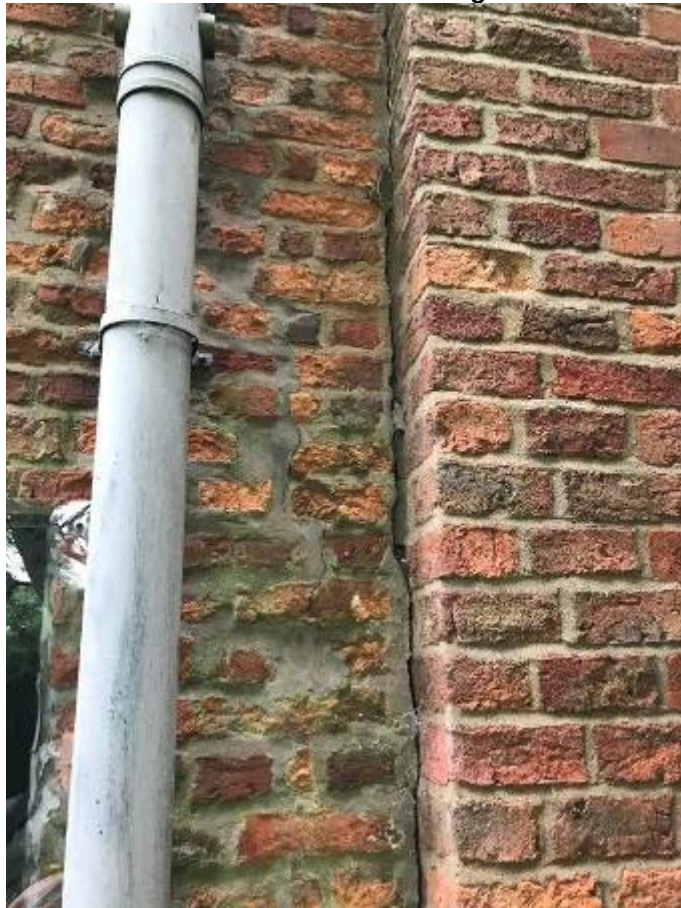
Photograph 42B: Opening up between stack projection and west wall hinging at base point

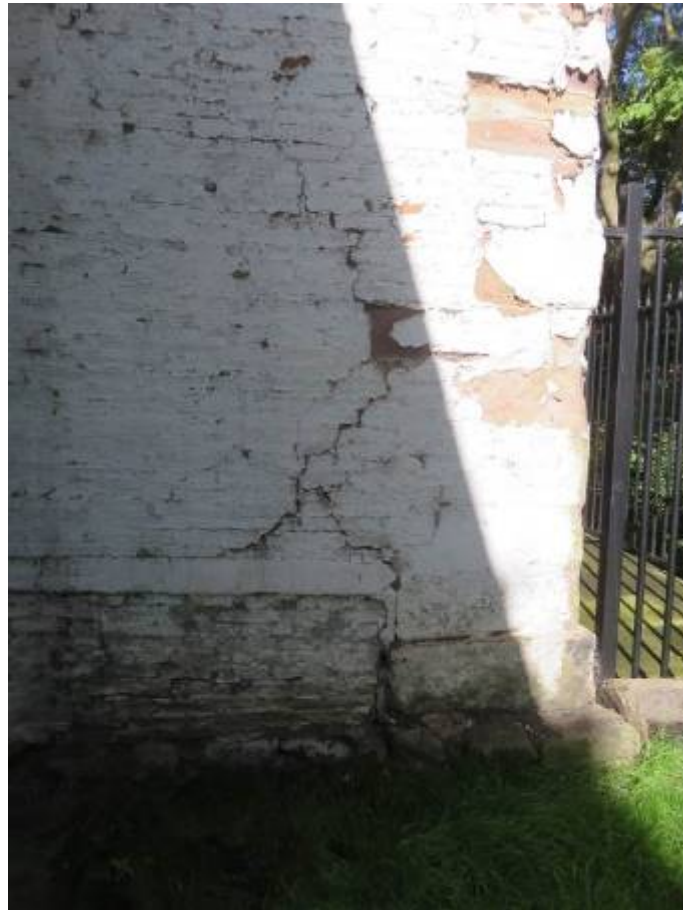
Photograph 48: Close up of movement to south gable

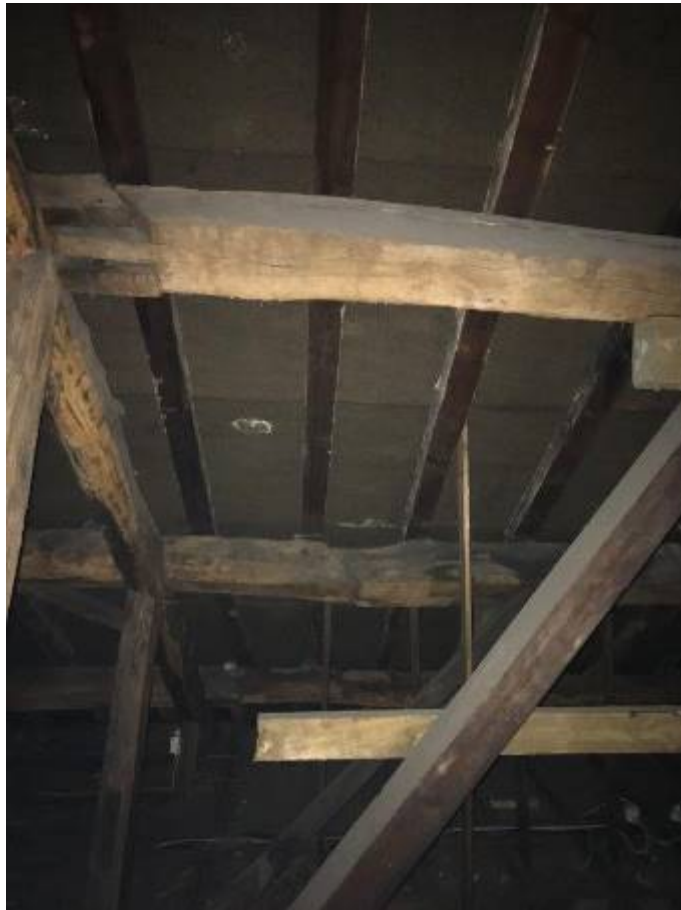
**Photograph 49A: Spliced joints to purlins with hinging taking place at these points. Note packing between purlin and rafter level**

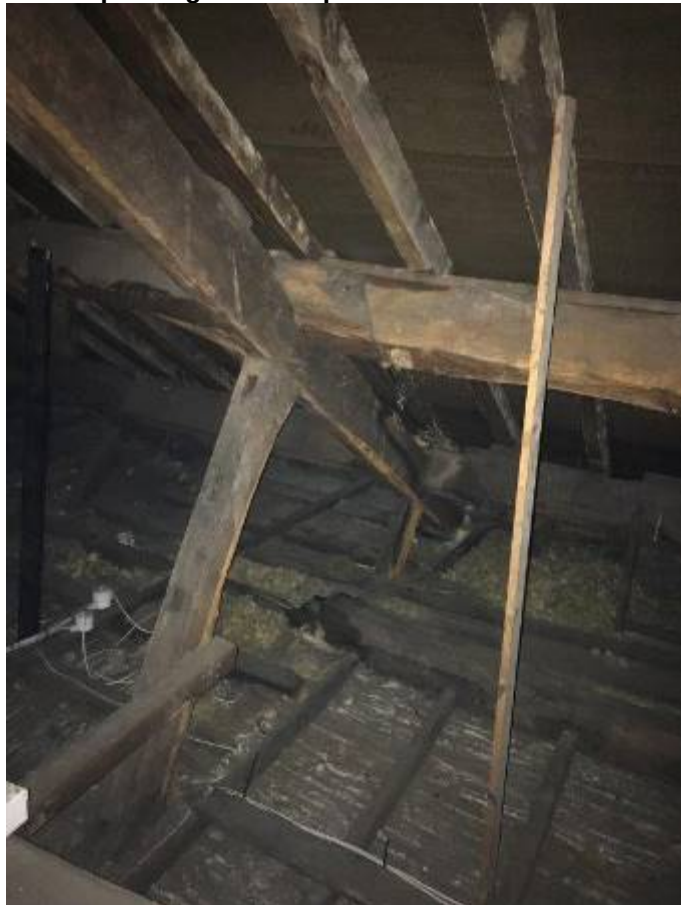
**Photograph 49B: Packing timbers upon purlin to level roof in previous re-roofing works**

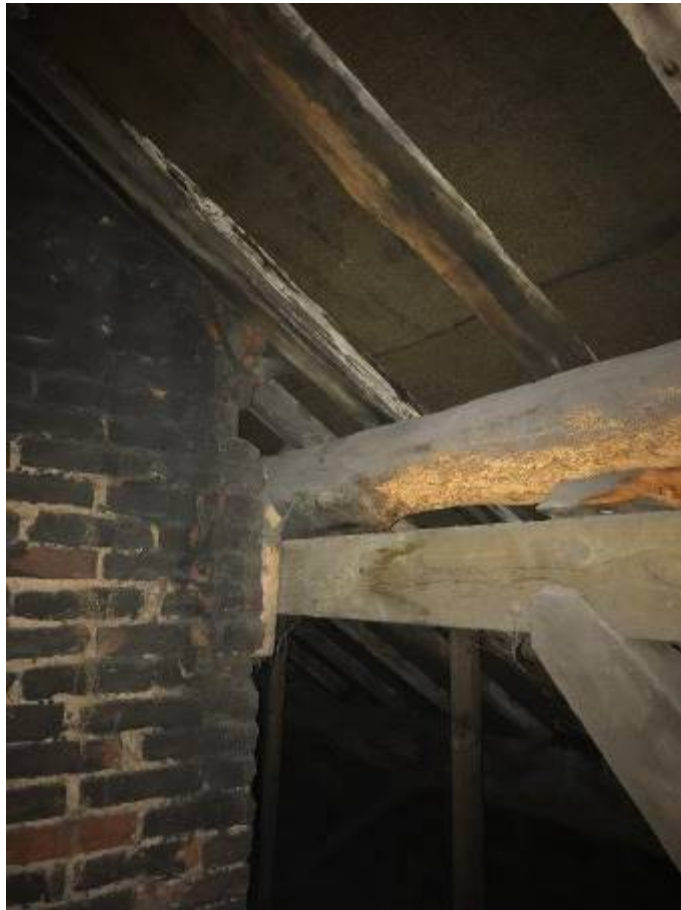
**Photograph 51A: Water ingress to common rafters and doubling up to purlin**

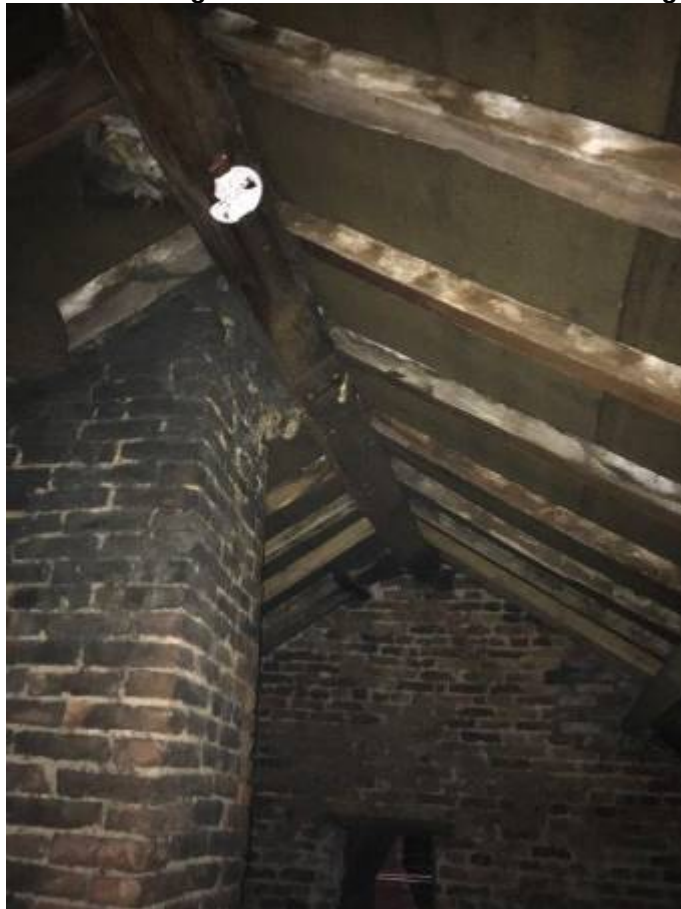
**Photograph 51B: Loss of membrane either side of stack. Note previous steel angle plate repair to ridge beam**

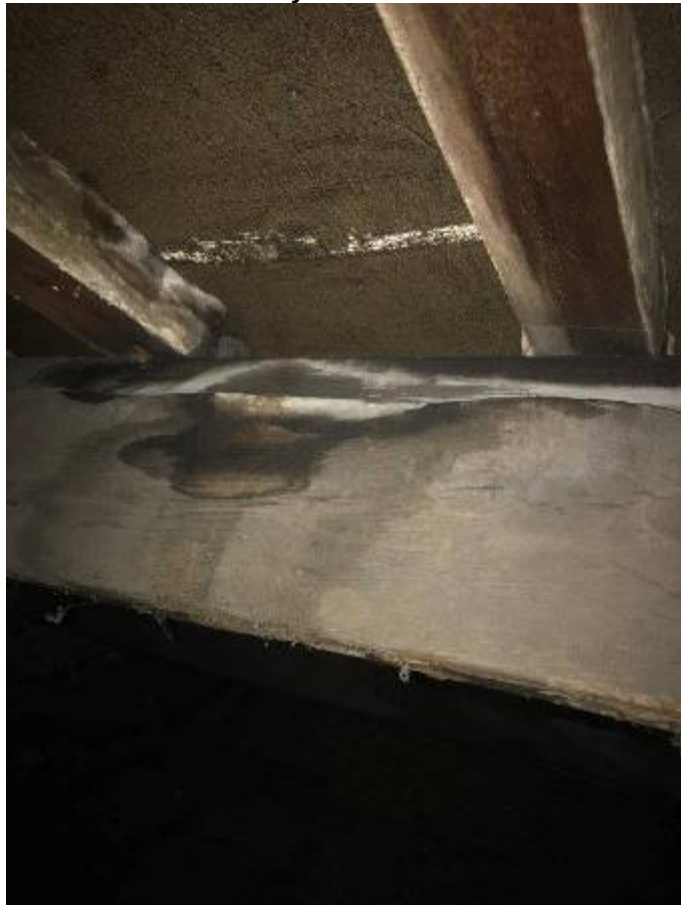
**Photograph 51D: Water ingress and leak at puncture to membrane upon purlin to east flank**
