### STRUCTURAL REPORT

#### CLAYTON HALL MANCHESTER

**Date:** February 2022

**Reference:** RGR/BBR/16076~srep rev 2

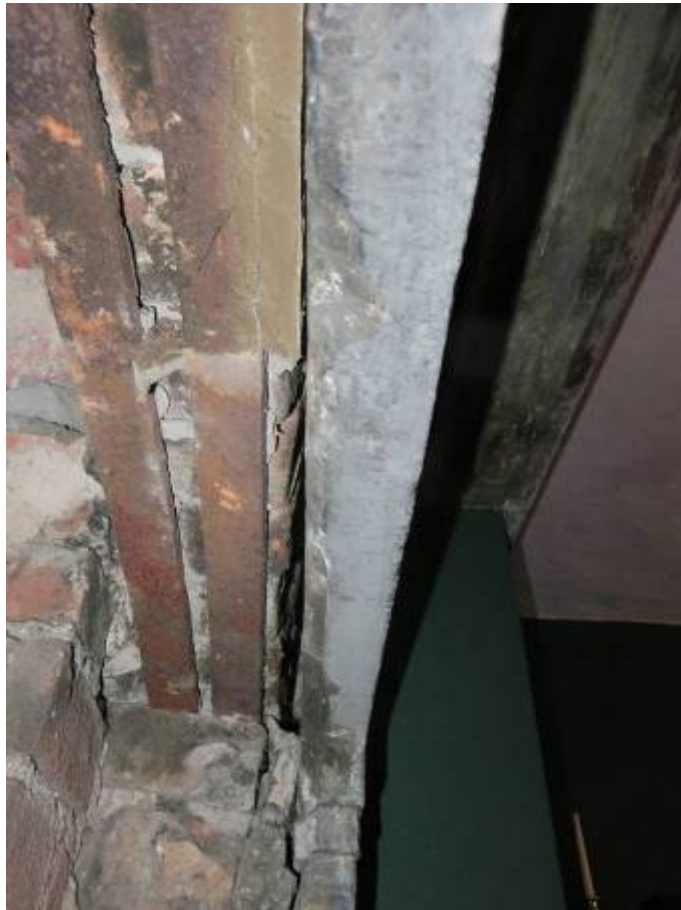
| 3.2.14 The fireplace has a thin 1.5 inch stone facing around it with a brick arch internally supported on iron bars (see photographs 57 and 58). Some small diameter brackets (6mm) stainless steel pins may be prudent from the stonework | There has been no change to this detail with no change in condition. |

Photograph 57: Thin stone veneer to front of fireplace

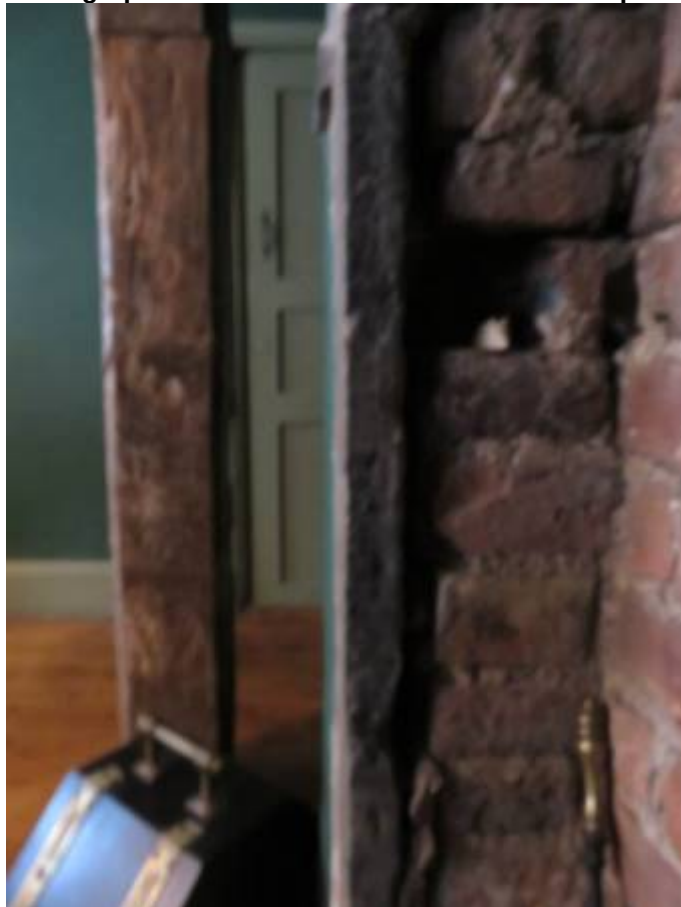
Photograph 58: Stone veneer to fireplace surround

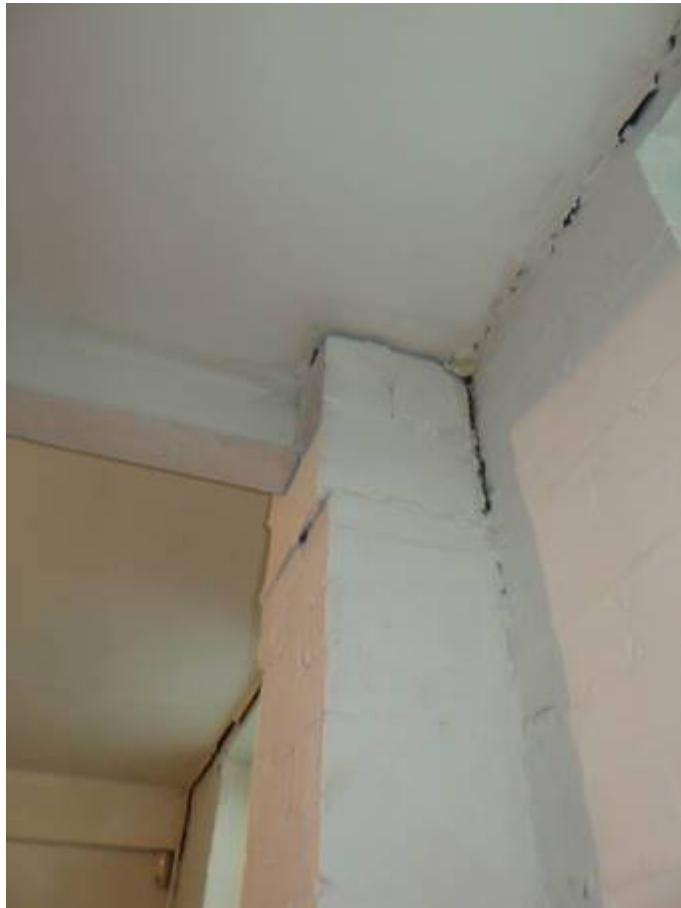
| <p>3.2.15 To the south-east room (larder) the floor drops down by 500-600mm. The ceiling (or floor above) has a steel beam spanning across the room east-west (see photograph 59) with apparent plasterboard or similar finishes, perhaps on the underside of an earlier finish? There has been some movement at the east end where the top three courses of an added brick pier have moved differentially to the main wall. This movement seems to extend in the ceilings to both sides, suggesting there has been some minor lateral movement of the wall in relation to the floor above (see photograph 60).</p> | <p>The arrangement has not changed and the movement present has increased by approximately a millimetre or so, but not too significantly (see photograph 59A). It can be noted that the 2No. walls that run perpendicular to this are plaster boarded and have hairline vertical cracks down their form in relation to the movement taking place.</p> |

**Photograph 59: Movement of added brick pier to west side of larder and steel beam**

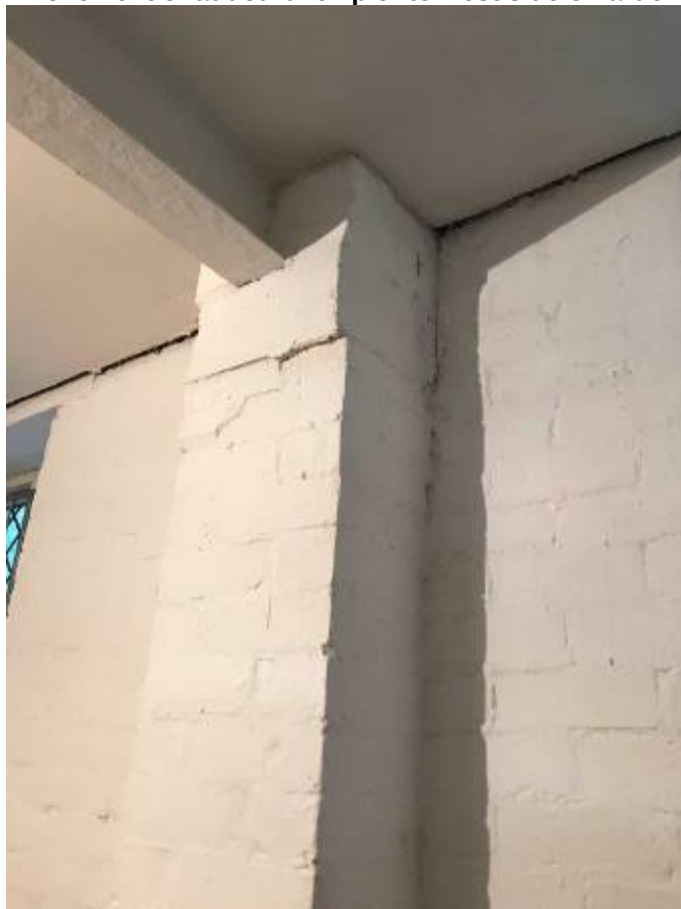
**Photograph 59A: Lateral displacement between wall and pier, as well as enlargement of gap between ceiling finish and wall**

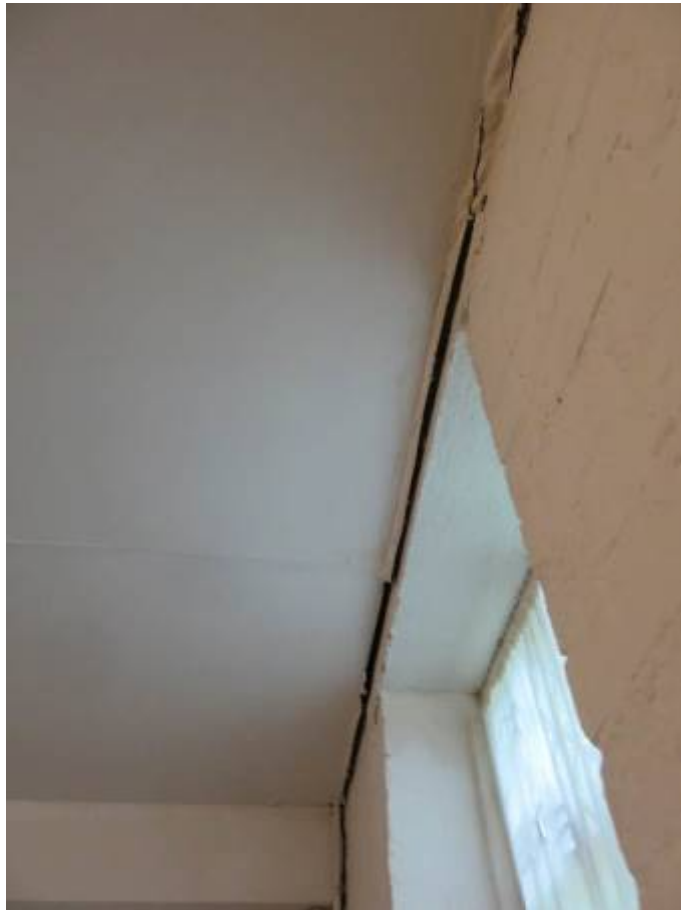
Photograph 60: Movement of floor/ceiling to east side of larder

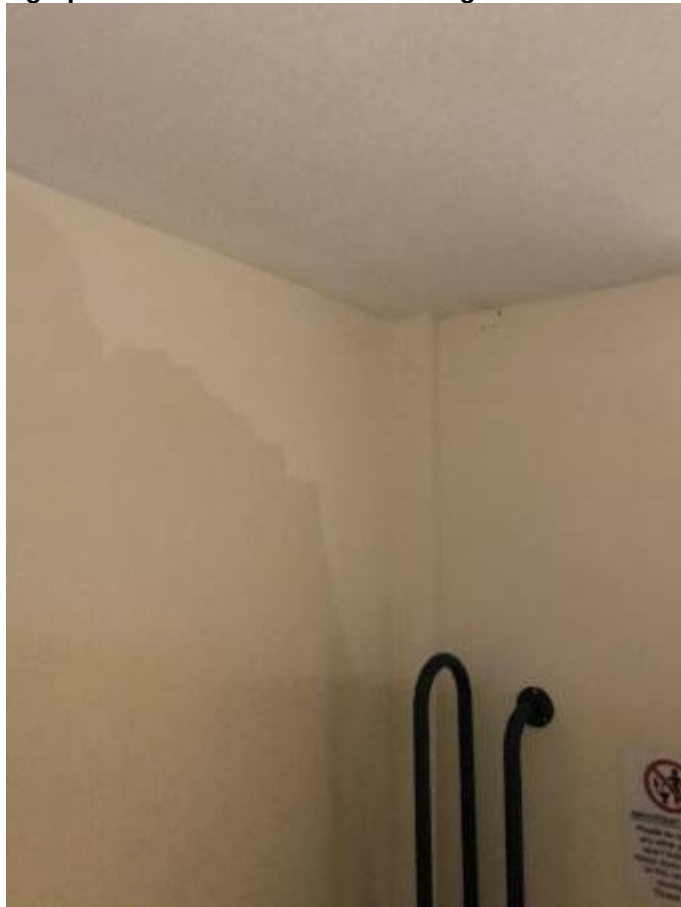
| <p>3.2.16 To the north-east corner are the WC's and a small lobby, with all the internal walls appearing to be of relatively recent construction, and confirmed by the Matrix report. No particular evidence to suggest any structural defects were noted.</p> | <p>No structural defects to note in this area, however there is a clear issue with water ingress/damp through the northern wall (see photograph 60A).</p> |

Photograph 60A: Damp staining to north wall of WC

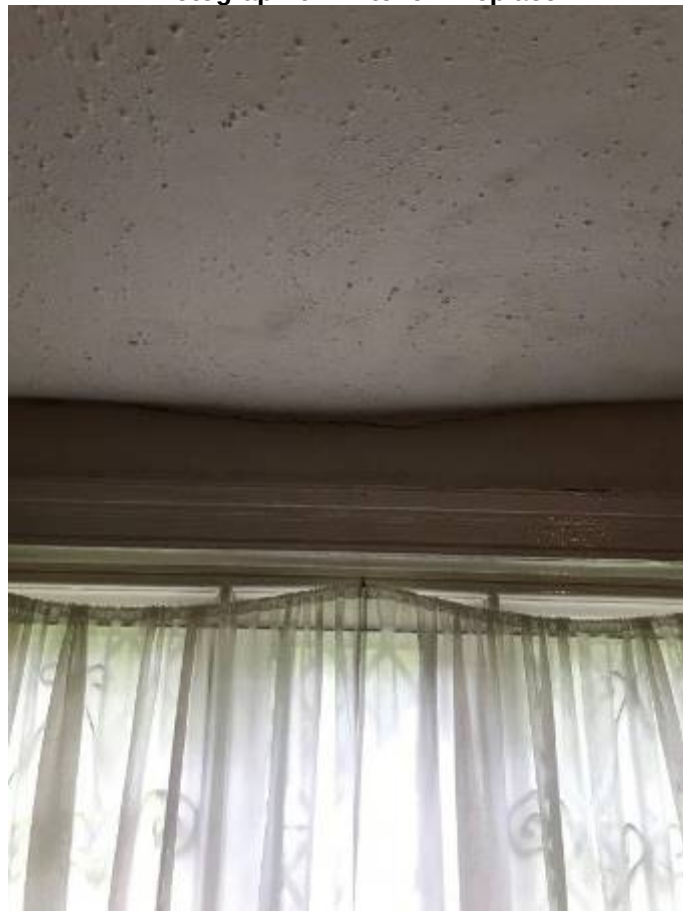
| <p>3.2.18 To the north-west room, the kitchen, the spine beam across the ceiling can be seen and presumably that to the south-west room was similar. There is also a setback fireplace with a timber bressumer set forward (see photograph 61). There is some minor further cracking above the timber bressumer (see photograph 62) in modern finishes perhaps suggesting some slight further deflection of this member. The floors at ground floor are all solid except for in the dining room, which is suspended.</p> | <p>Minor cracking spreading from the bressumer is still prevalent, with some separation also between the plaster ceiling and eastern wall (see photograph 61A).</p> |

Photograph 61A: Minor differential movement between west wall and ceiling within pressed kitchen

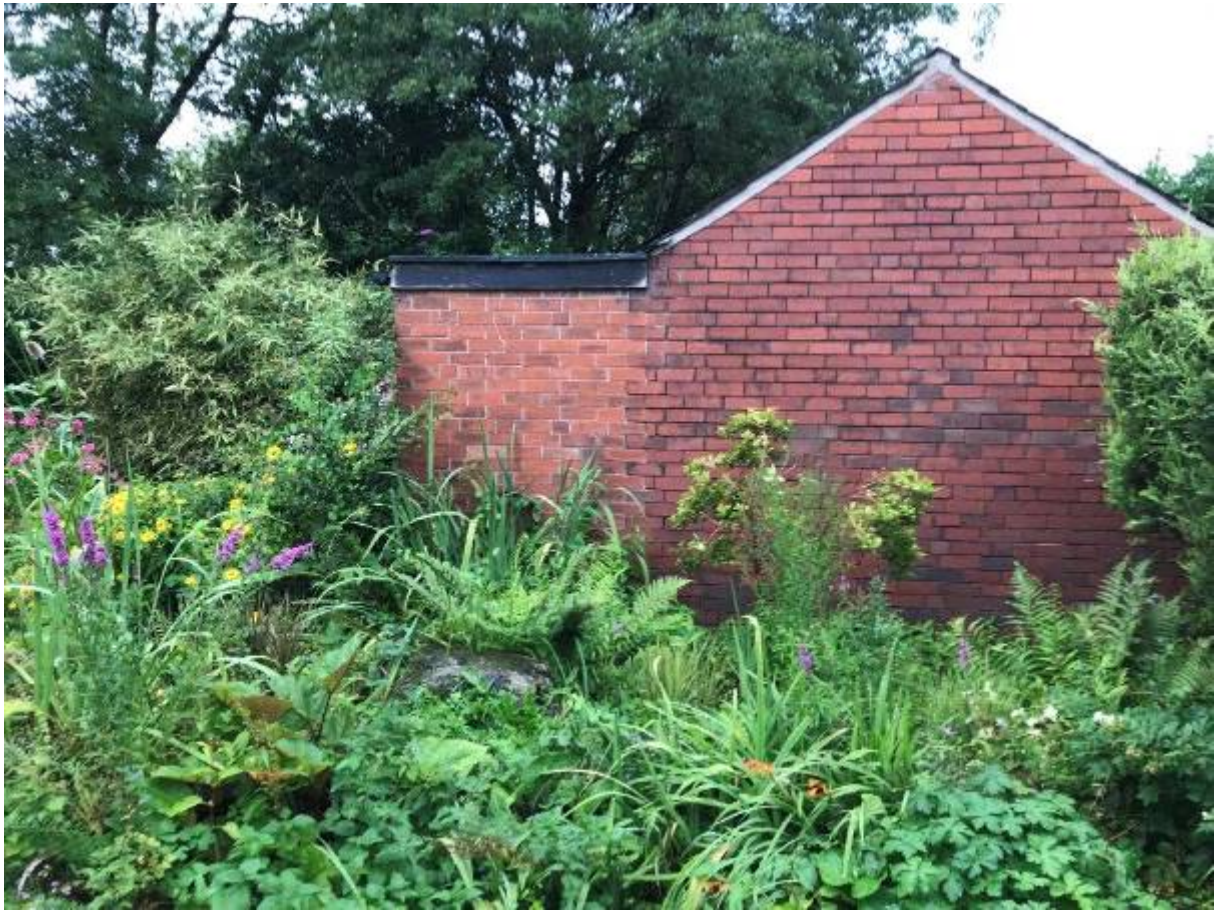
**Photograph 65A: General arrangement of outbuilding to its south elevation**

| 3.3.1 | The café and store is set a little to the north of the main building and adjoining the moat (see photograph 4). To the east elevation there appears to have been two open bays originally, then with a solid wall to the north (see photograph 64). It is constructed of 9 inch brick with a slate covered pitched roof over and a ceiling running through a short way above eaves. To the west side there is a flat roofed element felt covered roof (see photograph 65).<br>This area no longer serves as a café, with this now relocated into Clayton Hall at its southern wing. No changes have taken place to the building other than this since the previous report, with it largely being used as a storage space (see photograph 65A). |

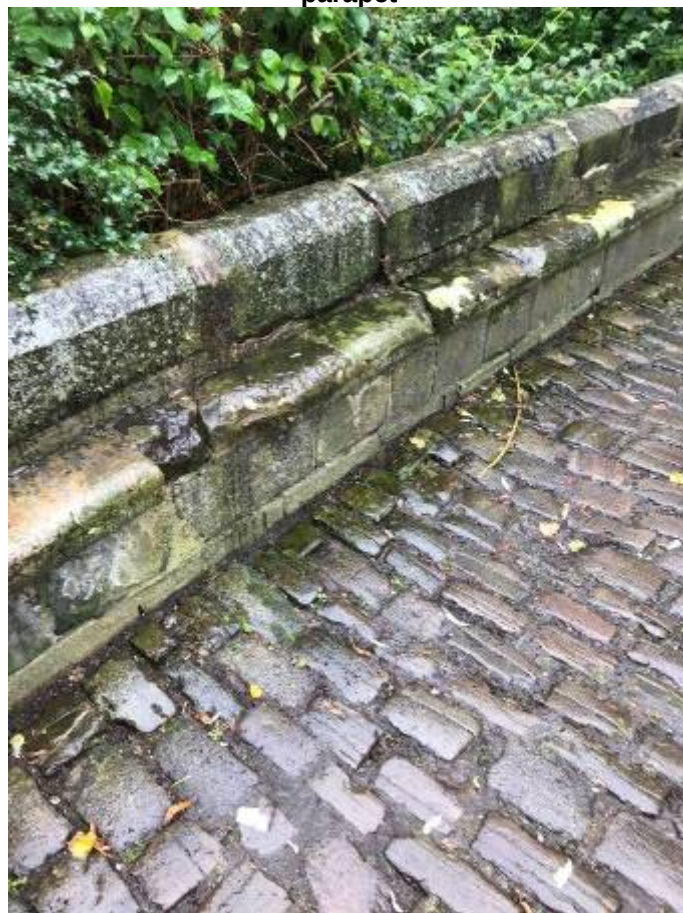
**Photograph 70C: Disjointed coping blocks to west side where vehicle impact may have influenced**

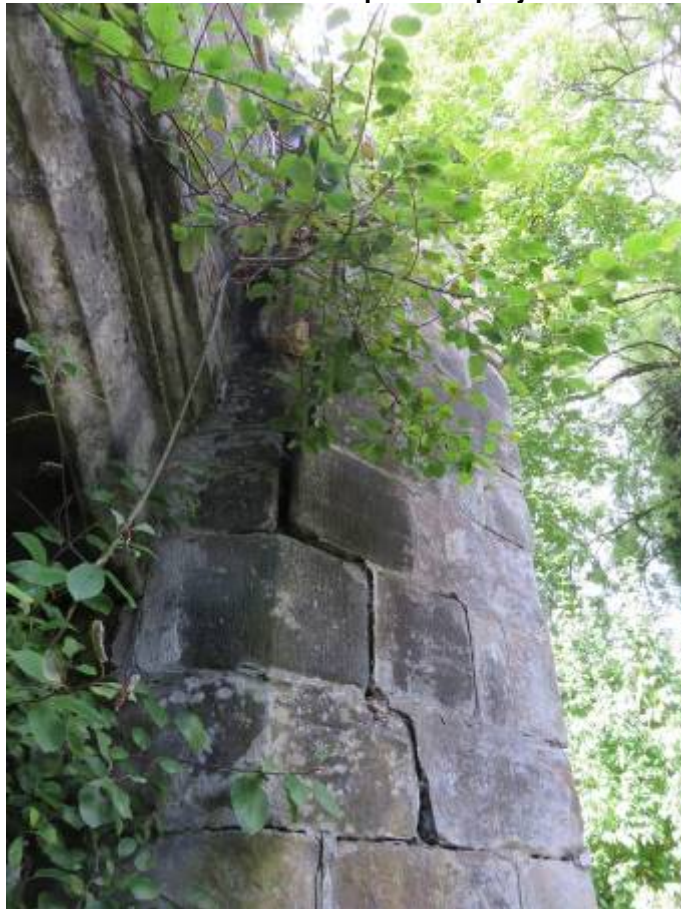
Photograph 71: Shrub growth to eastern side of bridge

| 3.4.4 The southern span is structurally in reasonable condition, but again saturated from water extending through the finishes above. To the east elevation there is a significant shrub growing (see photograph 71), although it has been cut back at some point but is continuing to grow. It has jacked the masonry open allowing water to ingress the pier. There are a number of fractures and voids around the structure, some of which have been patch infilled with cement pointing being used. | However, to the eastern cut water this exhibits buddleia growth with the root ball growing into joints at high level. This has been cut back to some degree and but has opened up the masonry joints. It appears that this has been left open for a substantial amount of time and water has been able to deteriorate the joints as well as the rubble infill material directly behind (Photograph 71A), so voids within the cutwater or likely present. It can be noted that to the eastern cut water, opening up of voids is at least to the level of 1". |

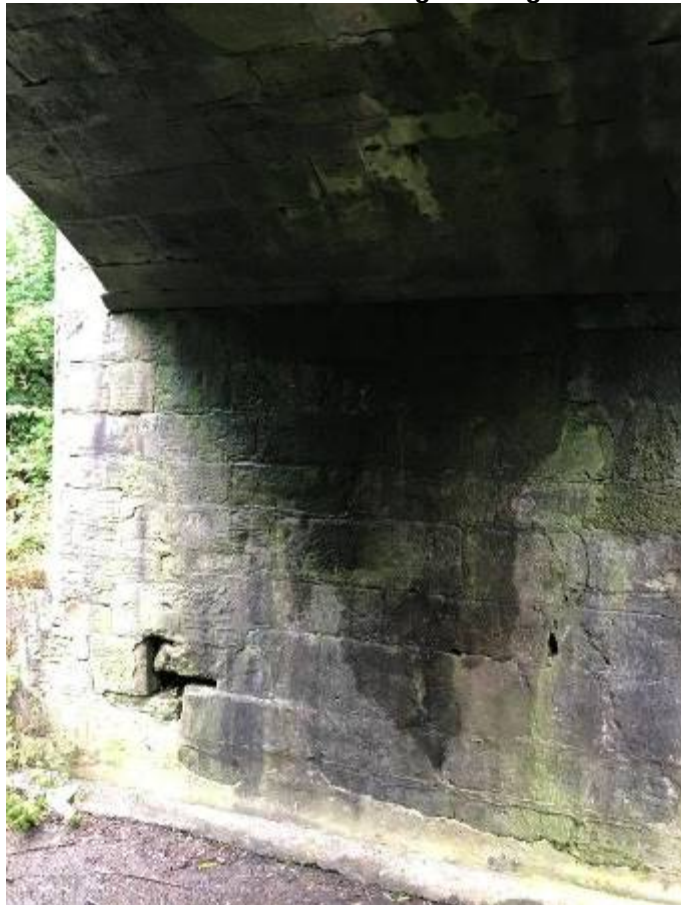
| | To the southern span, this clearly exhibits a greater amount of saturation through the barrel of the masonry vault and moisture is allowed to freely track onto the external face of its piers (Photograph 71B). |

**Photograph 71B: Water staining to intrados of central pier, from southern side. Low level void**
