**Table 2: First Floor Gazetteer – 18<sup>th</sup> Century Dwellings** (N.B It should be noted that since 2007 the condition of the building has become significantly worse and full access to the building is now limited due to health and safety reasons).

### 5.1.3 Building description – 1842-3 Bridgewater Canal Company office – Exterior

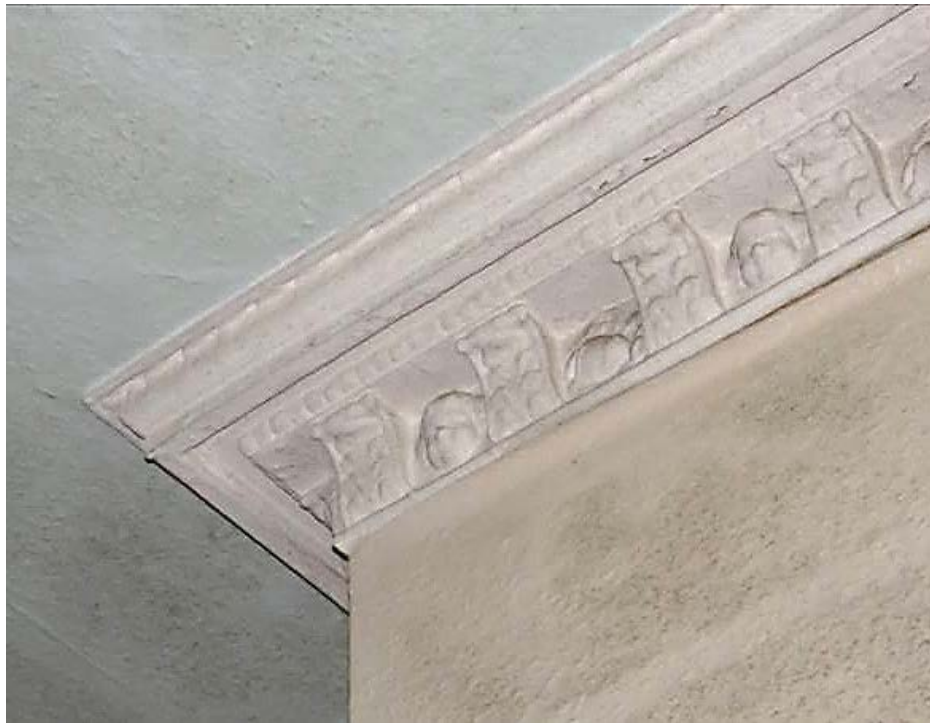
**Figure 52:** The 18<sup>th</sup> century cornice in Room G10. (Source: SLHA 2017)

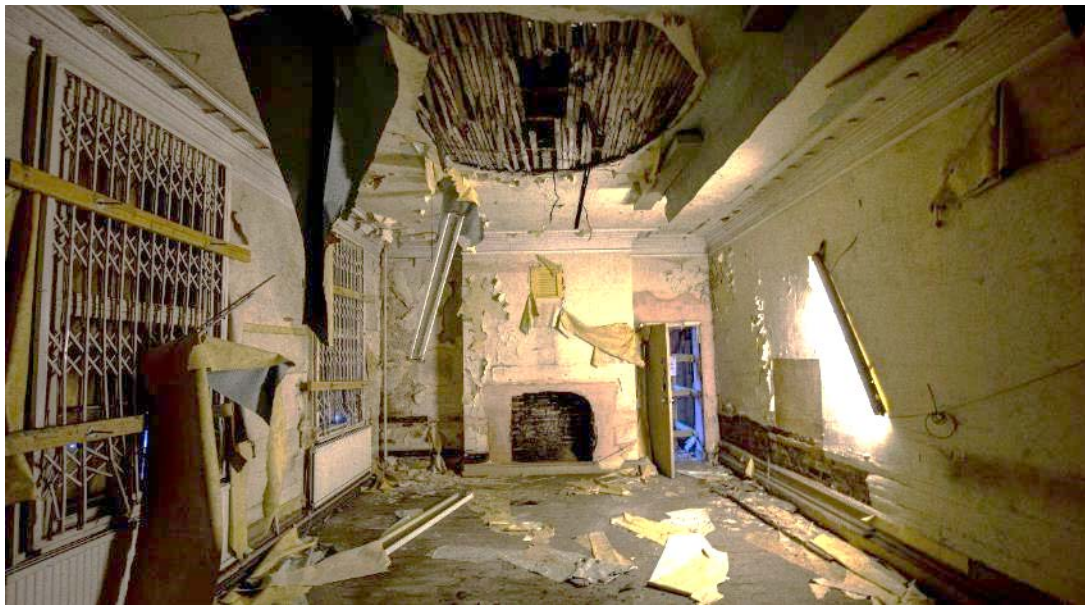
**Figure 53:** Room G04 (looking east) – This room was originally one of two reception rooms to the eastern dwelling and was divided into a main reception room to the eastern part (including chimney breast) and an entrance hall (located just off the image to the left). These two rooms were combined during the removal of the original entrance door from Chester Road and would have been redecorated accordingly during the c1880s with a new plaster cornice being installed. (Source: Watch This Space (Jembrana) Ltd 2022)

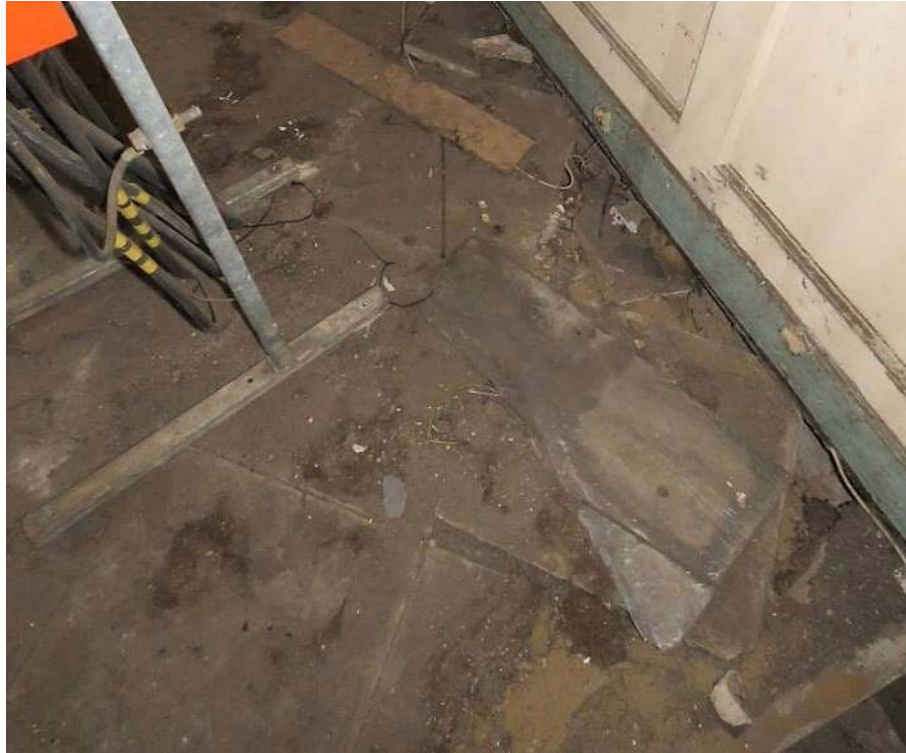
**Figure 62:** The original stone flag floor in Room G02. (Source: SLHA 2017)

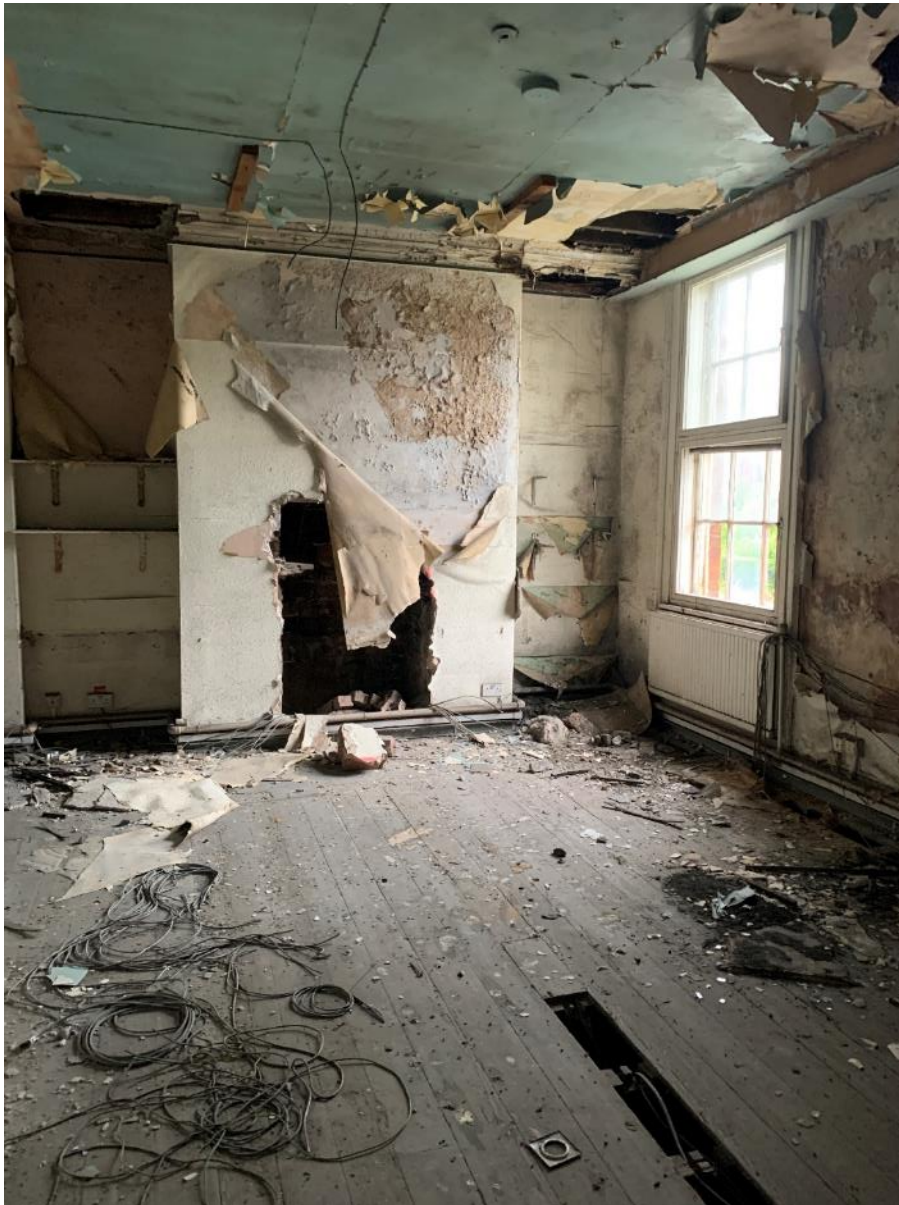
**Figure 64:** Room F17 (looking west) – This room retains areas of plain 18<sup>th</sup> century plaster cornice (Source: Watch This Space (Jembrana) Ltd 2022)

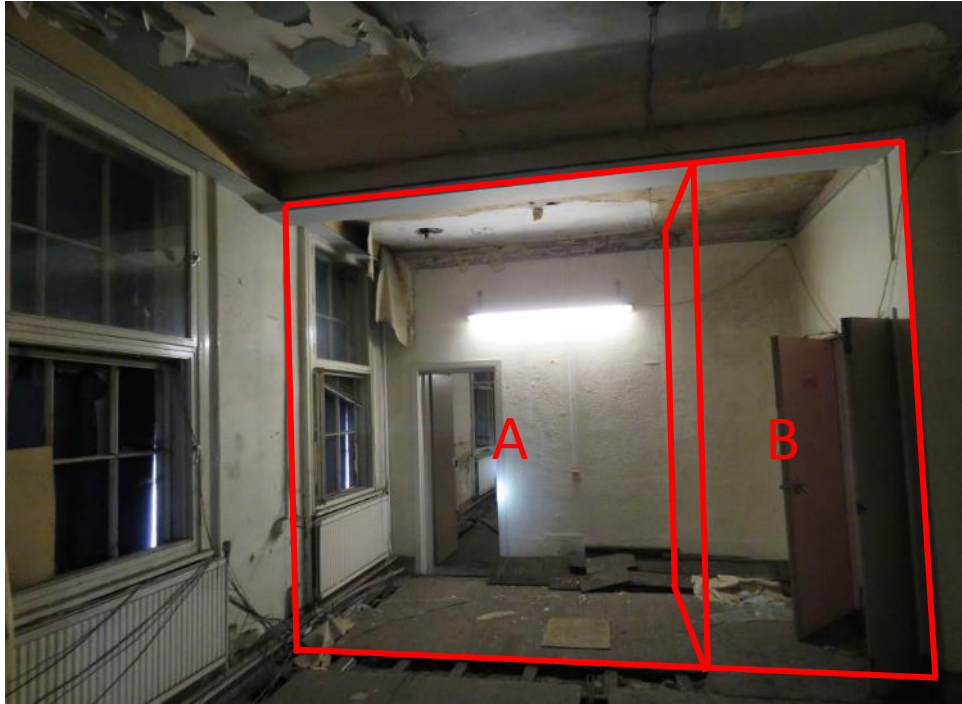
**Figure 65:** Looking towards the eastern end of Room F17– This room was originally two rooms (as mirrored in the eastern dwelling and below in the former entrance halls). The small room to the left (A) was likely originally a dressing room accessed from one or both principal front bedrooms.

The original location of the dressing room's landing wall is shown to the centre, which would have provided a slightly recessed extension (B) of the adjacent landing (Room F16). Evidence of this can be seen in the original landing plaster cornice return in this room and Room F16. (Source: SLHA 2017 - please note the condition of the building has significantly worsened since 2007)

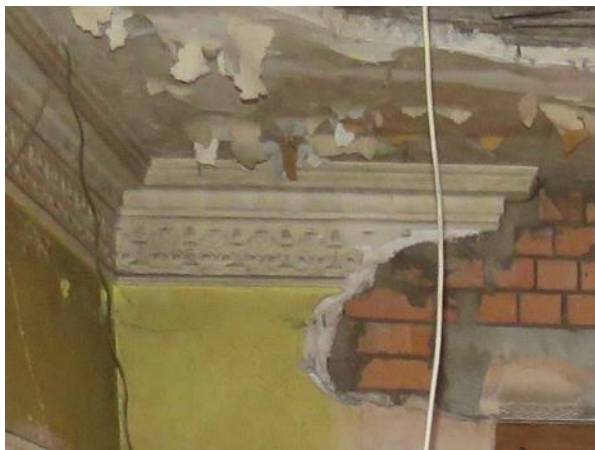
**Figure 68:** A closer view of the remaining piece of highly decorated plaster cornice return in Room F16. (Source: SLHA 2017)

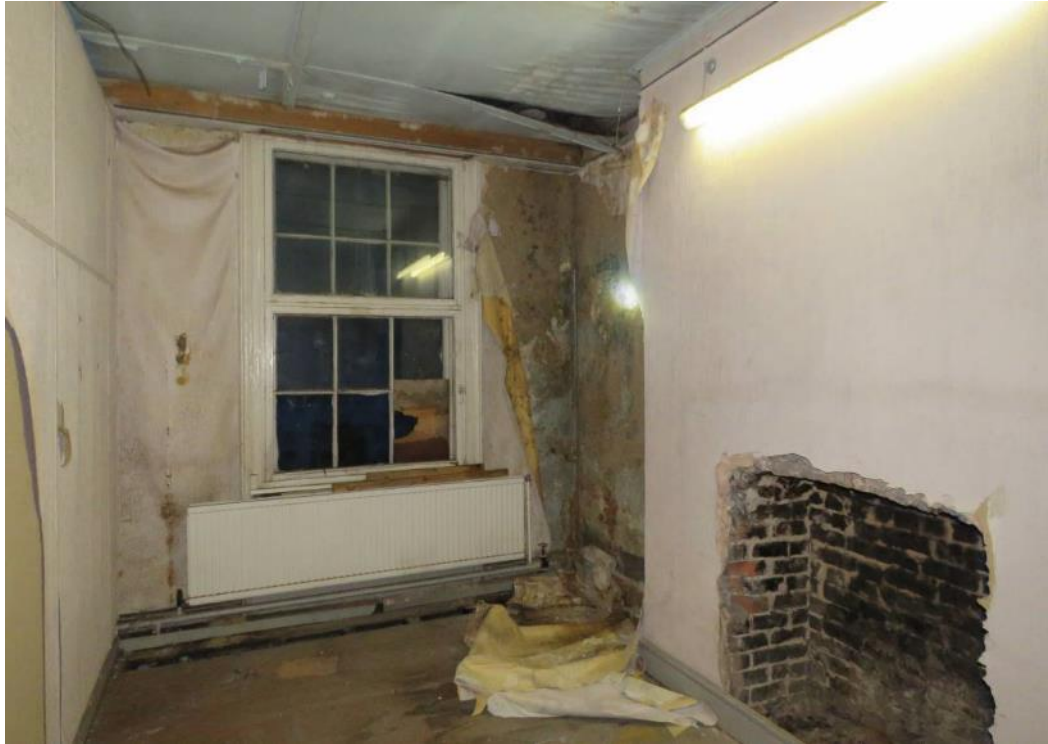
**Figure 70:** Room F22 (looking north) – this room was originally part of the adjacent Room F21, but subdivided in the 20<sup>th</sup> century. (Source: SLHA 2017 - please note the condition of the building has significantly worsened since 2007)

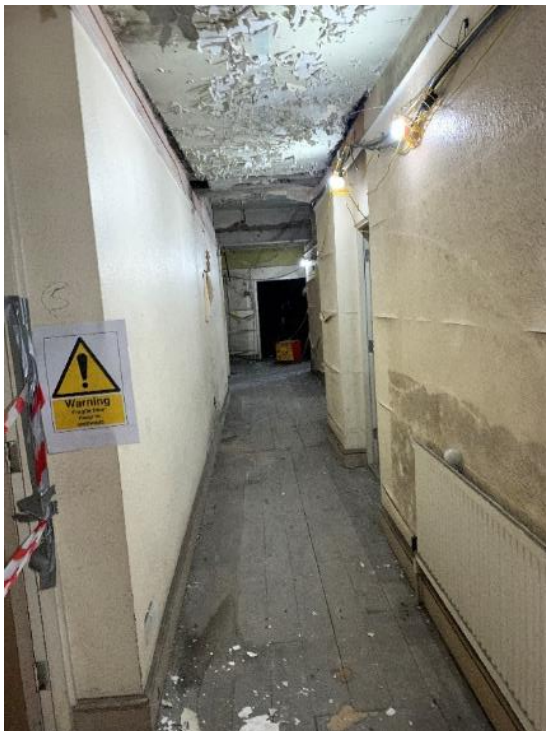
**Figure 71:** Room F32 (looking west) – This link corridor was inserted east-west through both dwellings in the c1880s. (Source: Watch This Space (Jembrana) Ltd 2022)

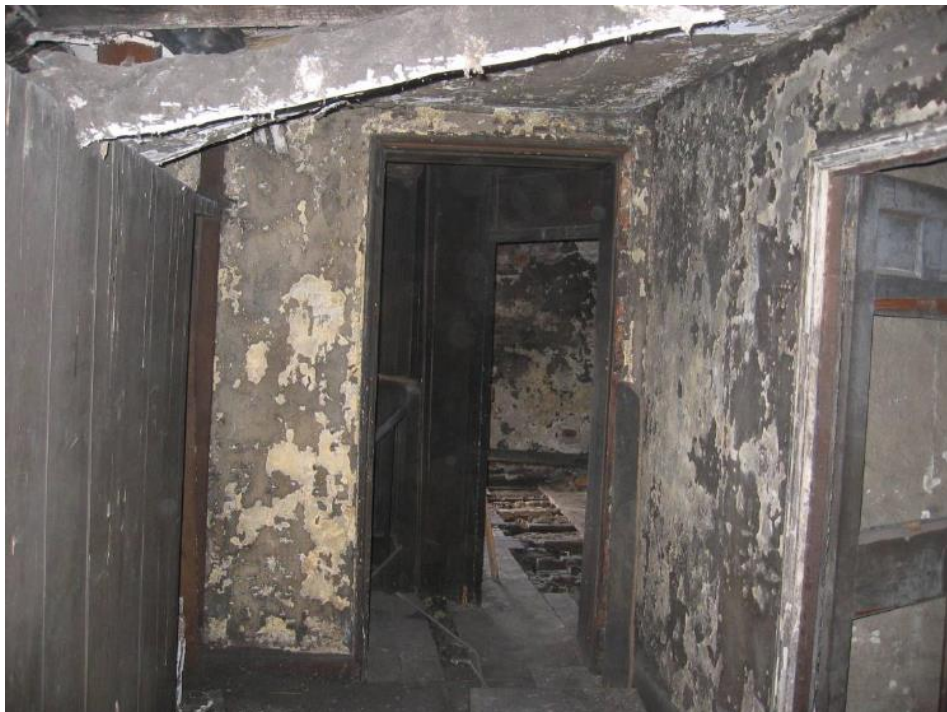
**Figure 82:** Room A15 (looking west) – This room forms the attic landing and corridor of the western dwelling and would have originally been used as servant's accommodation. This attic space, and the three rooms leading off have not been decorated since the 19<sup>th</sup> century, and retain early paint schemes, original doors/architrave and skirting. (Source: SLHA 2007 - please note the condition of the building has significantly worsened since 2007)

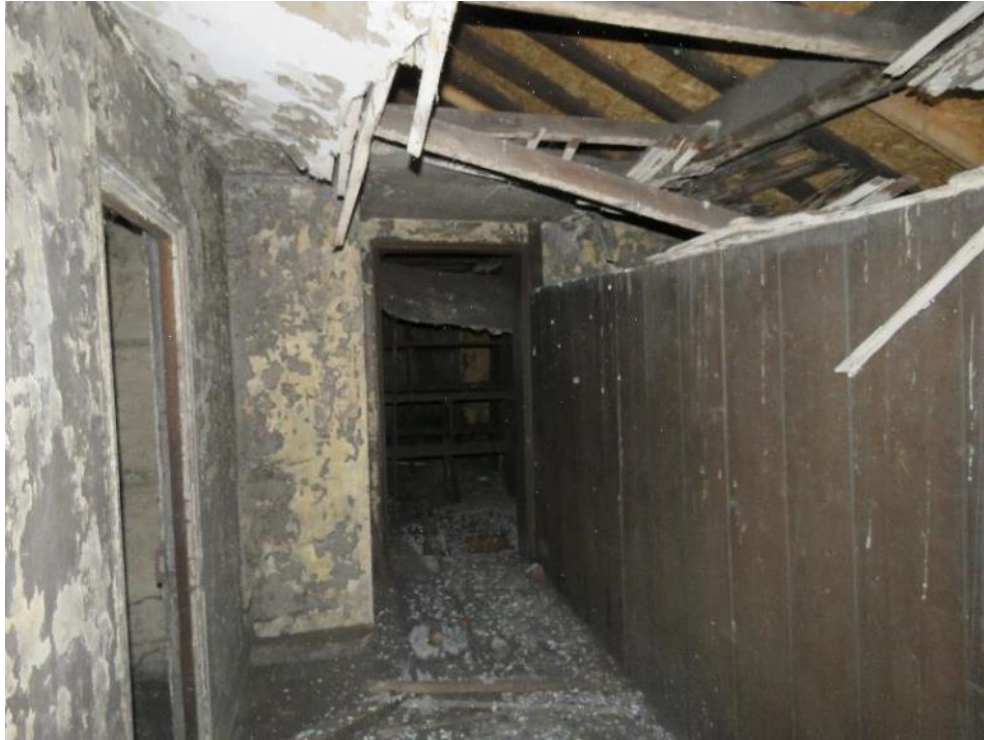
**Figure 83:** Room A15 (looking east) – The attic corridor is shown here looking east, and illustrates the original/early boarded partition to the right. (Source: SLHA 2020 - please note the condition of the building has significantly worsened since 2020)

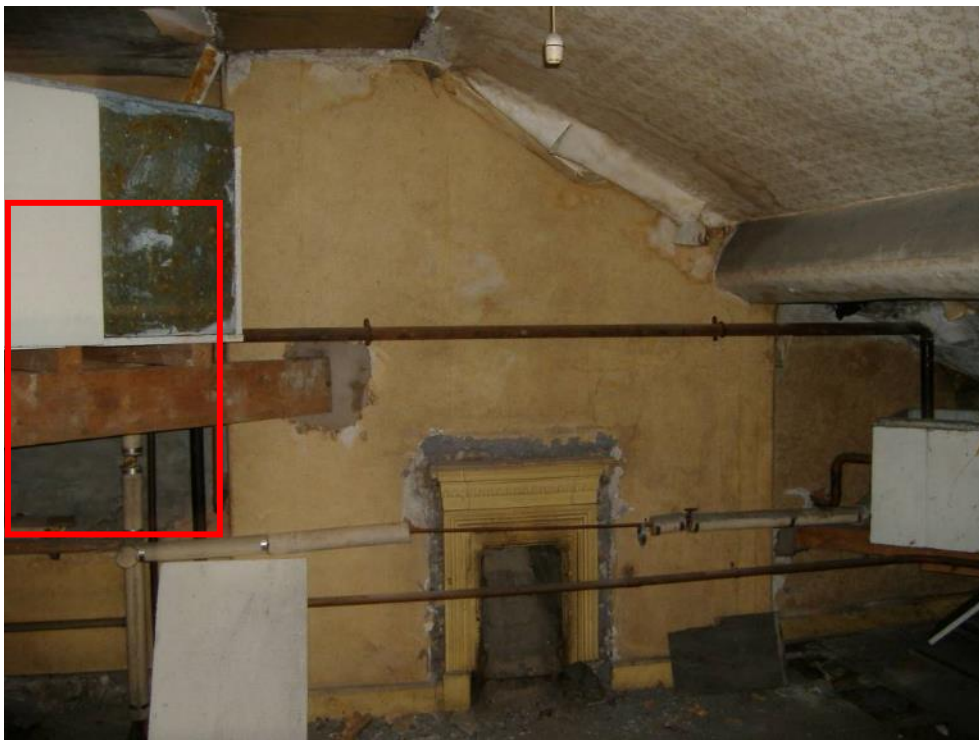
**Figure 91:** Room A02 (looking east) showing a 19<sup>th</sup> century cast iron fire surround and 19<sup>th</sup> century “sanitary” ceiling wallpaper. Note the now blocked window outlined (left), as seen in Figure 22 & 42. (Source: SLHA 2017 - please note the condition of the building has significantly worsened since 2017)

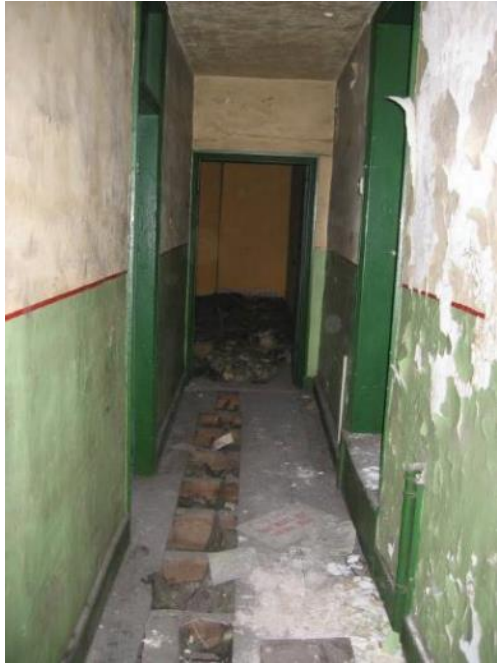
**Figure 92:** Room A03 (looking west) – the original attic corridor to the eastern dwelling, showing 1930s paint scheme. This attic area was lived in by the on site porter (Source: SLHA 2017 - please note the condition of the building has significantly worsened since 2017)

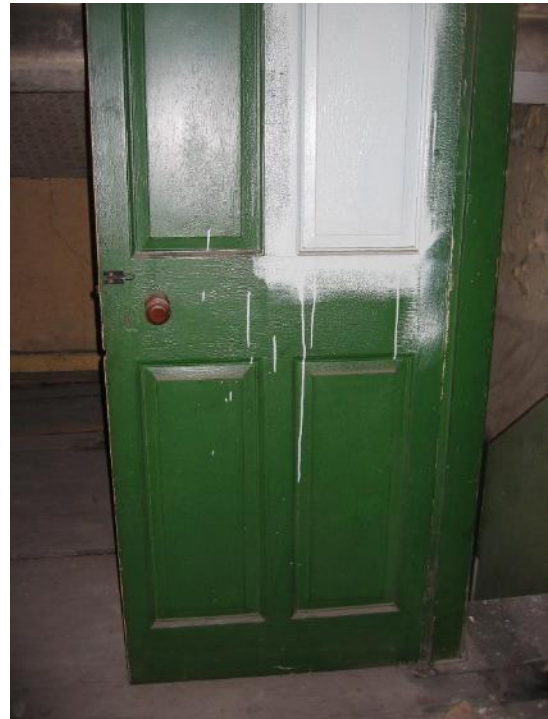
**Figure 97:** The original panelled door into Room A02 (Source: SLHA 2007)

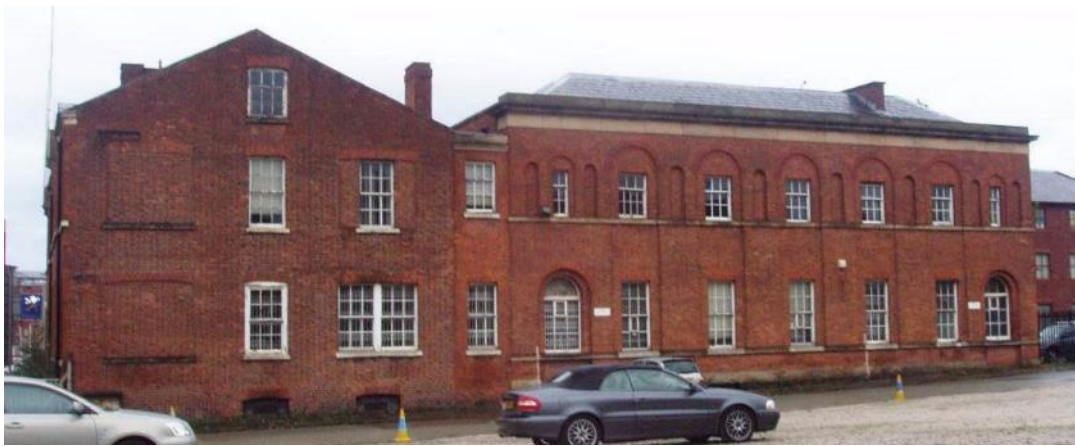
**Figure 98:** The west elevation as seen in 2007, showing the 18<sup>th</sup> century dwelling to the left, the 1842-43 office extension to the right, and later, narrow link in-between. (Source: SLHA 2007)

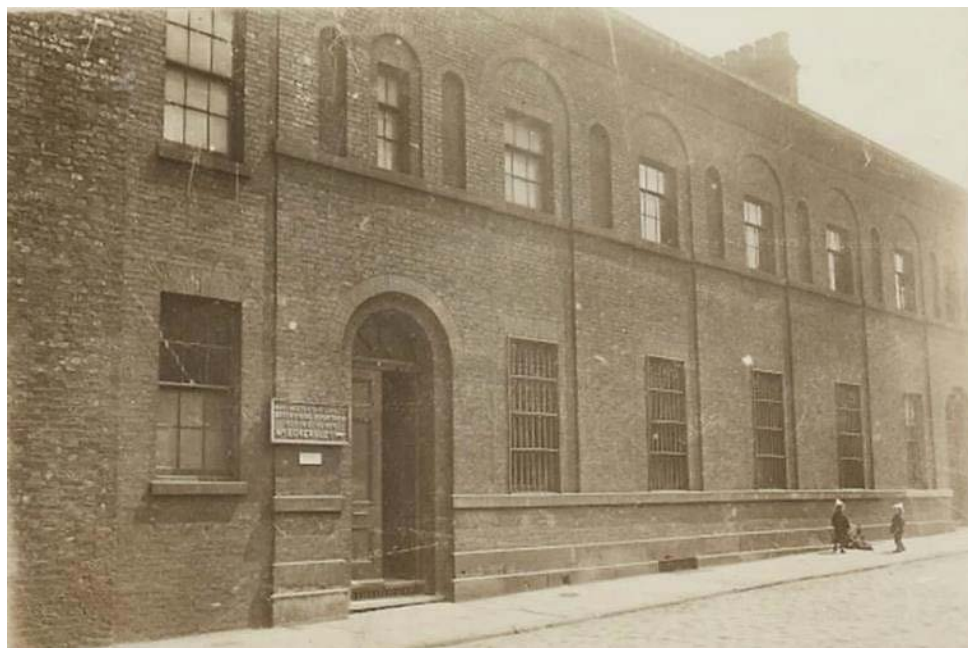
**Figure 99:** The principal west elevation of the 1842-3 Bridgewater Trustees Office, as seen when used by the Manchester Ship Canal in c1920 (Source: Canal & Rivers Trust)

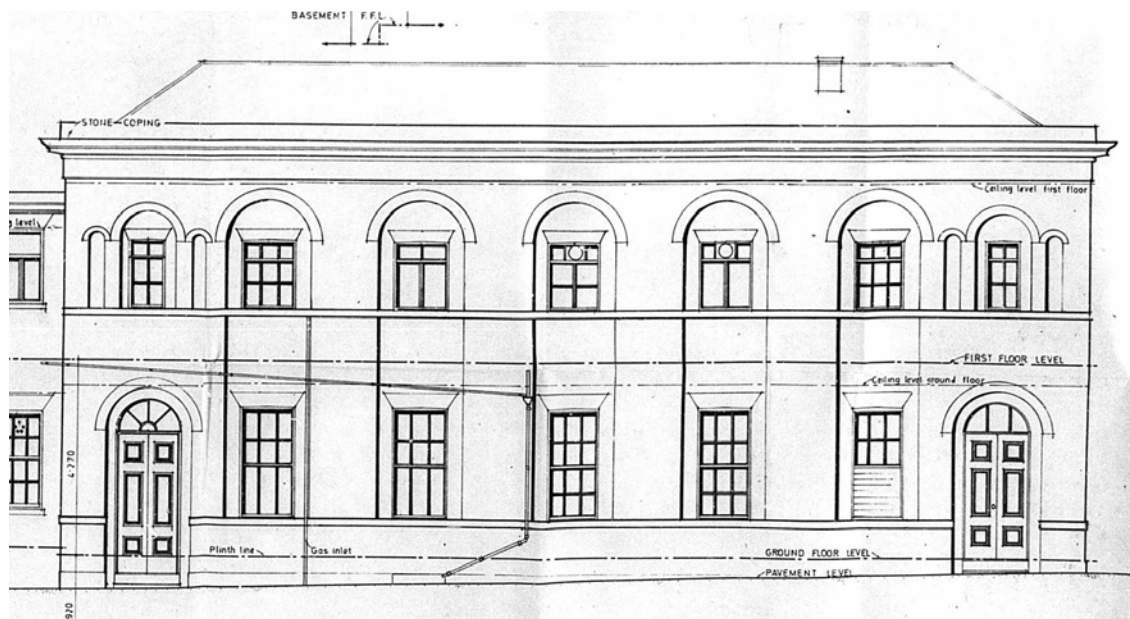
**Figure 100:** The same elevation as seen in 1976 following its purchase by Securicor Ltd, showing the alteration of some original sash windows and removal of original ground floor iron security railings. Source: Manchester City Council)

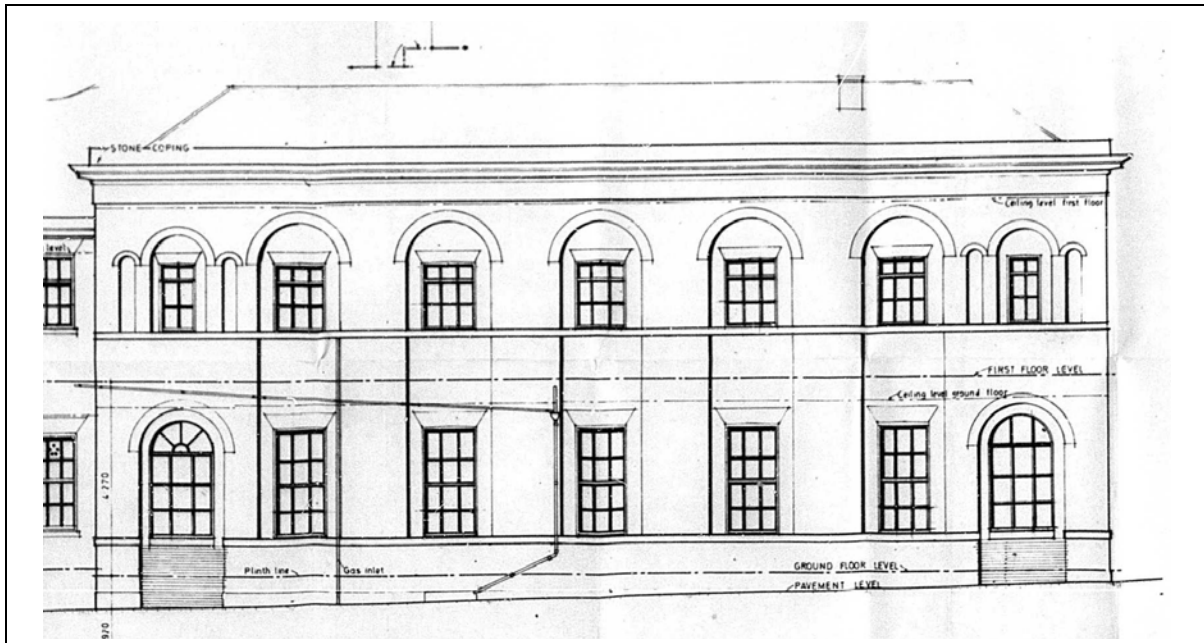
**Figure 101:** The proposed west office elevation as seen in 1976 following showing the alterations undertaken by Securicor Ltd, including the removal of the two original pairs of panelled entrance doors and the restoration of altered sash windows. (Source: Manchester City Council).

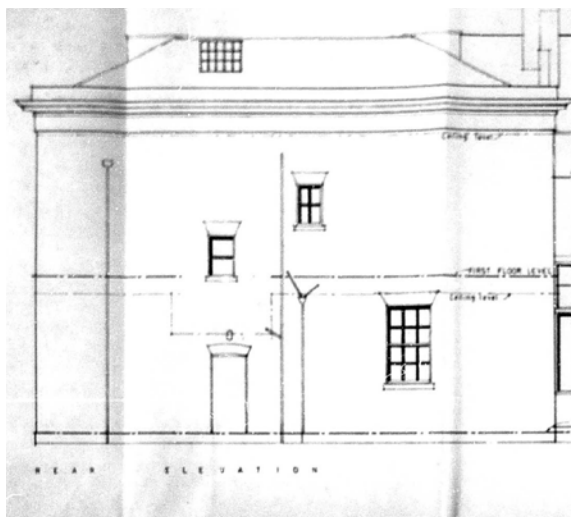
**Figure 103:** The southern office elevation as it appeared following its purchase by Securicor Ltd in 1977, showing the original single rear door and two small first floor windows to a former toilet and bathroom (Source: Manchester City Council).

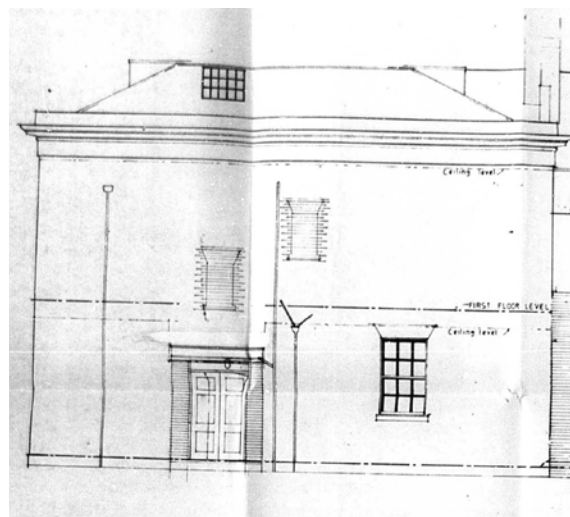
**Figure 104:** The proposed 1977 southern office elevation, showing the widened and extended rear door and blocking of first floor windows (Source: Manchester City Council).
