Phase I Geoenvironmental Site Assessment  
Sulby Street, Manchester

Reference: 15-395-R1-1  
Date: February 2022

Land off Sulby Street  
Manchester  
M40 5HY

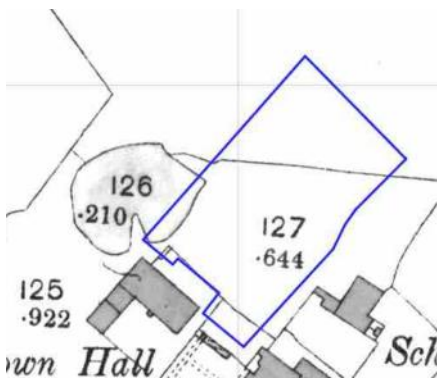
| MAP EDITION | HISTORICAL LAND USE | HISTORICAL MAP EXCERPT |
|---|---|---|
| <p><b>1893</b><br/><b>1:2,500</b></p> | <p>The field boundary or drain that crosses the site is now marked in the north of the site.</p> <p>A pond encroaches on the western boundary of the site.</p> | |

| POLLUTANT LINKAGE | CONTAMINANT (SOURCE) | PATHWAY | RECEPTOR | PROBABILITY | CURRENT RISK | RESIDUAL RISK AFTER MITIGATION |
|---|---|---|---|---|---|---|
| <p><b>Assessment:</b><br/>An infilled pond has been identified along the western boundary, along with others in the vicinity. Pond infill may contain degradable/putrescible organic material which may produce carbon dioxide and methane through anaerobic bacterial respiration. The historic landfill located 169 m northeast of the site also represents a source of ground gas. Glacial Till will likely restrict migration of any ground gas into shallow foundations which may reduce the risk to end-users.</p> <p><b>Recommendation:</b><br/>Intrusive site investigation and gas monitoring required.</p> | | | | | | |

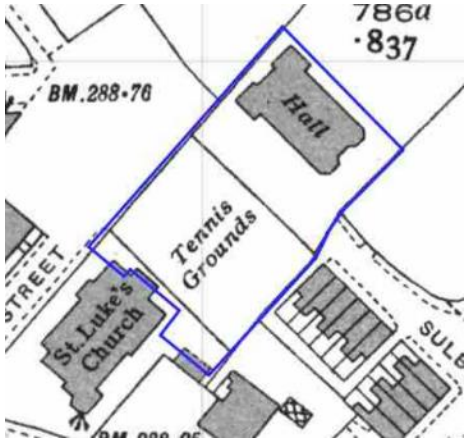
| MAP EDITION | HISTORICAL LAND USE | HISTORICAL MAP EXCERPT |
|---|---|---|
| <p><b>1931-1933</b><br/><b>1:2,500</b></p> | <p>The site is now utilised as tennis grounds in the south of the site, with a building marked as a hall in the north of the site.</p> <p>The small building in the east of the site has been demolished.</p> | |

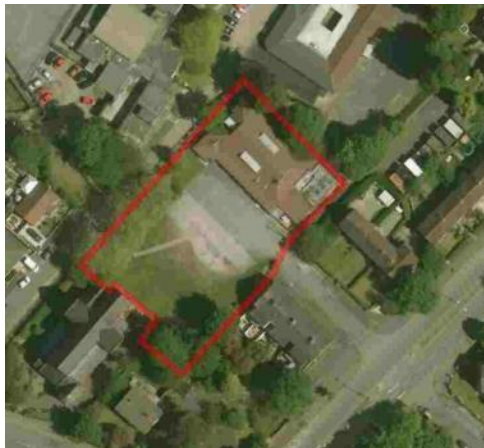
| MAP EDITION | HISTORICAL LAND USE | HISTORICAL MAP EXCERPT |
|---|---|---|
| <p><b>Recent Aerial photography</b><br/><b>2015</b></p> | <p>Recent aerial photography shows an area of hardstanding in the centre of the site, to the south of the Men's Club.</p> <p>The south of the site is vegetated with trees and soft cover, likely grass.</p> | |

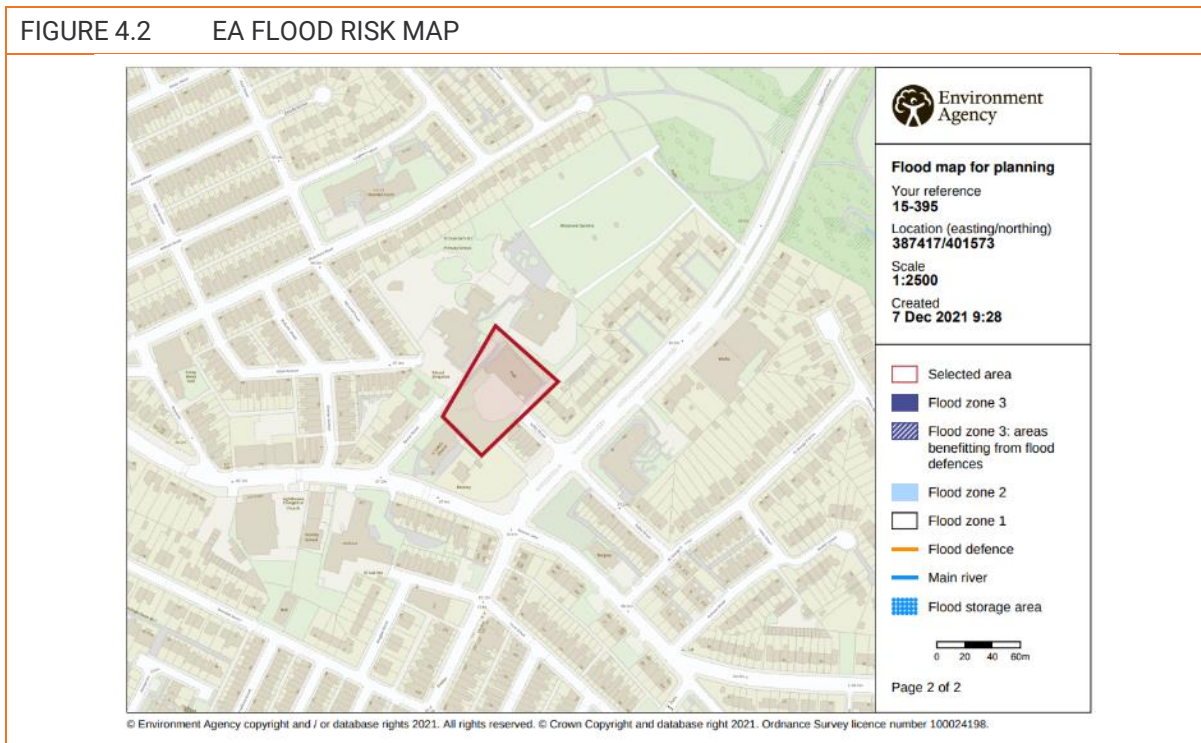
FIGURE 4.2 EA FLOOD RISK MAP

The site is predominantly located within a currently defined "Flood Risk Zone 1"; defined as land assessed as having less than 1 in 1,000 annual probability of river or sea flooding (< 0.1%), and as such is considered to be unaffected by river flooding. In addition, the Groundsure report states there is a low risk for groundwater flooding to occur at the site. The Environment Agency (EA) Flood Risk Map for the site is presented as Figure 4.2.

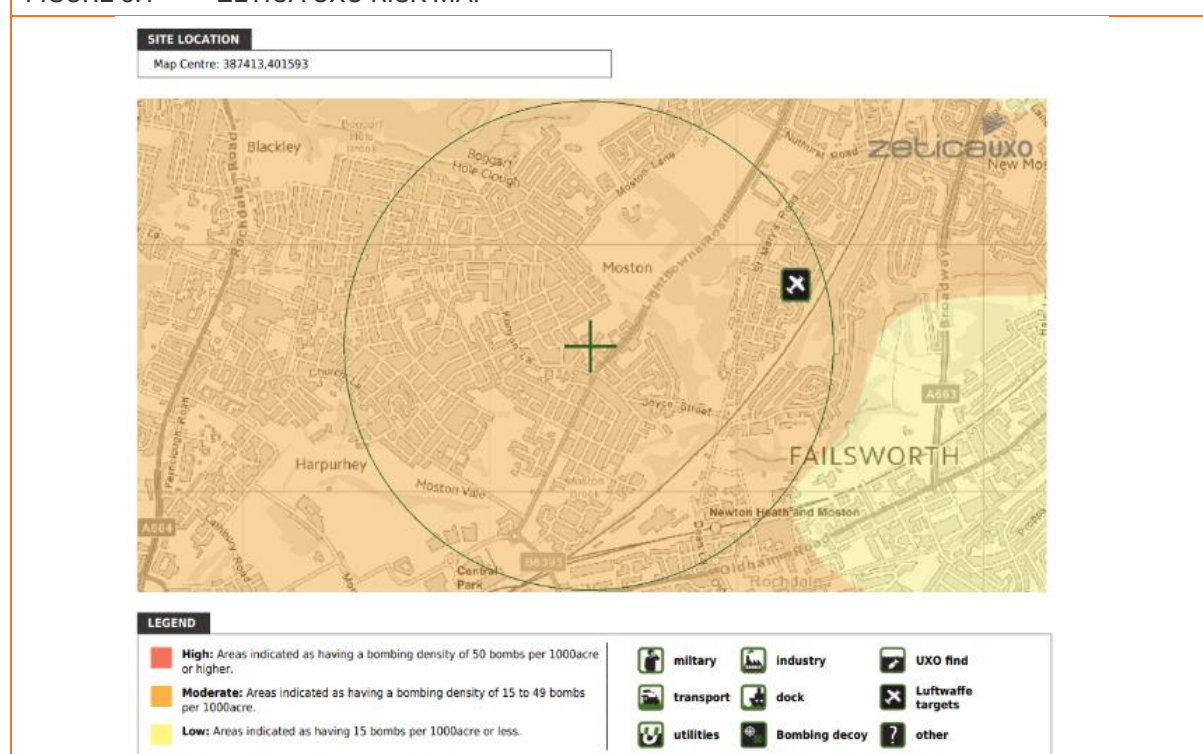
FIGURE 5.1 ZETICA UXO RISK MAP

The regional unexploded bomb risk map from Zetica (2014) indicates that the site is in an area at moderate risk from possible unexploded ordnance (UXO) resulting from the Second World War. The Zetica UXO Risk Map is presented in Figure 5.1.
