## SPECIFICATION FOR ASBESTOS REMEDIATION WORKS

**PREMIER HOUSE, 22 DEANS\_GATE, MANCHESTER, M3 1PH**

| <b>Job number:</b> | <b>R05655</b> | |
| Version 3 | 25/03/2021 | Issued – addition of Retail Unit items to scope |

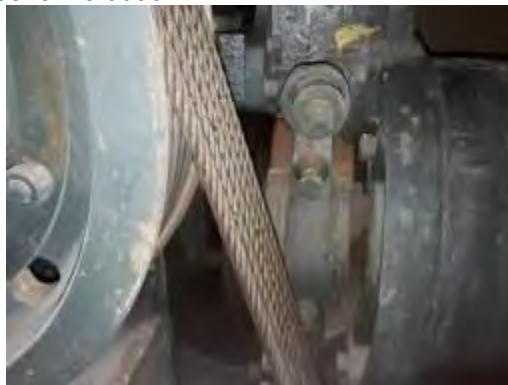
| Building | Floor/<br>Room | Assessment<br>Number | Location/<br>position | Product<br>type | Surface<br>treatment | Condition | Extent | Accessibility | Level of<br>identification | Asbestos<br>type |
|---|---|---|---|---|---|---|---|---|---|---|
| Premier house | External/E7 | J048245/0096 | Cement Brake shoes | Cement | Surface Sealed | Low Damage | 2no. | Occasionally likely to be disturbed | Identified | Chrysotile |

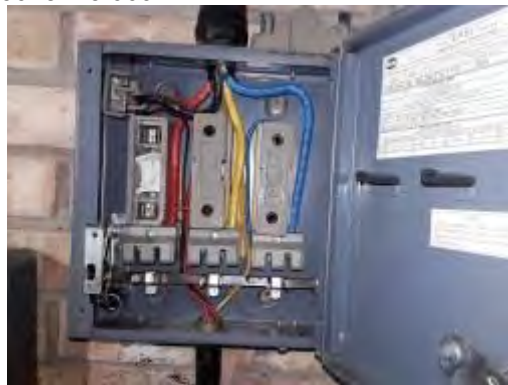
| Building | Floor/<br>Room | Assessment<br>Number | Location/<br>position | Product<br>type | Surface<br>treatment | Condition | Extent | Accessibility | Level of<br>identification | Asbestos<br>type |
|---|---|---|---|---|---|---|---|---|---|---|
| Premier house | External/E7 | J048245/0097 | Textiles flash guards | Textiles | Surface Sealed | Low Damage | 3no. | Occasionally likely to be disturbed | Identified | Chrysotile |

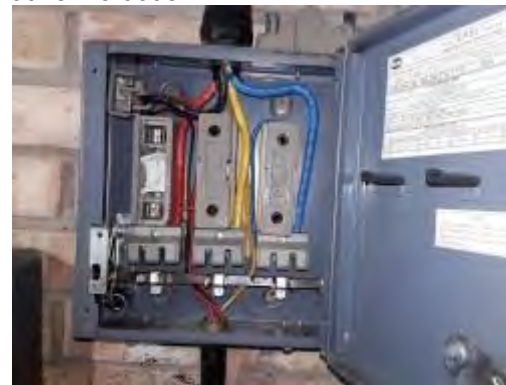
| Building | Floor/<br>Room | Assessment<br>Number | Location/<br>position | Product<br>type | Surface<br>treatment | Condition | Extent | Accessibility | Level of<br>identification | Asbestos<br>type |
|---|---|---|---|---|---|---|---|---|---|---|
| Premier house | External/E7 | J048245/0098 | Composite Putty to electric boxes | Well bound Material | Surface Sealed | Low Damage | 3LM | Occasionally likely to be disturbed | Identified | Chrysotile |

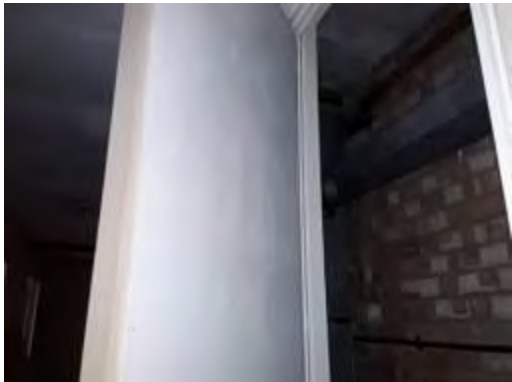
| Location 8 | | | | | | | | | | |
|---|---|---|---|---|---|---|---|---|---|---|
| Premier house | 1 <sup>st</sup> floor/1.1 | J048245/0044 | Board panel to doors | Board | Unsealed | Low Damage | 4no. | Occasionally likely to be disturbed | Identified | Amosite |

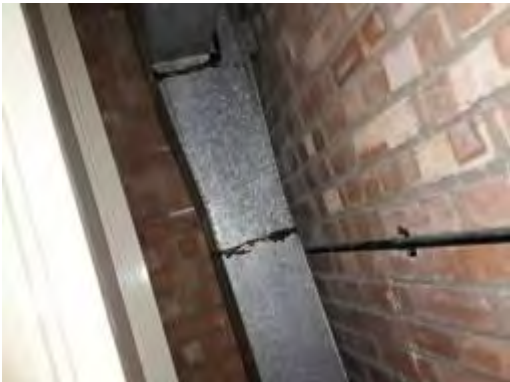
| Location 8 | | | | | | | | | | |
|---|---|---|---|---|---|---|---|---|---|---|
| Premier house | 1 <sup>st</sup> floor/1.1 | J048245/0045 | Composite putty to ducting | Well Bound Material | Surface Sealed | Low Damage | 3LM | Occasionally likely to be disturbed | Identified | Chrysotile |

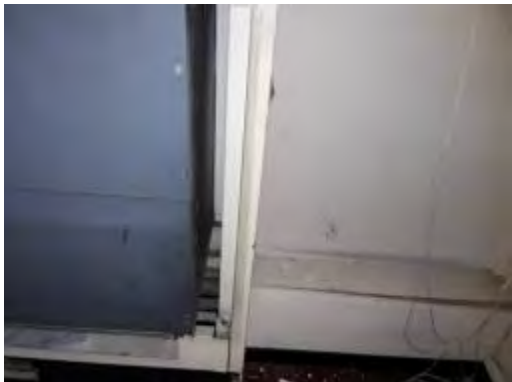
| Location 13 | | | | | | | | | | |
|---|---|---|---|---|---|---|---|---|---|---|
| Premier house | 1 <sup>st</sup> floor/1.7 | J048245/0053 | Board walls below windows and behind heaters | Board | Surface Sealed | Low Damage | 3m <sup>2</sup> | Occasionally likely to be disturbed | Strongly Presumed | Amosite |

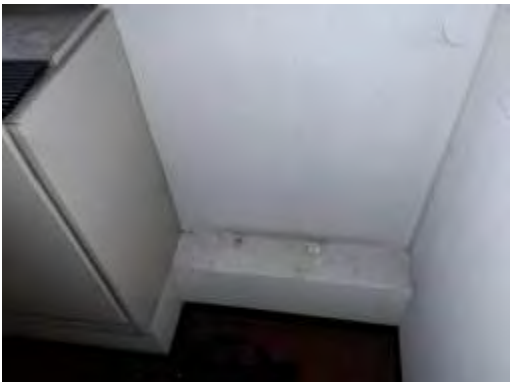
| Location 17 | | | | | | | | | | |
|---|---|---|---|---|---|---|---|---|---|---|
| Premier house | 1 <sup>st</sup> floor/1.14 | J048245/0058 | Board walls below windows and behind heaters | Board | Surface Sealed | Low Damage | 3m <sup>2</sup> | Occasionally likely to be disturbed | Strongly Presumed | Amosite |

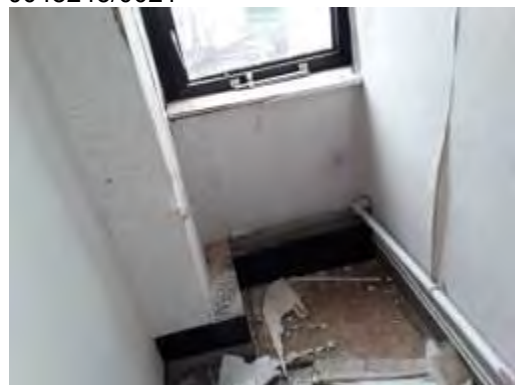
| Location 51 | | | | | | | | | | |
|---|---|---|---|---|---|---|---|---|---|---|
| Premier<br>house | 2nd floor/2.17 | J048245/0021 | Board walls<br>below windows<br>and behind<br>heaters | Board | Surface<br>Sealed | Low Damage | 2m <sup>2</sup> | Occasionally likely<br>to be disturbed | Strongly<br>presumed | Amosite |

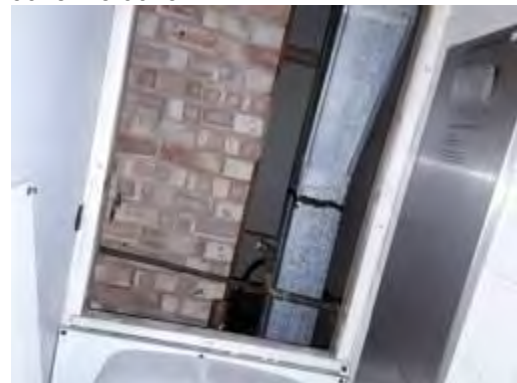
| Location 52 | | | | | | | | | | |
|---|---|---|---|---|---|---|---|---|---|---|
| Premier<br>house | 2nd floor/2.18 | J048245/0023 | Composite<br>Putty to<br>ducting | Well<br>bound<br>Material | Surface<br>Sealed | Low Damage | 3LM | Occasionally likely<br>to be disturbed | Strongly<br>presumed | Chrysotile |

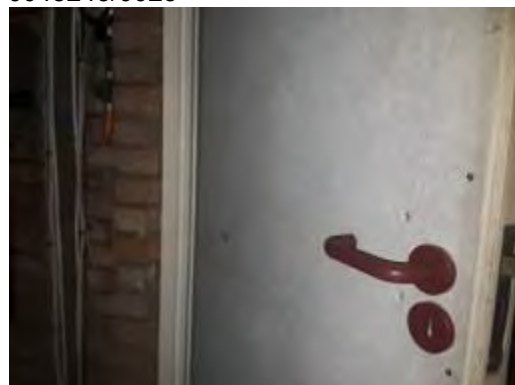
| Location 53 | | | | | | | | | | |
|---|---|---|---|---|---|---|---|---|---|---|
| Premier house | 2nd floor/2.19 | J048245/0025 | Board Panel to door | Board | Unsealed | Low Damage | 1no | Occasionally likely to be disturbed | Strongly presumed | Amosite |

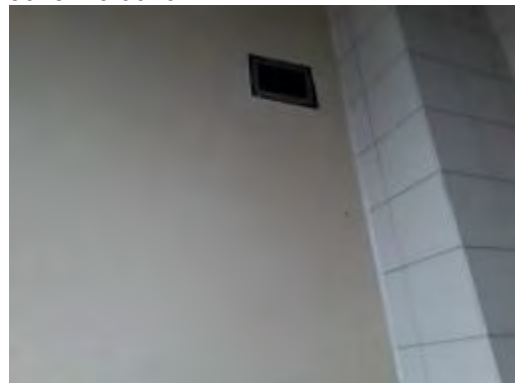
| Location 54 | | | | | | | | | | |
|---|---|---|---|---|---|---|---|---|---|---|
| Premier<br>house | 2nd floor/2.21 | J048245/0026 | Composite<br>Putty to<br>ducting | Well<br>bound<br>Material | Surface<br>Sealed | Low Damage | 2LM | Occasionally likely<br>to be disturbed | Strongly<br>presumed | Chrysotile |

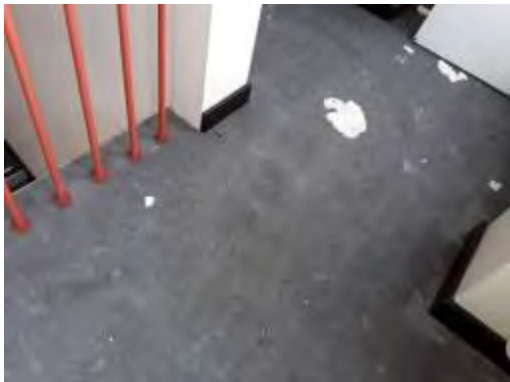
| Location 55 | | | | | | | | | | |
|---|---|---|---|---|---|---|---|---|---|---|
| Premier house | 2nd floor/2.22 | J048245/0029 | Floor Tiles and Bitumen to floor | Vinyl Floor Tiles | Completely Sealed | Low Damage | 8m <sup>2</sup> | Occasionally likely to be disturbed | Identified | Chrysotile |

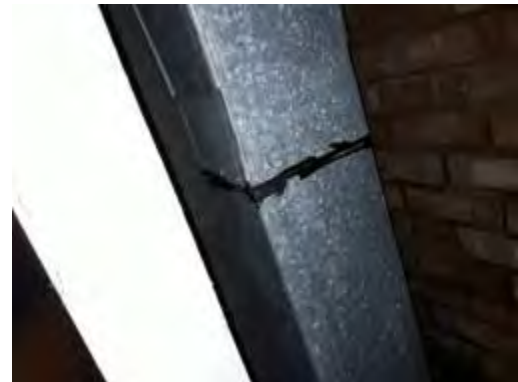
| Location 55 | | | | | | | | | | |
|---|---|---|---|---|---|---|---|---|---|---|
| Premier house | 2nd floor/2.22 | J048245/0030 | Composite Putty to ducting | Well bound Material | Surface Sealed | Low Damage | 6LM | Occasionally likely to be disturbed | Strongly presumed | Chrysotile |

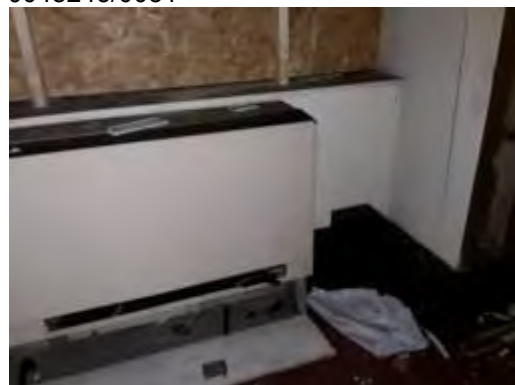
| Location 56 | | | | | | | | | | |
|---|---|---|---|---|---|---|---|---|---|---|
| Premier house | 2nd floor/2.23 | J048245/0031 | Board walls below windows and behind heaters | Board | Surface Sealed | Low Damage | 12m <sup>2</sup> | Occasionally likely to be disturbed | Strongly presumed | Amosite |

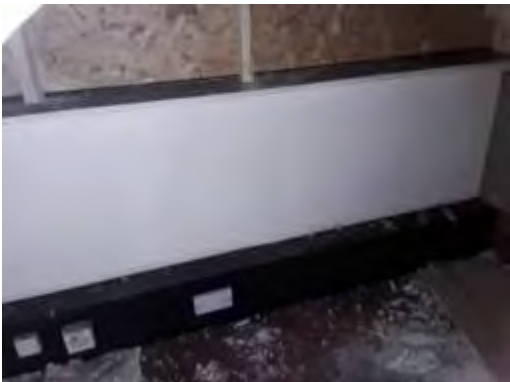
| Location 57 | | | | | | | | | | |
|---|---|---|---|---|---|---|---|---|---|---|
| Premier house | 2nd floor/2.24 | J048245/0032 | Board walls below windows and behind heaters | Board | Surface Sealed | Low Damage | 4m <sup>2</sup> | Occasionally likely to be disturbed | Strongly presumed | Amosite |

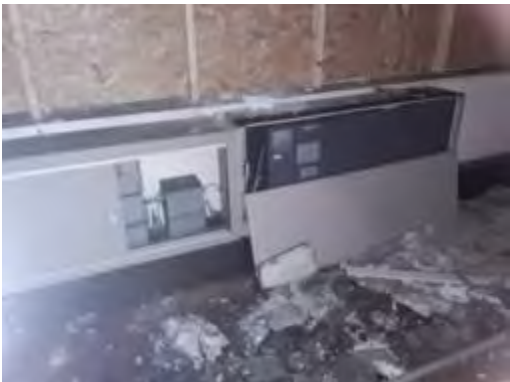
| Location 58 | | | | | | | | | | |
|---|---|---|---|---|---|---|---|---|---|---|
| Premier house | 2nd floor/2.25 | J048245/0033 | Board walls below windows and behind heaters | Board | Surface Sealed | Low Damage | 6m <sup>2</sup> | Occasionally likely to be disturbed | Strongly presumed | Amosite |

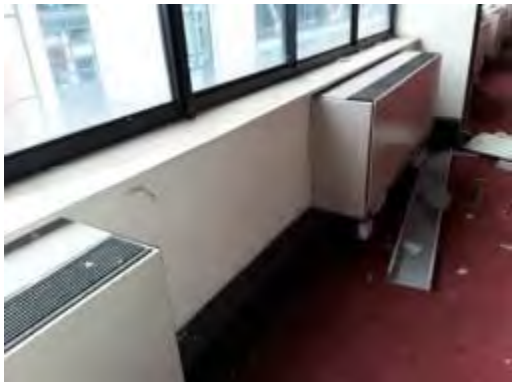
| Location 59 | | | | | | | | | | |
|---|---|---|---|---|---|---|---|---|---|---|
| Premier house | 2nd floor/2.26 | J048245/0034 | Board walls below windows and behind heaters | Board | Surface Sealed | Low Damage | 48m <sup>2</sup> | Occasionally likely to be disturbed | Strongly presumed | Amosite |

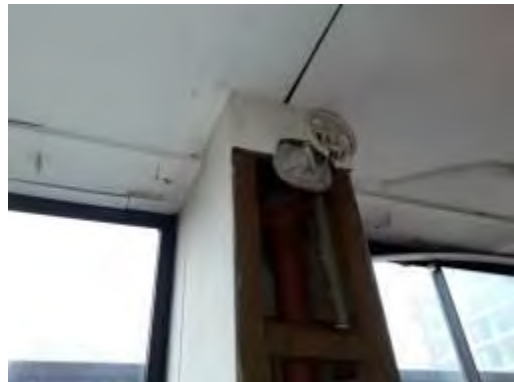
| Location 59 | | | | | | | | | | |
|---|---|---|---|---|---|---|---|---|---|---|
| Premier house | 2nd floor/2.26 | J048245/0035 | Gaskets to Pipes | Gaskets | Surface Sealed | Low Damage | 3no. | Occasionally likely to be disturbed | Identified | Chrysotile |

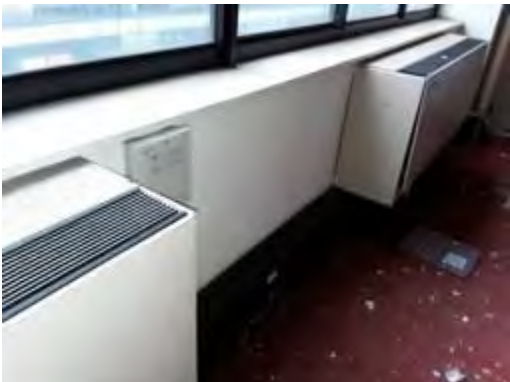
| Location 60 | | | | | | | | | | |
|---|---|---|---|---|---|---|---|---|---|---|
| Premier house | 2nd floor/2.27 | J048245/0036 | Board walls below windows and behind heaters | Board | Surface Sealed | Low Damage | 14m <sup>2</sup> | Occasionally likely to be disturbed | Identified | Amosite |

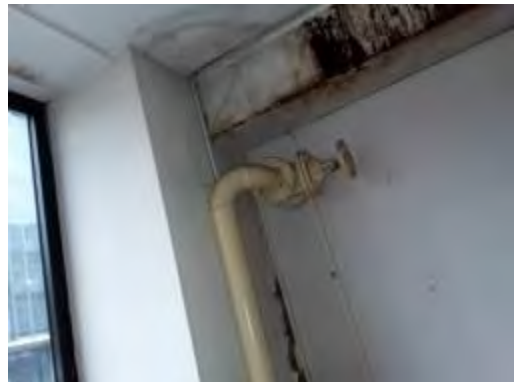
| Location 60 | | | | | | | | | | |
|---|---|---|---|---|---|---|---|---|---|---|
| Premier house | 2nd floor/2.27 | J048245/0037 | Gaskets to Pipes | Gaskets | Surface Sealed | Low Damage | 3no. | Occasionally likely to be disturbed | Identified | Chrysotile |

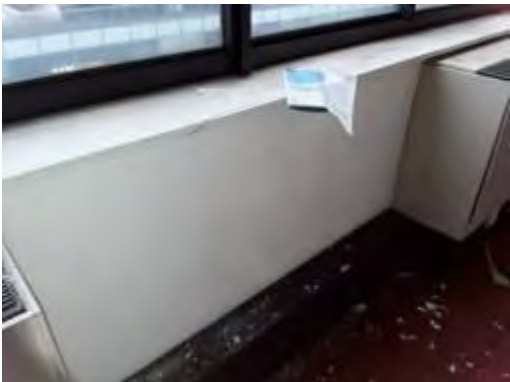
| Location 61 | | | | | | | | | | |
|---|---|---|---|---|---|---|---|---|---|---|
| Premier house | 2nd floor/2.28 | J048245/0038 | Board walls below windows and behind heaters | Board | Surface Sealed | Low Damage | 8m <sup>2</sup> | Occasionally likely to be disturbed | Strongly presumed | Amosite |

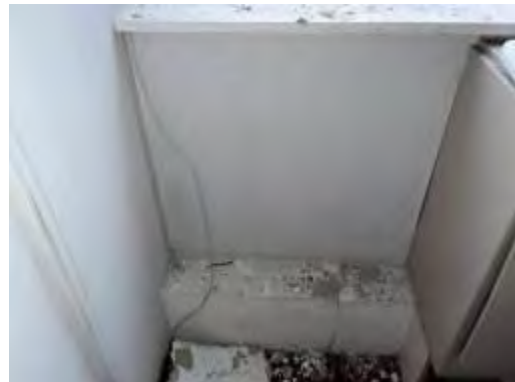
| Location 62 | | | | | | | | | | |
|---|---|---|---|---|---|---|---|---|---|---|
| Premier house | 2nd floor/2.29 | J048245/0039 | Board walls below windows and behind heaters | Board | Surface Sealed | Low Damage | 4m <sup>2</sup> | Occasionally likely to be disturbed | Strongly presumed | Amosite |

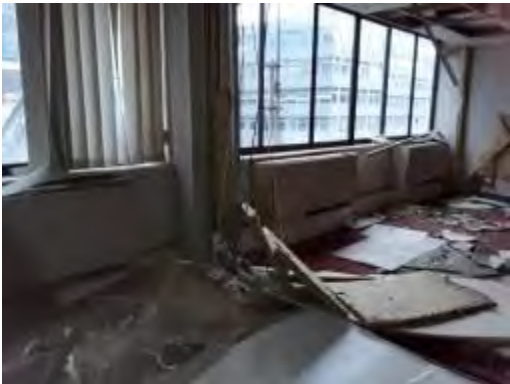
| Location 63 | | | | | | | | | | |
|---|---|---|---|---|---|---|---|---|---|---|
| Premier house | 2nd floor/2.30 | J048245/0040 | Board walls below windows and behind heaters | Board | Surface Sealed | Low Damage | 64m <sup>2</sup> | Occasionally likely to be disturbed | Strongly presumed | Amosite |

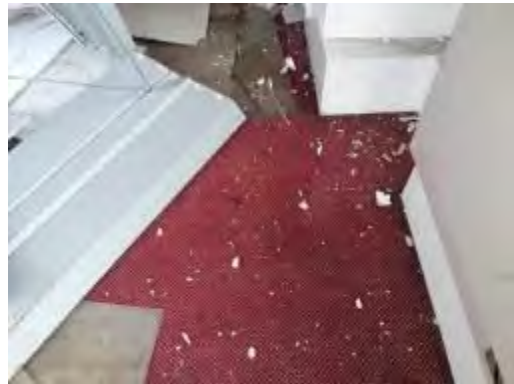
| Location 63 | | | | | | | | | | |
|---|---|---|---|---|---|---|---|---|---|---|
| Premier house | 2nd floor/2.30 | J048245/0041 | Board debris to floor | Board | Unsealed Lagging and Sprays | High Damage | 1m <sup>2</sup> | Routinely Disturbed | Identified | Amosite |

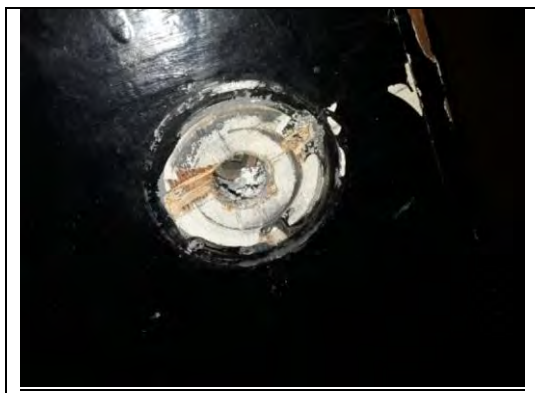
| Location 64 | | | | | | | | | | |
|---|---|---|---|---|---|---|---|---|---|---|
| 22 Deansgate | Ground Floor /<br>G1 | 0018 | Board lining<br>within door | Board | Surface<br>Sealed | Low Damage | 3m <sup>2</sup> | Occasionally likely<br>to be disturbed | Identified | Chrysotile +<br>Amosite |

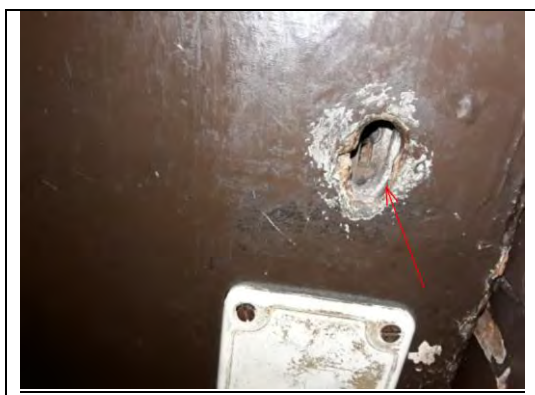
| Location 65 | | | | | | | | | | |
|---|---|---|---|---|---|---|---|---|---|---|
| 22 Deansgate | Ground Floor /<br>G7 | 0026 | Board lining<br>within door | Board | Surface<br>Sealed | Low Damage | 3m <sup>2</sup> | Occasionally likely<br>to be disturbed | Strongly<br>Presumed (018) | Chrysotile +<br>Amosite |

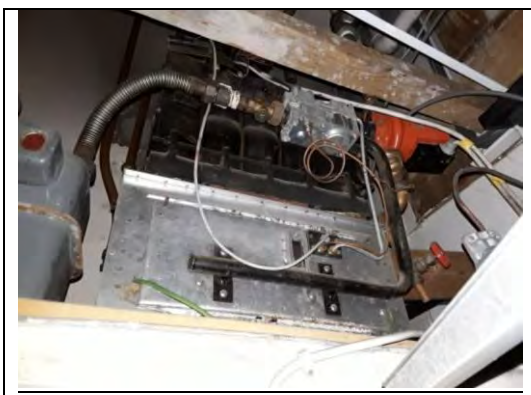
| Location 66 | | | | | | | | | | |
|---|---|---|---|---|---|---|---|---|---|---|
| 22 Deansgate | Ground Floor /<br>G11 | 0033 | Textiles around<br>small boiler top<br>seal | Textiles | Surface<br>Sealed | Low Damage | 1lm | Occasionally likely<br>to be disturbed | Identified | Chrysotile |

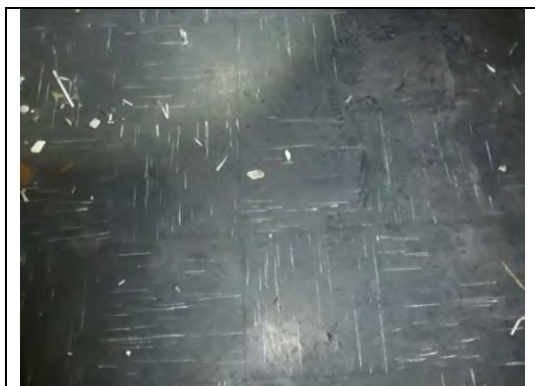
| Location 67 | | | | | | | | | | |
|---|---|---|---|---|---|---|---|---|---|---|
| 22 Deansgate | Ground Floor /<br>G13 | 0035 | Floor tiles and<br>bitumen to<br>floor | Vinyl<br>Floor Tiles | Completely<br>Sealed | Low Damage | 14m <sup>2</sup> | Occasionally likely<br>to be disturbed | Identified | Chrysotile |

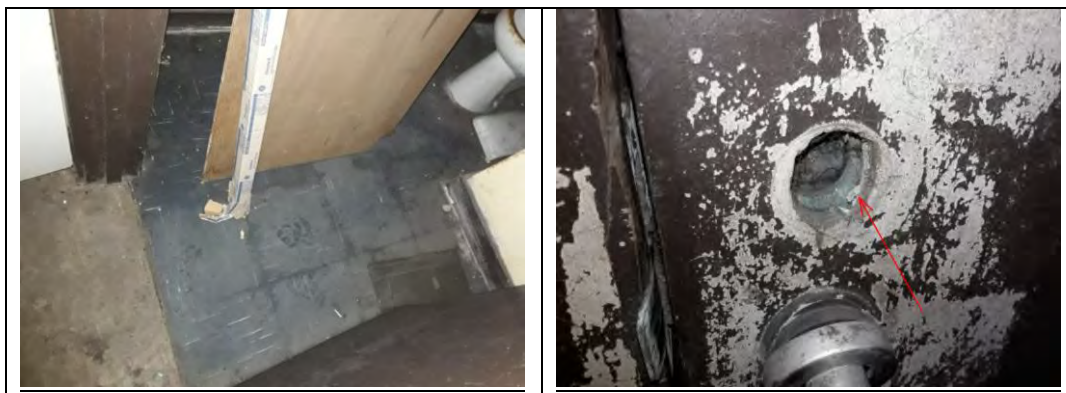
| Building | Floor/<br>Room | Assessment<br>Number | Location/<br>position | Product<br>type | Surface<br>treatment | Condition | Extent | Accessibility | Level of<br>identification | Asbestos<br>type |
|---|---|---|---|---|---|---|---|---|---|---|
| 22 Deansgate | Ground Floor /<br>G14 | 0038 | Floor tiles and<br>bitumen to<br>floor | Vinyl<br>Floor Tiles | Completely<br>Sealed | Low Damage | 8m <sup>2</sup> | Occasionally likely<br>to be disturbed | Strongly<br>Presumed (035) | Chrysotile |
| 22 Deansgate | Ground Floor /<br>G14 | 0039 | Board lining<br>within fire door | Board | Surface<br>Sealed | Low Damage | 2m <sup>2</sup> | Occasionally likely<br>to be disturbed | Identified | Chrysotile +<br>Amosite |

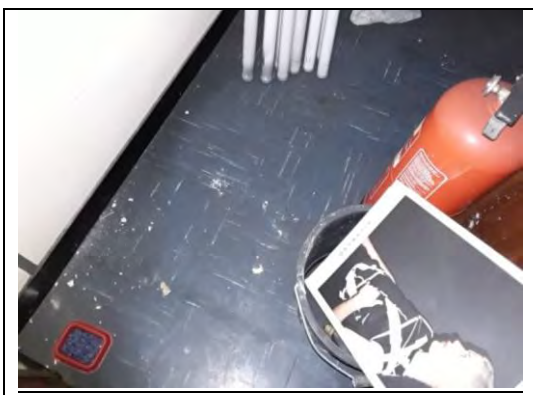
| Location 69 | | | | | | | | | | |
|---|---|---|---|---|---|---|---|---|---|---|
| 22 Deansgate | Ground Floor /<br>G16 | 0046 | Floor tiles and<br>bitumen to<br>floor | Vinyl<br>Floor Tiles | Completely<br>Sealed | Low Damage | 80m <sup>2</sup> | Occasionally likely<br>to be disturbed | Identified | Chrysotile |

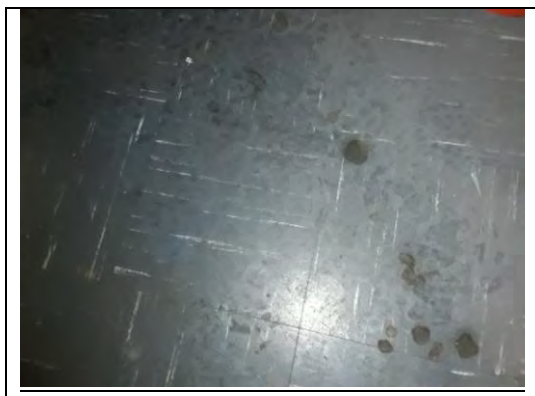
| Location 70 | | | | | | | | | | |
|---|---|---|---|---|---|---|---|---|---|---|
| 22 Deansgate | Ground Floor /<br>G17 | 0049 | Floor tiles and<br>bitumen to<br>floor | Vinyl<br>Floor Tiles | Completely<br>Sealed | Low Damage | 12m <sup>2</sup> | Occasionally likely<br>to be disturbed | Strongly<br>Presumed (046) | Chrysotile |

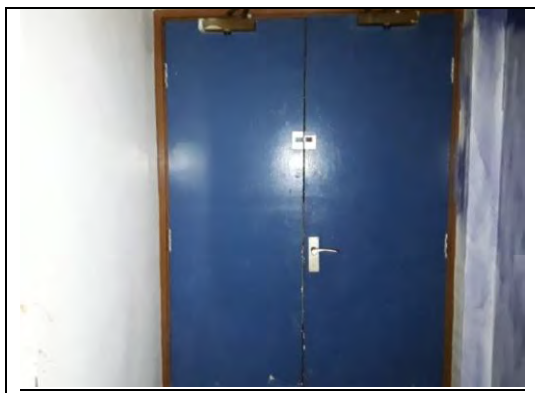
| Location 71 | | | | | | | | | | |
|---|---|---|---|---|---|---|---|---|---|---|
| 22 Deansgate | Ground Floor /<br>G20 | 0058 | Board lining<br>within doors | Board | Surface<br>Sealed | Low Damage | 6m <sup>2</sup> | Occasionally likely<br>to be disturbed | Identified | Amosite |

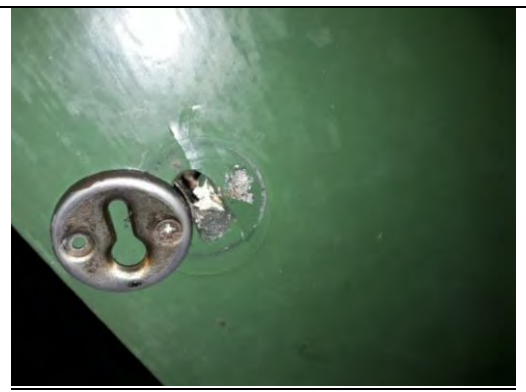
| Building | Floor/<br>Room | Assessment<br>Number | Location/<br>position | Product<br>type | Surface<br>treatment | Condition | Extent | Accessibility | Level of<br>identification | Asbestos<br>type |
|---|---|---|---|---|---|---|---|---|---|---|
| 22 Deansgate | 1st Floor /<br>F1 | 0012 | Board lining to<br>fire doors | Board | Surface<br>Sealed | Low Damage | 3m <sup>2</sup> | Occasionally likely<br>to be disturbed | Identified | Chrysotile |

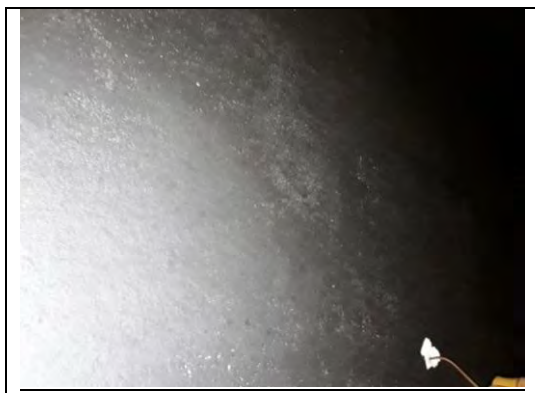
| Location 73 | | | | | | | | | | |
|---|---|---|---|---|---|---|---|---|---|---|
| 22 Deansgate | 1st Floor /<br>F2 | 0014 | Board panels in<br>ceiling void | Board | Surface<br>Sealed | Low Damage | 8m <sup>2</sup> | Occasionally likely<br>to be disturbed | Identified | Amosite |

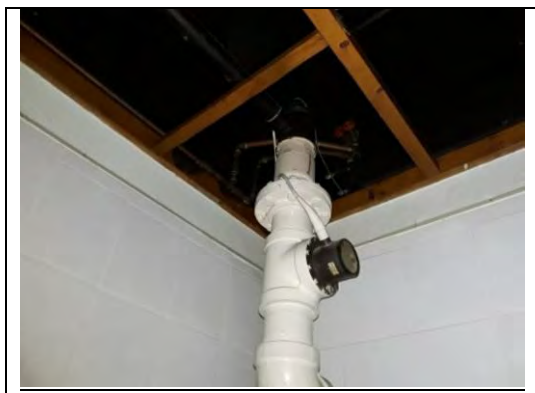
| Location 74 | | | | | | | | | | |
|---|---|---|---|---|---|---|---|---|---|---|
| 22 Deansgate | 1st Floor /<br>F3 | 0029 | Gasket to<br>water pipes | Gaskets | Surface<br>Sealed | Low Damage | 2no. | Occasionally likely<br>to be disturbed | Presumed | Chrysotile |

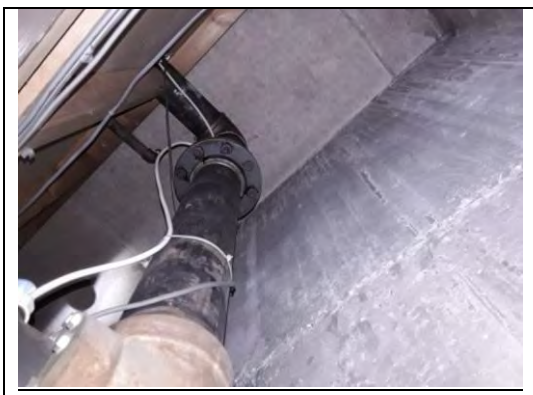
| Location 75 | | | | | | | | | | |
|---|---|---|---|---|---|---|---|---|---|---|
| 22 Deansgate | 1st Floor /<br>F4 | 0034 | Gasket to<br>water pipes | Gaskets | Surface<br>Sealed | Low Damage | 1no. | Occasionally likely<br>to be disturbed | Presumed | Chrysotile |

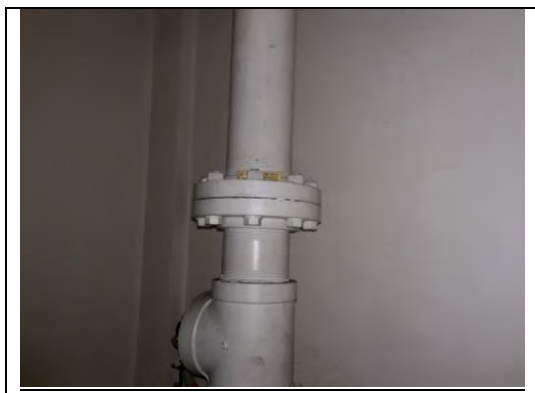
| Location 76 | | | | | | | | | | |
|---|---|---|---|---|---|---|---|---|---|---|
| 22 Deansgate | 1st Floor /<br>F5 | 0043 | Gasket to<br>water pipes | Gaskets | Surface<br>Sealed | Low Damage | 1no. | Occasionally likely<br>to be disturbed | Presumed | Chrysotile |

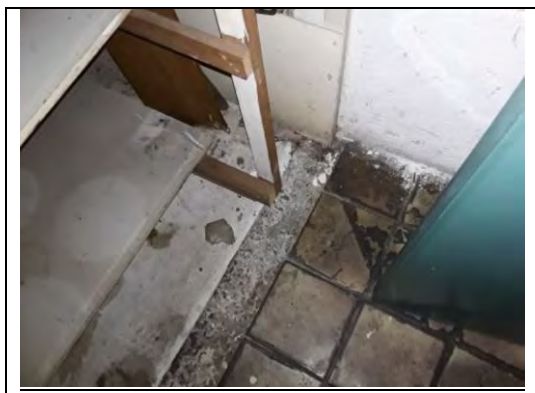
| Location 77 | | | | | | | | | | |
|---|---|---|---|---|---|---|---|---|---|---|
| 22 Deansgate | 2nd Floor /<br>S2 | 0003 | Board panel to<br>floor and debris | Board | Unsealed | Medium<br>Damage | 2m <sup>2</sup> | Occasionally likely<br>to be disturbed | Identified | Amosite |

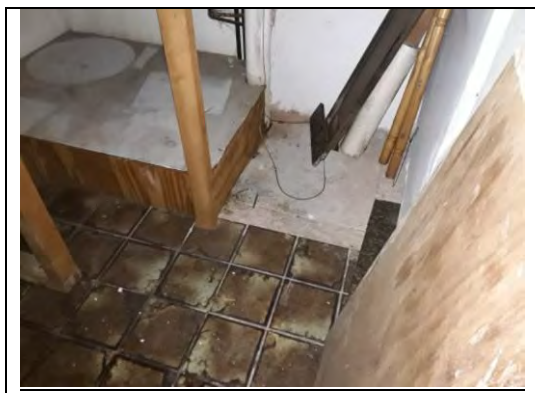
| Location 78 | | | | | | | | | | |
|---|---|---|---|---|---|---|---|---|---|---|
| 22 Deansgate | 2nd Floor /<br>S3 | 0005 | Board panel to<br>floor and debris | Board | Unsealed | Medium<br>Damage | 1m <sup>2</sup> | Occasionally likely<br>to be disturbed | Identified | Amosite |

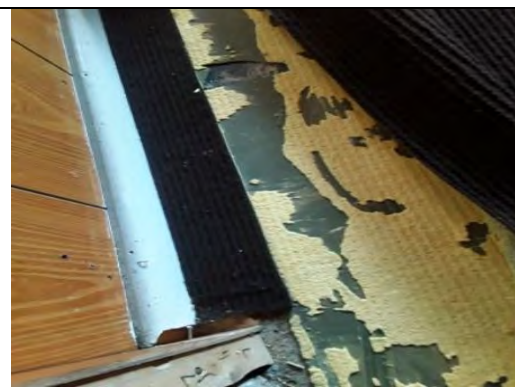
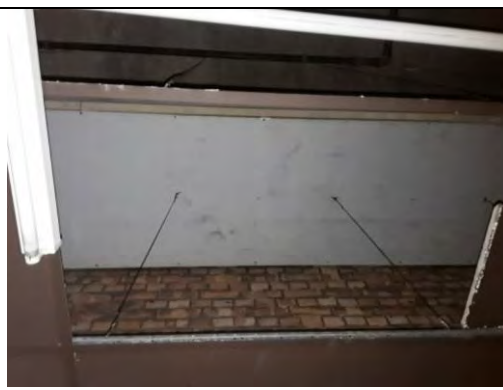
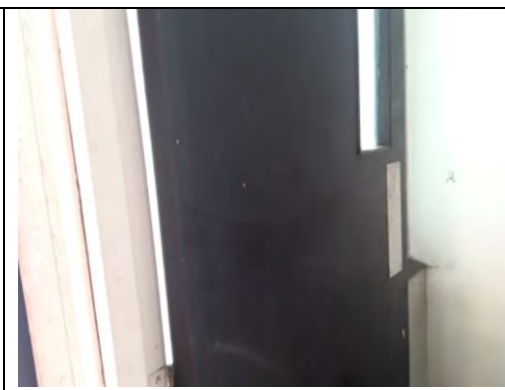
| Building | Floor/<br>Room | Assessment<br>Number | Location/<br>position | Product<br>type | Surface<br>treatment | Condition | Extent | Accessibility | Level of<br>identification | Asbestos<br>type |
|---|---|---|---|---|---|---|---|---|---|---|
| 22 Deansgate | 2nd Floor /<br>S5 | 0007 | Floor tiles and<br>bitumen to<br>floor | Vinyl<br>Floor Tiles | Completely<br>Sealed | Low Damage | 38m <sup>2</sup> | Occasionally likely<br>to be disturbed | Identified | Chrysotile |
| 22 Deansgate | 2nd Floor /<br>S5 | 0008 | Board boxing in<br>ceiling void | Board | Unsealed | Low Damage | 6m <sup>2</sup> | Occasionally likely<br>to be disturbed | Identified | Amosite |
| 22 Deansgate | 2nd Floor /<br>S5 | 0009 | Board lining to<br>fire door | Board | Surface<br>Sealed | Low Damage | 2m <sup>2</sup> | Occasionally likely<br>to be disturbed | Identified | Chrysotile |

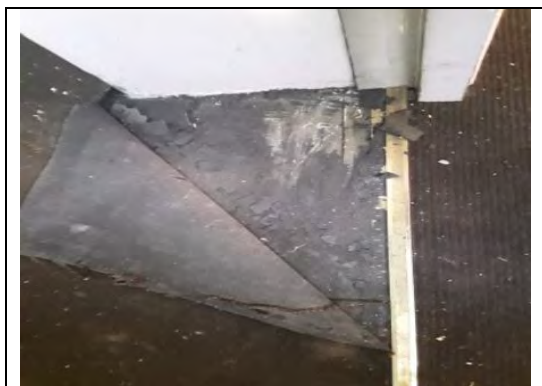
| Location 80 | | | | | | | | | | |
|---|---|---|---|---|---|---|---|---|---|---|
| 22 Deansgate | 2nd Floor /<br>S6 | 0010 | Floor tiles and<br>bitumen to<br>floor | Vinyl<br>Floor Tiles | Completely<br>Sealed | Low Damage | 9m <sup>2</sup> | Occasionally likely<br>to be disturbed | Strongly<br>Presumed (007) | Chrysotile |

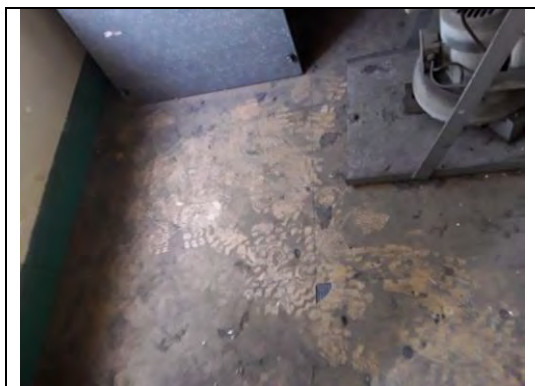
| Location 81 | | | | | | | | | | |
|---|---|---|---|---|---|---|---|---|---|---|
| 22 Deansgate | 2nd Floor /<br>S10 | 0041 | Floor tiles and<br>bitumen to<br>floor | Vinyl<br>Floor Tiles | Completely<br>Sealed | Low Damage | 6m <sup>2</sup> | Occasionally likely<br>to be disturbed | Identified | Chrysotile |
