## HERITAGE, DESIGN & ACCESS STATEMENT

### No. 73 and 75 - Entrance Lobby Repair Work India House, Whitworth Street, Manchester.

July 2022

**India House, Whitworth Street, Manchester**  
**Investigation into the Condition of the Historic Ceiling**  
**Plasters, in the Entrance Foyers and a Profile of the**  
**Cornice from the Entrance Lobby**

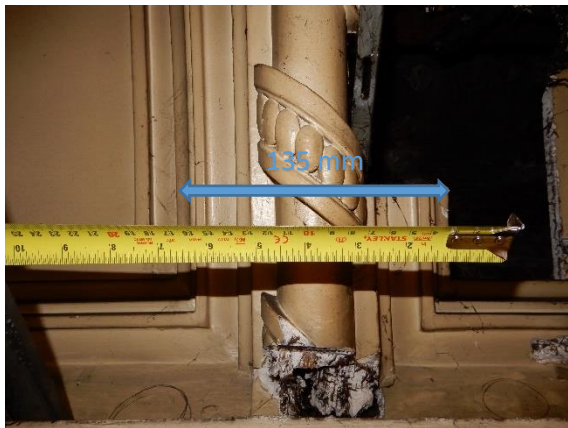
Photo 6: A semi-circular rib across the width

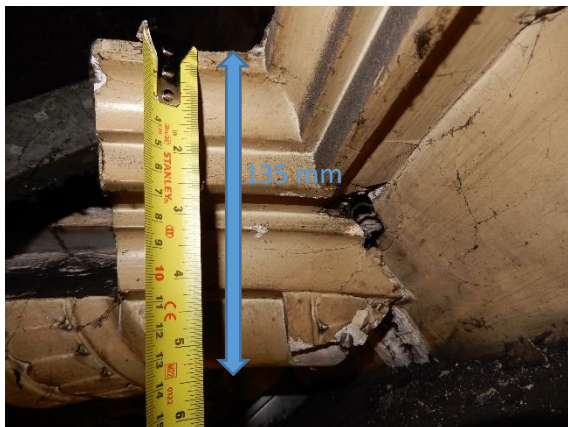
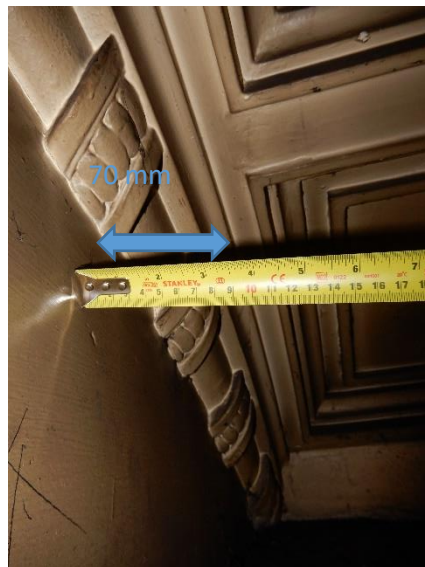
Photos 7 & 8: Showing the depth of a full cast piece that forms the semi-circular rib; and just over half the width of this rib, which are used where these curving ribs terminate the ends of the barrel vault.

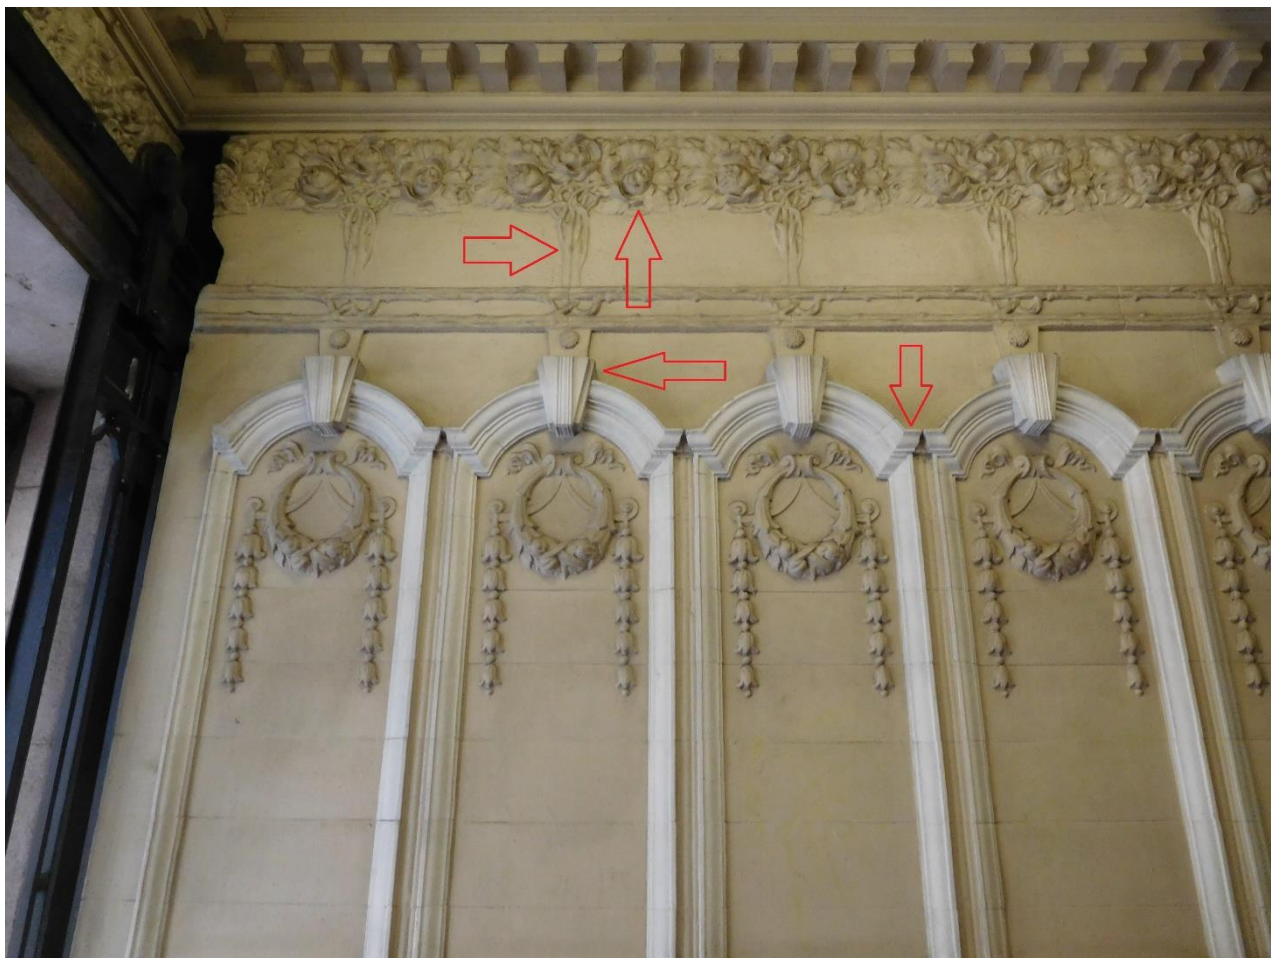
Fig 1

The schemes have an extraordinary number of different profiles and sizes of ceramic pieces which make up what is an elaborate and highly ornate design, as seen in Figs. 1 and 2.
