10 Minshull Street and 11 Bloom Street

**ADDITIONAL FEATURES**

PLANNING CONDITIONS RELEASE 11(a), (h), (r), (s)

Planning Permission 119374/FO/2018 – BOTH BUILDINGS

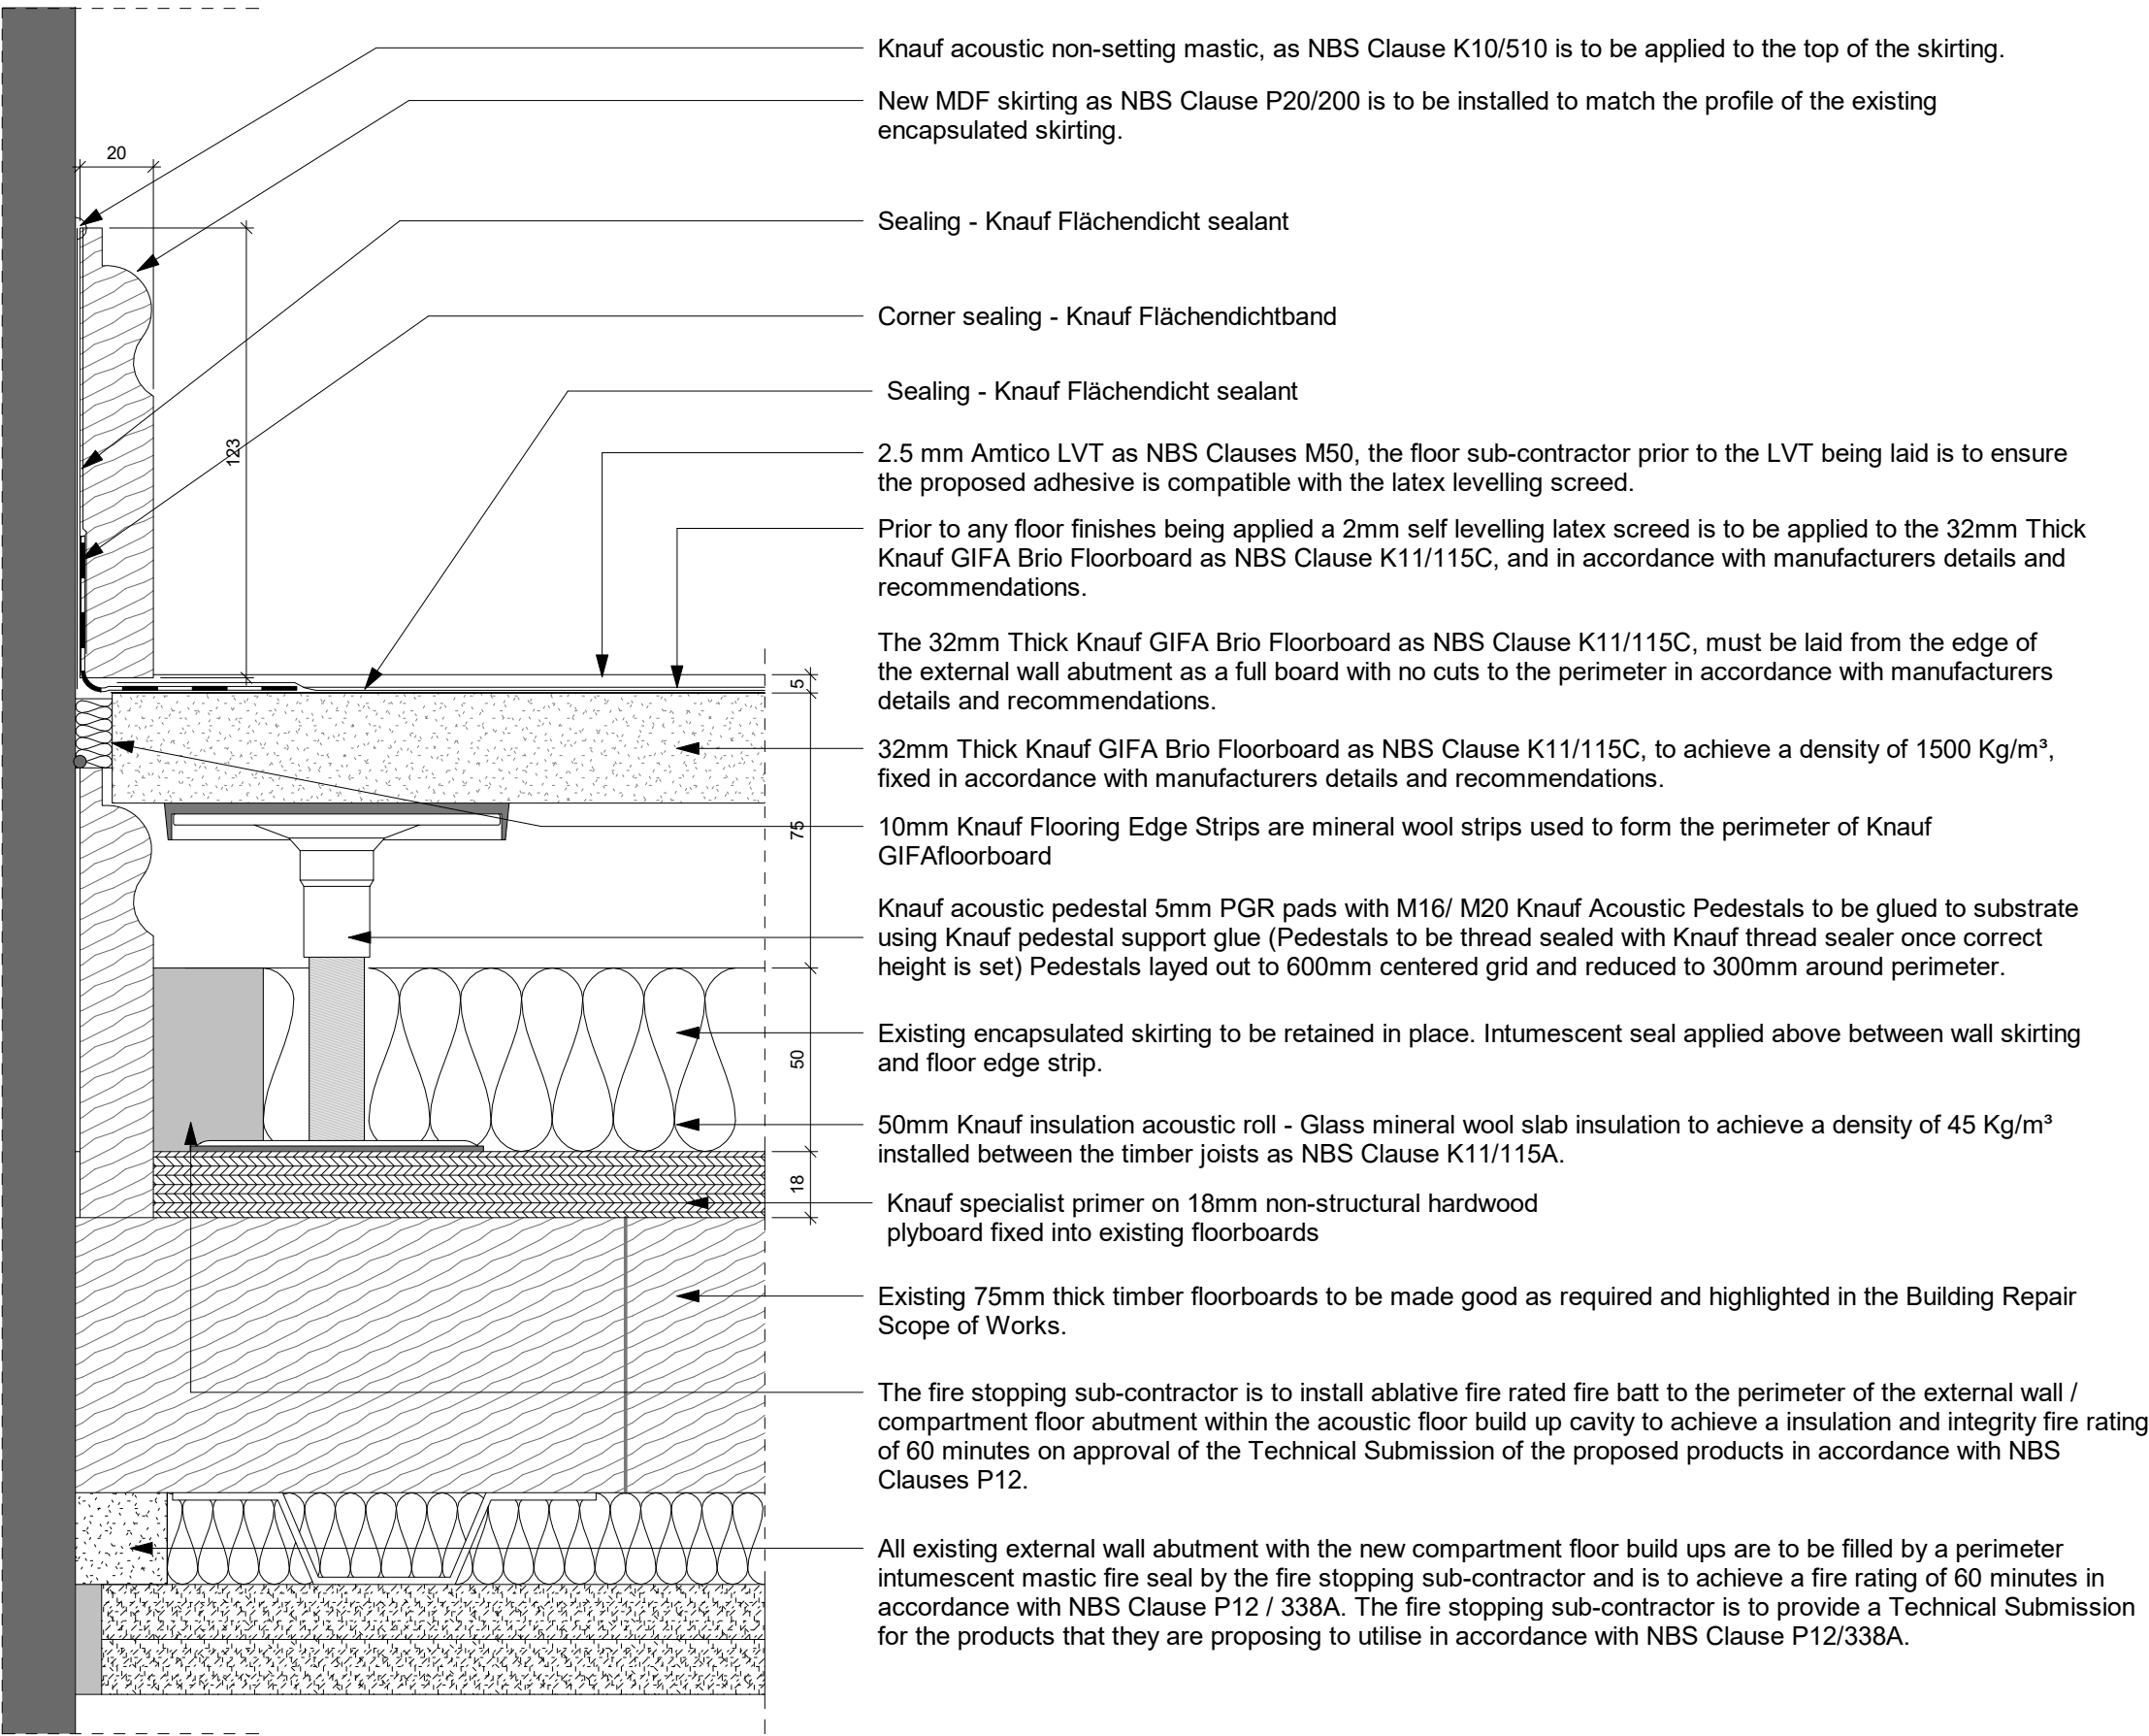
013-MDB-BS-ZZ-DT-A-2304

ENCAPSULATED EXISTING SKIRTING BOARD  
@ SCALE 1:2

As can be seen from the **(Appendix K)** proposed drawing package, where possible skirtings are carefully encapsulated in their existing locations in conjunction with the new internal floor build-up. Consideration has been given to the re-location of the skirting above the new floor build-up however an on site review from a specialist joiner has established that the removal would cause inevitable damage to the existing elements. Considering this, it has been decided that the better alternative is to retain in place these elements and match the new skirting to the former profiles in reference to their current locations. To this end, details have been included **(Appendix B)**.

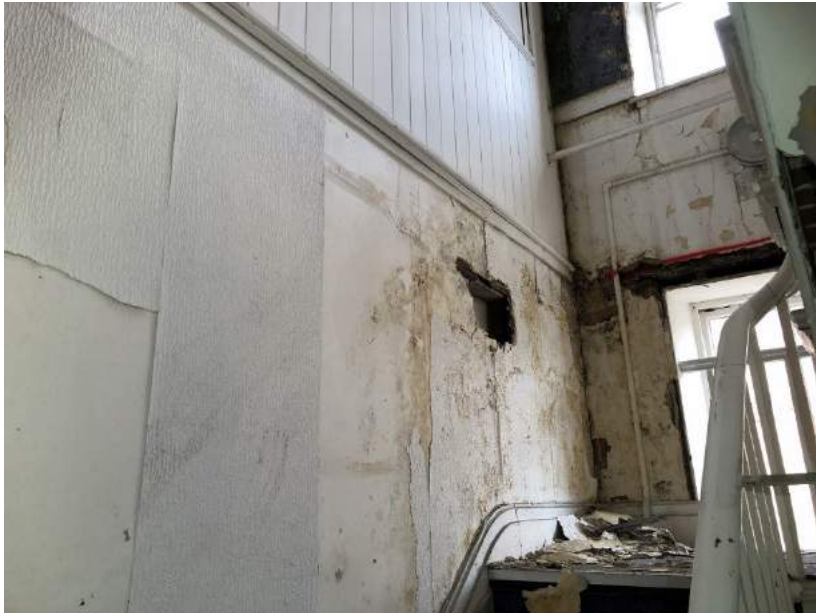
**Fig 37:**

Third Floor, MS-302; showing deterioration of the external and internal wall finishes in the area of water penetration

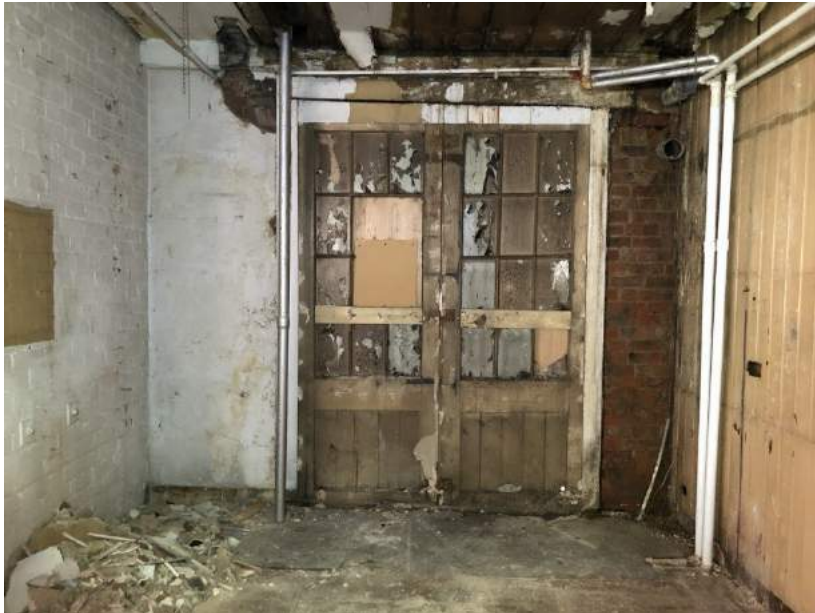
**Fig 47:**

Second Floor, MS-213; showing deterioration of the lime plaster in an area of ongoing water penetration

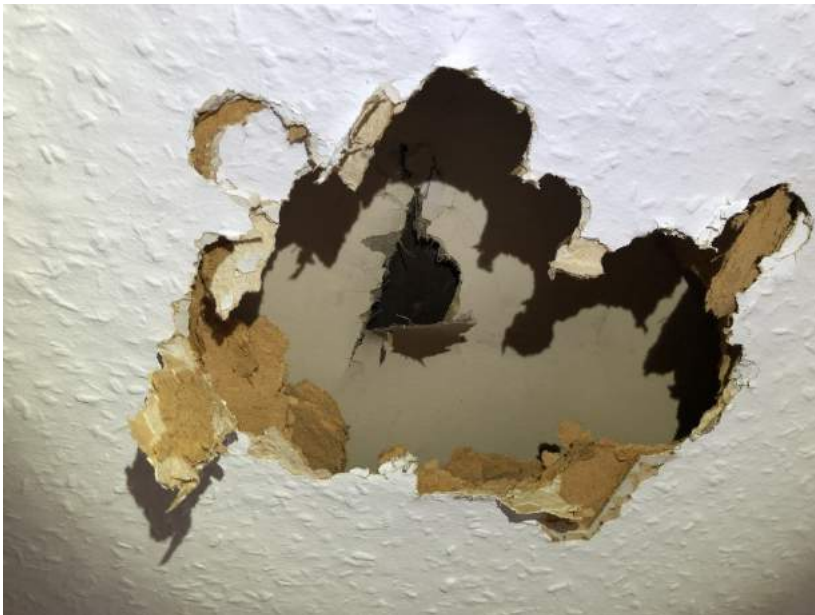
**Fig 70:**

First Floor, MS-117; showing non-original plasterboard supported on softwood battens fixed to the underside to the millboards. Note the earlier wallpaper to the underside of the millboards

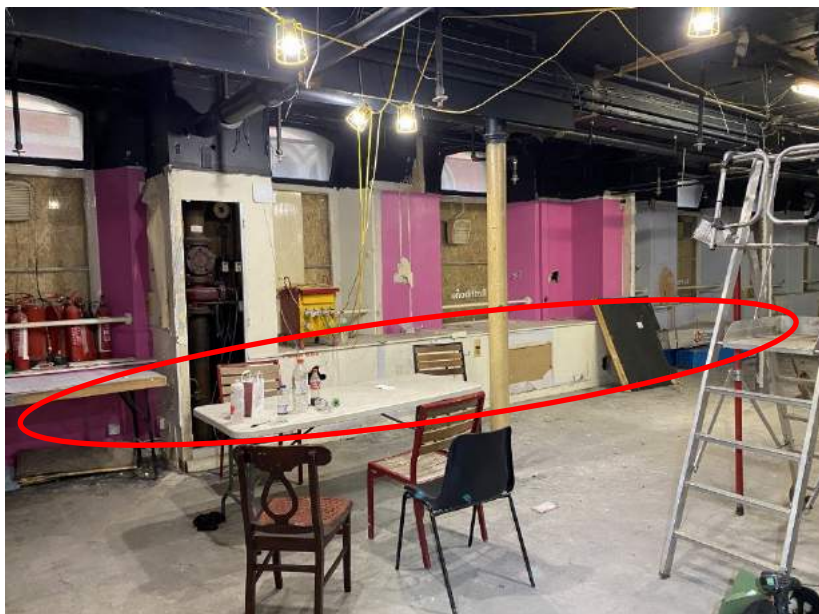
**Fig 75:**

Upper Ground Floor, MS-UG04;  
showing non-original fibreboard boxing  
with skirting board below window sills.  
The upper walls were plastered with  
lime

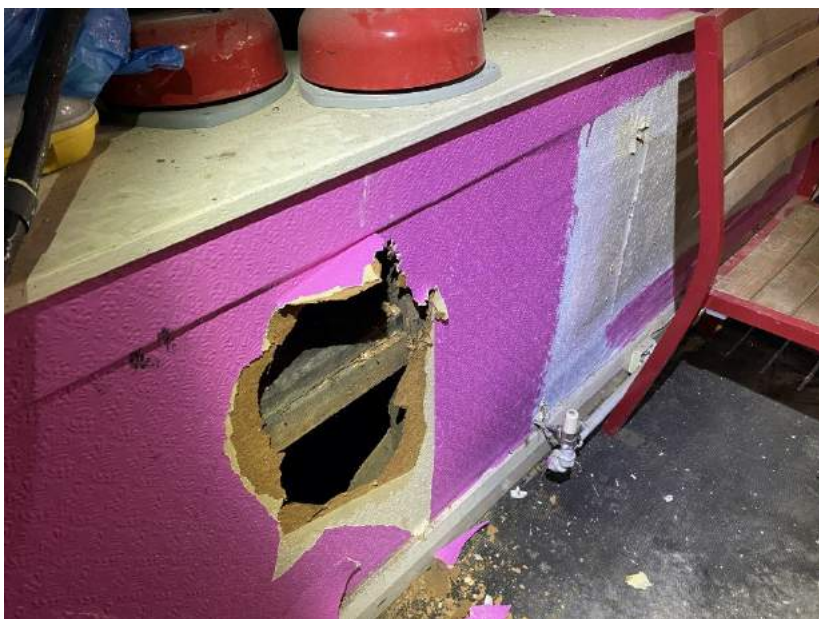
**Fig 76:**

Upper Ground Floor, MS-UG04;  
showing a close-up of the non-original  
fibreboard boxing at low-level

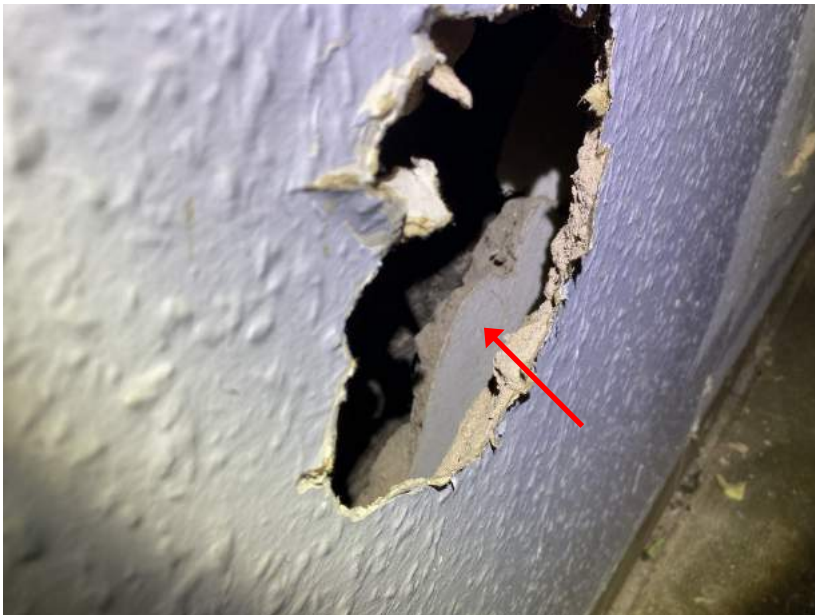
**Fig 84:**

Upper Ground Floor, MS-UG21;  
showing lime plaster visible within the  
plasterboard boxing. The plaster had  
debonded from the brick substrate in  
this location

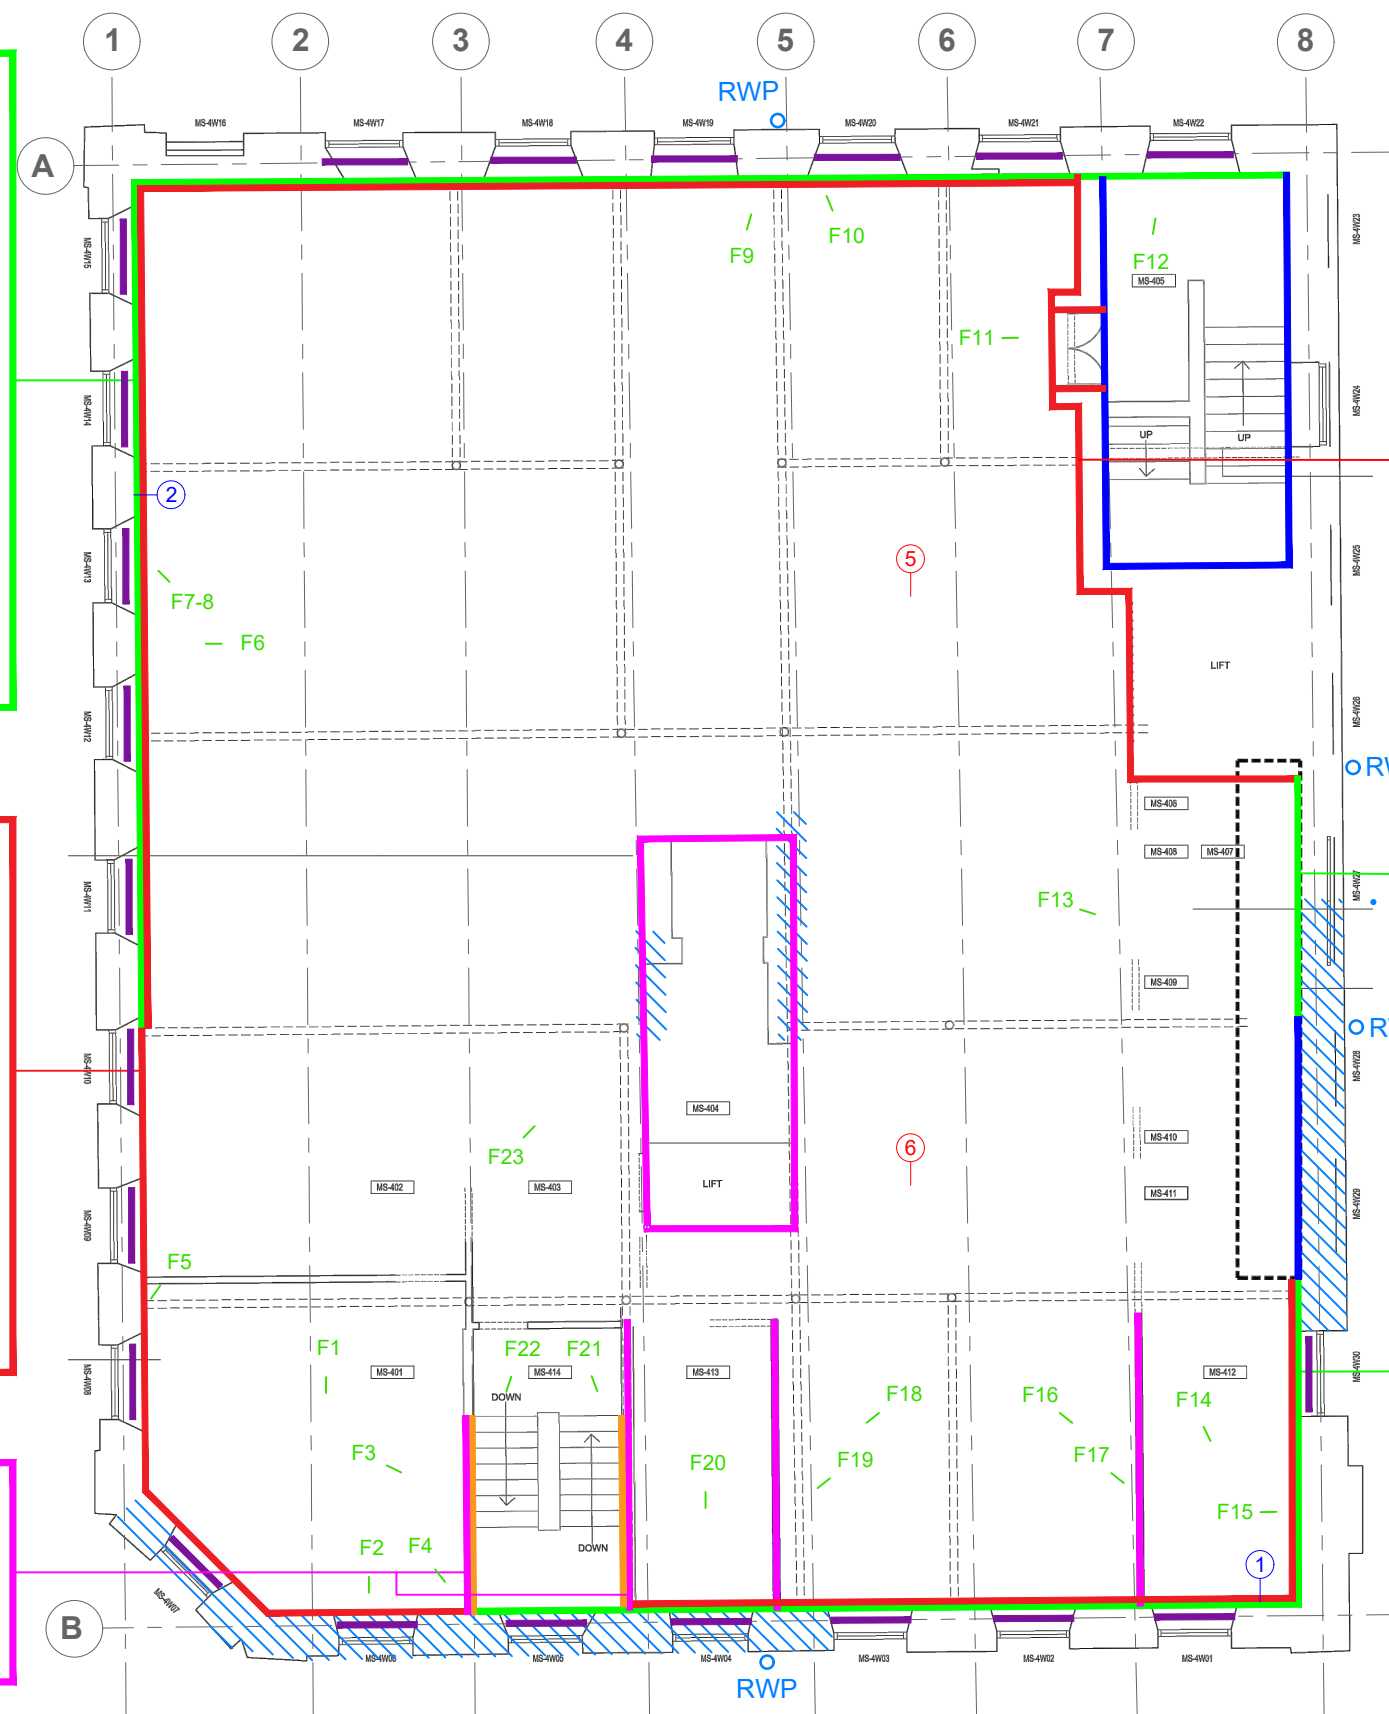
**Mindel House, Manchester - Fourth Floor**  
Plaster condition survey  
8 April 2021

Plaster condition: Generally in fair condition

Plaster condition: Wet and largely debonded

Plaster condition: Wet and largely debonded. Lath and plaster heavily decayed by wet rot in areas of water penetration

Plaster condition: Good 'key' prepared to brick substrate and plaster generally well bonded but wet in areas of water penetration

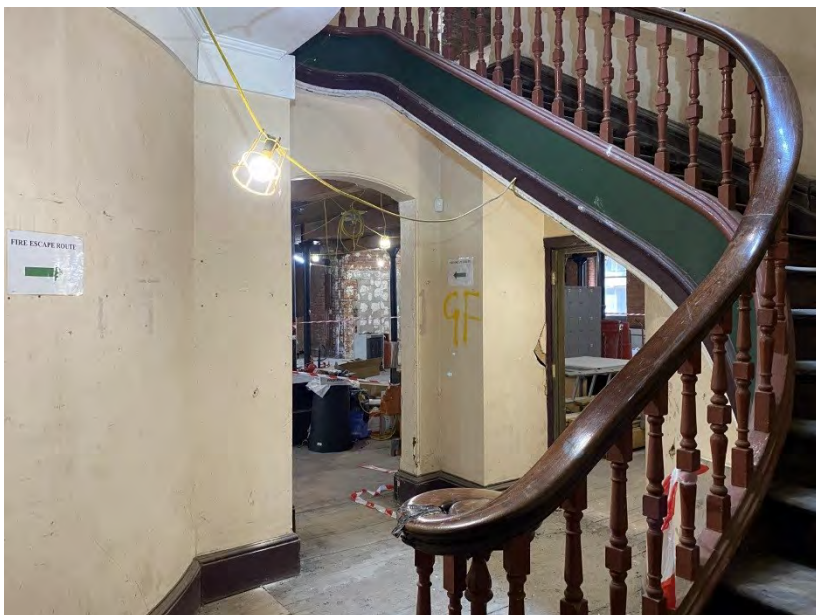
**Fig 54:**

Upper ground floor, West staircase lobby; showing lath and plaster to the partition and a lath and plaster ceiling. Plaster was generally in good condition

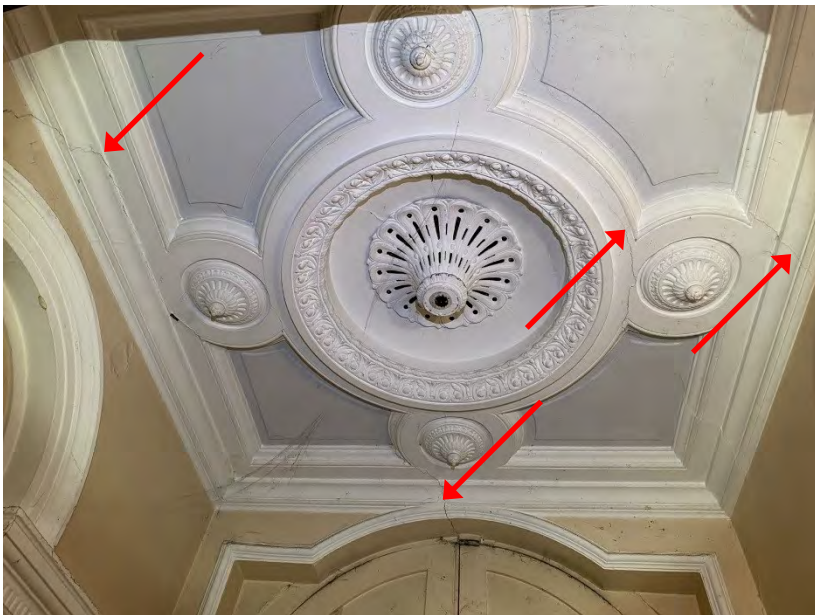
**Fig 56:**

Upper ground floor, West entrance lobby; showing examples of minor cracking in the decorative ceiling, mouldings and cornice

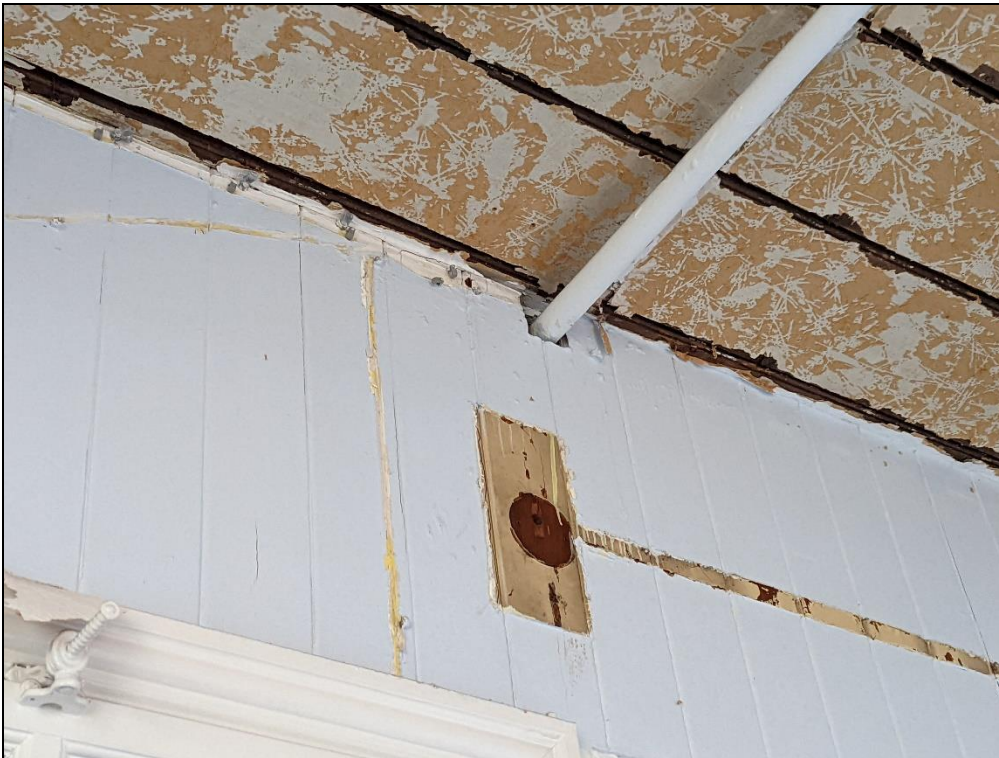
Timber panelling cut around sprinkler system

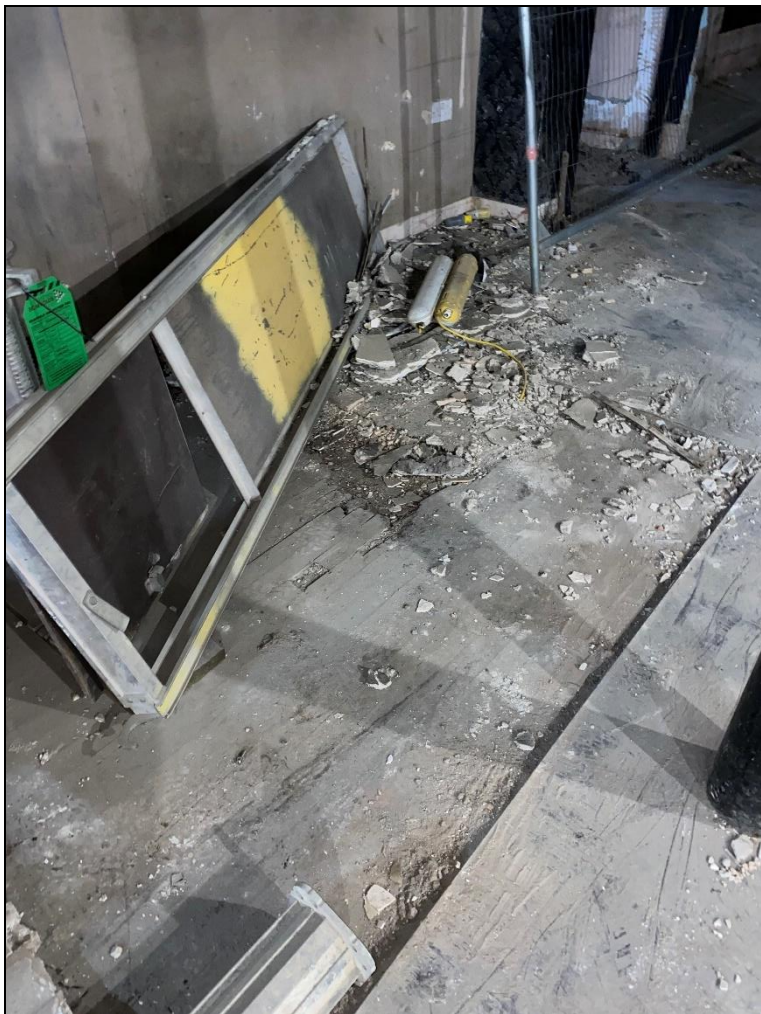
Timber flooring around the central lift shaft was observed and appears to comprise historic boards. Investigation by Hutton + Rostron has suggested that the boards are not thought to be original to this setting and may have been recycled from a late 19th Century warehouse or mill building.

Historic boards around the lift shaft at basement level.

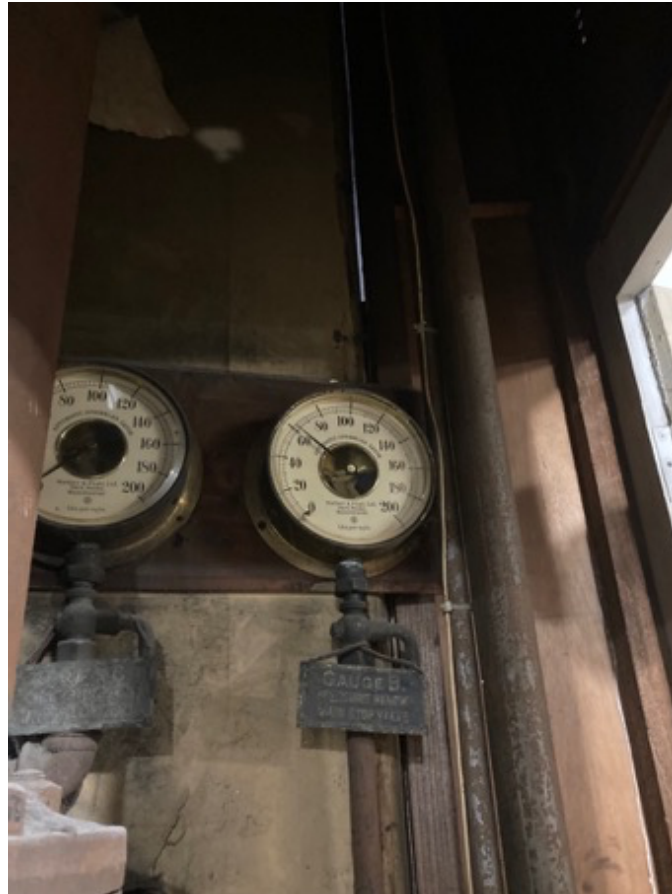
Photo 2: Pressure Gauges

Other components of interest include the large pressure gauges (Photo 2) and the rotary alarm gongs. Photo 3A shows the interior of the building with the gongs painted in white. Photo 3B shows the exterior of the gongs in red – these are a common sight in urban areas in Lancashire and the NW. Photo 3C shows the detail of the sprinkler valve warning plate which is intended to assist the fire brigade when responding to a protected building. This would originally have been painted white with red lettering.

3. At the time of my visit, the pressure indications on the gauges suggested that the system upstream of the stop and alarm valves was pressurised at 3.5 Bar. This in itself presents a hazard to the construction process during the conversion of the building<sup>3</sup>.

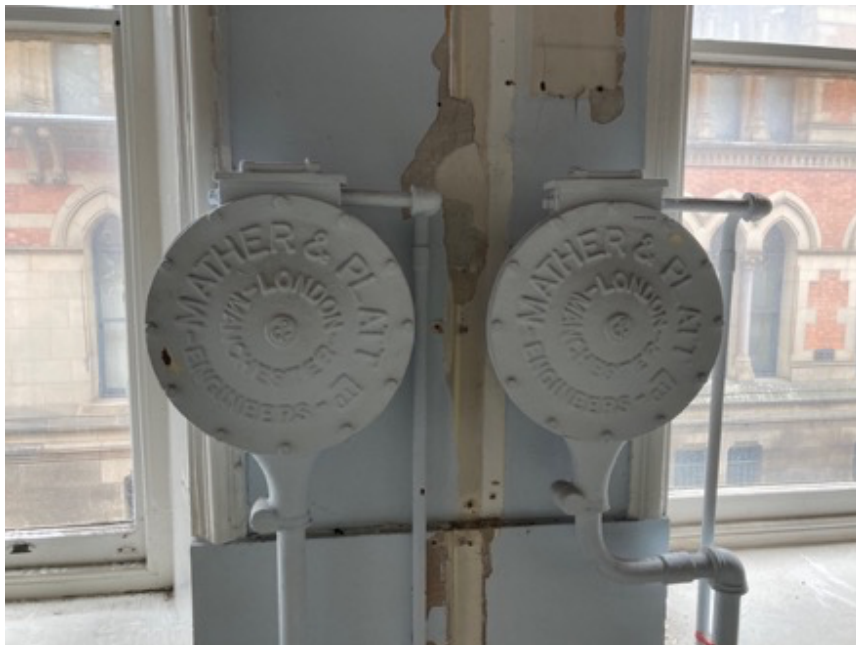
Photo 3A Interior of building showing rear of rotary alarm gongs

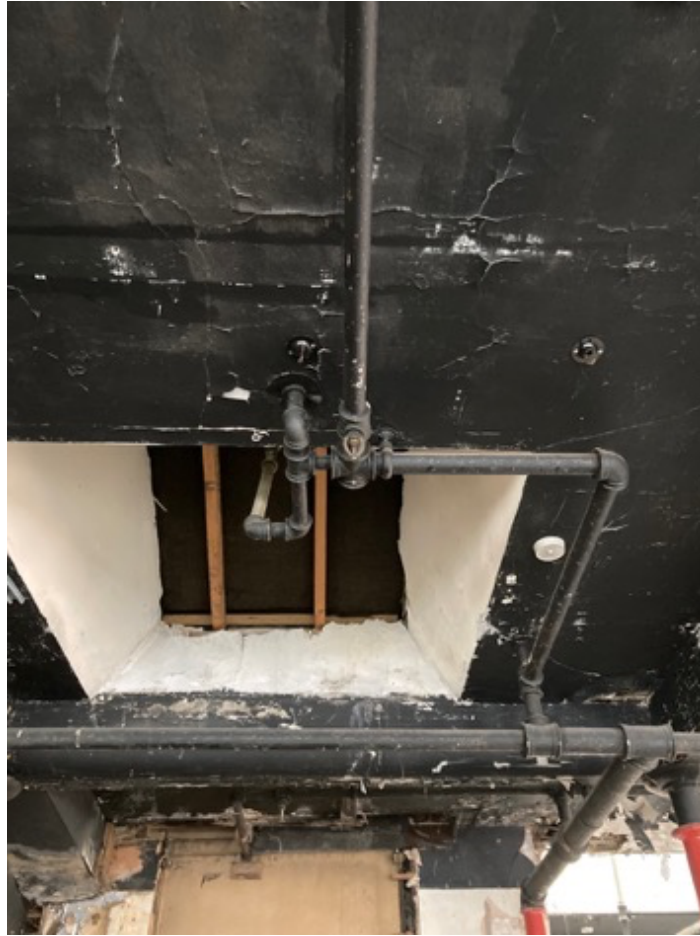
Much of the sprinkler pipework appears in poor condition with evidence of past leakage at the joints – not unusual in a pipe threaded system of this age. Perhaps the oldest part of the visible pipework is shown at Photo 4A. Photo 4B shows what may be the oldest sprinkler head in the building, possibly pre-WW1. For comparison, Photo 5 shows a relatively modern sprinkler head probably installed in the 1970's or later when the building's use changed. It will be possible to date the head precisely by close examination of the deflector or yoke which I was not able to do at the time of my visit.

Photo 4A: Old pipework and sprinkler head – certainly pre-WW2

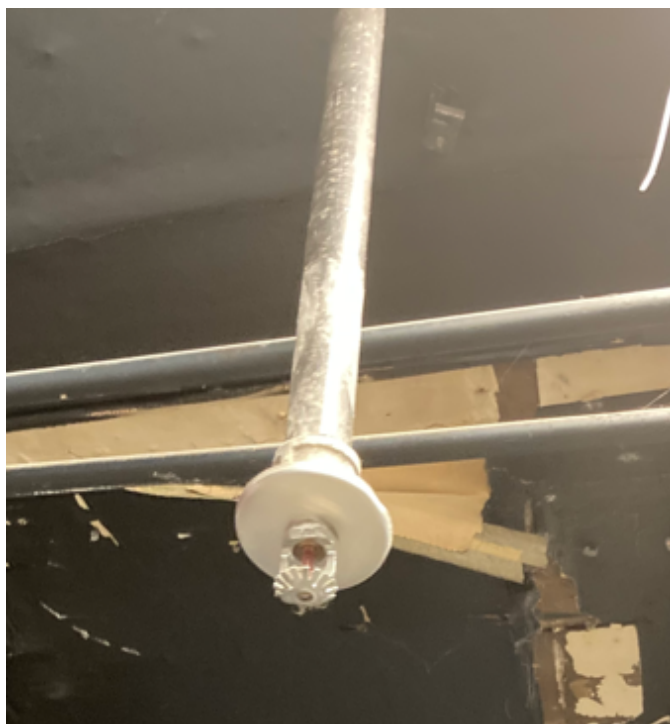
1. It should be recognised that although there has been a sprinkler system in the warehouse building for more than 100 years, it lacks significant authenticity and originality having been modified over the years to take account changes of use and the layout of the building. Much pipework and many sprinkler heads date from the 1970's. (Photo 5)

Photo 5: Modern sprinkler head and pipework
