**Asbestos Survey Report**  
**Public Car Park**  
**below Renaissance Hotel, Manchester**

**Report No. IC20126**

**Date of Issue: 3<sup>rd</sup> February 2021**

| <b>Survey Type:</b> | <b>Refurbishment &amp; Demolition</b> |

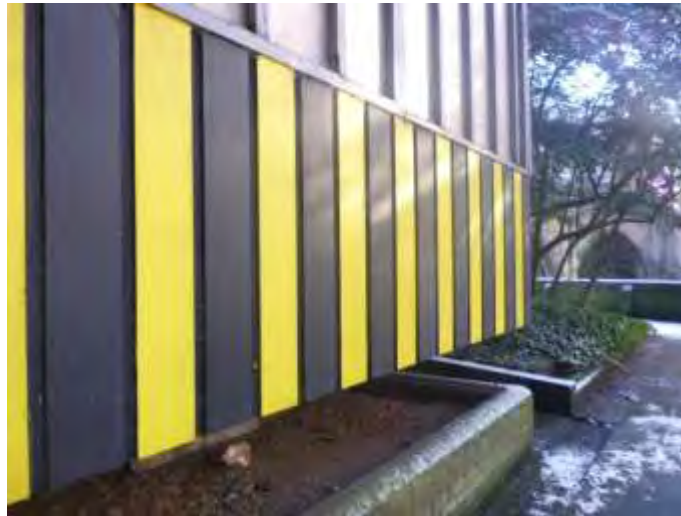
**Concrete Exterior Wall to Lower Level**

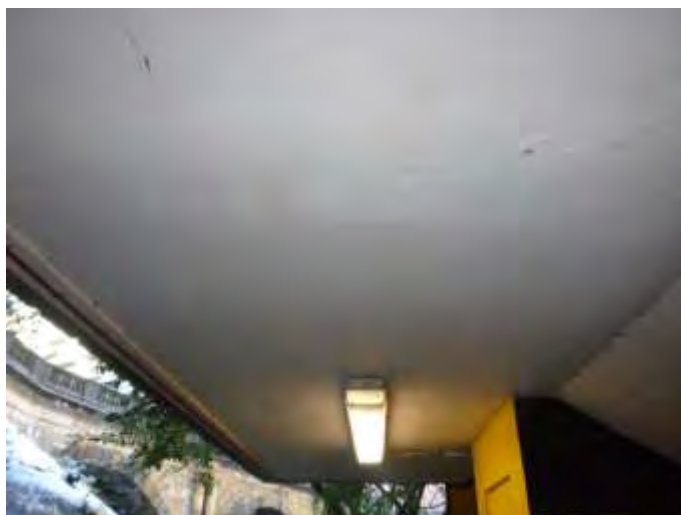
**Concrete Ceilings to Stairwells**

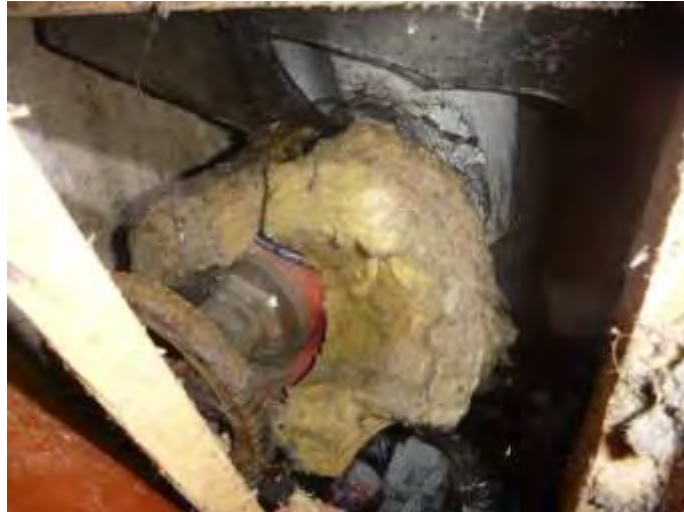
**Rockwool Insulation to Risers in Stairwells**

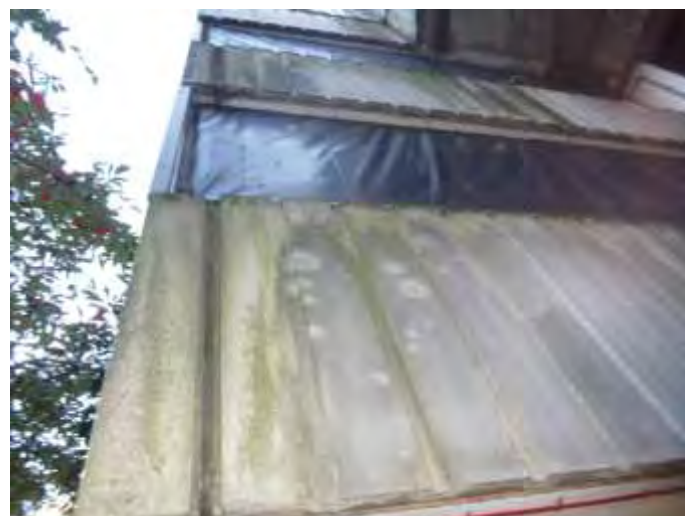
**Concrete Walls and Plastic to Stairwells**

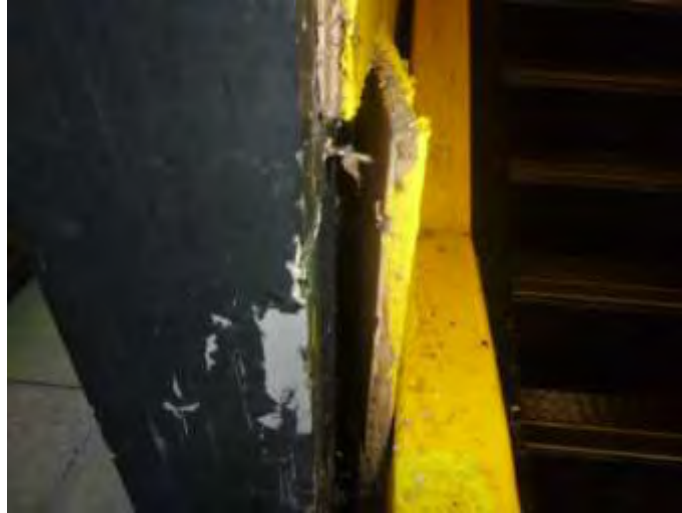
**Timber Lining to Stairs Wall Panels (front stairwell)**

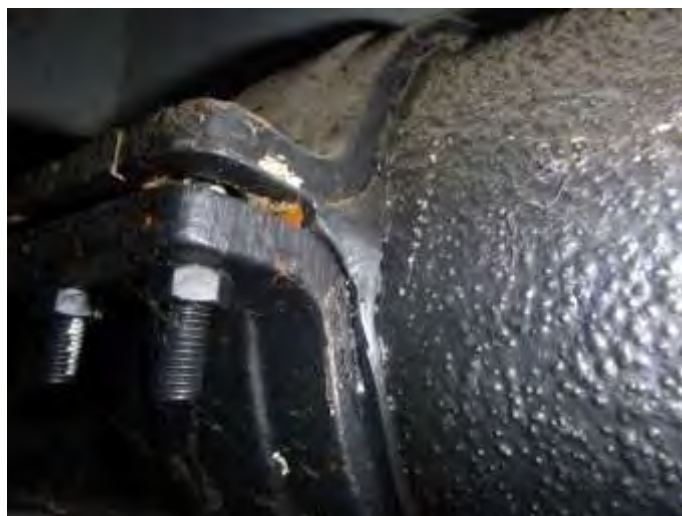
**Rubber Seals to Cast Pipes within Car Park**

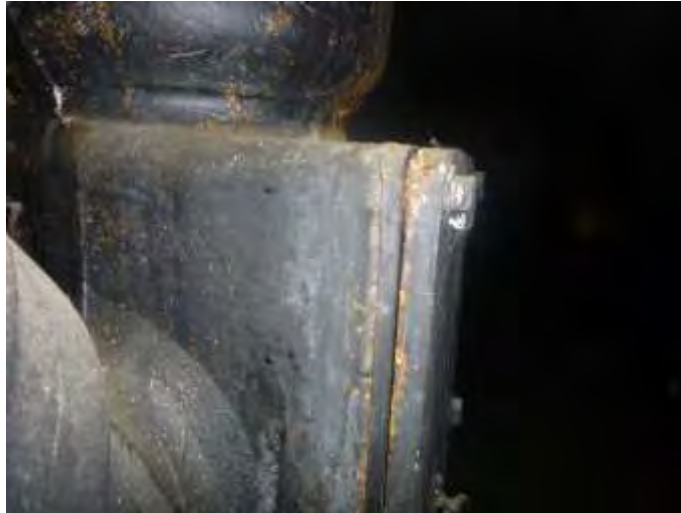
**Rubber Seals to Pipe Access Panels**

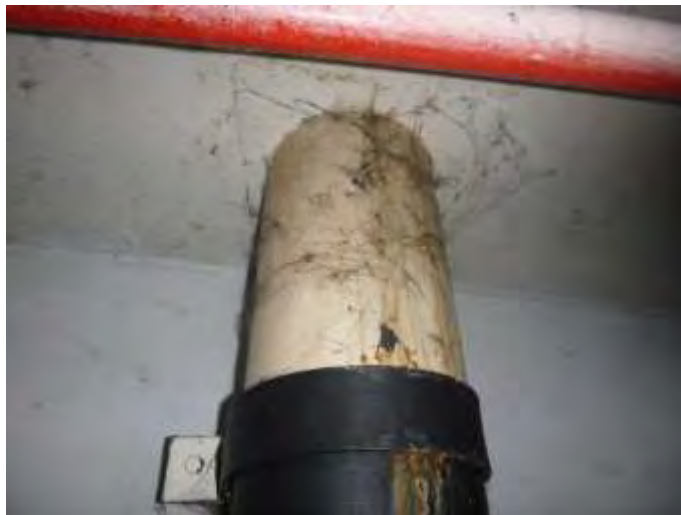
**Cast Pipes from Upper Levels**

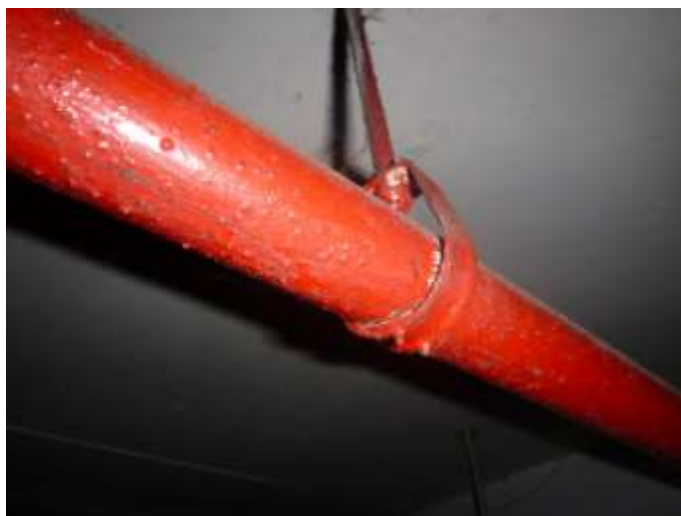
**Metal Sprinkler Pipes on Metal Hangers**

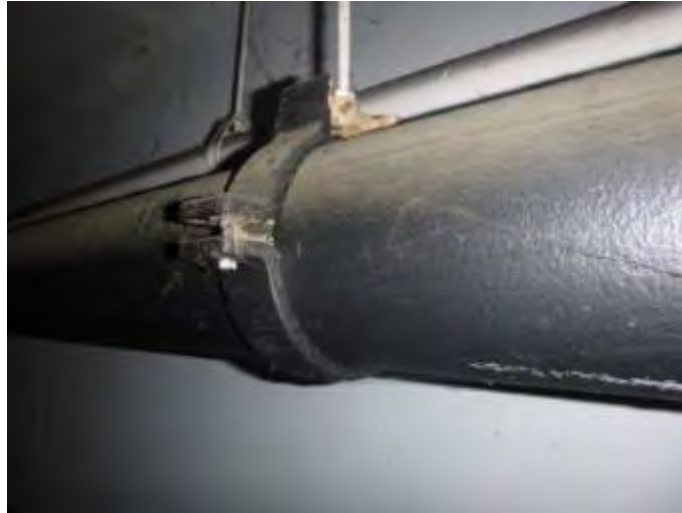
**Metal Hangers to Cast Pipes**

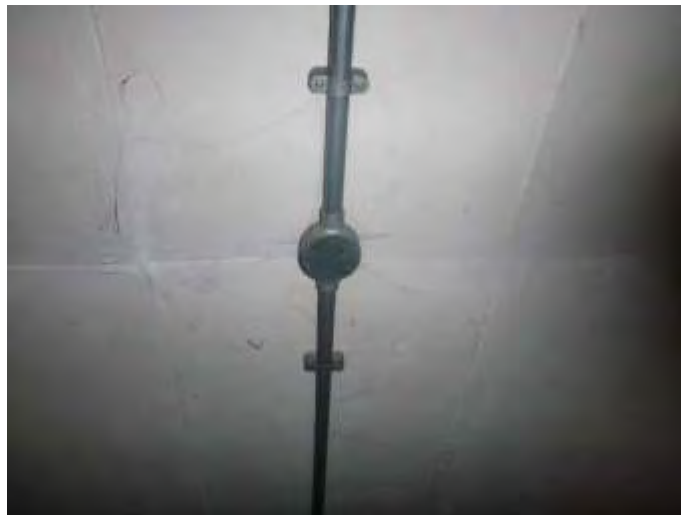
**Metal Electrical Conduit**

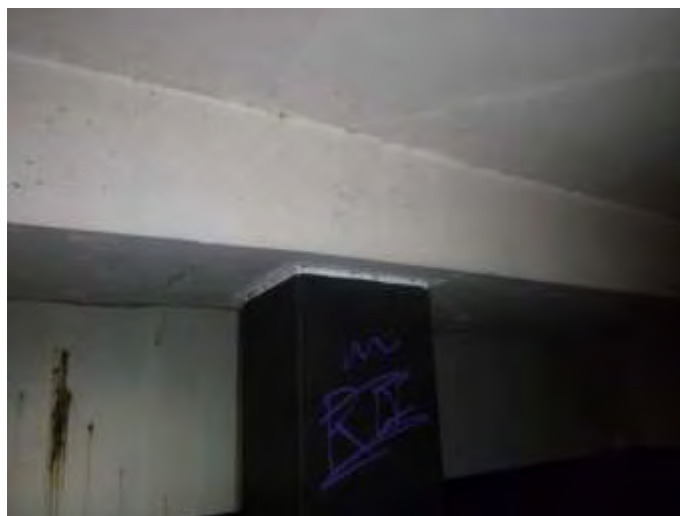
**Concrete Columns and Beams**

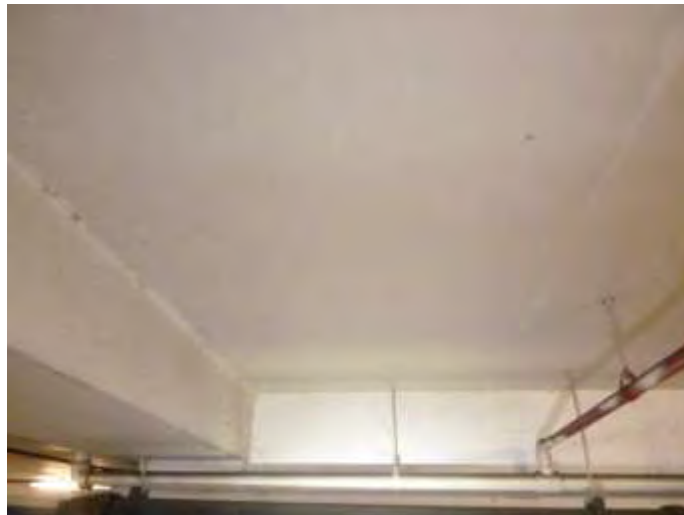
**Concrete Decks to Upper Levels**

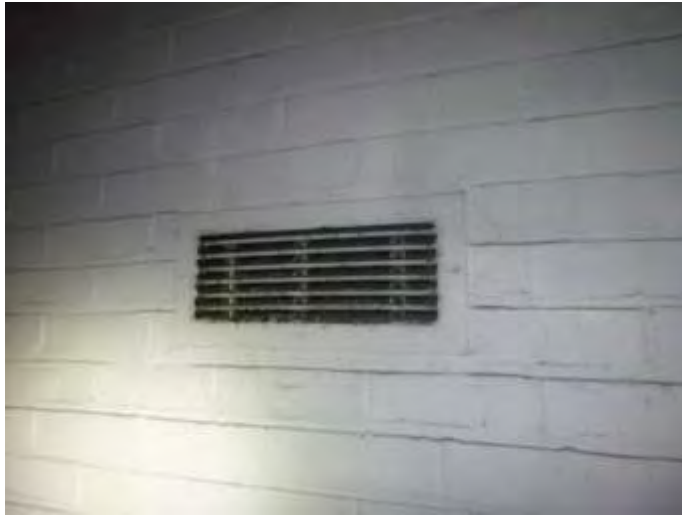
**Metal Duct Grates to Walls**

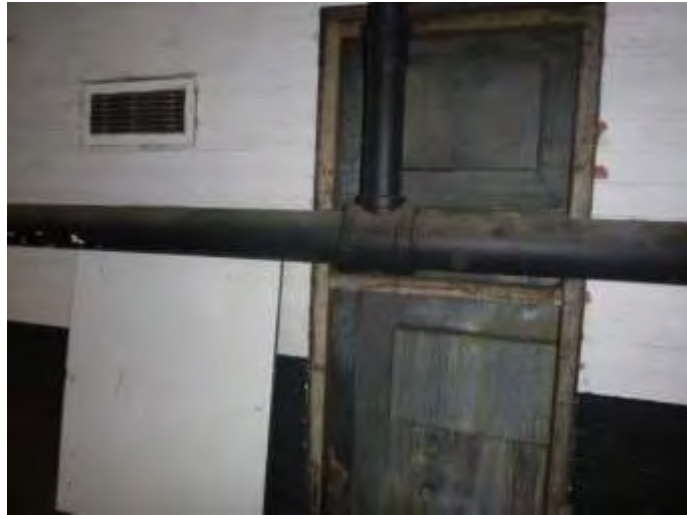
**Steel Vent / Ducts behind Timber Panels to Rear Wall (Lower Level)**

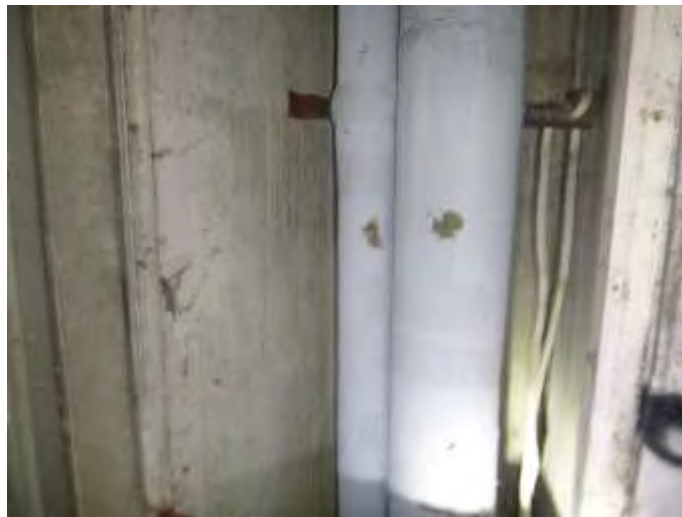
**Rockwool Pipe Insulation to Stairs Risers**

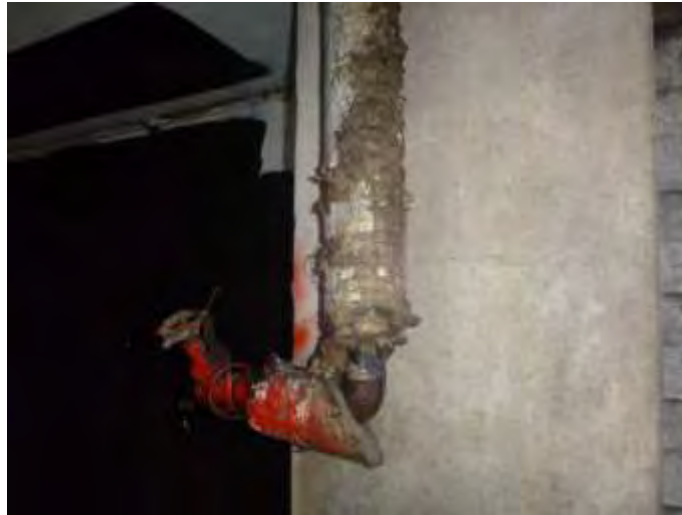
**Rockwool Insulation to Pipes adjacent to Exterior Wall**

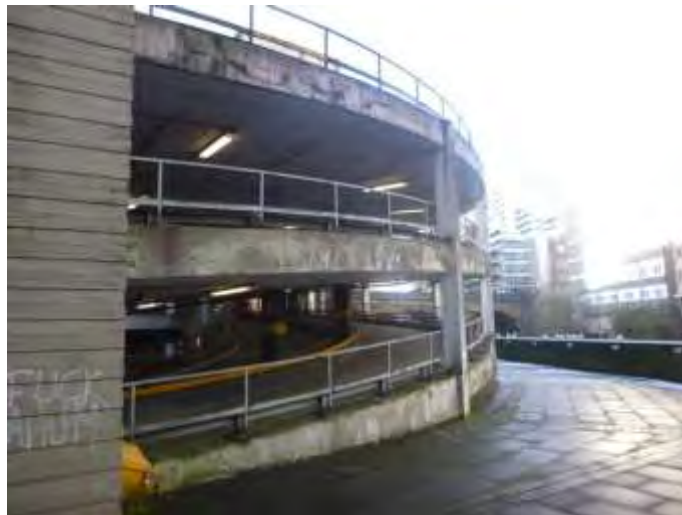
**Concrete Vehicle Ramp**

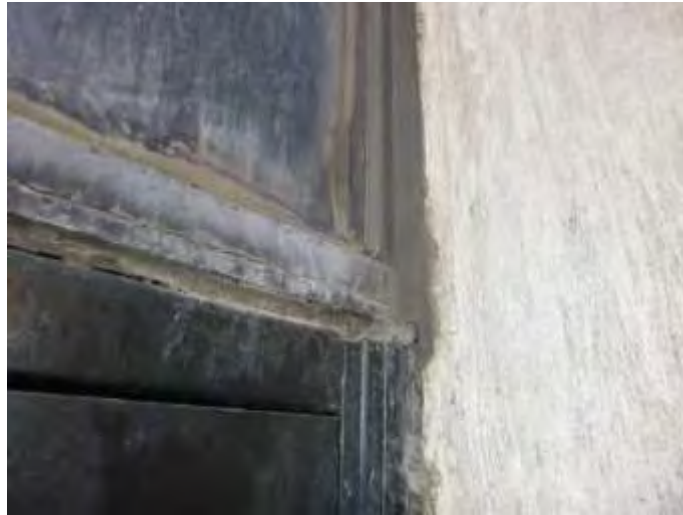
**Modern Sealant to Door Panel on Exterior Lower Wall**

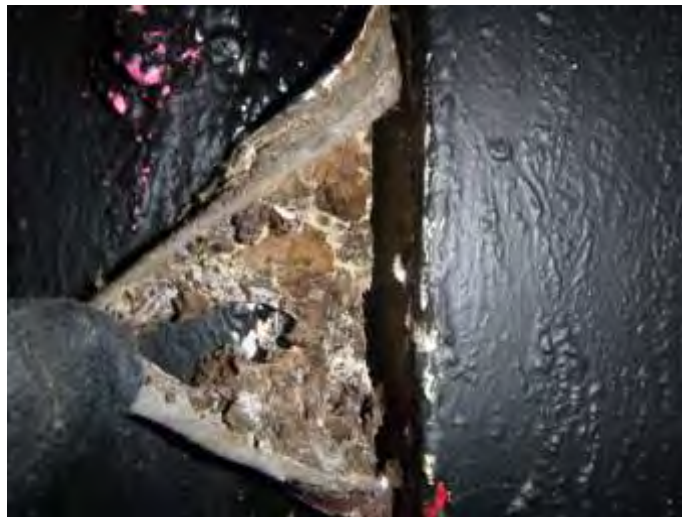
**Cork behind Modern Sealant to Concrete Joints**

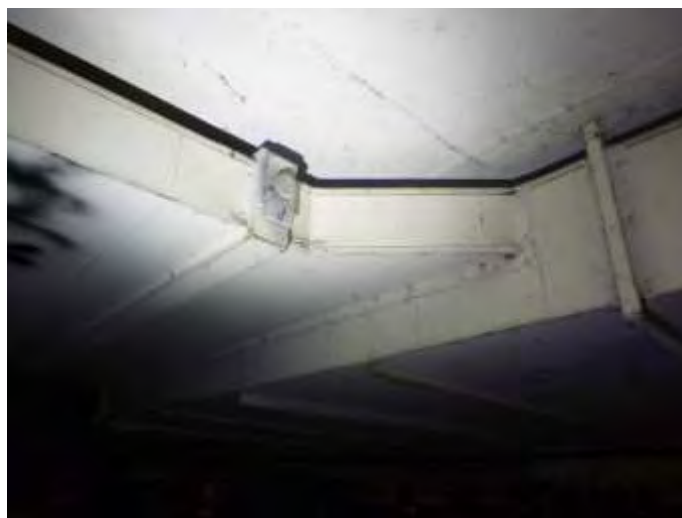
**Metal Ducting to Ceilings**

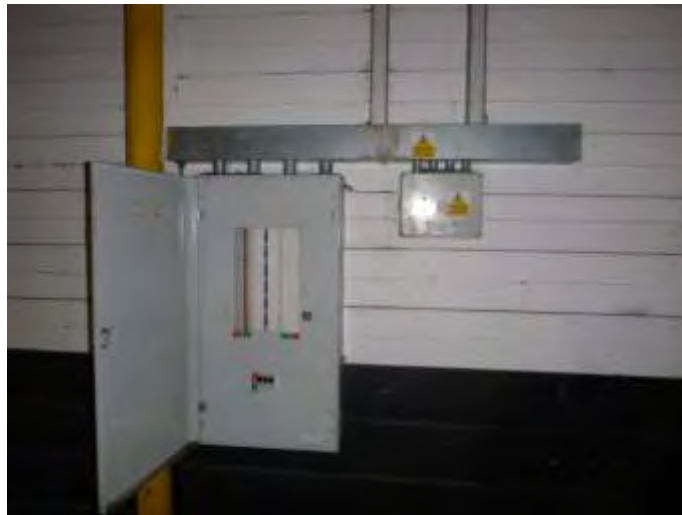
**Modern Electrical Switchgear**

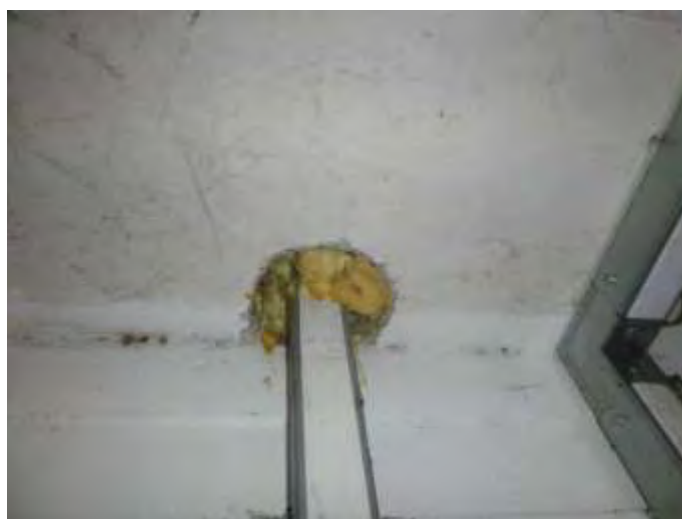
**Foam to Pipe Egress Points**

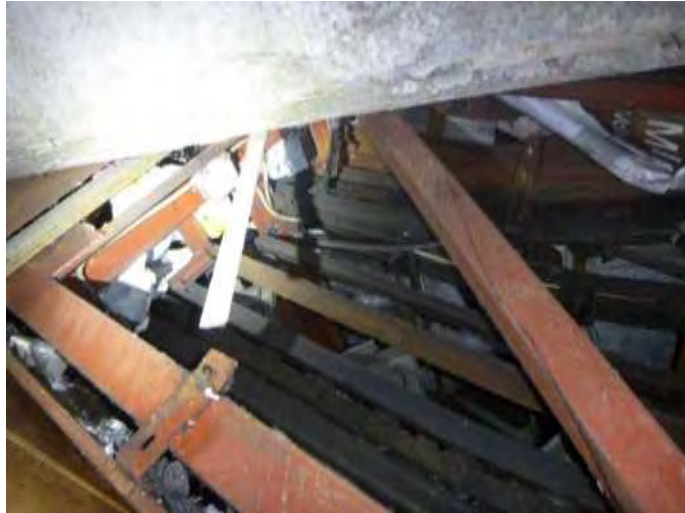
**Steel Disused Escalator (only underneath accessible)**

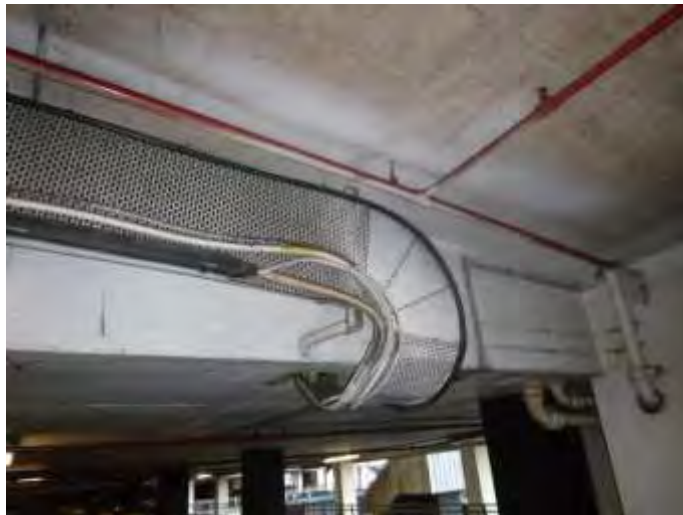
**Steel Electrical Cable Tray**

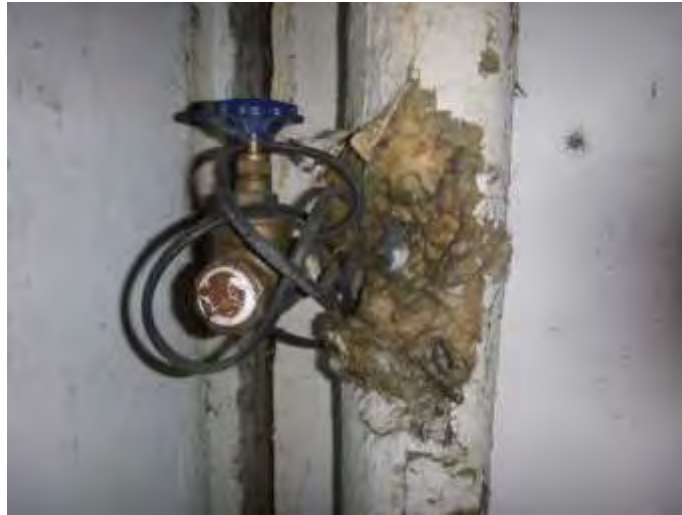
**Rockwool Pipe Insulation to Pipe on Mid-Level**

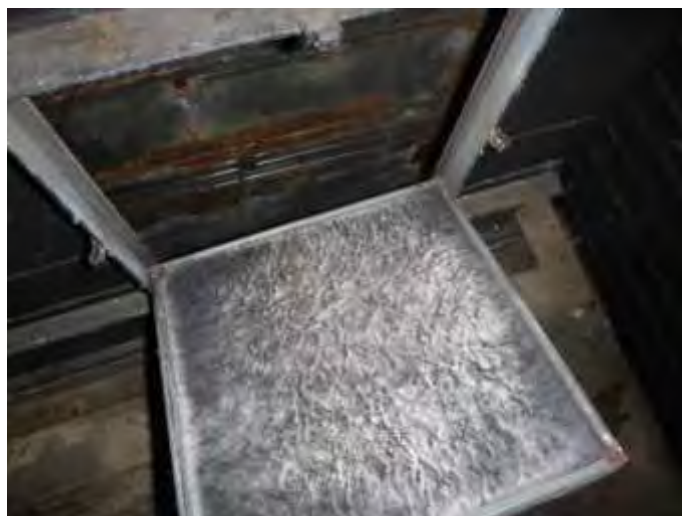
**Modern Insulation to Metal Vents**

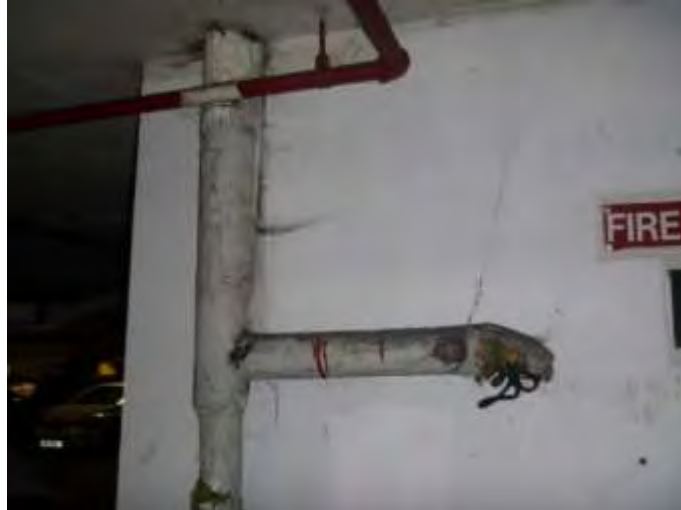
**Rockwool Pipe Insulation near Electrical Switchgear – Mid Level**

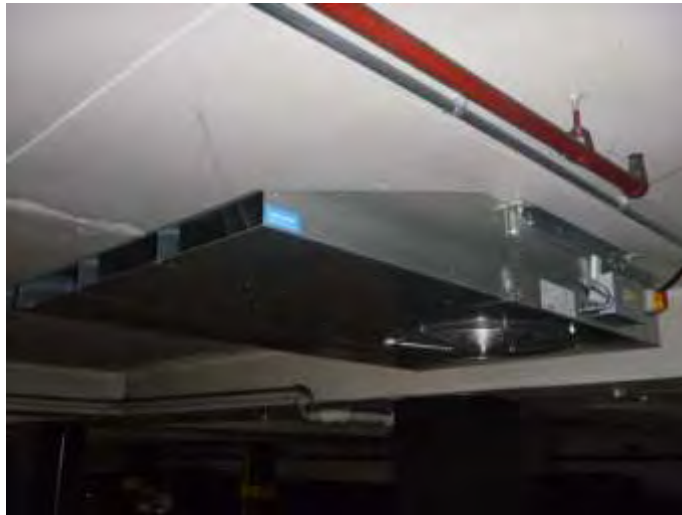
**New Vent Installation**

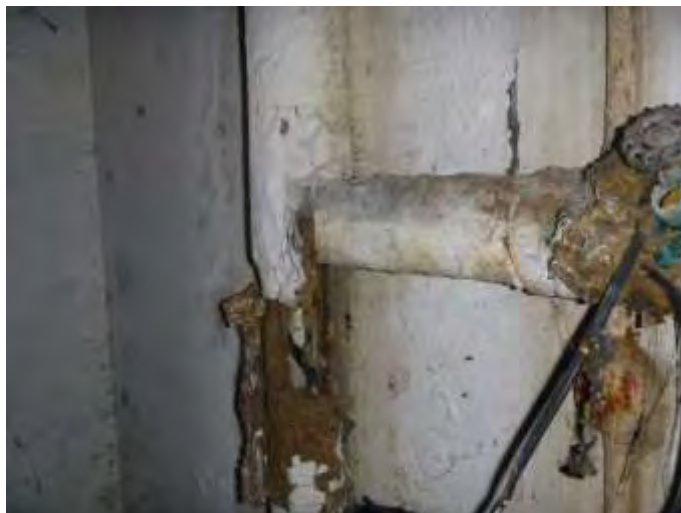
**Rockwool Pipe Insulation near Roller Shutter Door – Mid Level**

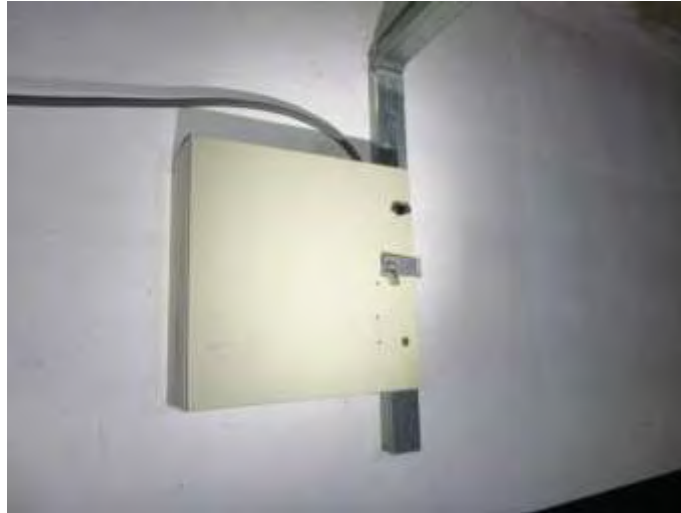
**Modern Electrical Equipment to Upper Level**

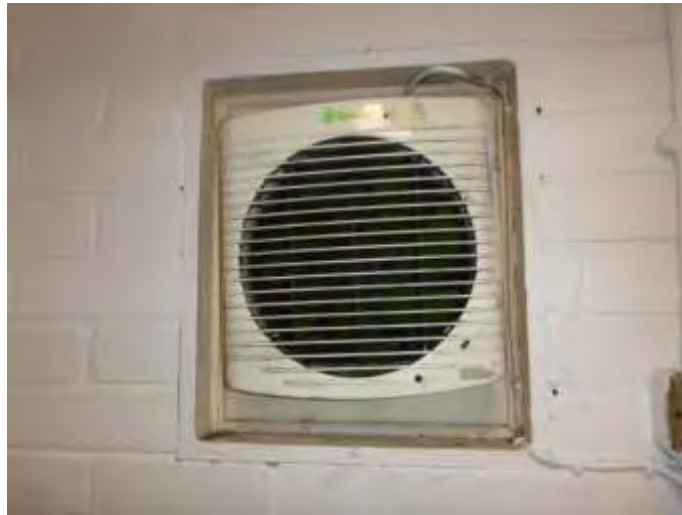
**Plastic Extractor Fan to Staff WC**

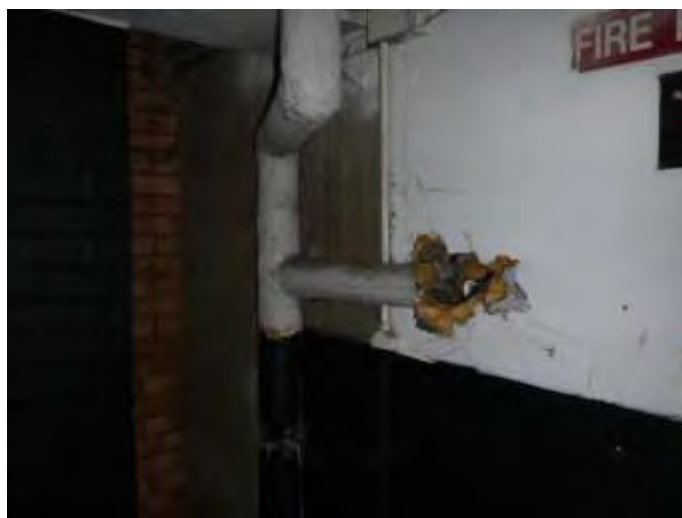
**Rockwool Pipe Insulation near Roller Shutter Door on Upper Level**

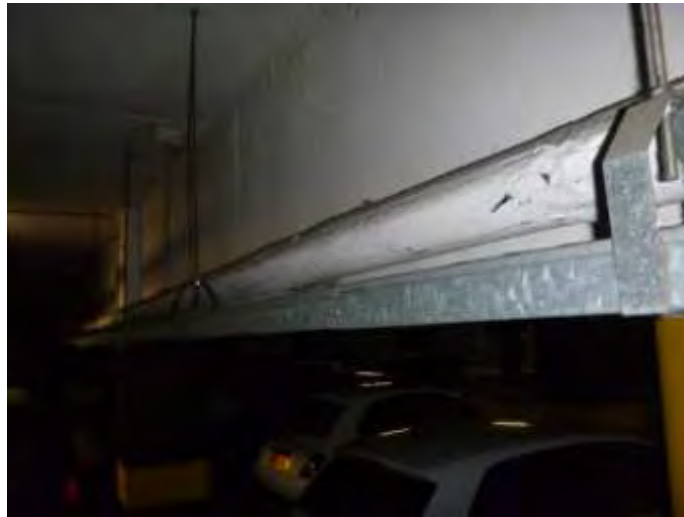
**Rockwool Insulation to Pipe along Beam on Upper Level**

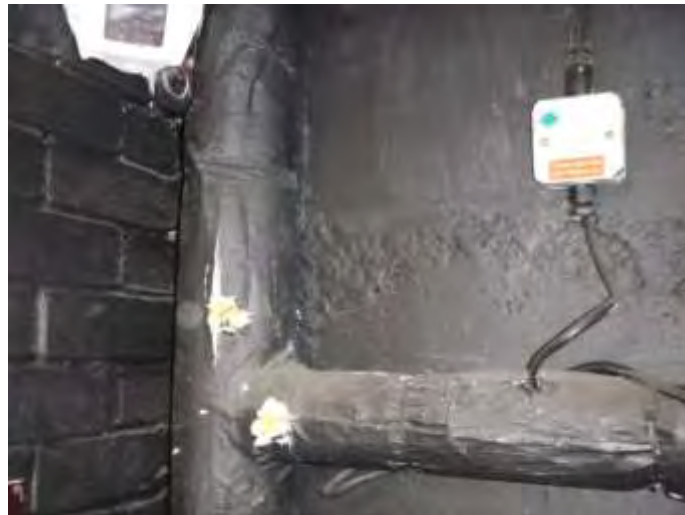
**Rockwool Pipe Insulation adjacent to Hotel Lift**

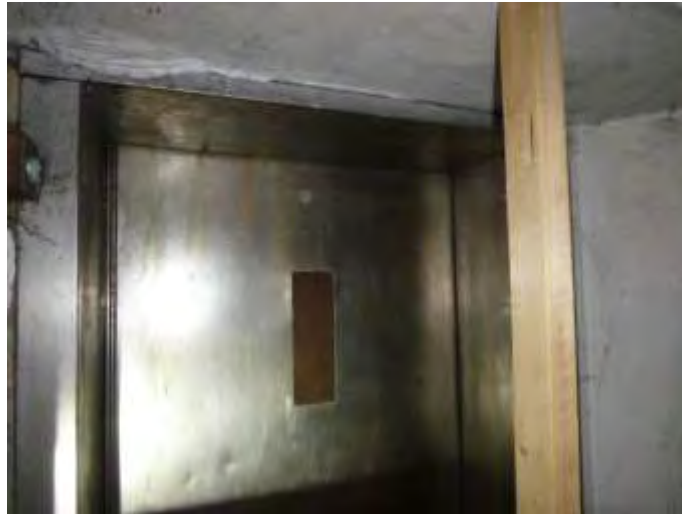
**Steel Doors and Surrounds to Disused Pedestrian Lift**

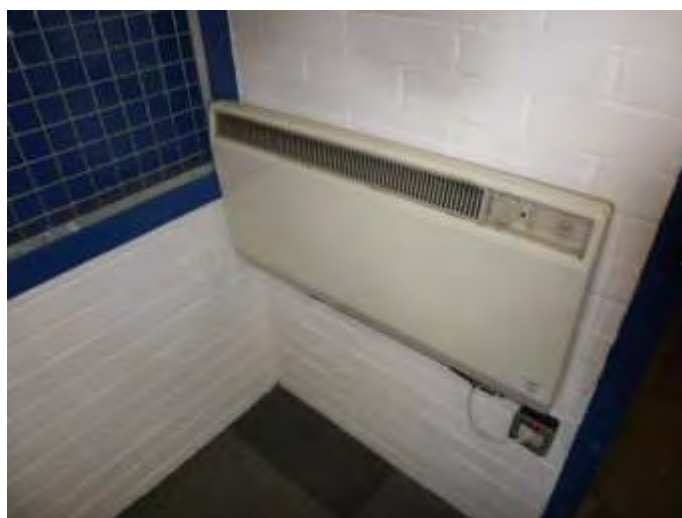
**Modern Heater in Security Office**

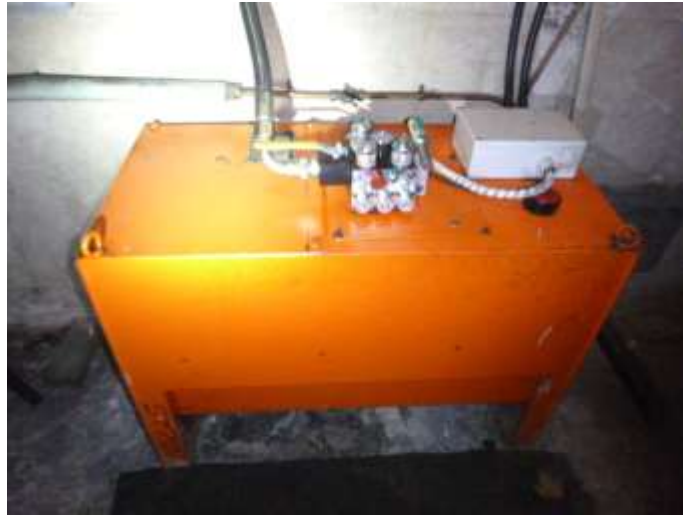
**Hydraulic Lift Motor to Hotel Laundry Lift**

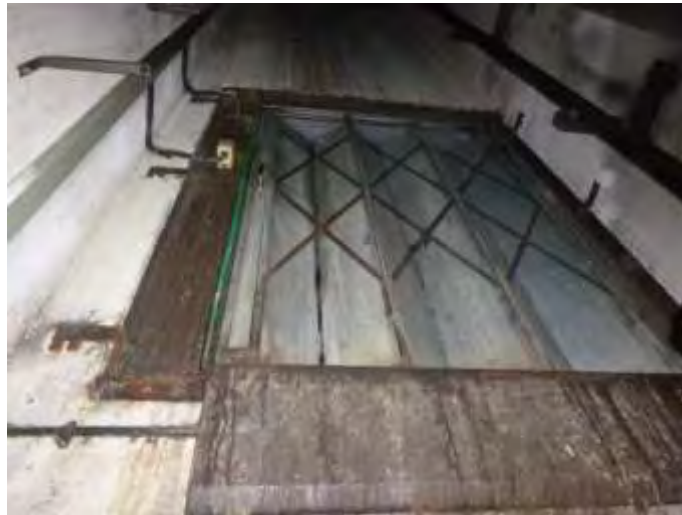
**Concrete Lift Shaft and Steel Doors to Hotel Laundry Lift**

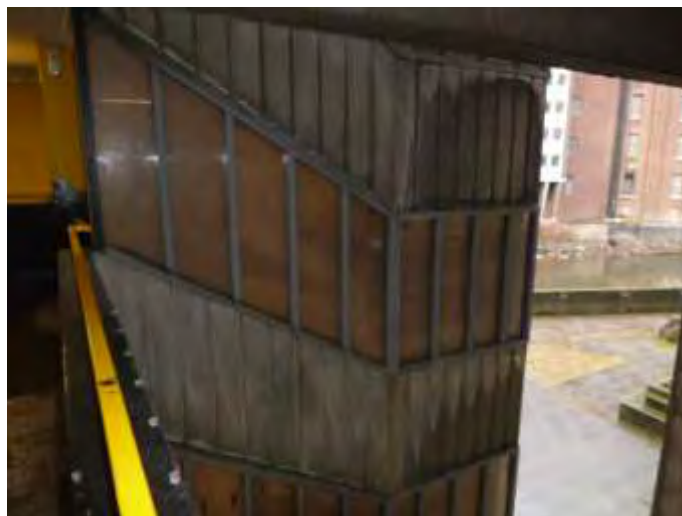
**Timber behind Glazed Panels to Stairwell**

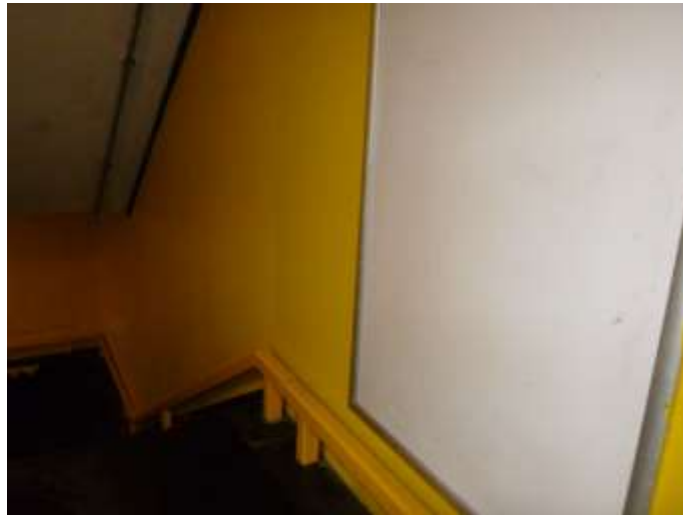
**Timber Lining to Stairs near Main Entrance**

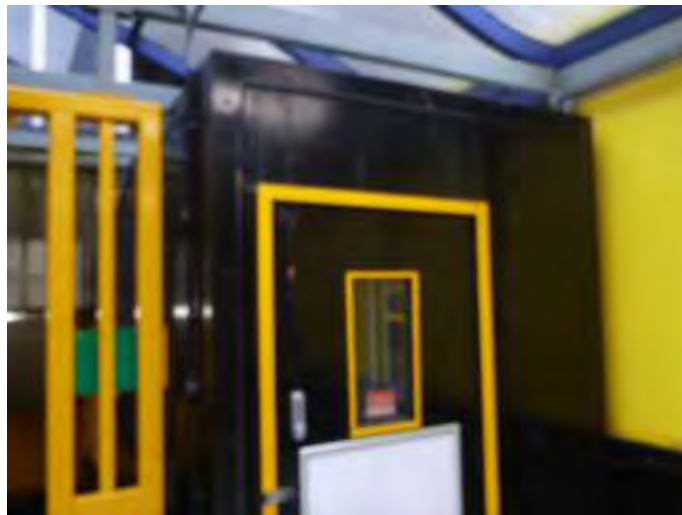
**Steel and Timber Cabin adjacent to Main Entrance**

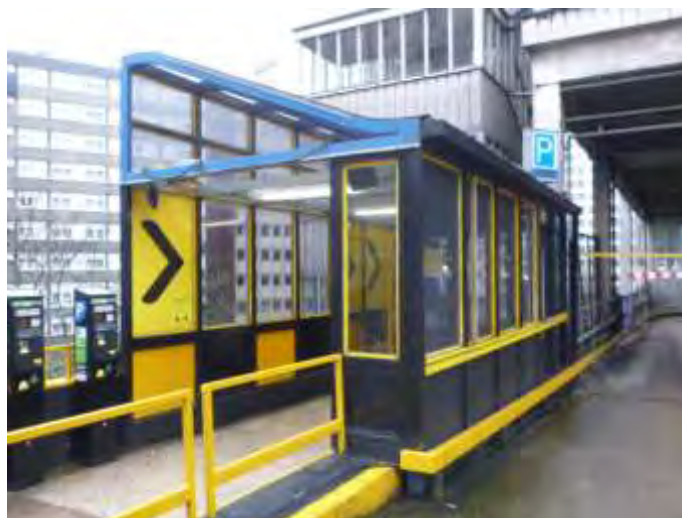
**Steel / Glazed Entrance Walkway**

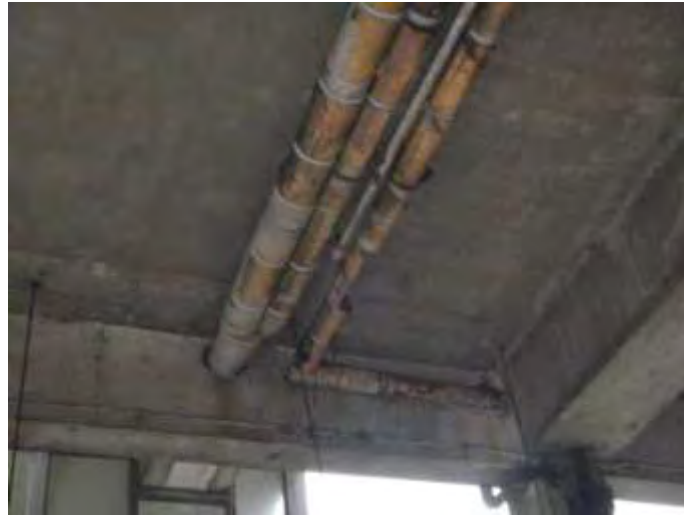
**Rockwool Pipe Insulation at High Level above Vehicle Entrance**

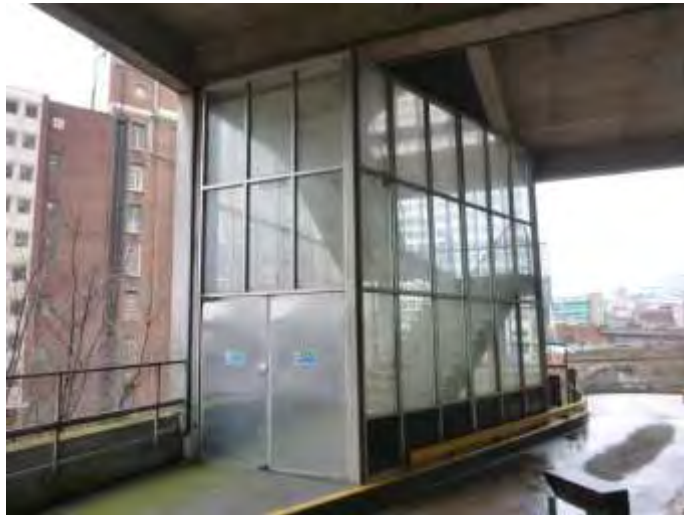
**Steel Glazed Panels to Concrete Stairs near Vehicle Entrance**
