# **BS 5837:2012**

## **Tree Survey and Preliminary Assessment**

**Report No:** LTM0055.PAA.01

**Project:** 120a Withington Rd, Manchester. M16 8FA

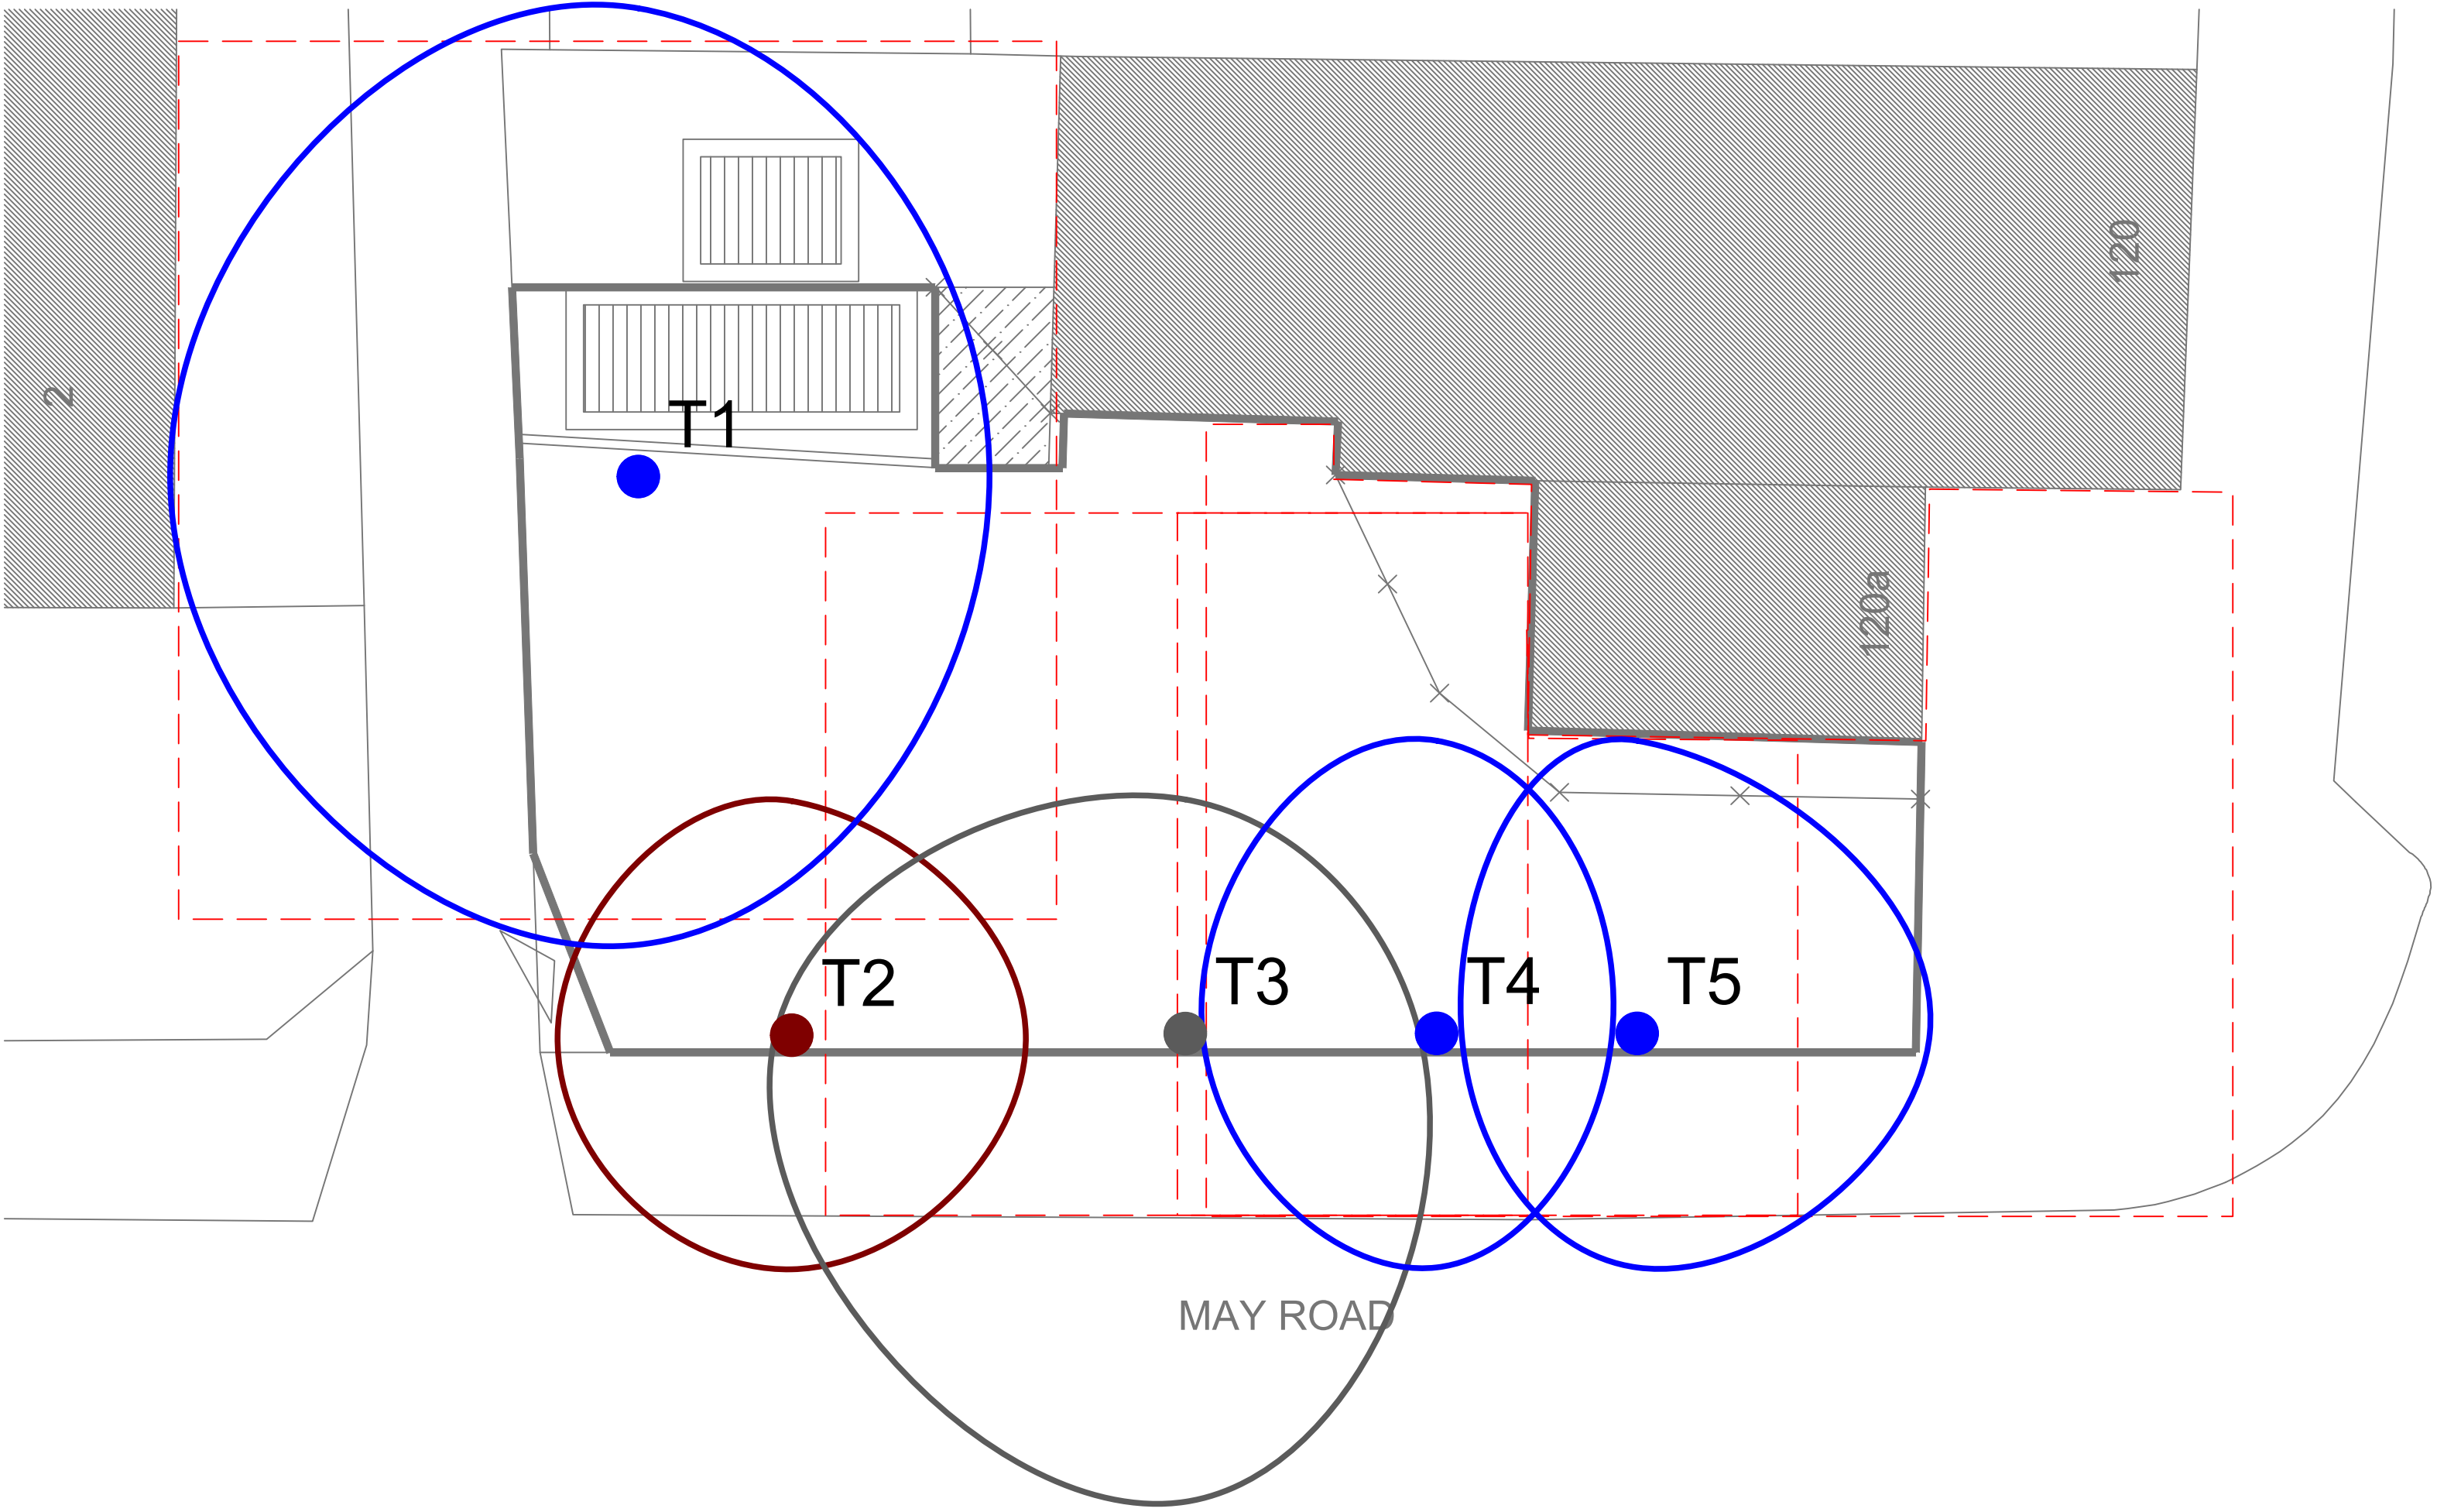
There are 3 category B trees and 1 category C tree located on the site boundaries. There is a category U tree located adjacent to the main gates. This category U tree has died and should be removed to prevent damage of injury.
