## REFURBISHMENT SURVEY FOR ASBESTOS-CONTAINING MATERIALS

**CLIENT:** Property Alliance Group Ltd

**SITE:** Premier House, 22 Deansgate, Manchester, M3 1PH

**TYPE OF SURVEY:** Refurbishment

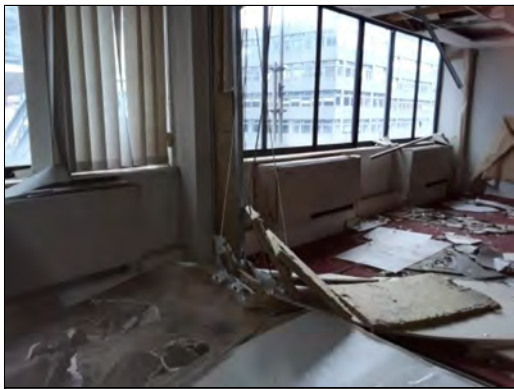
| Assessment details | | | | Comments | |
|---|---|---|---|---|---|
| Building | Premier house | Floor/ room | 2nd Floor / 2.30 | | |

| Assessment details | | | | Comments | |
|---|---|---|---|---|---|
| Assessment no. | 0040 | Accessibility | Occasionally likely to be disturbed | | |

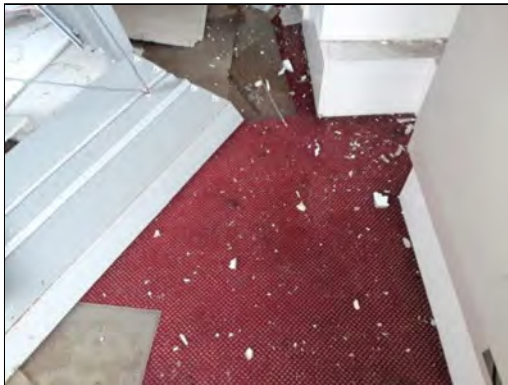
| Assessment details | | | | Comments | <div>Photograph</div> |
|---|---|---|---|---|---|
| Building | Premier house | Floor/ room | 2nd Floor / 2.30 | | |

| Assessment details | | | | Comments | <div>Photograph</div> |
|---|---|---|---|---|---|
| Assessment no. | 0041 | Accessibility | Routinely disturbed | | |

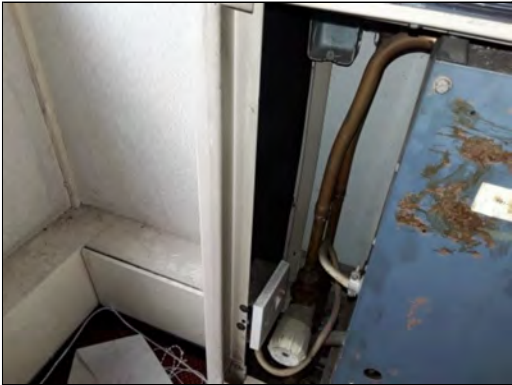
| Assessment details | | | | Comments | |
|---|---|---|---|---|---|
| Building | Premier house | Floor/ room | 1st Floor / 1.0 | | |

| Building | Floor/<br>Room | Assessment<br>Number | Location/<br>position | Product<br>type | Surface<br>treatment | Condition | Extent | Accessibility | Level of<br>identification | Asbestos<br>type | Material<br>risk | Priority<br>risk | Action |
|---|---|---|---|---|---|---|---|---|---|---|---|---|---|
| Premier house | 1st Floor / 1.0 | 0043 | Board walls below windows and behind heaters | Board | Surface Sealed | Low Damage | 22m <sup>2</sup> | Occasionally likely to be disturbed | Identified | Amosite | ( 6 ) Low | - | Remove |

| Assessment details | | | | Comments | |
|---|---|---|---|---|---|
| Assessment no. | 0043 | Accessibility | Occasionally likely to be disturbed | | |
| Material risk | Low | Material risk score | 6 | | |

| Assessment details | | | | Comments | |
|---|---|---|---|---|---|
| Action | Remove | | | | |

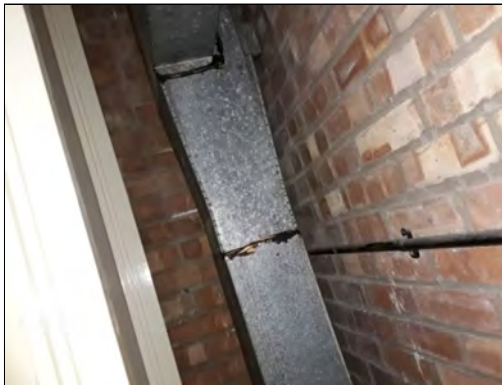
| Assessment details | | | | Comments | <div>Photograph</div> |
|---|---|---|---|---|---|
| Building | Premier house | Floor/ room | 1st Floor / 1.1 | | |

| Building | Floor/<br>Room | Assessment<br>Number | Location/<br>position | Product<br>type | Surface<br>treatment | Condition | Extent | Accessibility | Level of<br>identification | Asbestos<br>type | Material<br>risk | Priority<br>risk | Action |
|---|---|---|---|---|---|---|---|---|---|---|---|---|---|
| Premier house | 1st Floor / 1.1 | 0045 | Composite putty to ducting | Well Bound Material | Surface Sealed | Low Damage | 3lm | Occasionally likely to be disturbed | Identified | Chrysotile | ( 4 )<br>Very low | - | Remove |

| Assessment details | | | | Comments | <div>Photograph</div> |
|---|---|---|---|---|---|
| Assessment no. | 0045 | Accessibility | Occasionally likely to be disturbed | | |

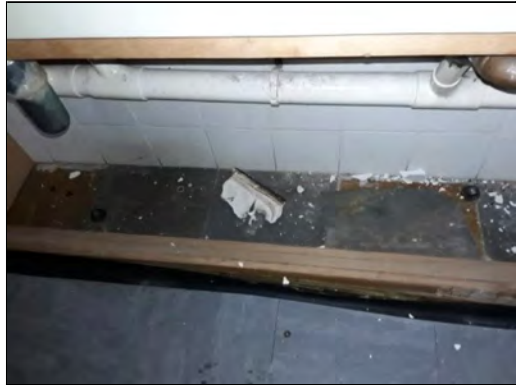
| Assessment details | | | | Comments | |
|---|---|---|---|---|---|
| Building | Premier house | Floor/ room | 1st Floor / 1.2 | | |

| Assessment details | | | | Comments | |
|---|---|---|---|---|---|
| Identification | Identified | Condition | | | |

| Assessment details | | | | Comments | |
|---|---|---|---|---|---|
| Action | No further action required | | | | |

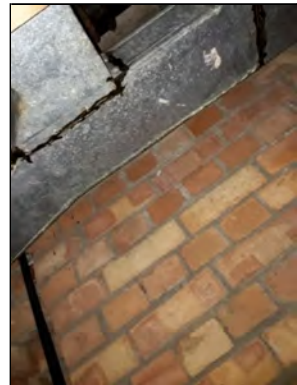
| Assessment details | | | | Comments | Photograph |
|---|---|---|---|---|---|
| Building | Premier house | Floor/ room | 1st Floor / 1.4 | | |

| Assessment details | | | | Comments | Photograph |
|---|---|---|---|---|---|
| Assessment no. | 0048 | Accessibility | Occasionally likely to be disturbed | | |
| Identification | Strongly Presumed (045) | Condition | Low Damage | | |

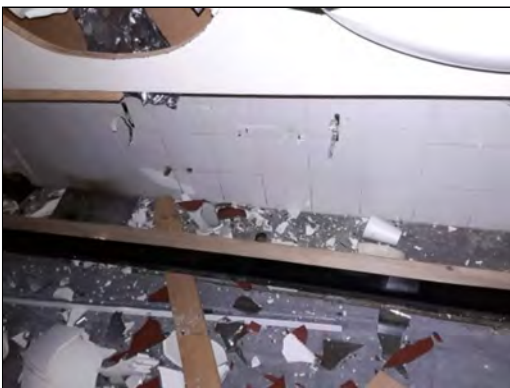
| Assessment details | | | | Comments | <div>Photograph</div> |
|---|---|---|---|---|---|
| Building | Premier house | Floor/ room | 1st Floor / 1.4 | | |

| Assessment details | | | | Comments | <div>Photograph</div> |
|---|---|---|---|---|---|
| Identification | Strongly Presumed (047) | Condition | | | |

| Assessment details | | | | Comments | <div>Photograph</div> |
|---|---|---|---|---|---|
| Action | No further action required | | | | |

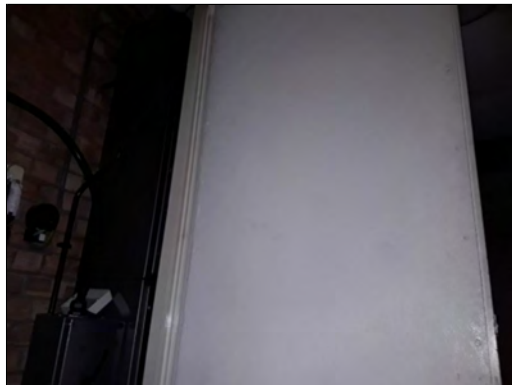
| Assessment details | | | | Comments | Photograph |
|---|---|---|---|---|---|
| Building | Premier house | Floor/ room | 1st Floor / 1.5 | | |

| Assessment details | | | | Comments | Photograph |
|---|---|---|---|---|---|
| Assessment no. | 0050 | Accessibility | Occasionally likely to be disturbed | | |
| Identification | Strongly Presumed (044) | Condition | Low Damage | | |

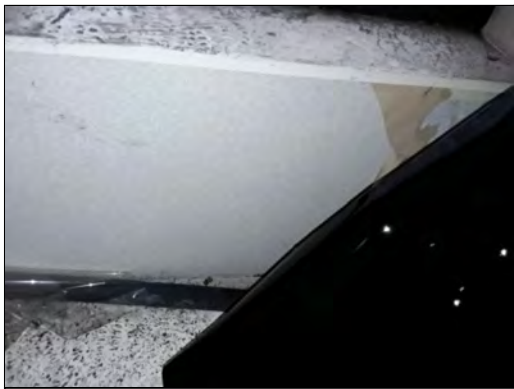
| Assessment details | | | | Comments | Photograph |
|---|---|---|---|---|---|
| Building | Premier house | Floor/ room | 1st Floor / 1.6 | | |

| Assessment details | | | | Comments | Photograph |
|---|---|---|---|---|---|
| Assessment no. | 0051 | Accessibility | Occasionally likely to be disturbed | | |
| Identification | Strongly Presumed (043) | Condition | Low Damage | | |

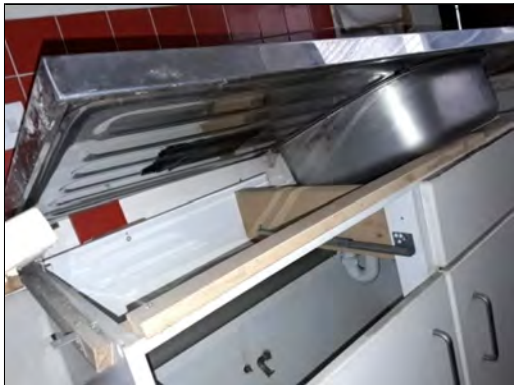
| Assessment details | | | | Comments | |
|---|---|---|---|---|---|
| Building | Premier house | Floor/ room | 1st Floor / 1.6 | | |

| Assessment details | | | | Comments | |
|---|---|---|---|---|---|
| Identification | Identified | Condition | | | |

| Assessment details | | | | Comments | |
|---|---|---|---|---|---|
| Action | No further action required | | | | |

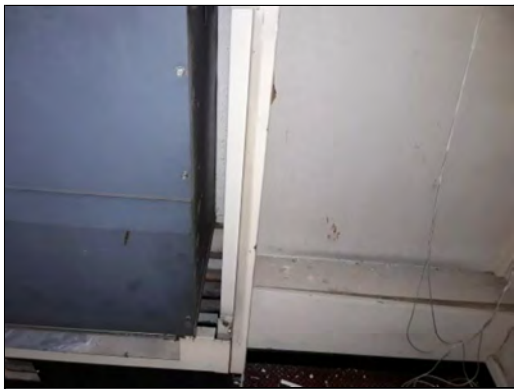
| Assessment details | | | | Comments | Photograph |
|---|---|---|---|---|---|
| Building | Premier house | Floor/ room | 1st Floor / 1.7 | | |

| Assessment details | | | | Comments | Photograph |
|---|---|---|---|---|---|
| Assessment no. | 0053 | Accessibility | Occasionally likely to be disturbed | | |
| Identification | Strongly Presumed (043) | Condition | Low Damage | | |

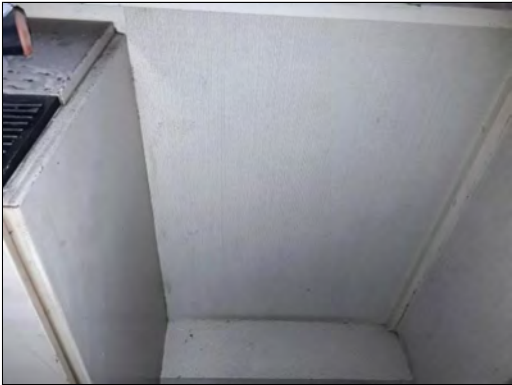
| Assessment details | | | | Comments | <div></div> |
|---|---|---|---|---|---|
| Building | Premier house | Floor/ room | 1st Floor / 1.8 | | |

| Assessment details | | | | Comments | <div></div> |
|---|---|---|---|---|---|
| Assessment no. | 0054 | Accessibility | Occasionally likely to be disturbed | | |
| Identification | Strongly Presumed (043) | Condition | Low Damage | | |
| Material risk | Low | Material risk score | 6 | | |

| Assessment details | | | | Comments | <div></div> |
|---|---|---|---|---|---|
| Action | Remove | | | | |

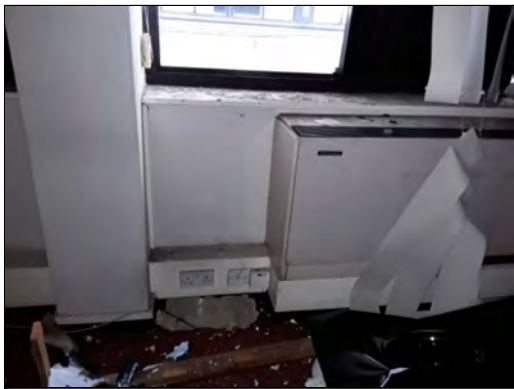
| Assessment details | | | | Comments | Photograph |
|---|---|---|---|---|---|
| Building | Premier house | Floor/ room | 1st Floor / 1.11 | | |

| Assessment details | | | | Comments | Photograph |
|---|---|---|---|---|---|
| Assessment no. | 0055 | Accessibility | Occasionally likely to be disturbed | | |
| Identification | Strongly Presumed (043) | Condition | Low Damage | | |

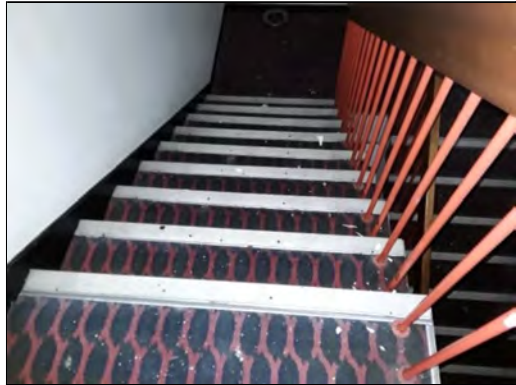
| Assessment details | | | | Comments | Photograph |
|---|---|---|---|---|---|
| Building | Premier house | Floor/ room | 1st Floor / 1.13 | | |

| Assessment details | | | | Comments | Photograph |
|---|---|---|---|---|---|
| Identification | Identified | Condition | | | |

| Assessment details | | | | Comments | Photograph |
|---|---|---|---|---|---|
| Action | No further action required | | | | |

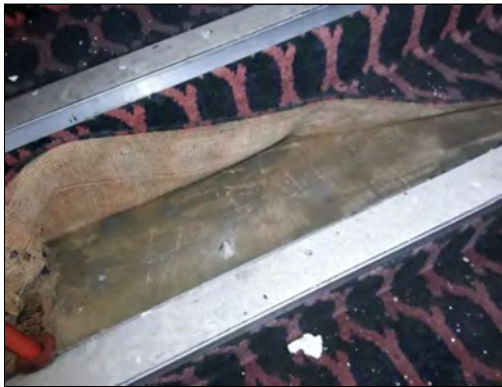
| Assessment details | | | | Comments | |
|---|---|---|---|---|---|
| Building | Premier house | Floor/ room | 1st Floor / 1.13 | | |

| Assessment details | | | | Comments | |
|---|---|---|---|---|---|
| Assessment no. | 0057 | Accessibility | Occasionally likely to be disturbed | | |
| Identification | Identified | Condition | Low Damage | | |

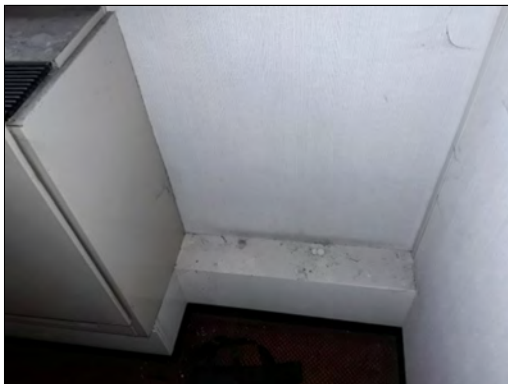
| Assessment details | | | | Comments | Photograph |
|---|---|---|---|---|---|
| Building | Premier house | Floor/ room | 1st Floor / 1.14 | | |

| Assessment details | | | | Comments | Photograph |
|---|---|---|---|---|---|
| Assessment no. | 0058 | Accessibility | Occasionally likely to be disturbed | | |
| Identification | Strongly Presumed (043) | Condition | Low Damage | | |

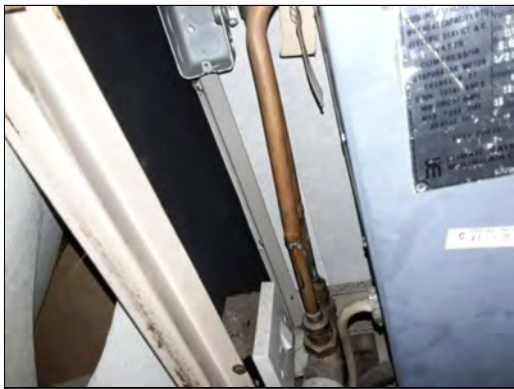
| Assessment details | | | | Comments | |
|---|---|---|---|---|---|
| Building | Premier house | Floor/ room | 1st Floor / 1.15 | | |

| Assessment details | | | | Comments | |
|---|---|---|---|---|---|
| Assessment no. | 0059 | Accessibility | Occasionally likely to be disturbed | | |
| Identification | Strongly Presumed (043) | Condition | Low Damage | | |

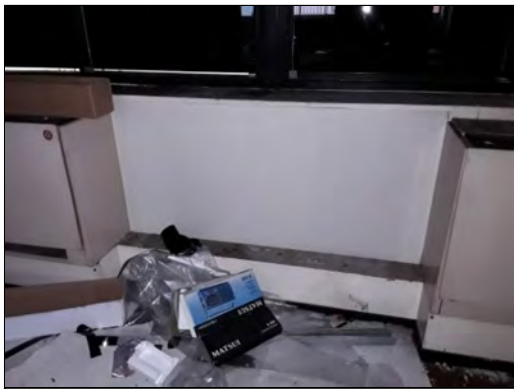
| Assessment details | | | | Comments | |
|---|---|---|---|---|---|
| Building | Premier house | Floor/ room | 1st Floor / 1.16 | | |

| Assessment details | | | | Comments | |
|---|---|---|---|---|---|
| Assessment no. | 0060 | Accessibility | Occasionally likely to be disturbed | | |
| Identification | Strongly Presumed (043) | Condition | Low Damage | | |

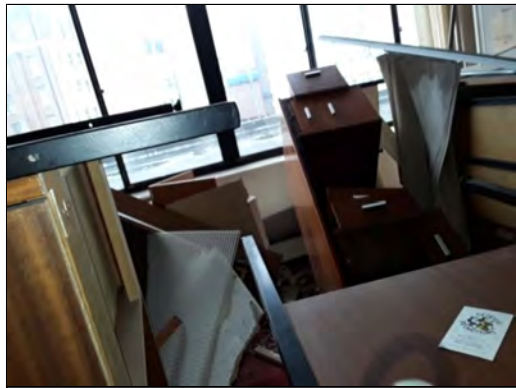
| Assessment details | | | | Comments | |
|---|---|---|---|---|---|
| Building | Premier house | Floor/ room | 1st Floor / 1.17 | | |

| Assessment details | | | | Comments | |
|---|---|---|---|---|---|
| Assessment no. | 0061 | Accessibility | Occasionally likely to be disturbed | | |
| Identification | Strongly Presumed (043) | Condition | Low Damage | | |

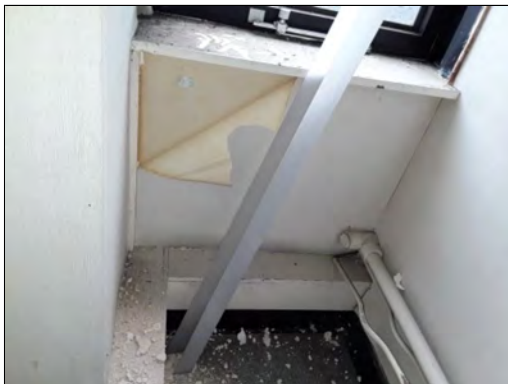
| Assessment details | | | | Comments | Photograph |
|---|---|---|---|---|---|
| Building | Premier house | Floor/ room | 1st Floor / 1.18 | | |

| Assessment details | | | | Comments | Photograph |
|---|---|---|---|---|---|
| Assessment no. | 0062 | Accessibility | Occasionally likely to be disturbed | | |
| Identification | Strongly Presumed (043) | Condition | Low Damage | | |

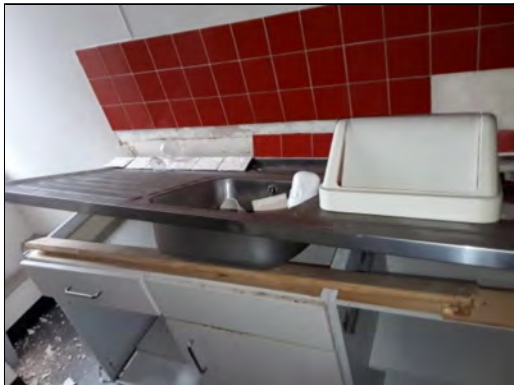
| Assessment details | | | | Comments | |
|---|---|---|---|---|---|
| Building | Premier house | Floor/ room | 1st Floor / 1.18 | | |

| Assessment details | | | | Comments | |
|---|---|---|---|---|---|
| Identification | Identified | Condition | | | |

| Assessment details | | | | Comments | |
|---|---|---|---|---|---|
| Action | No further action required | | | | |

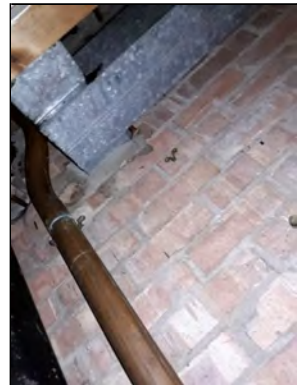
| Assessment details | | | | Comments | Photograph |
|---|---|---|---|---|---|
| Building | Premier house | Floor/ room | 1st Floor / 1.19 | | |

| Assessment details | | | | Comments | Photograph |
|---|---|---|---|---|---|
| Assessment no. | 0064 | Accessibility | Occasionally likely to be disturbed | | |
| Identification | Strongly Presumed (045) | Condition | Low Damage | | |

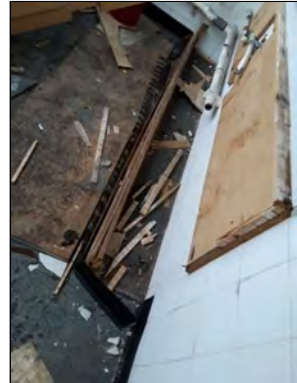
| Assessment details | | | | Comments | Photograph |
|---|---|---|---|---|---|
| Building | Premier house | Floor/ room | 1st Floor / 1.19 | | |

| Assessment details | | | | Comments | Photograph |
|---|---|---|---|---|---|
| Identification | Strongly Presumed (047) | Condition | | | |

| Assessment details | | | | Comments | Photograph |
|---|---|---|---|---|---|
| Action | No further action required | | | | |

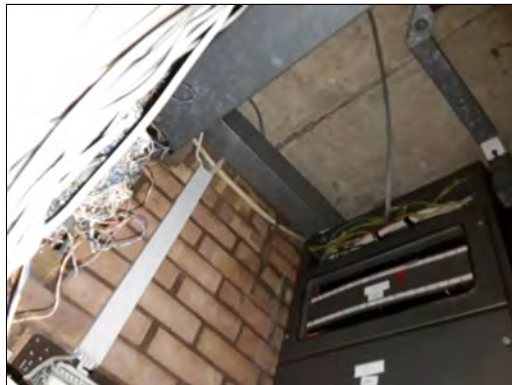
| Assessment details | | | | Comments | Photograph |
|---|---|---|---|---|---|
| Building | Premier house | Floor/ room | 1st Floor / 1.20 | | |

| Assessment details | | | | Comments | Photograph |
|---|---|---|---|---|---|
| Assessment no. | 0066 | Accessibility | Occasionally likely to be disturbed | | |
| Identification | Strongly Presumed (045) | Condition | Low Damage | | |

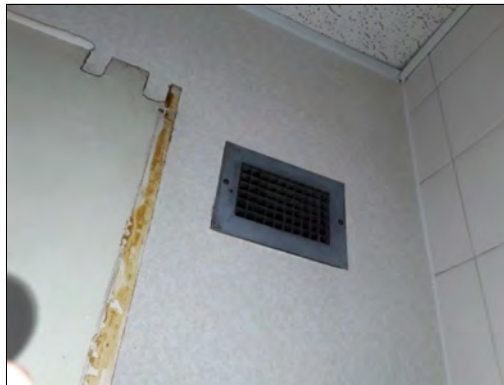
| Assessment details | | | | Comments | Photograph |
|---|---|---|---|---|---|
| Building | Premier house | Floor/ room | 1st Floor / 1.22 | | |

| Assessment details | | | | Comments | Photograph |
|---|---|---|---|---|---|
| Assessment no. | 0067 | Accessibility | Occasionally likely to be disturbed | | |
| Identification | Strongly Presumed (045) | Condition | Low Damage | | |

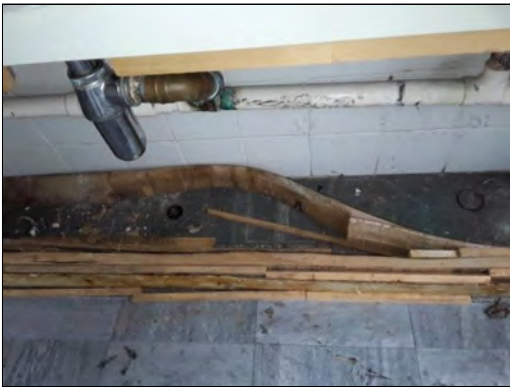
| Assessment details | | | | Comments | <div>Photograph</div> |
|---|---|---|---|---|---|
| Building | Premier house | Floor/ room | 1st Floor / 1.22 | | |

| Assessment details | | | | Comments | <div>Photograph</div> |
|---|---|---|---|---|---|
| Identification | Strongly Presumed (047) | Condition | | | |

| Assessment details | | | | Comments | <div>Photograph</div> |
|---|---|---|---|---|---|
| Action | No further action required | | | | |

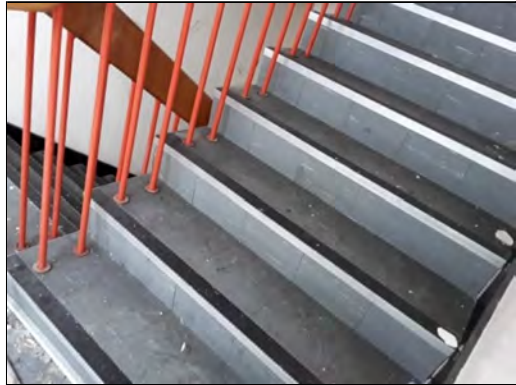
| Assessment details | | | | Comments | |
|---|---|---|---|---|---|
| Building | Premier house | Floor/ room | 1st Floor / 1.23 | | |

| Assessment details | | | | Comments | |
|---|---|---|---|---|---|
| Identification | Identified | Condition | | | |

| Assessment details | | | | Comments | |
|---|---|---|---|---|---|
| Action | No further action required | | | | |

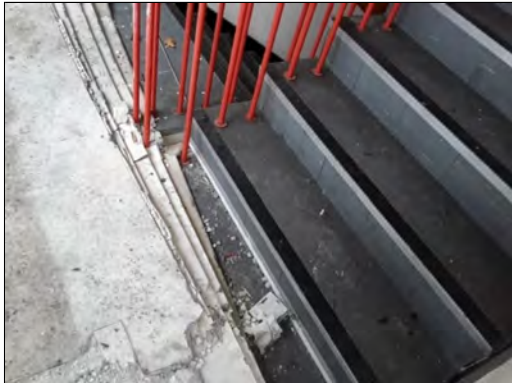
| Assessment details | | | | Comments | |
|---|---|---|---|---|---|
| Building | Premier house | Floor/ room | 1st Floor / 1.23 | | |

| Assessment details | | | | Comments | |
|---|---|---|---|---|---|
| Assessment no. | 0070 | Accessibility | Occasionally likely to be disturbed | | |
| Identification | Strongly Presumed (057) | Condition | Low Damage | | |

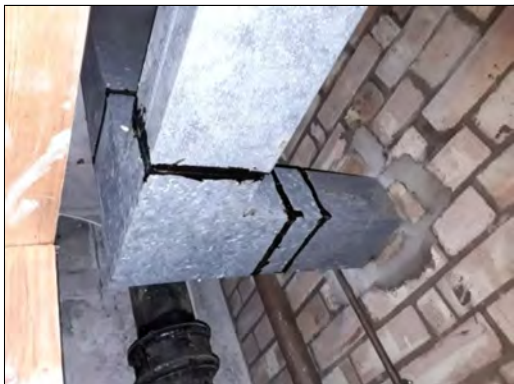
| Assessment details | | | | Comments | Photograph |
|---|---|---|---|---|---|
| Building | Premier house | Floor/ room | 1st Floor / 1.23 | | |

| Assessment details | | | | Comments | Photograph |
|---|---|---|---|---|---|
| Assessment no. | 0071 | Accessibility | Occasionally likely to be disturbed | | |
| Identification | Strongly Presumed (045) | Condition | Low Damage | | |

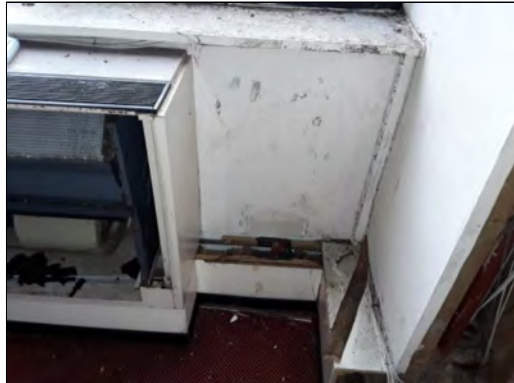
| Assessment details | | | | Comments | Photograph |
|---|---|---|---|---|---|
| Building | Premier house | Floor/ room | 1st Floor / 1.24 | | |

| Assessment details | | | | Comments | Photograph |
|---|---|---|---|---|---|
| Assessment no. | 0072 | Accessibility | Occasionally likely to be disturbed | | |
| Identification | Identified | Condition | Low Damage | | |

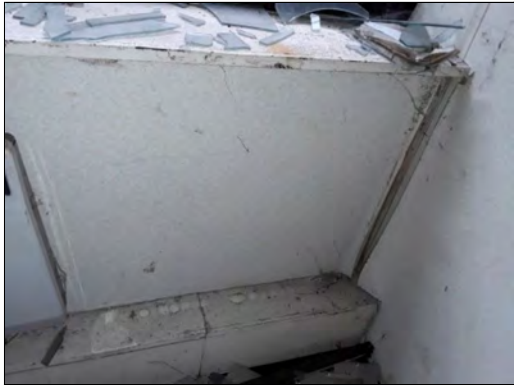
| Assessment details | | | | Comments | Photograph |
|---|---|---|---|---|---|
| Building | Premier house | Floor/ room | 1st Floor / 1.25 | | |

| Assessment details | | | | Comments | Photograph |
|---|---|---|---|---|---|
| Assessment no. | 0073 | Accessibility | Occasionally likely to be disturbed | | |
| Identification | Strongly Presumed (072) | Condition | Low Damage | | |

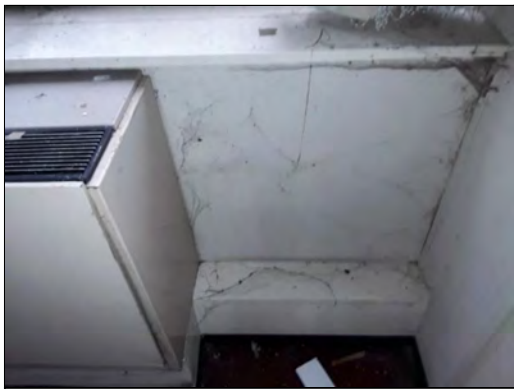
| Assessment details | | | | Comments | Photograph |
|---|---|---|---|---|---|
| Building | Premier house | Floor/ room | 1st Floor / 1.26 | | |

| Assessment details | | | | Comments | Photograph |
|---|---|---|---|---|---|
| Assessment no. | 0074 | Accessibility | Occasionally likely to be disturbed | | |
| Identification | Strongly Presumed (072) | Condition | Low Damage | | |

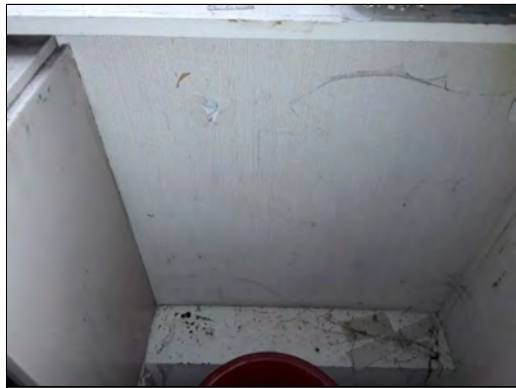
| Assessment details | | | | Comments | Photograph |
|---|---|---|---|---|---|
| Building | Premier house | Floor/ room | 1st Floor / 1.27 | | |

| Assessment details | | | | Comments | Photograph |
|---|---|---|---|---|---|
| Assessment no. | 0075 | Accessibility | Occasionally likely to be disturbed | | |
| Identification | Strongly Presumed (072) | Condition | Low Damage | | |

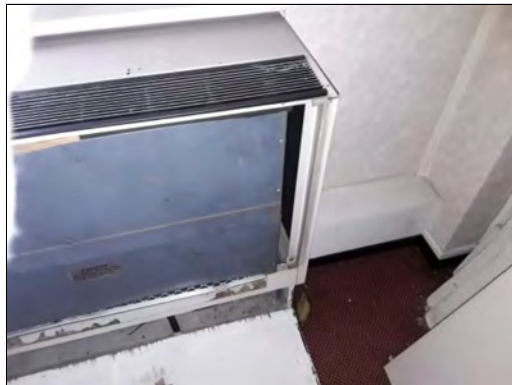
| Assessment details | | | | Comments | Photograph |
|---|---|---|---|---|---|
| Building | Premier house | Floor/ room | 1st Floor / 1.28 | | |

| Assessment details | | | | Comments | Photograph |
|---|---|---|---|---|---|
| Assessment no. | 0076 | Accessibility | Occasionally likely to be disturbed | | |
| Identification | Strongly Presumed (072) | Condition | Low Damage | | |

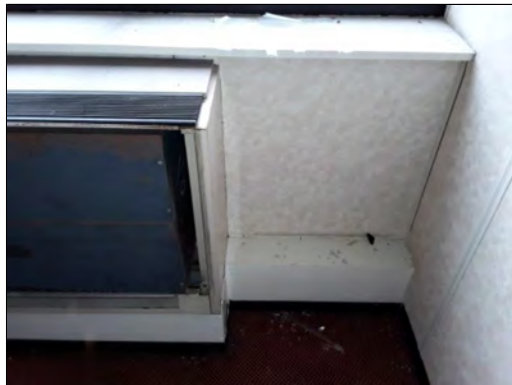
| Assessment details | | | | Comments | Photograph |
|---|---|---|---|---|---|
| Building | Premier house | Floor/ room | 1st Floor / 1.29 | | |

| Assessment details | | | | Comments | Photograph |
|---|---|---|---|---|---|
| Assessment no. | 0077 | Accessibility | Occasionally likely to be disturbed | | |
| Identification | Strongly Presumed (072) | Condition | Low Damage | | |

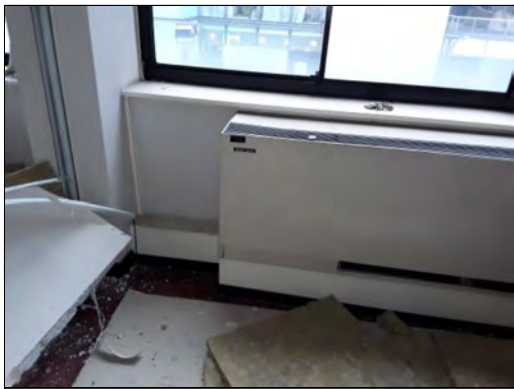
| Assessment details | | | | Comments | |
|---|---|---|---|---|---|
| Building | Premier house | Floor/ room | 1st Floor / 1.30 | | |

| Assessment details | | | | Comments | |
|---|---|---|---|---|---|
| Assessment no. | 0078 | Accessibility | Occasionally likely to be disturbed | | |
| Identification | Strongly Presumed (072) | Condition | Low Damage | | |

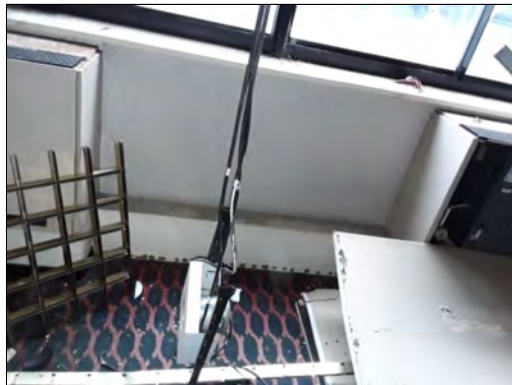
| Assessment details | | | | Comments | Photograph |
|---|---|---|---|---|---|
| Building | Premier house | Floor/ room | 1st Floor / 1.31 | | |

| Assessment details | | | | Comments | Photograph |
|---|---|---|---|---|---|
| Assessment no. | 0079 | Accessibility | Occasionally likely to be disturbed | | |
| Identification | Strongly Presumed (072) | Condition | Low Damage | | |

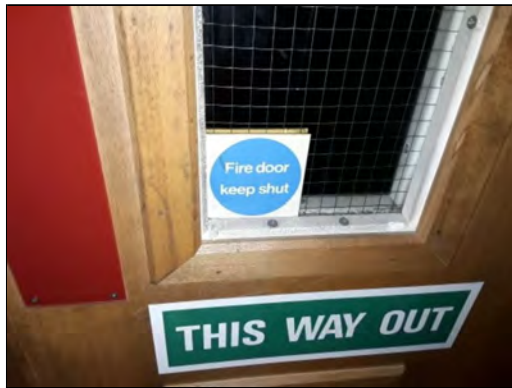
| Assessment details | | | | Comments | Photograph |
|---|---|---|---|---|---|
| Building | Premier house | Floor/ room | 1st Floor / 1.31 | | |

| Assessment details | | | | Comments | Photograph |
|---|---|---|---|---|---|
| Identification | Identified | Condition | | | |

| Assessment details | | | | Comments | Photograph |
|---|---|---|---|---|---|
| Action | No further action required | | | | |

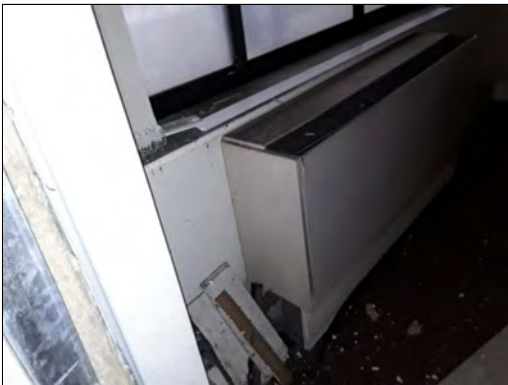
| Assessment details | | | | Comments | Photograph |
|---|---|---|---|---|---|
| Building | Premier house | Floor/ room | 1st Floor / 1.32 | | |

| Assessment details | | | | Comments | Photograph |
|---|---|---|---|---|---|
| Assessment no. | 0081 | Accessibility | Occasionally likely to be disturbed | | |
| Identification | Strongly Presumed (072) | Condition | Medium Damage | | |

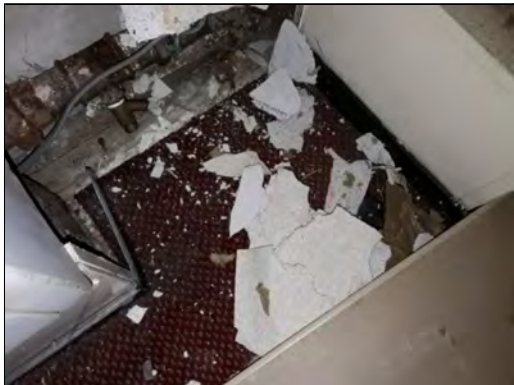
| Assessment details | | | | Comments | <div>Photograph</div> |
|---|---|---|---|---|---|
| Building | Premier house | Floor/ room | 1st Floor / 1.32 | | |

| Assessment details | | | | Comments | <div>Photograph</div> |
|---|---|---|---|---|---|
| Assessment no. | 0082 | Accessibility | Routinely disturbed | | |
| Identification | Identified | Condition | High Damage | | |

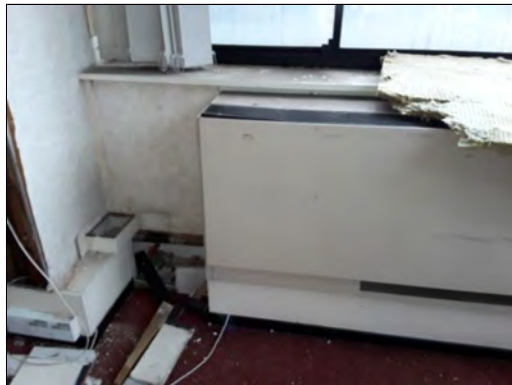
| Assessment details | | | | Comments | Photograph |
|---|---|---|---|---|---|
| Building | Premier house | Floor/ room | 1st Floor / 1.32 | | |

| Assessment details | | | | Comments | Photograph |
|---|---|---|---|---|---|
| Assessment no. | 0083 | Accessibility | Occasionally likely to be disturbed | | |
| Identification | Strongly Presumed (072) | Condition | Low Damage | | |

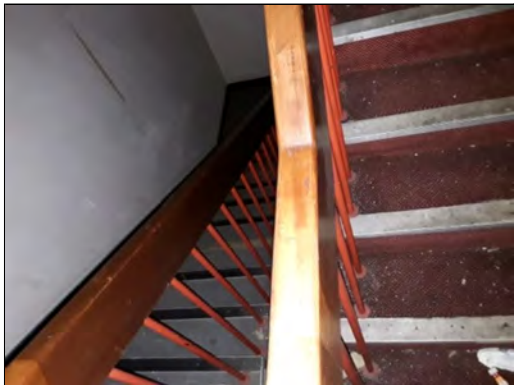
| Assessment details | | | | Comments | Photograph |
|---|---|---|---|---|---|
| Building | Premier house | Floor/ room | 1st Floor / 1.33 | | |

| Assessment details | | | | Comments | Photograph |
|---|---|---|---|---|---|
| Assessment no. | 0084 | Accessibility | | | |
| Identification | Strongly Presumed (056) | Condition | | | |
| Action | No further action required | | | | |

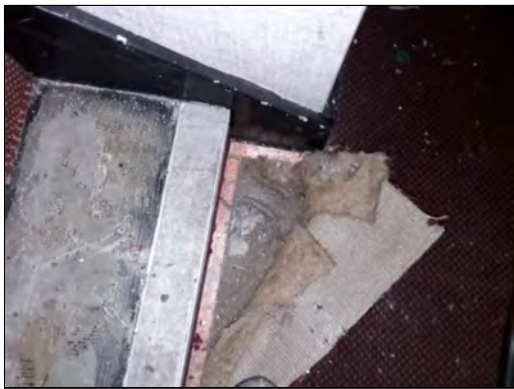
| Assessment details | | | | Comments | Photograph |
|---|---|---|---|---|---|
| Building | Premier house | Floor/ room | 1st Floor / 1.33 | | |

| Assessment details | | | | Comments | Photograph |
|---|---|---|---|---|---|
| Assessment no. | 0085 | Accessibility | Occasionally likely to be disturbed | | |
| Identification | Strongly Presumed (057) | Condition | Low Damage | | |

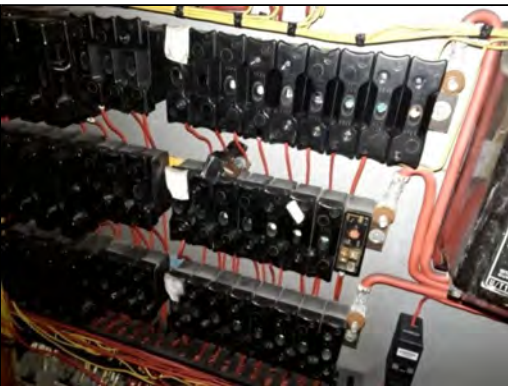
| Assessment details | | | | Comments | |
|---|---|---|---|---|---|
| Building | Premier house | Floor/ room | External / E1 | | |

| Assessment details | | | | Comments | |
|---|---|---|---|---|---|
| Assessment no. | 0086 | Accessibility | | | |
| Identification | Identified | Condition | | | |
| Action | No further action required | | | | |

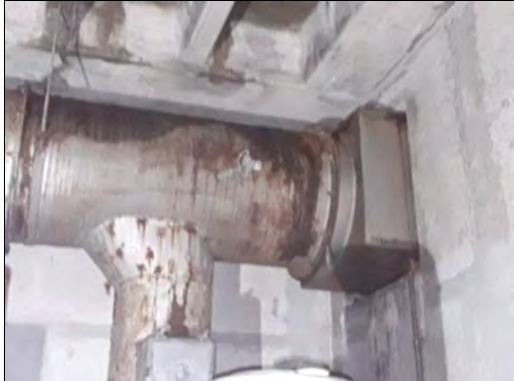
| Assessment details | | | | Comments | |
|---|---|---|---|---|---|
| Building | Premier house | Floor/ room | External / E1 | | |

| Assessment details | | | | Comments | |
|---|---|---|---|---|---|
| Assessment no. | 0087 | Accessibility | Occasionally likely to be disturbed | | |
| Identification | Identified | Condition | Low Damage | | |

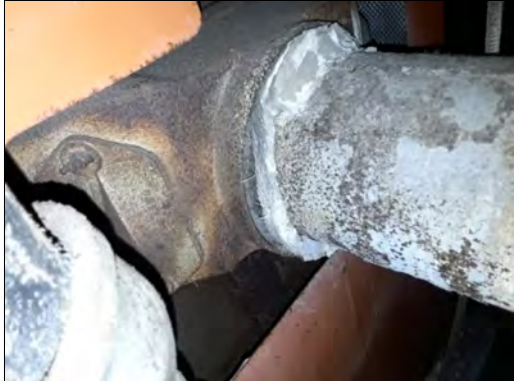
| Assessment details | | | | Comments | |
|---|---|---|---|---|---|
| Building | Premier house | Floor/ room | External / E1 | | |

| Assessment details | | | | Comments | |
|---|---|---|---|---|---|
| Assessment no. | 0088 | Accessibility | Occasionally likely to be disturbed | | |
| Identification | Identified | Condition | Low Damage | | |

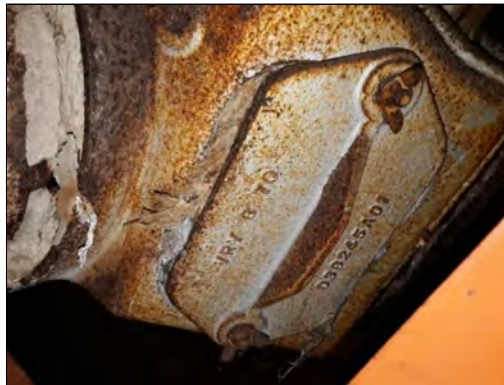
| Assessment details | | | | Comments | <div>Photograph</div> |
|---|---|---|---|---|---|
| Building | Premier house | Floor/ room | External / E1 | | |

| Assessment details | | | | Comments | <div>Photograph</div> |
|---|---|---|---|---|---|
| Assessment no. | 0089 | Accessibility | Occasionally likely to be disturbed | | |
| Identification | Identified | Condition | Low Damage | | |

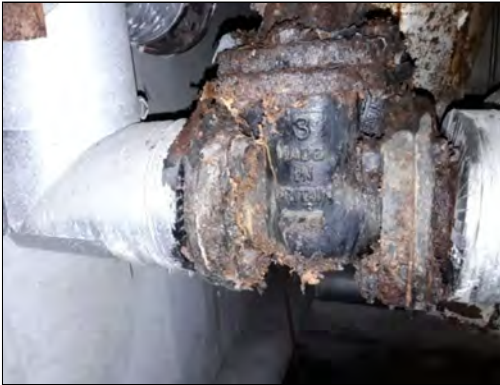
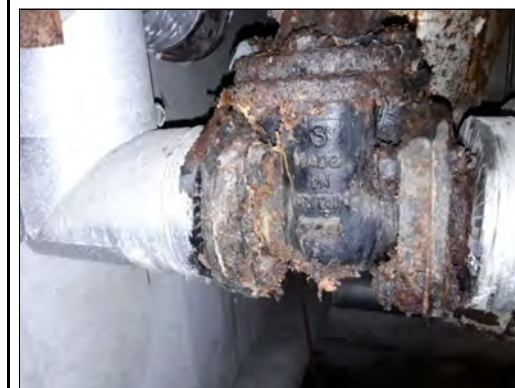
| Assessment details | | | | Comments | <div>Photograph</div> |
|---|---|---|---|---|---|
| Building | Premier house | Floor/ room | External / E1 | | |

| Assessment details | | | | Comments | <div>Photograph</div> |
|---|---|---|---|---|---|
| Assessment no. | 0090 | Accessibility | Occasionally likely to be disturbed | | |
| Identification | Identified | Condition | Low Damage | | |
| Material risk | Low | Material risk score | 5 | | |

| Assessment details | | | | Comments | <div>Photograph</div> |
|---|---|---|---|---|---|
| Action | Remove | | | | |

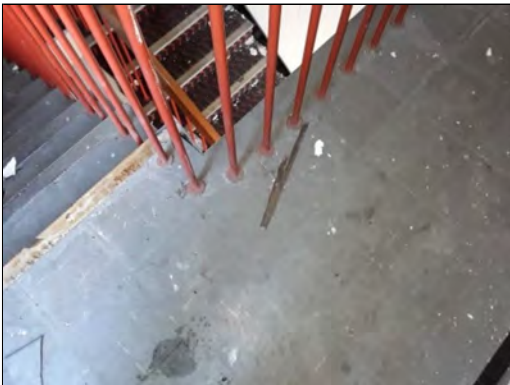
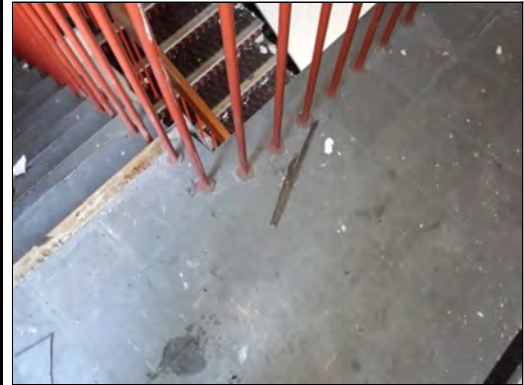
| Assessment details | | | | Comments | <div>Photograph</div> |
|---|---|---|---|---|---|
| Building | Premier house | Floor/ room | External / E5 | | |

| Assessment details | | | | Comments | <div>Photograph</div> |
|---|---|---|---|---|---|
| Assessment no. | 0091 | Accessibility | Occasionally likely to be disturbed | | |
| Identification | Identified | Condition | Low Damage | | |
| Material risk | Very low | Material risk score | 3 | | |

| Assessment details | | | | Comments | <div>Photograph</div> |
|---|---|---|---|---|---|
| Action | Remove | | | | |

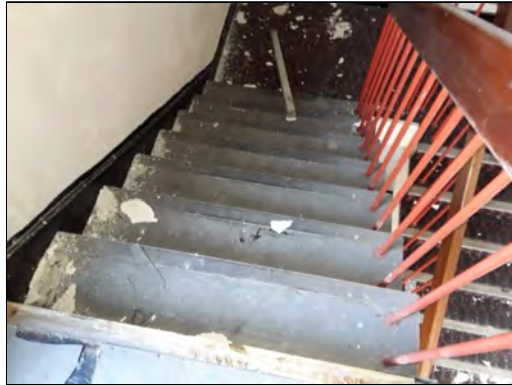
| Assessment details | | | | Comments | |
|---|---|---|---|---|---|
| Building | Premier house | Floor/ room | External / E5 | | |

| Assessment details | | | | Comments | |
|---|---|---|---|---|---|
| Assessment no. | 0092 | Accessibility | | | |
| Identification | Identified | Condition | | | |
| Action | No further action required | | | | |

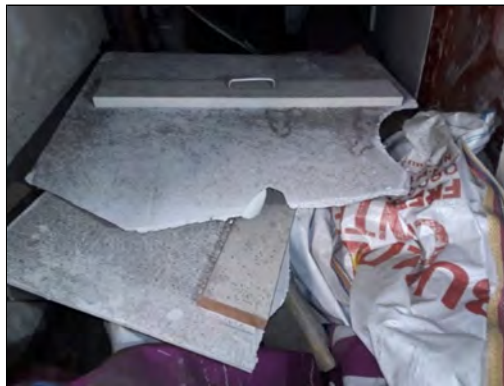
| Assessment details | | | | Comments | <div></div> |
|---|---|---|---|---|---|
| Building | Premier house | Floor/ room | External / E6 | | |

| Assessment details | | | | Comments | <div></div> |
|---|---|---|---|---|---|
| Assessment no. | 0093 | Accessibility | Occasionally likely to be disturbed | | |
| Identification | Identified | Condition | Low Damage | | |

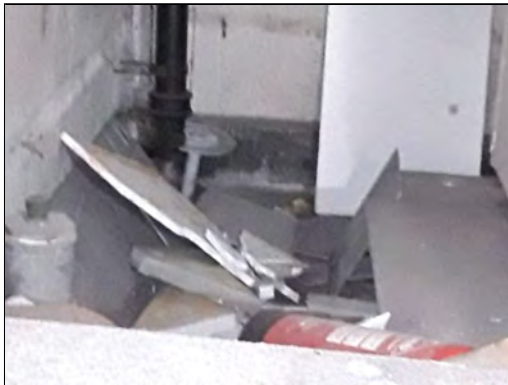
| Assessment details | | | | Comments | Photograph |
|---|---|---|---|---|---|
| Building | Premier house | Floor/ room | External / E6 | | |

| Assessment details | | | | Comments | Photograph |
|---|---|---|---|---|---|
| Assessment no. | 0094 | Accessibility | | | |
| Identification | Identified | Condition | | | |
| Action | No further action required | | | | |

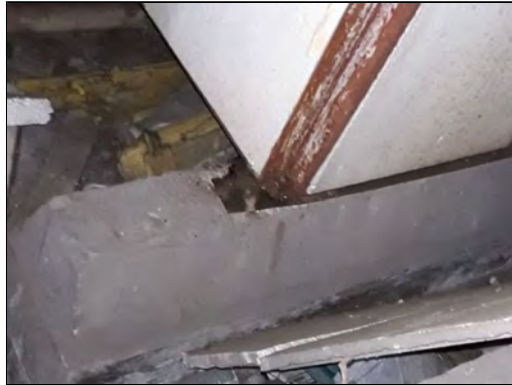
| Assessment details | | | | Comments | |
|---|---|---|---|---|---|
| Building | Premier house | Floor/ room | External / E6 | | |

| Assessment details | | | | Comments | |
|---|---|---|---|---|---|
| Assessment no. | 0095 | Accessibility | | | |
| Identification | Identified | Condition | | | |
| Action | No further action required | | | | |

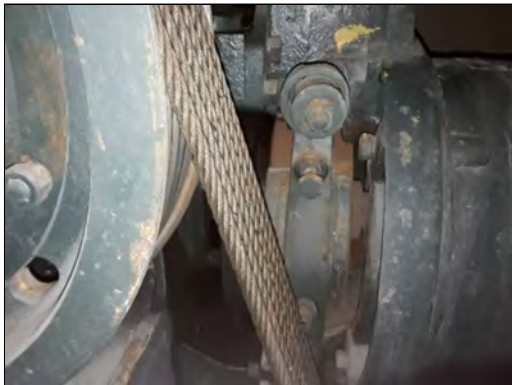
| Assessment details | | | | Comments | |
|---|---|---|---|---|---|
| Building | Premier house | Floor/ room | External / E7 | | |

| Assessment details | | | | Comments | |
|---|---|---|---|---|---|
| Assessment no. | 0096 | Accessibility | Occasionally likely to be disturbed | | |
| Identification | Identified | Condition | Low Damage | | |

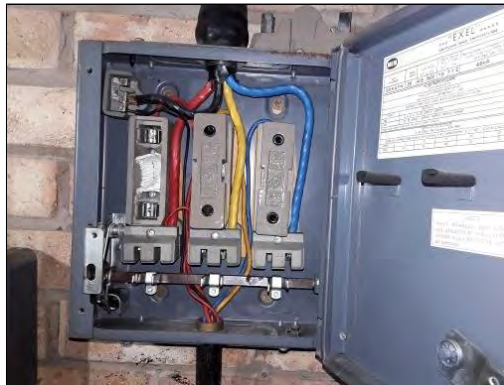
| Assessment details | | | | Comments | |
|---|---|---|---|---|---|
| Building | Premier house | Floor/ room | External / E7 | | |

| Assessment details | | | | Comments | |
|---|---|---|---|---|---|
| Assessment no. | 0097 | Accessibility | Occasionally likely to be disturbed | | |
| Identification | Identified | Condition | Low Damage | | |

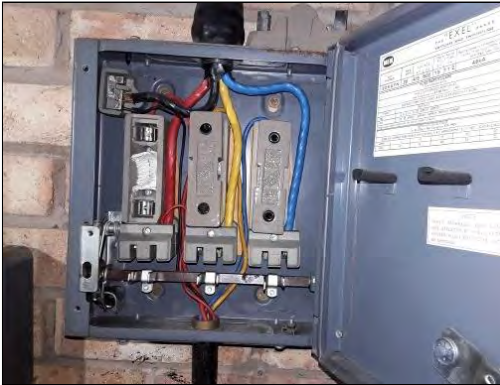
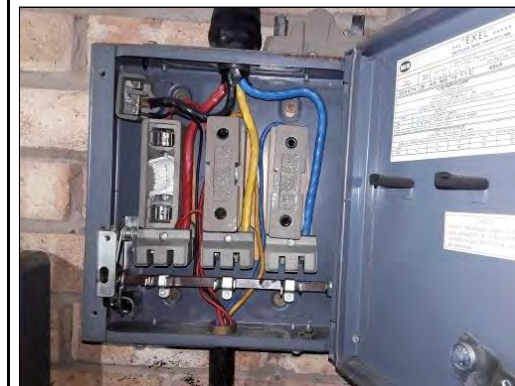
| Assessment details | | | | Comments | |
|---|---|---|---|---|---|
| Building | Premier house | Floor/ room | External / E7 | | |

| Assessment details | | | | Comments | |
|---|---|---|---|---|---|
| Assessment no. | 0098 | Accessibility | Occasionally likely to be disturbed | | |
| Identification | Identified | Condition | Low Damage | | |
| Material risk | Very low | Material risk score | 4 | | |

| Assessment details | | | | Comments | |
|---|---|---|---|---|---|
| Action | Remove | | | | |

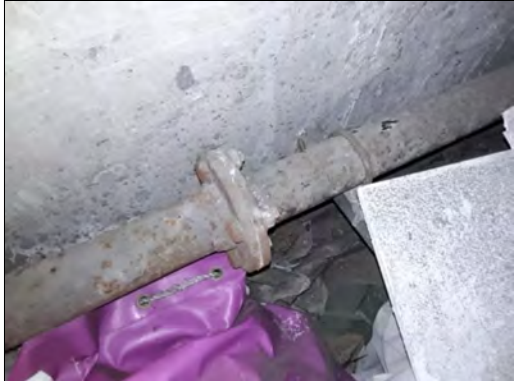
| Assessment details | | | | Comments | Photograph |
|---|---|---|---|---|---|
| Building | Premier house | Floor/ room | External / E6 | | |

| Assessment details | | | | Comments | Photograph |
|---|---|---|---|---|---|
| Assessment no. | 0099 | Accessibility | Occasionally likely to be disturbed | | |
| Identification | Identified | Condition | Low Damage | | |

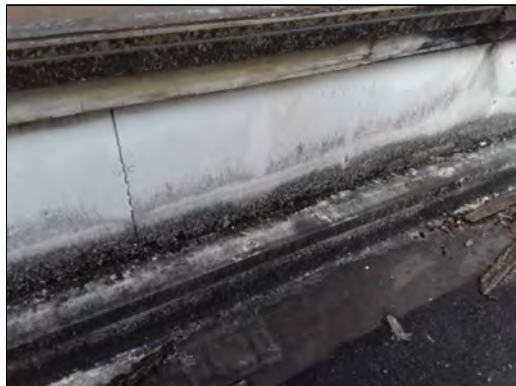
| Assessment details | | | | Comments | |
|---|---|---|---|---|---|
| Building | Premier house | Floor/ room | External / E8 | | |

| Assessment details | | | | Comments | |
|---|---|---|---|---|---|
| Assessment no. | 0100 | Accessibility | | | |
| Identification | Identified | Condition | | | |
| Action | No further action required | | | | |

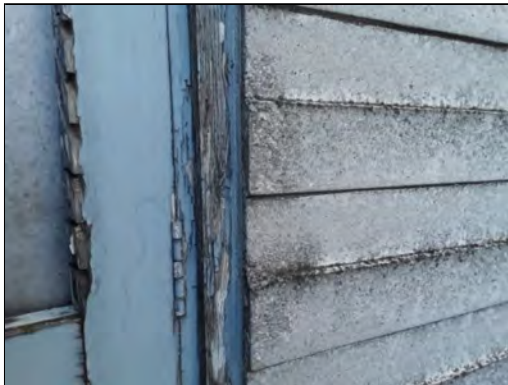
| Assessment details | | | | Comments | <div>Photograph</div> |
|---|---|---|---|---|---|
| Building | Premier house | Floor/ room | External / E8 | | |

| Assessment details | | | | Comments | <div>Photograph</div> |
|---|---|---|---|---|---|
| Assessment no. | 0101 | Accessibility | | | |
| Identification | Identified | Condition | | | |
| Action | No further action required | | | | |

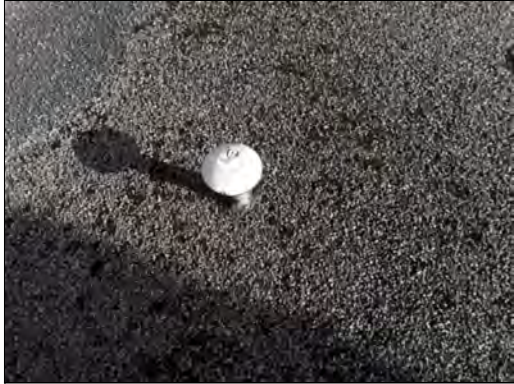
| Assessment details | | | | Comments | <div>Photograph</div> |
|---|---|---|---|---|---|
| Building | Premier house | Floor/ room | External / E8 | | |

| Assessment details | | | | Comments | <div>Photograph</div> |
|---|---|---|---|---|---|
| Assessment no. | 0102 | Accessibility | Occasionally likely to be disturbed | | |
| Identification | Identified | Condition | Low Damage | | |

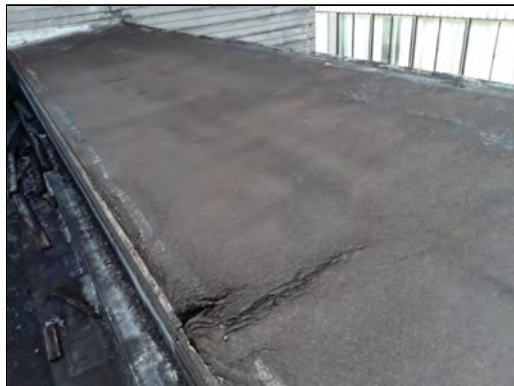
| Assessment details | | | | Comments | <div>Photograph</div> |
|---|---|---|---|---|---|
| Building | Premier house | Floor/ room | External / E8 | | |

| Assessment details | | | | Comments | <div>Photograph</div> |
|---|---|---|---|---|---|
| Assessment no. | 0103 | Accessibility | | | |
| Identification | Identified | Condition | | | |
| Action | No further action required | | | | |

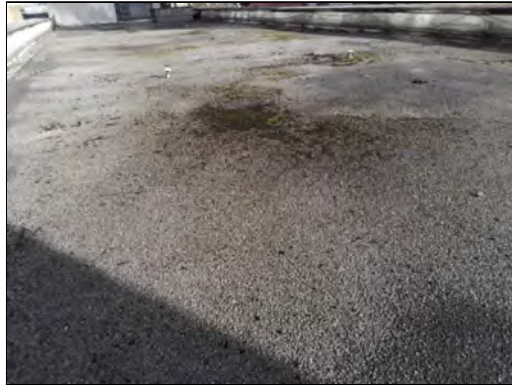
| Assessment details | | | | Comments | <div>Photograph</div> |
|---|---|---|---|---|---|
| Building | Premier house | Floor/ room | External / E8 | | |

| Assessment details | | | | Comments | <div>Photograph</div> |
|---|---|---|---|---|---|
| Assessment no. | 0104 | Accessibility | | | |
| Identification | Identified | Condition | | | |
| Action | No further action required | | | | |

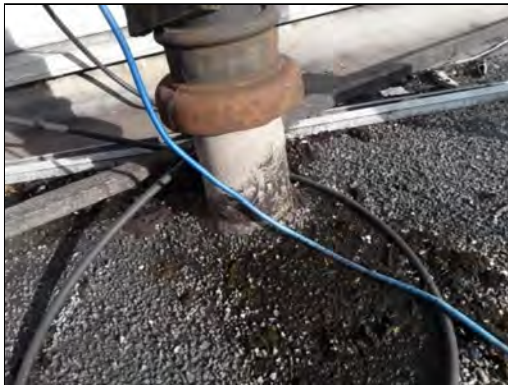
| Assessment details | | | | Comments | |
|---|---|---|---|---|---|
| Building | Premier house | Floor/ room | External / E8 | | |

| Assessment details | | | | Comments | |
|---|---|---|---|---|---|
| Assessment no. | 0105 | Accessibility | | | |
| Identification | Identified | Condition | | | |
| Action | No further action required | | | | |

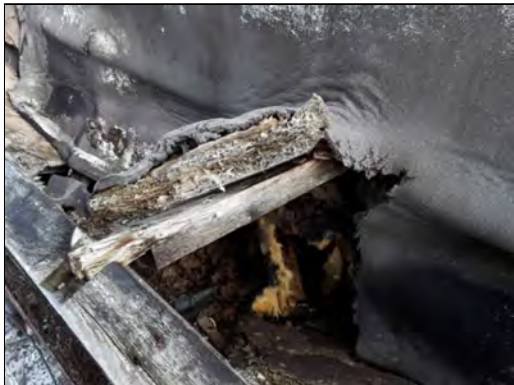
| Assessment details | | | | Comments | <div>Photograph</div> |
|---|---|---|---|---|---|
| Building | Premier house | Floor/ room | External / E8 | | |

| Assessment details | | | | Comments | <div>Photograph</div> |
|---|---|---|---|---|---|
| Assessment no. | 0106 | Accessibility | | | |
| Identification | Identified | Condition | | | |
| Action | No further action required | | | | |

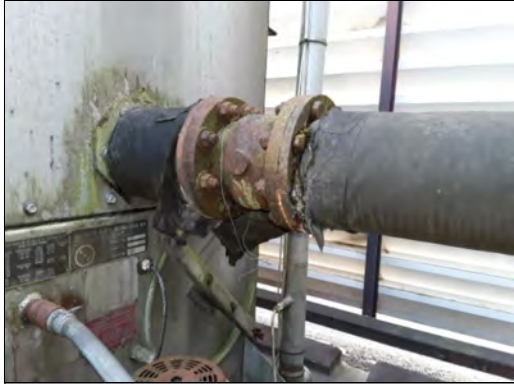
| Assessment details | | | | Comments | <div>Photograph</div> |
|---|---|---|---|---|---|
| Building | Premier house | Floor/ room | External / E8 | | |

| Assessment details | | | | Comments | <div>Photograph</div> |
|---|---|---|---|---|---|
| Assessment no. | 0107 | Accessibility | Occasionally likely to be disturbed | | |
| Identification | Identified | Condition | Low Damage | | |

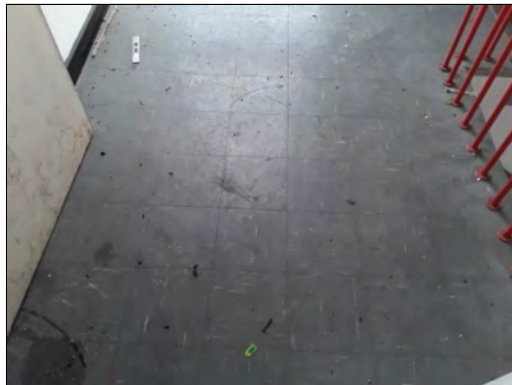
| Assessment details | | | | Comments | Photograph |
|---|---|---|---|---|---|
| Building | Premier house | Floor/ room | External / Stairs 1 | continue down to entrance to hotel | |

| Assessment details | | | | Comments | Photograph |
|---|---|---|---|---|---|
| Assessment no. | 0109 | Accessibility | Occasionally likely to be disturbed | | |
| Identification | Strongly Presumed (091) | Condition | Low Damage | | |

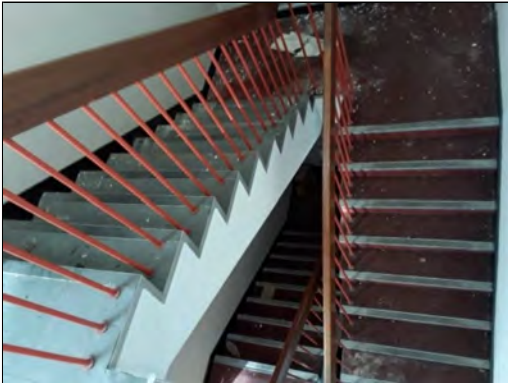
| Assessment details | | | | Comments | Photograph |
|---|---|---|---|---|---|
| Building | Premier house | Floor/ room | External / Stairs 1 | continue down to entrance to hotel | |

| Assessment details | | | | Comments | Photograph |
|---|---|---|---|---|---|
| Assessment no. | 0110 | Accessibility | | | |
| Identification | Strongly Presumed (092) | Condition | | | |
| Action | No further action required | | | | |

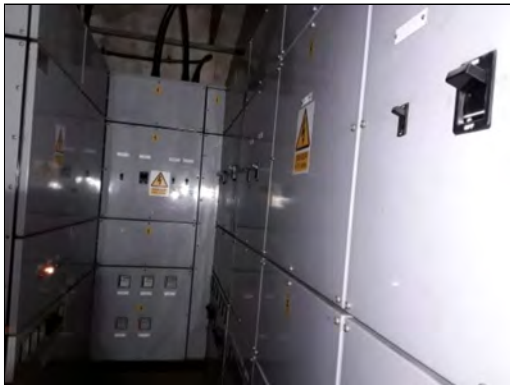
| Assessment details | | | | Comments | Photograph |
|---|---|---|---|---|---|
| Building | Premier house | Floor/ room | Ground Floor / Electric room | live electric equipment | |

| Assessment details | | | | Comments | Photograph |
|---|---|---|---|---|---|
| Assessment no. | 0111 | Accessibility | | | |
| Identification | Inaccessible (Presumed) | Condition | n/a | | |
