## REFURBISHMENT SURVEY FOR ASBESTOS-CONTAINING MATERIALS

**CLIENT:** Property Alliance Group Ltd

**SITE:** Premier House, 22 Deansgate, Manchester, M3 1PH

**TYPE OF SURVEY:** Refurbishment

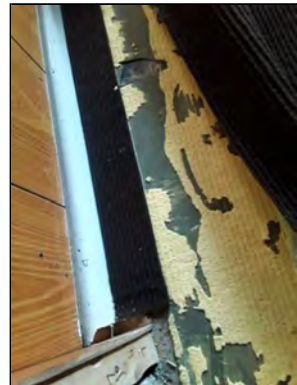
| Assessment details | | | | Comments | Photograph |
|---|---|---|---|---|---|
| Assessment no. | 0007 | Accessibility | Occasionally likely to be disturbed | | |

| Building | Floor/<br>Room | Assessment<br>Number | Location/<br>position | Product<br>type | Surface<br>treatment | Condition | Extent | Accessibility | Level of<br>identification | Asbestos<br>type | Material<br>risk | Priority<br>risk | Action |
|---|---|---|---|---|---|---|---|---|---|---|---|---|---|
| 22<br>Deansgate | 2nd Floor /<br>S5 | 0007 | Floor tiles and<br>bitumen to floor | Vinyl Floor<br>Tiles | Completely<br>Sealed | Low<br>Damage | 38m <sup>2</sup> | Occasionally<br>likely to be<br>disturbed | Identified | Chrysotile | ( 3 )<br>Very low | - | Remove |

| Assessment details | | | | Comments | Photograph |
|---|---|---|---|---|---|
| Building | 22 Deansgate | Floor/ room | 2nd Floor / S5 | | |

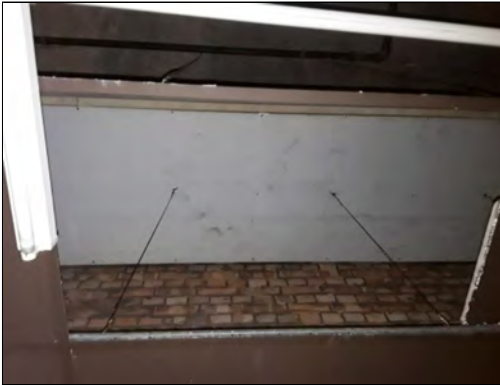
| Assessment details | | | | Comments | |
|---|---|---|---|---|---|
| Assessment no. | 0008 | Accessibility | Occasionally likely to be disturbed | | |

| Assessment details | | | | Comments | |
|---|---|---|---|---|---|
| Building | 22 Deansgate | Floor/ room | 2nd Floor / S5 | | |
| Product type | Board | | | | |
| Material risk | Medium | Material risk score | 7 | | |

| Assessment details | | | | Comments | |
|---|---|---|---|---|---|
| Action | Remove | | | | |

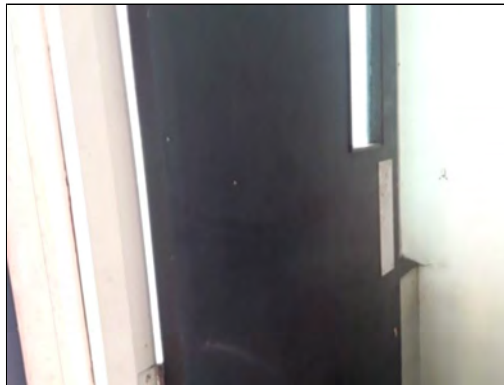
| Assessment details | | | | Comments | Photograph |
|---|---|---|---|---|---|
| Assessment no. | 0009 | Accessibility | Occasionally likely to be disturbed | | |

| Building | Floor/<br>Room | Assessment<br>Number | Location/<br>position | Product<br>type | Surface<br>treatment | Condition | Extent | Accessibility | Level of<br>identification | Asbestos<br>type | Material<br>risk | Priority<br>risk | Action |
|---|---|---|---|---|---|---|---|---|---|---|---|---|---|
| 22<br>Deansgate | 2nd Floor /<br>S5 | 0009 | Board lining to fire<br>door | Board | Surface<br>Sealed | Low<br>Damage | 2m <sup>2</sup> | Occasionally<br>likely to be<br>disturbed | Identified | Chrysotile | ( 5 ) Low | - | Remove |

| Assessment details | | | | Comments | Photograph |
|---|---|---|---|---|---|
| Building | 22 Deansgate | Floor/ room | 2nd Floor / S5 | | |

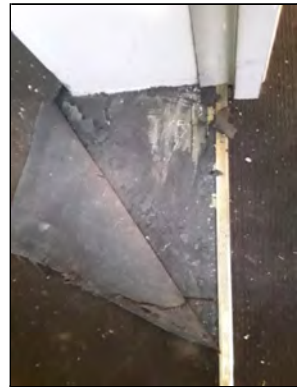
| Assessment details | | | | Comments | Photograph |
|---|---|---|---|---|---|
| Assessment no. | 0010 | Accessibility | Occasionally likely to be disturbed | | |

| Building | Floor/<br>Room | Assessment<br>Number | Location/<br>position | Product<br>type | Surface<br>treatment | Condition | Extent | Accessibility | Level of<br>identification | Asbestos<br>type | Material<br>risk | Priority<br>risk | Action |
|---|---|---|---|---|---|---|---|---|---|---|---|---|---|
| 22<br>Deansgate | 2nd Floor /<br>S6 | 0010 | Floor tiles and<br>bitumen to floor | Vinyl Floor<br>Tiles | Completely<br>Sealed | Low<br>Damage | 9m <sup>2</sup> | Occasionally<br>likely to be<br>disturbed | Strongly<br>Presumed (007) | Chrysotile | ( 3 )<br>Very low | - | Remove |

| Assessment details | | | | Comments | Photograph |
|---|---|---|---|---|---|
| Building | 22 Deansgate | Floor/ room | 2nd Floor / S6 | continue downstairs | |

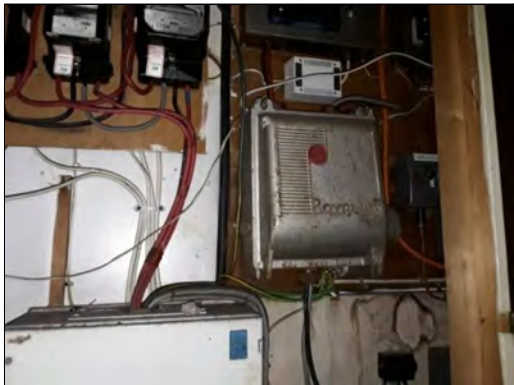
| Assessment details | | | | Comments | Photograph |
|---|---|---|---|---|---|
| Assessment no. | 0027 | Accessibility | | | |

| Assessment details | | | | Comments | Photograph |
|---|---|---|---|---|---|
| Building | 22 Deansgate | Floor/ room | Ground Floor / G7 | No access to electrics - live services | |

| Assessment details | | | | Comments | Photograph |
|---|---|---|---|---|---|
| Action | Inspect Prior to Disturbance | | | | |

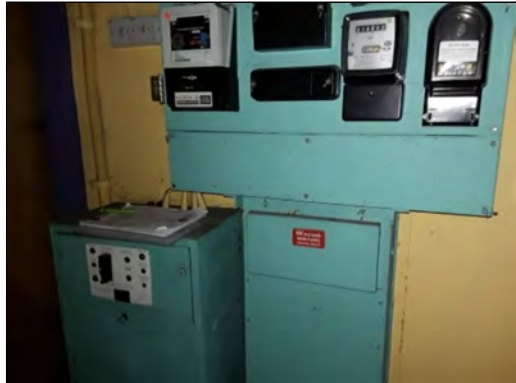
| Assessment details | | | | Comments | Photograph |
|---|---|---|---|---|---|
| Assessment no. | 0031 | Accessibility | | | |

| Assessment details | | | | Comments | Photograph |
|---|---|---|---|---|---|
| Building | 22 Deansgate | Floor/ room | Ground Floor / G11 | No access to electrics - live services | |

| Assessment details | | | | Comments | Photograph |
|---|---|---|---|---|---|
| Action | Inspect Prior to Disturbance | | | | |

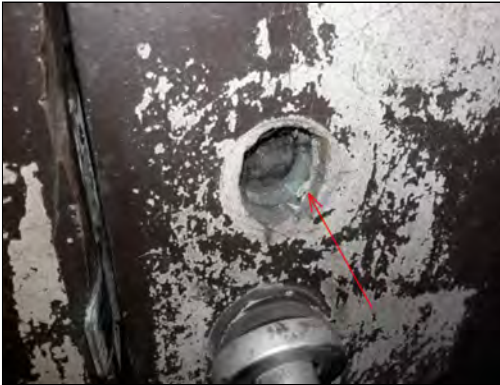
| Assessment details | | | | Comments | <div>Photograph</div> |
|---|---|---|---|---|---|
| Assessment no. | 0039 | Accessibility | Occasionally likely to be disturbed | | |

| Assessment details | | | | Comments | <div>Photograph</div> |
|---|---|---|---|---|---|
| Building | 22 Deansgate | Floor/ room | Ground Floor / G14 | | |
| Material risk | Low | Material risk score | 6 | | |

| Assessment details | | | | Comments | <div>Photograph</div> |
|---|---|---|---|---|---|
| Action | Remove | | | | |

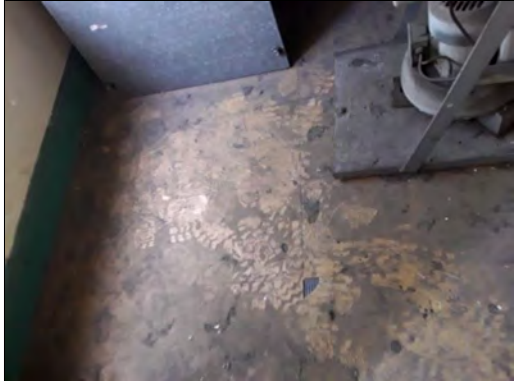
| Assessment details | | | | Comments | Photograph |
|---|---|---|---|---|---|
| Assessment no. | 0041 | Accessibility | Occasionally likely to be disturbed | | |

| Building | Floor/<br>Room | Assessment<br>Number | Location/<br>position | Product<br>type | Surface<br>treatment | Condition | Extent | Accessibility | Level of<br>identification | Asbestos<br>type | Material<br>risk | Priority<br>risk | Action |
|---|---|---|---|---|---|---|---|---|---|---|---|---|---|
| 22<br>Deansgate | 2nd Floor /<br>S10 | 0041 | Floor tiles and<br>bitumen to floor | Vinyl Floor<br>Tiles | Completely<br>Sealed | Low<br>Damage | 6m <sup>2</sup> | Occasionally<br>likely to be<br>disturbed | Identified | Chrysotile | ( 3 )<br>Very low | - | Remove |

| Assessment details | | | | Comments | Photograph |
|---|---|---|---|---|---|
| Building | 22 Deansgate | Floor/ room | 2nd Floor / S10 | | |

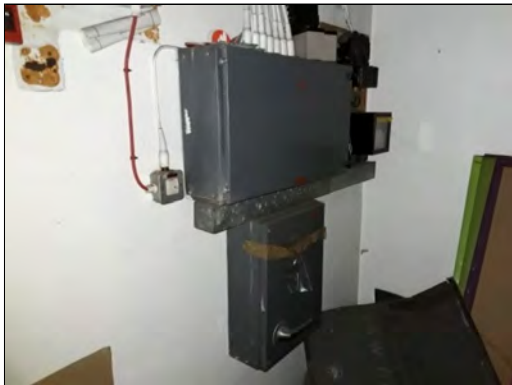
| Assessment details | | | | Comments | Photograph |
|---|---|---|---|---|---|
| Building | 22 Deansgate | Floor/ room | Ground Floor / G17 | No access to electrics - live services | |
| Identification | Inaccessible (Presumed) | Condition | n/a | | |

| Assessment details | | | | Comments | Photograph |
|---|---|---|---|---|---|
| Action | Inspect Prior to Disturbance | | | | |

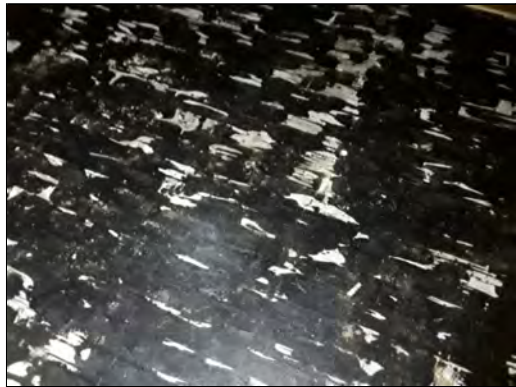
| Assessment details | | | | Comments | |
|---|---|---|---|---|---|
| Building | 22 Deansgate | Floor/ room | 2nd Floor / S15 | | |
| Identification | Identified | Condition | | | |

| Assessment details | | | | Comments | |
|---|---|---|---|---|---|
| Action | No further action required | | | | |

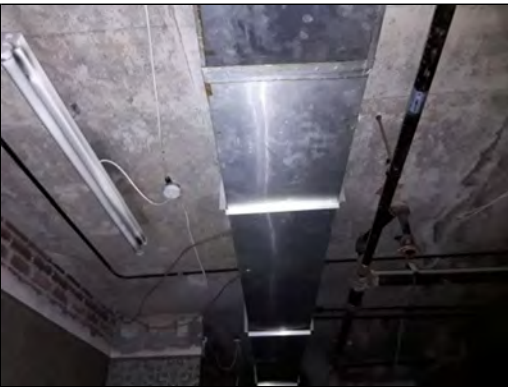
| Assessment details | | | | Comments | |
|---|---|---|---|---|---|
| Building | 22 Deansgate | Floor/ room | 1st Floor / F6 | | |
| Identification | Strongly Presumed (016) | Condition | | | |

| Assessment details | | | | Comments | |
|---|---|---|---|---|---|
| Action | No further action required | | | | |

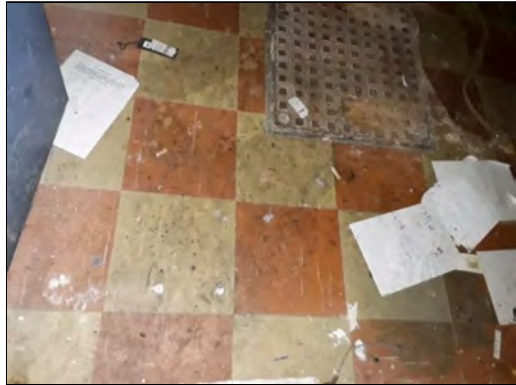
| Assessment details | | | | Comments | |
|---|---|---|---|---|---|
| Building | 22 Deansgate | Floor/ room | Ground Floor / G18 | | |
| Identification | Identified | Condition | | | |

| Assessment details | | | | Comments | |
|---|---|---|---|---|---|
| Action | No further action required | | | | |

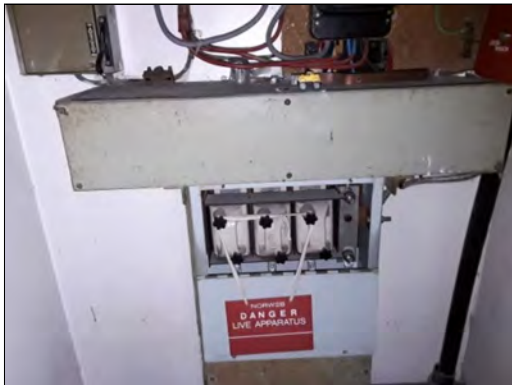
| Assessment details | | | | Comments | Photograph |
|---|---|---|---|---|---|
| Building | 22 Deansgate | Floor/ room | Ground Floor / G20 | No access to electrics - live services | |
| Identification | Inaccessible (Presumed) | Condition | n/a | | |

| Assessment details | | | | Comments | Photograph |
|---|---|---|---|---|---|
| Action | Inspect Prior to Disturbance | | | | |

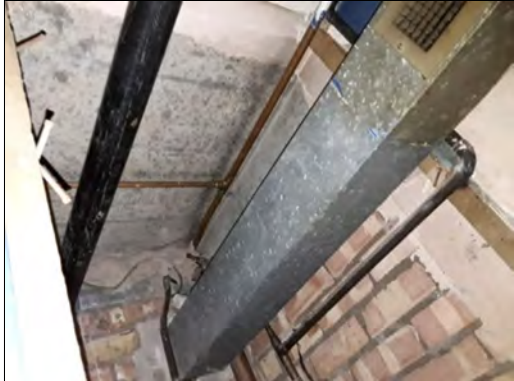
| Assessment details | | | | Comments | <div>Photograph</div> |
|---|---|---|---|---|---|
| Building | 22 Deansgate | Floor/ room | Ground Floor / G20 | | |
| Identification | Strongly Presumed (020) | Condition | | | |

| Assessment details | | | | Comments | <div>Photograph</div> |
|---|---|---|---|---|---|
| Action | No further action required | | | | |

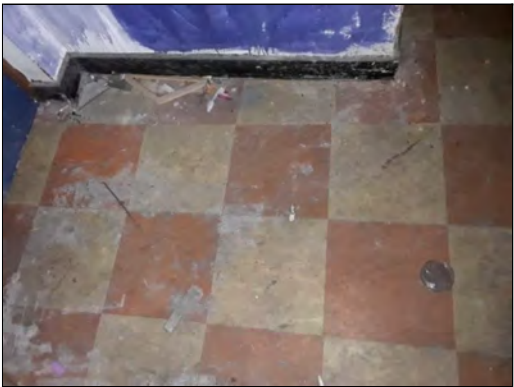
| Assessment details | | | | Comments | <div></div> |
|---|---|---|---|---|---|
| Building | 22 Deansgate | Floor/ room | Ground Floor / G20 | | |
| Identification | Strongly Presumed (054) | Condition | | | |

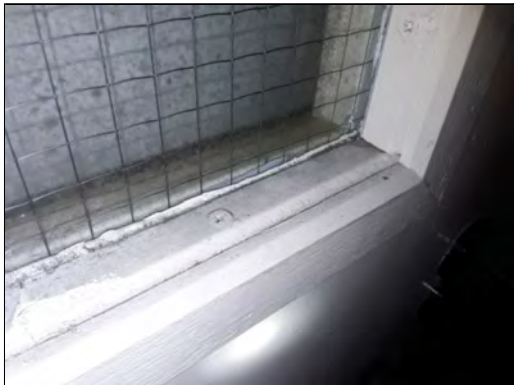
| Assessment details | | | | Comments | |
|---|---|---|---|---|---|
| Building | 22 Deansgate | Floor/ room | Ground Floor / G23 | | |
| Identification | Identified | Condition | | | |

| Assessment details | | | | Comments | |
|---|---|---|---|---|---|
| Action | No further action required | | | | |

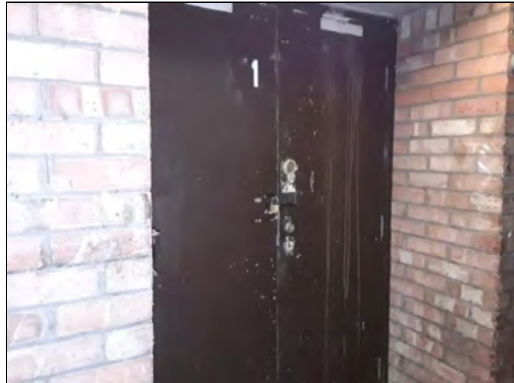
| Assessment details | | | | Comments | Photograph |
|---|---|---|---|---|---|
| Building | 22 Deansgate | Floor/ room | Ground Floor / G24 unit 1 | No access - locked, no key available at time of survey | |
| Identification | Inaccessible (Presumed) | Condition | n/a | | |

| Assessment details | | | | Comments | Photograph |
|---|---|---|---|---|---|
| Action | Inspect Prior to Disturbance | | | | |
