## Museum of Science & Industry Fire Compartmentation Survey Report

## **Fire Stopping Report**

### **Neo Property Solutions**

## Ancillary Buildings - Goods Office, VE Block, Toilet Block, Workshop, Stores and Photographic Studio

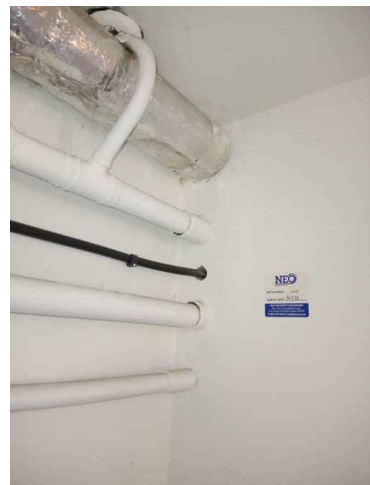
**Pin Number:** 0001:38

| Location - Room: | VE staircase |
| X3 pipes | |
| X 1 lagged pipe | |
| X 1 cable | |
| Breach identified: | Pipe x 3, Cable, Insulated metal pipes |
| Fire rating: | 30 minutes (not suitable if basement or > 5m to top floor above ground) |
| Priority: | Red |

| Pull lagging back to seal top copper pipe. | |
| Installation type: | SD-128-RDW |
| Once back sealed | |

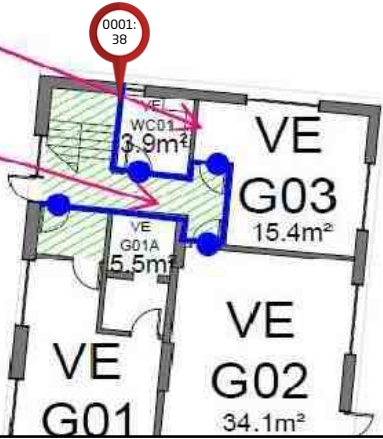
**Pin Number:** 0002:38

| Location - Room: | VE block staircase |
| X6 pipes | |
| X1 cable | |
| Breach identified: | Pipe x 6, Cable |
| Priority: | Red |

| Installation type: | SD-128-RDW |

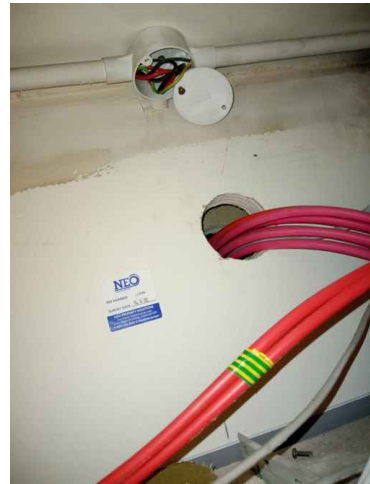
Survey  
1 of 1

**Pin Number:** 0003:38

| Survey | |
|---|---|
| Location - Room: | VE block entrance lobby |
| Void with cables | |
| Breach identified: | Cable, Hole |
| Priority: | Red |

| Survey | |
|---|---|
| Installation type: | SD-113-RDW |

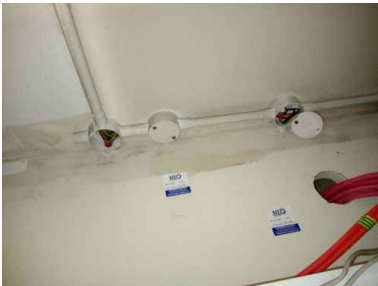
| Pin Number: | 0004:38 | Date Added: | 14/02/2022 - 12:32 |

| Once correct annular gap acheived. | |

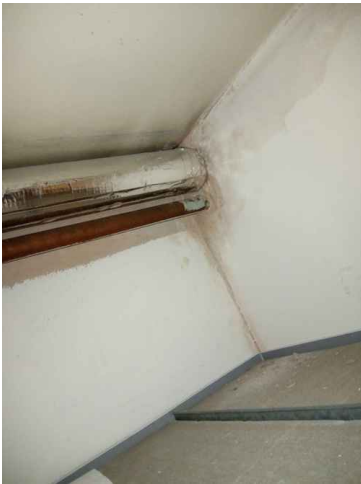
Survey  
2 of 2

**Pin Number:** 0005:38  
**Company:** Neo Property Solutions  
**Contractor:** Matthew Brown - 38

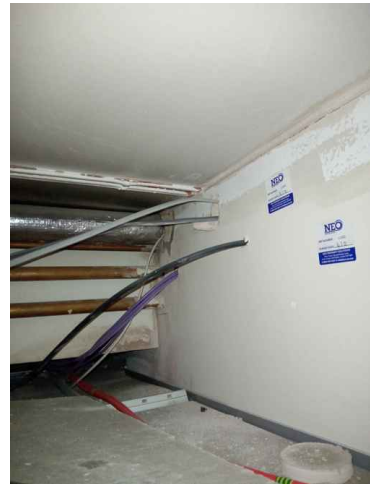
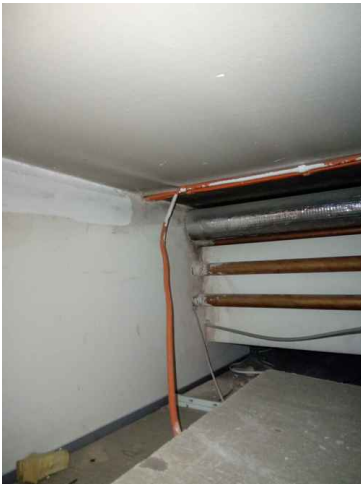
**Pin Number:** 0006:38  
**Company:** Neo Property Solutions  
**Contractor:** Tony Narkevicius - 30

| Survey | |
|---|---|
| Once back sealed | |

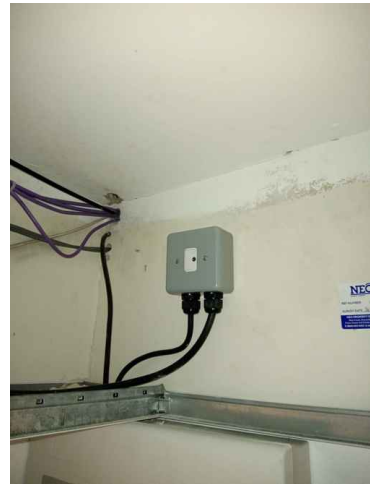
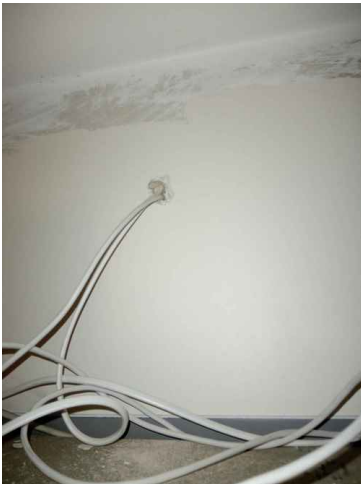
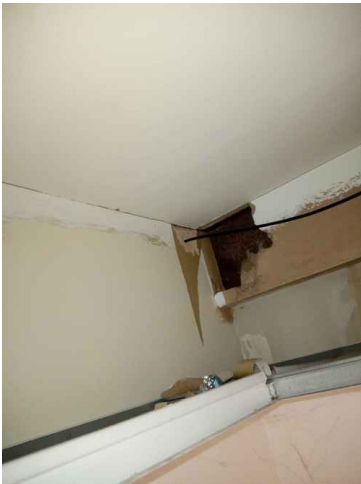
**Pin Number:** 0008:38

| Survey | |
|---|---|
| Once back sealed | |

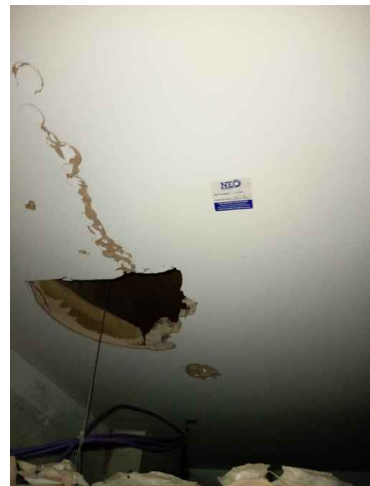
**Pin Number:** 0009:38

| Survey | |
|---|---|
| Detail only covers Vertical installation | |

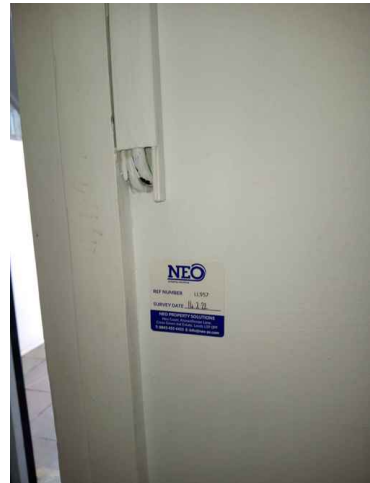
Survey  
1 of 1

**Pin Number:** 0011:38  
**Company:** Neo Property Solutions  
**Contractor:** Tony Narkevicius - 30

| Survey | |
|---|---|
| Once back sealed | |

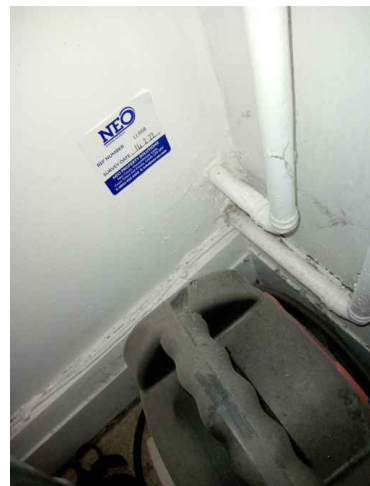
Survey  
1 of 1

**Pin Number:** 0012:38  
**Company:** Neo Property Solutions  
**Contractor:** Tony Narkevicius - 30

| Survey | |
|---|---|
| Once back sealed | |

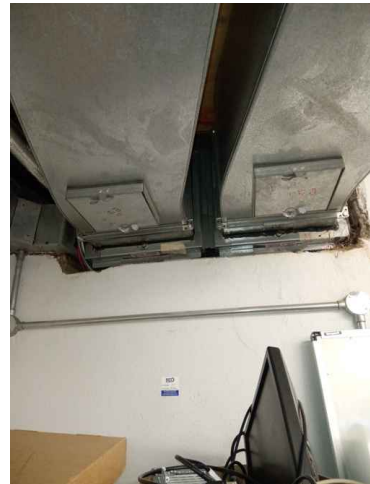
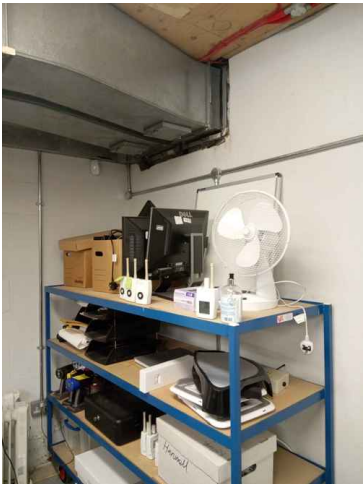
**Pin Number:** 0014:38  
**Company:** Neo Property Solutions  
**Contractor:** Matthew Brown - 38

| Survey | |
|---|---|
| Cannot back seal | |

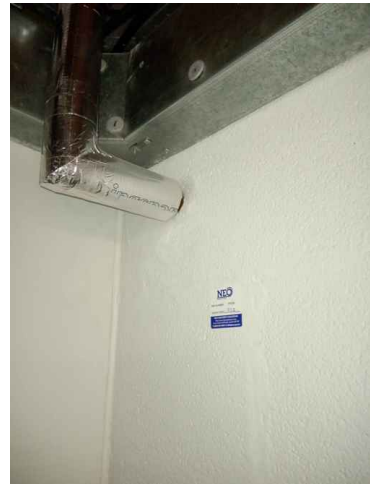
Survey  
1 of 1

**Pin Number:** 0015:38

| Once back sealed | |

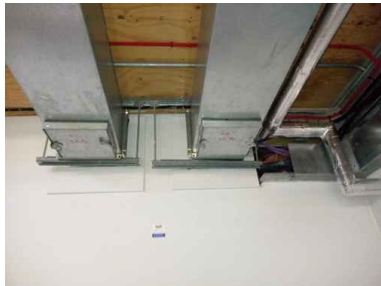
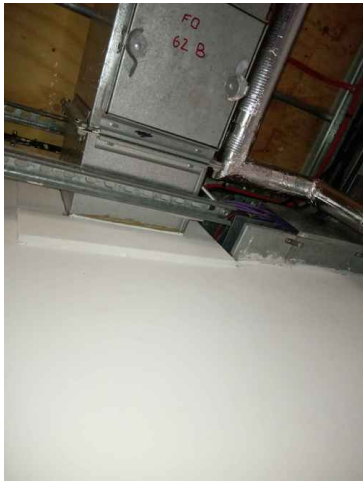
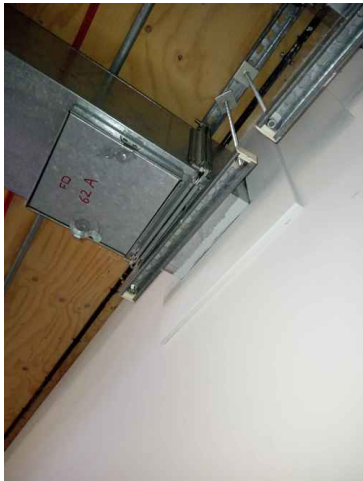
**Pin Number:** 0016:38  
**Company:** Neo Property Solutions  
**Contractor:** Tony Narkevicius - 30

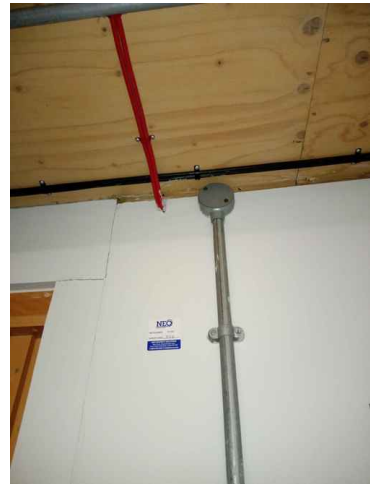
Survey  
1 of 1

**Pin Number:** 0017:38

| Once back sealed | |

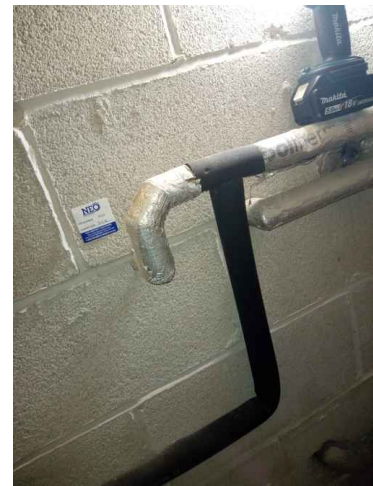
Survey  
1 of 2

**Pin Number:** 0018:38  
**Company:** Neo Property Solutions  
**Contractor:** Tony Narkevicius - 30

| Survey | |
|---|---|
| Needs to be replaced with fire rated door | |

| Survey | |
|---|---|
| Once back sealed | |

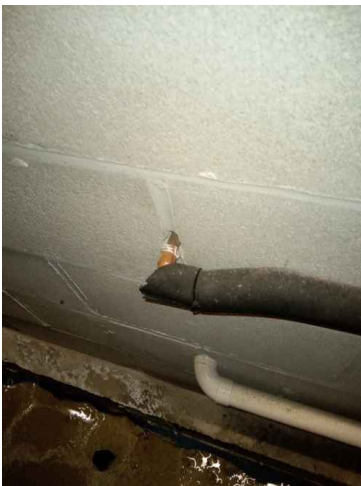
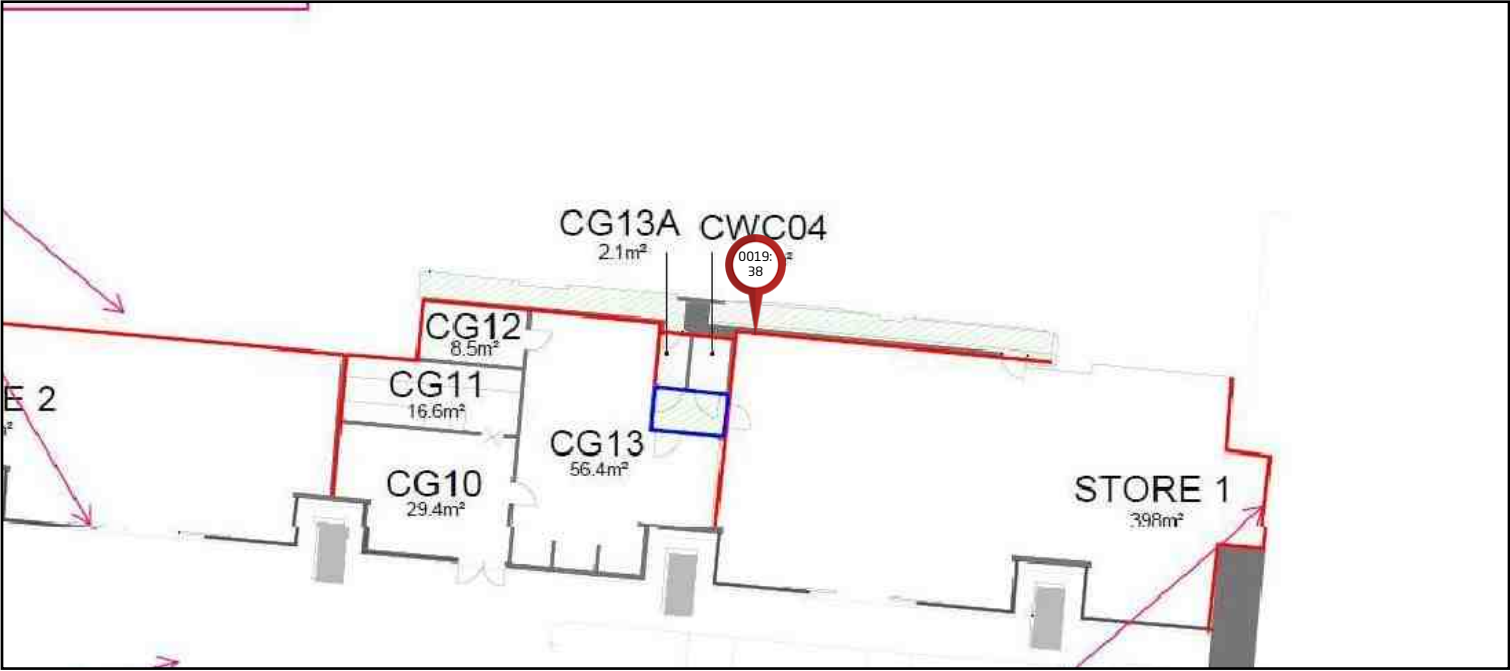
**Pin Number:** 0020:38

| X2 50mm plastic pipes | |
| Breach identified: | Plastic Pipe x 2 |
| We will need to chip out around the pipes to get the correct annulus and depth required in this detail | |
| Priority: | Red |

| Installation type: | SD-192-RDW |

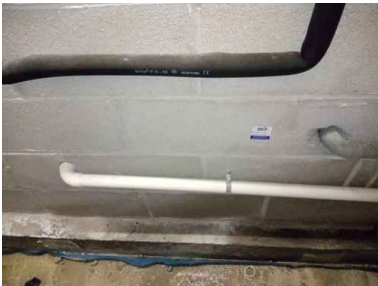
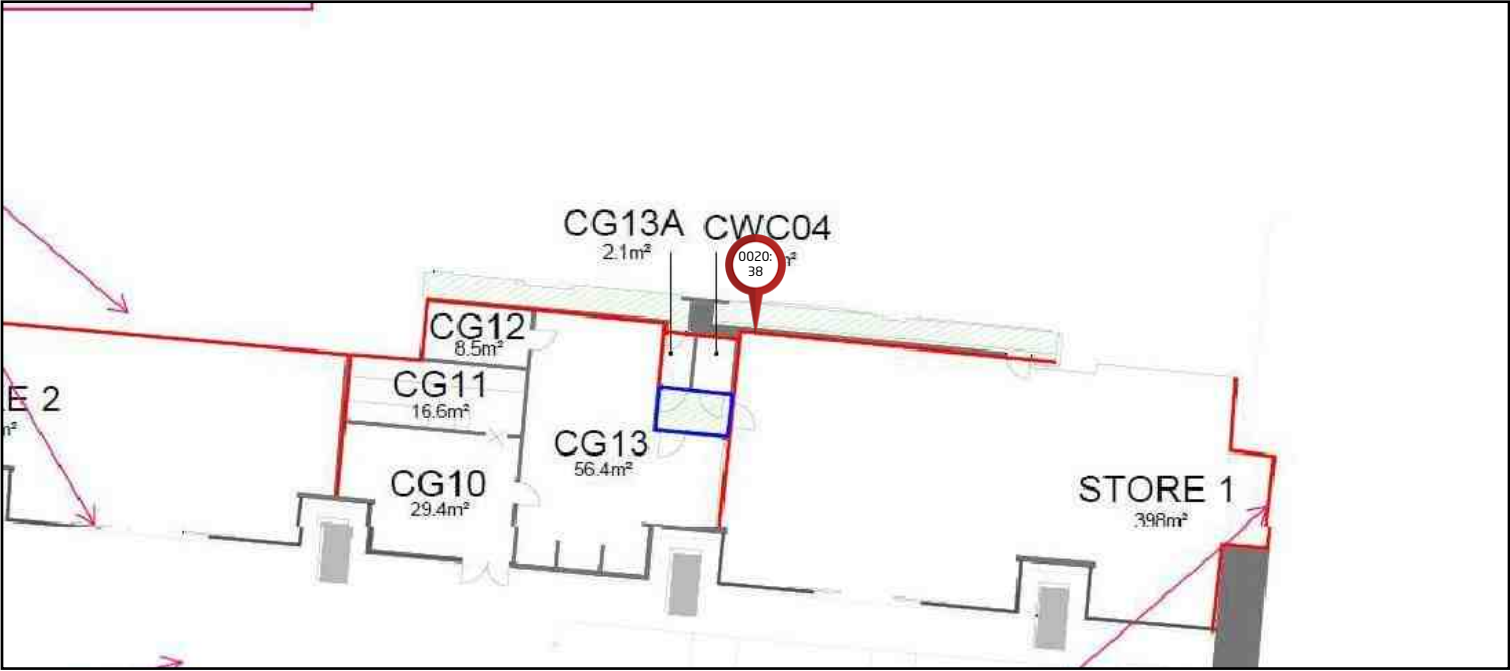
| Pin Number: | 0021:38 | Date Added: | 28/02/2022 - 15:00 |

| Copper pipe | |
| Conduit | |
| Breach identified: | Pipe, Conduit |
| Priority: | Red |

| Installation type: | SD-128-RDW |

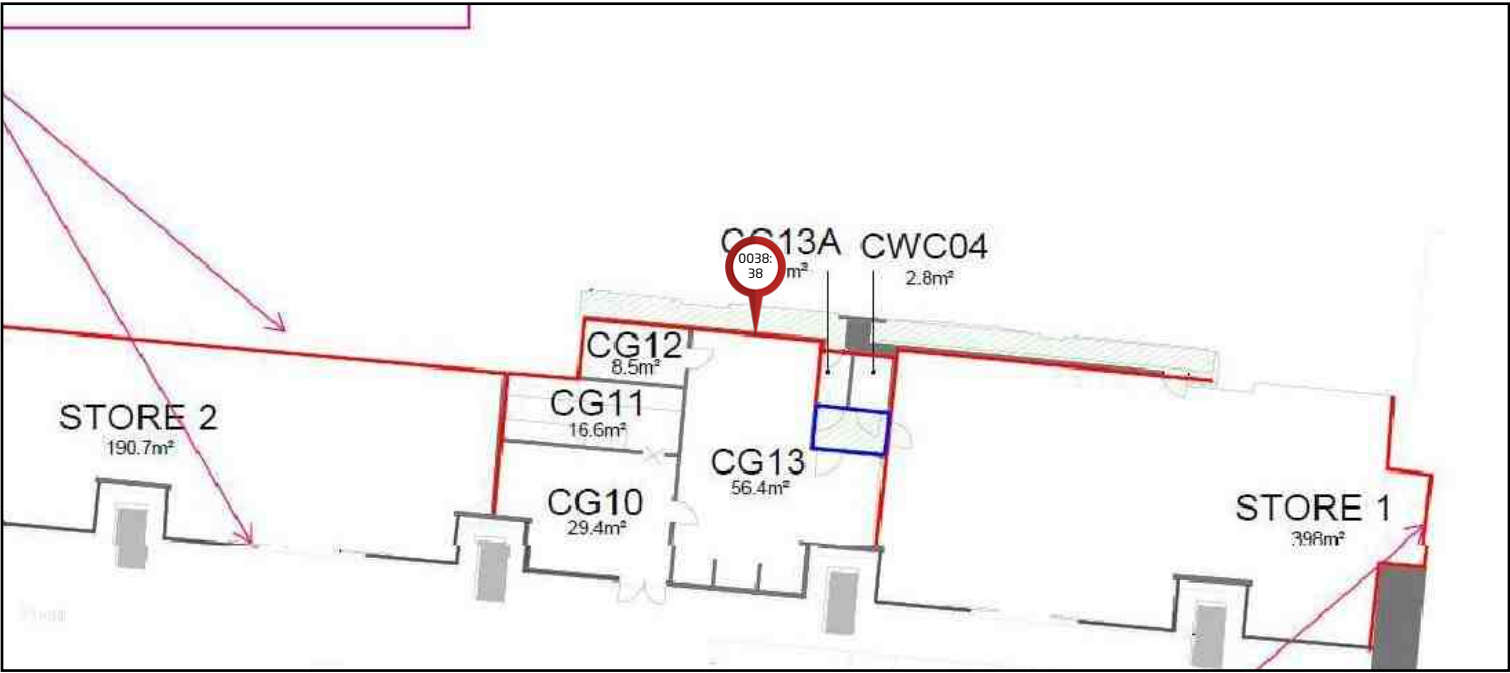
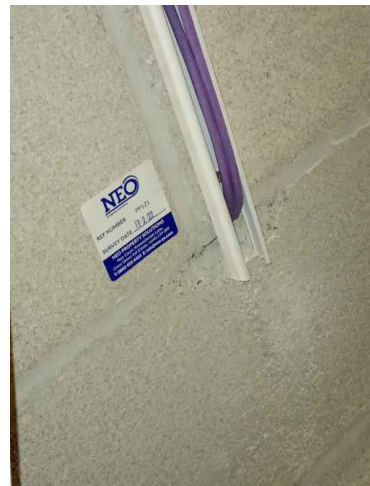
| Survey | |
|---|---|
| <b>Client/tag reference:</b> | PP121 |

| Survey | |
|---|---|
| Cable | |
| <b>Breach identified:</b> | Cable |
| <b>Fire rating:</b> | 60 minutes (not suitable if > 11m to top floor above ground) |
| <b>Priority:</b> | Red |

| Survey | |
|---|---|
| <b>Installation type:</b> | SD-128-RDW |
| Once back sealed | |

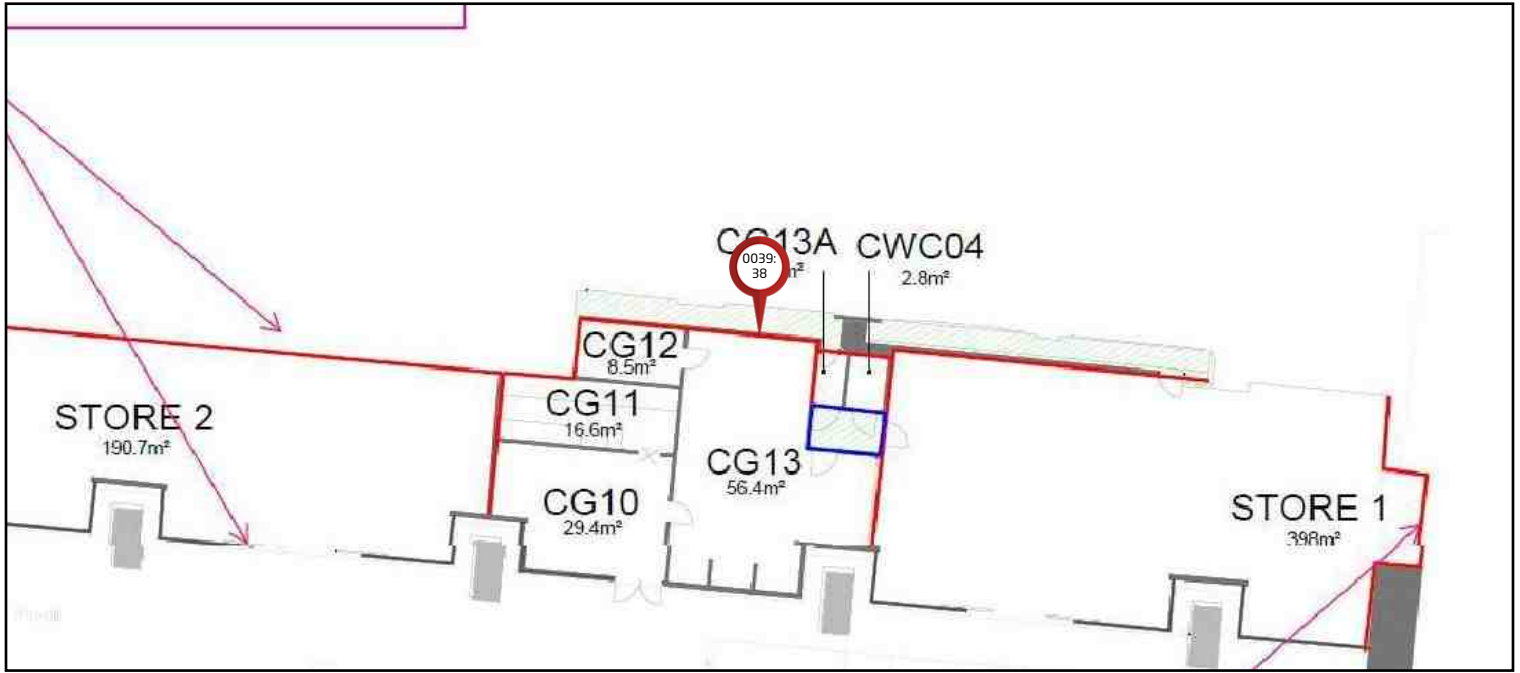
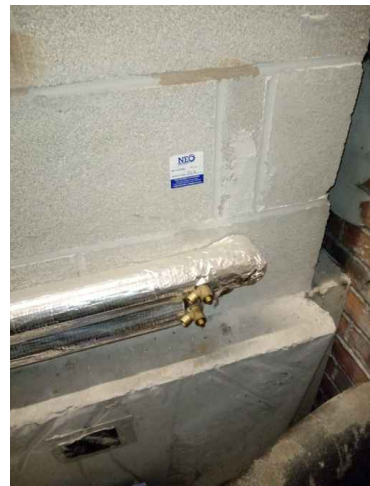
| Survey | |
|---|---|
| Client/tag reference: | PP122 |

| Survey | |
|---|---|
| X2 copper pipes | |
| Breach identified: | Pipe x 2 |
| Priority: | Red |
| Only access one side | |

| Survey | |
|---|---|
| Installation type: | SD-128-RDW |

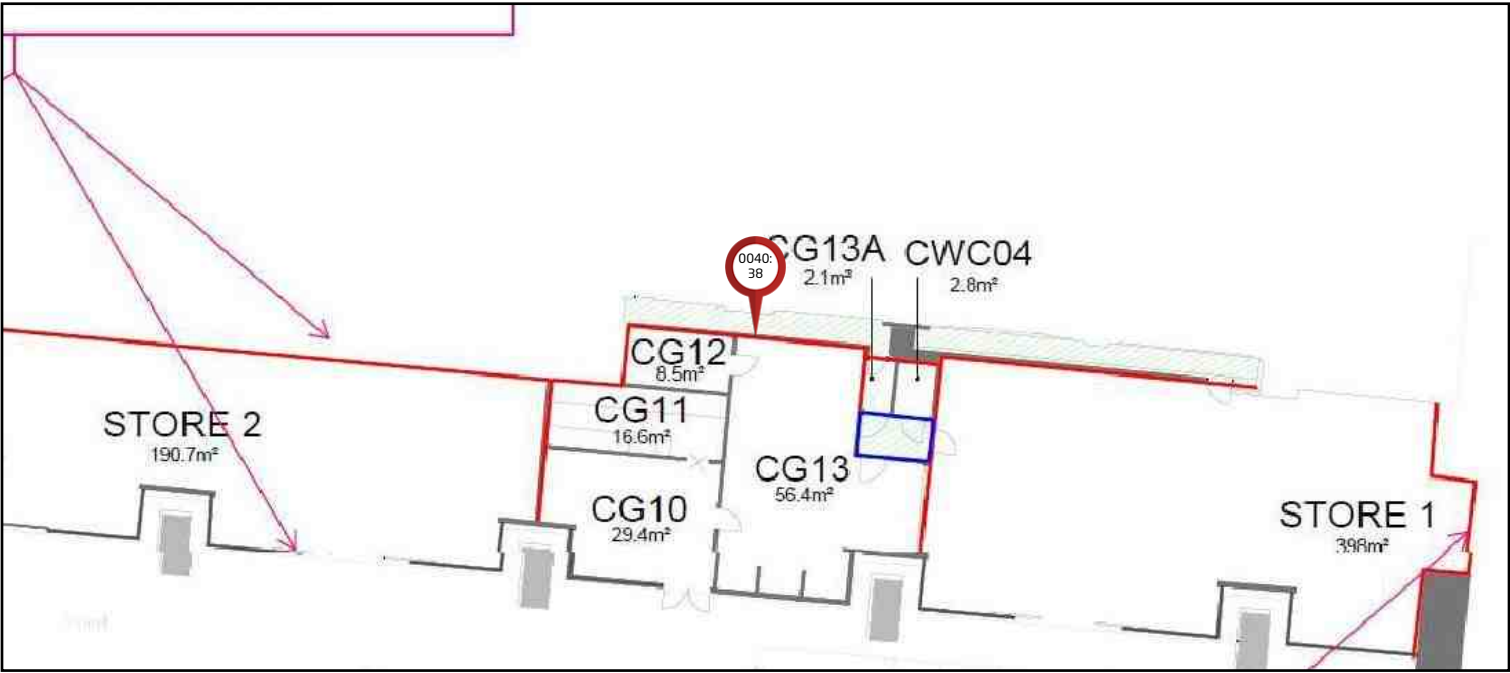
| Survey | |
|---|---|
| <b>Client/tag reference:</b> | PP123 |

| Survey | |
|---|---|
| Trunking | |
| <b>Breach identified:</b> | Trunking |
| <b>Priority:</b> | Red |
| Cant access other side of wall. | |

| Survey | |
|---|---|
| RWSD-ACB-0104 | |

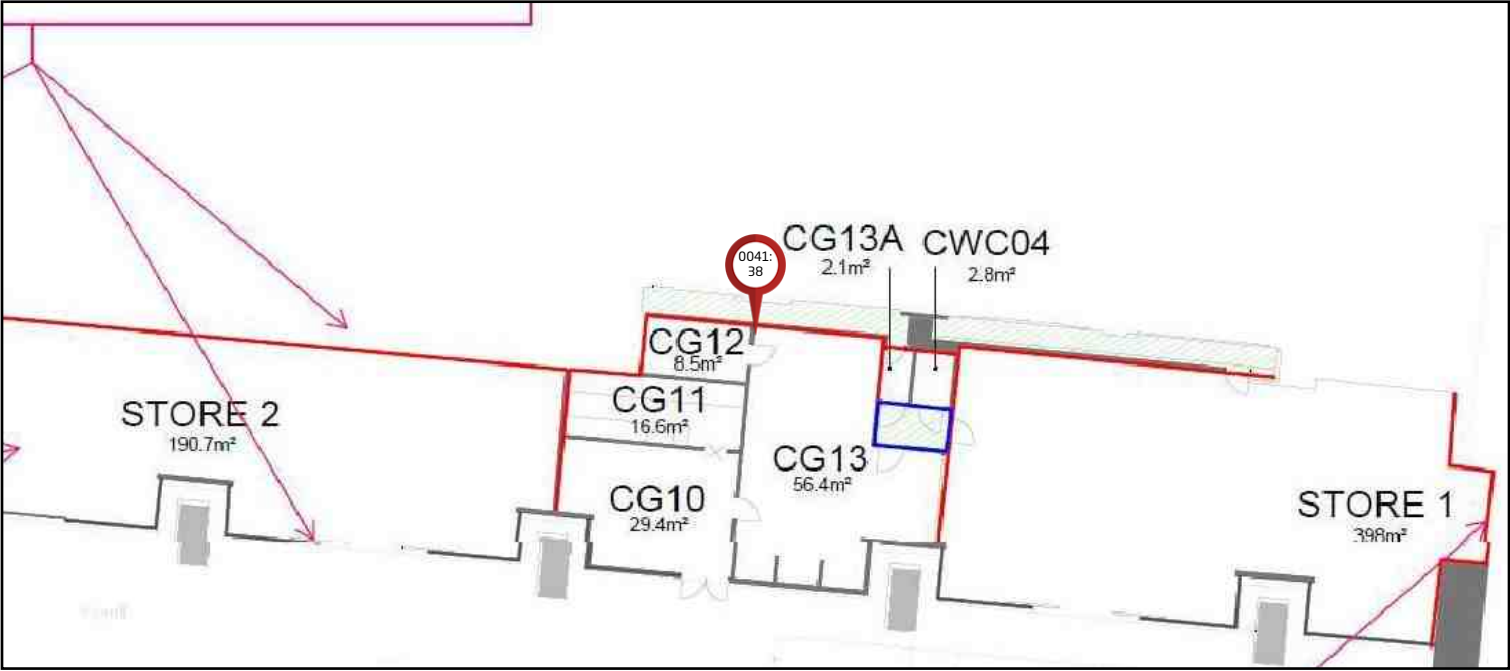
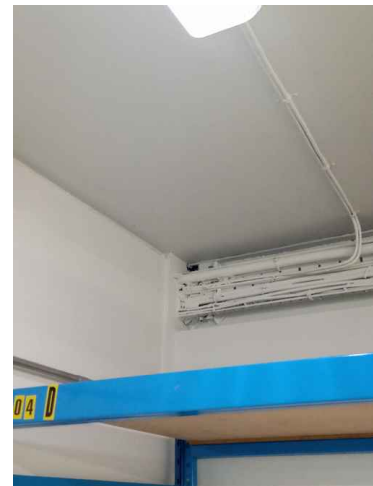
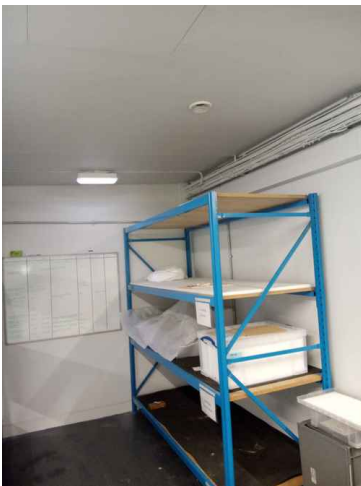
| <b>Client/tag reference:</b> | PP124 |

| Cable tray with cable. Remove wooden patress and facefix both sides of wall. | |
| Racking needs moving. See photos | |
| <b>Breach identified:</b> | Cable, Cable Tray |
| <b>Priority:</b> | Red |

| <b>Installation type:</b> | SD-113-RDW |
| Allow for a second seal on the opposite side of the wall so two in total | |

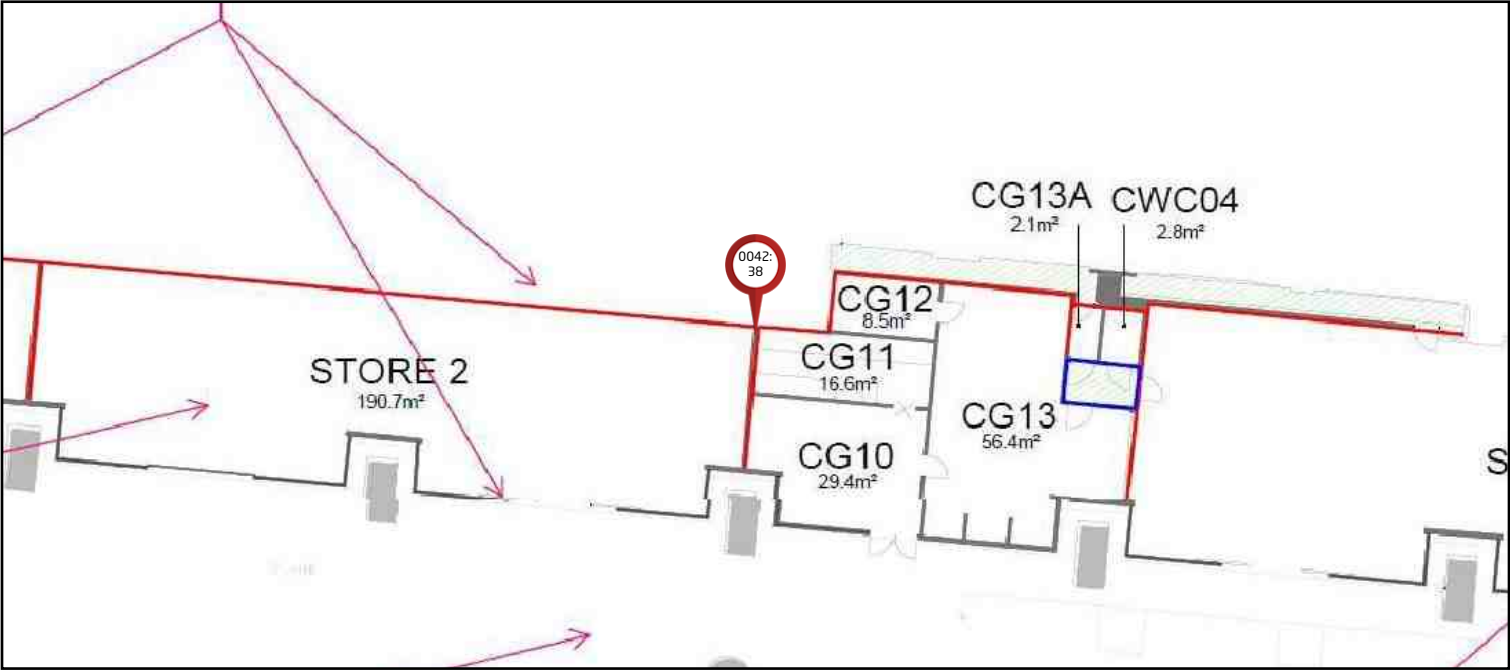
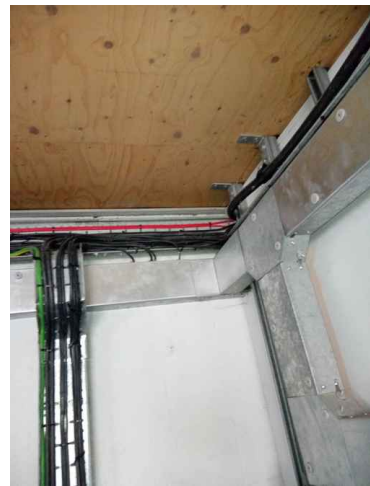
| Survey | |
|---|---|
| Client/tag reference: | PP125 |

| Survey | |
|---|---|
| Cannot back seal | |
