# Design & Heritage Statement

## St Anselm Hall, University of Manchester Roof Replacement & Remedial Works

Document Ref: PN9104\_St Ansem Hall\_Design & Heritage Statement  
Revision: 00  
Date: March 2026

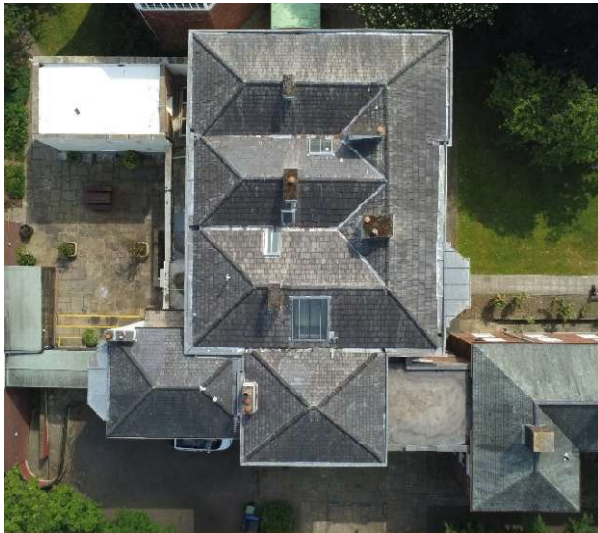
#### Slate Covered Pitched Roofs

- Slate covered hipped pitched roof coverings; combination of regular and diminishing coursing.
- The slate roof coverings represent a key architectural styling of the villa and are a prominent visual feature. The proposed replacement is a significant intervention but deemed necessary to maintain the building weathertight and prevent further internal deterioration.
- Due to the significance of the existing roof's aesthetic appearance, there is a presumption in favour of retaining existing slates where viable. Existing slates will be re-instated to principal roof pitches; new / salvaged slates will be sourced to UK quarries to match existing gauge, profile, appearance etc. The existing roof pitches and associated details (i.e. hips, ridges, etc.) will be maintained. The proposed replacement roof coverings with outlined controls will have minimal visual change impact.

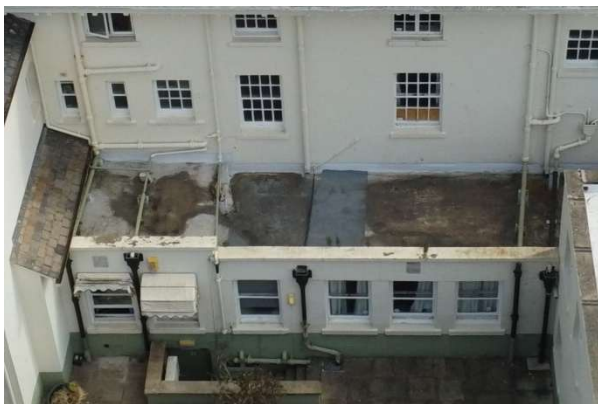
#### Asphalt Covered Flat Roofs

- Asphalt covered flat roofs to later extensions / modifications to the villa.
- The flat roof coverings are a later addition to the property and are not a prominent visual architectural feature. Their purpose is functional.
- The roofs have been subject to previous dissimilar material repairs; their condition is design life expired and their replacement is deemed necessary to maintain the building weathertight and prevent further internal deterioration. The proposed replacement flat roof coverings will have minimal visual change impact.

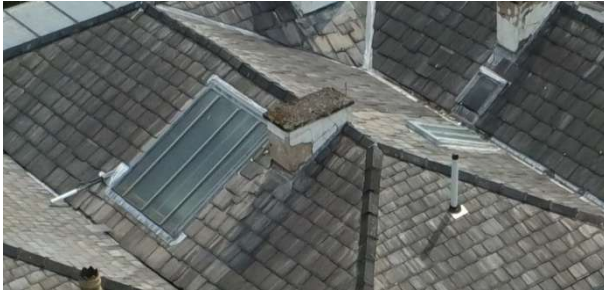
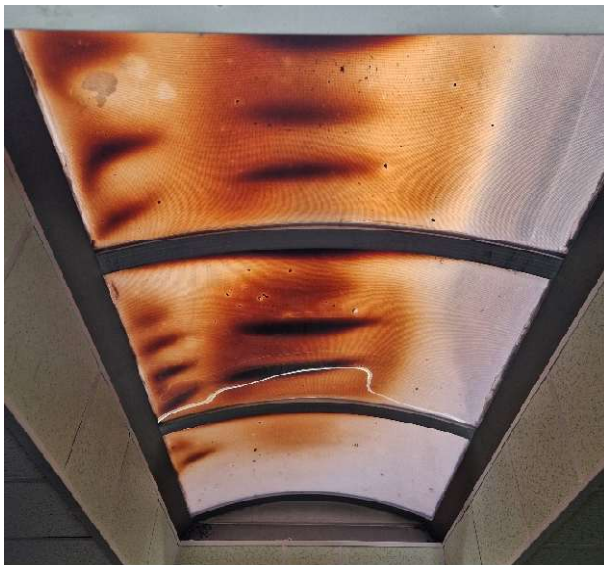
## Rooflights

- The existing inline roof lights to the slate covered pitched roofs are single glazed with narrow glazing bars and vertical fenestration. It is unclear if these rooflights are original; however, provide function providing natural light to inner spaces of the property.

- Their existing profile is sympathetic to architectural styling of the roof line / coverings; there is a presumption on favour of retaining should further investigation determine their condition acceptable. It is noted that there are direct water leaks in the vicinity of the roof lights though this may be a consequence of associated detailing. Should replacement be determined then replacement will be with similar fenestrated units matching the existing profile in order not to detract for the existing roof profile.

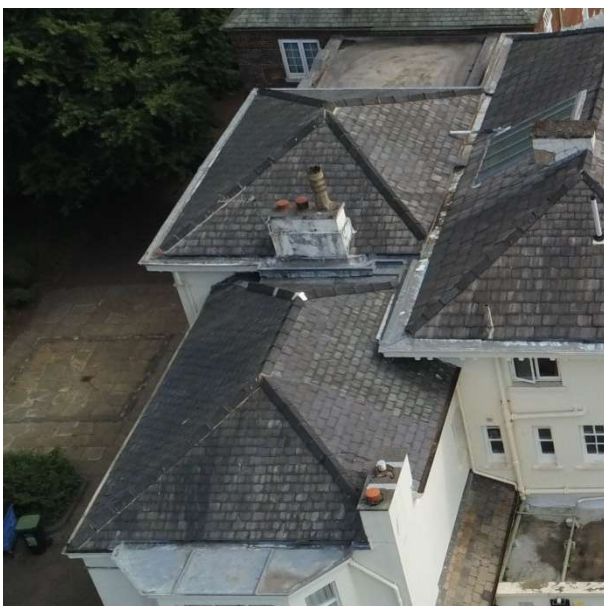
## Chimney Stacks

The existing 6no. projecting chimney stacks are plain and rendered in an assumed similar material to principal building facades; all chimneys are generally capped with some retaining original pots or later terracotta replacements. The existing render has failed in a number of locations resulting in de-bonding and / or cracking to the existing covering.

- The existing projecting chimney stacks represent moderate value; their function is diminished as numerous fireplaces have been de-commissioned. A number of original chimney pots remain whilst others have been replaced with modern terracotta units or the flues capped.
- The existing stacks are in poor condition with failed render coating; the coatings are proposed to be replaced with a commensurate lime-based render and new flaunching / capping as required.
- The existing pots will be retained in position. The proposed remedial works will have minimal visual change impact.

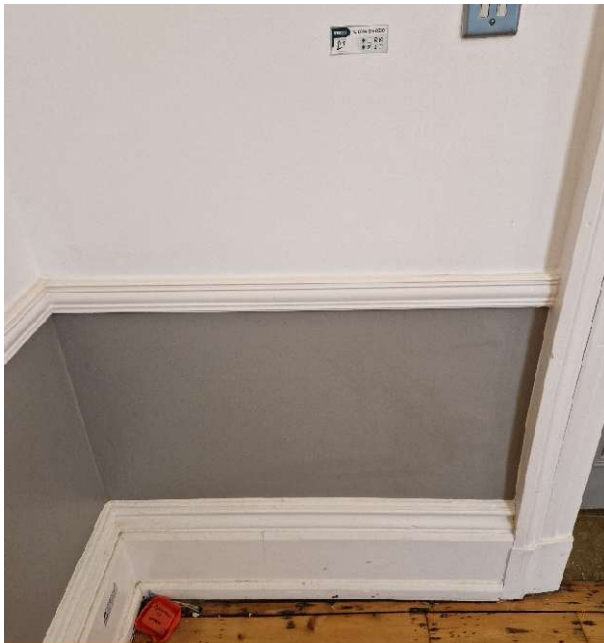
#### Plastered Wall Linings

- The existing walls are generally plastered over a masonry substate.
- Remedial works and replastering will be limited in scope to those areas directly affected by the water ingress and associated decay. Existing sound plaster will be retained.
- Replacement plaster will be a lime-based system to be sympathetic to the original construction finish and allow the building to operate in a holistic environmental manner. The proposed remedial works are deemed necessary due to material defect failure and will have minimal visual change impact.

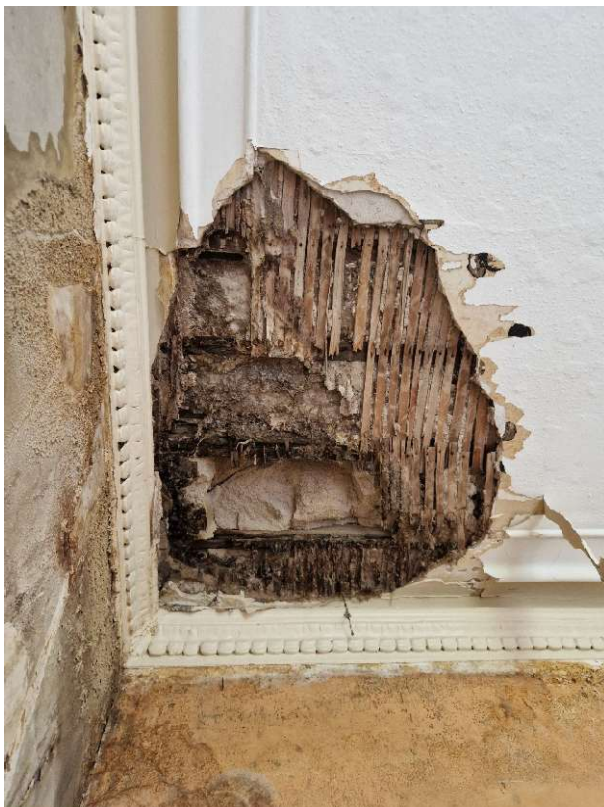
#### Lathe & Plaster Ceiling Linings

- Generally internal ceilings are lathe and plaster, and this has been assumed to be consistent throughout where existing plasters have not detached or been removed. Lathe and plaster ceilings are typical of the original construction period and are deemed of value for retention.
- Remedial works and replastering will be limited in scope to those areas directly affected by the water ingress and associated decay. Existing sound plaster will be retained. Where the supporting lathe system has been compromised, this will be repaired using traditional heritage methodologies and commensurate materials.
- Replacement plaster will be a lime-based system to be sympathetic to the original construction finish and allow the building to operate in a holistic environmental manner. The proposed remedial works are deemed necessary due to material defect failure and will have minimal visual change impact.

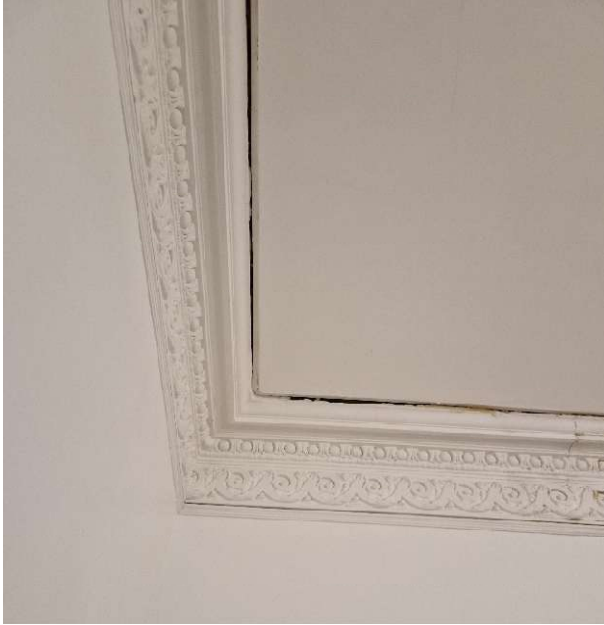
## Ceiling Over-boarding

- Existing ceilings are generally lathe and plaster; in isolated rooms the existing ceiling has been over-boarded as a safety precaution due to concerns over the adhesion of the plaster to existing lathes.
- The over-boarding detracts from the original ceiling line and articulation due to the increased depth. Despite being undertaken for safety purposes it detracts and has a negative impact on the building.
- It is proposed that as part of the remedial works to remove this later additional and remediation the substrate lathe's and plaster as required. Removal of the over-boarding will have a positive impact on reading the room.

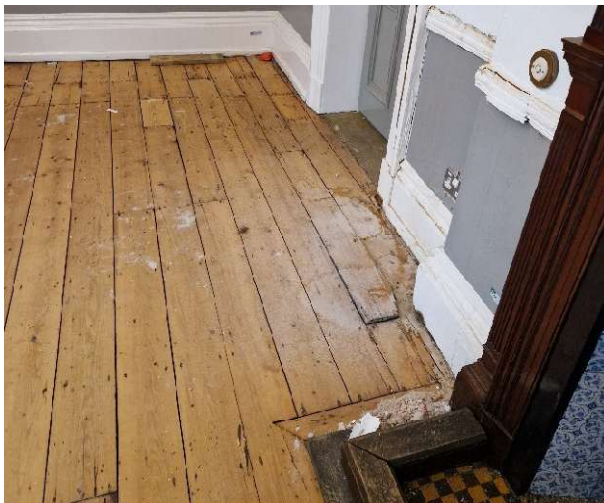
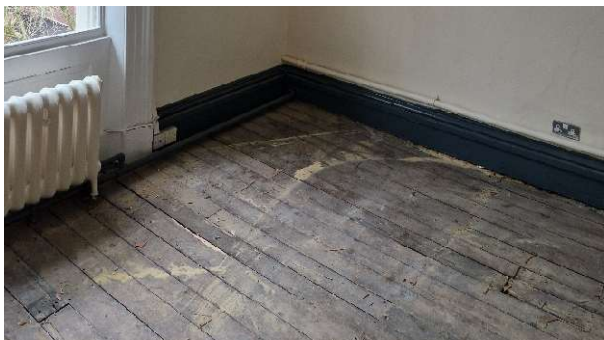
## Floor Construction

- Floors throughout generally comprise boarded timber; in the majority of rooms these have been covered with modern floor coverings (i.e. carpet and vinyl). In isolated rooms the existing boards are exposed with a sanded / varnished finish.
- The existing boards are representative of the original construction and therefore there is a presumption to retain.
- Where existing floors have been compromised by the direct water ingress, replacement will be limited to those boards affected by decay and no longer functionally operational. Replacement boards will be sourced to match the existing profile and of commensurate timber grade. Replacement boards will not be artificially aged or distressed to allow future identification.

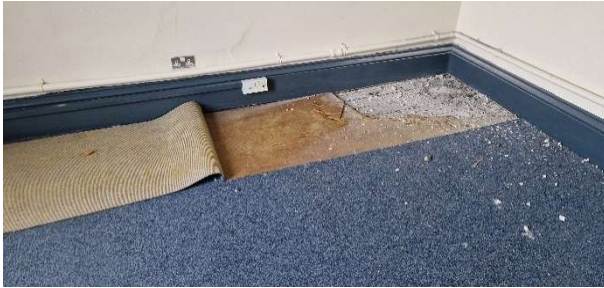
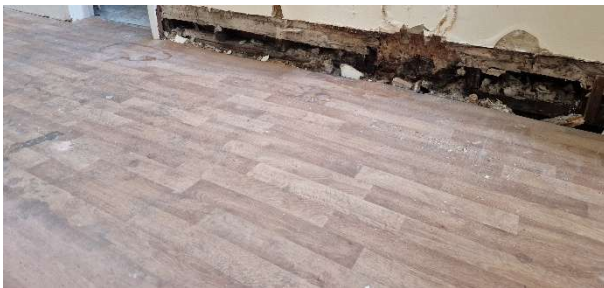
## Floor Coverings

- Floors throughout generally comprise boarded timber; in the majority of rooms these have been covered with modern floor coverings (i.e. carpet and vinyl). Isolated rooms the existing boards are exposed with a sanded / varnished finish.
- The modern floor coverings generally have a sacrificial carrier / adhesive board beneath (i.e. pinboard / chipboard) to avoid fixing directly to the original timber boards.
- These modern floor coverings are a later addition and have a neutral impact; their proposed replacement will be undertaken in a manner that protects the original timber boarding.

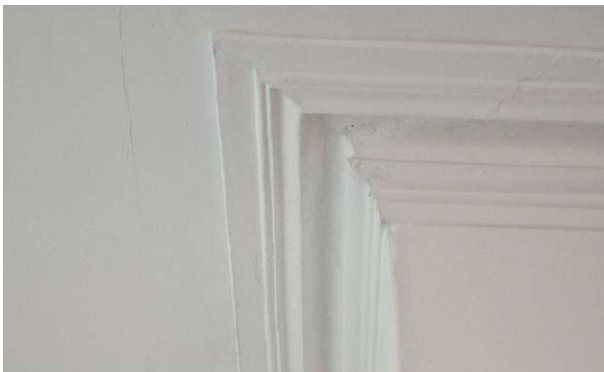
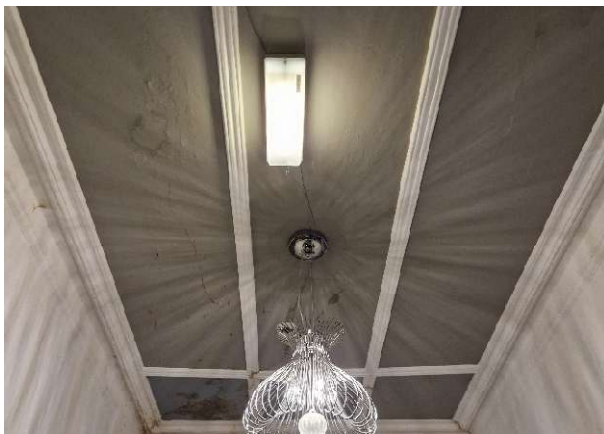
#### Wall and Ceiling Articulation (i.e. corners, ribs etc.)

- There are various wall and ceiling articulations throughout the property and within the proposed areas of works of varying design.
- These ornamentations are representative of the architectural style and detailing of the period and of high value for retention and preservation.

- Where the articulation is sound and unaffected by the water ingress and associated material failings they are to be retained and preserved in position. Where replacement sections are required, these will be based on templates / mouldings of the original retained sections to ensure authenticity.

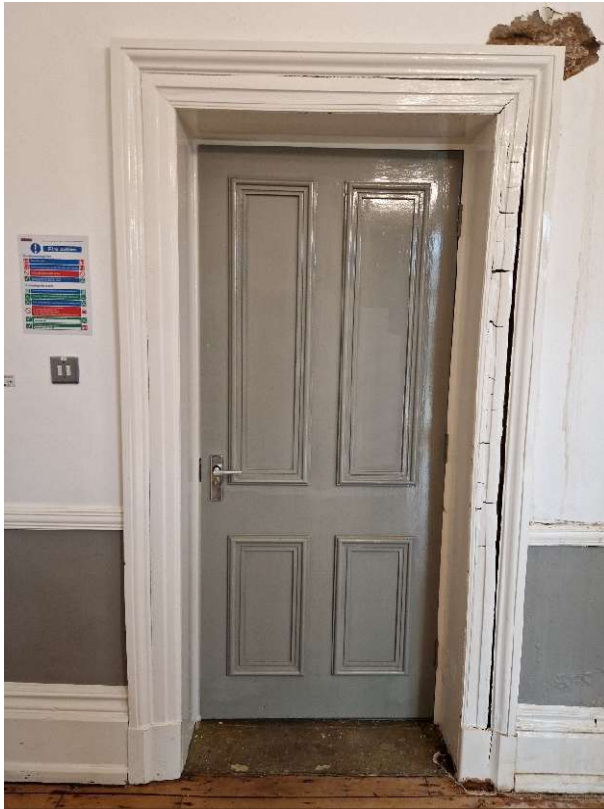
### Joinery Articulation (i.e. skirtings, architraves etc)

- There are various joinery articulations throughout the property and within the proposed areas of works of varying design including skirtings, architraves, door sets etc.
- These ornamentations are representative of the architectural style and detailing of the period and of high value for retention and preservation.
- Where the existing joinery is sound and unaffected by the water ingress and associated material failings they are to be retained and preserved in position or careful removed and reinstated to original positions upon completion.
- Where replacement sections are required, these will be based on templates / mouldings of the original retained sections to ensure authenticity.

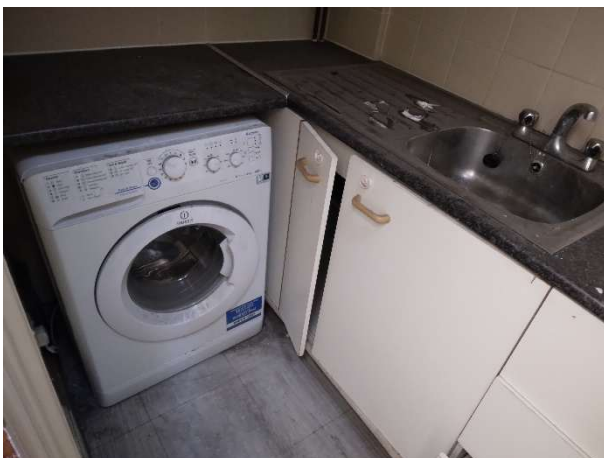
### Kitchenette Facility

- The existing modern kitchenette facility comprising base units, wall units, worktop etc. is a later insertion within a previously adapted space.
  - The facility is of neutral value to the property and its replacement of a like for like basis will not impact the reading of the property.
-

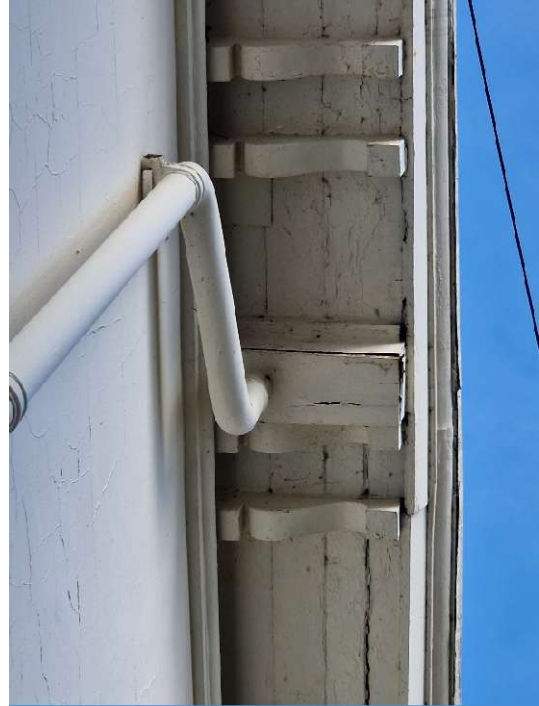
Photo 14 – Existing Projecting Eaves
