# Concord House, Wythenshawe

Assessment for Bats

**Report Title:** Concorde House, Wythenshaw  
Assessment for Bats

**Issue Date:** 03/10/2025  
**Document Ref:** 0968/Assessment for Bats

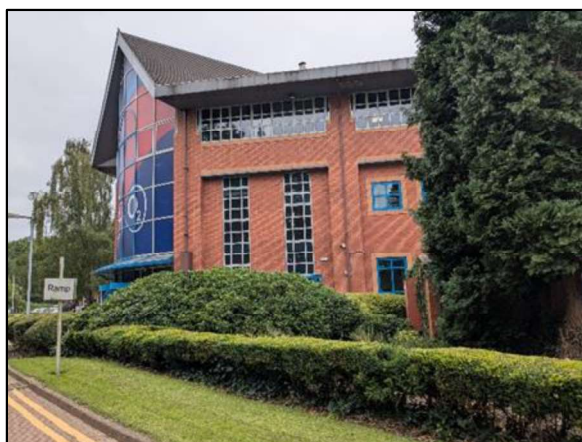
- 4.2.1 A three-story office building, constructed of red-brick with a pitched, concrete tiled, roof was present (**Photograph 1**). The building was erected in 2000 (approximately). A plant room was situated in the roof void (**Photograph 2**).

**Photograph 1.** Virgin Media House building

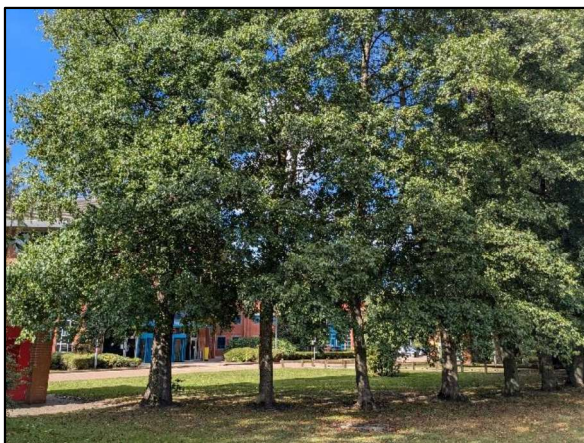
- 4.4.1 No trees within the Site were identified as having PRFs.
- 4.4.2 Trees present were young/semi-mature and not of sufficient age for PRFs to have developed. An example of such trees is given in **Photograph 8**.
- 4.4.3 A number of trees around the perimeter of the south-west car park were ivy-clad, however, ivy was immature and not considered to be a feature in itself or obstructing any other PRF's. An example of these trees is shown in **Photograph 9**.
- 4.4.4 The woodland area was densely planted and, even if PRFs were present, would only have allowed access for bats around the periphery. Trees were semi-mature, hence not old enough for PRF's to have developed yet. Many of the woodland trees were ivy-clad, however, ivy was considered semi-mature and an obstruction to flight and access rather than a PRF.

**Photograph 8.** Typical example of Site trees.

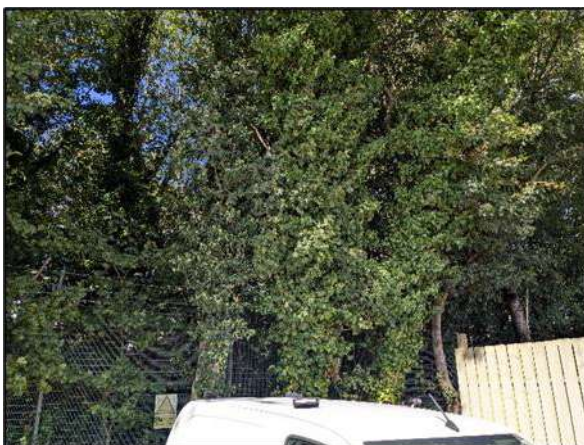
**Photograph 9.** Example of ivy-covered trees.
