## Castlefield Viaduct – Phase 2

Truss End Support Boxes – Remedial Options Appraisal

| Document verification | | | | | | |
|---|---|---|---|---|---|--|
| Document title | | Truss End Support Boxes – Options Appraisal | | | 282210 | |
| Revision | Date | Filename | CVI-ARUP-ZZ-ZZ-RP-S-000003 | | | |

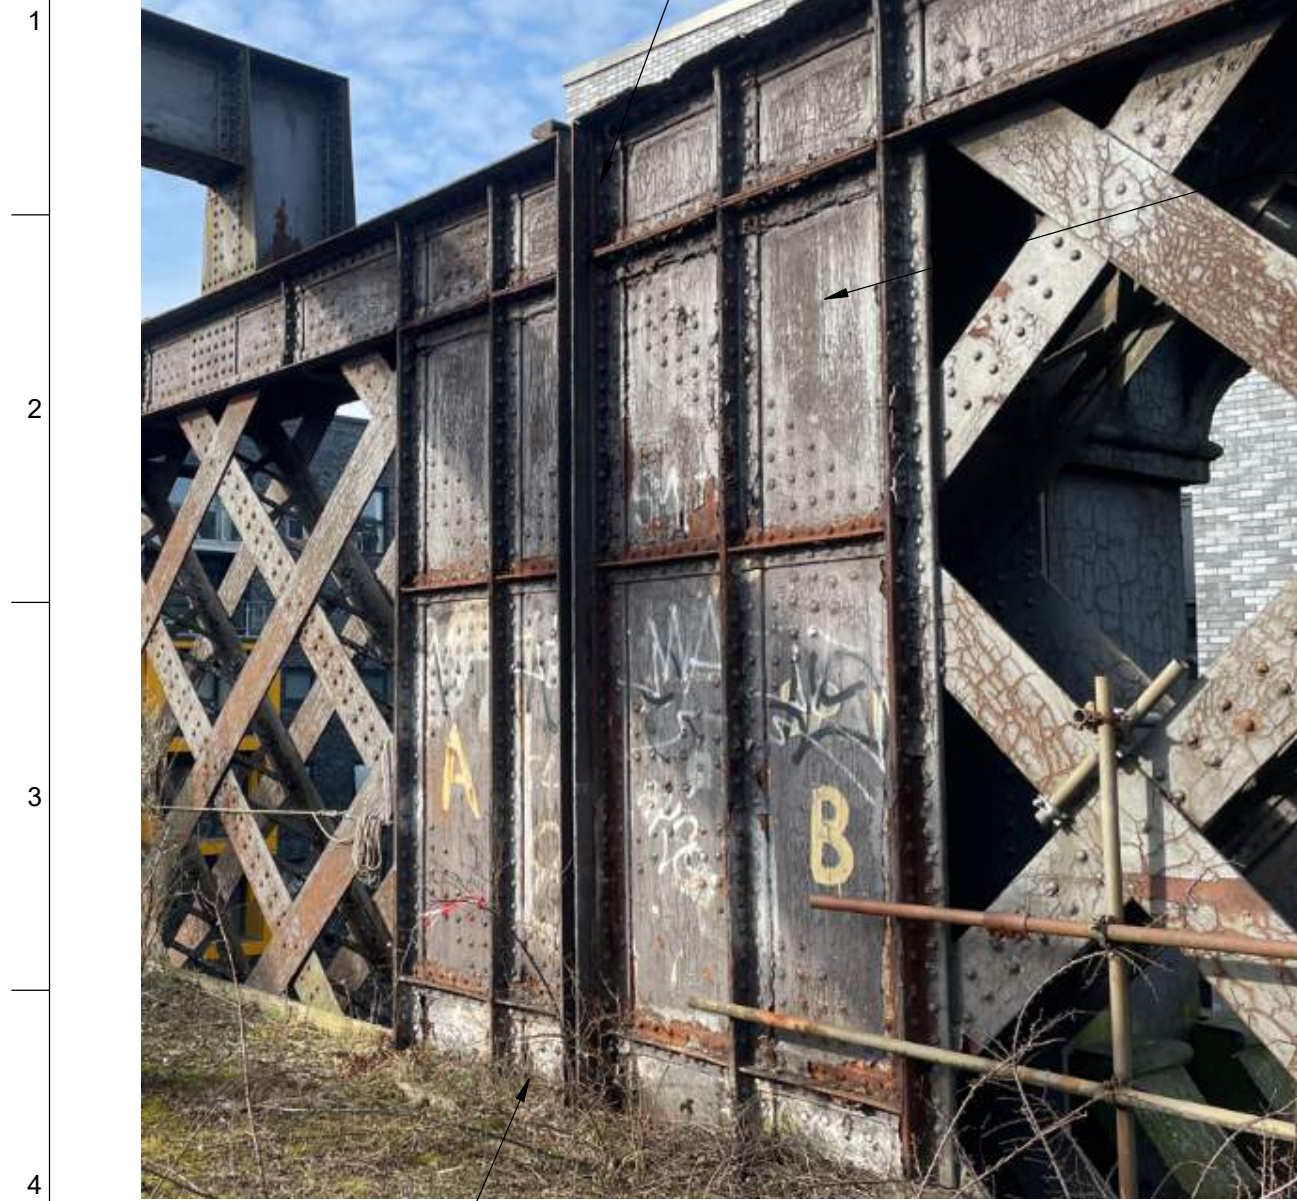
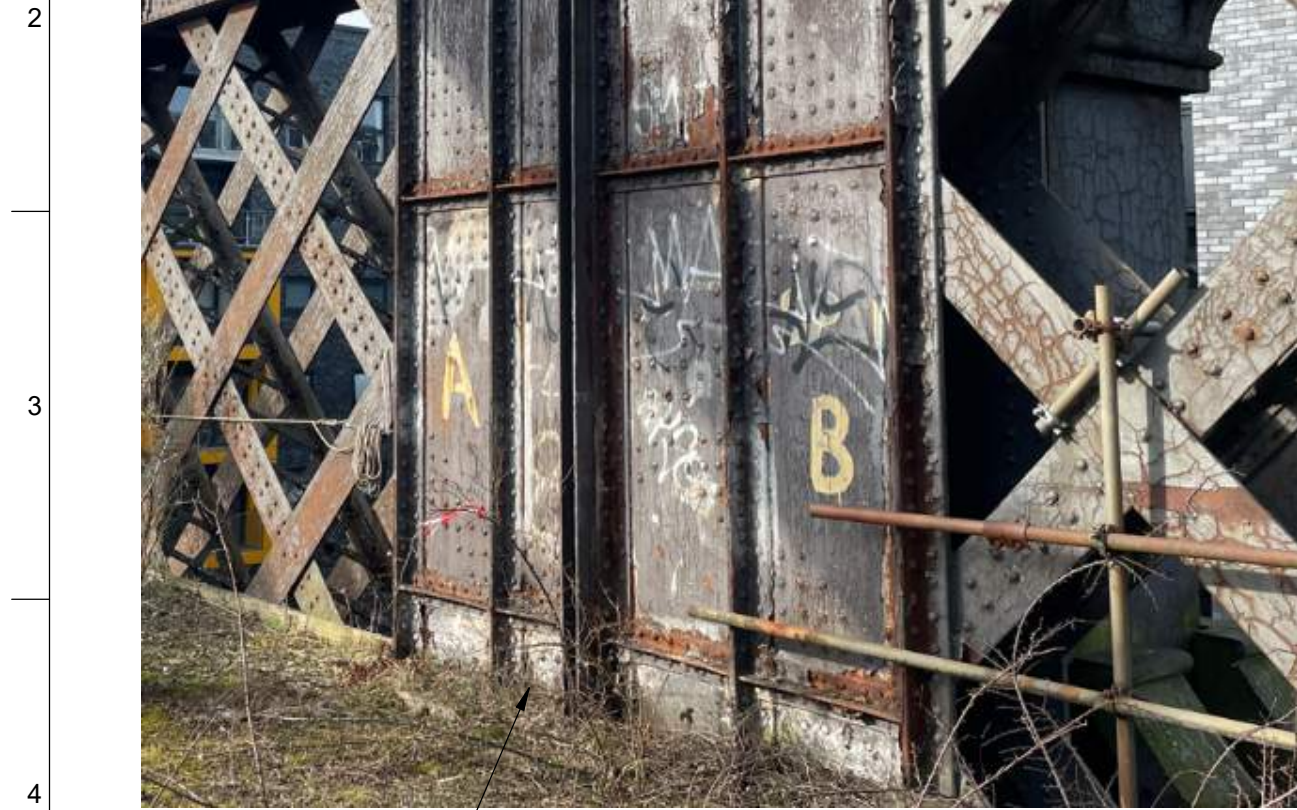
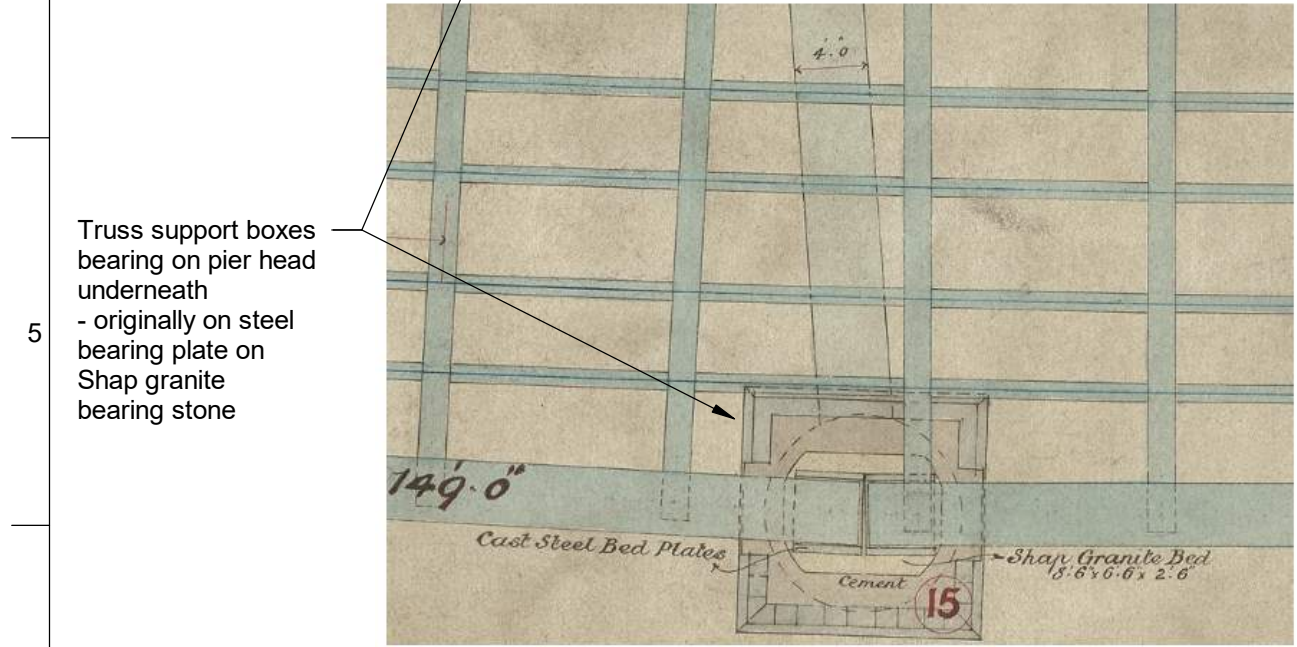
## TYPICAL ARRANGEMENT

Support box length varies per condition, approximate range 1613-1753mm - also note irregular asymmetry between lengths of panel 1-2 and panel 2-3

Lower web panels - area of worst case corrosion

Incoming transverse beam - setting out varies per span: not always, but sometimes, incident to truss support box

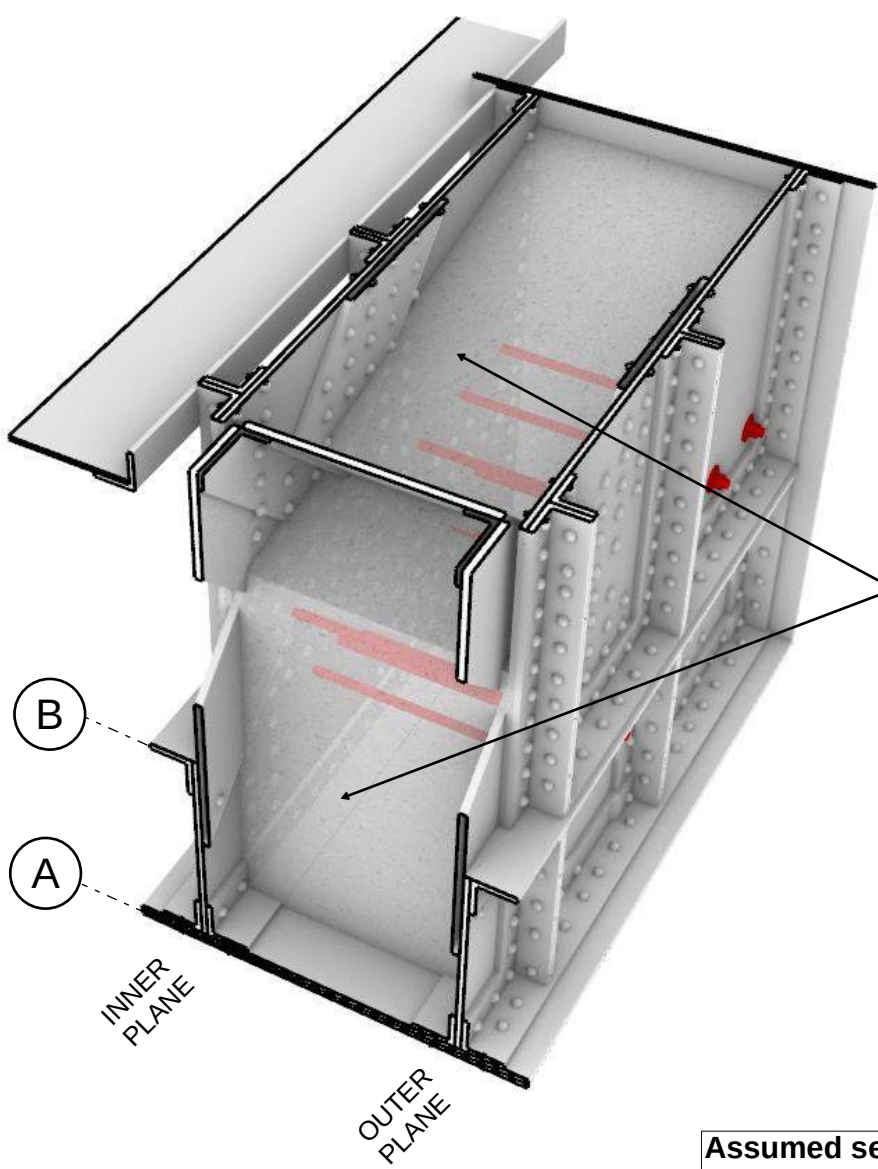
At conditions where compression diagonal (solid plate) intersects with concrete infill:

- 30mm dia half-round drainage hole to be drill centrally through diagonal for water discharge, infill benched to sides to encourage transverse flow

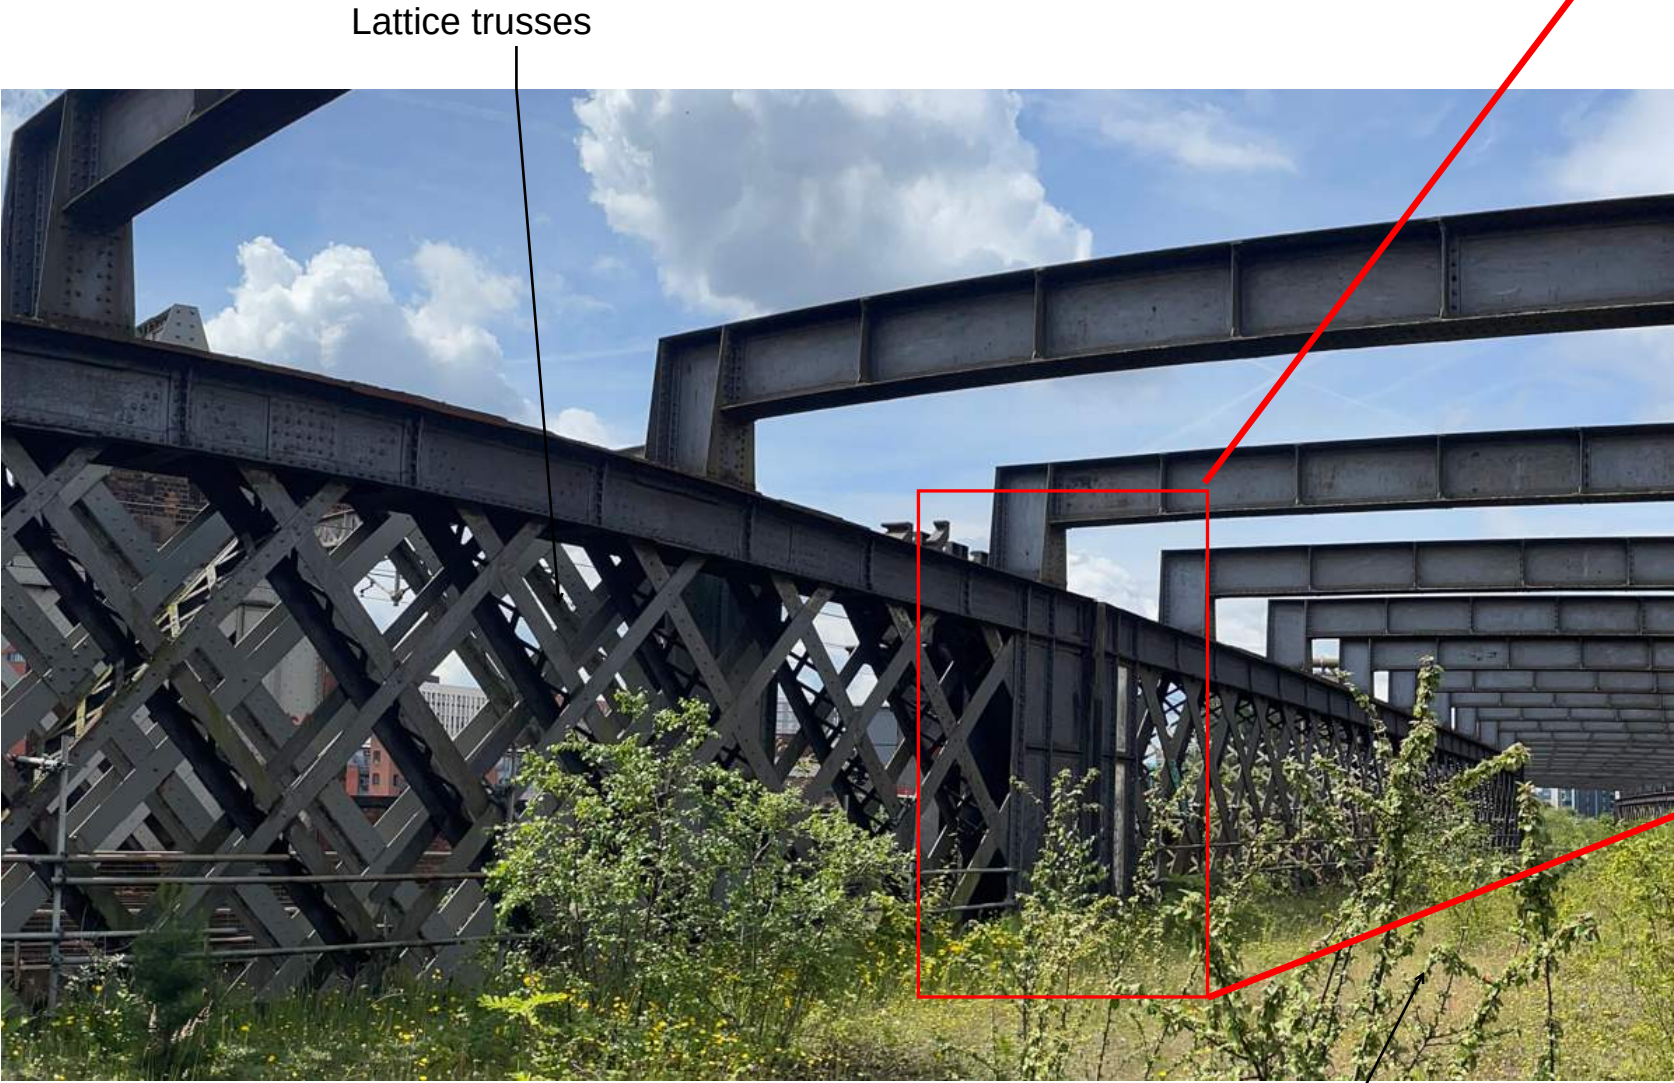
Vegetation and ballast above deck plate

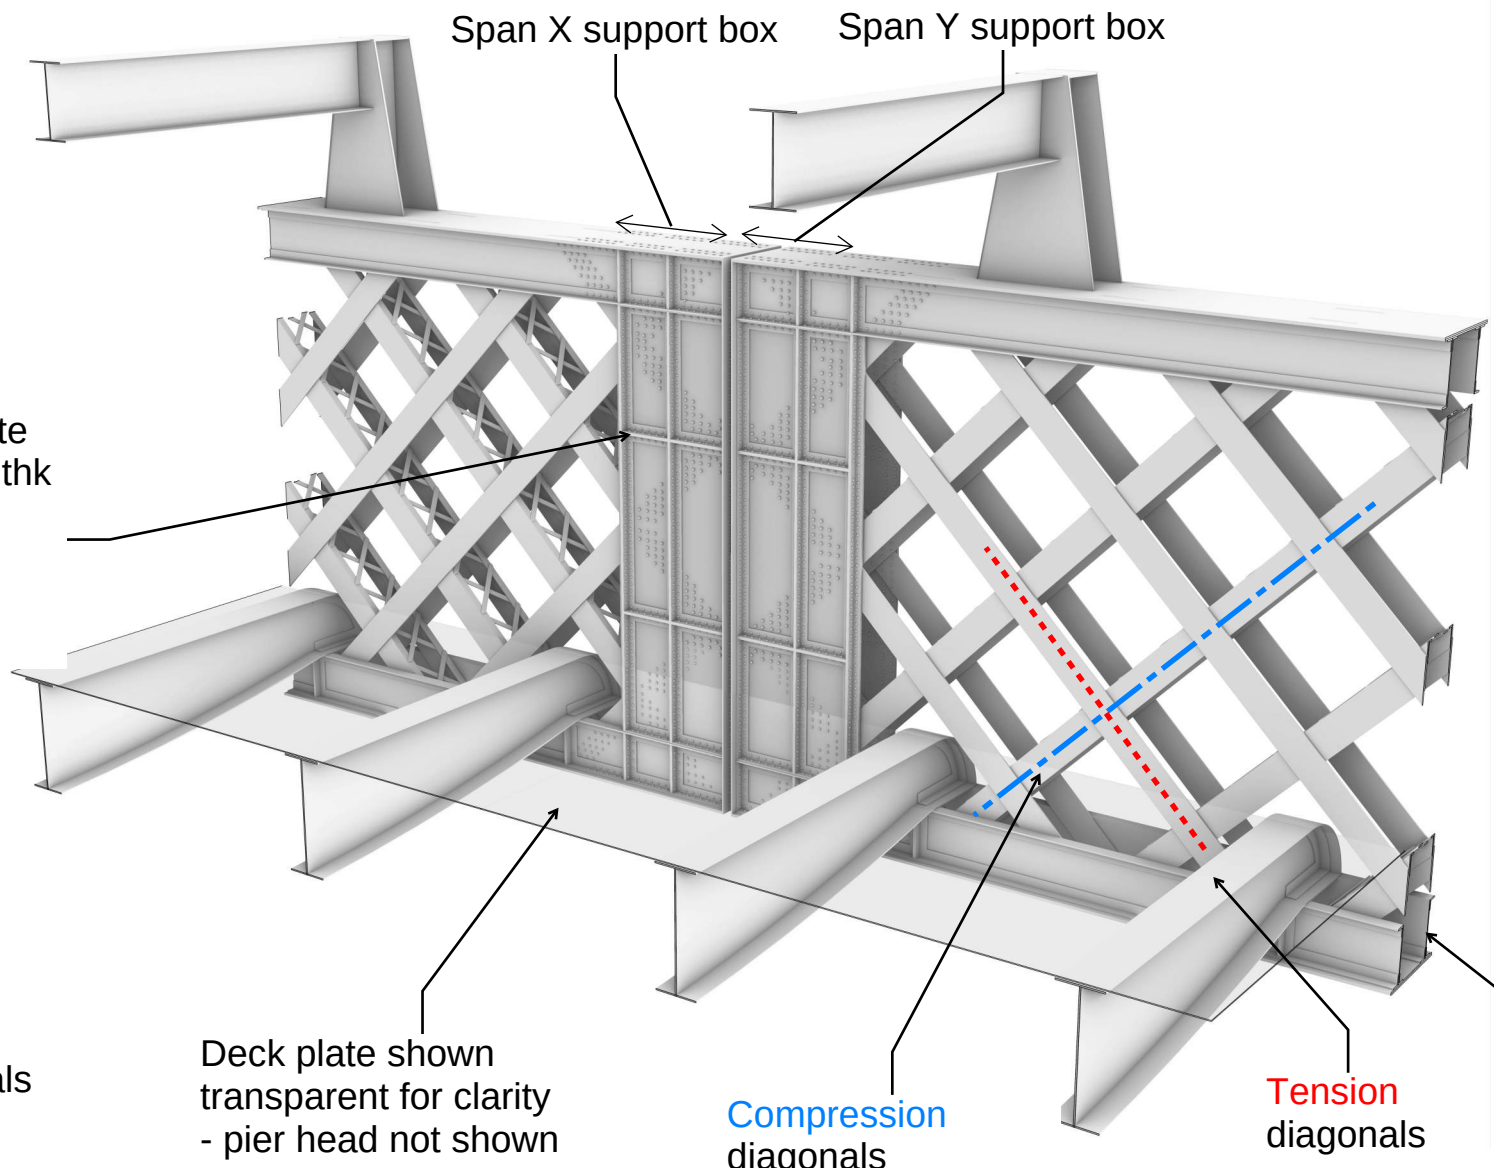
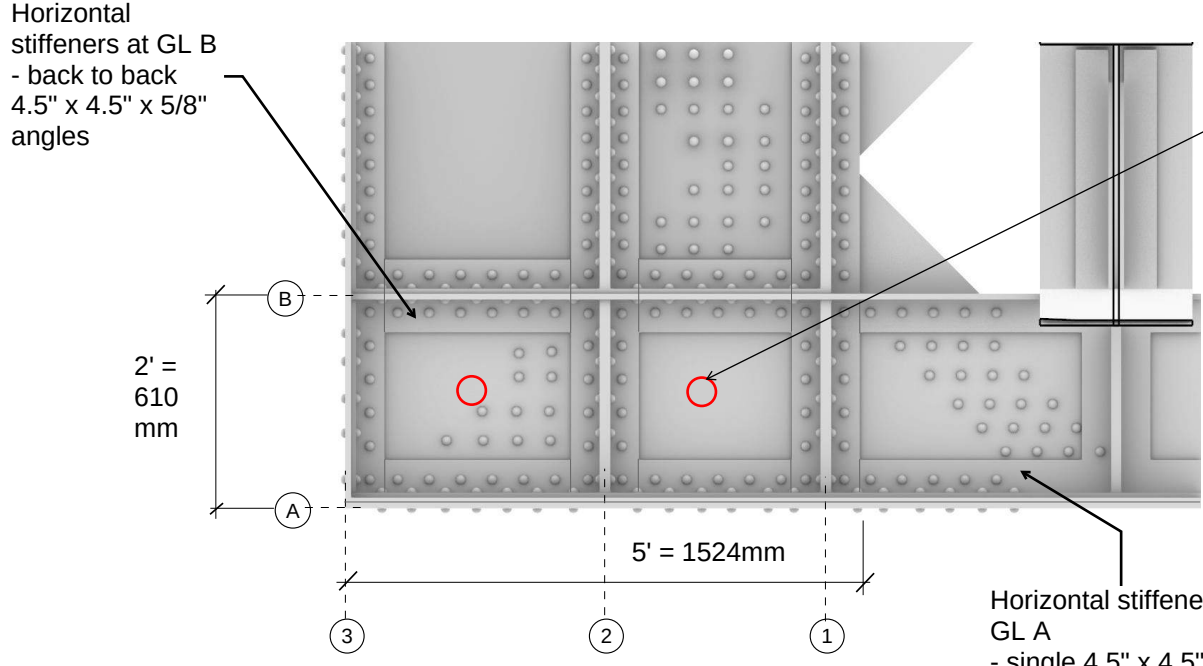
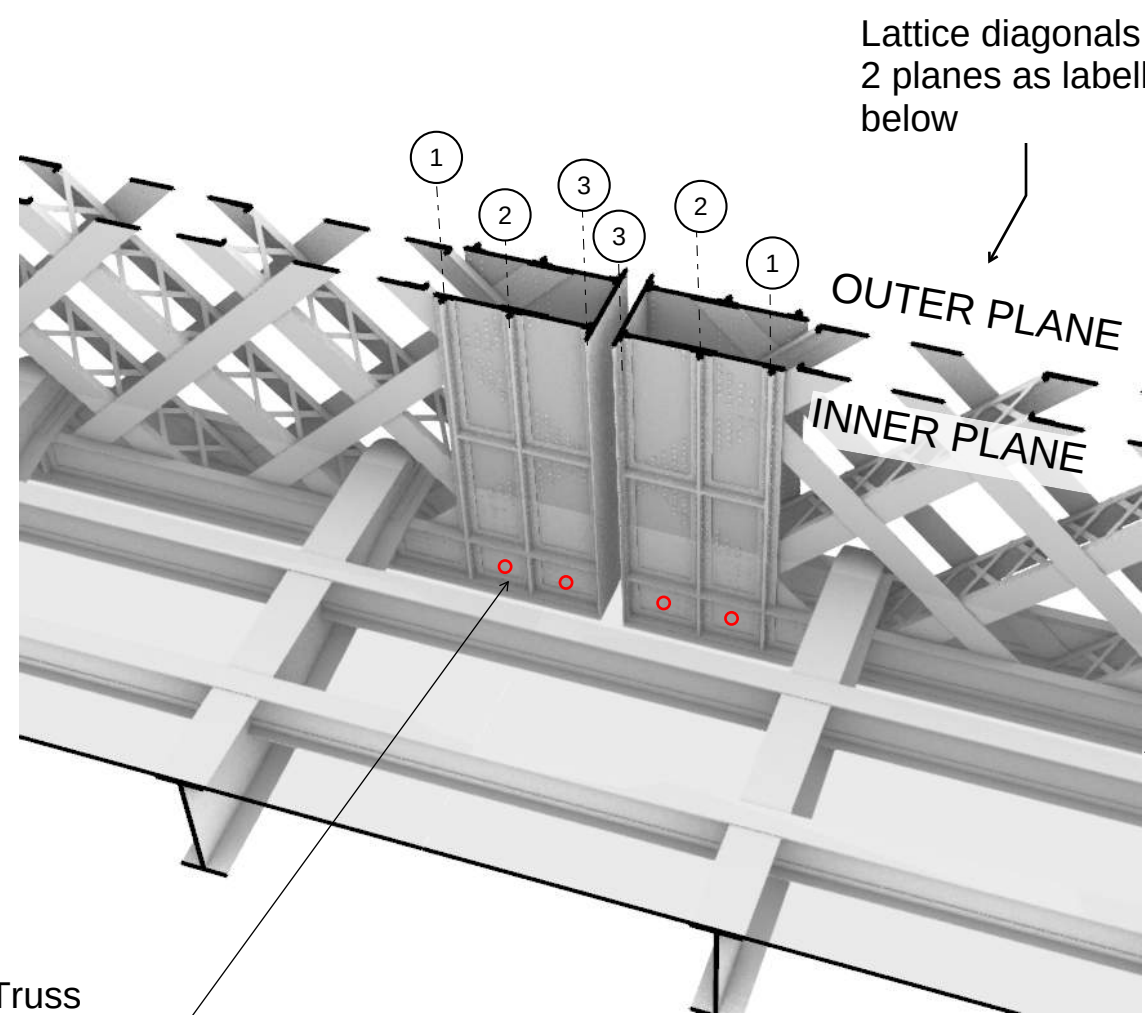
Lower web panels - area of worst case corrosion

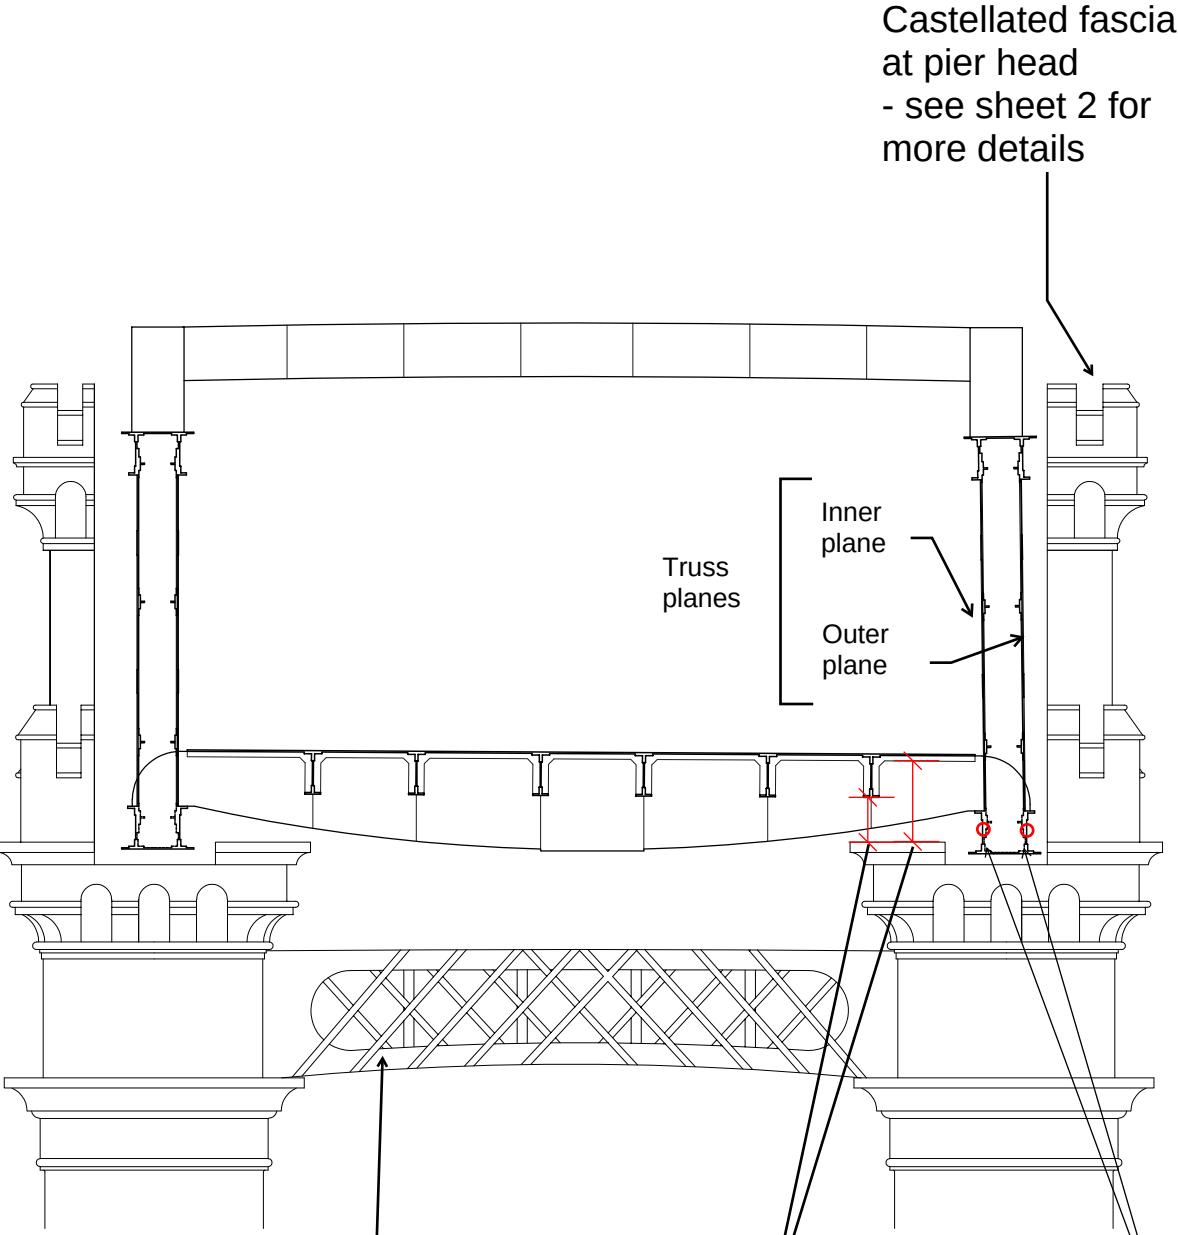
TYPICAL ARRANGEMENT  
NTS

Clearance to pier head castellated head - varies per pier - indicatively 650mm below longitudinal beam, 1200mm below deck plate

Lower web panels - area of worst case corrosion

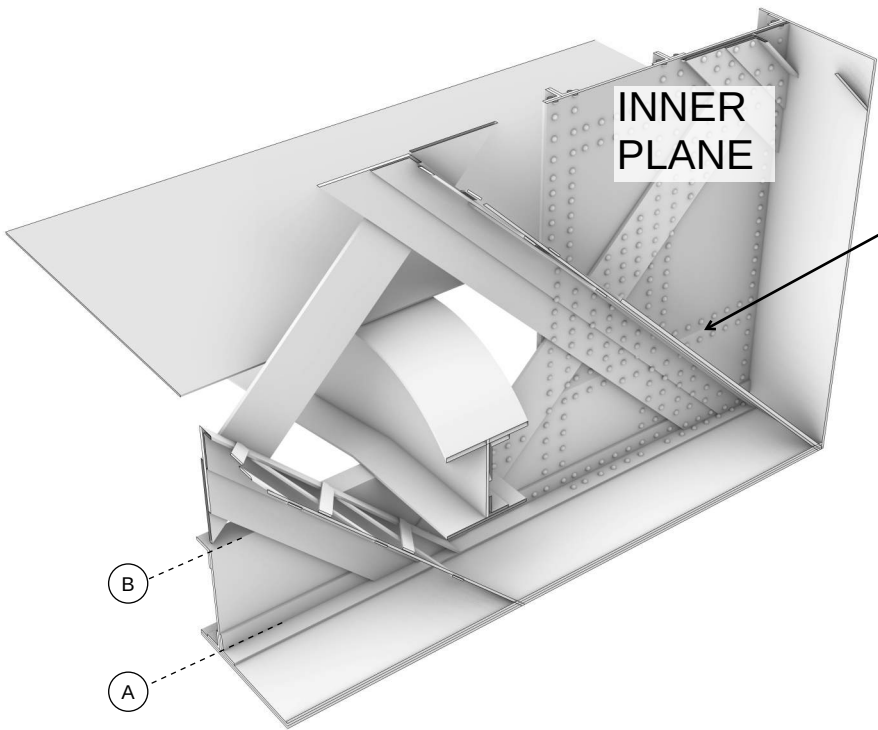
Assumed cross stiffener from bottom chord which runs into support box - not assumed typical

Debris at bottom of support box

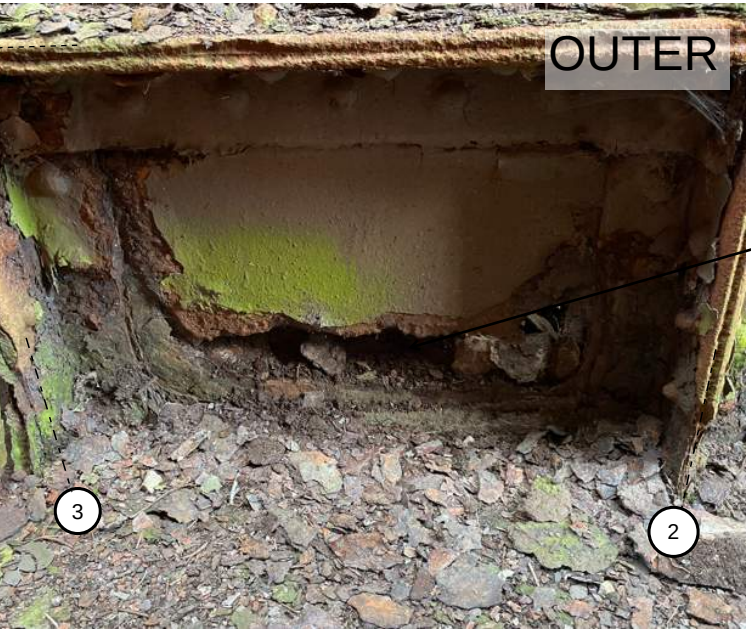
Hole to bottom of lower panel

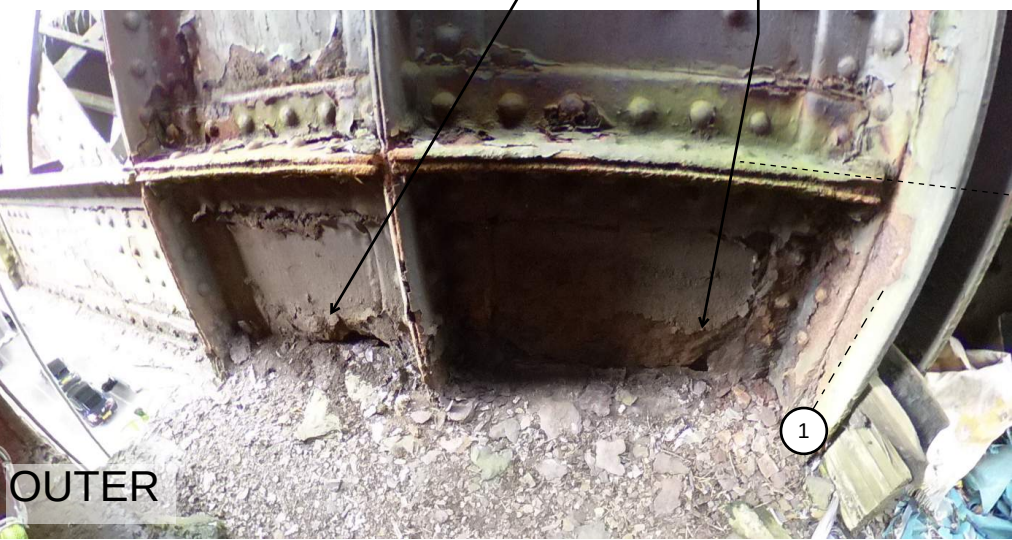
Holes to bottom of lower panels

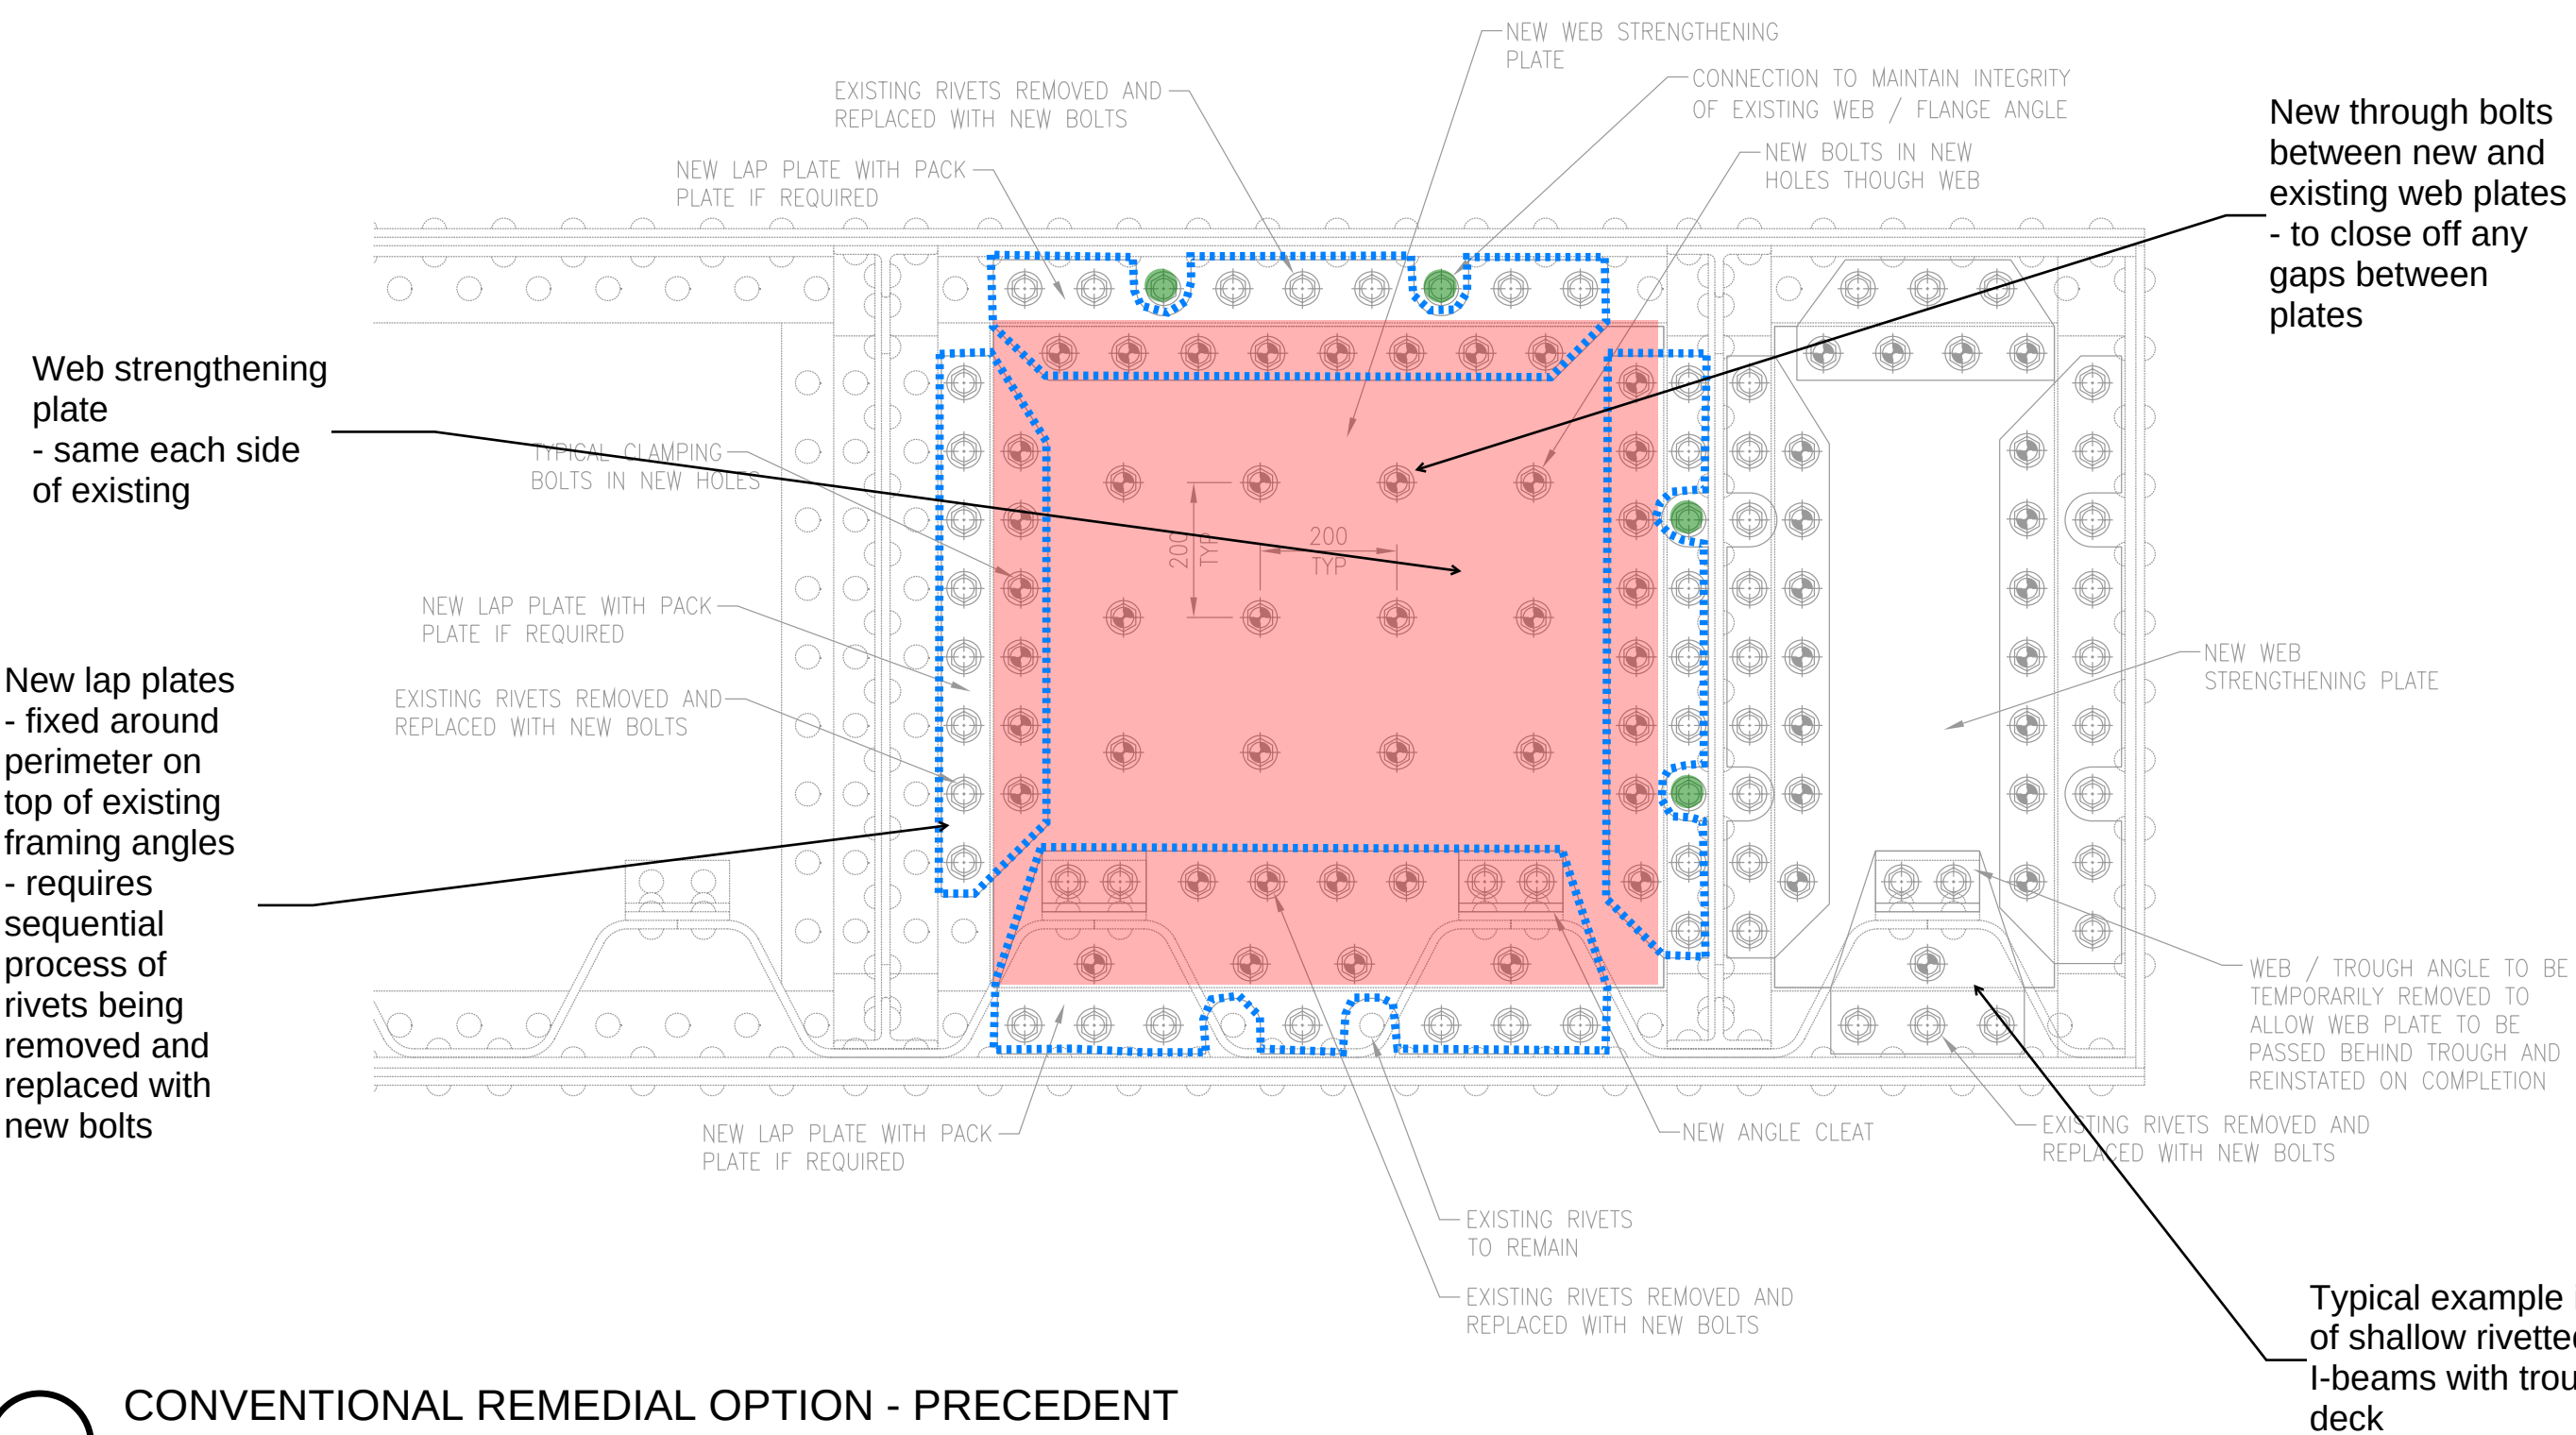
## CONVENTIONAL REMEDIAL OPTION

- assumes all rivets sequentially removed for new lap plates: potential temporary works required for support during removal + consequent lots of access required within box
- prevents future access to original steelwork behind: potentially creates water trap thus encouraging further corrosion

Web strengthening  
plate  
- same each side  
of existing

New lap plates  
- fixed around  
perimeter on  
top of existing  
framing angles  
- requires  
sequential  
process of  
rivets being  
removed and  
replaced with  
new bolts

New web plates either side of  
existing  
- provides symmetric remedial  
with no eccentricities  
- new web plate approx same  
thickness as existing stiffener  
flanges

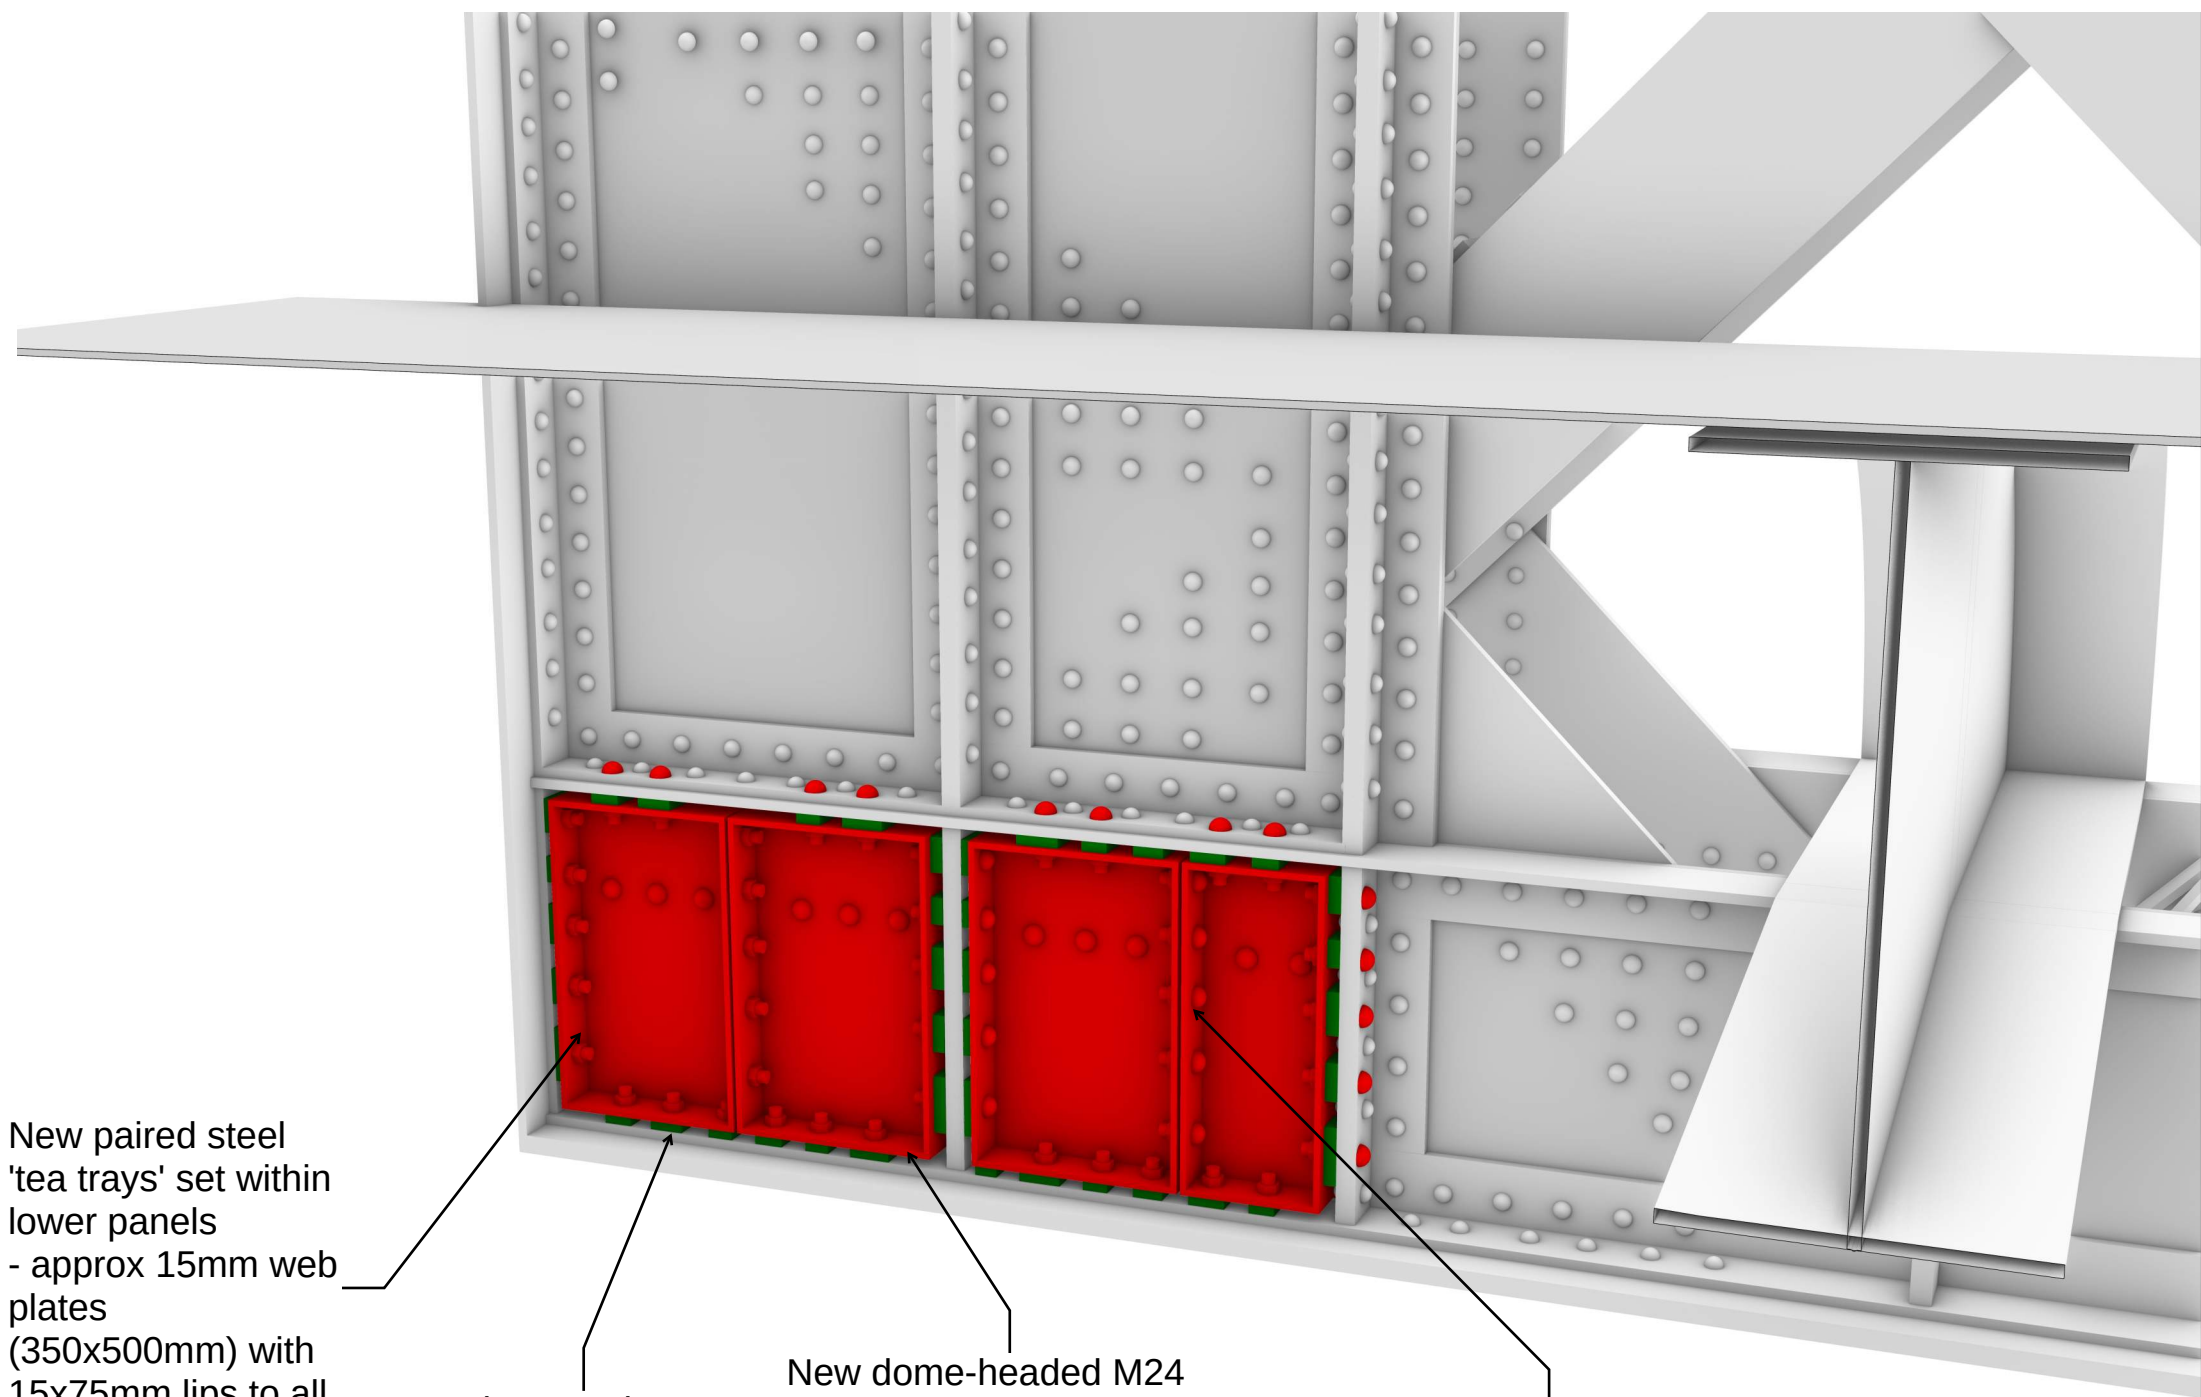
## ALTERNATIVE A - 'TEA TRAYS'

**CONS**  
- prohibits future access to original steelwork behind: proposes paired plates to allow for sequential future removal if required  
- tea tray spaced off existing plates, increases resulting eccentricities versus conventional remedial. Means horizontal bolts in bending and shear.  
- bolting around perimeter of tea tray requires new holes through existing stiffening angles, potentially weakening existing structure

New paired steel 'tea trays' set within lower panels  
- approx 15mm web plates (350x500mm) with 15x75mm lips to all 4 sides

Packers to close gaps to existing flanges, set between rivets  
- same all sides

Discrete bottom packers allows discharge of water from between vertical plates

Bolts into existing web plate require access within box  
- number shown approximately

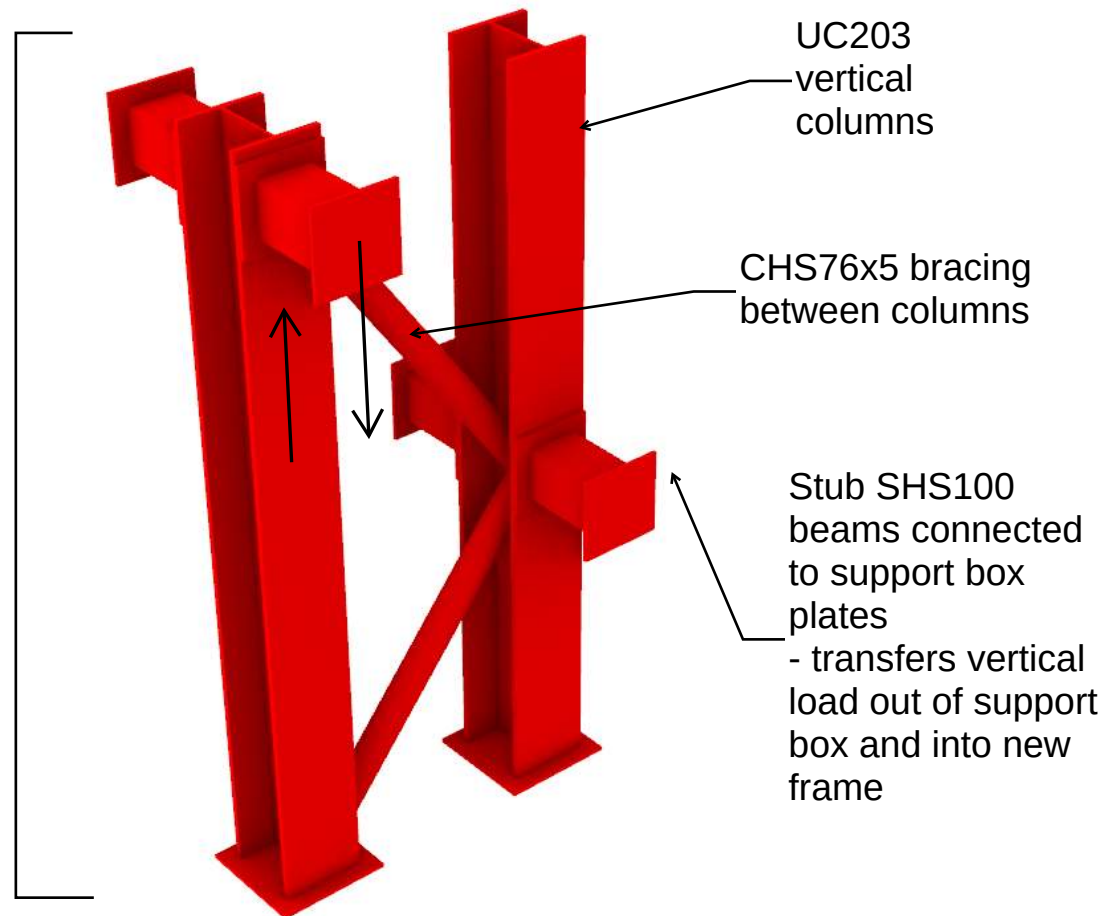
## ALTERNATIVE B - 'INTERNAL FRAME'

NOTE: Clashes with solid plate from compression diagonal. May require solid plate being temporarily cut out and reinstated around internal frame

Base plates with bolts through bottom plate and into pier head

Level of stubs set out to avoid clashes with diagonals

Bolts through plates requires access both sides

New internal steel frame  
- positioned centrally within support box

UC203 vertical columns

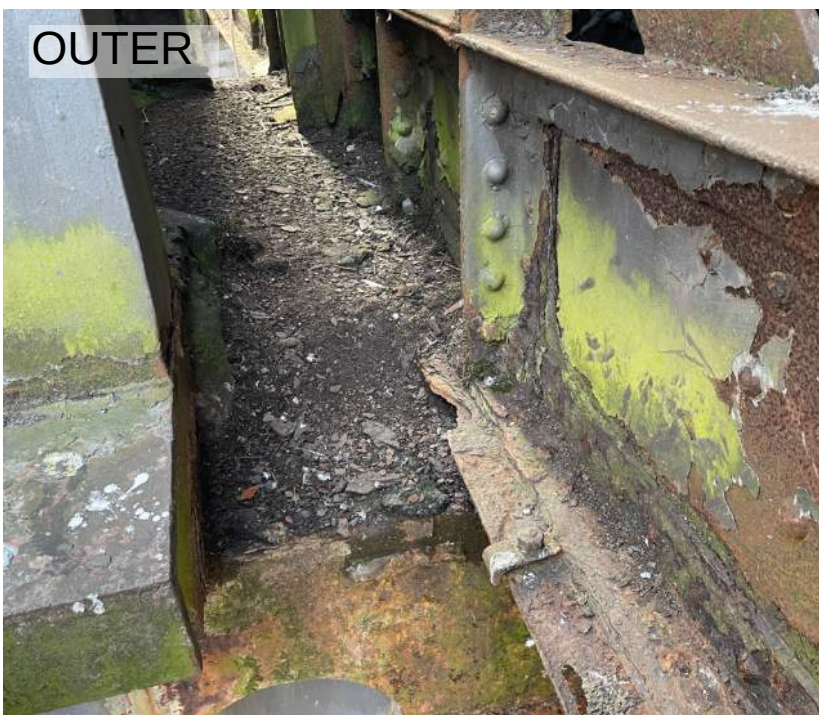
Reference examples of debris to be removed  
- sufficient for S.I  
- to avoid risk of falling debris to public
