## Castlefield Viaduct – Phase 2

Truss End Support Boxes – Remedial Options Appraisal

| Document verification | | | | | | |
|---|---|---|---|---|---|--|
| Document title | | Truss End Support Boxes – Options Appraisal | | | 282210 | |
| Revision | Date | Filename | CVI-ARUP-ZZ-ZZ-RP-S-000003 | | | |

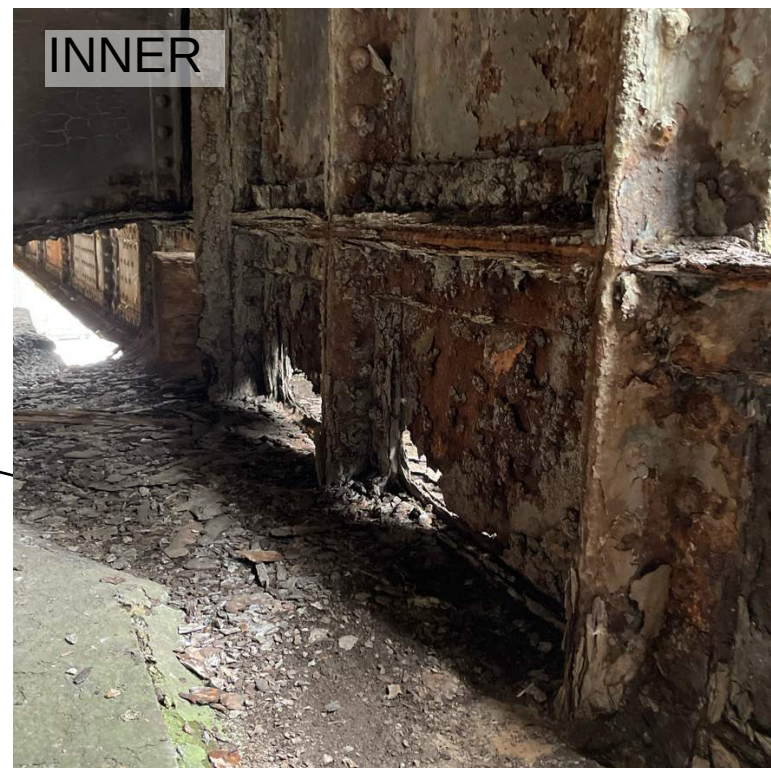
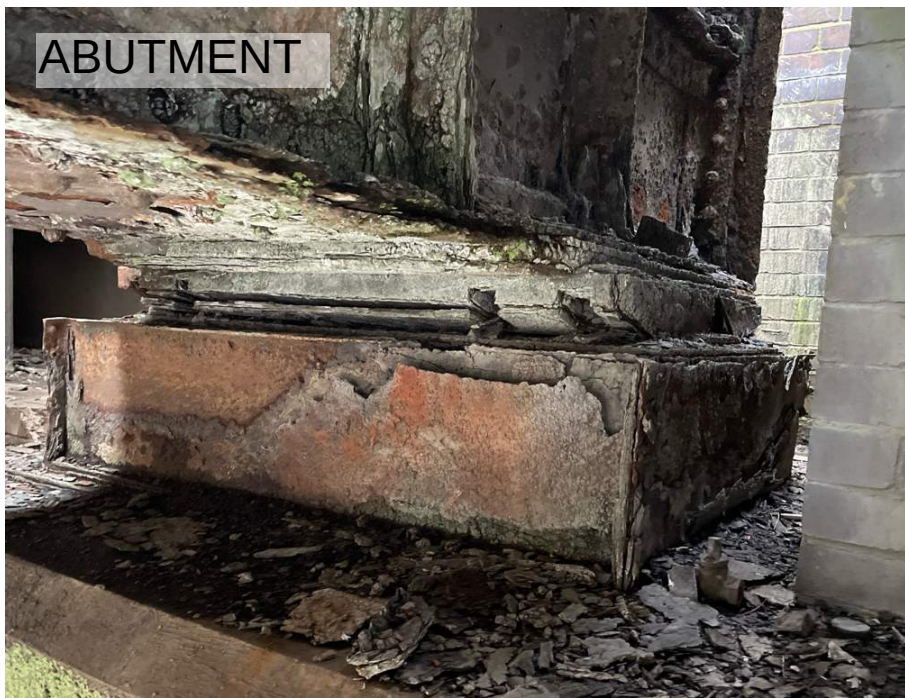
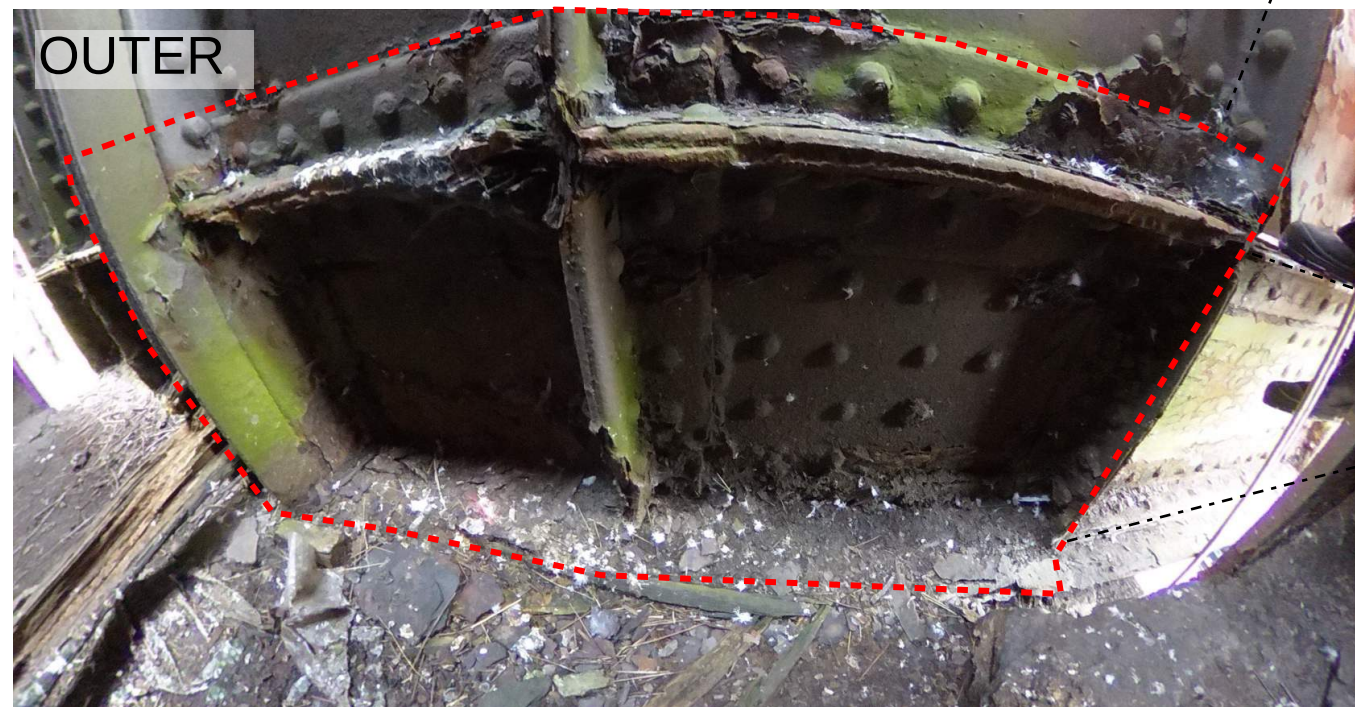
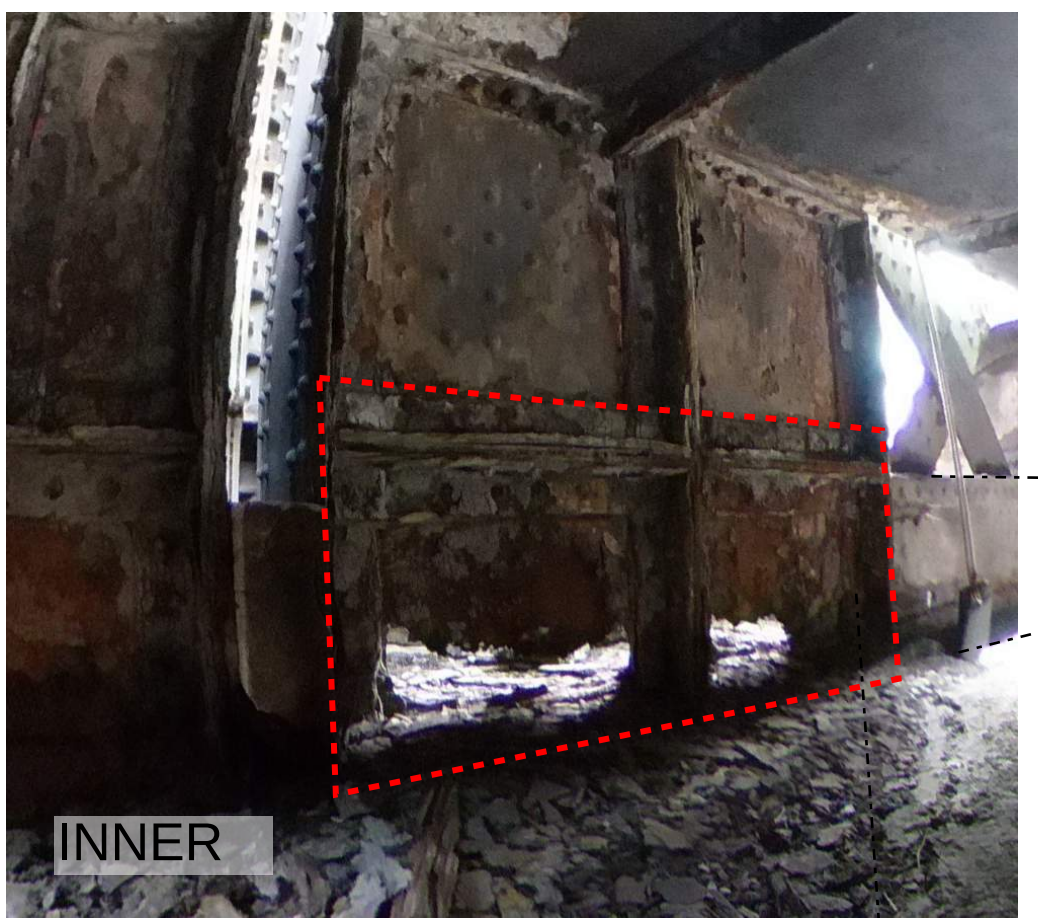
Reference examples of debris to be removed  
- sufficient for S.I  
- to avoid risk of falling debris to public

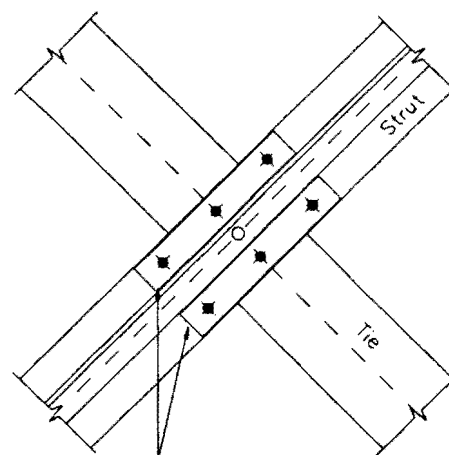
Internal Elevation  
Plating repair of corrosion to laced compressive member only

Plating repairs, 12mm plate + M20 bolts required if loss of lattice section exceeds 40% i.e. 1/2" (13mm) plate reduced to less than 8mm 5/8" (16mm) plate reduced to less than 10mm

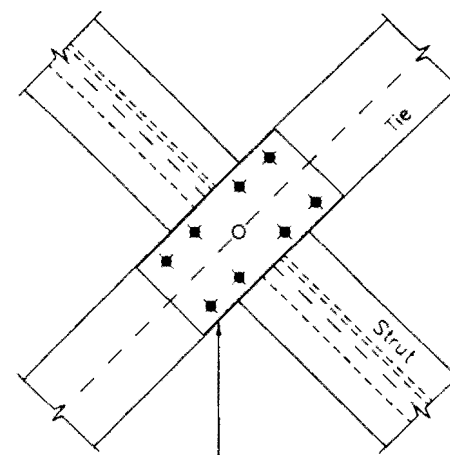
External Elevation  
Plating repair of corrosion to laced tension member only

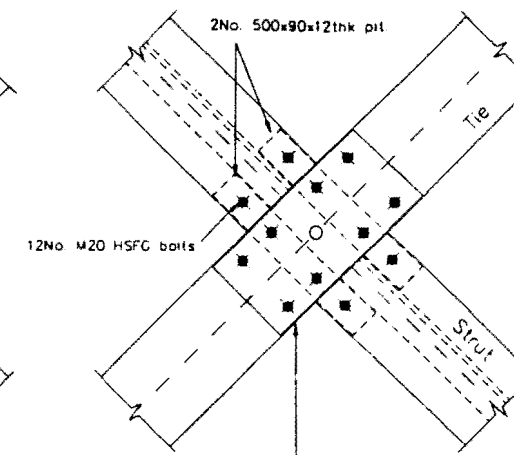
External Elevation  
Plating repair of corrosion to both tension and compression members

MR12 & MR13 : Plating repair of Lattice Intersections

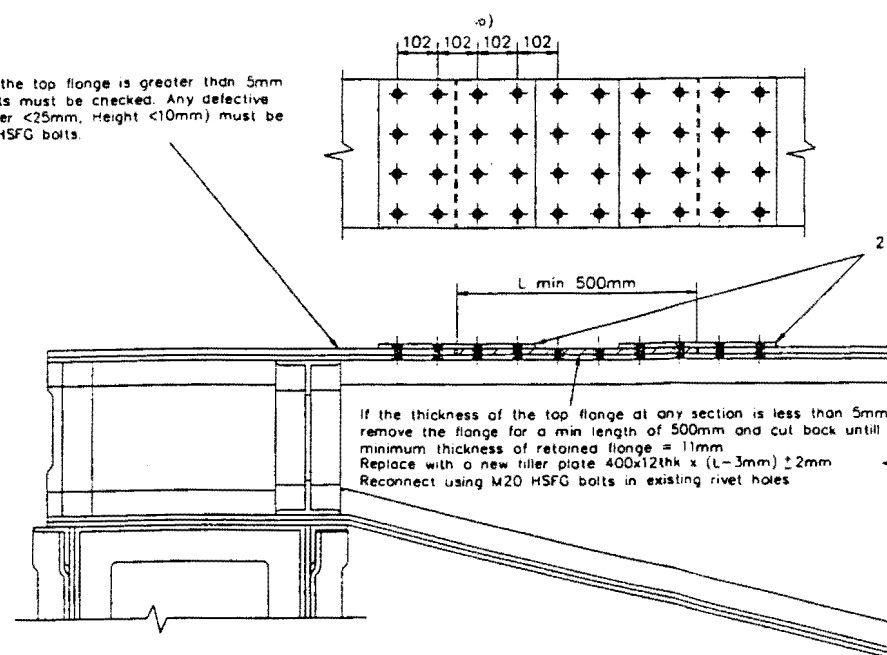
Elevation of Cross Girder  
MR11 : Repairs to top flange of  
Fish Belly Girders

Additional plating repairs required if cross girder stiffeners are corroded >40% loss of stock

If the thickness of the top flange at any section is less than 5mm remove the flange for a min length of 500mm and cut back until minimum thickness of retained flange = 11mm Replace with a new filler plate 400x12thk x (L-3mm) ±2mm Reconnect using M20 HSFG bolts in existing rivet holes

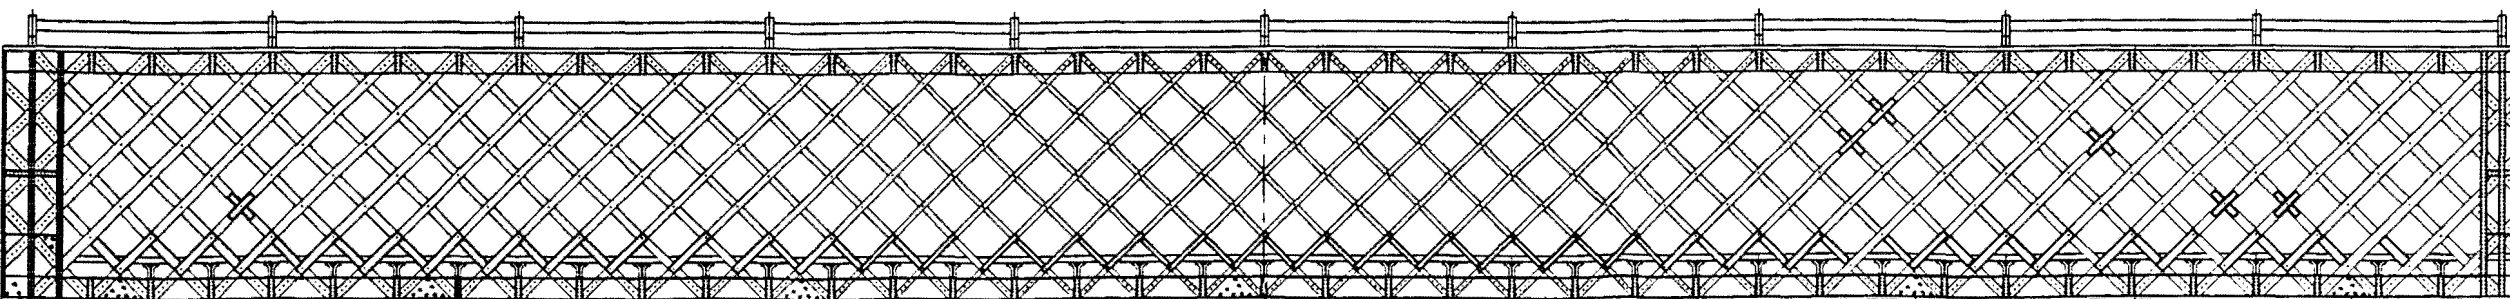
**INNER ELEVATION OF SOUTH GIRDER**

31% (85 No.) Rivet replacement on Lattice Intersections

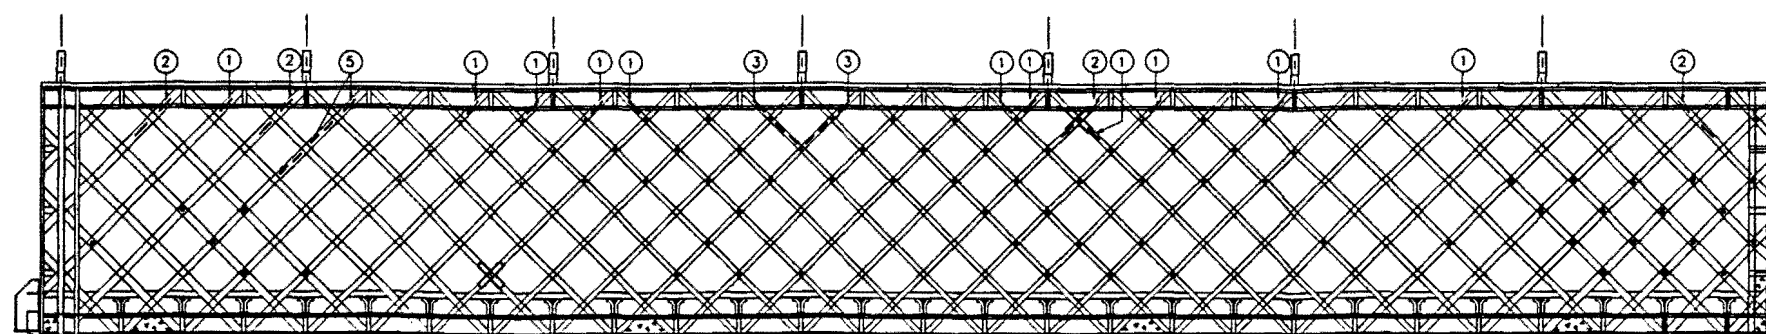
INNER ELEVATION OF SOUTH GIRDER

- ② Lacing Bars (26 No.)  
Number replaced on member shown
- ✕ MR13 Repairs (6 No.)
- Rivet Replacement (75 No.)
