Gas Membrane Installation  
Validation Report  
Kier  
Nelson Street  
Miles Platting  
Manchester  
M40 8BB

## Appendix 1 – Site Survey Sheets

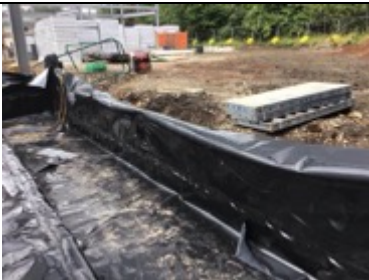
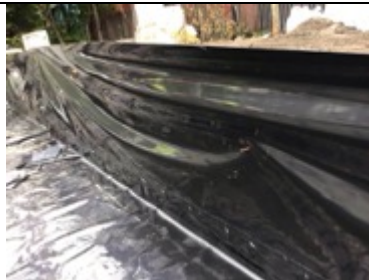
Perimeter membrane extended over the temporary shuttering

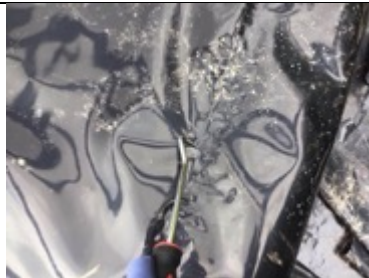
Testing sealed hand welded membrane lap joint

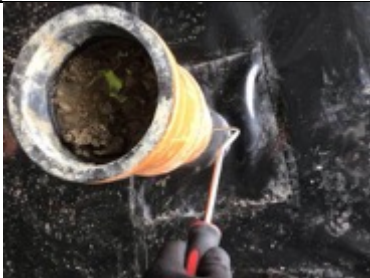
Testing Juta GP1 SAM sealing the top hat to the pipe sleeve

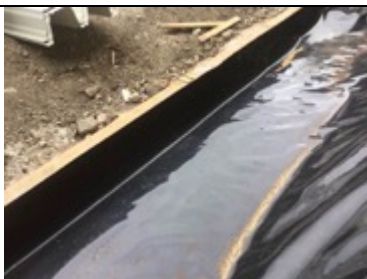
Membrane extended up the perimeter temporary shuttering

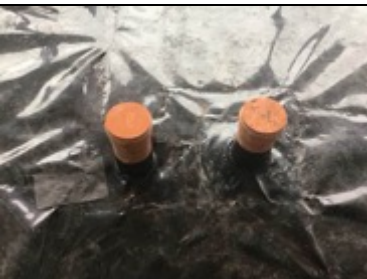
Sealed pipe penetrations

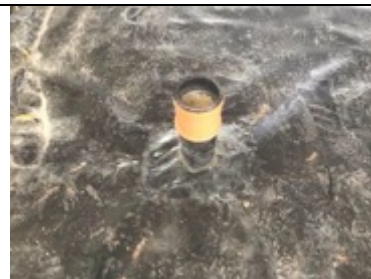
Sealed pipe penetration

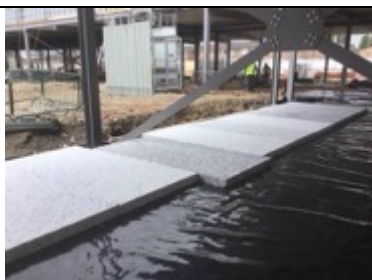
Insulation installed after the  
inspection

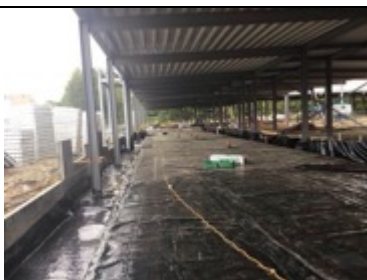
Pour 3 overview of completed works

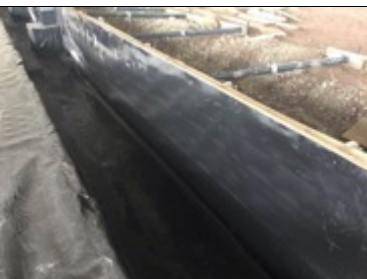
Membrane extended up the internal perimeter shuttering

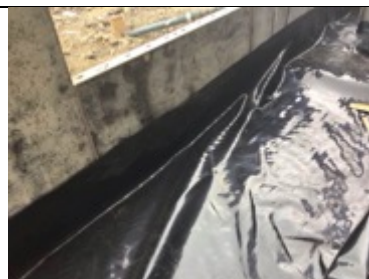
Membrane extended up the outer perimeter shuttering

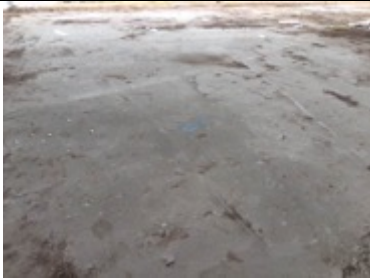
Sand blinded well rolled and compacted

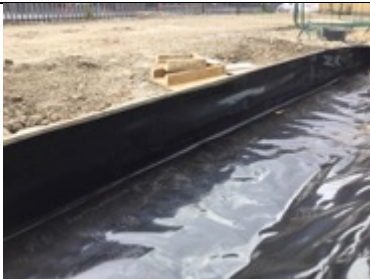
Membrane returned up the perimeter shutter and stapled at the top into place.

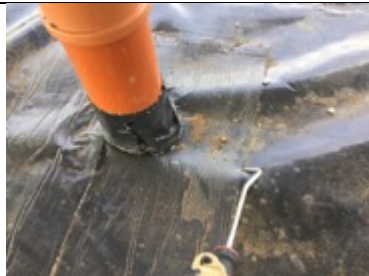
Pick testing to the pipe detail to Pour area 3.

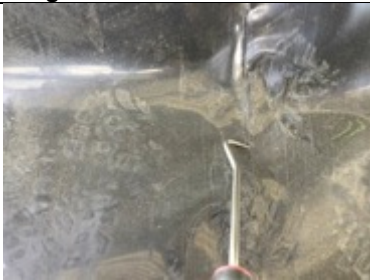
Pick testing to the hand welded Lap joint within pour area 3.

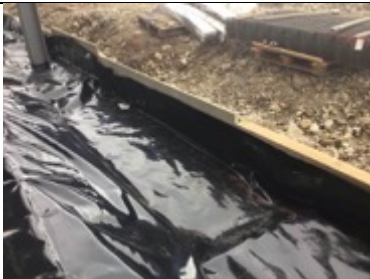
Perimeter membrane extended up the shuttering

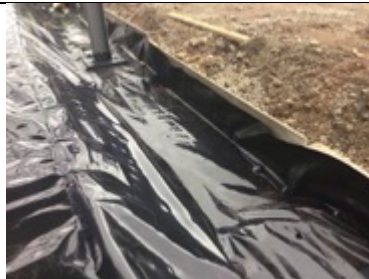
Perimeter membrane extended up the shuttering

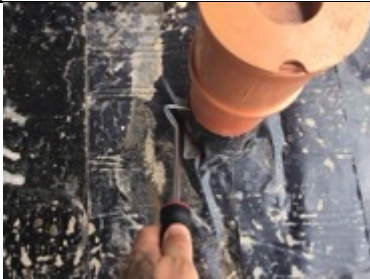
Testing pipe seals

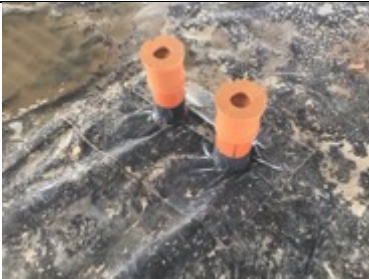
Sealed pipe penetrations
