## MCFC Project Taverna

### Coal Mining Risk Assessment

For: Manchester City Football Club

| <b>Report Reference:</b> | | <b>4490-02A</b> |

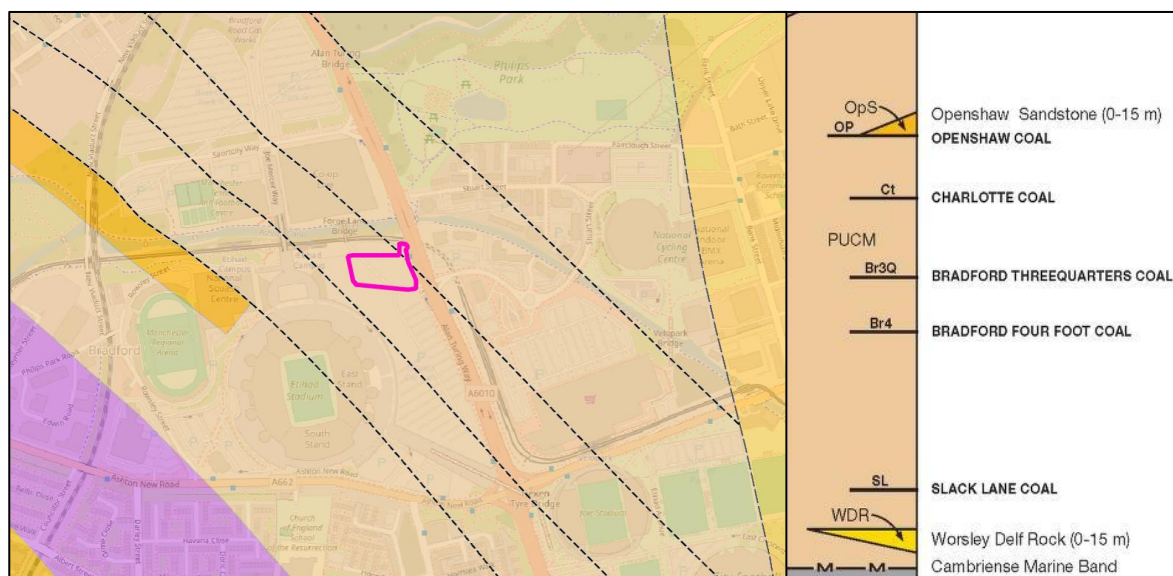
Figure 3: Extract of the BGS 1:50,000 solid geological map (Sheet 85 dated 2011) and associated GVS

The BGS 1:50,000 bedrock geological map (Figure 3) records 4 No. coal seams subcropping within 500m of the site. Given the bedrock dip of approximately 18° to the southwest, the seams that subcrop on and to the northeast of the site are expected to dip beneath the site and therefore represent the primary seams of concern with respect to potential shallow underground workings.

The BGS 1:50,000 scale map records the Bradford Fault approximately 500m east of the site, marking the boundary of the local fault block. Additional coal seams are expected to be present beneath the site; however, based on the geological sequence in this area, these are anticipated to occur at depths in excess of 100m below ground level and are therefore not considered a risk to the proposed development.

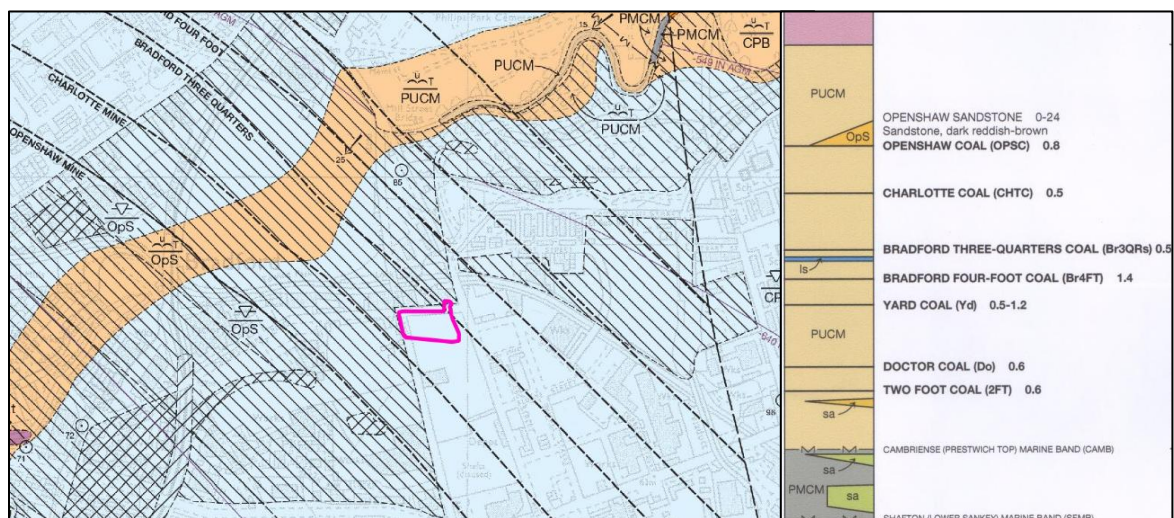
Figure 4: Extract of the BGS 1:10,560 solid geological map (ref: SJ89NE dated 2004) and associated GVS.

The subcrop position of the **Bradford Four Foot** coal seam is shown to be closer to the site than indicated on the BGS 1:50,000 scale mapping. An additional seam, identified as the **Yard Coal**, is recorded stratigraphically below the **Bradford Four Foot** seam and occupies the position where the 1:50,000 map locates the **Bradford Four Foot** seam.

The 1:10,000 scale map suggests that the **Bradford Three Quarters**, the **Bradford Four Foot** and **Yard Coal** all underly the site and could be at potentially shallow depths. The 1:10,000 scale geological map and general vertical section showing the sequence is shown below:

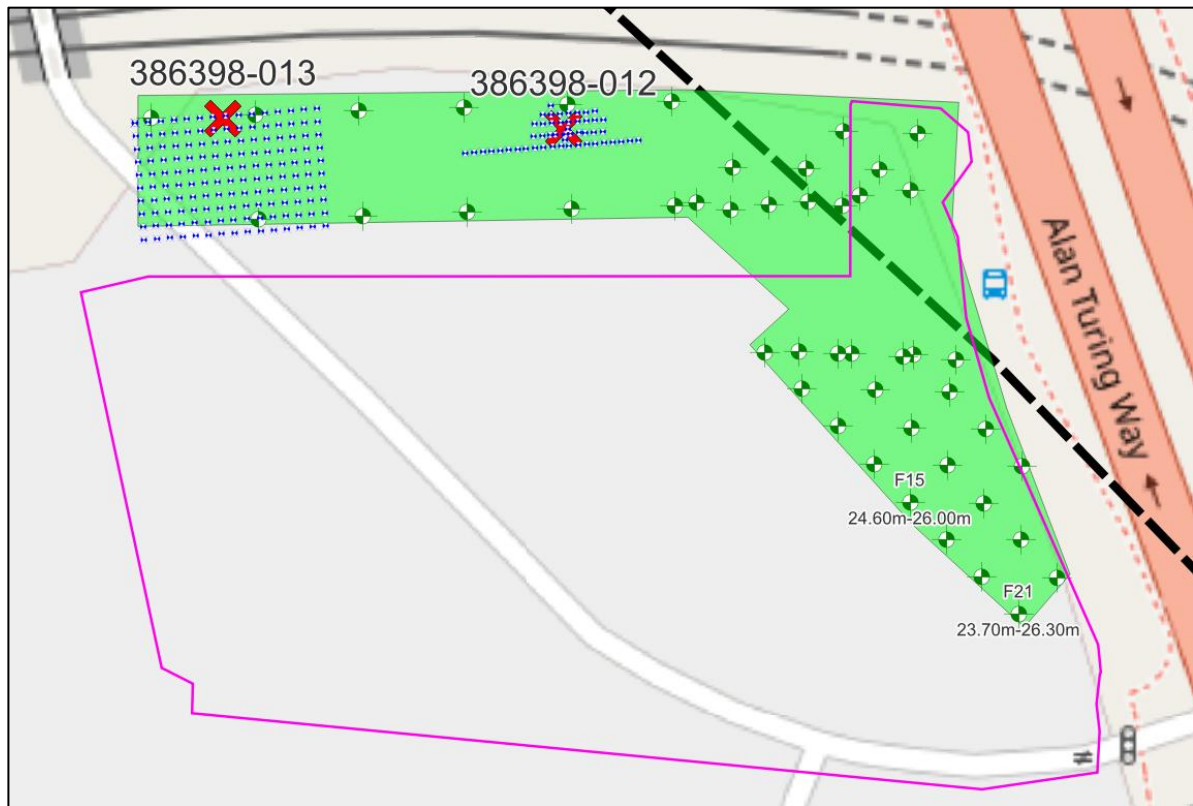
Figure 8: Mineshaft probing and drill & grout treatment areas in relation to the site (magenta).

The majority of the drill holes encountered intact coal. However, broken ground combined with a loss of flush was identified in two boreholes (F15 and F21) at depths of 24.60m to 26.00m and 23.70m to 26.30m bgl, respectively. The thickness of broken ground / lost flush on these holes is greater than the intact seam thickness recorded elsewhere. There is the potential for further broken ground west of these boreholes as they were located on the edge of the treatment area as shown in Figure 7, below.

Each hole was backfilled with grout upon completion of drilling, with the majority of holes taking no more than 0.3 to 0.4 tonnes, with the average grout take being recorded at 0.33 tonne per hole. The 2 No. boreholes with identified broken ground (F15 and F21) took 0.7 tonne and 0.4 tonne, respectively.

Mineshaft number 386398-012, which had previously been located and treated in 2001, had treatment works validated and a further 29 tonnes of grout injected to the full depth of the shaft.

However, broken ground, loss of flush and elevated grout takes potentially attributed with workings were recorded in drill holes F15 and F21. In these locations, the broken ground was recorded to extend to a thickness of 1.40m and 2.60m in F15 and F21 respectively. Although these holes were grouted, they were on the edge of the previous treatment area and no further holes were undertaken to the west of them. If further broken ground is present to the west of a similar thickness, then there would not be sufficient bedrock cover based on the 10T rule in this localised area.

It is recommended that further investigative works are undertaken immediately west of the previously grouted area to confirm whether additional zones of broken ground, of similar thickness to those recorded in boreholes F15 and F21, are present. The findings will determine whether supplementary grouting is required in this localised area. The 10T (10:1) cover line above the **Bradford Three Quarters** seam based solely on a 0.90 m seam thickness (rather than the greater broken ground

It is recommended that rotary boreholes are undertaken targeting the central and eastern parts of the site to confirm whether additional zones of broken ground or unrecorded shallow workings are present. These should be carried out to a target depth of at least 30m bgl. The outcome of this investigation will determine whether further remediation (i.e. drill & grout treatment), is required to stabilise the site for the proposed development.
