Whitworth Art Gallery, Manchester  
Results of Architectural Paint  
Research

28/10/2025

| Nature of Project | Architectural Paint Research to selected exterior railings to inform redecoration as part of renovation of the boundary wall. |

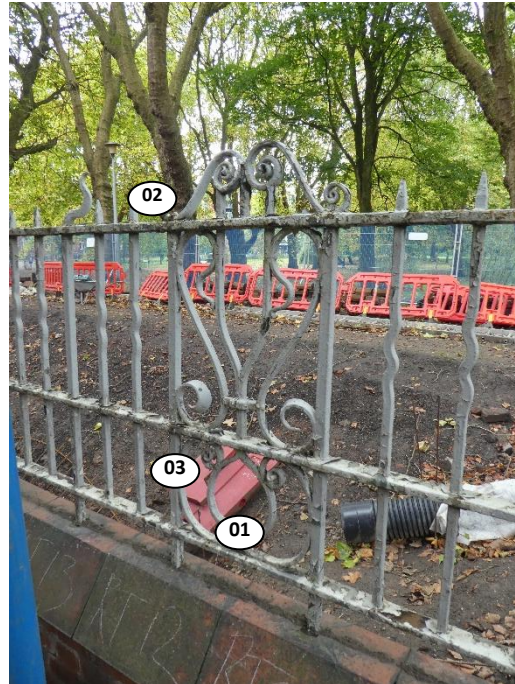
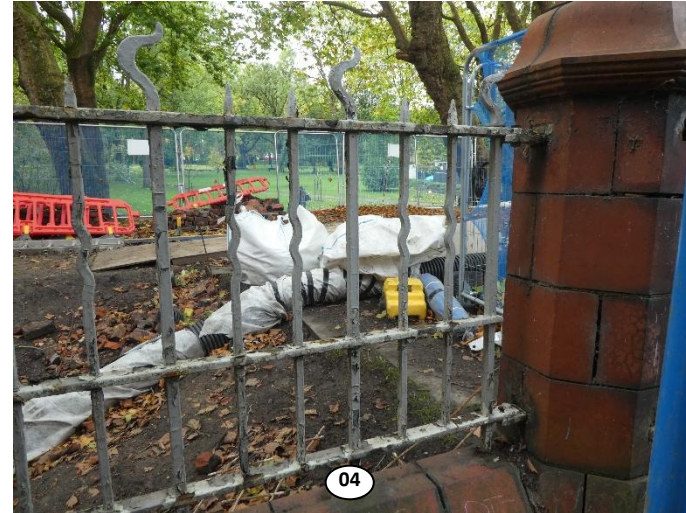
### 5.1. South elevation: west

- 01 – southwest, long length of railing, base of enrichment
- 02 – southwest, long length of railing, top of enrichment, scroll
- 03 – southwest, long length of railing, lower section of enrichment, bracket junction
- 04 – southwest, long length of railing, base of dog bar

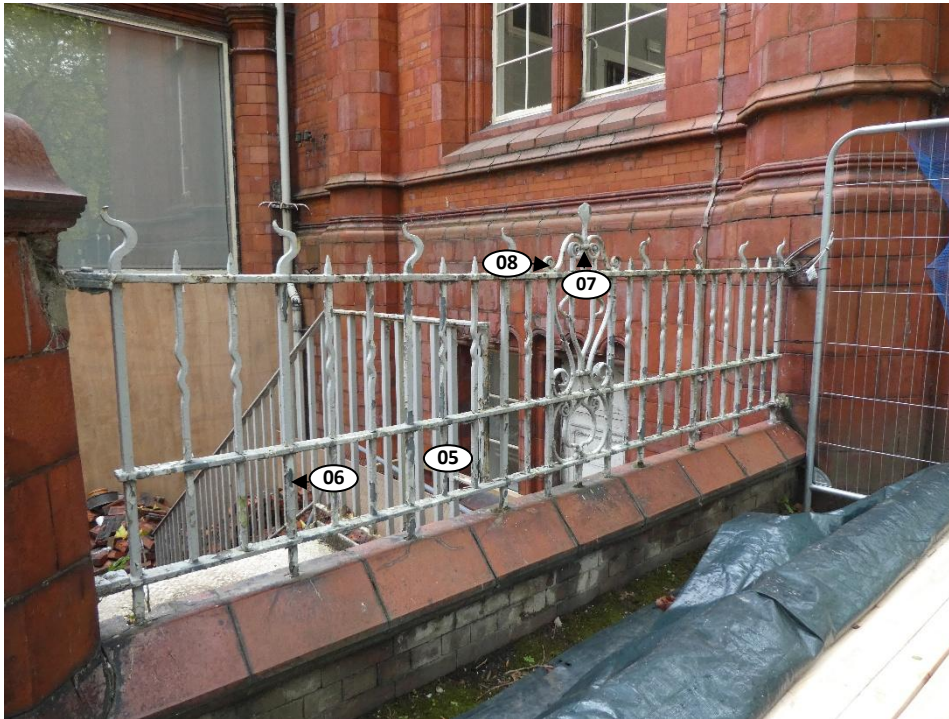
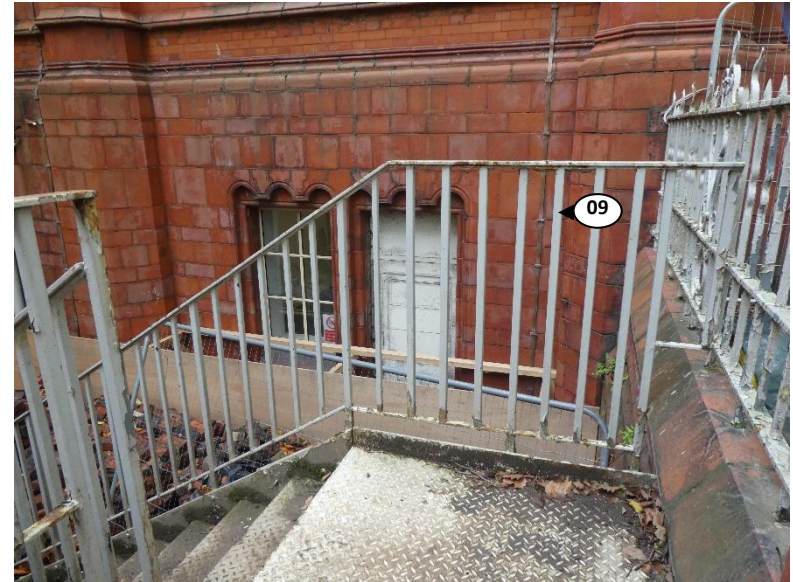
## 5.2. South elevation: east

- 05 – southeast short length of railing, dog bar, twisted**
- 06 – southeast short length of railing, dog bar, primary**
- 07 – southeast short length of railing, enrichment, upper, bracket**
- 08 – southeast short length of railing, enrichment, scroll**

- 09 – southeast railings to staircase, vertical dog bar (straight)**
