# Tree Condition Survey & Management Report

Hayescroft Gardens  
Didsbury  
Manchester  
M20 2AA

BE.240815.R

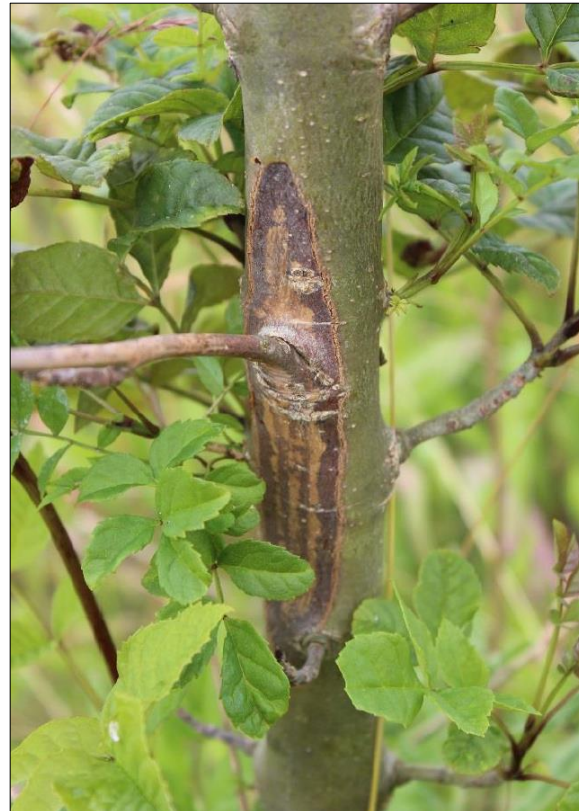
Figure C.1:  
Bartlett Library Image of Lesion Caused by Ash Dieback

- C.1.8 Consequence: Significant dieback throughout the crowns of affected trees, leading to brittle failures of branches and stem. Affected trees are also susceptible to secondary pathogens, such as Honey Fungus (*Armillaria mellea*) and subsequently prone to windthrow from root decay.
