## **Whitworth Art Gallery Spire Inspection**

16/04/2024

Client: NOVUS

| Project: | Whitworth Art Gallery – Spire Inspection |

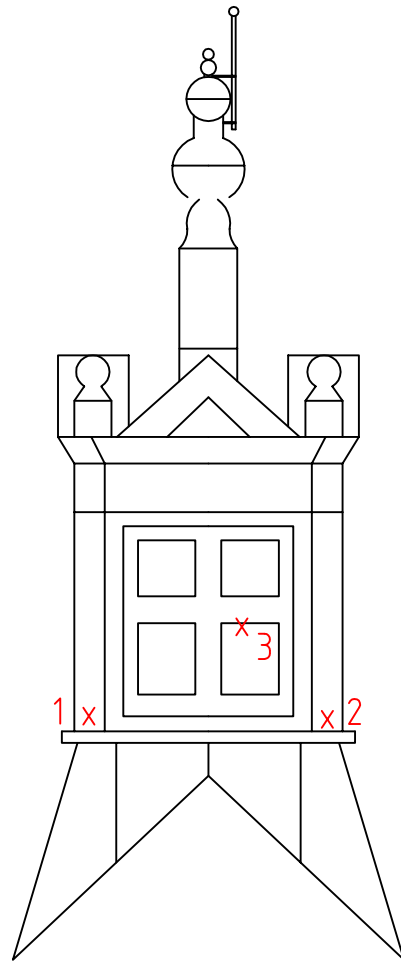
North

| Ref. | Description | Quantity | Length (mm) | Width (mm) | Depth (mm) | Comments | Photos |
|---|---|---|---|---|---|---|---|
| 1 | Timber - Missing, Timber - Rotten | 1No. | 200 | 150 | | | N1_1 |
| 3 | Timber - Missing | 1No. | 400 | 10 | | | N3_1 |

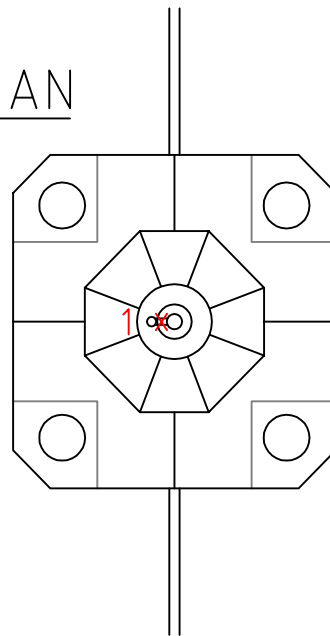
PLAN

| Ref. | Description | Quantity | Length (mm) | Width (mm) | Depth (mm) | Comments | Photos |
|---|---|---|---|---|---|---|---|
| 1 | Bracket - Corrosion | 1No. | 300 | 300 | | Corrosion and coating failure present on bracket holding the lightening rod | P1_1 |

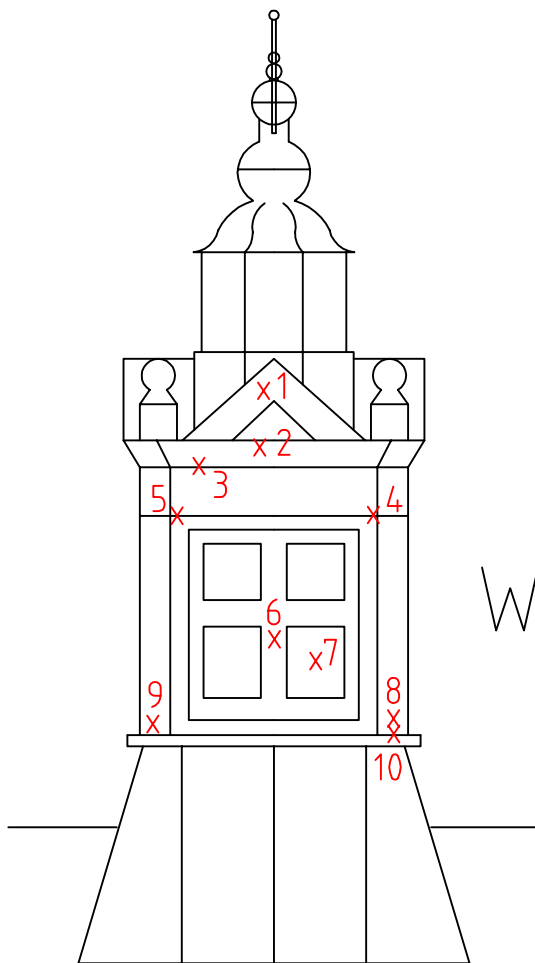
West

| Ref. | Description | Quantity | Length (mm) | Width (mm) | Depth (mm) | Comments | Photos |
|---|---|---|---|---|---|---|---|
| 2 | Coating - Degraded, Timber - Rotten, Timber - Split | 1No. | 1650 | 50 | 50 | Timber starting to rot and fixing starting to fail, small amount of movement within timber | W2_1 |
| 3 | Coating - Degraded, Timber - Rotten | 1No. | 900 | 100 | 20 | | W3_1 |
| 6 | Coating - Degraded, Timber - Rotten | 4No. | 450 | 25 | | All beading to base area of each opening are rotten | W6_1, W6_2, W6_3, W6_4 |
| 7 | Coating - Degraded | 1No. | 1100 | 1200 | | Coating to wire mesh degraded | W7_1, W7_2 |
| 8 | Timber - Missing, Timber - Rotten, Timber - Split | 1No. | 800 | 400 | 25 | Timber boarding and moulding to corners rotten at base | W8_1 |
