Gas Membrane Installation  
Validation Report  
Kier  
Nelson Street  
Miles Platting  
Manchester  
M40 8BB

## Appendix 1 – Site Survey Sheets

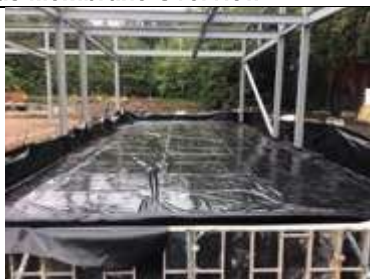
Overview of pour 1a line out installation

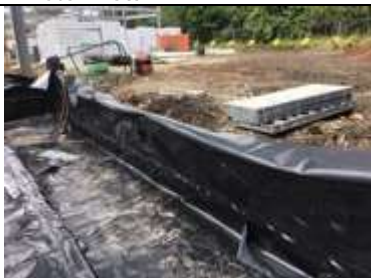
Perimeter membrane extended over the temporary shuttering

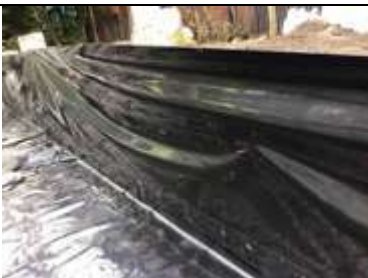
Perimeter membrane extended over the temporary shuttering

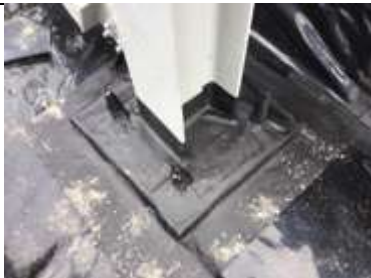
Stanchion detailing sealed using Juta GP1 SAM and heat applied

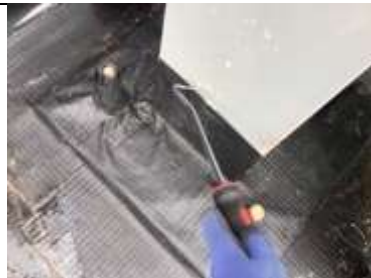
Pick testing stanchion sealing

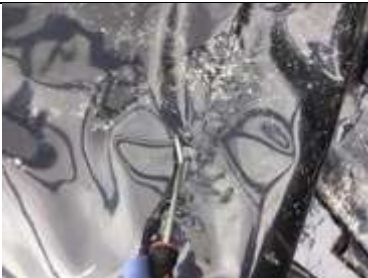
Testing sealed hand welded membrane lap joint

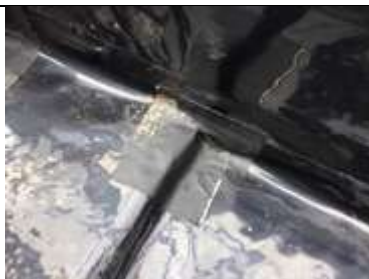
Corner detailing sealed using Juta  
GP1 SAM and heat applied

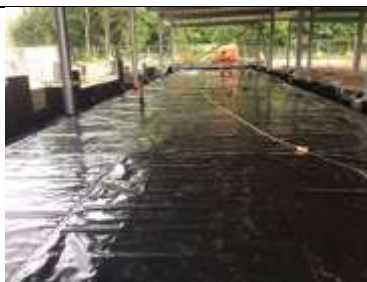
Alternate overview of the pour area installed

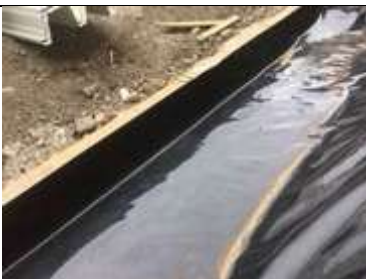
Membrane extended up the perimeter temporary shuttering

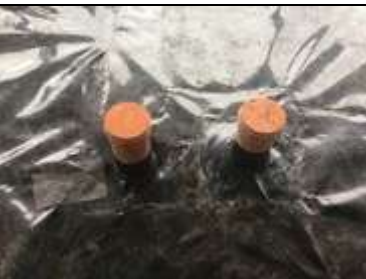
Sealed pipe penetrations

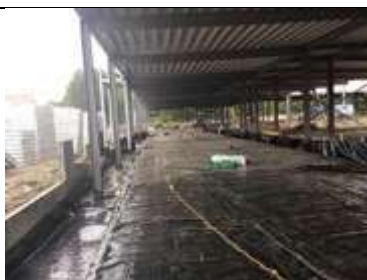
Pour 3 overview of completed works

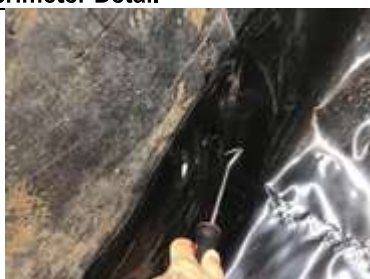
Testing perimeter hand weld

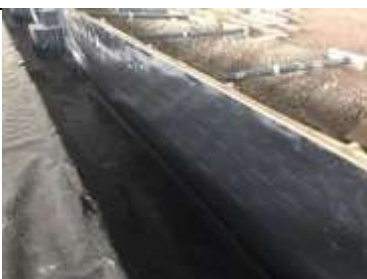
Membrane extended up the internal perimeter shuttering

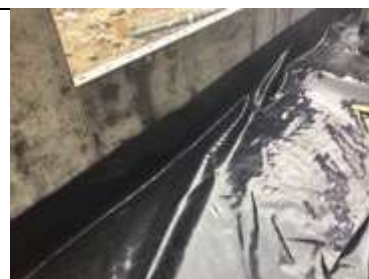
Membrane extended up the outer perimeter shuttering

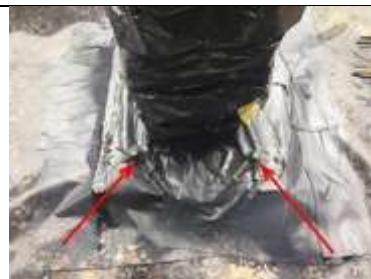
Double sided butyl tape used on  
the stanchion bolts

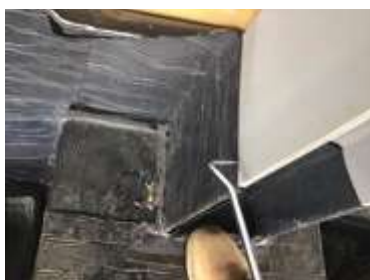
Probe testing stanchion sealing

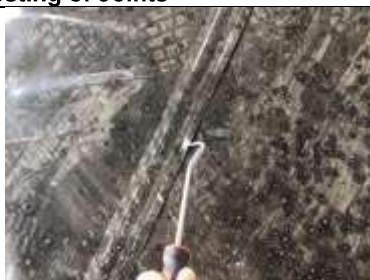
Testing auto welded membrane  
lap joint

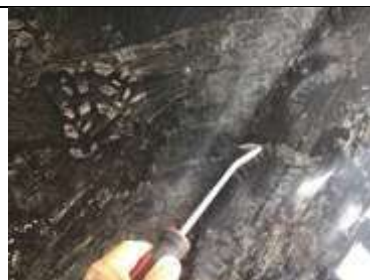
Testing hand welded membrane  
lap joint

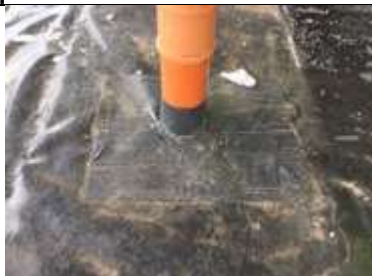
Sealed pipe penetration detail within pour area 3.

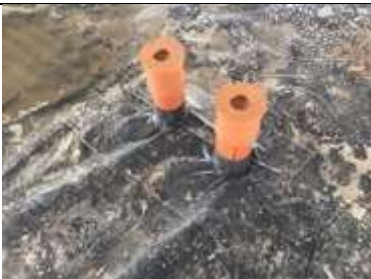
Sealed pipe penetrations

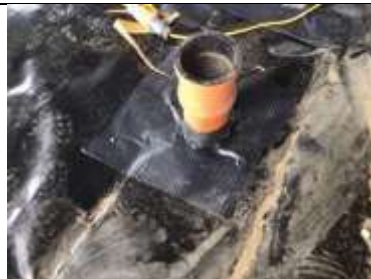
Sealed pipe penetrations
