**PHASE I DESK STUDY & SITE  
INVESTIGATION REPORT**

**PALATINE ROAD**

**DIDSBURY**

**Report Ref: A6550/25/SI**

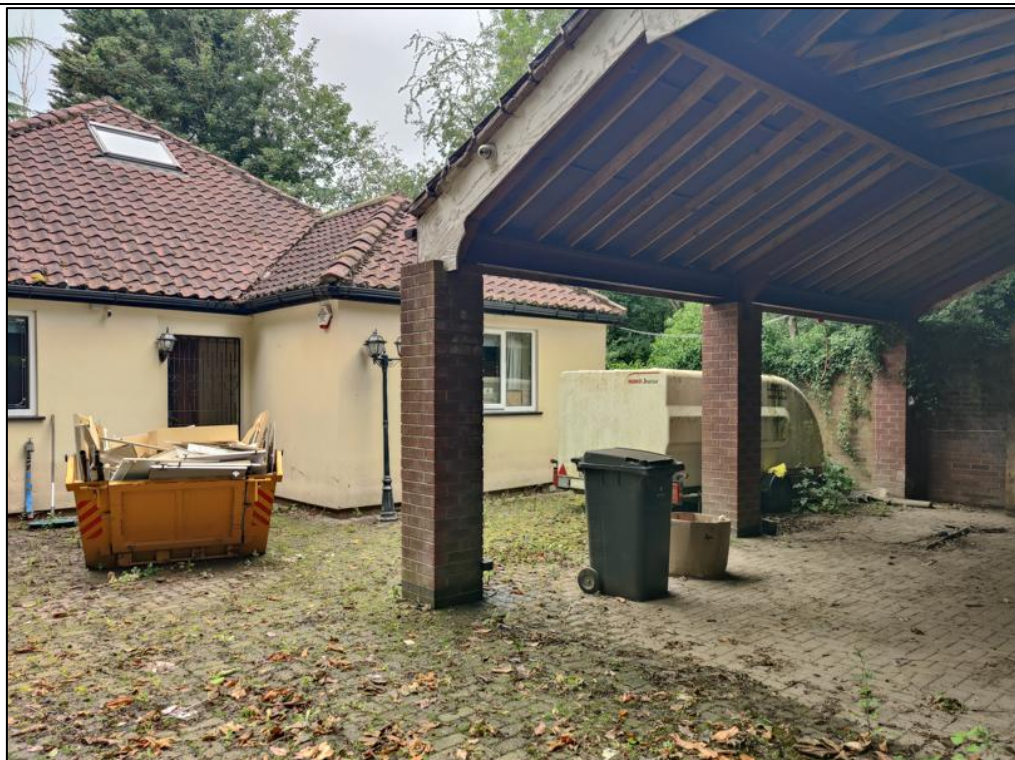
Photograph viewing northeast showing the front of the existing property

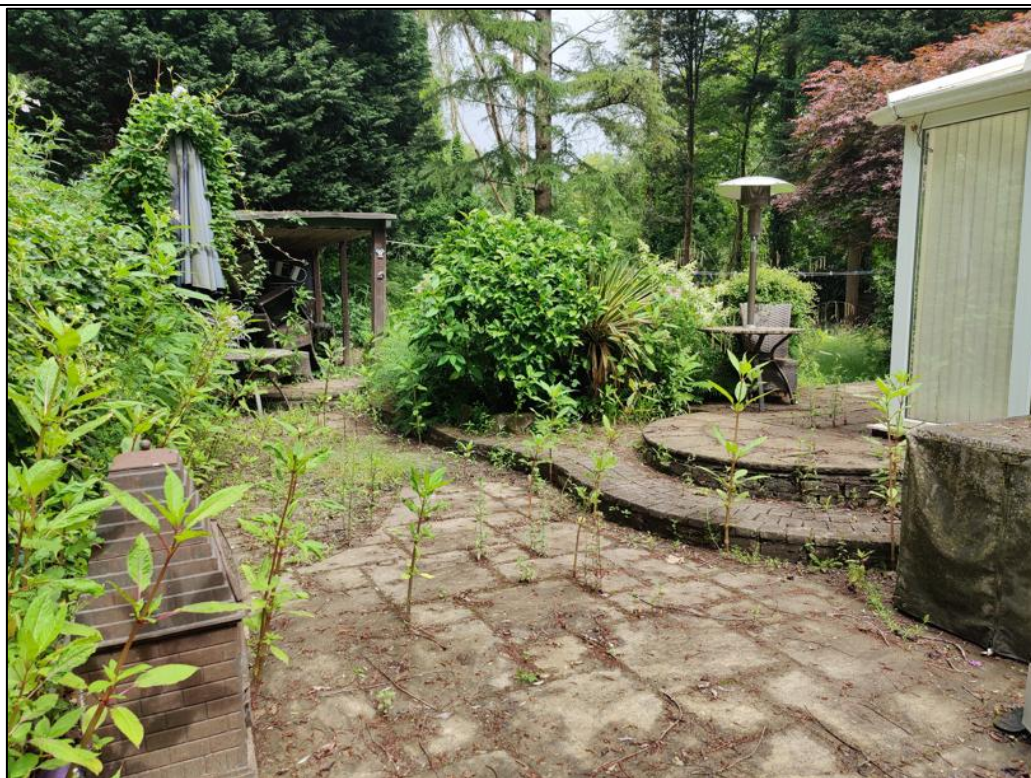
| Contamination Assessment | No significant sources of contamination identified during the desk study.<br>Gravel layer containing ash and clinker to the rear of the property should be removed during redevelopment of the garden area.<br>No further visual or olfactory evidence of contamination observed during the ground investigation. |

Photograph viewing southeast showing the rear of the existing property

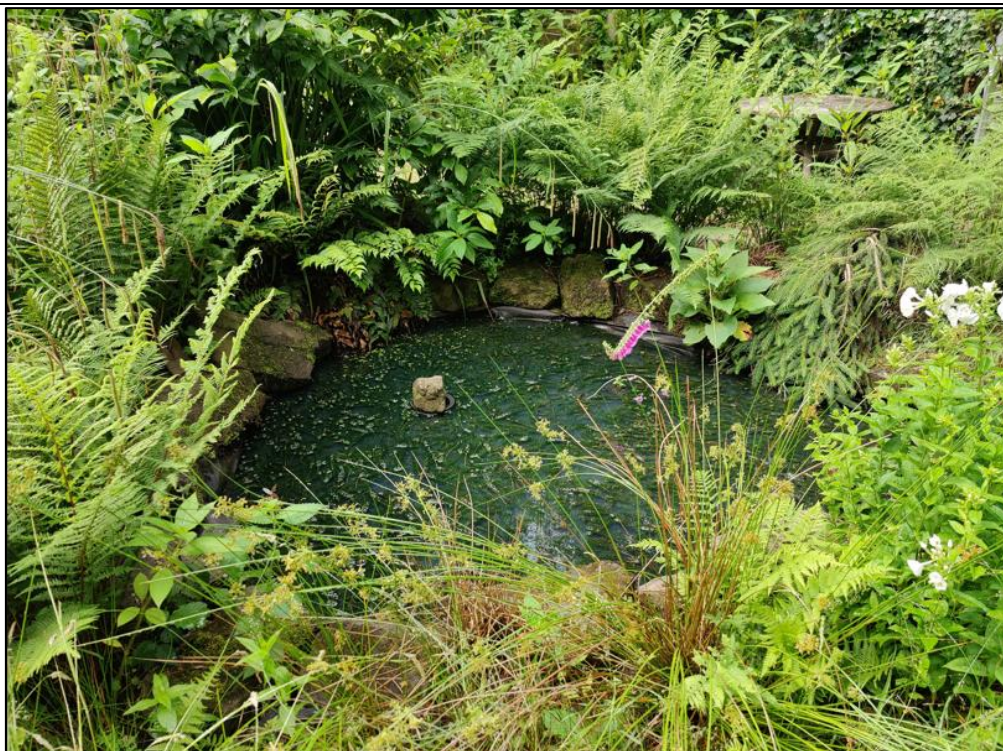
Photograph viewing north showing the pond, north of the existing property

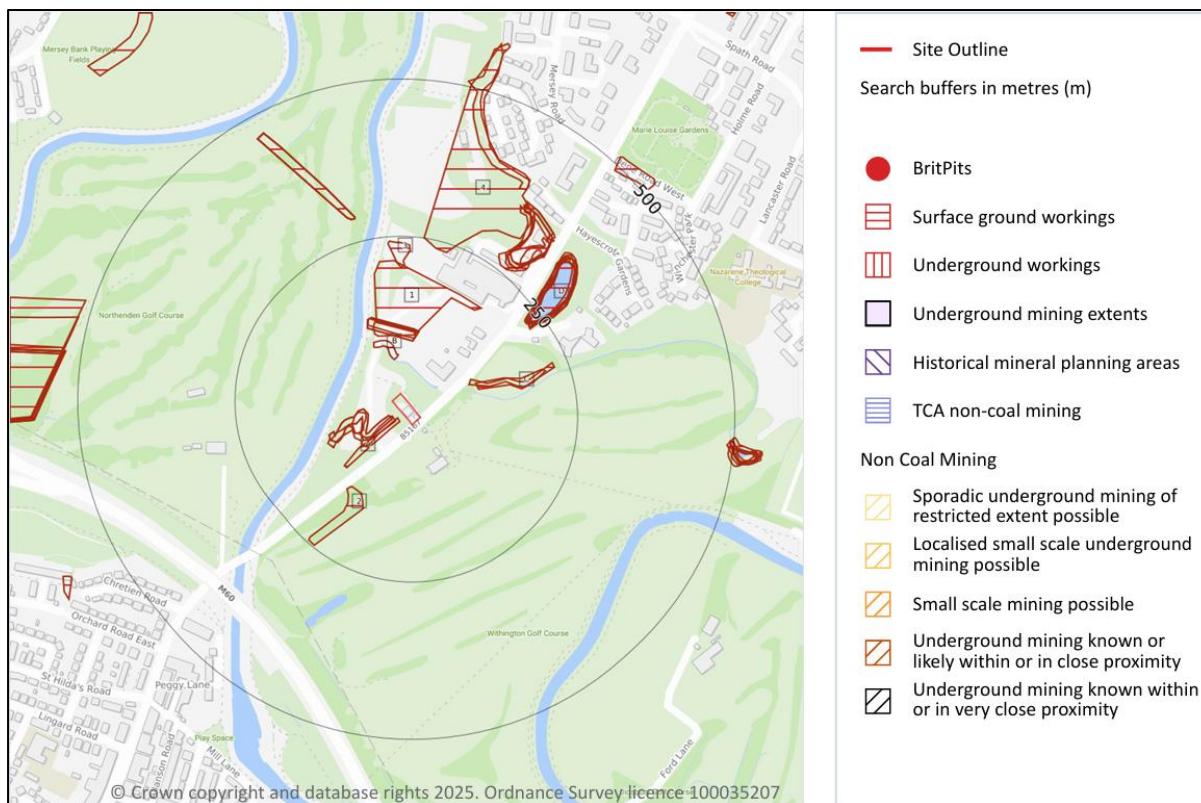
**Figure 4: Mining & Ground Workings Map**

There are 27no. records of historical surface ground working features identified within 250m of the site boundary. The closest record refers to unspecified ground workings located 11m southwest of the site, mapped in 1923. The remaining records refer to further unspecified ground workings, gravel pit, unspecified pits, unspecified heaps and ponds.

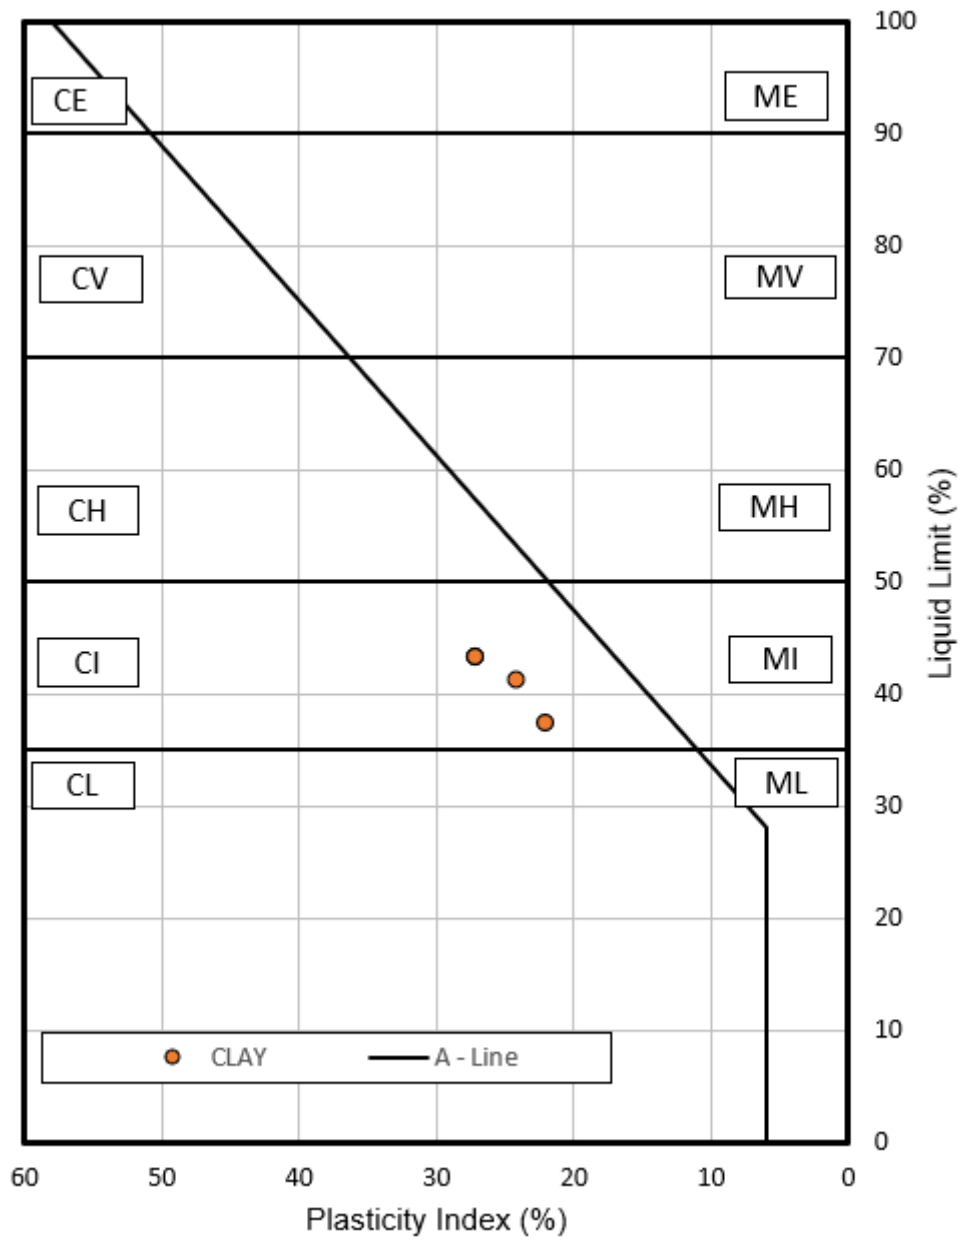
Figure 13: Plasticity Chart

Atterberg Limit tests were carried out on four samples of the clay. Results of the test reported **liquid limit** values in the range of 37% to 43% and **plastic limit** values in the range of 15% to 17%, resulting in values of **plasticity index** in the range of 22% to 27%. These results suggest the clay to be of **intermediate plasticity**. Results are shown on the Plasticity Chart in Figure 13, overleaf.
