**PHASE I GEOENVIRONMENTAL DESK STUDY**

**BOAT LANE**

**NORTHENDEN**

**Report Ref: A6986/25/FDS/V2**

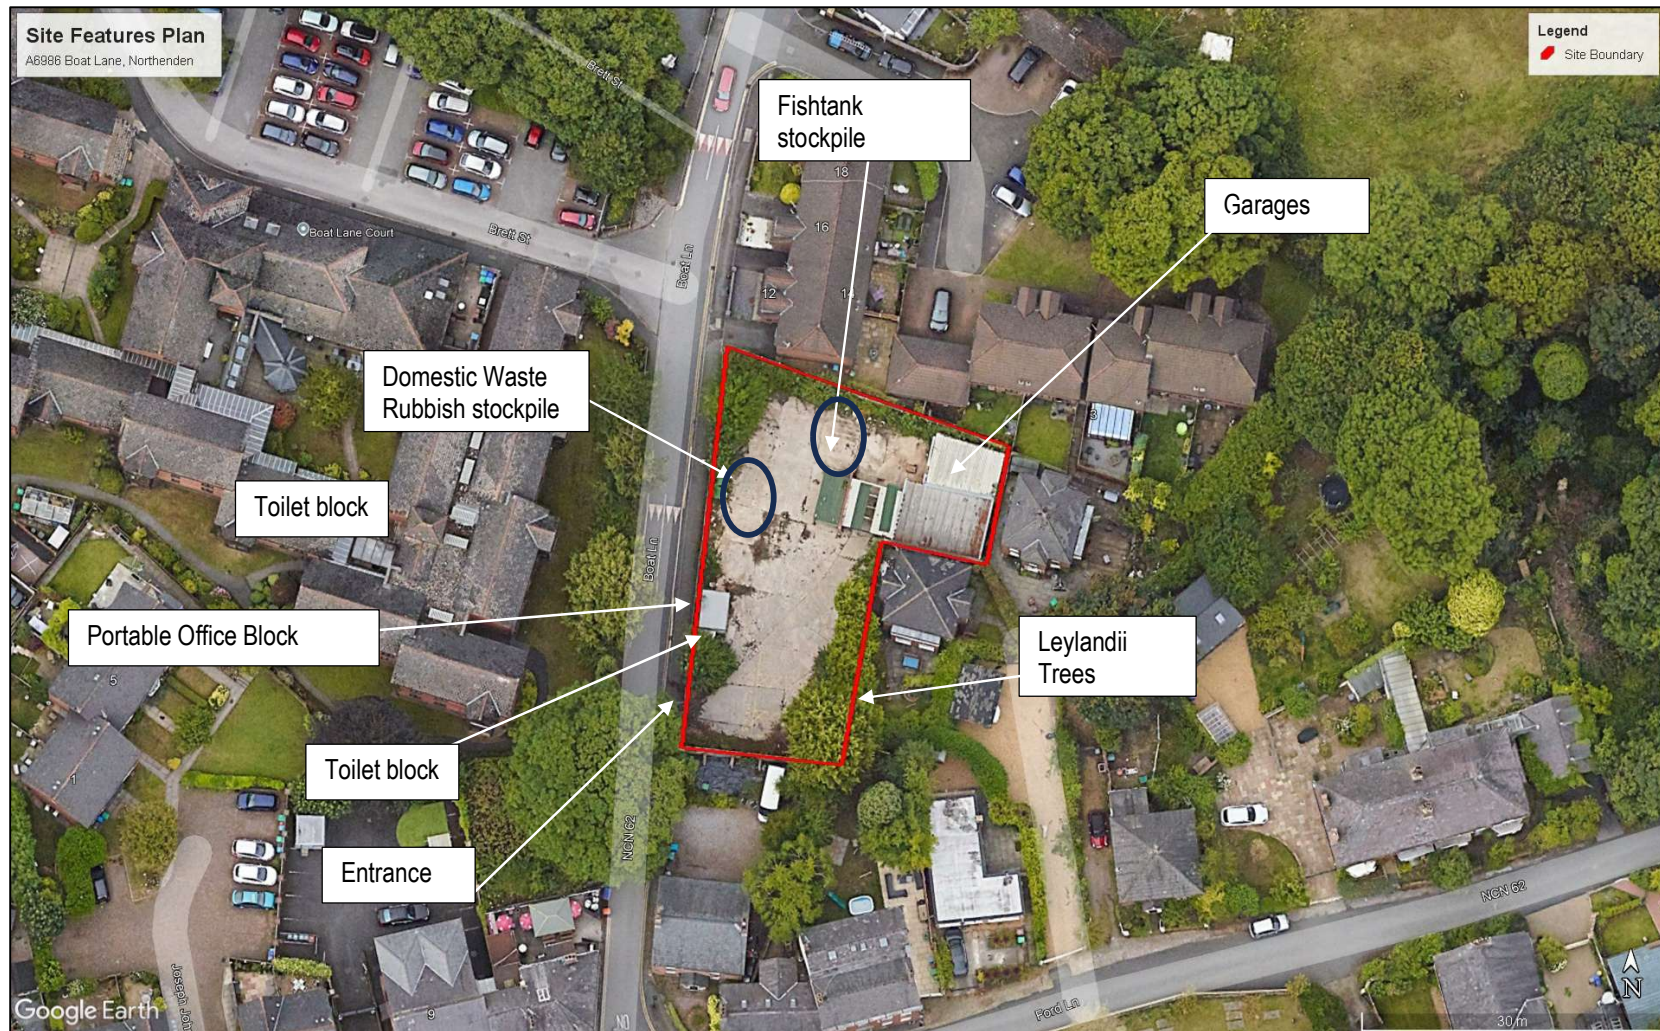
**Figure 8 Site Features Plan**

- 5.6 The surrounding area is residential in all directions with multiple mature trees, including Leylandii, silver birch, sycamore, and cherry.
