# Grosvenor West- Front Stone Elevation observations and recommended interventions

## Appraisal Report & Design proposals

**Curtins Ref: 073425-CUR-ZZ-ZZ-RP-S-000090**

Site Address: Grosvenor West, 153 Oxford Rd, Manchester M15 6AD

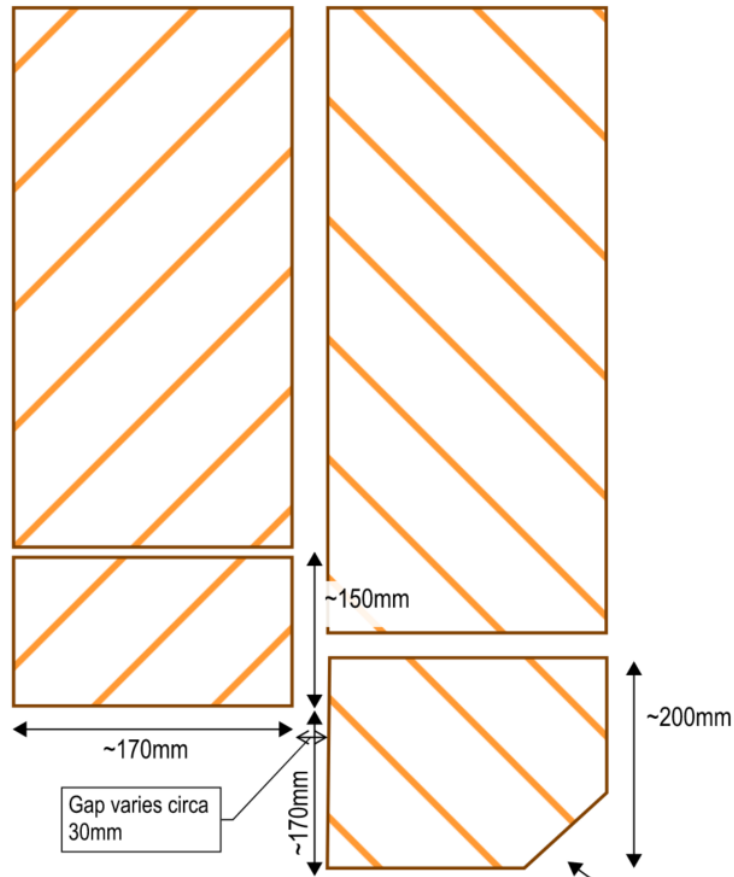
Close inspection in 2023 (from scaffolding) showed the arches are composed of an outer decorative arch and an inner leaf arch. The inner arch is elevated by approximately 150mm and the two appear not to be keyed together (at least those near the arches).

To the Western arched gable, this has resulted in some differential lateral movement which has widened the original vertical mortar joint between them (little mortar is present implying it has dropped out). The joint between varies up to around 40mm, which is assumed to be roughly double the original joint size. This implies there has been some lateral separation of the arches suggesting the outer arched gable has moved outwards, away from the main structure.

Therefore, given the risks and modest sensitive remedial measures proposed, it is considered proportionate to perform tying repairs now to mitigate risk of the outer archway / gable wall pulling away from the building elevation.

It is proposed to install specialist metallic reinforcement designed for masonry / stone retrofit tying. These are only to provide a tension 'cavity tie' between the arches, not transfer vertical loading. This enables the ties to be a minimal cross section, minimising the drilled holes in stonework to sensitively repair. Quality Finishing to these ties in the stone façade is required to be both visually unobtrusive and to minimise environmental degradation to the stone or the metallic ties. To achieve this depends on the particular proprietary system employed. This generally involves recessing the ties below the surface and covering over with a matching stone/ mortar (if in the mortar joint). Recommendations from the Helifix Cemtie product proposed are:

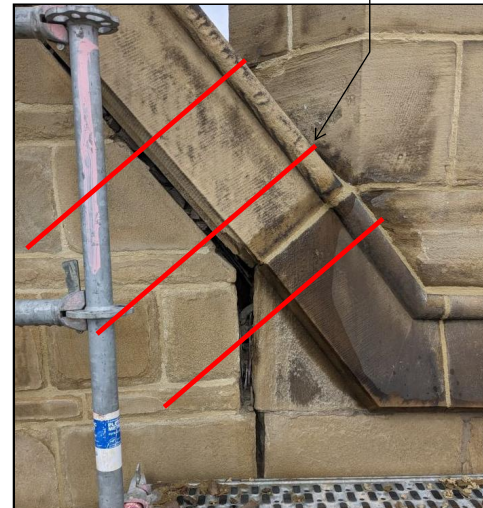
**Issue:** Locally enlarged stone joints under coping & vertically indicates previous movement cracking. (Has been reinstated with mortar).  
**Proposals:** Local crack stitching to mitigate risk of crack growth. See **Detail 2**

**PROPOSALS:** SPECIALIST LOCALISED CRACK STITCHING TO MITIGATE RISK OF CRACK GROWTH.  
**WARNING:** FRONT STONE LEAF APPEARS 100mm ONLY- METHODOLOGY IS TO GUARENTEE CENTERING OF FIXINGS.

**METHODOLOGY**  
1. PRE-DRILL INCLINED HOLES USING CONTROLLED TECHNIQUE TO GUARENTEE CORRECT ANGLE.  
2. SPECIALIST INSTALLER OF TIES  
3. COUNTERSINK THE TIES AND REMEDIATE STONE SURFACE WITH SENSITIVE TECHNIQUE- REINSERTED CYLINDRICAL CORE OR RECONSTITUTED STONE DUST

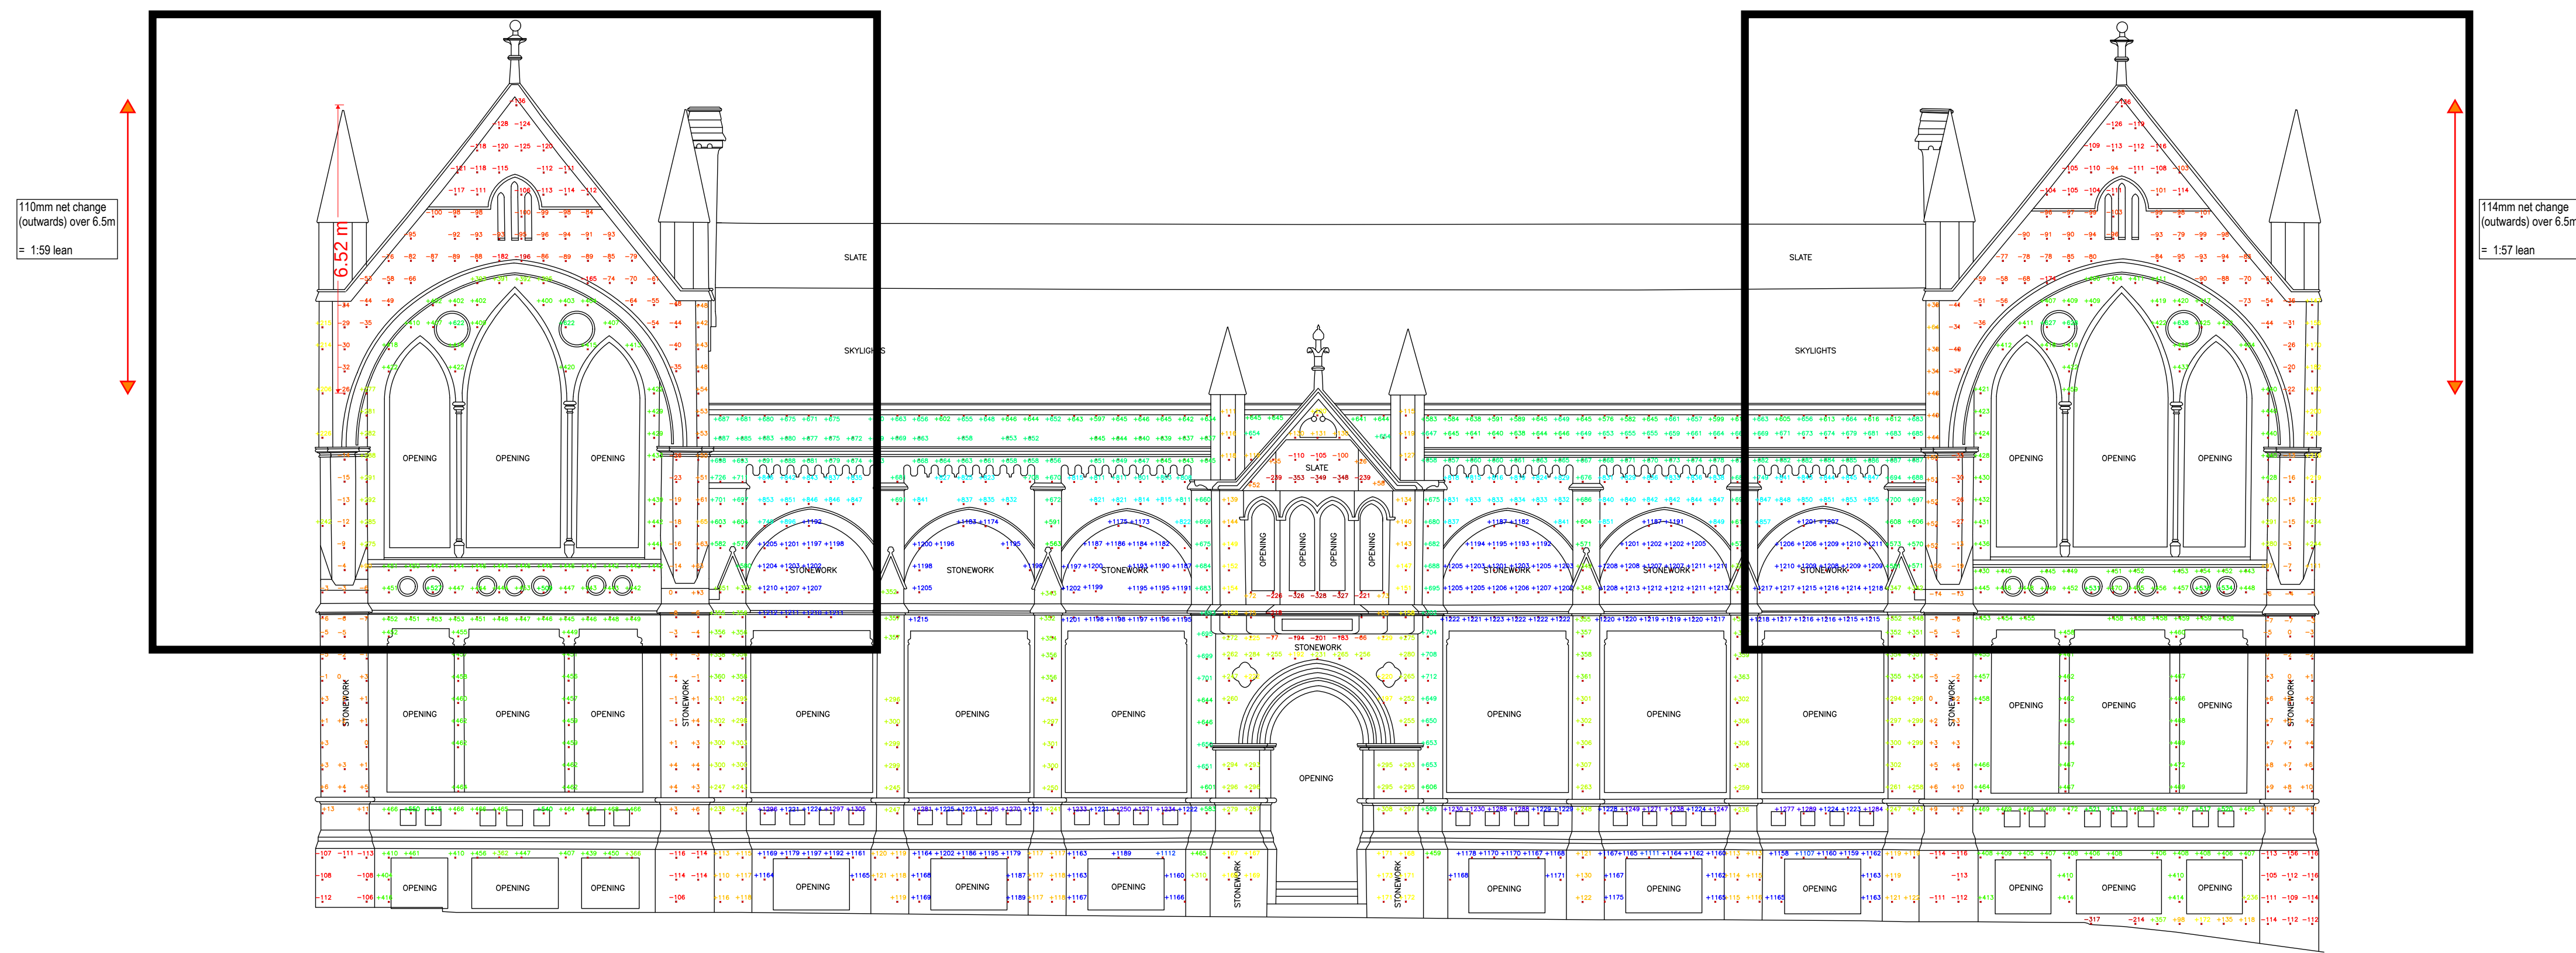
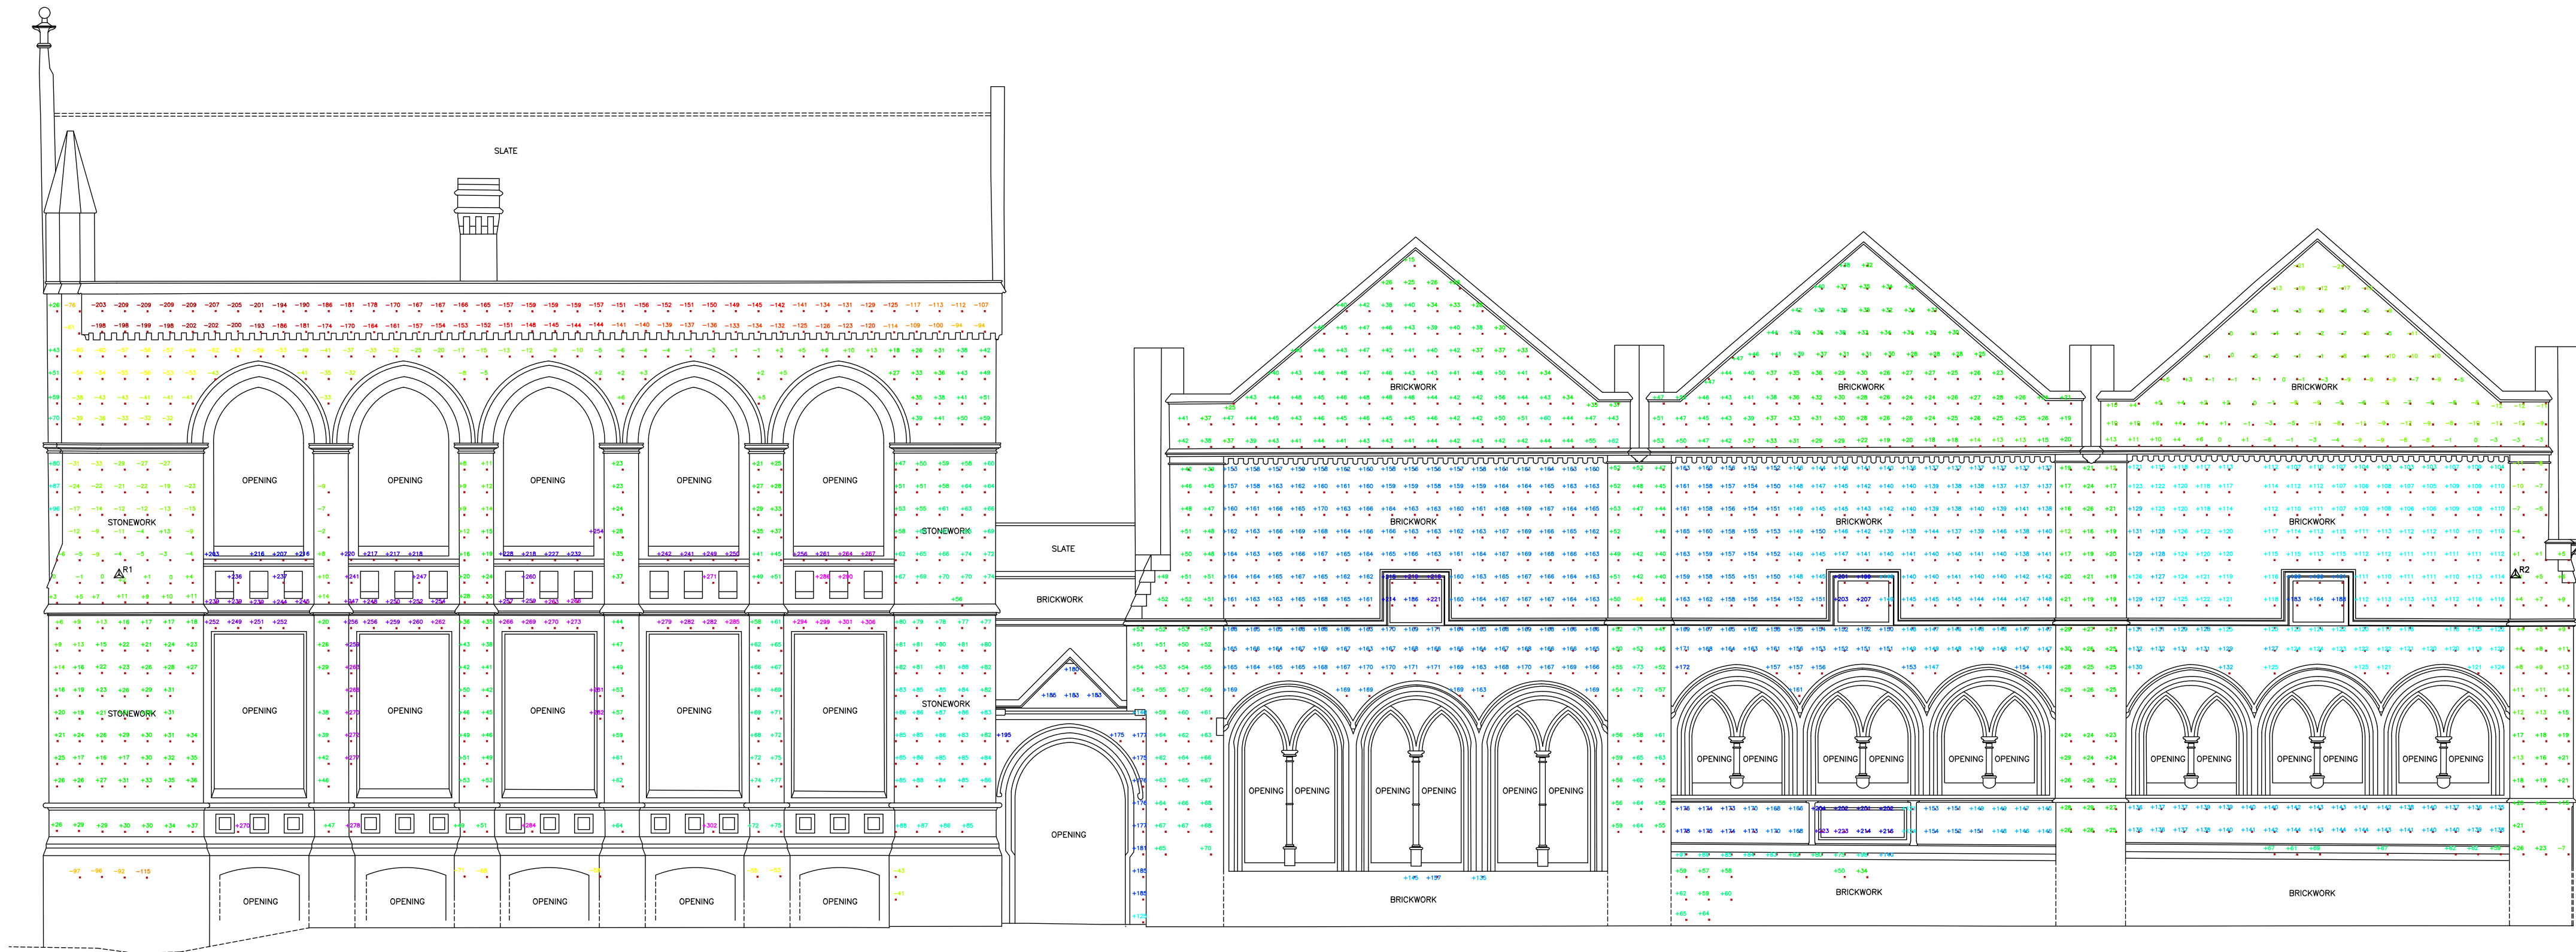
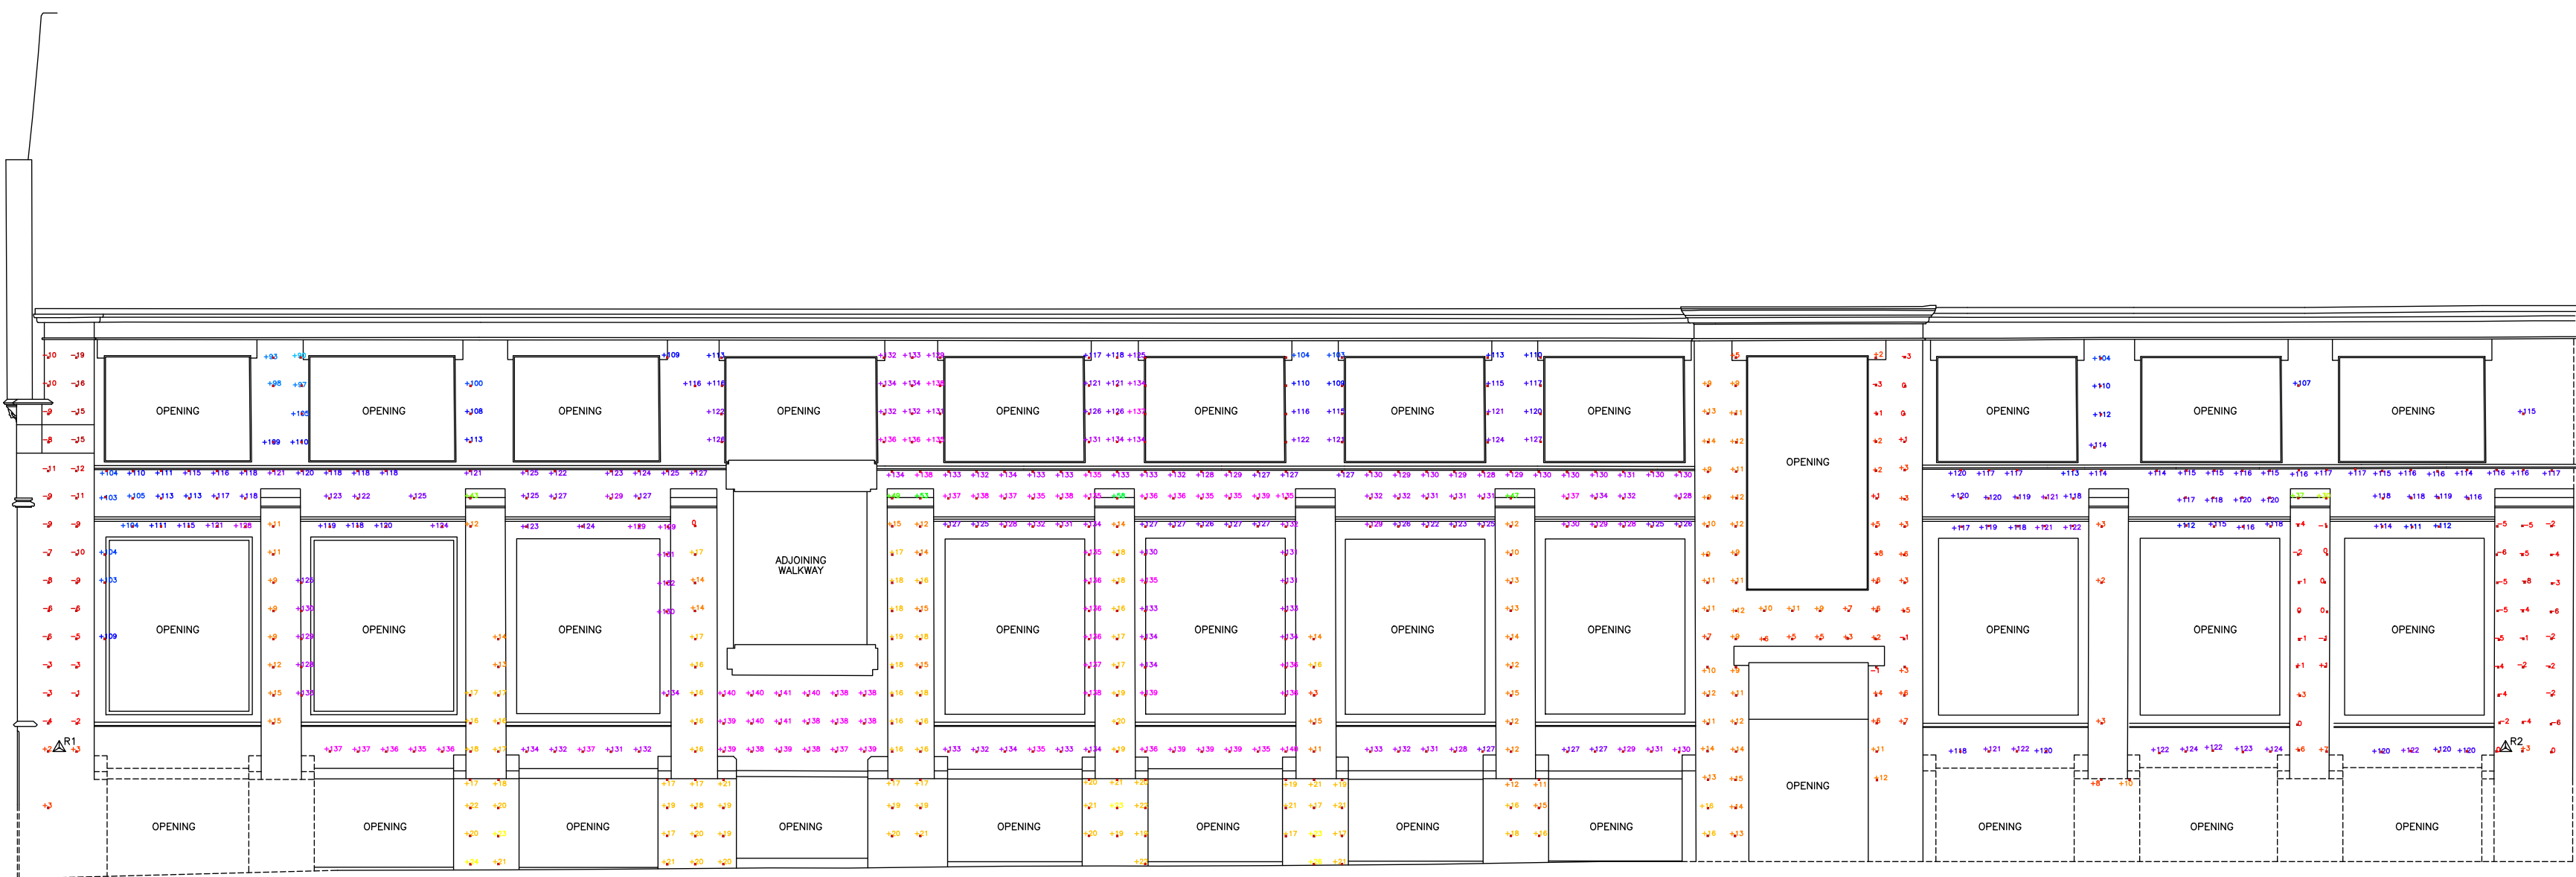
2no surveys were carried out over less than 12-month period. Little change of results suggests no changes but these were over a relatively short time interval and so may be affected by seasonal variations rather than overall movement. See Recommendations for further monitoring recommendations.
