## Specification for Asbestos Abatement Works

Jabez Clegg

**Specification Ref Number:** INS-RP1135

## **Asbestos Survey Report 21/03/2025 - 26/03/2025**

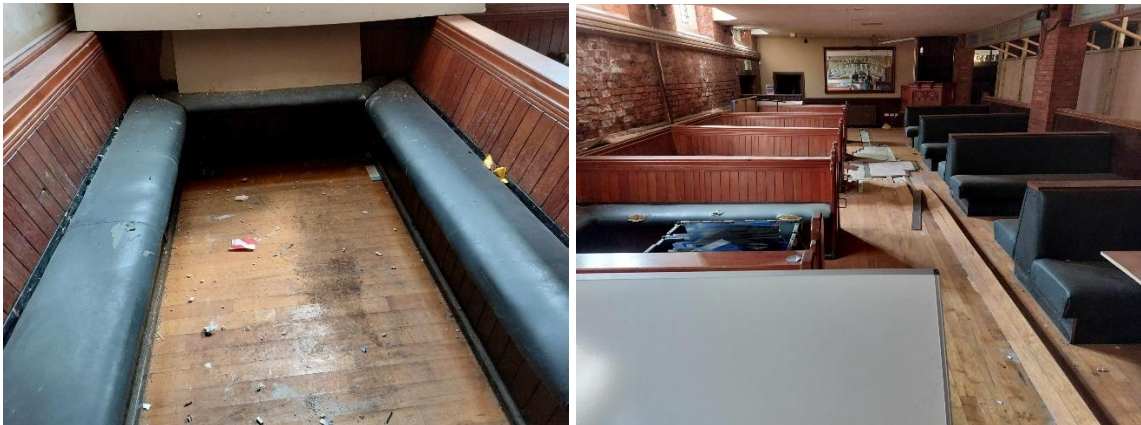
*All original timber flooring is to be removed and disposed of, the church pews, pulpit and balustrade within the grade 2 listing status of the building and needs to be protected from damage and remain in situ.*

*Below the timber floor is a contaminated void the depth is envisaged to be 2 ft from viewing within the boiler room area. Due to this there is minimal risk of falling when lifting the timber floor. This needs documenting within detailed construction phase plan*

Option 1 - Seating balustrade and pulpit to be removed carefully and stored during works and re-instated in the same place upon completion  
Option 2 – Seating balustrade and pulpit to be removed carefully and stored without the need to re-instate

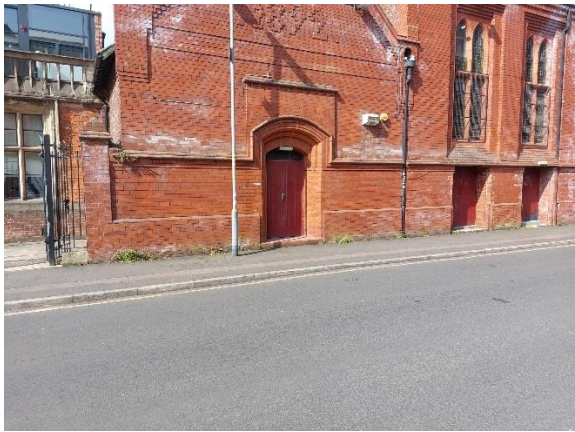
Exit for Transit Route across road to car park

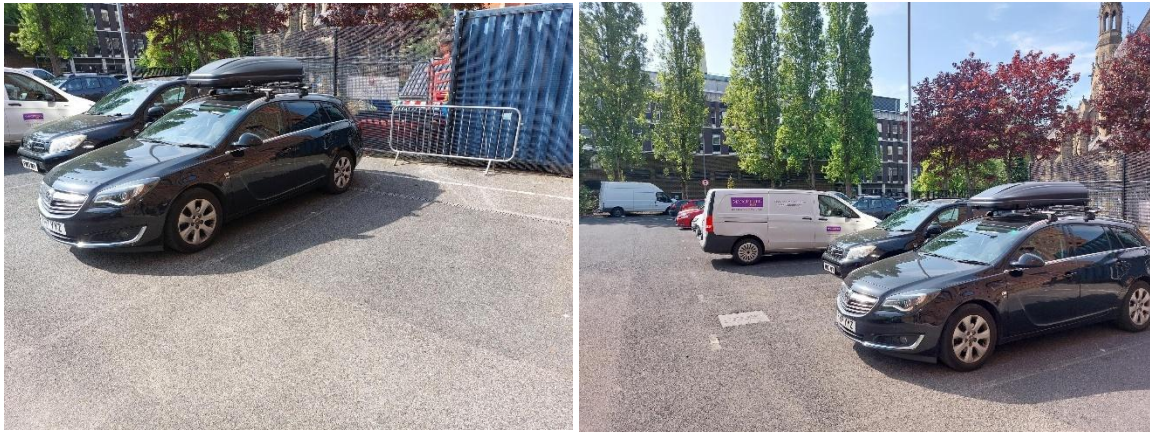
Area for Skip, Welfare and transport

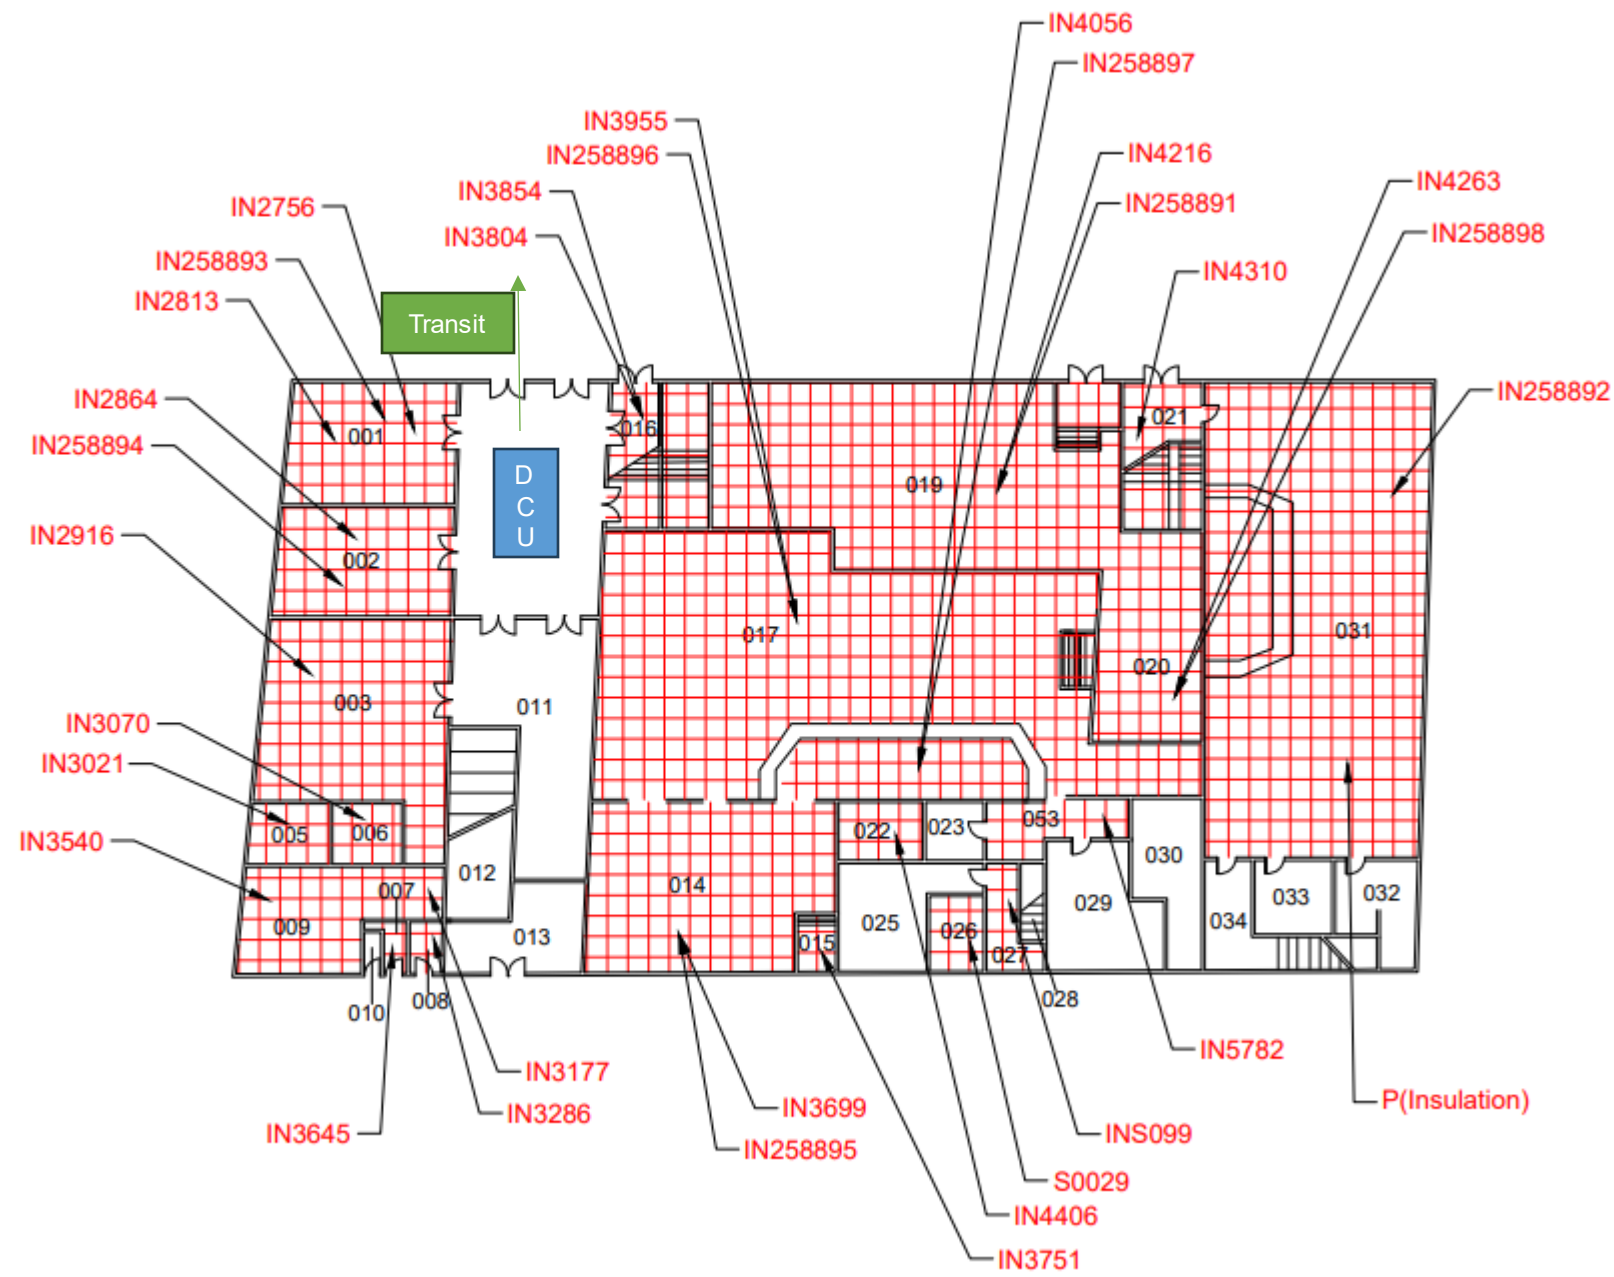
Site plan – Flooring and joists to be removed and void cleaned.

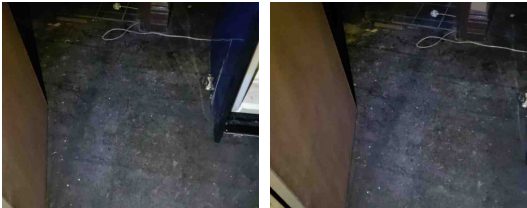
| Item ID | Insulation to pipework beneath timber floorboards - Sample No P0018 - SOSS |

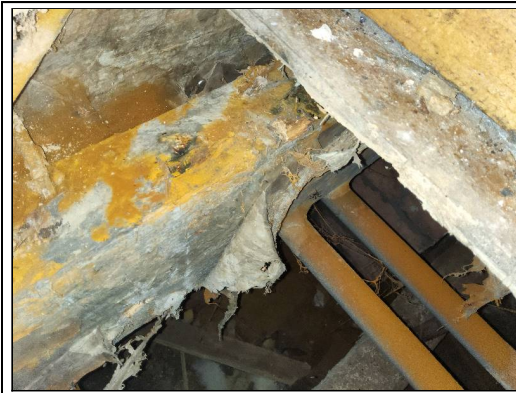
| Sample Date: | Sampled By: | Floor: | Room: |
|---|---|---|---|
| S<br>GS003144 | Amosite (2) | 100lm | Asbestos Insulation/Coating (3) |
| <b>Sample Location:</b> Thermal insulation lagging to pipework below timber floor. | | | |

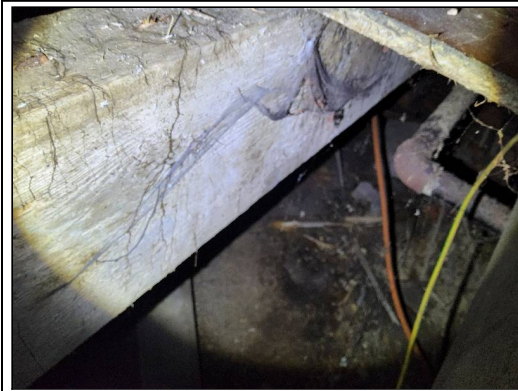
| Sample Date: | Sampled By: | Floor: | Room: |
|---|---|---|---|
| S<br>GS003145 | No Asbestos Detected (0) | Throughout | Insulation (0) |
| <b>Sample Location:</b> Thermal insulation lagging contamination to timber beams, surfaces. | | | |

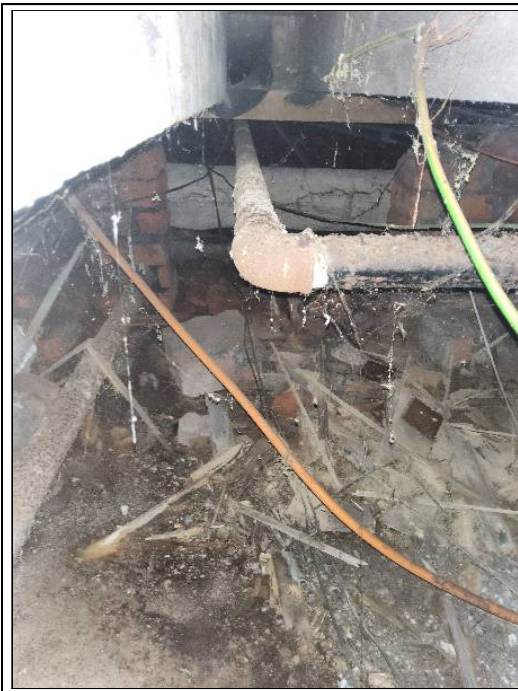
| Sample Date: | Sampled By: | Floor: | Room: |
|---|---|---|---|
| S<br>GS003146 | No Asbestos Detected (0) | Throughout | Insulation (0) |
| <b>Sample Location:</b> Thermal insulation lagging contamination to timber beams, surfaces. | | | |
