**Technical Submittal Proposal**  
**Project: Peeler Yard**  
**Heritage Conservation and Repair Work and initial scoping.**

**Scope: External façade, chimney, cast iron columns, and associated brickwork repairs**

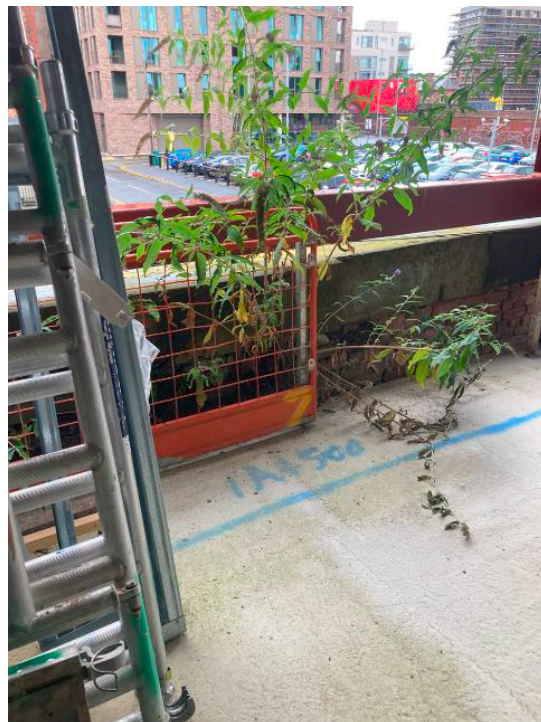
Removal of plant growth and treat

- New Window Opening 1: Repairs to be completed in lime mortar and matching brick work, sequence noted below.
- Vegetation Removal: Plant growth excised and treated.
- Steam Cleaning: Low-pressure superheated water cleaning to façade.
- Survey Works: Confirm repair locations and details.
- Complete works not yet completed but started.
- Planned Works:
  - Brick replacements (162 no.) around window opening.
  - Stonework repairs and 1 no. stone indent replacement.
  - Stone pointing (26 lm).
  - Stone repairs works to be completed.
