Application for Listed Building Consent –  
Supporting Statement

6-14a Oxford Road,  
Manchester M1 5QA

Prepared by: Delwyn Jones BSc (Hons) MRICS  
Rheith Limited  
Date: 05 February 2026  
Reference: 128507-101

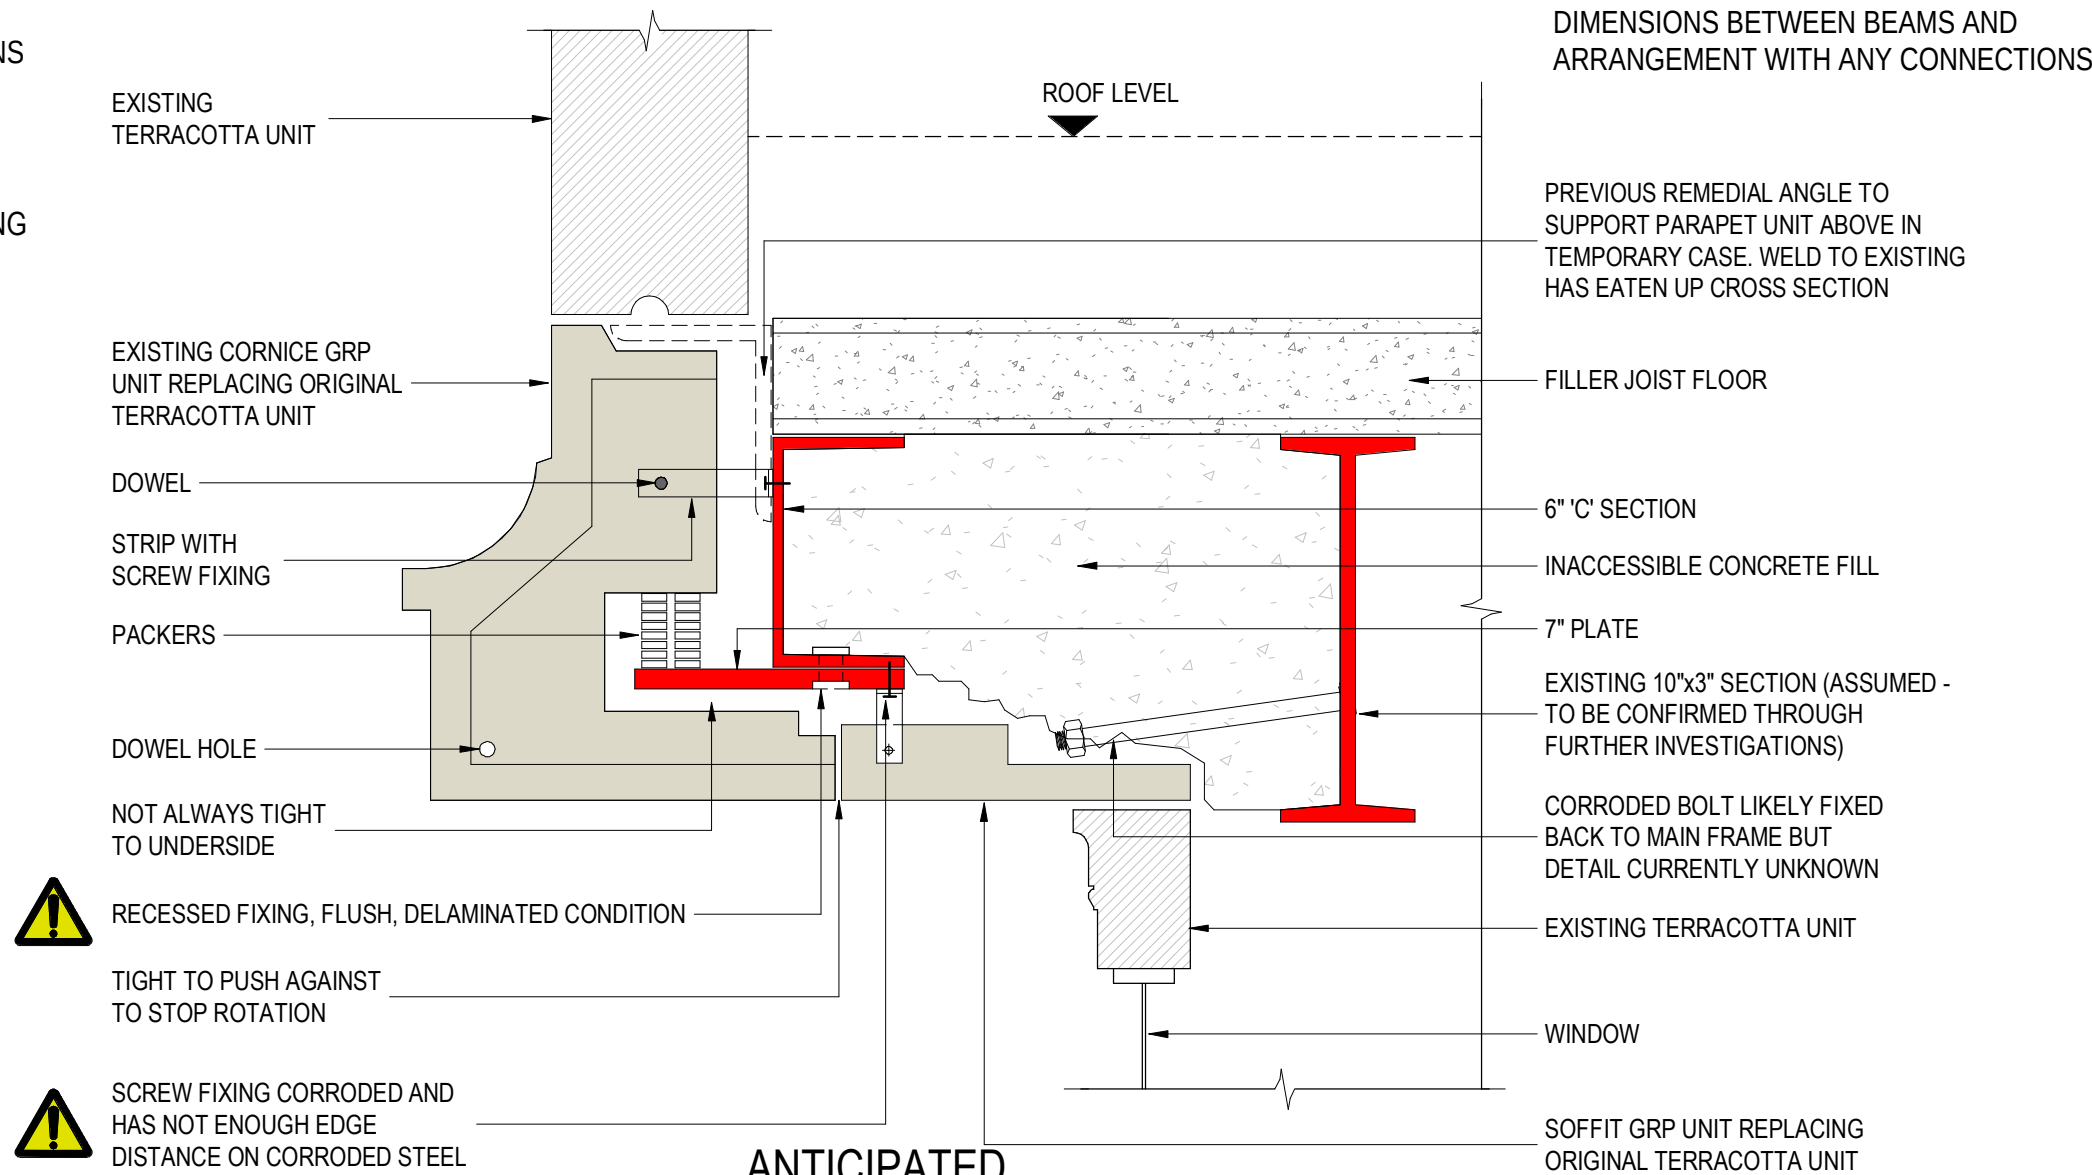
ANTICIPATED  
DETAIL1  
EXISTING CONDITION  
SCALE: 1:5

INVESTIGATION UNDERTAKEN BEGINNING  
OF FEBRUARY 2025 AND RECORDED IN  
SURVEY RECORD DRAWING

INVESTIGATION NOTE:  
AT EACH INVESTIGATION LOCATION, CHECK THE FOLLOWING:  
- CONDITION OF STEELWORK  
- CONDITION AND TYPES OF CONNECTION DETAILS  
(terracotta to steel and steel to steel)  
- SIZE OF STRUCTURAL MEMBERS  
- CHECK 'T' TIE MEMBER ARRANGEMENT AND CENTERS  
- ANY CHANGE IN STRUCTURAL ARRANGEMENT
