**DXH/45506 – Barrass Street - Structural survey of boundary wall**

**Address: Barrass Street, Manchester, M11 1WP**

**Property Type: Boundary wall to former Varna Street Primary School grounds**

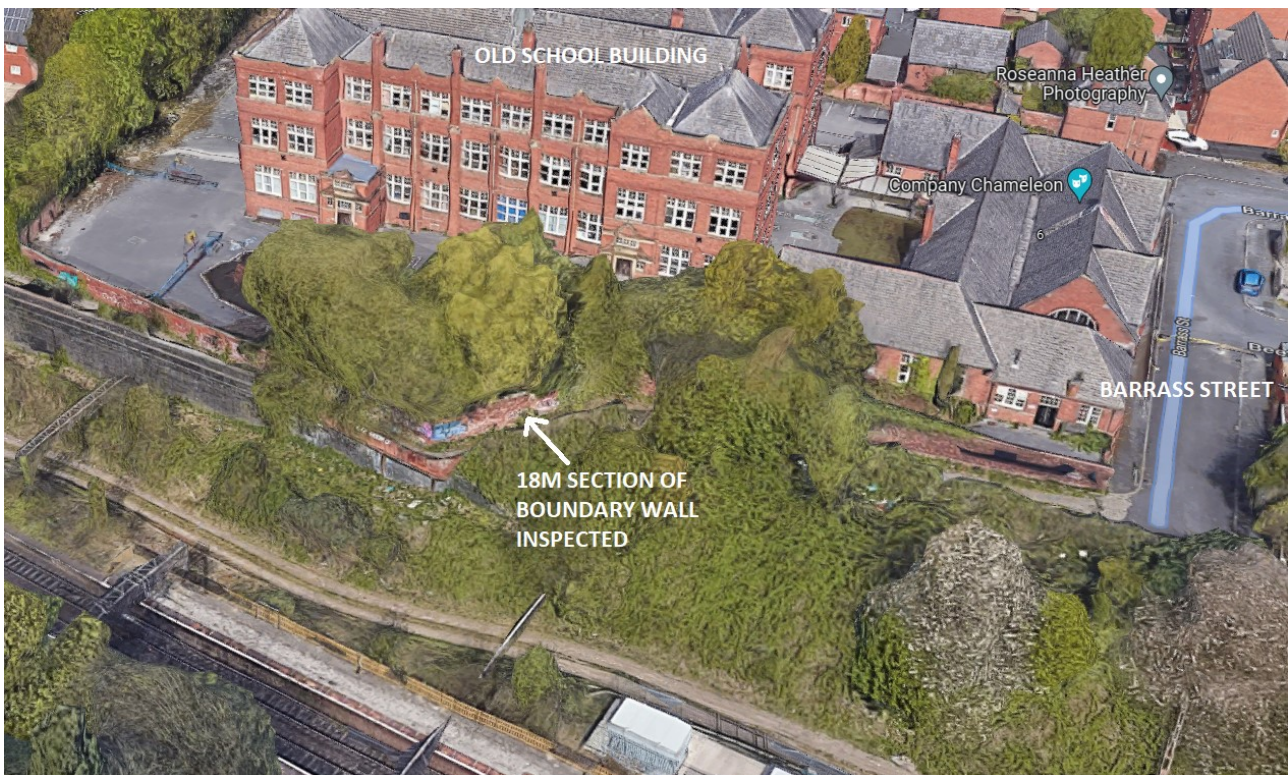
Figure 2 – Boundary wall extent

The boundary wall runs along the south edge of the school grounds from Barrass Street to the east and the railway bridge to the west. The inspection was focussed on an 18m long section of wall as shown in figures 1 and 2 below, where existing defects had been observed. The boundary wall changes direction either side of the 18m long section inspected. The ground level along the footpath rises from west to east, with the wall height above ground level varying from 3.3m high to 2.5m high. The wall retains approximately 1.2 metres height of soil on the school side, and there are three trees behind the wall on the school side within 2 metres distance from the wall face.
