## Castlefield Viaduct – Phase 2

Truss End Support Boxes – Remedial Options Appraisal

| Document verification | | | | | |
|---|---|---|---|---|---|
| Document title | | Truss End Support Boxes – Options Appraisal | | | 282210 |
| Revision | Date | Filename | CVI-ARUP-ZZ-ZZ-RP-S-000003 | | |

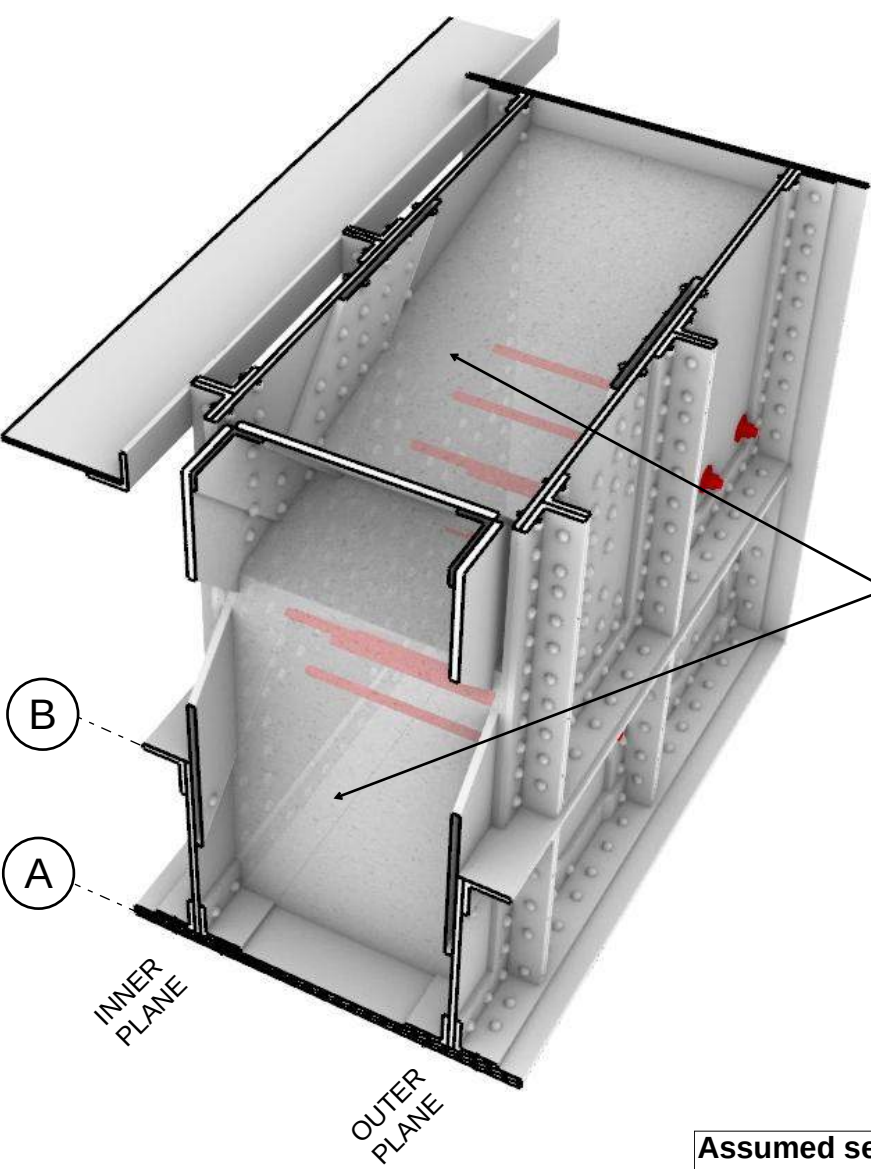
At conditions where compression diagonal (solid plate) intersects with concrete infill:

- 30mm dia half-round drainage hole to be drill centrally through diagonal for water discharge, infill benched to sides to encourage transverse flow

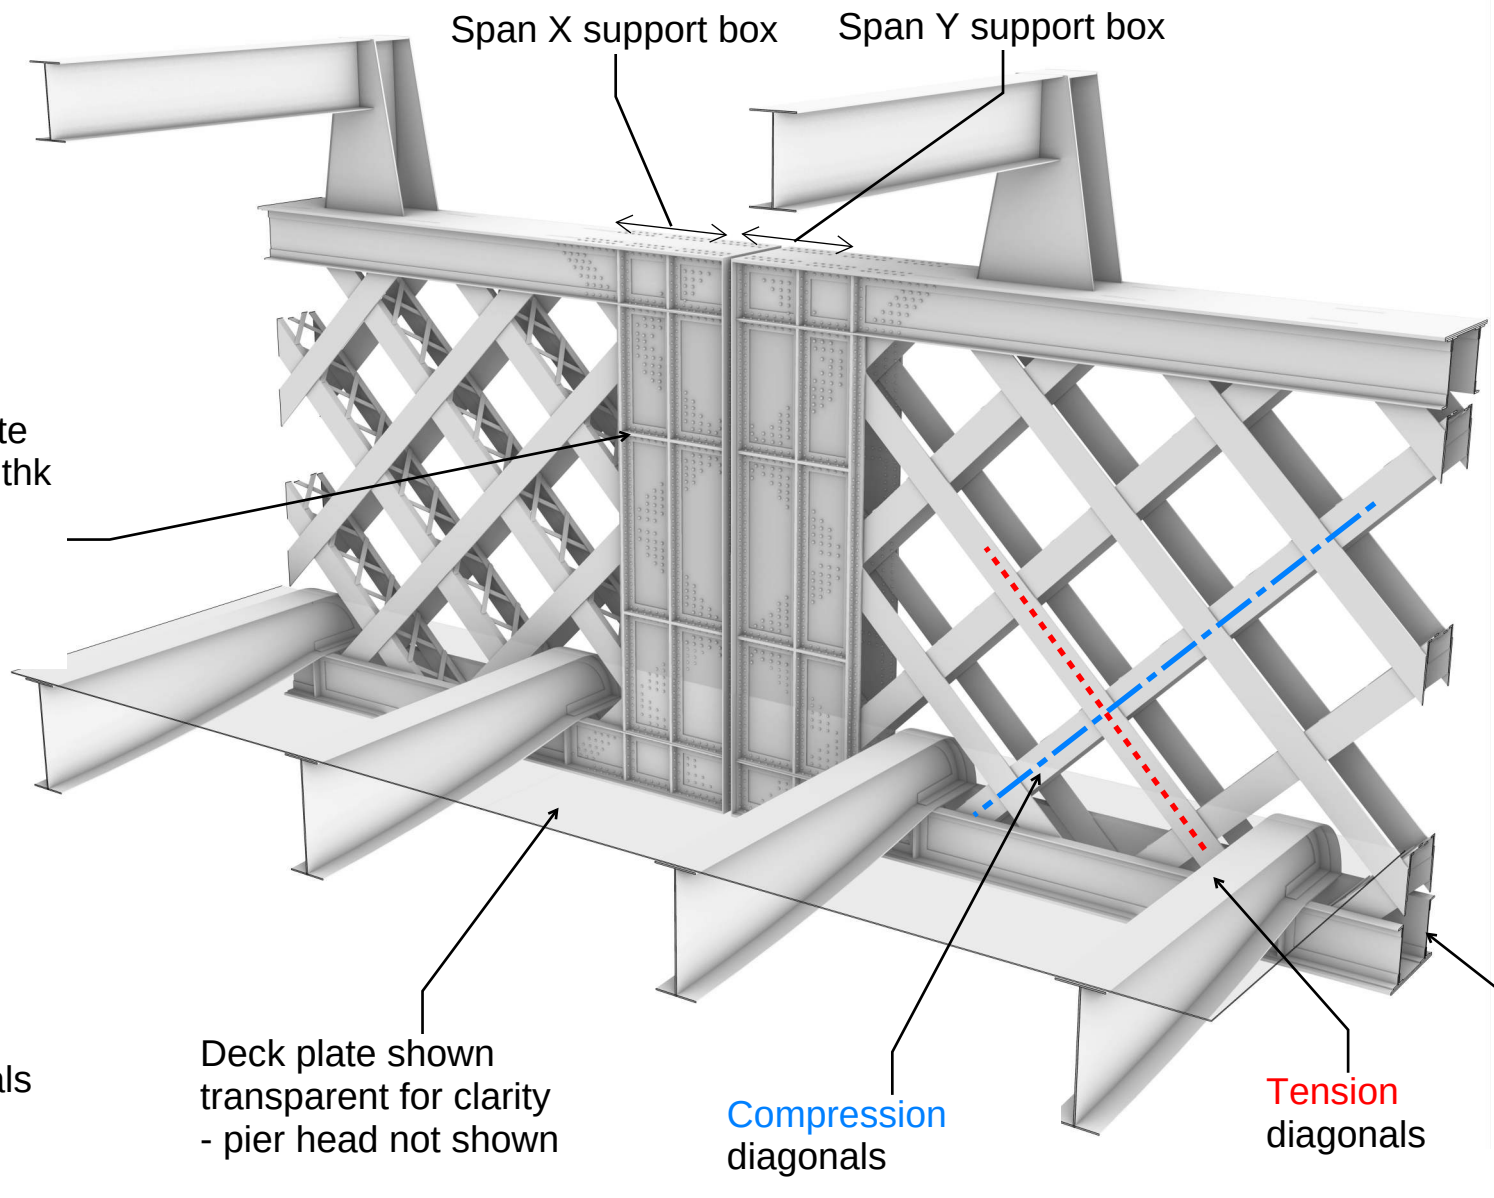
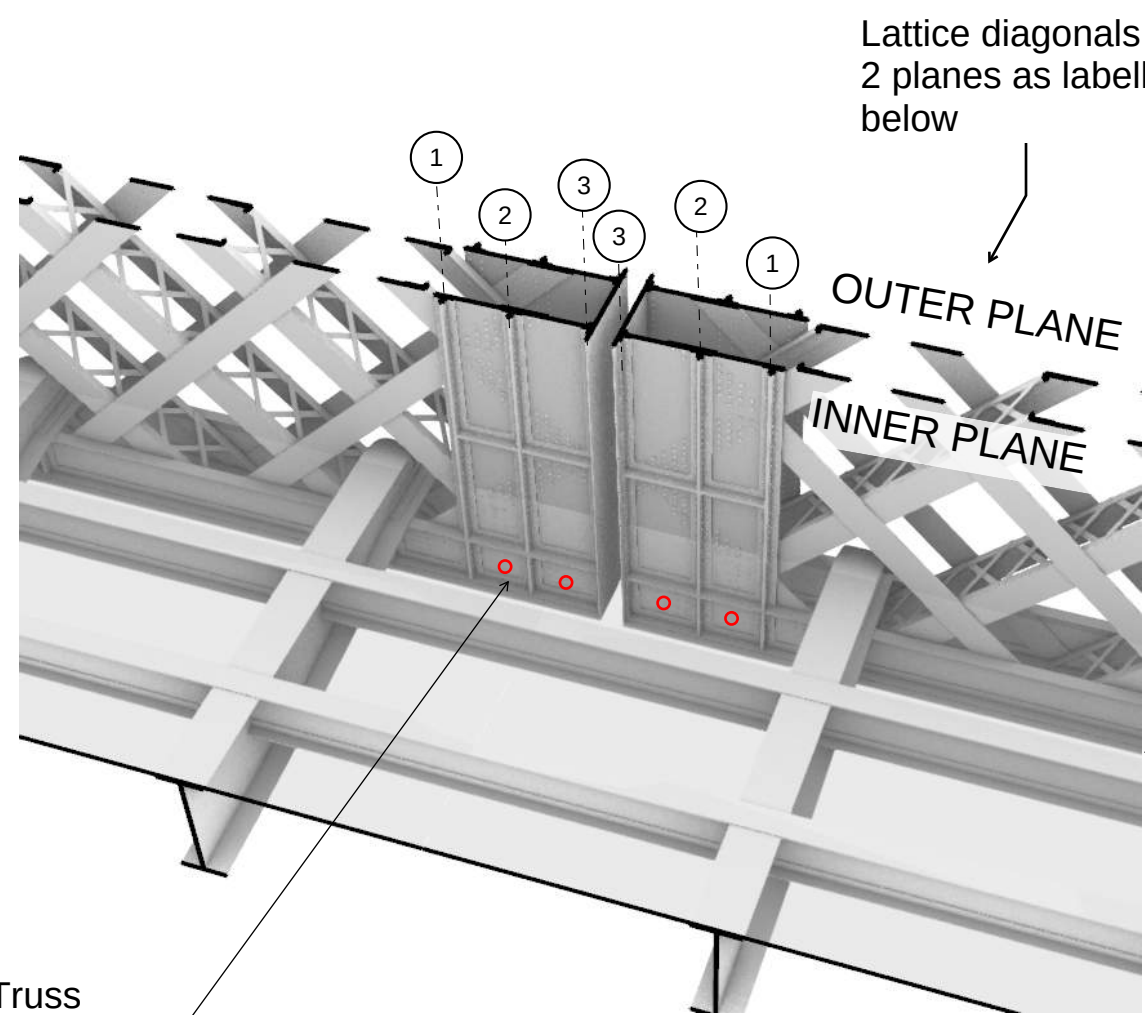
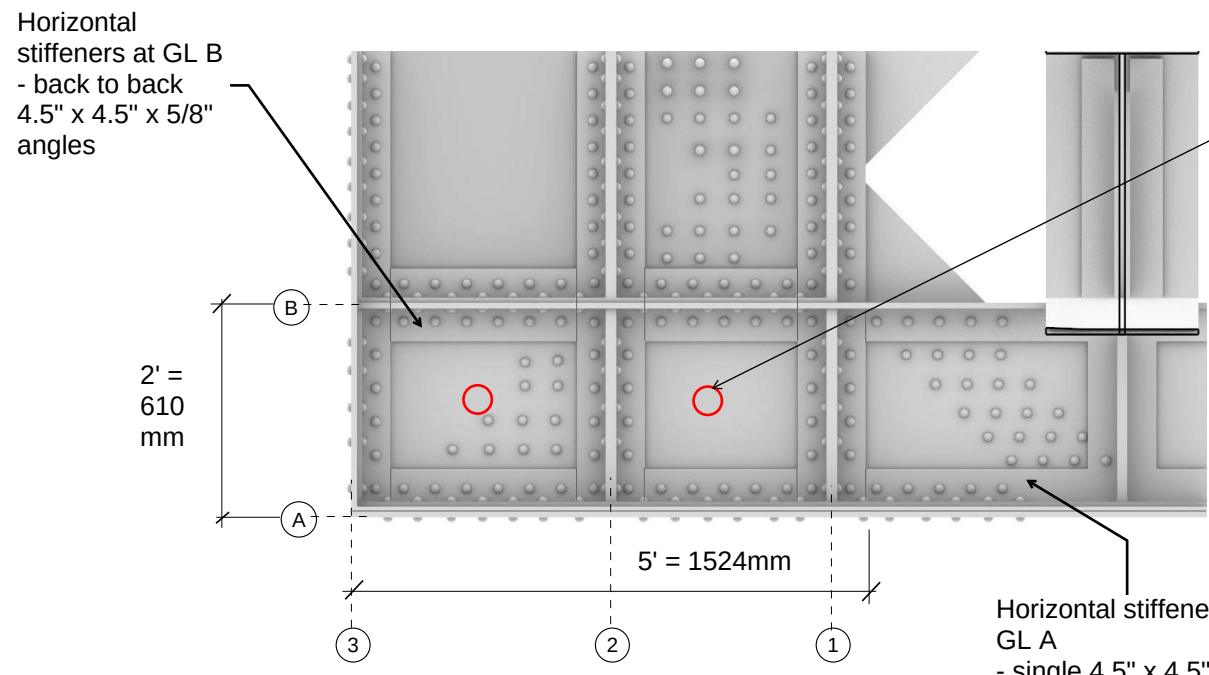
Lower web panels - area of worst case corrosion

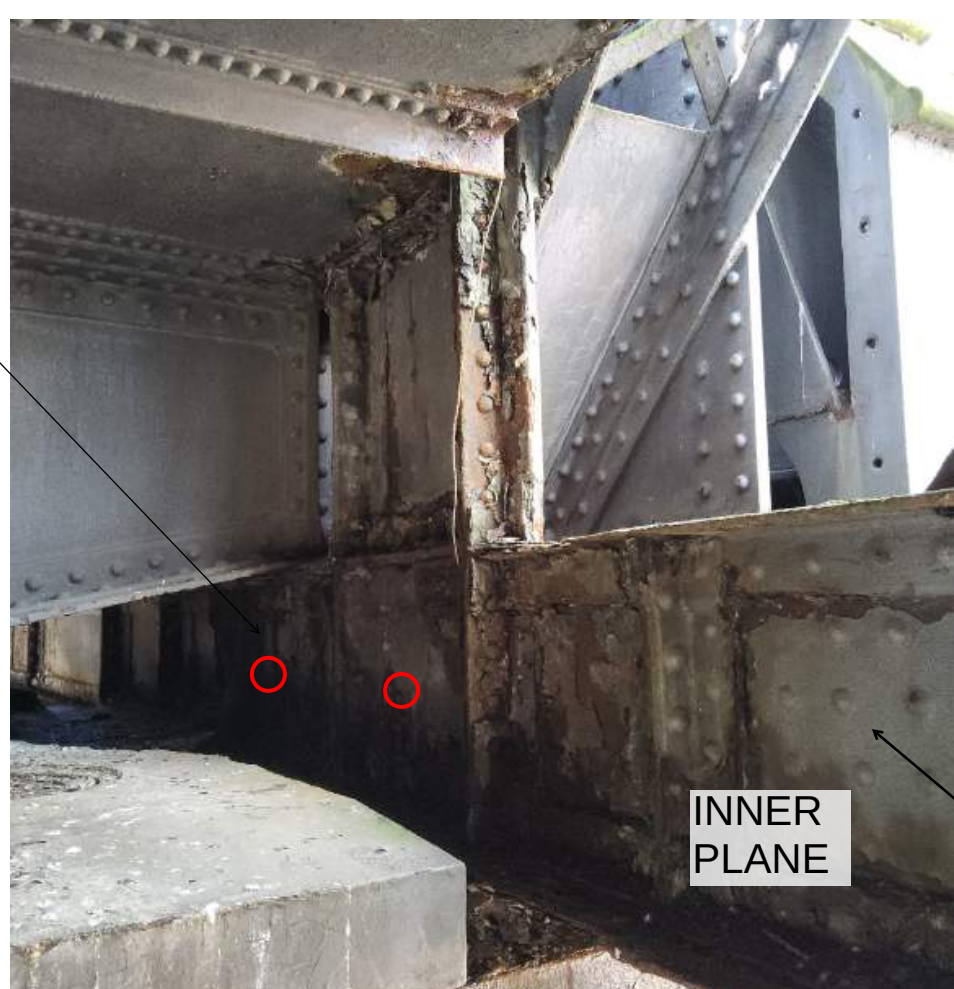
Lower web panels - area of worst case corrosion

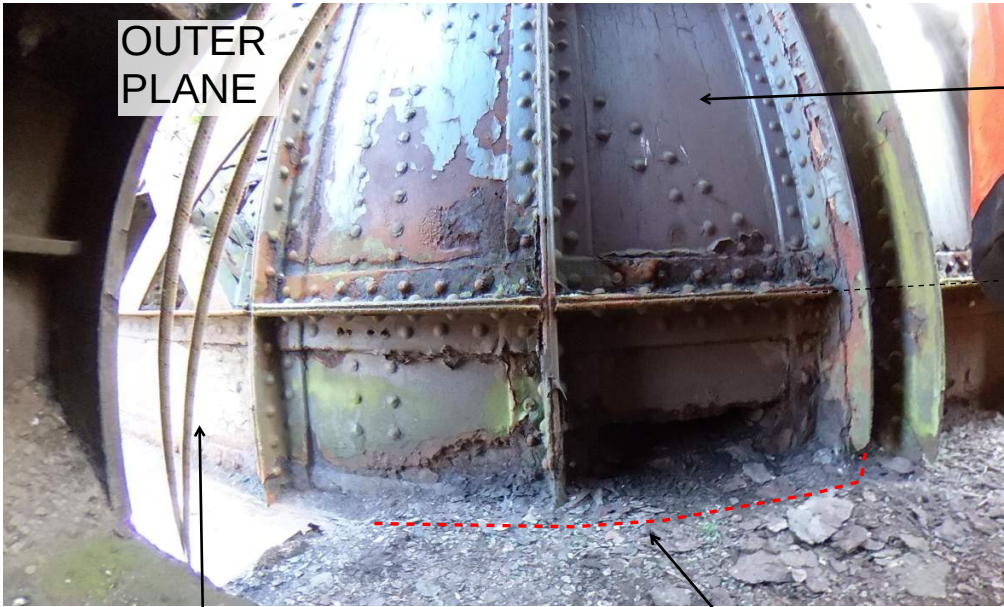
Internal view of fascia - assumed bolted assembly of CI frames

Connection into pier head unknown - buried within debris

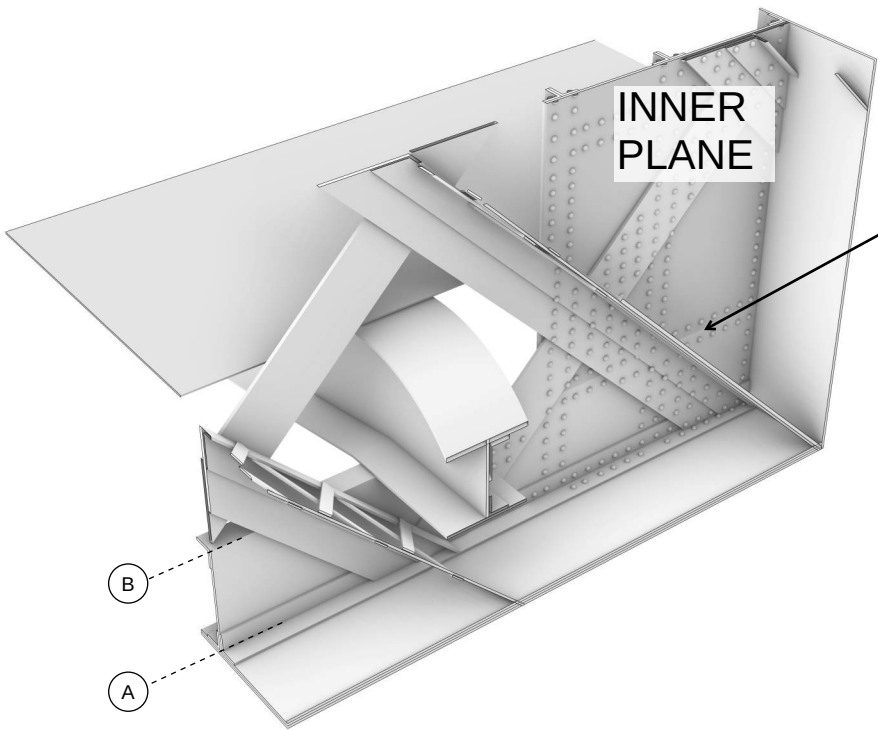
Assumed cross stiffener from bottom chord which runs into support box - not assumed typical

Debris at bottom of support box

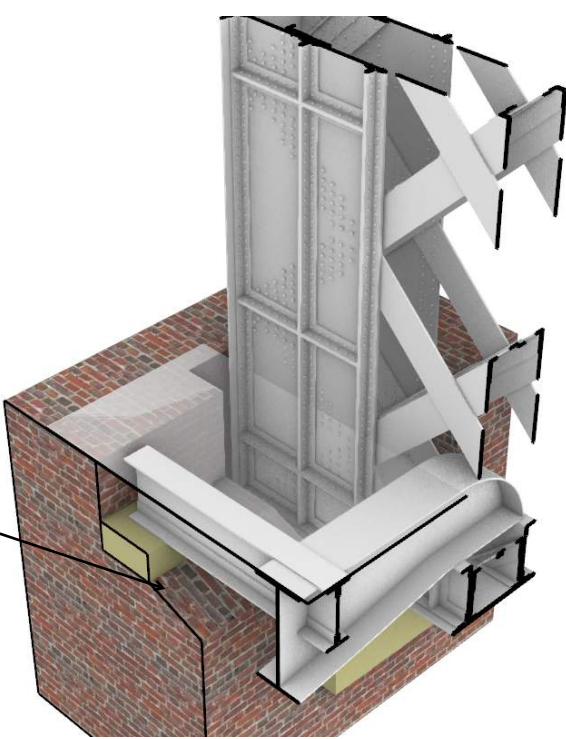
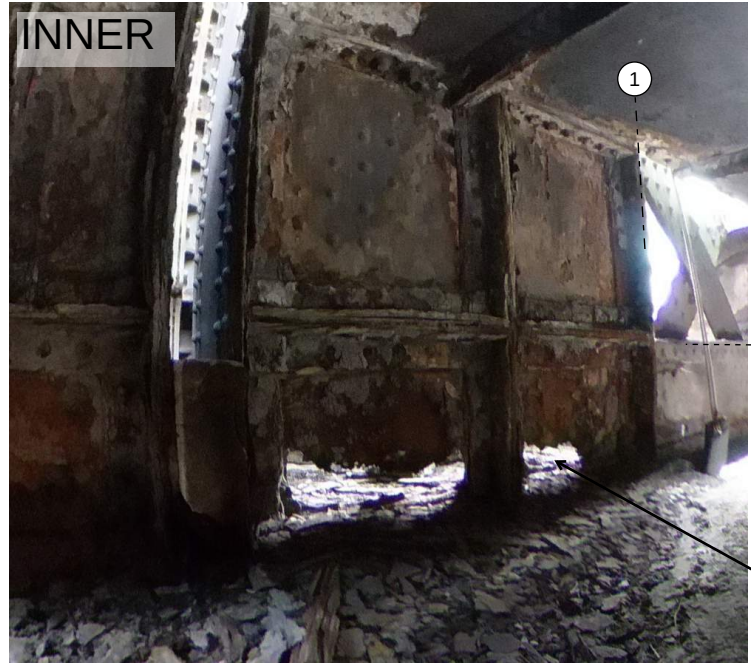
Holes to bottom of lower panels

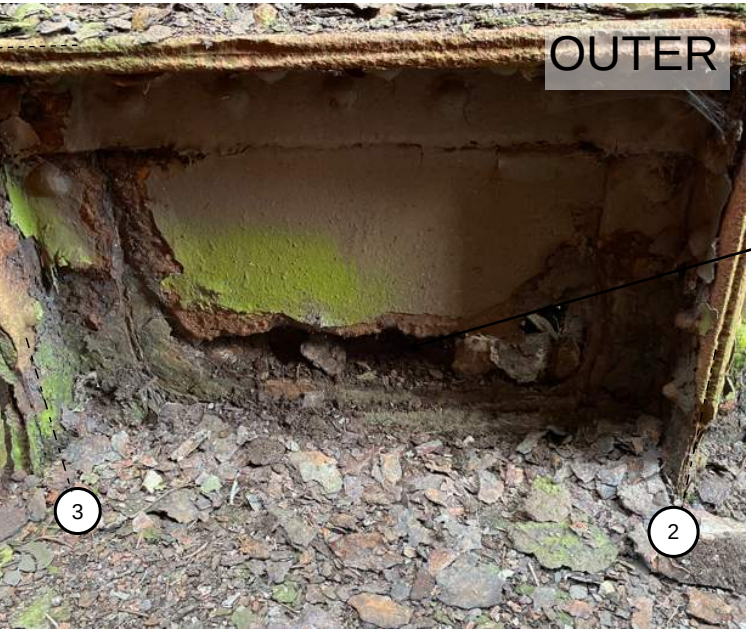
Hole to bottom of lower panel

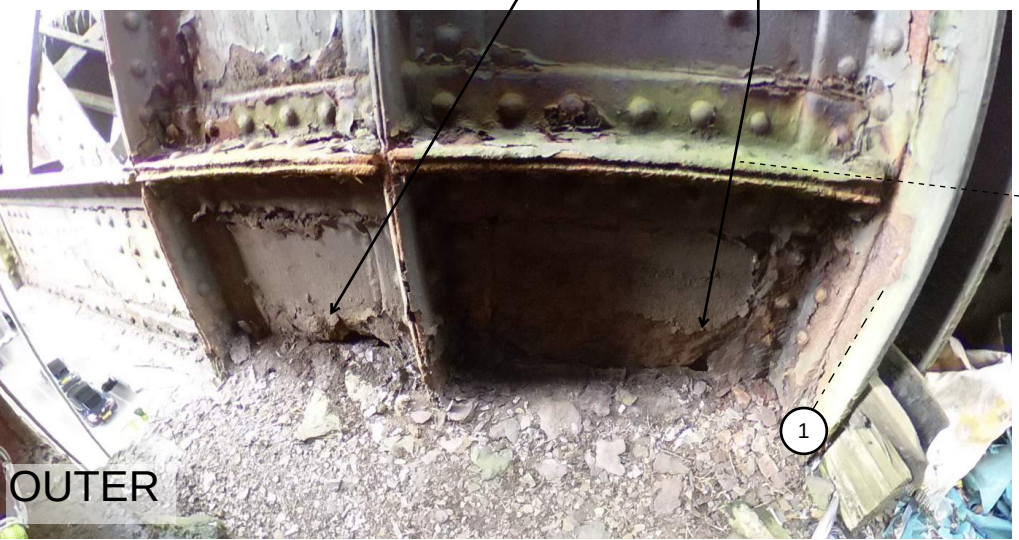
Holes to bottom of lower panels

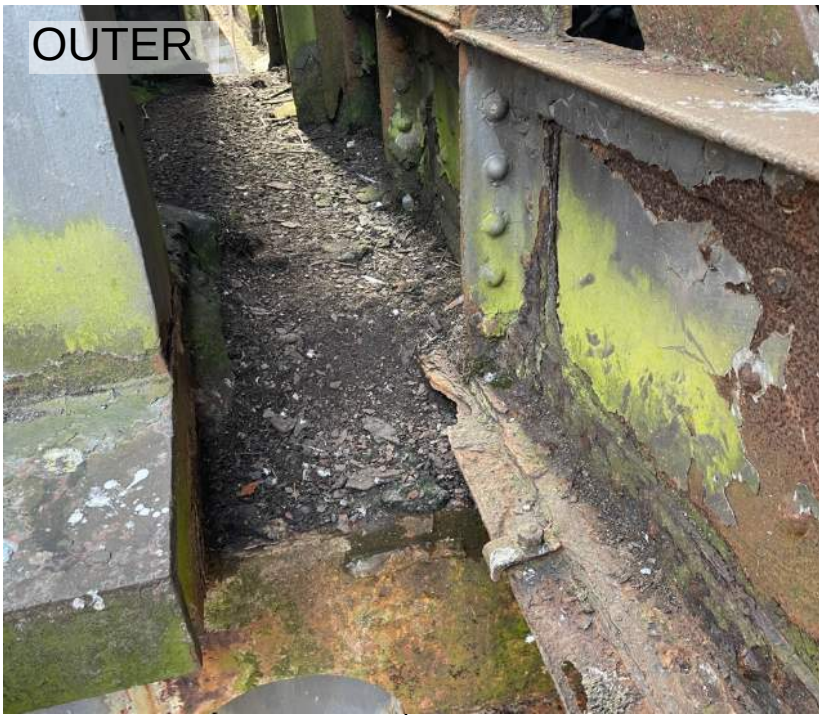
Reference examples of debris to be removed  
- sufficient for S.I  
- to avoid risk of falling debris to public

- Brushing down deposited rust and other debris from pier head, to inner and outer planes

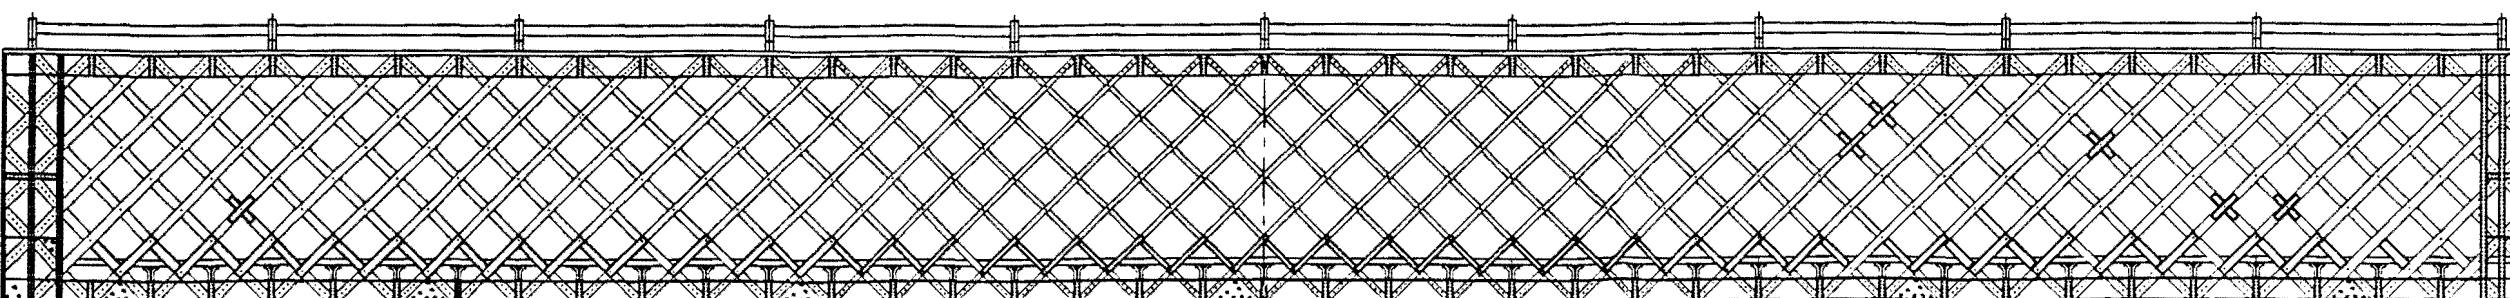
**INNER ELEVATION OF SOUTH GIRDER**

31% (85 No.) Rivet replacement on Lattice Intersections

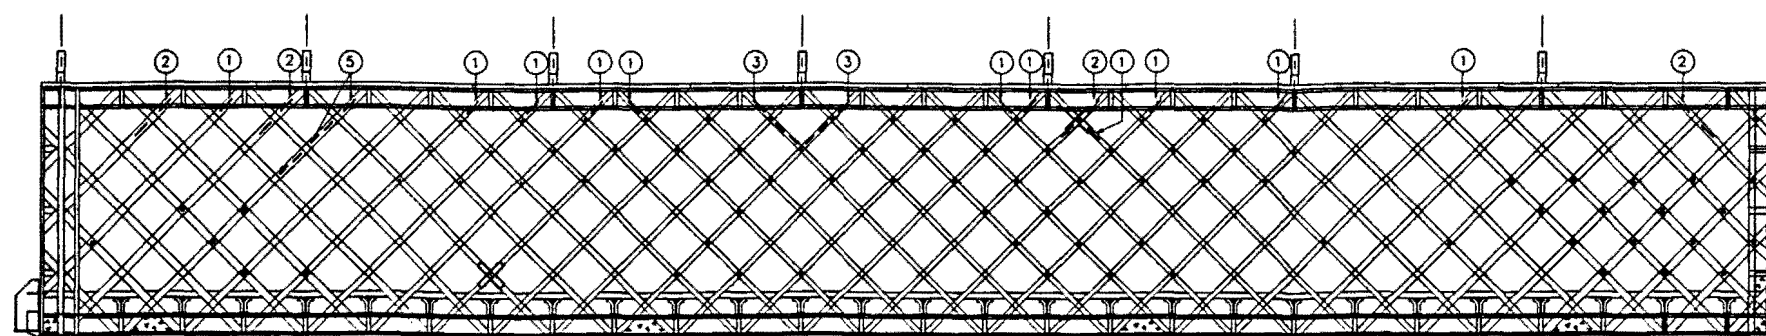
INNER ELEVATION OF SOUTH GIRDER

Lacing Bars (26 No.)  
Number replaced on member shown

MR13 Repairs (6 No.)

Rivet Replacement (75 No.)
