# **SCHEDULE OF WORKS TO IDENTIFIED HERITAGE ASSETS**

## **ST MARY'S CHURCH HULME**

**SEPTEMBER 2025  
REV A**

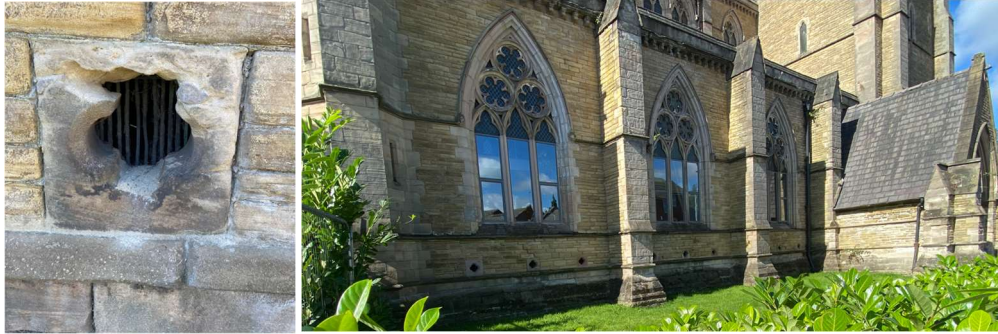
*Fig 9 & 10 Proposed extract grille to mimic existing as utilised on previous conversion*

| 6.2.7 | A new feature ashlar stone is to be inserted an and proposed low level ventilation extracts. This method appears to have been used for extracts within the previously converted building |

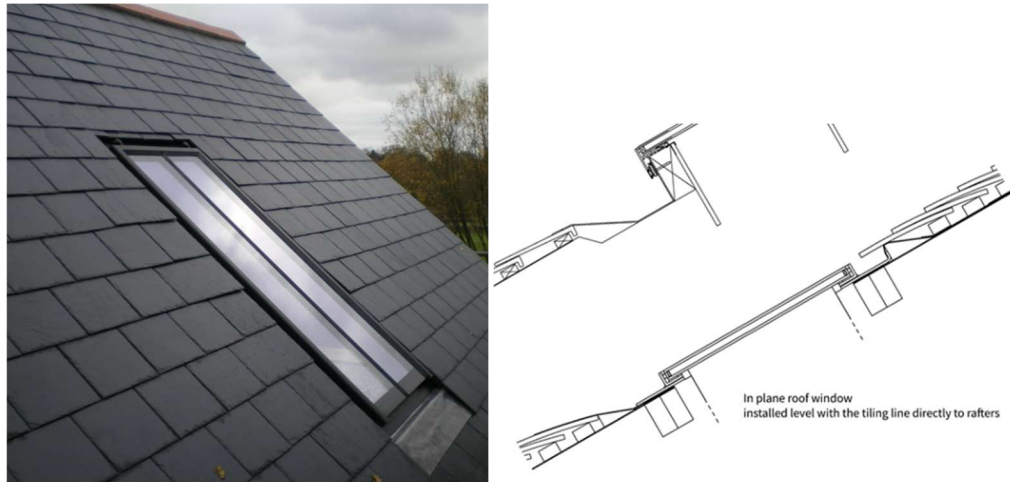
Fig 12 & 13 Flush fitting conservation style rooflight

- 7.3.6 Install new rooflight in accordance with manufacturers recommendations using lead soakers and flashings to perimeter

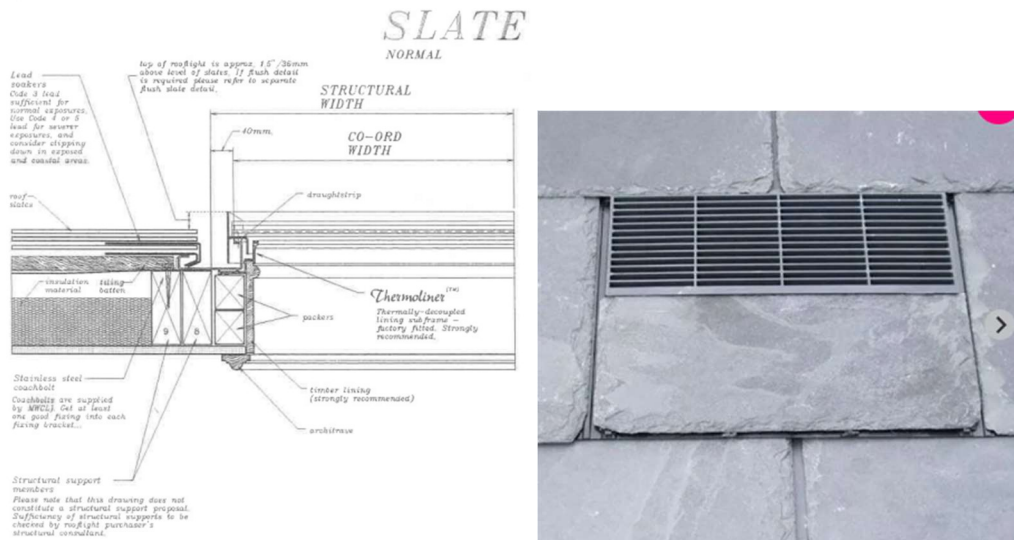
Fig 14 & 15 Typical recessed jamb detail for flush rooflight

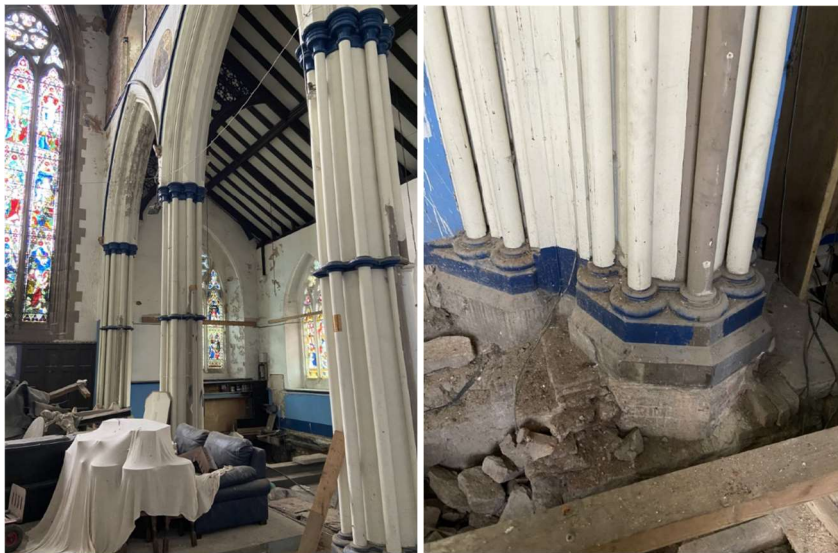
- 11.1.1 The nave and aisles are separated by a series of pointed arches
- 11.1.2 The columns in the part of the church that has been renovated appear to be quite simple designs but those within the southeast part of the church are much more ornate and the columns have a series of circular pipes forming a fluted appearance to the columns
- 11.1.3 The 'pipes' appear to be of plaster as there are numerous areas where fixings have been used at the location of former partitions
- 11.1.4 The octagonal plinths, painted blue, also show areas where original partitions may have been installed as the plinth is incomplete and some of the 'pipes' are unpainted
- 11.1.5 Numerous services are fixed to the columns including lights, sensors and former speakers
- 11.16 The columns and arches, along with the stained-glass windows, are the most striking architectural feature within the church

*Fig 28 & 29 Fluted columns to arches*

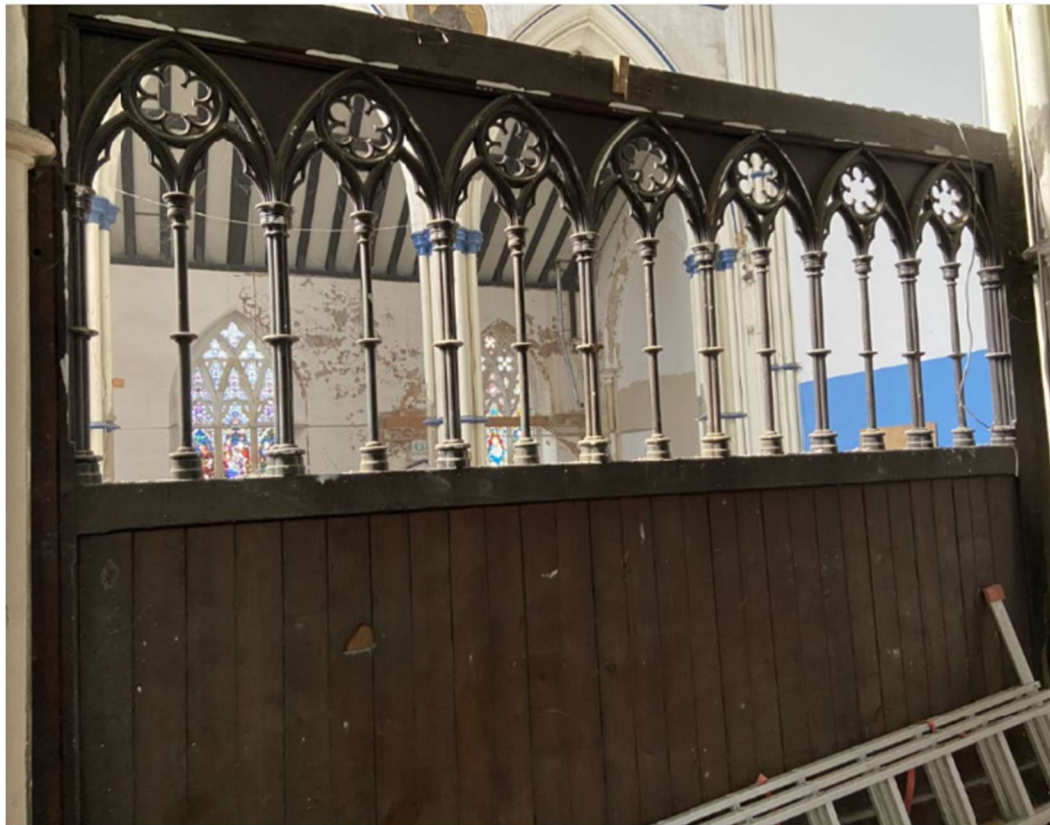
- 13.1.1 The church building has little by way of existing timber panelling.
- 13.1.2 Some timber panelling is present beneath the feature gable window but it is not clear whether this is original. The detailing is relatively simple and the timber has been painted.
- 13.1.3 The panelling sits either side of the window where perhaps a religious centre piece probably stood in the past.
- 13.1.4 A more ornate timber rood screen is still present to one of the arches. The top fretwork of the screen is ornate but the lower half comprises of simple planks.
- 13.1.5 The screed collides with the existing fluted columns in a quite crude way with a simple timber plank applied to cover the junction
- 13.1.6 A second rood screen has been removed by the previous works to the building and is currently stored within the building. The screen is much planer

*Fig 36 Existing timber rood screen*

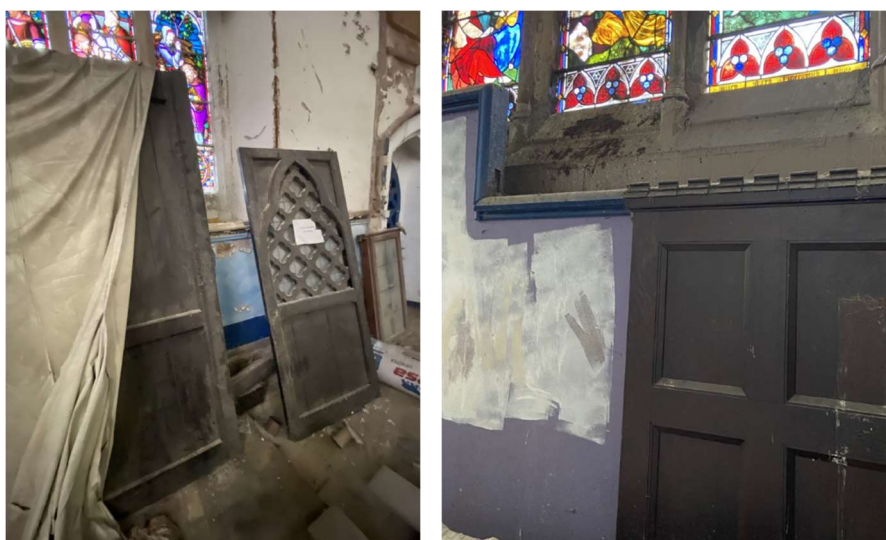
*Fig 37 & 38 loose timber screen and painted panelling beneath window*

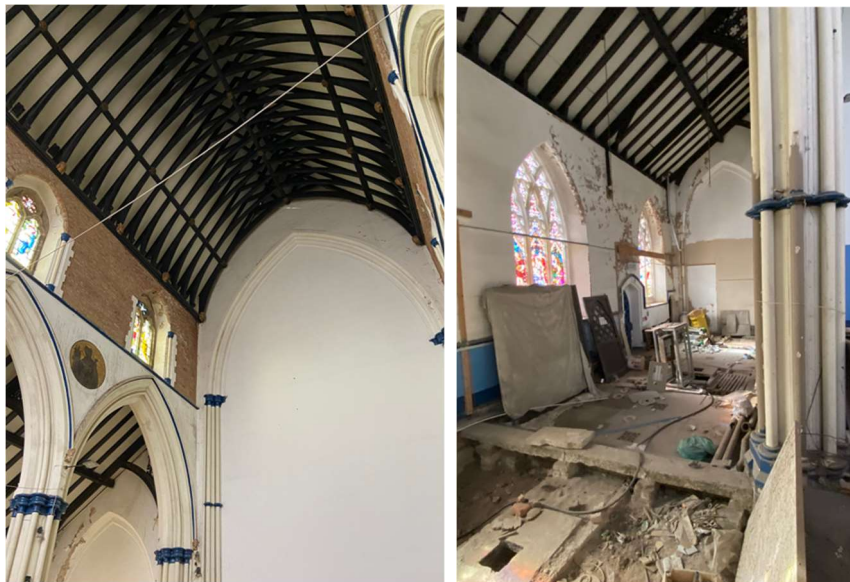
- 14.1.1 The underside of the main roof to the nave is formed from ornate timber trusses supported on a ledge in the clerestorey with some carved figure heads at intervals
- 14.1.2 The previously applied breathable roof felt is visible between the trusses. A number of holes appear to have been cut in to the felt by the previous contractor but their purpose is not known and a closer inspection will be required
- 14.1.3 The side aisles are formed by four trusses supporting purlins which in turn support exposed timber rafters
- 14.1.4 The trusses included some ornamental fretwork at each end but these are missing on several trusses. Those to the Parsonage Street side appear to have been deliberately cut, perhaps to improve headroom issues on the previously approved mezzanine floors

*Fig 39 & 40 timber framed ceilings*
