# Parrs Wood High School

**Flood Risk Assessment**

**FINAL DRAFT REPORT**

**May 2018**

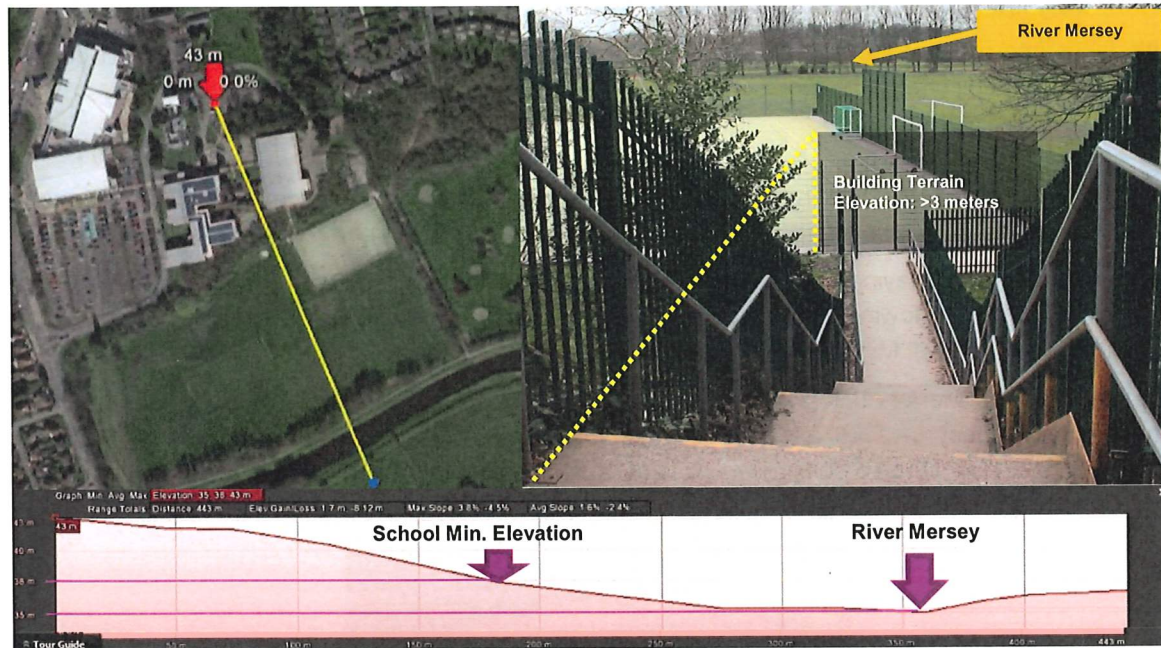
Figure 5 – School's Building area elevation profile (source: Google Earth and Willis Towers Watson)

River Mersey is located along the south perimeter of the sports grounds. The elevation profile from the river to the main school buildings proximity mitigates the flood risk. The figure below shows an approximated elevation profile for the river and the school. It can be observed that the school's main building's lower ground floor (the lowest area of the school's facility) is generally elevated to above a 1 in 100 year return period flood level (more than 3 meters high when compared to the river level).

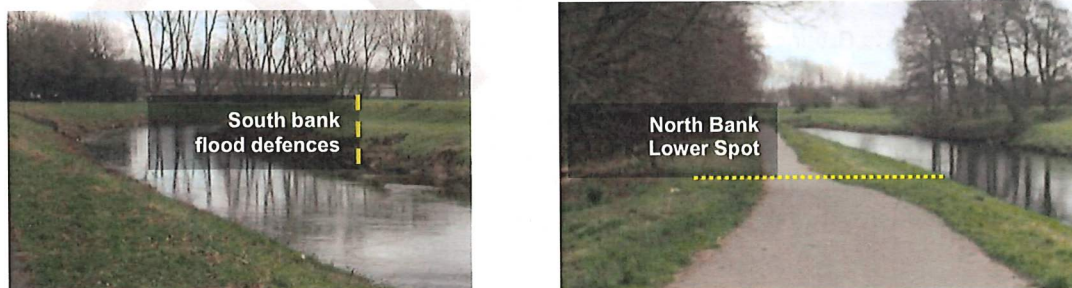
Figure 6 – River banks: southern flood defences elevation and northern bank lower spot

It should be noted that the area south of the River Mersey is protected by flood defences with an estimated design return period of approximately 1 in 100 years. In addition, the eastern area of the northern embankment has been observed to be the least elevated (with lower spots sections) and in the past this caused flood waters to reach the sports grounds.

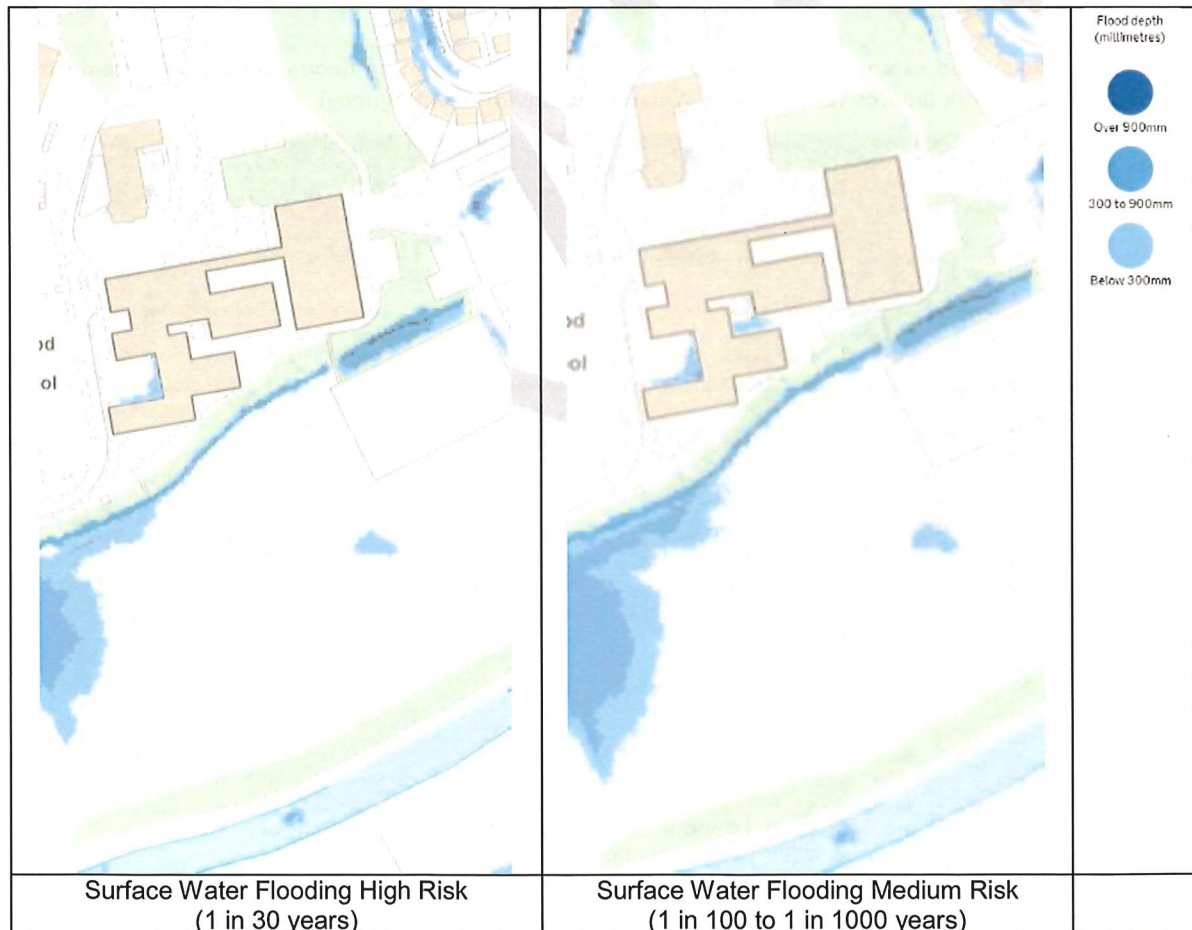
**Figure 9 - Potential surface water flooding areas  
(source Environment Agency)**

Surface water flooding was assessed comparing risk information and maps from sources such as JBA and Environment Agency. It can be seen in Figure 9 that localised surface water flooding with depths up to 300mm could occur in the vicinity of the main electrical area entrance. This level of flooding is associated with a return period of 1 in 30 years and higher water accumulation is possible in the north side of the campus within return period of 1 in 100 years to 1 in 1000 years. In this second case additional areas could be at risk:

- the basement area of the music block, where the boiler room is located;
- the lower ground area of the potting shed, where the greenhouse boiler is located.

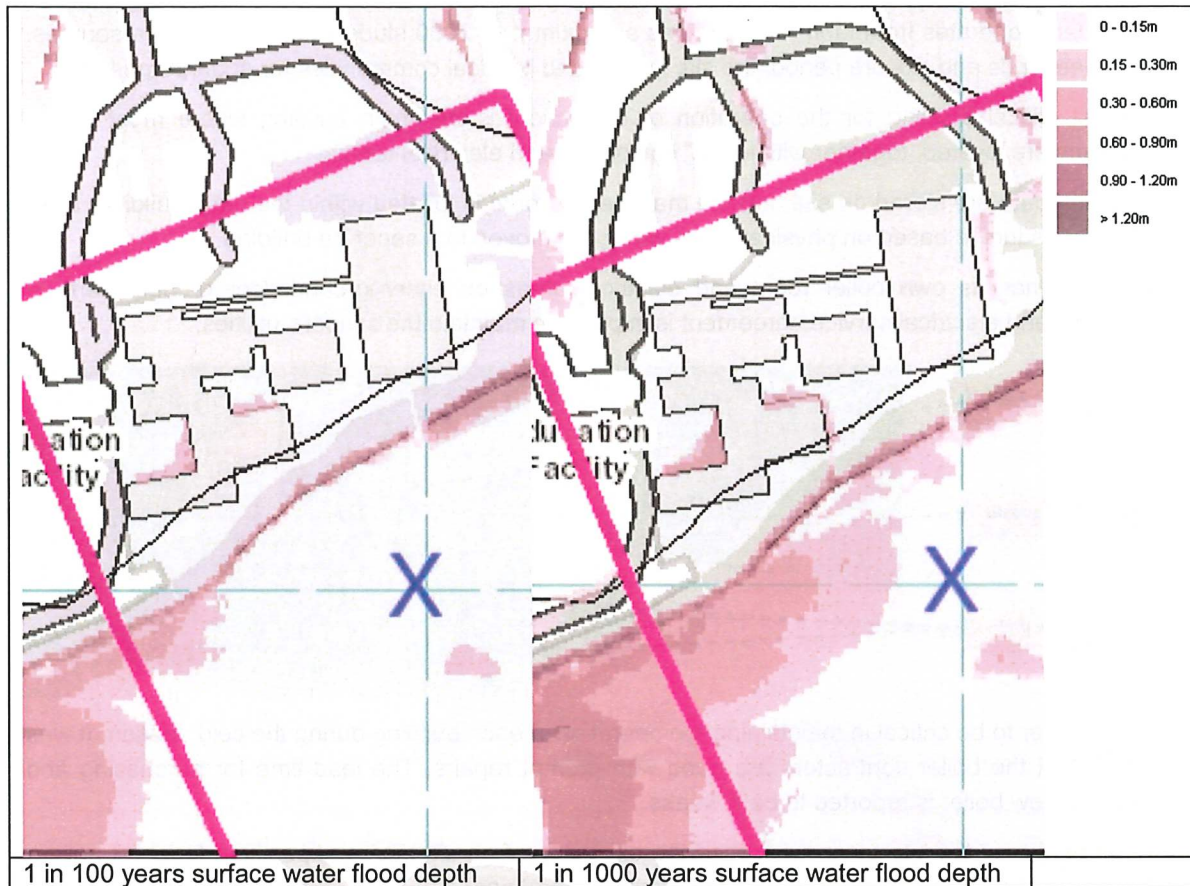
Figure 10 - Potential surface water flooding areas (source JBA)

The information in Figure 10 by JBA confirms the likely extent and risk associated with flash floods in the area. In terms of the potential water depths, these are indicated to be in the range of 300mm to 600mm. The return periods are slightly higher which indicates that occurrence of such depths is in the conservative likelihood ranges.

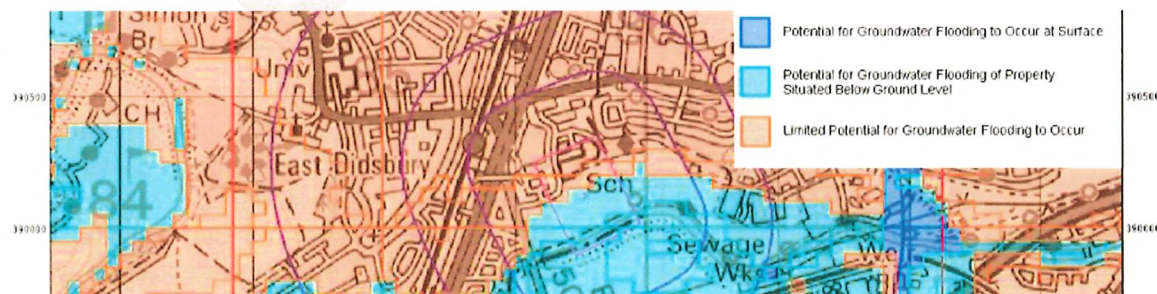
Figure 11 - Groundwater flooding potential (source: British Geological Survey)

There is a limited potential for groundwater flooding to basements at the site, due to the local terrain which could act as a collector of groundwater and raise the underground water table. Information by the British Geological Survey is presented in the figure below indicating the potential for such flooding. However, the academy team reported that for the most vulnerable areas no historical events have been observed in the recent past.

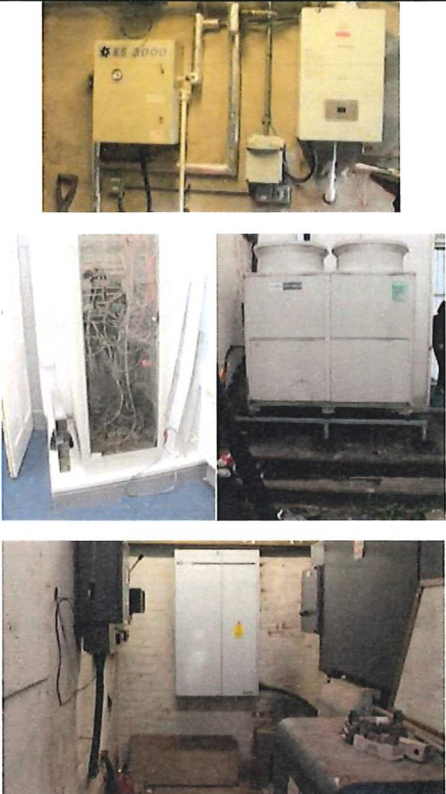
- **Boiler Room:** A small boiler room is located at the ground floor of the building and contains a 1 x condensation boiler at the wall, raised, a 1 x pressure unit at wall (1.5 bar) together with electrical panels are also installed on the walls, generally elevated at least 30 cm from the floor. Housekeeping standards observed during the

| | <p>survey were generally low in this room.</p> <ul style="list-style-type: none"> <li>• <i>Information Technology Main Server Room:</i> the main IT server room is located on the ground floor. 1 x metal rack hosts the IT equipment and is positioned on a 15 cm elevated plinth. The roof of this room collapsed in the past due to the humidity and has been replaced.</li> <li>• <i>Air-Con Refrigerators</i> are located outside, elevated 40 cm from the ground.</li> <li>• <i>Electrical Room:</i> an electrical room is located at the ground floor, containing the 1.20m elevated from ground arrival points of 2 x 415 volts power lines connected to the school's electrical substation. Electrical power is then distributed from here to the building through 2 electrical panels 1.20 m elevated. Other obsolete and unused electrical equipment is stored in this room.</li> <li>• Parrs Wood Lane Substation No: 172032 (located in Parrs Wood House's Courtyard): this substation contains a 1MVA oil filled transformer, built in 1964, which feeds the house and satellite buildings</li> </ul> |

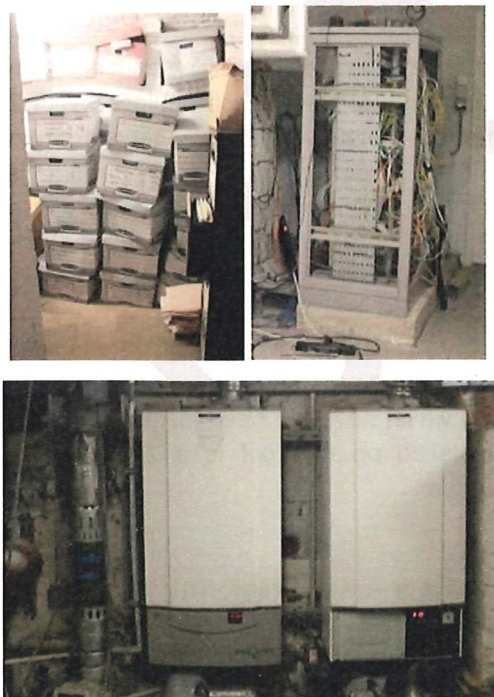
| | <p><b>Basement Level – Key Areas</b></p> <p>The building basement is accessible from the internal corridor and hosts general equipment storage, a hard copy paper archive, a small server room, and a boiler room. No openings such as windows or skylights were observed during the survey, while heating pipes are displaced at ceiling level. Paper files are stored in cardboard boxes piled on the ground.</p> <ul style="list-style-type: none"> <li>• The server room consists of a 1 x rack 15 cm elevated from the ground on its plinth and cooled down by an A/C fan. The server room is not provided with drainage system nor false ceiling / floor.</li> <li>• The boiler room burns natural gas through 2 x small condensation boilers, approximately 40 cm elevated from the ground. Electrical panels are also installed in the basement, generally elevated from the ground. Minor water pipe leakage was observed during the survey in this room.</li> </ul> |

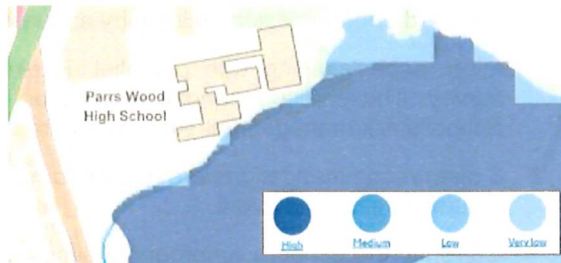
1. The sports grounds would be likely flooded.
  - a. Direct Damage: 20,000 GBP;
  - b. Downtime: 1 to 3 months;
2. The all-weather football pitch would be also flooded and damaged.
  - a. Direct Damage: 20,000 GBP;
  - b. Downtime: 1 to 3 months;

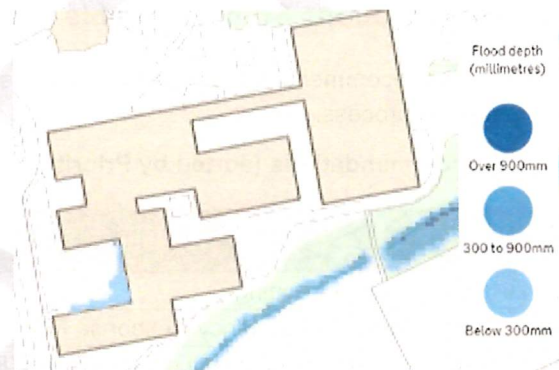
1. The electrical room would likely be minimally affected by the event, being the surface water runoff of a minor entity and the room corridor wide enough to allow the water depth to decrease further.
  - a. Direct Damage: None;
  - b. Downtime: None;
