**SHELDON BAKERY,  
OPENSHAW,  
MANCHESTER,  
M11 2FB**

## **CULVERT DIVERSION STRATEGY**

**8885-HBL-XX-XX-RP-C-0010**

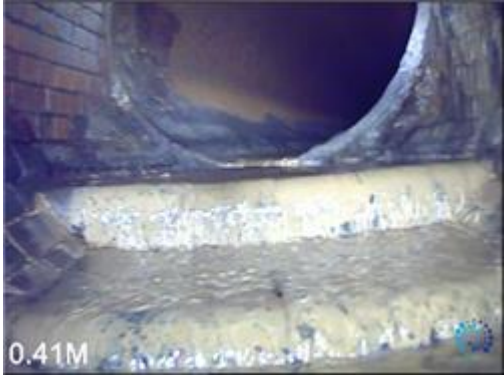
| Pos | Video Ref | Code | Description | Image |
|---|---|---|---|---|
| 00.00m | | MH | Start node type, manhole<br>MH SW 1 | Image Provided - Ref: 0_0<br> 0.41M |

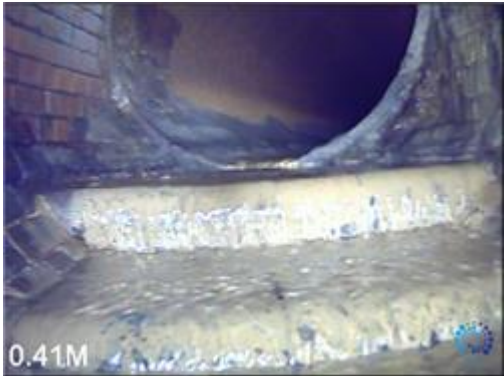
| Pos | Video Ref | Code | Description | Image |
|---|---|---|---|---|
| 00.00m | 0:00:00 | WL | Water level: 5%<br>Height/Diameter | Image Provided - Ref: 0_1<br> 0.41M |

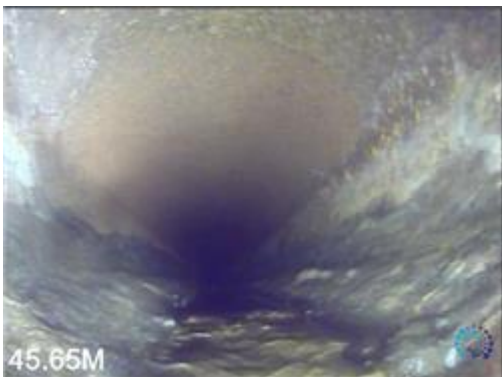
| Pos | Video Ref | Code | Description | Image |
|---|---|---|---|---|
| 45.65m | | MHF | Finish node type, manhole<br>MH SW2 | Image Provided - Ref: 0_9999<br> 45.65M |

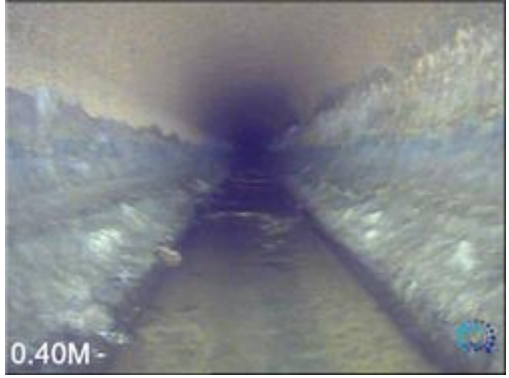
| Pos | Video Ref | Code | Description | Image |
|---|---|---|---|---|
| 00.00m | | MH | Start node type, manhole<br>MH SW2 | Image Provided - Ref: 1_0<br> |

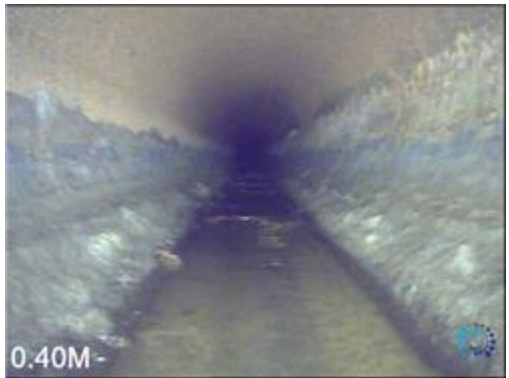
| Pos | Video Ref | Code | Description | Image |
|---|---|---|---|---|
| 00.00m | 0:00:00 | WL | Water level: 5%<br>Height/Diameter | Image Provided - Ref: 1_1<br> |

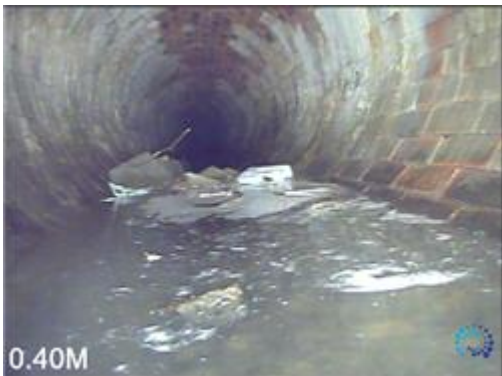
| Pos | Video Ref | Code | Description | Image |
|---|---|---|---|---|
| 00.00m | | MH | Start node type, manhole<br>MH SW1 | Image Provided - Ref: 2_0<br> |

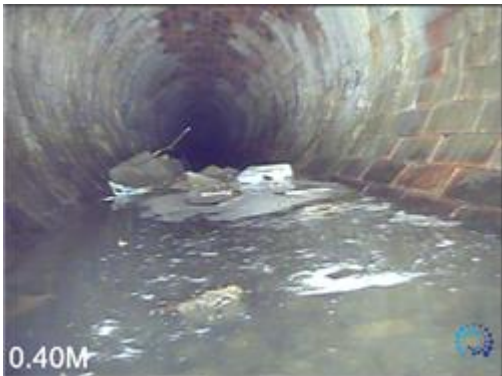
| Pos | Video Ref | Code | Description | Image |
|---|---|---|---|---|
| 00.00m | 0:00:00 | WL | Water level: 10%<br>Height/Diameter | Image Provided - Ref: 2_1<br> |

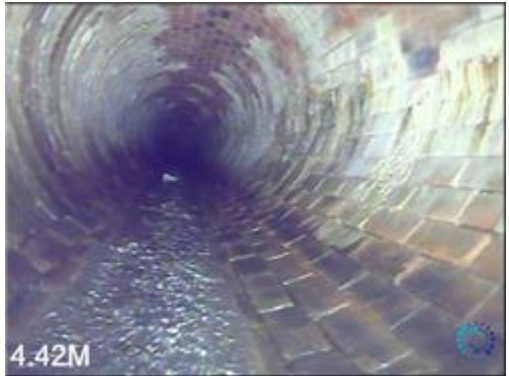
| Pos | Video Ref | Code | Description | Image |
|---|---|---|---|---|
| 04.42m | 0:00:57 | WL | Water level: 5% Height/Diameter | <p>Image Provided - Ref: 2_3</p> <p>4.42M</p> |

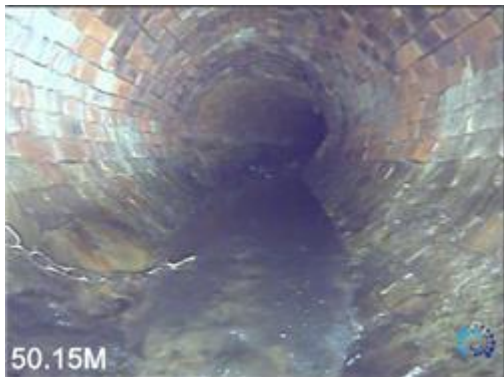
| Pos | Video Ref | Code | Description | Image |
|---|---|---|---|---|
| 50.20m | | MHF | Finish node type, manhole<br>MH SW3 | <p>Image Provided - Ref: 2_9999</p> |

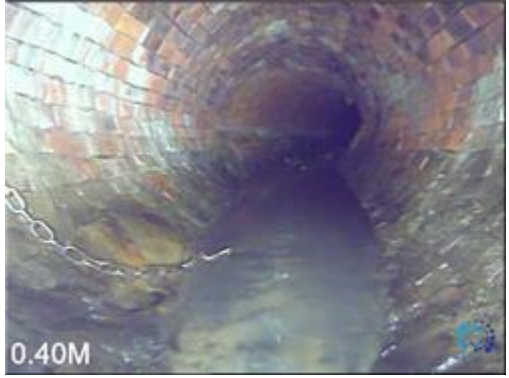
| Pos | Video Ref | Code | Description | Image |
|---|---|---|---|---|
| 00.00m | | MH | Start node type, manhole<br>MH SW3 | Image Provided - Ref: 3_0<br> 0.40M |

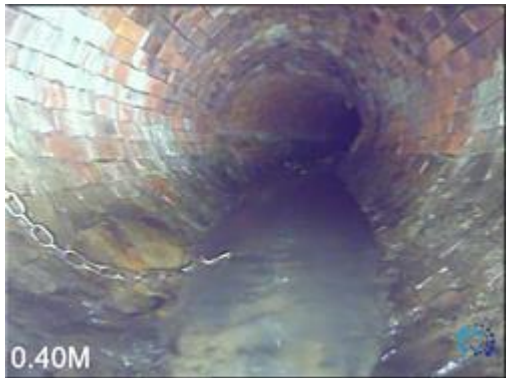
| Pos | Video Ref | Code | Description | Image |
|---|---|---|---|---|
| 00.00m | 0:00:00 | WL | Water level: 5%<br>Height/Diameter | Image Provided - Ref: 3_1<br> 0.40M |

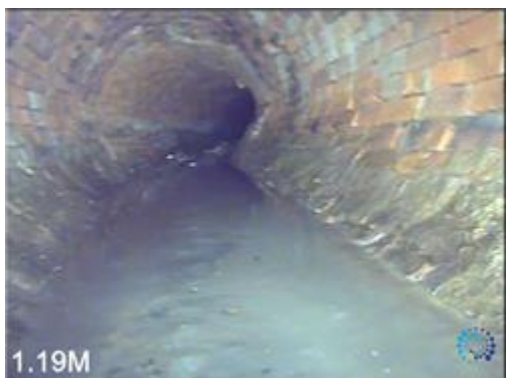
| Pos | Video Ref | Code | Description | Image |
|---|---|---|---|---|
| 01.19m | 0:00:10 | WL | Water level: 10%<br>Height/Diameter | Image Provided - Ref: 3_2<br> 1.19M |

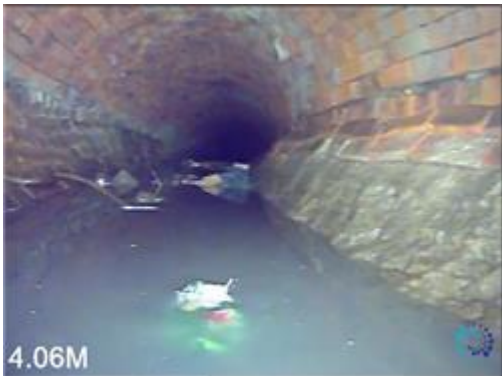
| Pos | Video Ref | Code | Description | Image |
|---|---|---|---|---|
| 04.06m | 0:00:29 | WL | Water level: 20% Height/Diameter | Image Provided - Ref: 3_4<br> |
