| KELIOS AMEY METROLINK INSPECTIONS |
| A53 - WILLIAM STREET ARCHES |

## Appendix B: Photographs

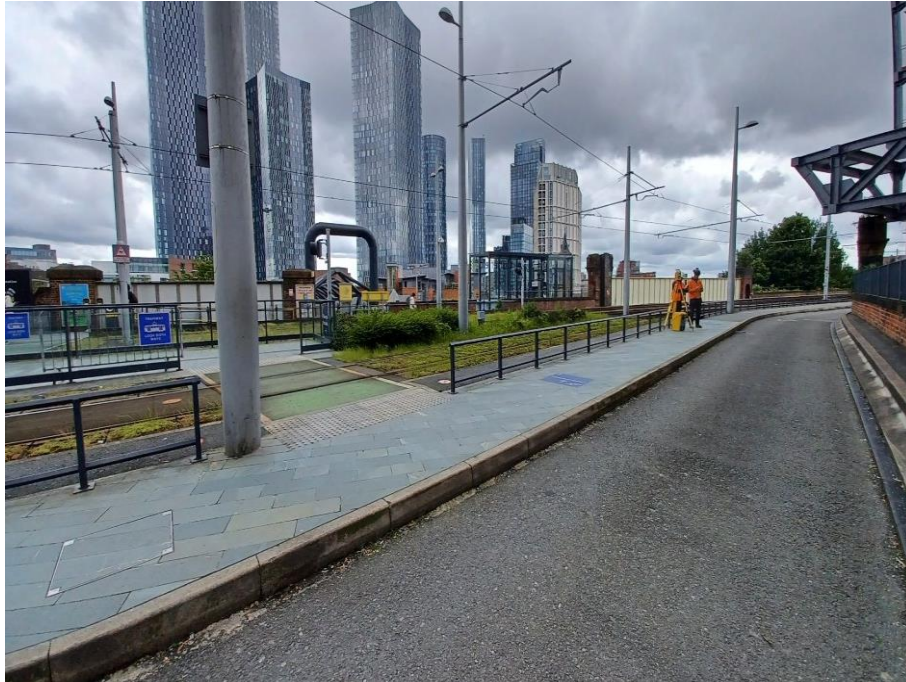
Photo 3: General view across topside looking north to south.

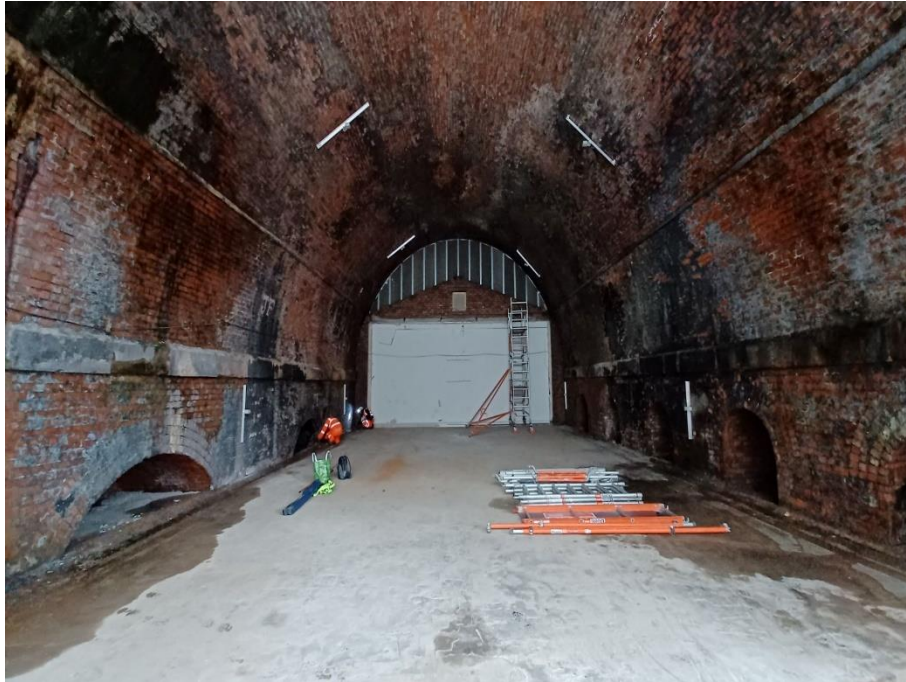
Photo 5: General view through span 1 looking north to south.

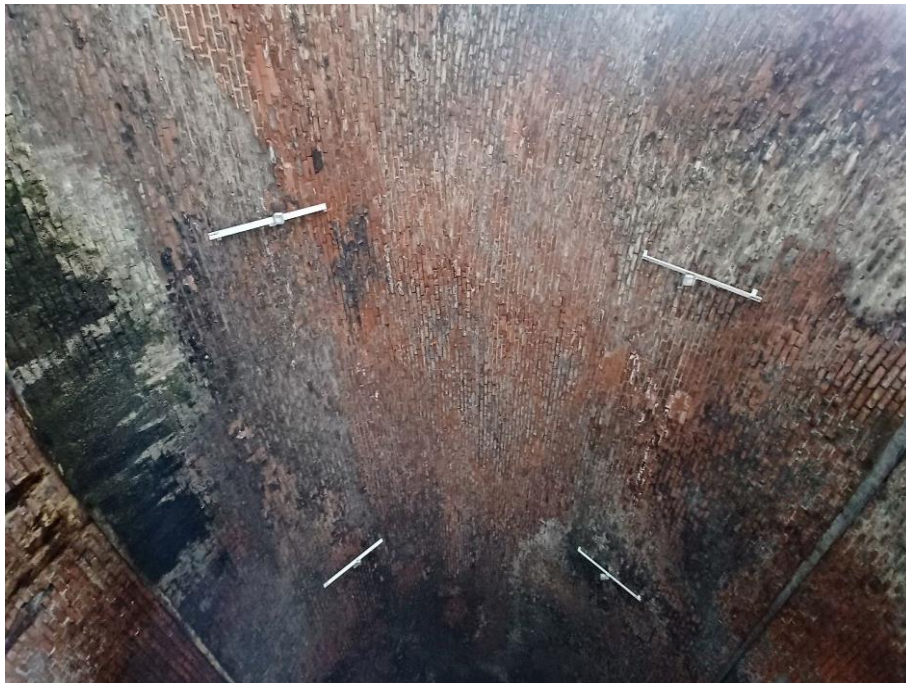
Photo 6: General view of span 1 soffit looking north to south.

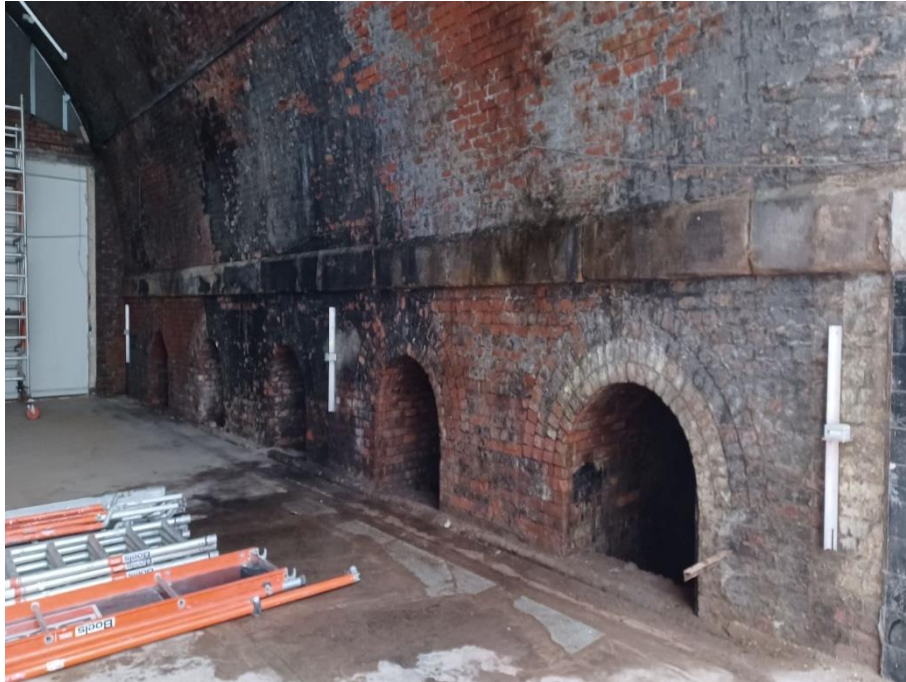
Photo 7: General view of west abutment showing relieving arches.

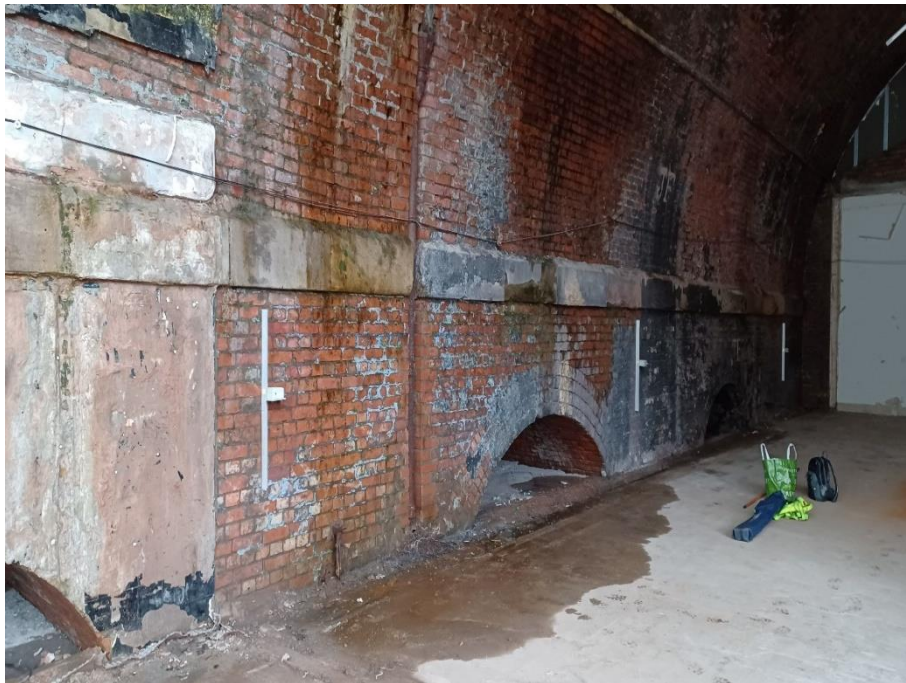
Photo 8: General view of west face of central pier showing relieving arch.

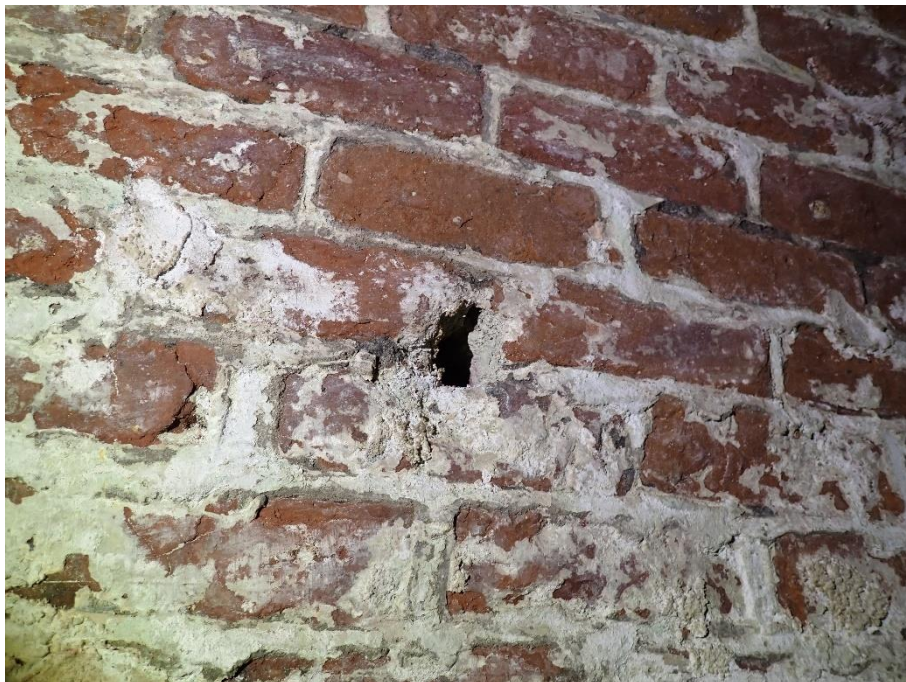
Photo 40: Hole (possible historic core hole) to east face south end of internal section of arch barrel span 2.

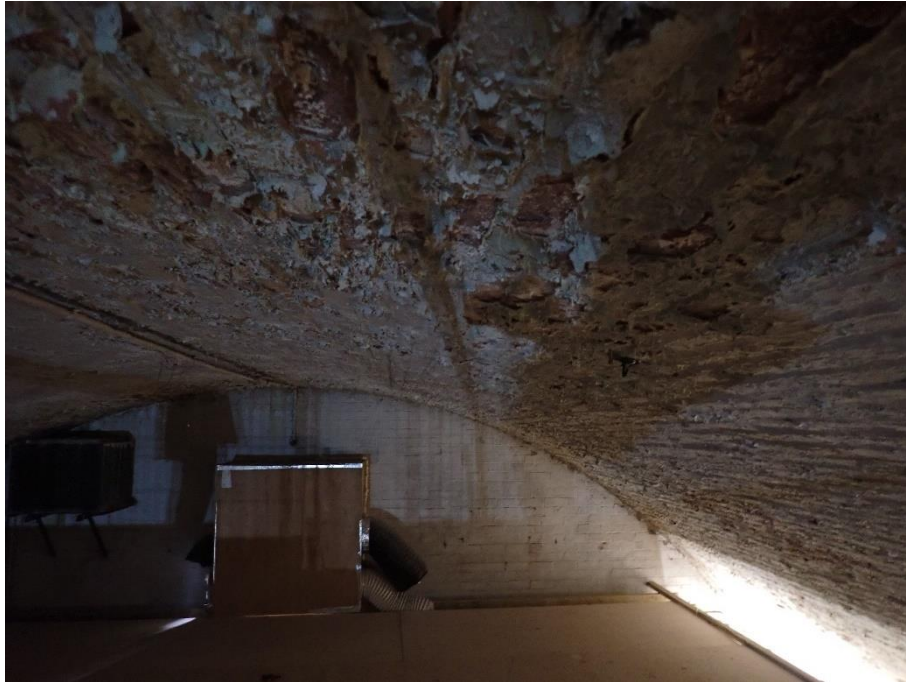
Photo 41: Hollow sounding area of brickwork 3x1.5m to west quarter point starting at south infill wall with 10mm displaced course of bricks within same area of span 2 arch barrel.

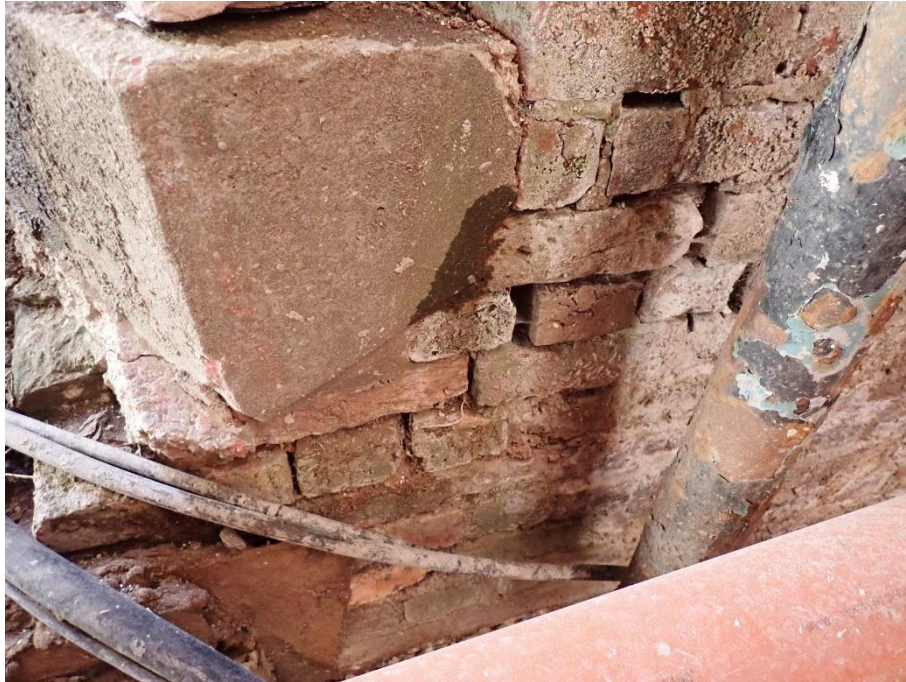
Photo 43: Area of displaced brickwork and mortar loss 500x250mm to north end of east abutment.

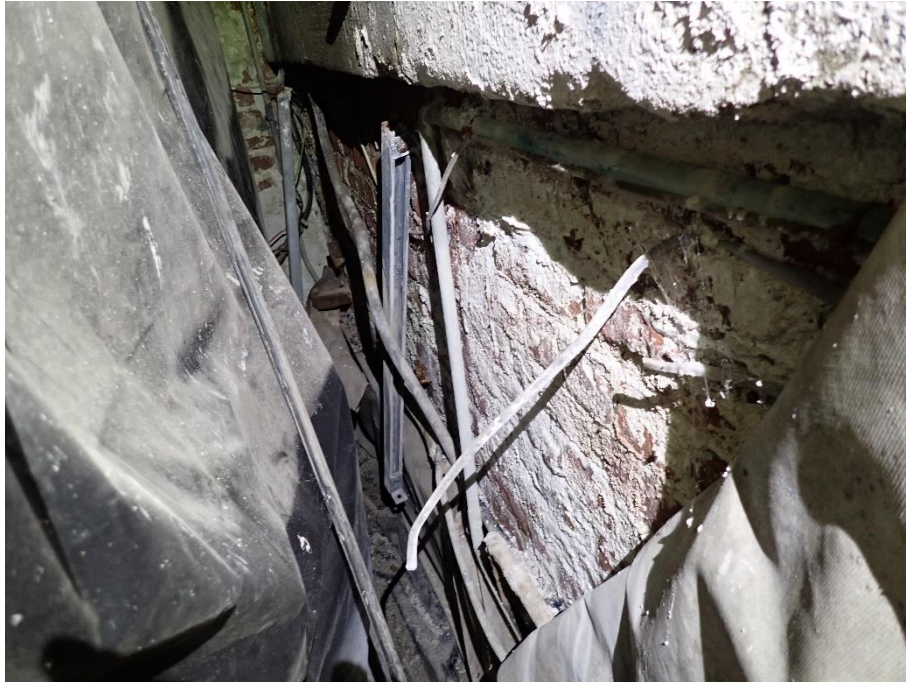
Photo 45: Wet brickwork and water pooling at base of east abutment at exposed section below Photo. 37.

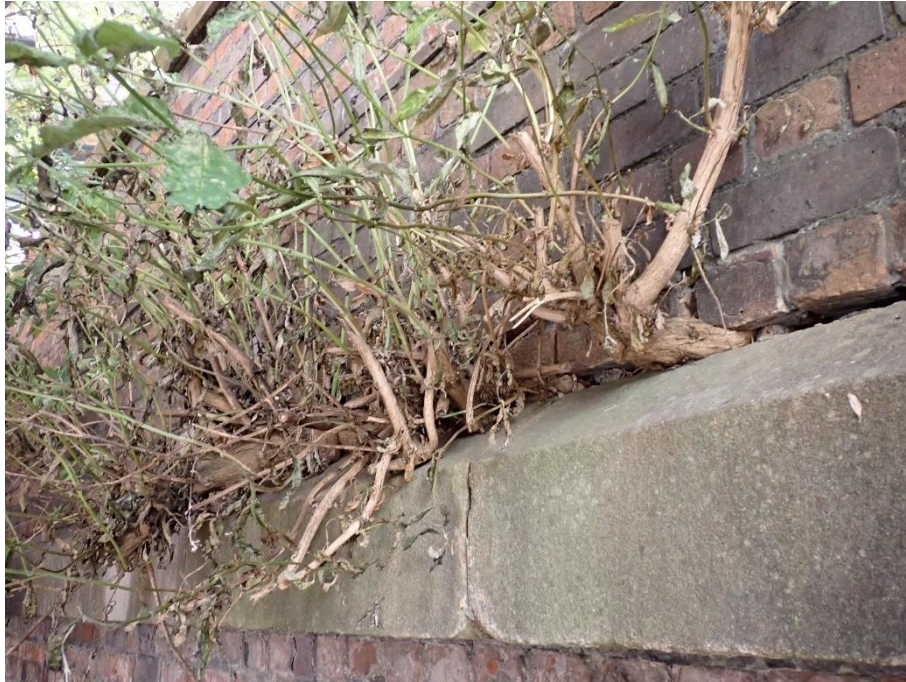
Photo 57: Significant root growth displacing brickwork up to 20mm to string course of north elevation of span 1.

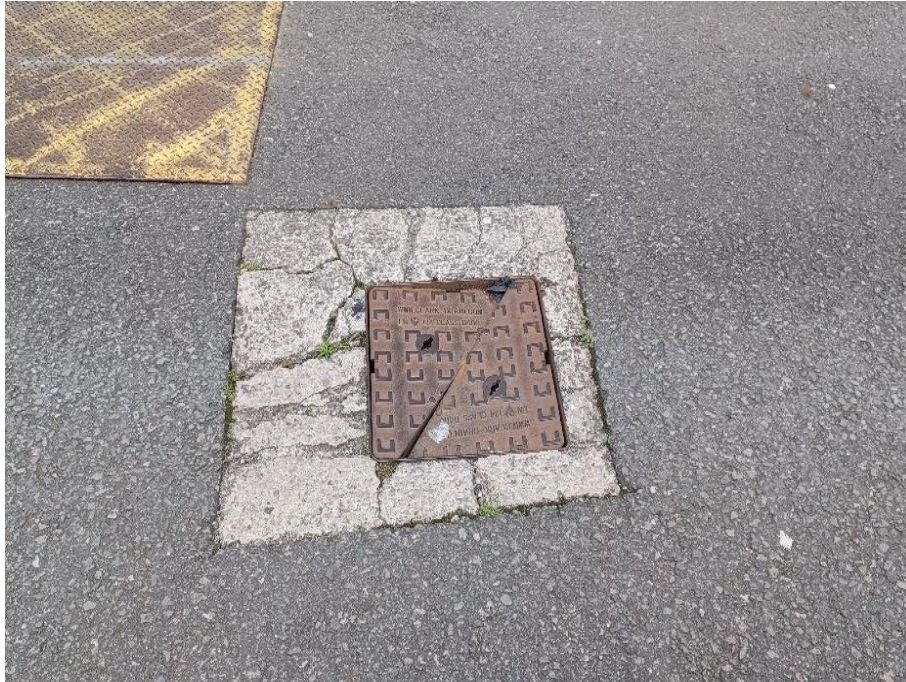
Photo 65: Sunken/displaced access cover in north carriageway.
