**AN ARBORICULTURAL IMPACT ASSESMENT AND  
METHOD STATEMENT  
AT PARRSWOOD LEISURE COMPLEX ,  
WILMSLOW ROAD, DIDSBURY.**

**Prepared for Charlie Coghlan of Raw Charging Ltd.**

**Paul Hanson – LANTRA Professional Tree Inspector**

**1<sup>st</sup> December 2025**

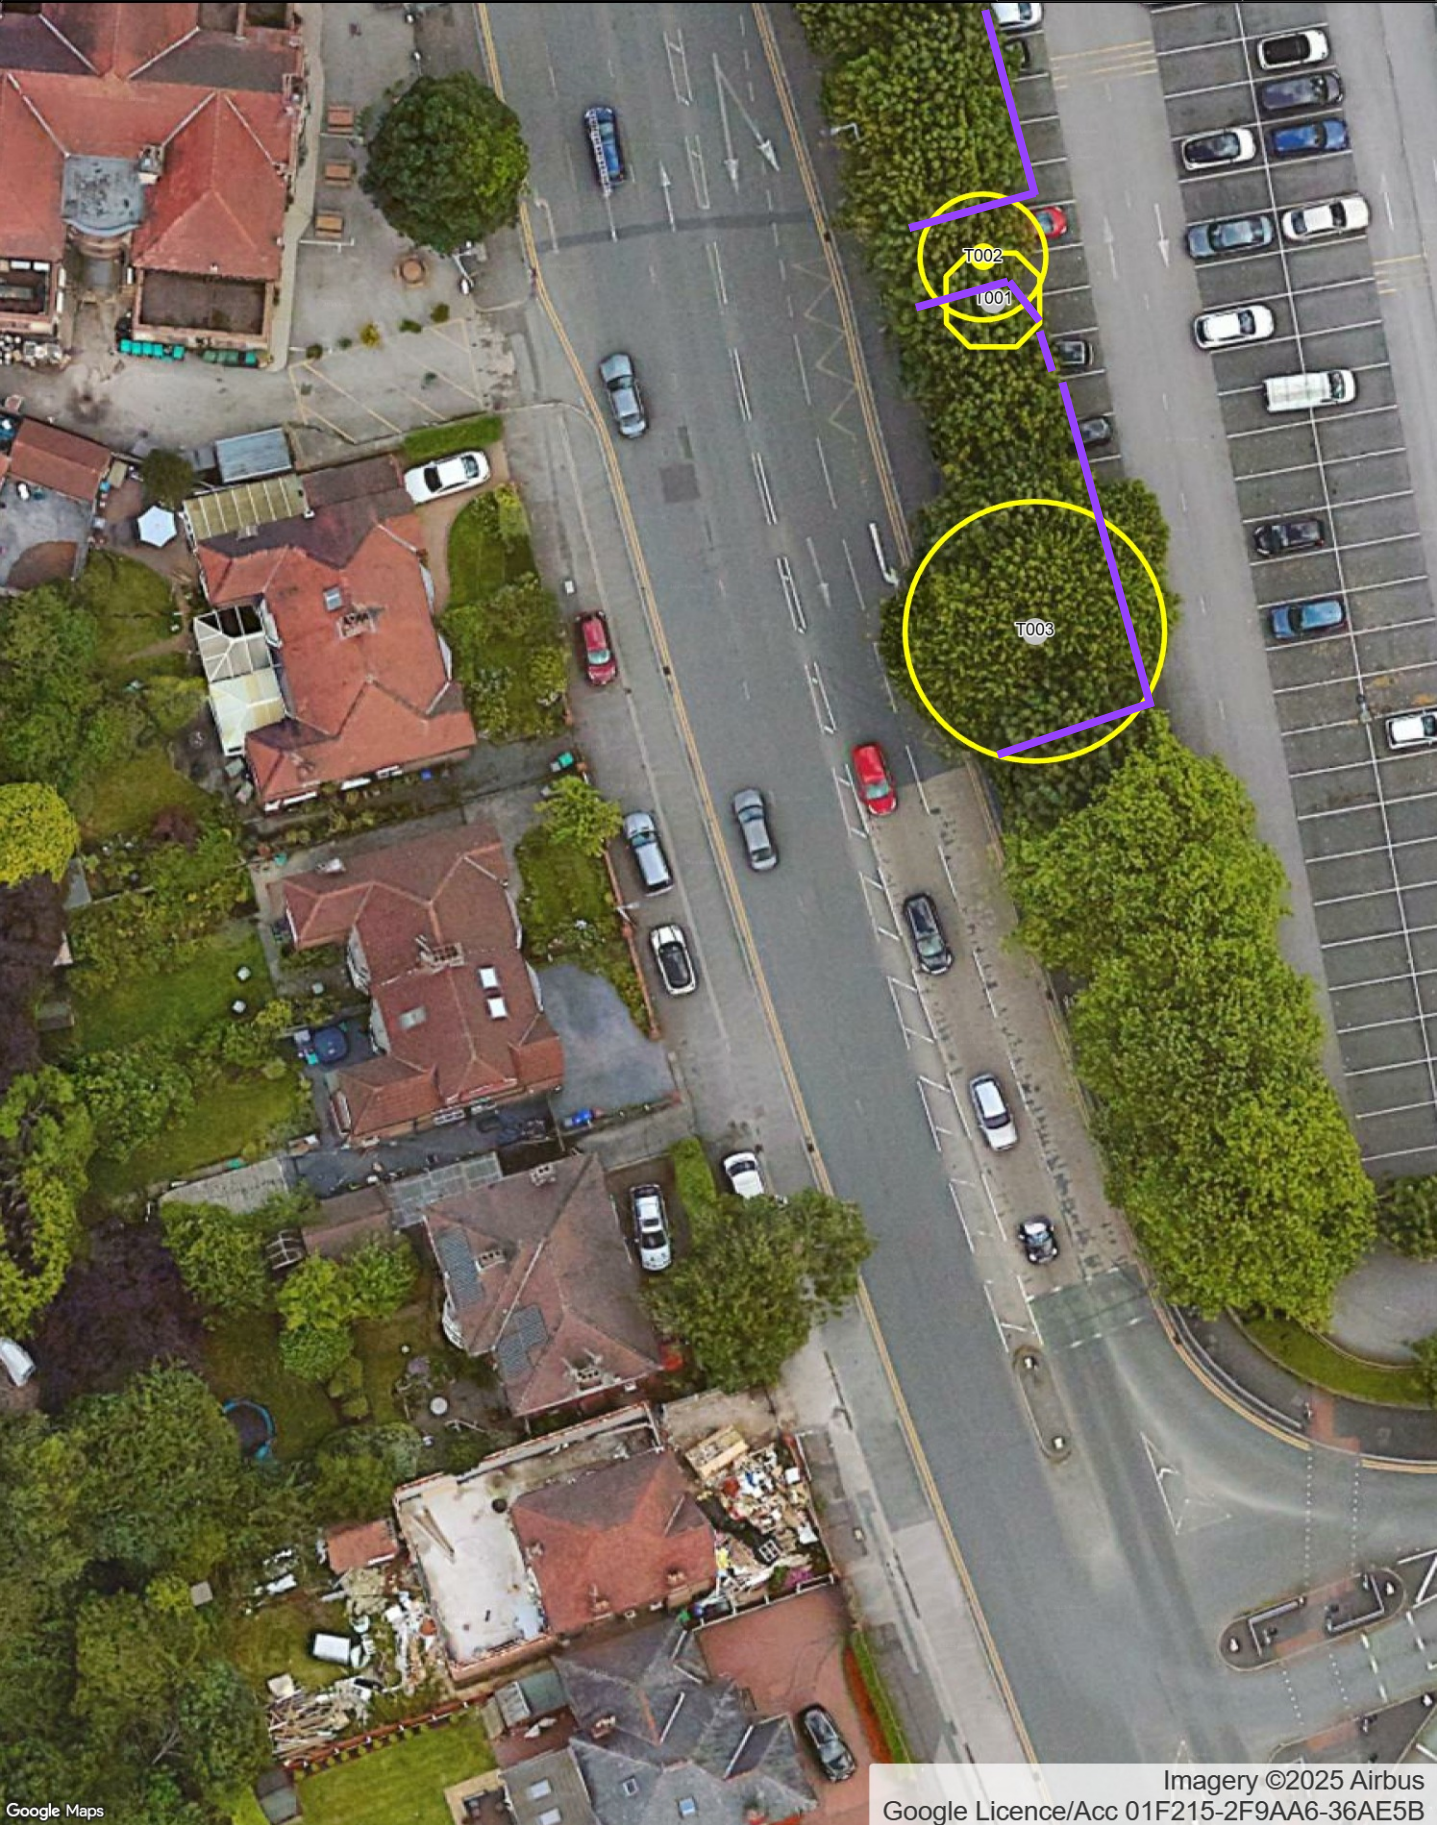
TREE PROTECTION PLAN,RPAS  
IN YELLOW ,TREE PROTECTIVE  
FENCING IN PURPLE

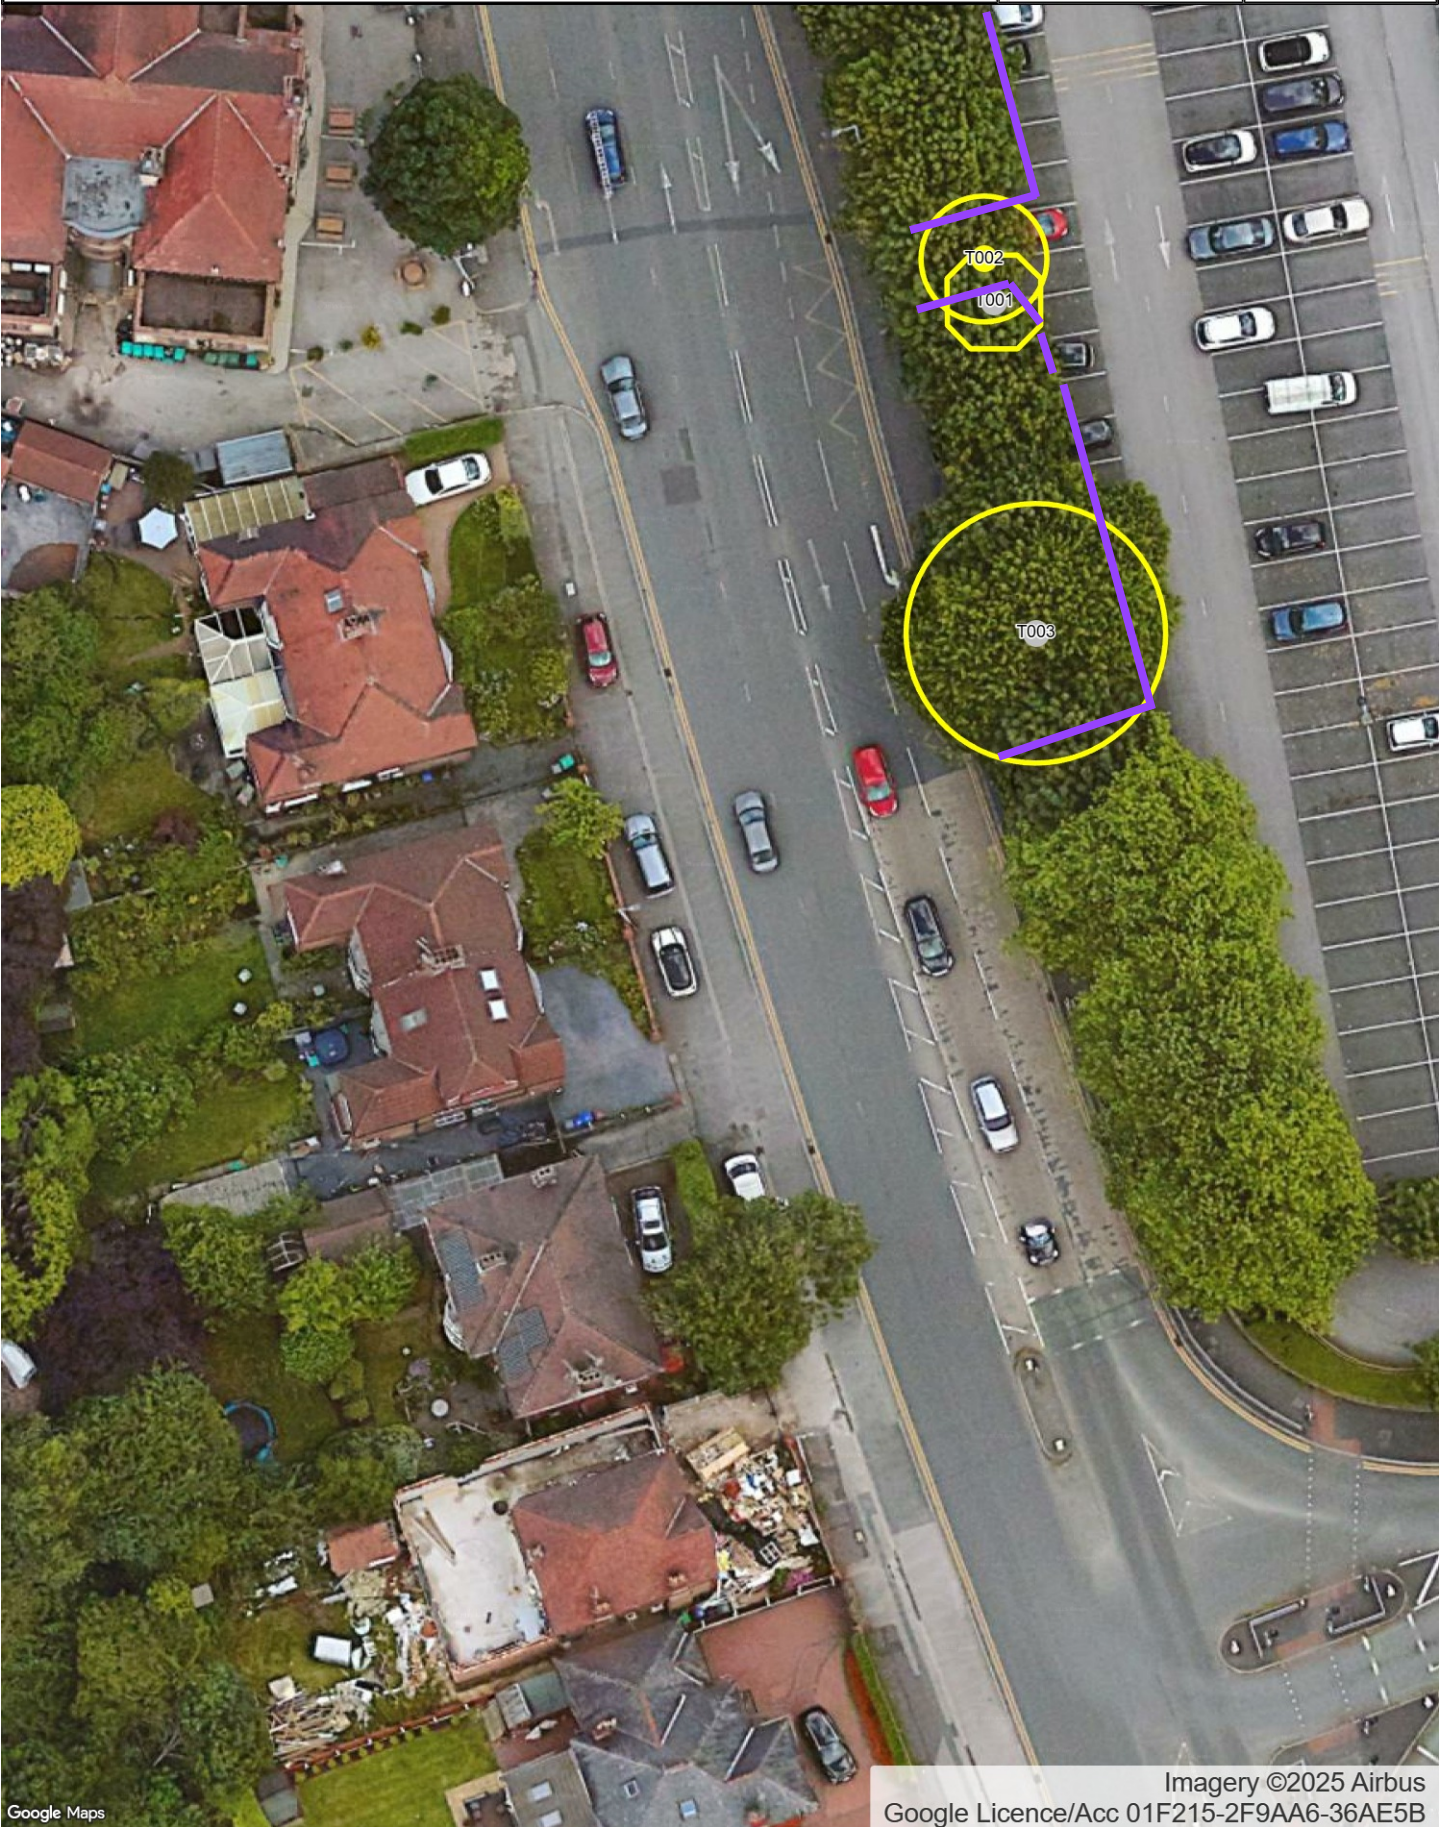
- \* Tree Removal – One tree is scheduled for removal due to infection from a fungal bacterium and basal damage.

| Ref. | Species | Full Structure | Measurements | Survey Notes | Retention Category | RPA | Comments | Measurements2 | Recommendations | Photo |
|---|---|---|---|---|---|---|---|---|---|---|
| T002 | Norway maple<br>( <i>Acer platanoides</i> ) | Tree | Height (m): 8<br>Stem Diam(mm): 290<br>Spread (m): 3N, 5E, 3S, 5W<br>Crown Clearance (m): 2.5<br>Lowest Branch (m): 2.5(E)<br>Life Stage: Semi Mature<br>Rem. Contrib.: <10 years | Large wound to basal area of stem<br><br>Pests and Diseases:<br>Sooty Bark Disease (Cryptostroma corticale) | U | Radius: 3.5m.<br>Area: 38 sq m. | Tree to be removed to facilitate construction of the Electrical distribution unit . | Other Reference:<br>Physiological Condition: Fair<br>Structural Condition: Good<br>Distance1:<br>Distance2:<br>You customise:<br>Public Amenity Value: Good<br>Inspection Limitations: None<br>Bat Habitat: Unknown | Pre construction:<br>Fell tree to facilitate construction.<br><br>During construction:<br>No action required.<br><br>Post construction:<br>Replacement tree to be planted of the same species. | |
