**Mitchells and Butlers**

**Browns Manchester**

**Condition Survey 2026**

**Engineers Report**

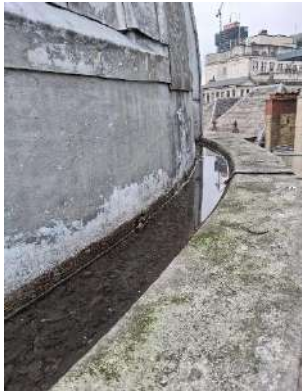
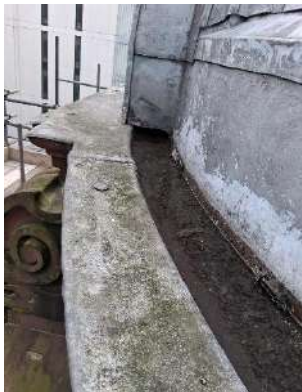
| 003 | | <p>The lead box gutter to the dome on the front elevation was found to be blocked at this location. The blockage may prevent rainwater from draining correctly, resulting in ponding or overflowing rainwater and potentially causing water ingress and further deterioration to the surrounding structure.</p> <p>We would recommend that the lead box gutter and associated outlets are carefully cleared of all debris and blockages to allow rainwater to disperse effectively and prevent overflow from the rainwater goods.</p> |

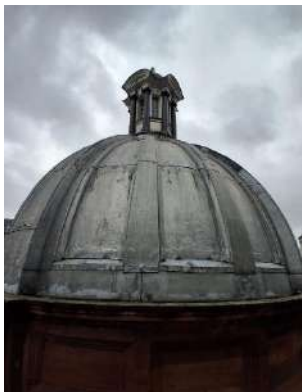
| 004 | | <p>No scaffold access was provided to the dome and upper cupola at the time of inspection. From the areas visible to our engineer using the access available, no obvious defects were identified to these areas.</p> |

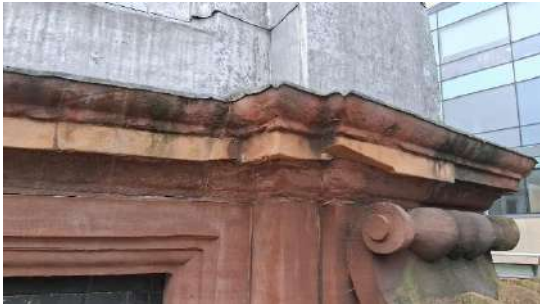
| 005 | | <p>Friable masonry and a damaged historic repair were identified to the underside of the cornice at this location, together with an open joint to the window head. The friable masonry may become loose and potentially dislodged and fall, presenting a potential hazard, while the open joint may allow water ingress and lead to further deterioration of the surrounding masonry.</p> <p>We would recommend that the affected masonry is carefully de-frassed back to sound material, removing all loose and unstable material, and that the integrity of the historic repair is assessed. Any failed pointing should be carefully removed and patch repointing carried out using an approved mortar mix compatible with the existing masonry.</p> |

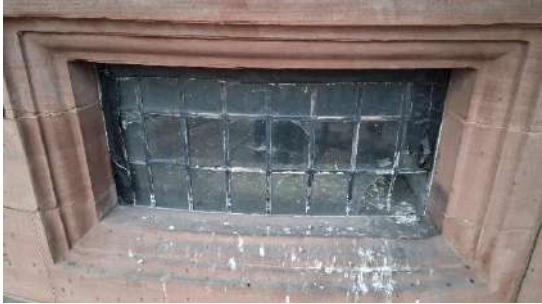
| 006 | | <p>Two damaged glazing units were identified within the leaded window at this location. The damaged glazing may allow water ingress and could deteriorate further if left untreated.</p> <p>We would recommend that a suitably experienced specialist glazier is employed to carefully remove and replace the two defective glazing units, matching the existing glass and leaded detailing as closely as practicable.</p> |

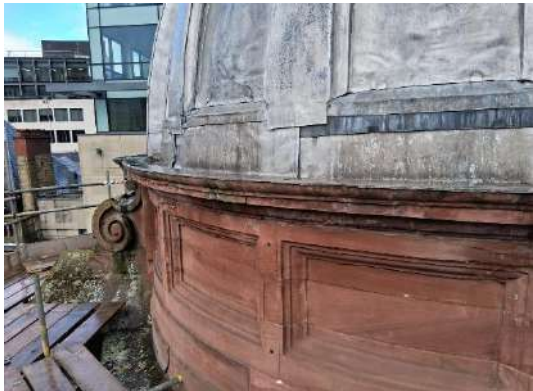
| 008 | | <p>Friable masonry was identified around the high-level cornice detail below the dome at this location. The affected masonry may continue to deteriorate, with loose material potentially becoming dislodged and falling, presenting a potential hazard if left untreated.</p> |

| | | We would recommend that a full de-frass of the high-level masonry is undertaken to carefully remove all loose and unstable material, exposing sound masonry. |

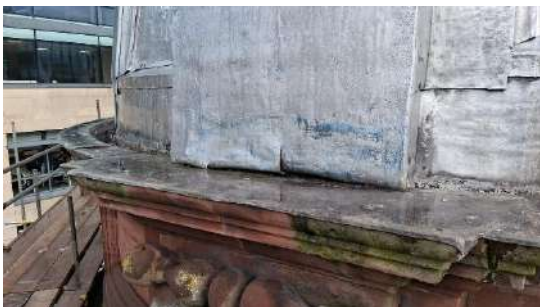
| 009 | | <p>A split was identified to the lead sheet at this location. If left untreated, the split may allow water ingress and could lead to further deterioration of the underlying structure and surrounding materials.</p> <p>We would recommend that a lead weld patch repair is carried out to the affected area to provide a durable, weatherproof repair and prevent further water ingress.</p> |

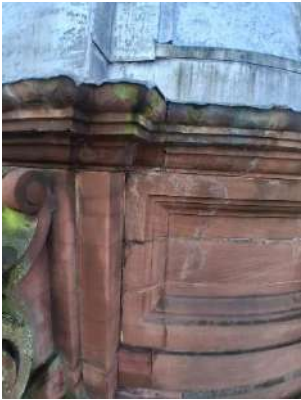
| 013 | | <p>Failed pointing was identified to the stonework at this location. The defective pointing may allow water ingress and could lead to further deterioration of the surrounding stonework if left untreated.</p> <p>We would recommend that the failed pointing is carefully removed and localised patch repointing works are carried out using an approved mortar mix compatible with the existing stonework, finished to match the surrounding pointing as closely as practicable.</p> |

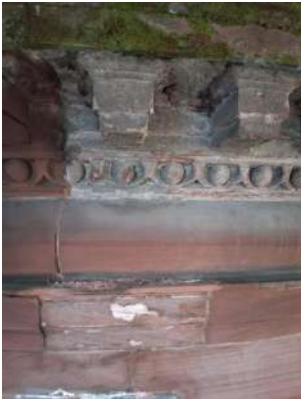
| 014 | | <p>Friable masonry was identified at this location. The affected masonry may continue to deteriorate, with loose material potentially becoming dislodged and falling, presenting a potential hazard if left untreated.</p> <p>We would recommend that the affected masonry is carefully de-frassed back to sound material, removing all loose and unstable material only.</p> |

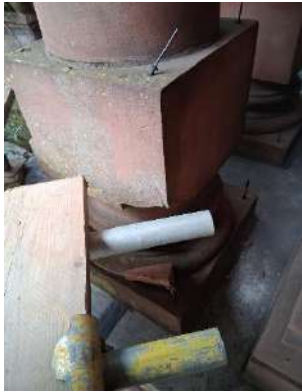
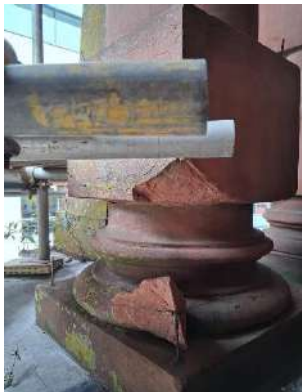
| 019 | | <p>The stone column base was found to be damaged at this location, with a section of stone caught within the bird deterrent wire. The damaged stone may contain loose and unstable material which could become dislodged and fall if left untreated.</p> |

| | | <p>We would recommend that the affected area is carefully de-frassed to remove all loose and unstable material. Following removal, consideration should be given to carrying out either a suitable stone indent repair or a colour-matched mortar repair, depending on the extent of deterioration identified.</p> |

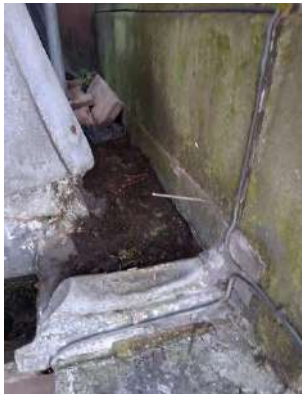
| 020 | | <p>Debris was identified within the lead box gutter, together with algae growth to the adjoining masonry, indicating a potential issue with rainwater drainage and possible water ingress at this location. If left untreated, restricted drainage may result in overflowing rainwater and further deterioration to the surrounding masonry.</p> |

| | | <p>We would recommend that all debris is carefully removed from the lead box gutter and associated outlets to allow rainwater to disperse correctly. The affected masonry should then be carefully cleaned using a DOFF steam cleaning system to remove the algae growth. Further investigation should subsequently be undertaken to determine the potential source of the water ingress and identify any additional remedial works required.</p> |

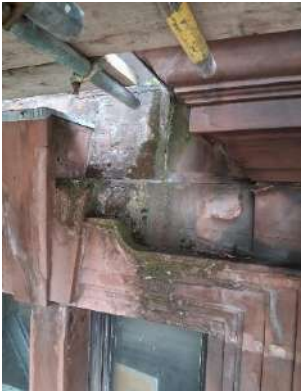
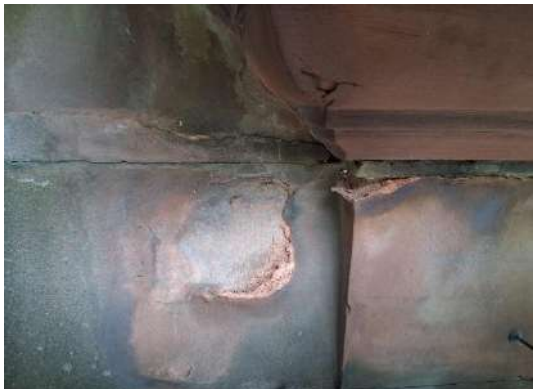
| 029 | <br> | <p>Friable and delaminating masonry were identified at this location. The affected masonry may continue to deteriorate, with loose material potentially becoming dislodged and falling, presenting a potential hazard if left untreated.</p> <p>We would recommend that the affected masonry is carefully de-frassed back to sound material, removing all loose and unstable material only.</p> |

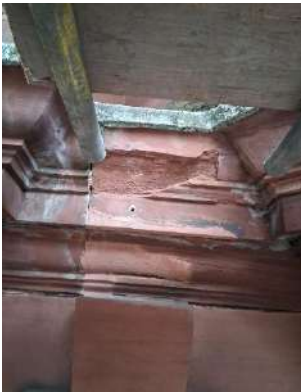
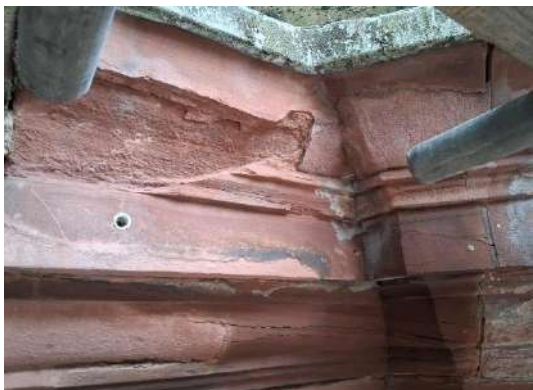
| 030 | <br> | <p>The historic repairs at this location have failed and may become loose and potentially dislodged if left untreated.</p> <p>We would recommend that the failed historic repairs are carefully removed to expose and assess the underlying stonework. New repairs should then be undertaken using a suitable colour-matched stone repair mortar incorporating suitable stainless-steel reinforcement to provide additional stability and reduce the risk of further failure.</p> |

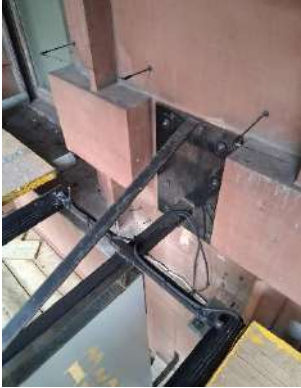
| 034 | | <p>The metal sign bracket was found to be in good overall condition, with no defects identified at the time of inspection. No remedial works are considered necessary at this time.</p> |

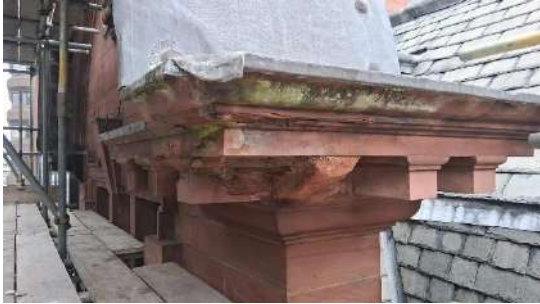
| 004 | | <p>Algae growth, friable masonry and failed historic repairs were identified at this location. The biological growth can retain moisture against the masonry and may contribute to staining and gradual surface deterioration, while the friable masonry may continue to deteriorate, with loose material potentially becoming dislodged and falling, presenting a potential hazard. The failed historic repairs may also become loose and detached if left untreated.</p> <p>We would recommend that the affected masonry is carefully cleaned using a DOFF steam cleaning system to remove the algae growth, using a controlled method appropriate to the existing stonework. The friable masonry should then be carefully de-frassed back to sound material, removing all loose and unstable material. The failed historic repairs should be carefully removed to expose and assess the underlying stonework, with consideration given to carrying out suitable stone indent repairs where the extent of deterioration warrants.</p> |

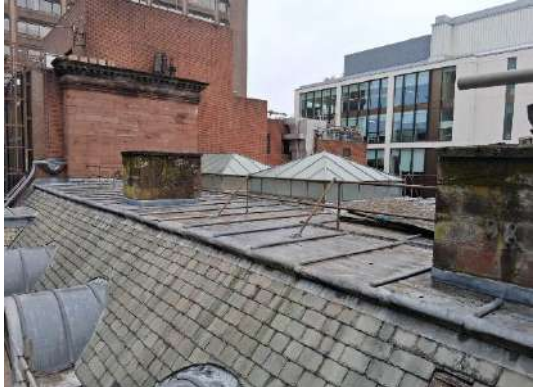
| 006 | | <p>The lead roof and roof lights were found to be in good overall condition at the time of inspection, with no defects identified. No remedial works are considered necessary at this time.</p> |

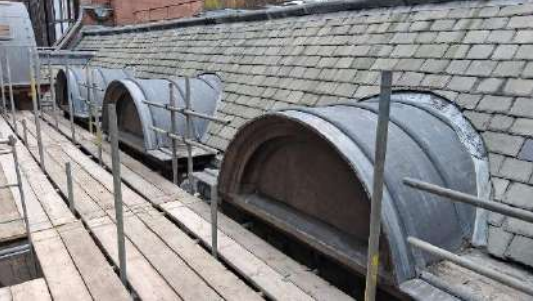
| 007 | | <p>The slate roof and leaded dormer roofs were found to be in good overall condition at the time of inspection, with no defects identified. No remedial works are considered necessary at this time.</p> |

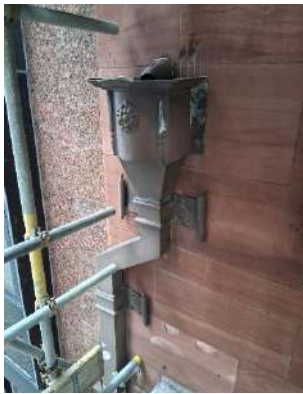
| 008 | | <p>The lead rainwater downpipe was found to be in good overall condition; however, the existing paint coating system is deteriorating and is no longer providing adequate protection to the surface.</p> |

| | | <p>We would recommend that the lead rainwater downpipe is suitably prepared and redecorated using an approved paint coating system suitable for application to lead, in accordance with the manufacturer's recommendations.</p> |

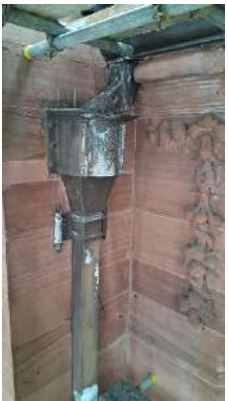
| 010 | | <p>The lead rainwater downpipe was found to be in good overall condition; however, the existing paint coating system is deteriorating and is no longer providing adequate protection to the surface.</p> <p>We would recommend that the lead rainwater downpipe is suitably prepared and redecorated using an approved paint coating system suitable for application to lead, in accordance with the manufacturer's recommendations.</p> |

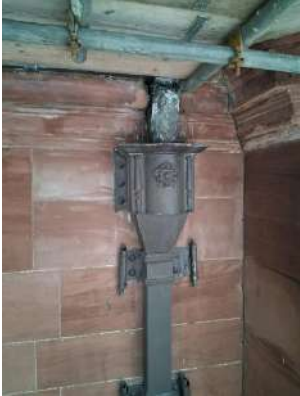
| 011 | | <p>The lead rainwater downpipe was found to be in good overall condition; however, the existing paint coating system is deteriorating and is no longer providing adequate protection to the surface.</p> <p>We would recommend that the lead rainwater downpipe is suitably prepared and redecorated using an approved paint coating system suitable for application to lead, in accordance with the manufacturer's recommendations.</p> |

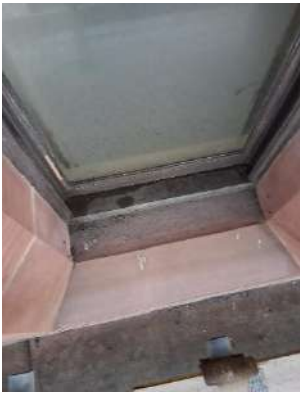
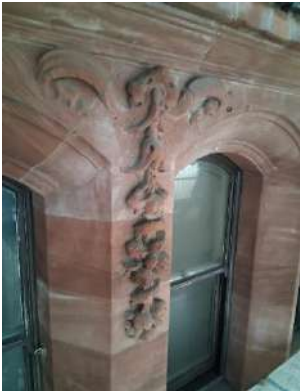
| 012 | | <p>The timber window frames and surrounding masonry were found to be in good overall condition at the time of inspection, with no defects identified. No remedial works are considered necessary at this time.</p> |

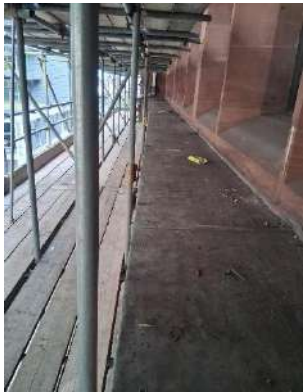
| 014 | | <p>The lead covering to the stone string course was found to be in good overall condition at the time of inspection, with no defects identified. No remedial works are considered necessary at this time.</p> |

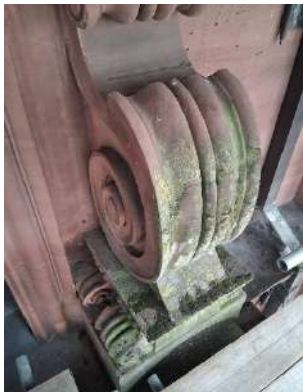
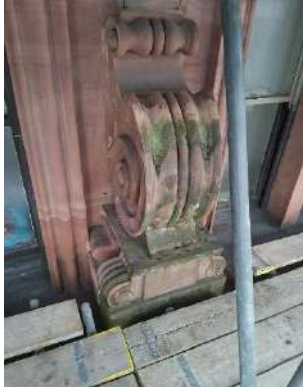
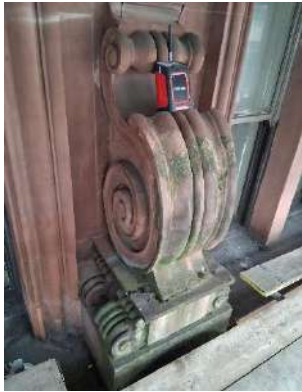
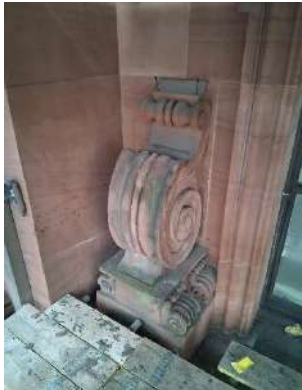
| 015 | | <p>Five ornamental stone corbels, comprising decorative scroll (volute) mouldings and curved, fluted stone detailing, were found to have algae growth and friable masonry. The biological growth can retain moisture against the stonework and may contribute to staining and gradual surface deterioration, while the friable masonry may continue to deteriorate, with loose material potentially becoming dislodged and falling, presenting a potential hazard if left untreated.</p> <p>We would recommend that the affected ornamental stonework is carefully cleaned using a DOFF steam cleaning system to remove the algae growth, using a controlled method appropriate to the existing stonework.</p> |

| | | The friable masonry should then be carefully de-frassed back to sound material, removing all loose and unstable material only. |

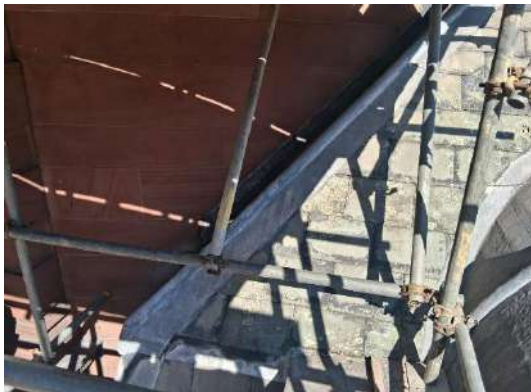
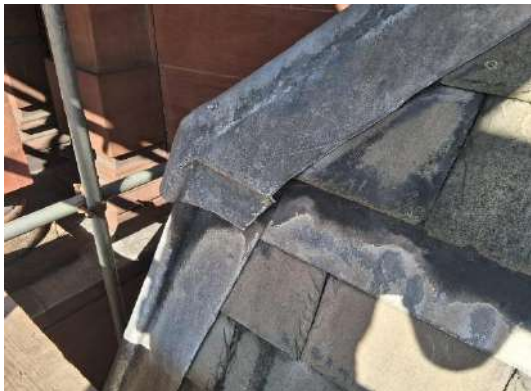
| | Photograph | Description |
|---|---|---|
| 001 | | The lead hip detail has slipped from its original position in this location. |

| | Photograph | Description |
|---|---|---|
| | | We would recommend refixing the lead hip detail. |

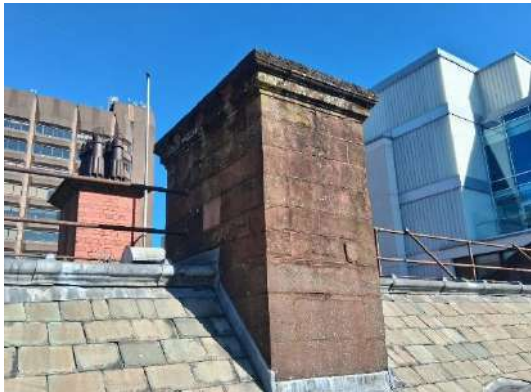
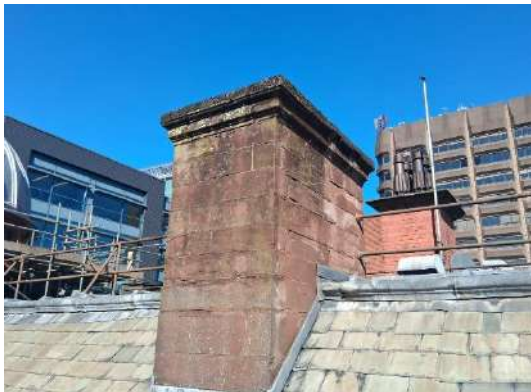
| | Photograph | Description |
|---|---|---|
| 002 | | The 3 no chimneys at roof level on this elevation were identified to have algae growth and friable masonry. |

| | Photograph | Description |
|---|---|---|
| | | We would recommend carrying out a DOFF steam clean to remove all algae and carrying out defrassing works to remove all loose material. |

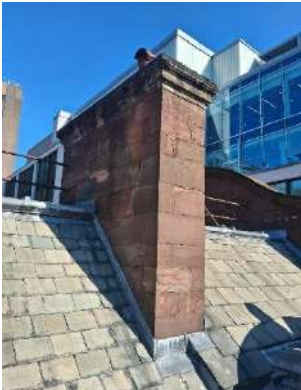
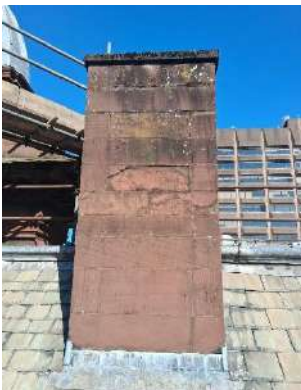
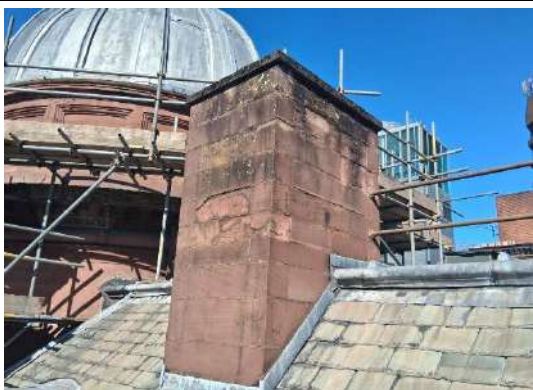
| 002 | | <p>The three chimneys at roof level on this elevation were found to have algae growth and friable masonry. The biological growth can retain moisture against the masonry and may contribute to staining and gradual surface deterioration, while the friable masonry may continue to deteriorate, with loose material potentially becoming dislodged and falling, presenting a potential hazard if left untreated.</p> <p>We would recommend that the affected chimney masonry is carefully cleaned using a DOFF steam cleaning system to remove the algae growth, using a controlled method appropriate to the existing masonry. The friable masonry should then be carefully de-frassed back to sound material, removing all loose and unstable material only.</p> |

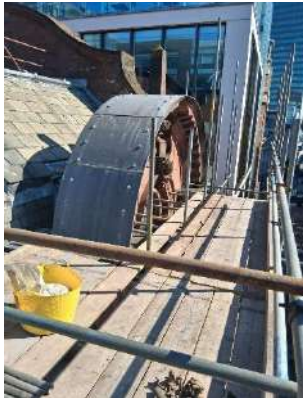
| 003 | | <p>The stone arch was inaccessible at the time of inspection due to incomplete scaffold access; however, our engineer noted algae growth and friable masonry from the areas visible. The biological growth can retain moisture against the masonry and may contribute to staining and gradual surface deterioration, while the friable masonry may continue to deteriorate, with loose material potentially becoming dislodged and falling, presenting a potential hazard if left untreated.</p> <p>We would recommend that the affected stone arch is carefully cleaned using a DOFF steam cleaning system to remove the algae growth, using a controlled method appropriate to the existing stonework. The friable masonry should then be carefully de-frassed back to sound material, removing all loose and unstable material only. Suitable scaffold access should be provided to allow the works to be safely and thoroughly completed.</p> |

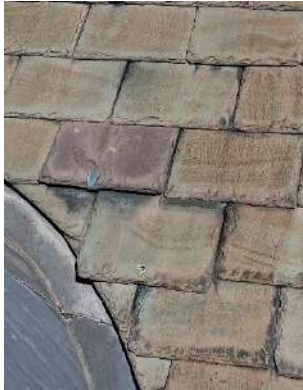
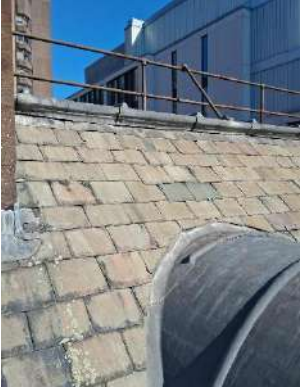
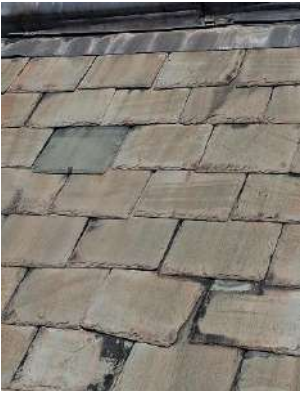
| 004 | | <p>Ten slipped slates were identified to this roof pitch. The displaced slates may allow water ingress and could lead to further deterioration of the underlying roof structure if left untreated.</p> |

| | | <p>We would recommend that remedial slate repairs are undertaken to reinstate and secure the slipped slates, providing a weatherproof finish and preventing further water ingress.</p> |

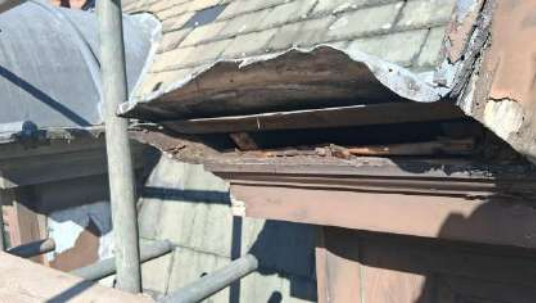
| 005 | <br> | <p>One area of defective timberwork was identified to the lead dormers, with the remaining lead dormers found to be in good overall condition. The defective timber may continue to deteriorate if left untreated.</p> <p>We would recommend that a suitably qualified joiner is employed to assess and carry out the necessary timber repairs to the affected area, using materials compatible with the existing dormer construction.</p> |

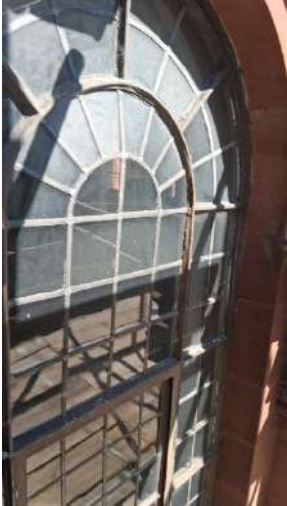
| 009 | | <p>The large leaded window was found to be bevelled at the time of inspection. The distortion may affect the integrity and weather-tightness of the glazing if left untreated.</p> <p>We would recommend that a suitably experienced specialist glazier is employed to carefully reset the glazing and carry out the necessary remedial repairs, retaining and matching the existing leaded detailing as closely as practicable.</p> |

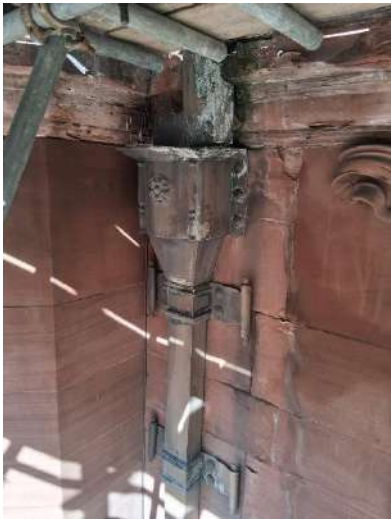
| 010 | | <p>The lead rainwater pipe was found to be in good overall condition; however, the existing paint coating system has deteriorated and is no longer providing adequate protection to the surface.</p> <p>We would recommend that the lead rainwater pipe is suitably prepared and redecorated using an approved paint coating system suitable for application to lead, in accordance with the manufacturer's recommendations.</p> |

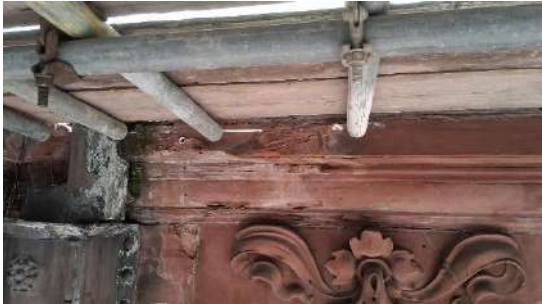
| 011 | | <p>Algae growth and friable masonry were identified to the underside of the cornice detail at this location. The biological growth can retain moisture against the masonry and may contribute to staining and gradual surface deterioration, while the friable masonry may continue to deteriorate, with loose material potentially becoming dislodged and falling, presenting a potential hazard if left untreated.</p> <p>We would recommend that the affected masonry is carefully cleaned using a DOFF steam cleaning system to remove the algae growth, using a controlled method appropriate to the existing stonework. The friable masonry should then be carefully de-frassed back to sound material, removing all loose and unstable material only.</p> |

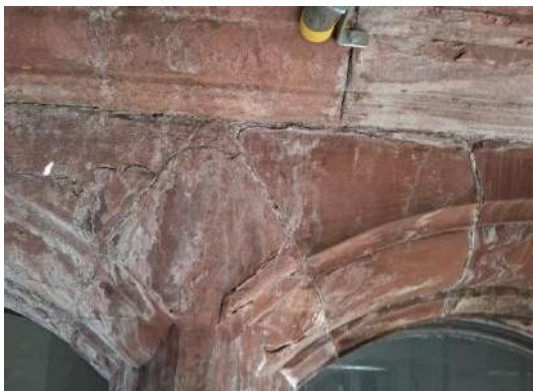
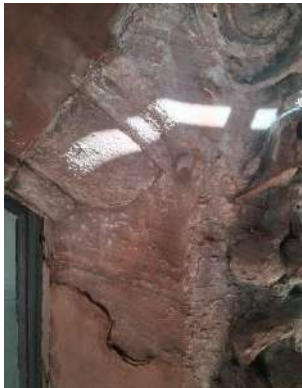
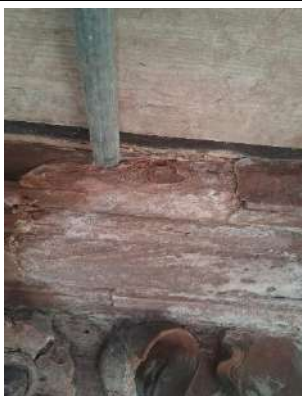
| 013 | | <p>Salt staining and friable masonry were identified to the masonry at this location. The salt deposits may indicate moisture movement through the masonry and, if left untreated, may contribute to further surface deterioration. The friable masonry may also continue to deteriorate, with loose material potentially becoming dislodged and falling, presenting a potential hazard.</p> |

| | | <p>We would recommend that the affected masonry is carefully cleaned using a DOFF steam cleaning system to attempt to remove the salt staining, using a controlled method appropriate to the existing masonry. The friable masonry should then be carefully de-frassed back to sound material, removing all loose and unstable material only.</p> |

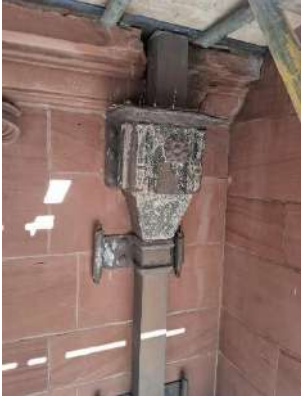
| 014 | | <p>The lead rainwater pipe was found to be in good overall condition; however, the existing paint coating system has deteriorated and is no longer providing adequate protection to the surface.</p> <p>We would recommend that the lead rainwater pipe is suitably prepared and redecorated using an approved paint coating system suitable for application to lead, in accordance with the manufacturer's recommendations.</p> |

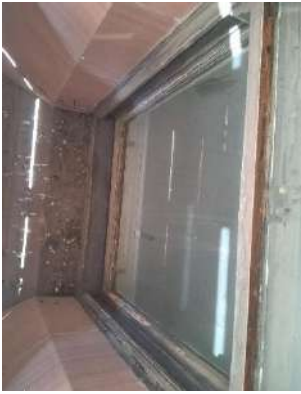
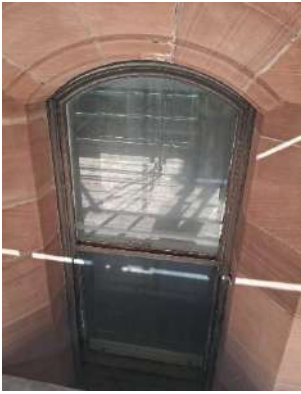
| 015 | | <p>The 15 timber sash windows were found to be in good overall condition; however, the existing paint coating system has deteriorated. If left untreated, the exposed timber may become susceptible to moisture ingress and further deterioration.</p> <p>We would recommend that the sash windows are suitably prepared and redecorated using an appropriate external timber paint coating system to protect and preserve the existing timber.</p> |

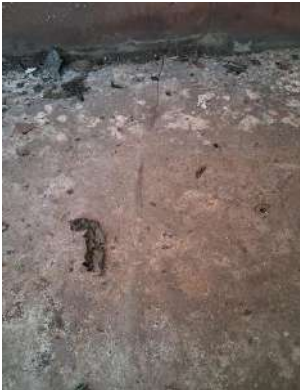
| 017 | | <p>Several holes and splits were identified to the lead cornice covering at this location. The defects may allow water ingress and could lead to further deterioration of the underlying masonry and surrounding materials if left untreated.</p> |

| | | <p>We would recommend that suitable lead weld repairs are carried out to the affected areas to provide a durable, weatherproof repair and prevent further water ingress.</p> |

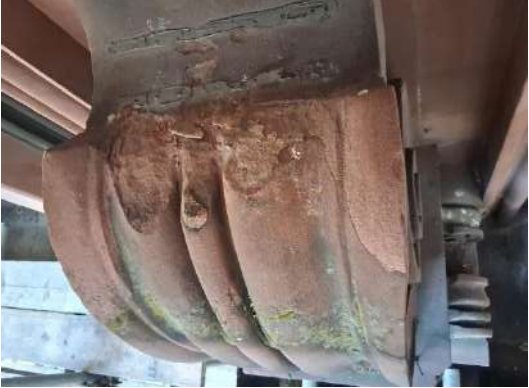
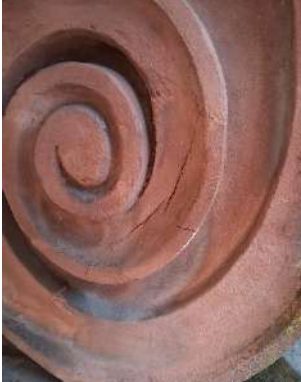
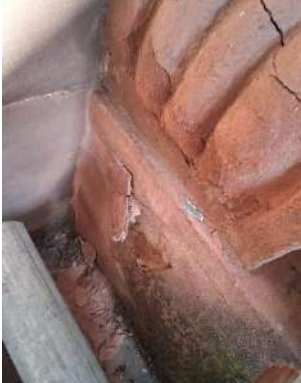
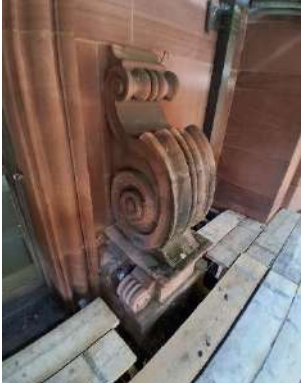
| 019 | | <p>Six ornamental stone corbels, comprising decorative scroll (volute) mouldings and curved, fluted stone detailing, were identified to have algae growth and friable masonry. The biological growth can retain moisture against the stonework and may contribute to staining and gradual surface deterioration, while the friable masonry may continue to deteriorate, with loose material potentially becoming dislodged and falling, presenting a potential hazard if left untreated.</p> |

| | | <p>We would recommend that the affected ornamental stonework is carefully cleaned using a DOFF steam cleaning system to remove the algae growth, using a controlled method appropriate to the existing stonework. The friable masonry should then be carefully de-frassed back to sound material, removing all loose and unstable material. Following removal, localised stone repairs should be carried out using a suitable colour-matched stone repair mortar, finished to blend with the surrounding stonework as closely as practicable.</p> |

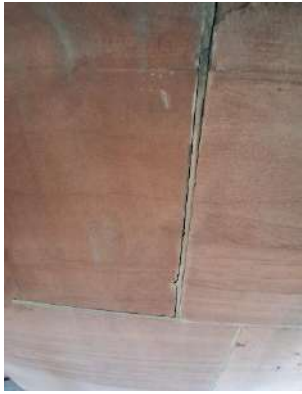
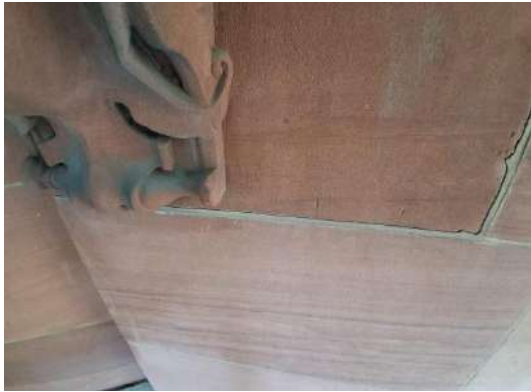
| 020 | | Open joints were identified to the stonework at this location. The open joints may allow water ingress and could lead to further deterioration of the surrounding masonry if left untreated. |

| | | We would recommend that the open joints are carefully cleaned out and localised repointing works are carried out using an approved mortar mix compatible with the existing stonework, finished to match the surrounding pointing as closely as practicable. |

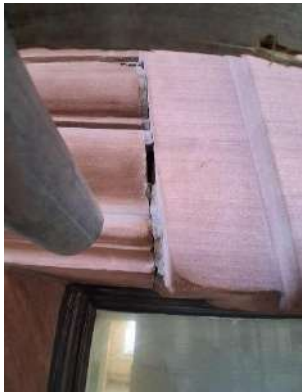
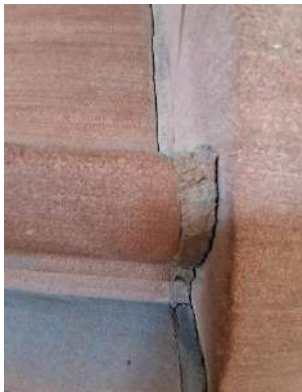
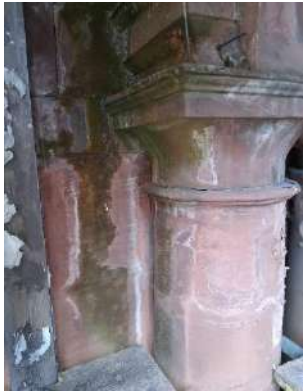
| 021 | | Open joints were identified to the stonework at this location. The open joints may allow water ingress and could lead to further deterioration of the surrounding masonry if left untreated. |

| | | We would recommend that the open joints are carefully cleaned out and localised repointing works are carried out using an approved mortar mix compatible with the existing stonework, finished to match the surrounding pointing as closely as practicable. |

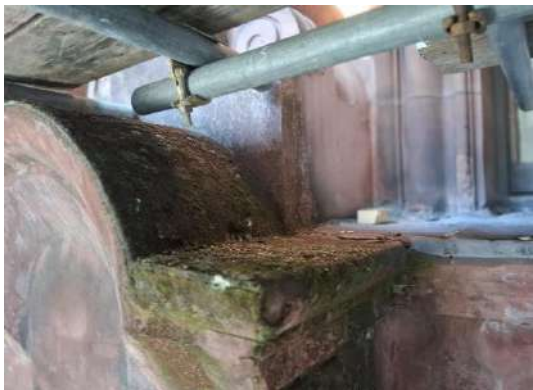
| 022 | | <p>Algae growth and friable masonry were identified at this location. The biological growth can retain moisture against the masonry and may contribute to staining and gradual surface deterioration, while the friable masonry may continue to deteriorate, with loose material potentially becoming dislodged and falling, presenting a potential hazard if left untreated.</p> |

| | | <p>We would recommend that the affected masonry is carefully cleaned using a DOFF steam cleaning system to remove the algae growth, using a controlled method appropriate to the existing masonry. The friable masonry should then be carefully de-frassed back to sound material, removing all loose and unstable material only.</p> |

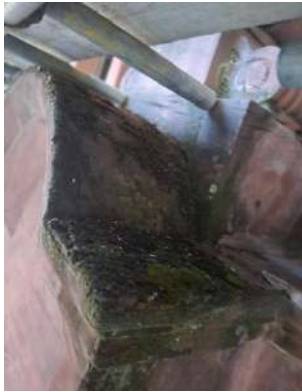
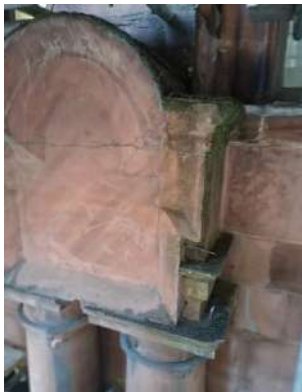
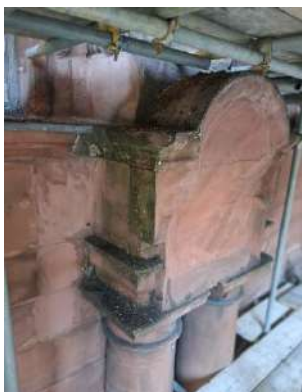
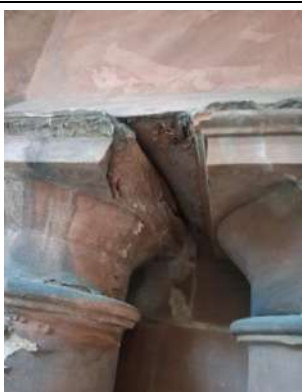
| 023 | | <p>Algae growth and friable masonry were identified at this location. The biological growth can retain moisture against the masonry and may contribute to staining and gradual surface deterioration, while the friable masonry may continue to deteriorate, with loose material potentially becoming dislodged and falling, presenting a potential hazard if left untreated.</p> <p>We would recommend that the affected masonry is carefully cleaned using a DOFF steam cleaning system to remove the algae growth, using a controlled method appropriate to the existing masonry. The friable masonry should then be carefully de-frassed back to sound material, removing all loose and unstable material only.</p> |

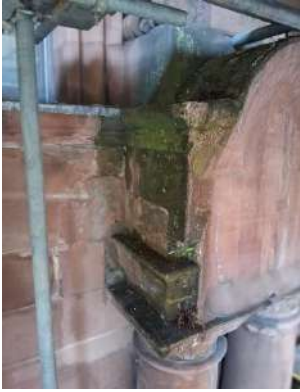
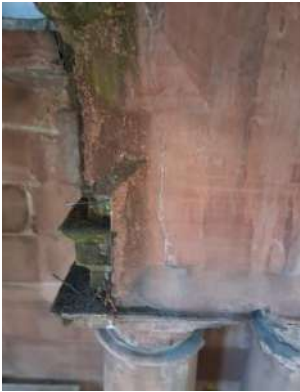
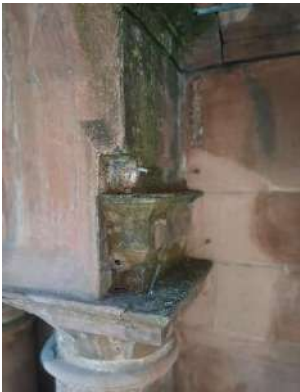
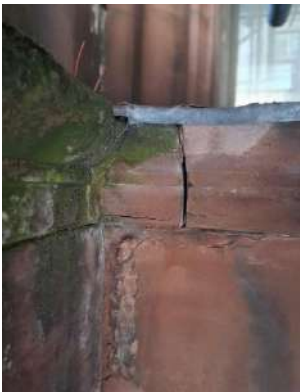
| 024 | | <p>Algae growth, localised open jointing and friable masonry were identified at this location. The biological growth can retain moisture against the masonry and may contribute to staining and gradual surface deterioration, while the open joints may allow water ingress and the friable masonry may continue to deteriorate, with loose material potentially becoming dislodged and falling, presenting a potential hazard if left untreated.</p> |

| | | <p>We would recommend that the affected masonry is carefully cleaned using a DOFF steam cleaning system to remove the algae growth, using a controlled method appropriate to the existing masonry. The localised open joints should then be carefully cleaned out and repointed using an approved mortar mix compatible with the existing masonry. The friable masonry should also be carefully de-frassed back to sound material, removing all loose and unstable material only.</p> |

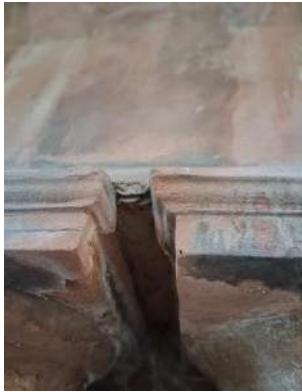
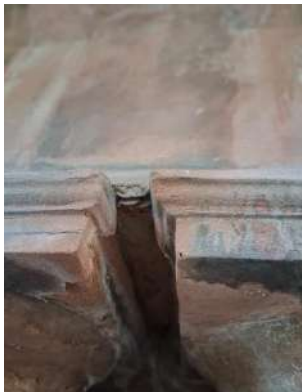
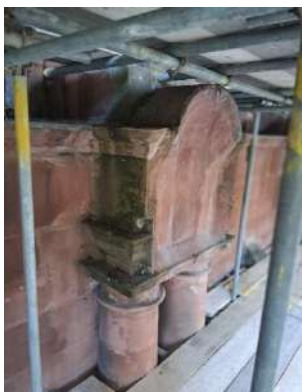
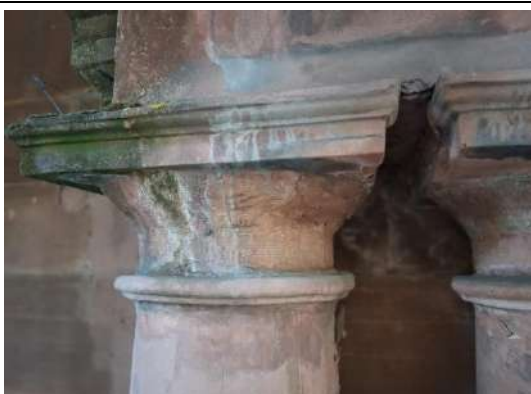
| 025 | | <p>Algae growth and friable masonry were identified at this location. The biological growth can retain moisture against the masonry and may contribute to staining and gradual surface deterioration, while the friable masonry may continue to deteriorate, with loose material potentially becoming dislodged and falling, presenting a potential hazard if left untreated.</p> <p>We would recommend that the affected masonry is carefully cleaned using a DOFF steam cleaning system to remove the algae growth, using a controlled method appropriate to the existing masonry. The friable masonry should then be carefully de-frassed back to sound material, removing all loose and unstable material only.</p> |

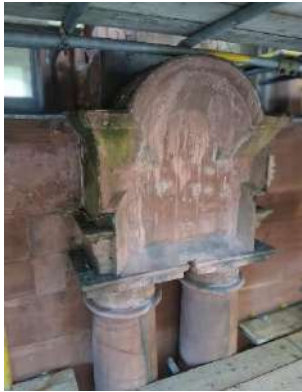
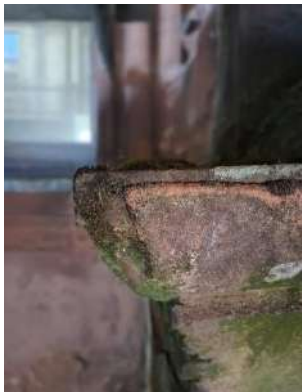
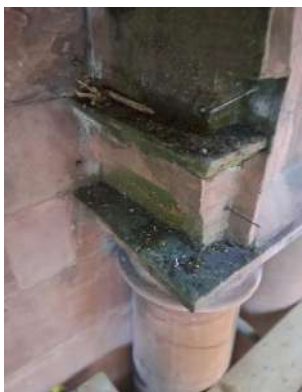
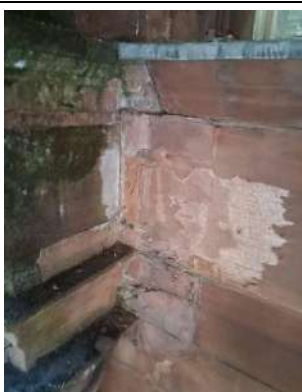
| 026 | | <p>Algae growth and friable masonry were identified at this location. The biological growth can retain moisture against the masonry and may contribute to staining and gradual surface deterioration, while the friable masonry may continue to deteriorate, with loose material potentially becoming dislodged and falling, presenting a potential hazard if left untreated.</p> <p>We would recommend that the affected masonry is carefully cleaned using a DOFF steam cleaning system to remove the algae growth, using a controlled method appropriate to the existing masonry. The friable masonry should then be carefully de-frassed back to sound material, removing all loose and unstable material only.</p> |

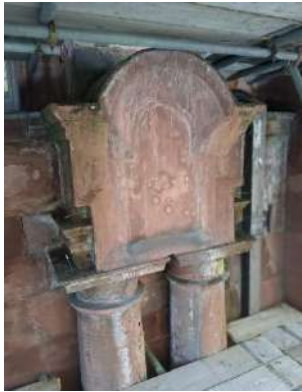
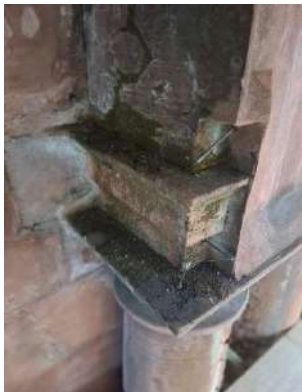
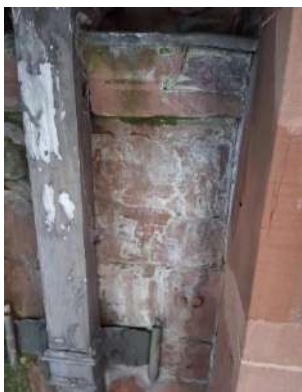
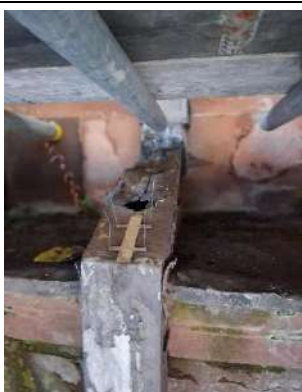
| 027 | | <p>Algae growth and friable masonry were identified at this location, with the deterioration considered likely to be contributed to by the leaking lead downpipe. The leaking rainwater pipe may be allowing water to discharge onto the masonry, contributing to moisture retention and further deterioration. The biological growth can retain moisture against the masonry, while the friable masonry may continue to deteriorate, with loose material potentially becoming dislodged and falling, presenting a potential hazard if left untreated.</p> <p>We would recommend that the defective lead downpipe is repaired to prevent further water discharge onto the masonry. The affected masonry should then be carefully cleaned using a DOFF steam cleaning system to remove the algae growth, using a controlled method appropriate to the existing masonry. The friable masonry should also be carefully de-frassed back to sound material, removing all loose and unstable material only.</p> |

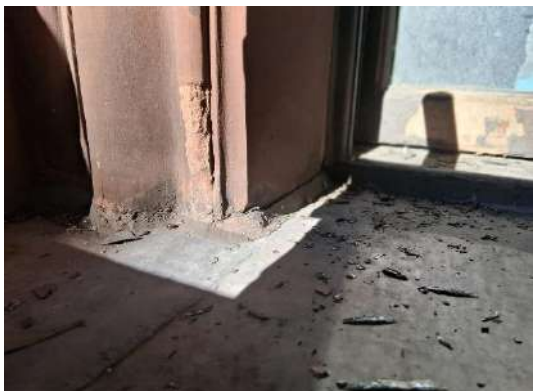
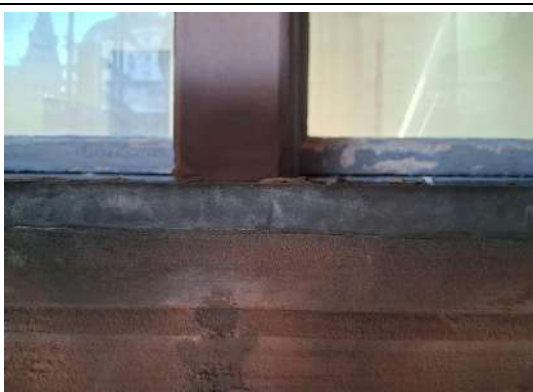
| 028 | | <p>Water ingress was reported at this location. The lead covering to the cornice detail was inspected and no splits or tears were identified; however, the pointing where the lead terminates into the masonry had failed. In addition, there was no sealant to the upstand at the window cill, which may be allowing water to track behind the leadwork. Friable masonry was also identified within this area.</p> <p>We would recommend that all failed pointing is carefully removed and the affected areas are repointed using a suitable mortar compatible with the existing masonry. The upstand at the window cill should then be sealed using a suitable flexible sealant to prevent further water tracking behind the leadwork. The friable masonry should also be carefully de-frassed back to sound material, removing all loose and unstable material only.</p> |

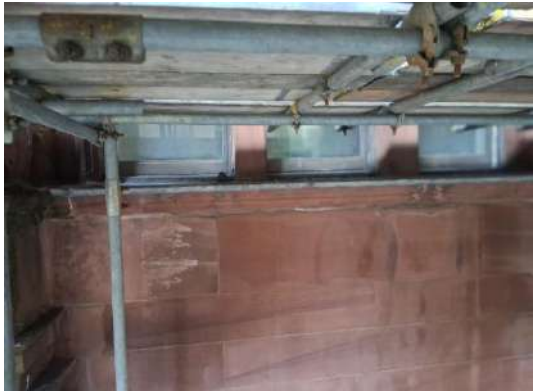
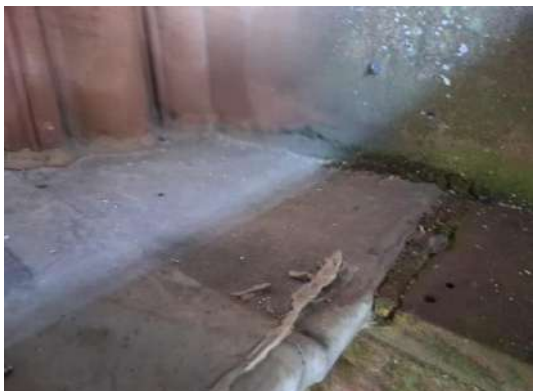
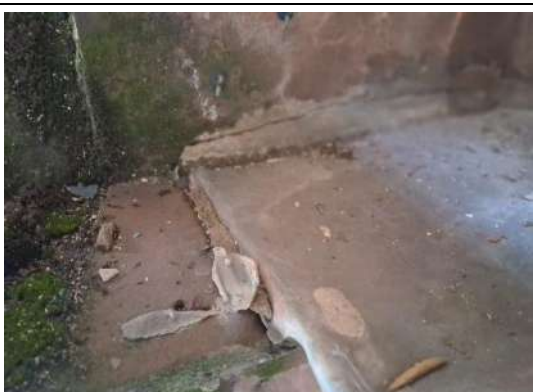
| 029 | | <p>Water ingress was reported at this location. The lead covering to the cornice detail was inspected and no splits or tears were identified; however, the pointing where the lead terminates into the masonry had failed. In addition, there was no sealant to the upstand at the window cill, which may be allowing water to track behind the leadwork. Friable masonry was also identified within this area.</p> <p>We would recommend that all failed pointing is carefully removed and the affected areas are repointed using a suitable mortar compatible with the existing masonry. The upstand at the window cill should then be sealed using a suitable flexible sealant to prevent further water tracking behind the leadwork. The friable masonry should also be carefully de-frassed back to sound material, removing all loose and unstable material only.</p> |

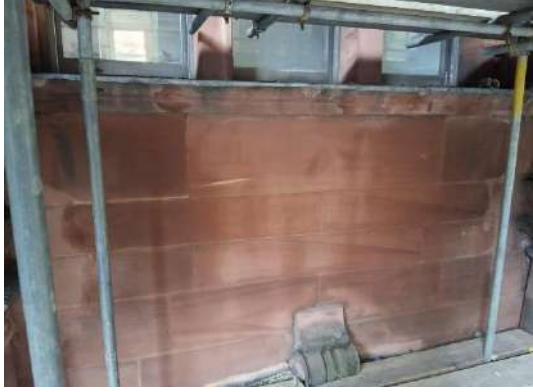
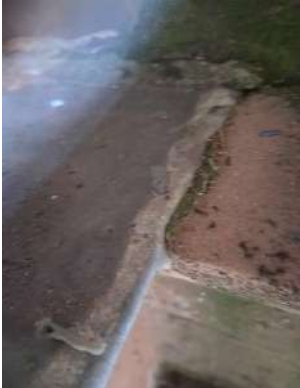
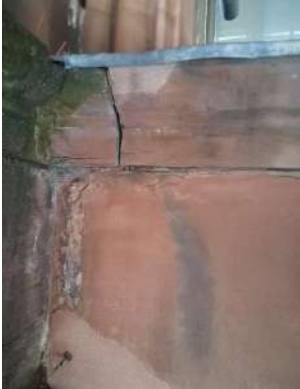
| 030 | | <p>Water ingress was reported at this location. The lead covering to the cornice detail was inspected and no splits or tears were identified; however, the pointing where the lead terminates into the masonry had failed. In addition, there was no sealant to the upstand at the window cill, which may be allowing water to track behind the leadwork. Friable masonry and open jointing were also identified within this area.</p> <p>We would recommend that all failed pointing and open jointing are carefully removed and localised repointing works are carried out using an approved mortar mix compatible with the existing masonry. The upstand at the window cill should then be sealed using a suitable flexible sealant to prevent further water tracking behind the leadwork. The friable masonry should also be carefully de-frassed back to sound material, removing all loose and unstable material only.</p> |

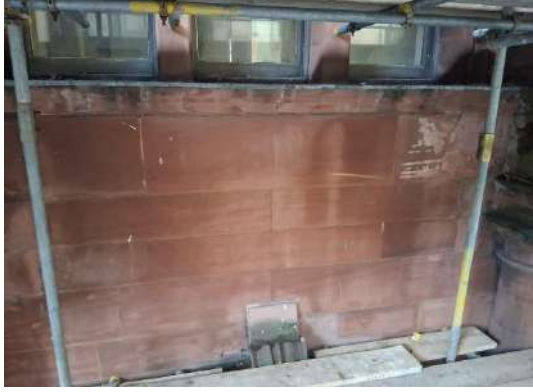
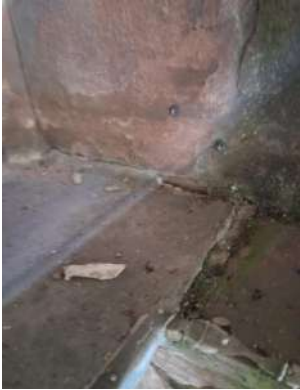
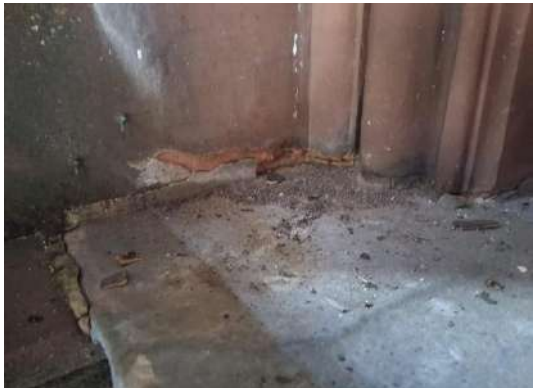
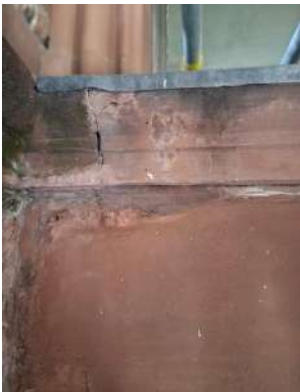
| 031 | | <p>Water ingress was reported at this location. The lead covering to the cornice detail was inspected and no splits or tears were identified; however, the pointing where the lead terminates into the masonry had failed. In addition, there was no sealant to the upstand at the window cill, which may be allowing water to track behind the leadwork. Friable masonry and open jointing were also identified within this area.</p> <p>We would recommend that all failed pointing and open jointing are carefully removed and localised repointing works are carried out using an approved mortar mix compatible with the existing masonry. The upstand at the window cill should then be sealed using a suitable flexible sealant to prevent further water tracking behind the leadwork. The friable masonry should also be carefully de-frassed back to sound material, removing all loose and unstable material only.</p> |

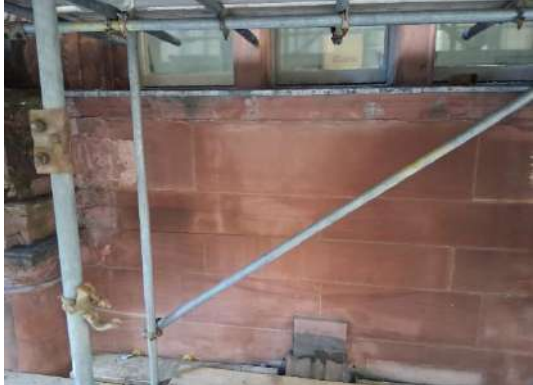
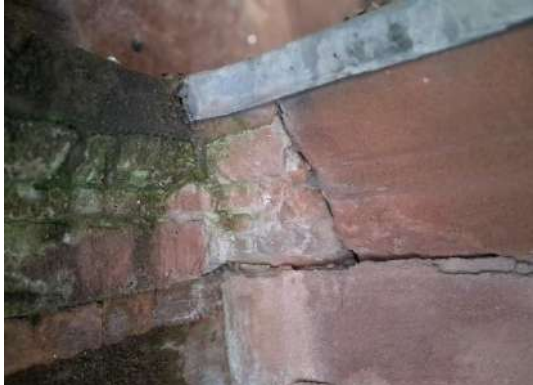
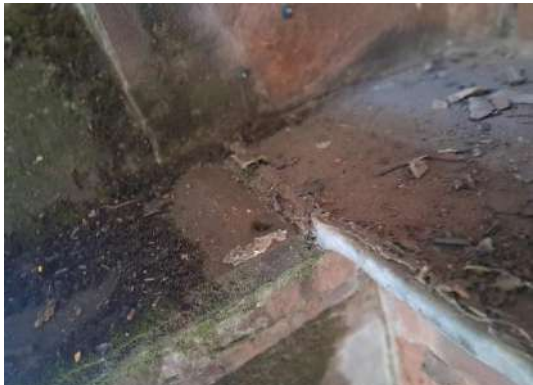
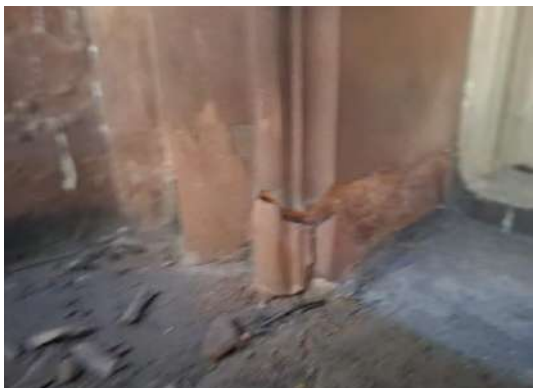
| 032 | | <p>Water ingress was reported at this location. The lead covering to the cornice detail was inspected and no splits or tears were identified; however, the pointing where the lead terminates into the masonry had failed. In addition, there was no sealant to the upstand at the window cill, which may be allowing water to track behind the leadwork. Friable masonry and open jointing were also identified within this area.</p> <p>We would recommend that all failed pointing and open jointing are carefully removed and localised repointing works are carried out using an approved mortar mix compatible with the existing masonry. The upstand at the window cill should then be sealed using a suitable flexible sealant to prevent further water tracking behind the leadwork. The friable masonry should also be carefully de-frassed back to sound material, removing all loose and unstable material only.</p> |
