**Mitchells and Butlers**

**Browns Manchester**

**Condition Survey 2026**

**Engineers Report**

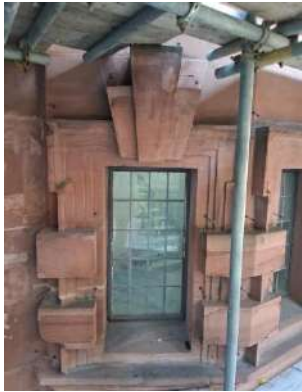
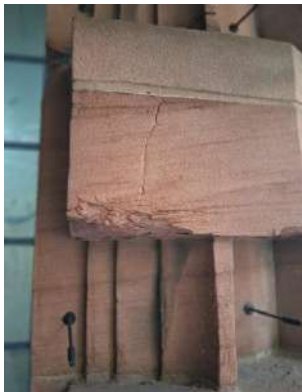
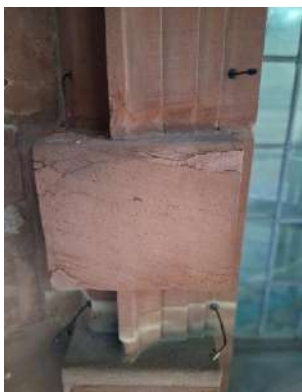
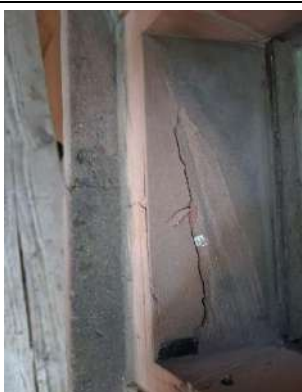
| 034 | | <p>Friable masonry, delaminating masonry and fissures were identified to the stone window surrounds at this location. The affected masonry may continue to deteriorate, with loose material potentially becoming dislodged and falling, presenting a potential hazard, while the fissures may allow water ingress and contribute to further deterioration if left untreated.</p> <p>We would recommend that the affected masonry is carefully de-frassed back to sound material, removing all loose and unstable material. Localised stone repairs should then be carried out using a suitable colour-matched stone repair mortar. The fissures should also be carefully raked out, cleaned and made good using a suitable colour-matched stone repair mortar, finished to blend with the surrounding stonework as closely as practicable.</p> |

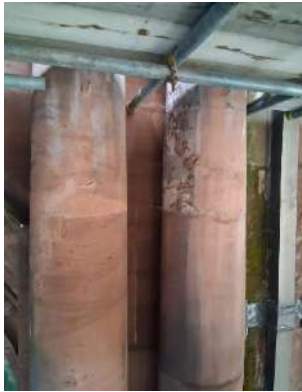
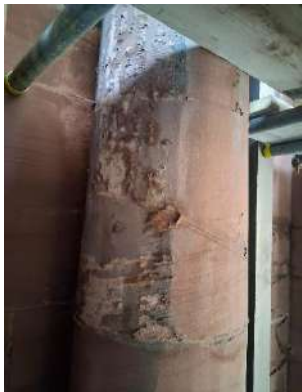
| 035 | | <p>Friable masonry was identified to the stone columns at this location. The affected masonry may continue to deteriorate, with loose material potentially becoming dislodged and falling, presenting a potential hazard if left untreated.</p> <p>We would recommend that the affected masonry is carefully de-frassed back to sound material, removing all loose and unstable material only.</p> |

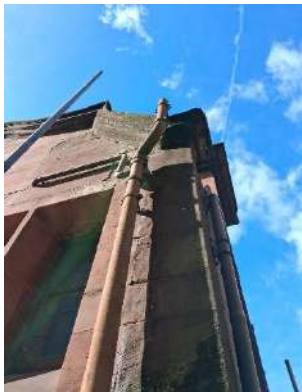
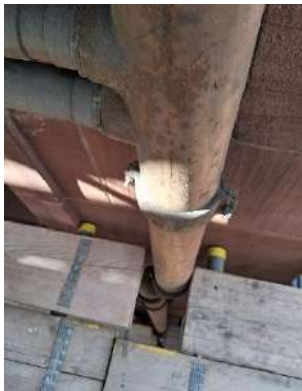
| | Photograph | Description |
|---|---|---|
| 001 | | The cast iron soil stack was found to be in good overall condition at the time of inspection; however, the existing paint coating system was showing signs of deterioration. If left untreated, further deterioration of the coating may expose the cast iron to moisture and increase the risk of corrosion. |

| | Photograph | Description |
|---|---|---|
| | | We would recommend that the cast iron soil stack is suitably prepared and redecorated using an appropriate protective coating system to preserve the cast iron and help prevent further corrosion. |

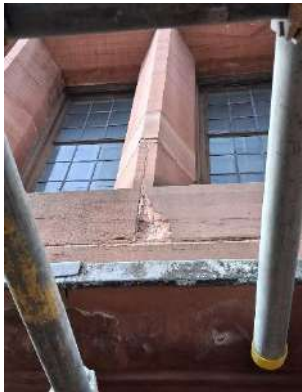
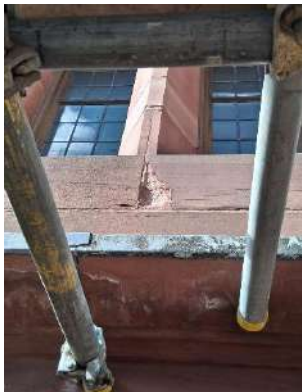
| | Photograph | Description |
|---|---|---|
| 002 | | Friable masonry was identified at this location. The affected masonry may continue to deteriorate, with loose material potentially becoming dislodged and falling, presenting a potential hazard if left untreated. |

| | Photograph | Description |
|---|---|---|
| | | We would recommend that the affected masonry is carefully de-frassed back to sound material, removing all loose and unstable material. A localised stone repair should then be undertaken using a suitable colour-matched stone repair mortar, finished to blend with the surrounding masonry as closely as practicable. |

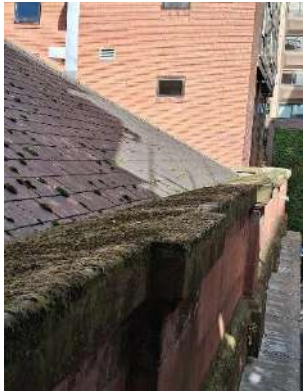
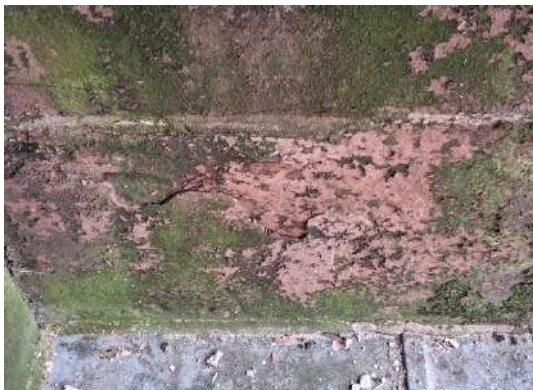
| 005 | | <p>Algae growth and delaminating masonry were identified to the parapet wall at this location. The biological growth can retain moisture against the masonry and may contribute to staining and gradual surface deterioration, while the delaminating masonry may continue to deteriorate, with loose material potentially becoming dislodged and falling, presenting a potential hazard if left untreated.</p> |

| | | <p>We would recommend that the affected parapet wall is carefully cleaned using a DOFF steam cleaning system to remove the algae growth, using a controlled method appropriate to the existing masonry. The delaminating masonry should then be carefully de-frassed back to sound material, removing all loose and unstable material only.</p> |

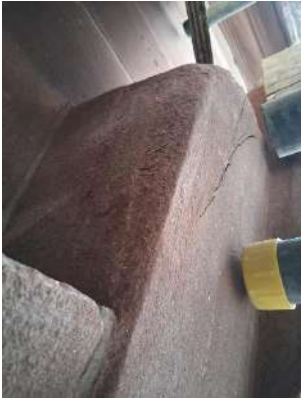
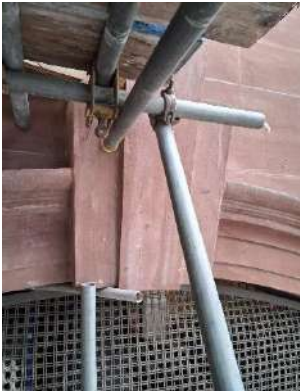
| 007 | | <p>A crack was identified to the apex stone of the stone arch at this location. The crack may allow water ingress and could lead to further deterioration of the surrounding stonework if left untreated.</p> |

| 007 | | <p>We would recommend that the crack is carefully raked out and cleaned before being made good using a suitable colour-matched stone repair mortar, finished to blend with the surrounding stonework as closely as practicable.</p> |

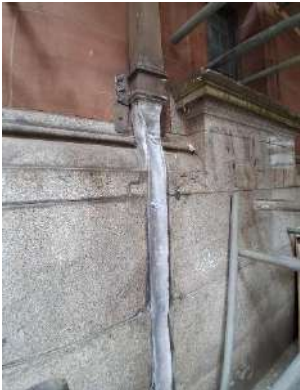
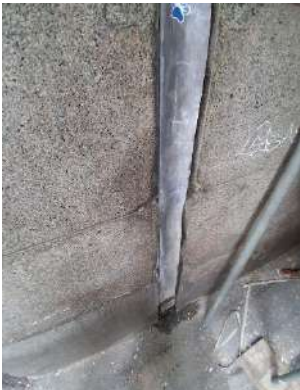
| 008 | | <p>The lower section of the lead rainwater pipe was found to have some localised damage; however, the pipe remains functional and was operating as intended at the time of inspection. No active leakage or other significant defects were identified.</p> <p>No remedial works are considered necessary at this time. The condition should be monitored during routine inspections.</p> |

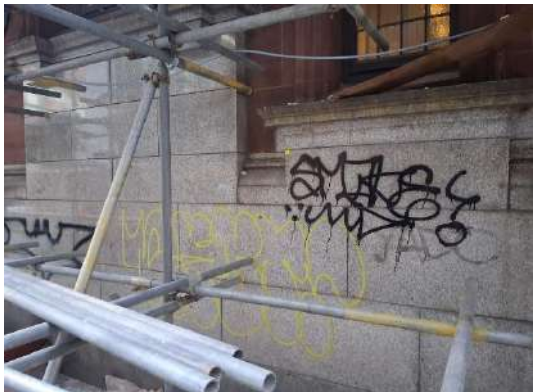
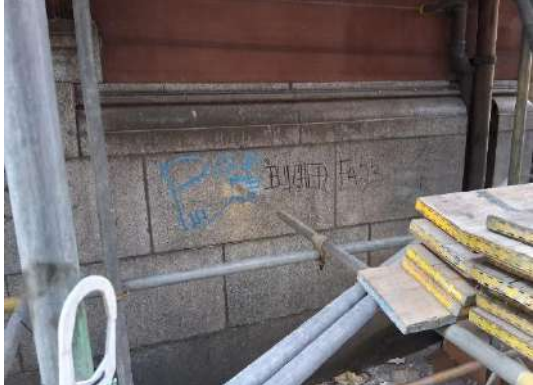
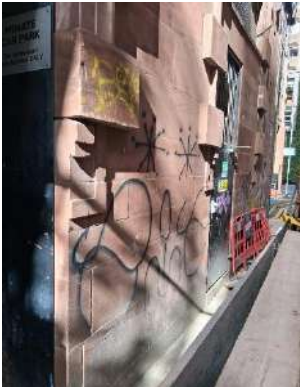
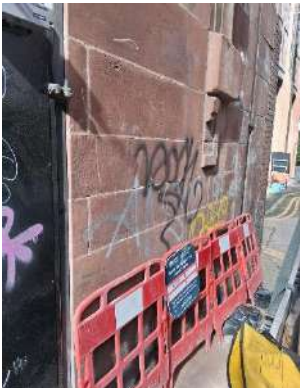
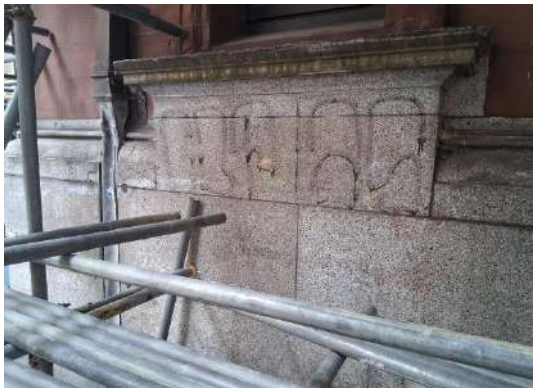
| 009 | | <p>Graffiti was identified to the low-level masonry on the Milk Street elevation. If left untreated, the graffiti may cause staining and detract from the appearance of the masonry.</p> |

| 009 | | <p>Graffiti was identified to the low-level masonry on the Milk Street elevation. If left untreated, the graffiti may cause staining and detract from the appearance of the masonry.</p> |

| | | <p>We would recommend that the affected area is treated with a suitable paint removal agent and subsequently cleaned using a DOFF steam cleaning system, using a controlled method appropriate to the existing masonry, in an attempt to remove the graffiti without causing damage to the underlying stonework.</p> |

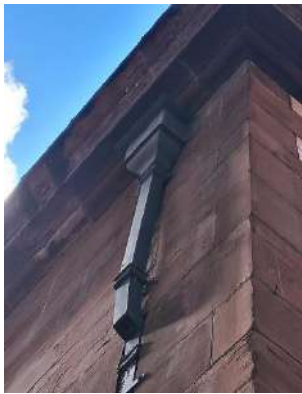
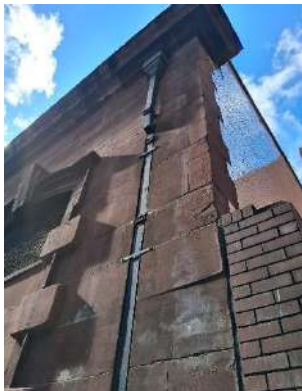
| 011 | | <p>The lead downpipe appeared to be missing some high-level fixings, with the existing paint coating system also showing signs of deterioration. The lack of adequate fixings may reduce the stability of the downpipe and could result in movement at the upper joint if left unaddressed.</p> <p>We would recommend that suitable new fixings are installed at the upper joint to securely support the lead downpipe. The downpipe should then be suitably prepared and redecorated using an appropriate protective coating system suitable for application to lead.</p> |

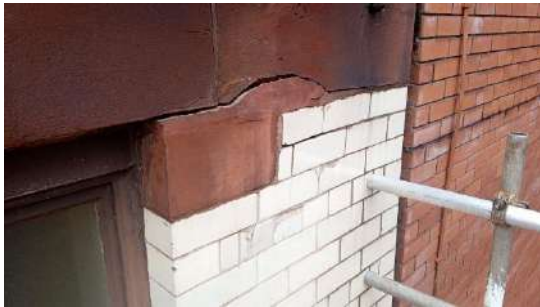
| | Photograph | Description |
|---|---|---|
| 1 | | Fissured masonry unit, this masonry unit appear to have been repaired historically with further widening of the joint following previous repair. It is suspected that there will be internal iron content that is expanding to this area. |

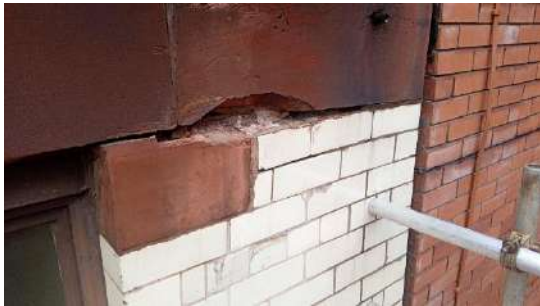
| | Photograph | Description |
|---|---|---|
| 2 | | Loose materials removed, preventing materials falling from height. |

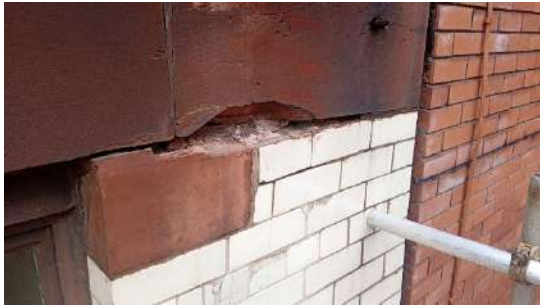
| | Photograph | Description |
|---|---|---|
| 3 | | Photograph showing expanded iron content within the mortar joints, it is recommended that the iron cramps are removed and replaced for stainless steel. |

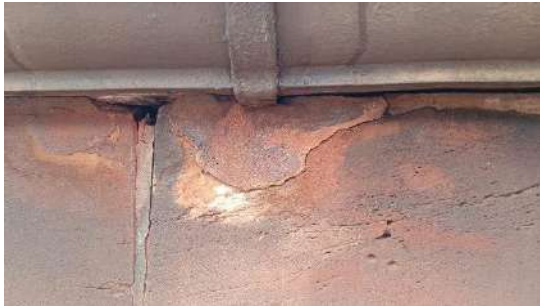
| | Photograph | Description |
|---|---|---|
| 4 | | Fissured masonry unit would benefit from defective area being removed and lime-based compound repair application to colour match surrounding masonry. |

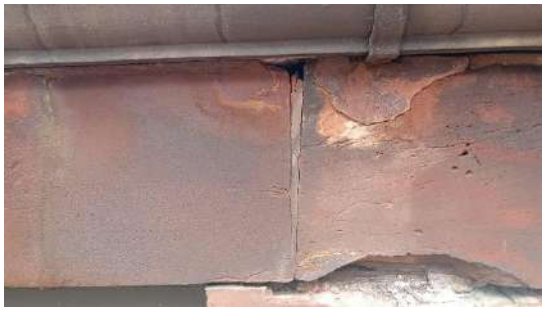
| 5 | | <p>Failed mortar joint would benefit from being raked out and repointed with appropriate lime mortar.</p> |

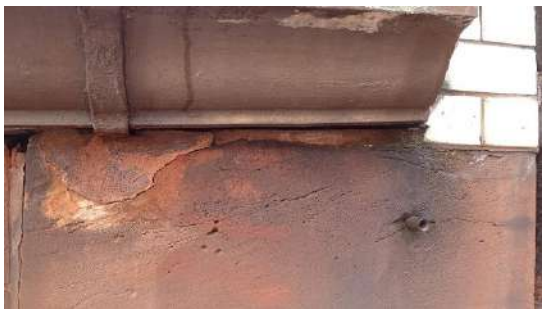
| 6 | | <p>Failed mortar joint would benefit from being raked out and repointed with appropriate lime mortar. Historic scaffold tie would also benefit from removal to prevent expansion and damage to surrounding masonry.</p> |

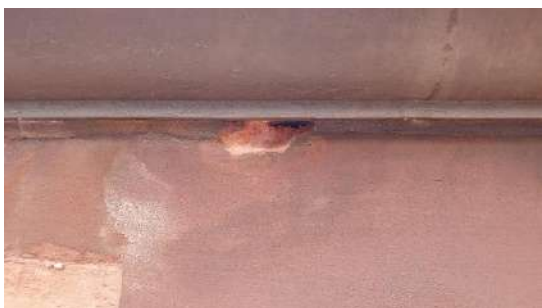
| 8 | | <p>Defective section of missing masonry and mortar joint would benefit from re-instatement.</p> |

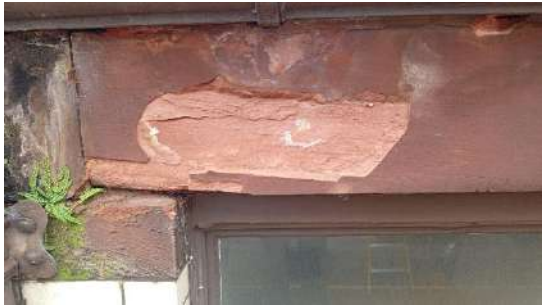
| 9 | | <p>Laminated section of masonry would benefit from lime-based compound repair application to colour match surrounding masonry. Open joints and vegetation growth would also benefit from repointing.</p> |

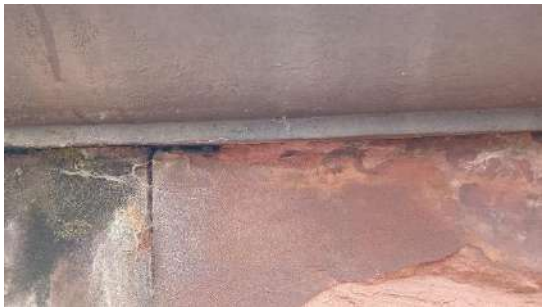
| 10 | | <p>Open mortar joints would benefit from being repointed using a suitable lime-based mortar.</p> |

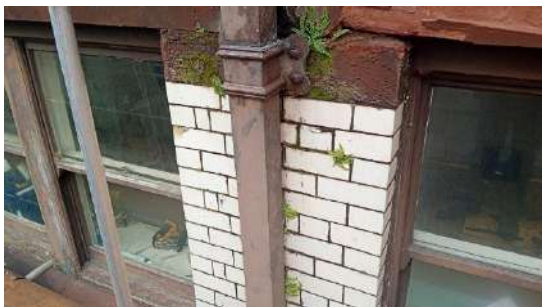
| 11 | | <p>Vegetation growth evident to façade, suspected damp area caused by overflow on rainwater downpipe. Perhaps blockage within downpipe causing overspill.</p> |

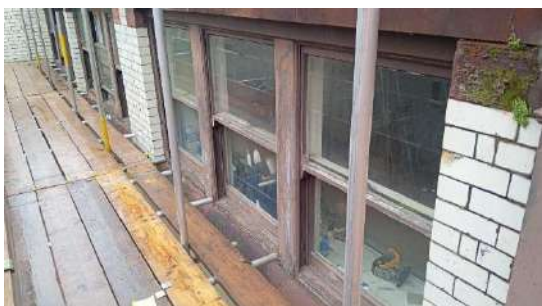
| 12 | | <p>Timber window frames would benefit from being overhauled by sanding, filling and new paint coating application. It is believed M&amp;B already have a contractor onsite carrying out these works.</p> |

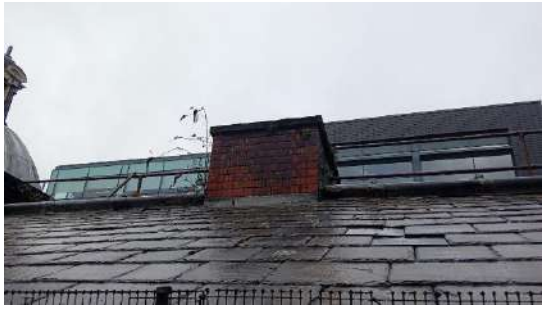
| 13 | | Vegetation growth to chimney area would benefit from treatment/ removal and associated defective mortar joints being repointed. |

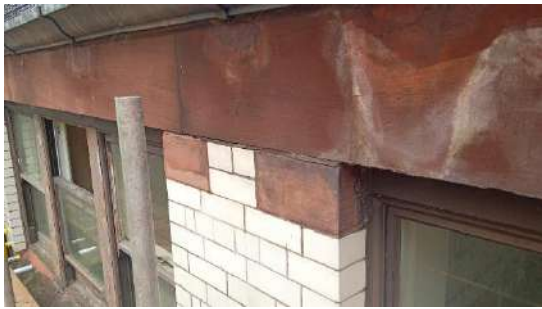
| 14 | | Failed mortar joint would benefit from being raked out and repointed with appropriate lime mortar. |

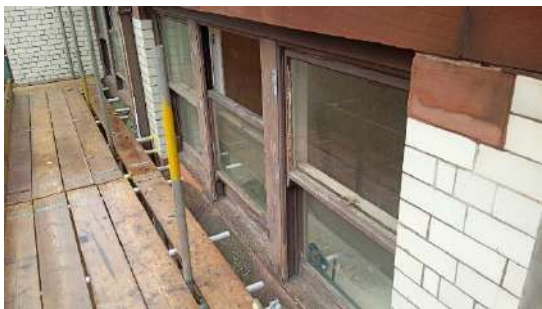
| 15 | | Timber window frames would benefit from being overhauled by sanding, filling and new paint coating application. It is believed M&B already have a contractor onsite carrying out these works. |

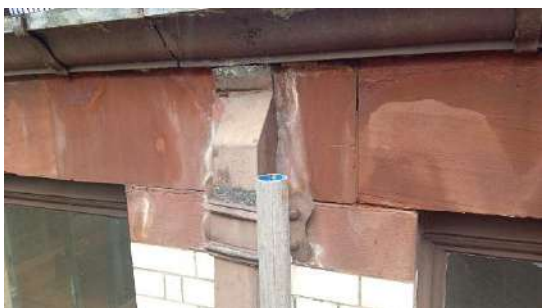
| 16 | | Failed mortar joint would benefit from being raked out and repointed with appropriate lime mortar. Damp areas evident under gutter position, potential failure of gutter joints allowing for water leaks. |

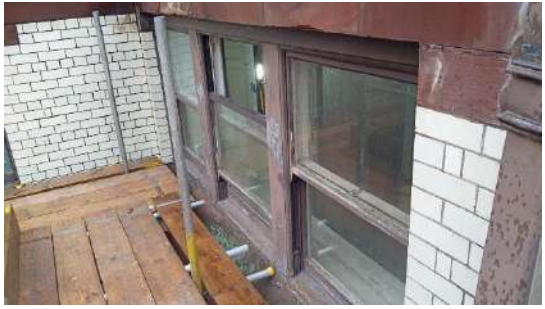
| 17 | | <p>Timber window frames would benefit from being overhauled by sanding, filling and new paint coating application. It is believed M&amp;B already have a contractor onsite carrying out these works.</p> |

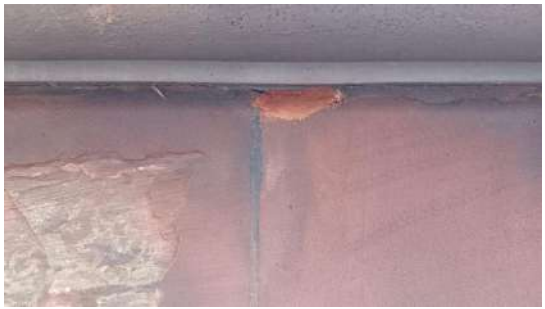
| 18 | | <p>Defective section of missing masonry and mortar joint would benefit from re-instatement.</p> |

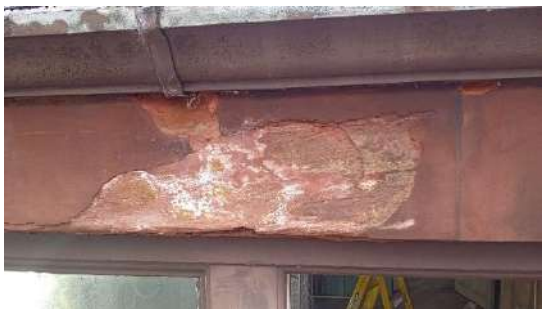
| 19 | | <p>Laminated section of masonry would benefit from lime-based compound repair application to colour match surrounding masonry. Open joints and vegetation growth would also benefit from repointing.</p> |

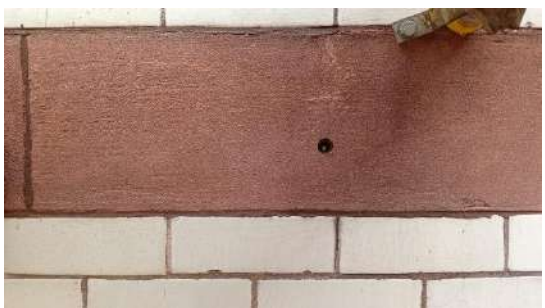
| 20 | | <p>Historic scaffold tie would benefit from removal to prevent expansion and damage to surrounding masonry unit.</p> |

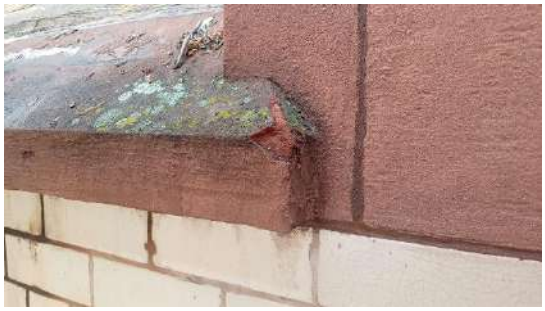
| 21 | | Corner to sill detail has become detached and would benefit from lime based compound repair application. |

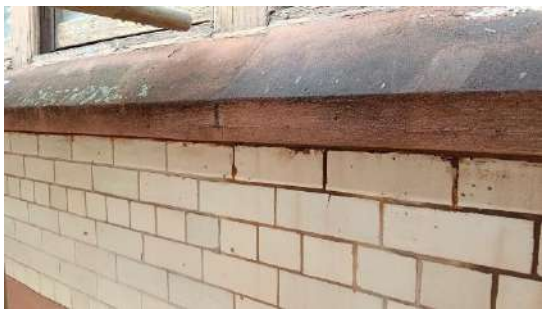
| 22 | | Hairline fissure to sill detail to be monitored. |

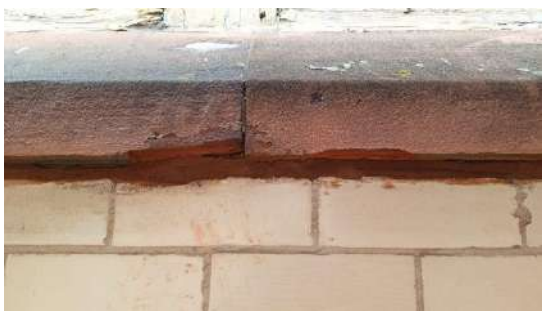
| 23 | | Defective stone area would benefit from lime-based compound repair application to rebuild and colour match surrounding masonry. |

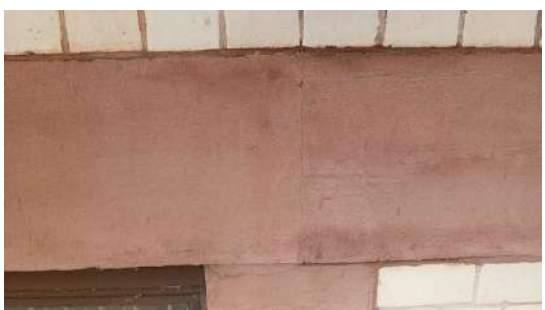
| 24 | | Hairline fissure to masonry unit would benefit from being monitored and recorded for future inspections. |

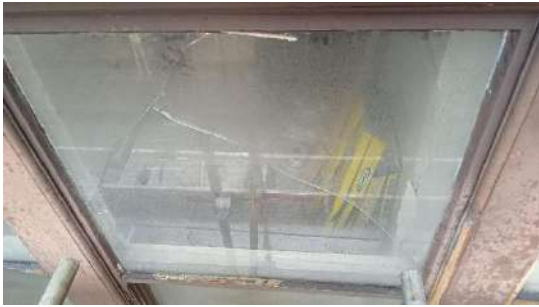
| 25 | | Defective window pane would benefit from removal and replacement. |

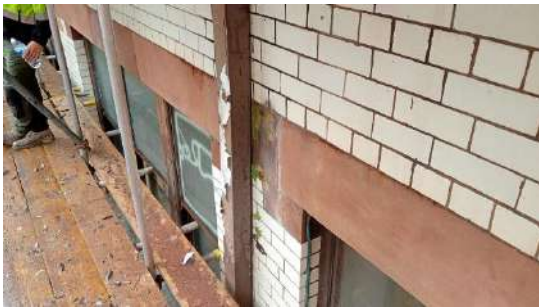
| 26 | | Paint coating application to lead downpipes is failing and would benefit from re-application. |

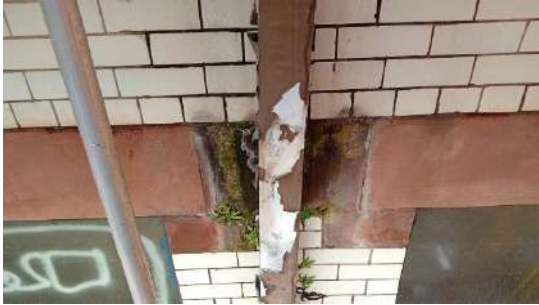
| 27 | | Paint coating application to lead downpipes is failing and would benefit from re-application. Potential splits to the rear of the downpipe causing damp issues to rear masonry and vegetation growth. Treatment of vegetation is recommended. |

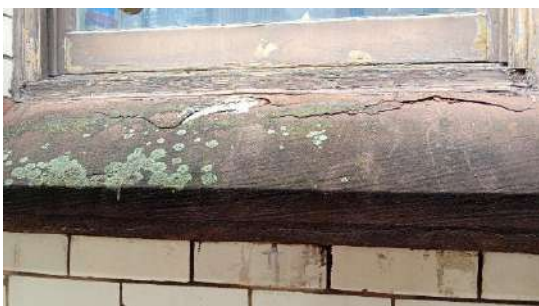
| 28 | | Fissure to stone sill detail. Slurry coat application would help prevent further deterioration. |

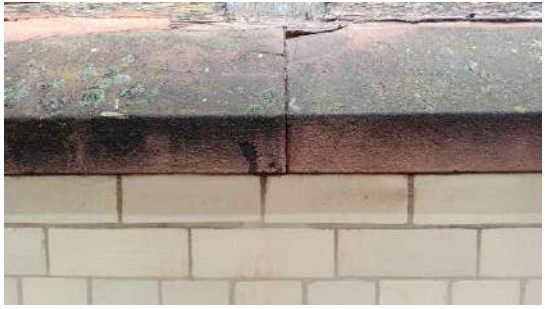
| 29 | | <p>Minor open mortar joint would benefit from being raked out and repainted using lime-mortar.</p> |

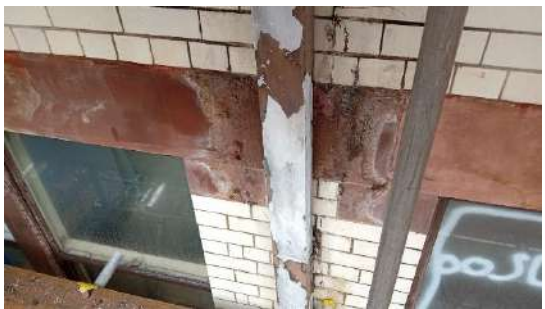
| 30 | | <p>Paint coating application to lead downpipes is failing and would benefit from re-application. Potential splits to the rear of the downpipe causing damp issues to rear masonry and vegetation growth. Treatment of vegetation is recommended.</p> |

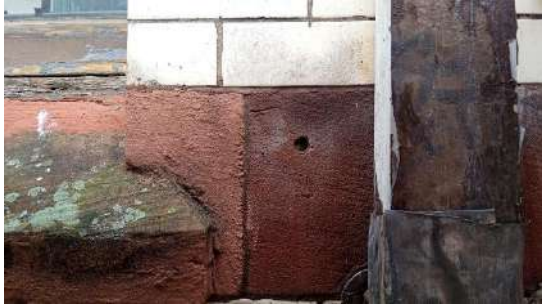
| 31 | | <p>Historic scaffold tie would benefit from removal to prevent expansion and damage to masonry unit.</p> |

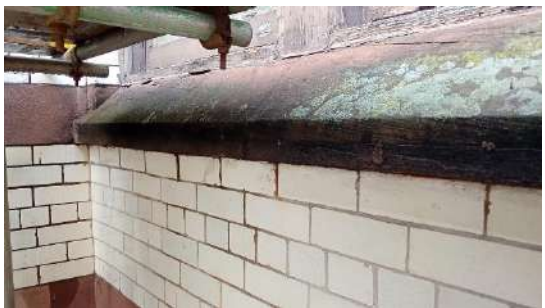
| 32 | | <p>Hairline fissures to sill would benefit from having a slurry coat applied to consolidate and cover masonry units.</p> |

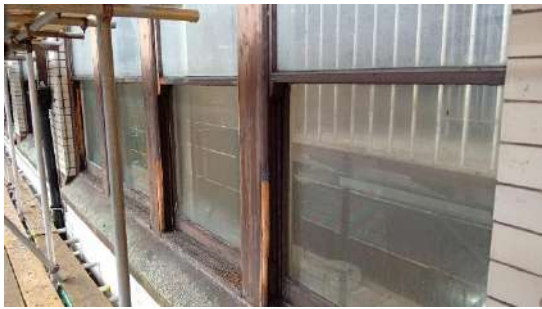
| 33 | | <p>Timber window frames would benefit from being overhauled by sanding, filling and new paint coating application. It is believed M&amp;B already have a contractor onsite carrying out these works.</p> |

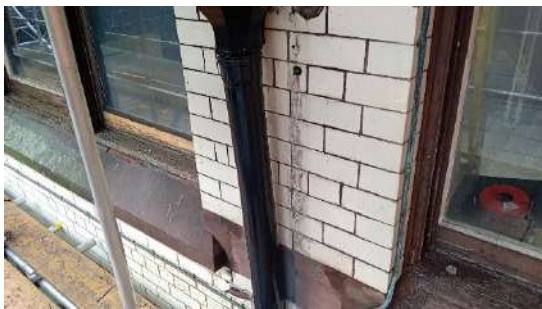
| 34 | | <p>Defective missing downpipe bracket would benefit from new bracket installation.</p> |

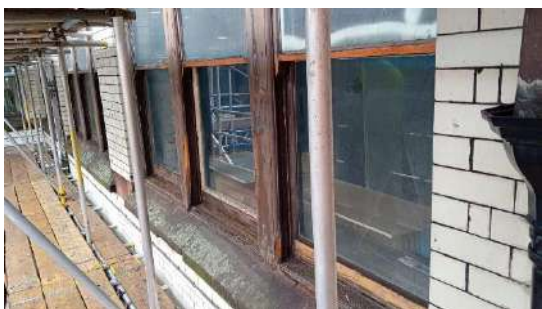
| 35 | | <p>Timber window frames would benefit from being overhauled by sanding, filling and new paint coating application. It is believed M&amp;B already have a contractor onsite carrying out these works.</p> |

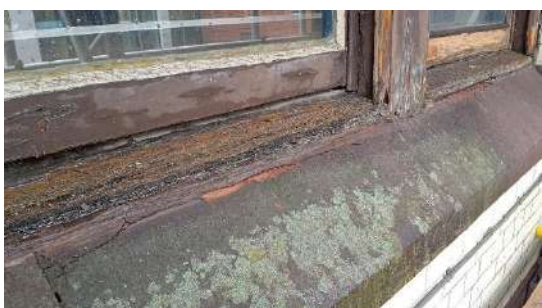
| 36 | | <p>Timber window frames would benefit from being overhauled by sanding, filling and new paint coating application. It is believed M&amp;B already have a contractor onsite carrying out these works.</p> |

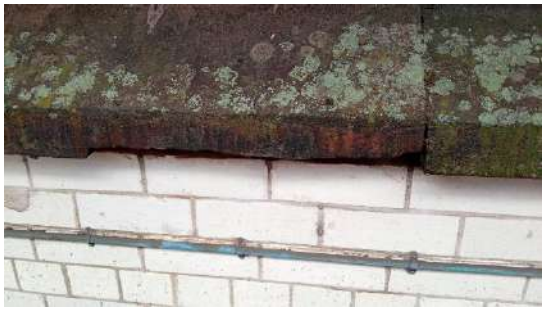
| 37 | | <p>Missing section of stone sill detail would benefit from being reformed using lime-based compound repair mortar.</p> |

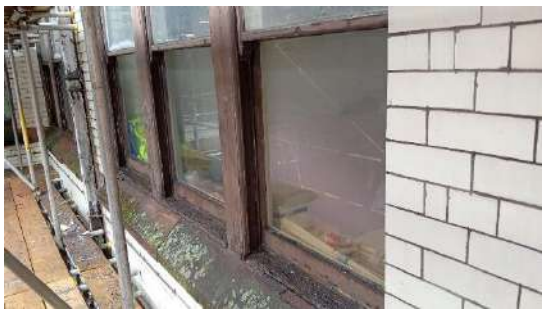
| 38 | | <p>Timber window frames would benefit from being overhauled by sanding, filling and new paint coating application. It is believed M&amp;B already have a contractor onsite carrying out these works.</p> |

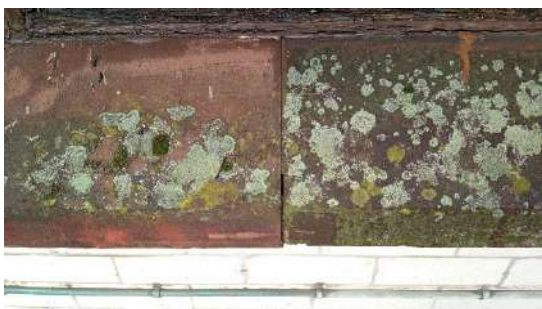
| 39 | | <p>Open mortar joint would benefit from being raked out and repointed using lime0-based mortar.</p> |

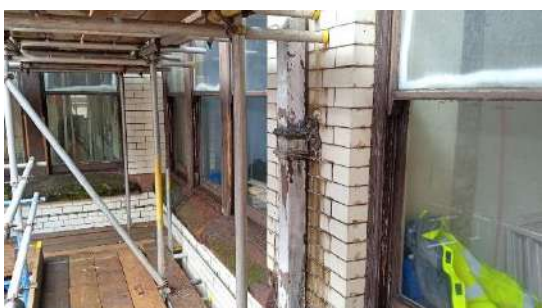
| 40 | | <p>Paint coating application to lead downpipes is failing and would benefit from re-application. Potential splits to the rear of the downpipe causing damp issues to rear masonry.</p> |

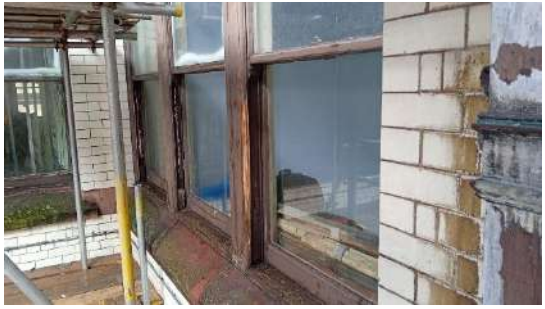
| 41 | | <p>Timber window frames would benefit from being overhauled by sanding, filling and new paint coating application. It is believed M&amp;B already have a contractor onsite carrying out these works.</p> |

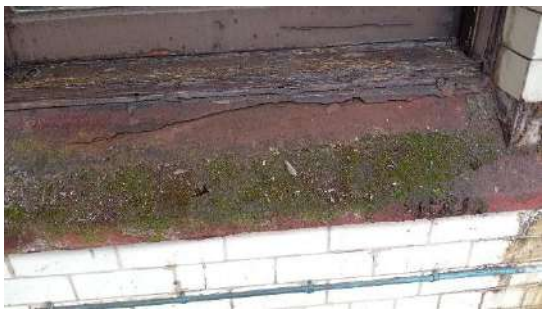
| 42 | | <p>Fissures to sill would benefit from having a slurry coat applied to consolidate and cover masonry units.</p> |

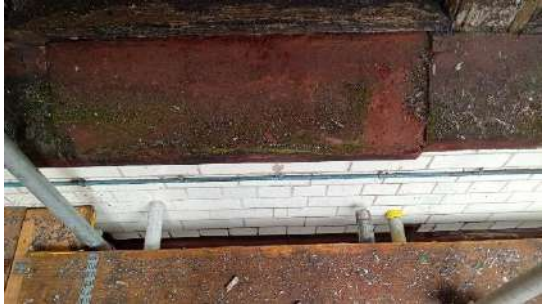
| 43 | | <p>Sill surface lamination evident, it is recommended that lime-based compound repair mortar is used to repair defective areas.</p> |

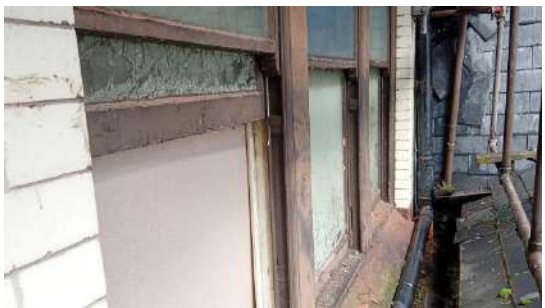
| 44 | | <p>Timber window frames would benefit from being overhauled by sanding, filling and new paint coating application. It is believed M&amp;B already have a contractor onsite carrying out these works.</p> |

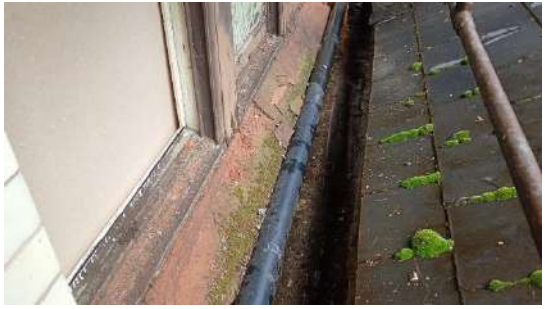
| 45 | | <p>Sill surface lamination evident, it is recommended that lime-based compound repair mortar is used to repair defective areas.</p> |

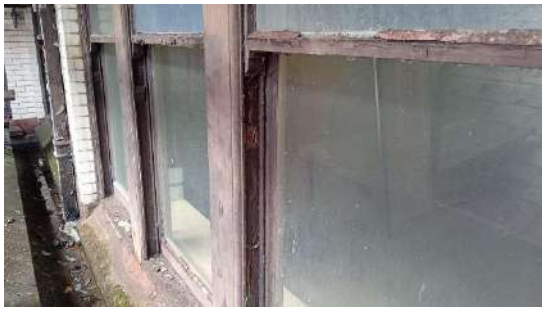
| 46 | | <p>Timber window frames would benefit from being overhauled by sanding, filling and new paint coating application. It is believed M&amp;B already have a contractor onsite carrying out these works.</p> |

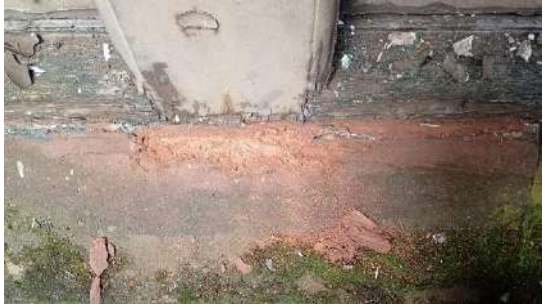
| 47 | | <p>Friable masonry suggesting damp areas caused by run off of water.</p> |

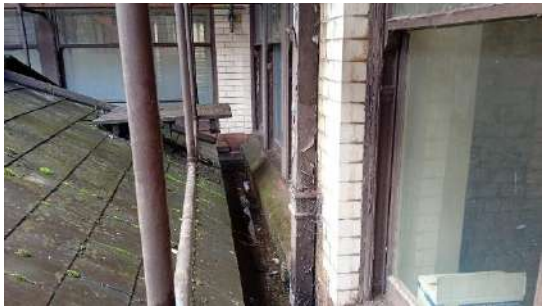
| 48 | | <p>Paint coating application to lead downpipes is failing and would benefit from re-application. Potential splits to the rear of the downpipe causing damp issues to rear masonry.</p> |

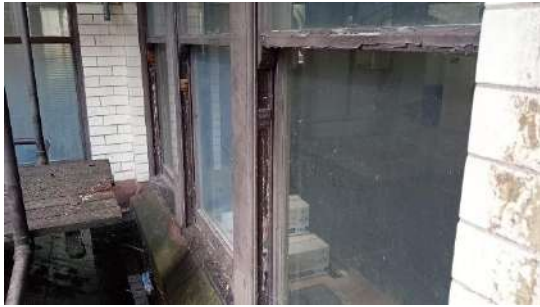
| 49 | | Timber window frames would benefit from being overhauled by sanding, filling and new paint coating application. It is believed M&B already have a contractor onsite carrying out these works. |

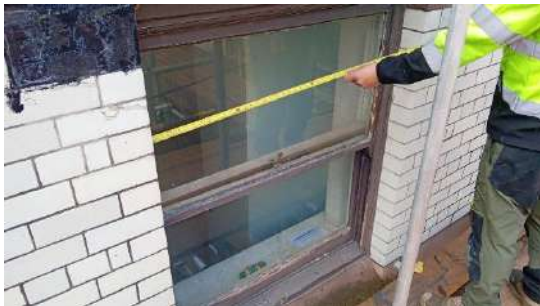
| | Photograph | Description |
|---|---|---|
| 1 | | Timber window frames would benefit from being overhauled by sanding, filling and new paint coating application. It is believed M&B already have a contractor onsite carrying out these works. |

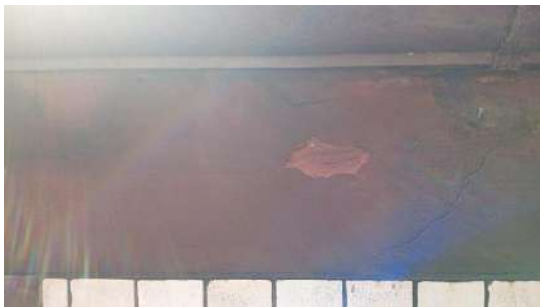
| | Photograph | Description |
|---|---|---|
| 2 | | Friable masonry area requires repairing using lime-based compound repair mortar to colour match surrounding masonry. |

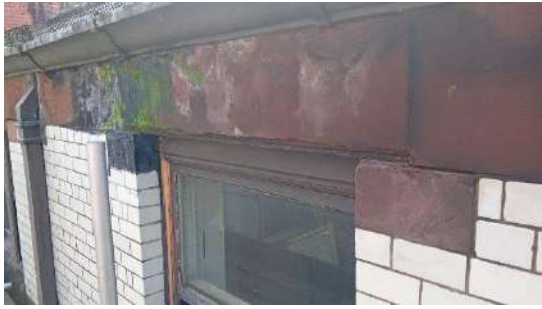
| 3 | | <p>Exposed iron lintel detail spanning over window opening, zinc rich primer application is recommended to exposed iron to prevent and slow down rusting and expansion.</p> |

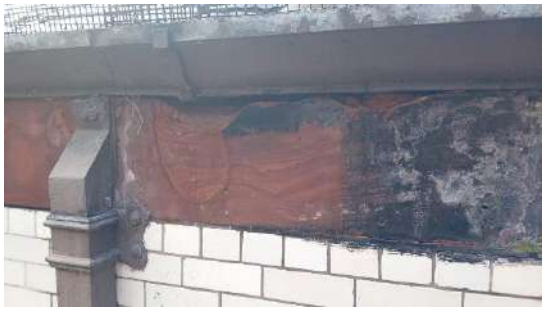
| 4 | | <p>Defective masonry require lime-based mortar repair application, these defects may be caused by leaking gutters and water running from the underside of gutter.</p> |

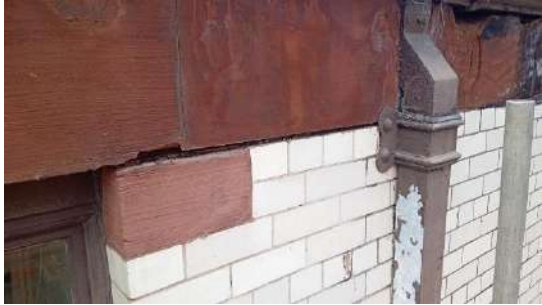
| 5 | | <p>Open mortar joint would benefit from being repointed using appropriate lime-based mortar.</p> |

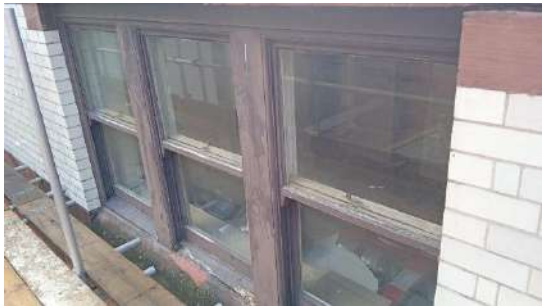
| 6 | | <p>Timber window frames would benefit from being overhauled by sanding, filling and new paint coating application. It is believed M&amp;B already have a contractor onsite carrying out these works.</p> |

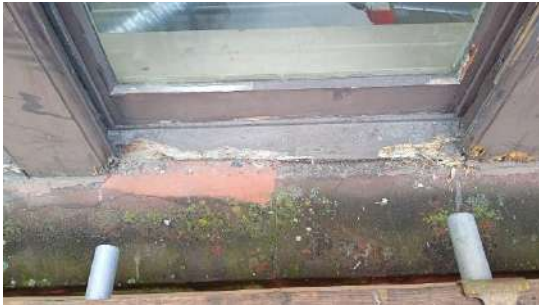
| 7 | | <p>Defective timber sill would benefit from being replaced, and epoxy repairs carried out to surrounding defect areas. Compound repair works required to defective stone sill areas.</p> |

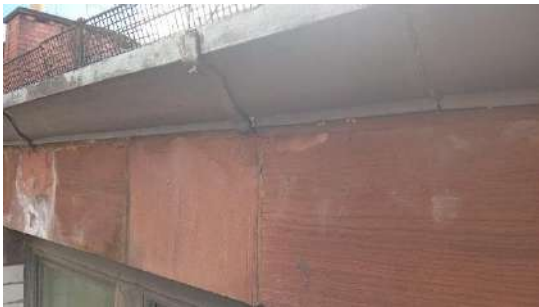
| 8 | | <p>Failed mortar joints to underside of guttering require raking out and repointing.</p> |

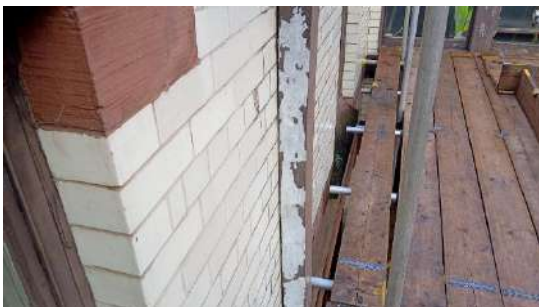
| 9 | | <p>Flaking paint coating system to downpipe would benefit from preparation and re-application of suitable paint system.</p> |

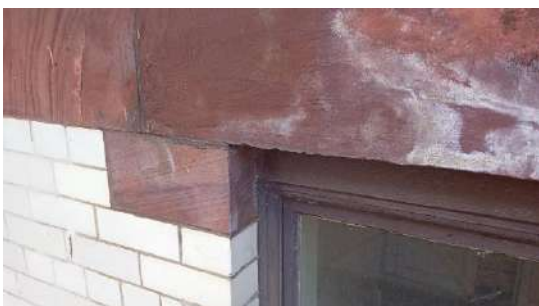
| 10 | | <p>Hairline fissure to stone lintel detail that would benefit from future monitoring during inspection phases.</p> |

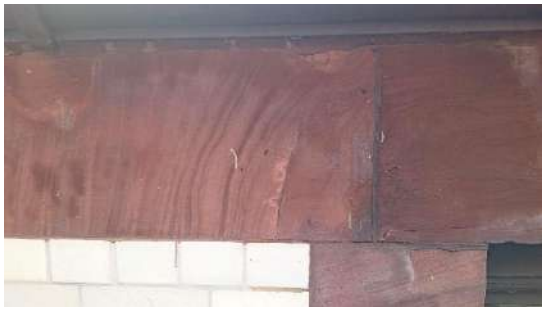
| 11 | | <p>Vertical crack would benefit from being monitored during future inspections.</p> |

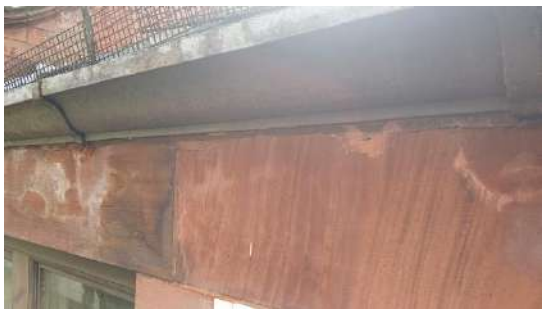
| 12 | | <p>Failed mortar joints to underside of guttering require raking out and repointing.</p> |

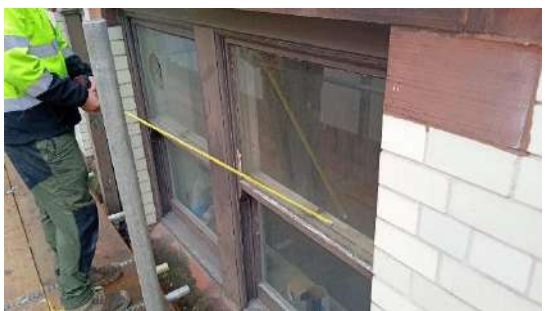
| 13 | | <p>Timber window frames would benefit from being overhauled by sanding, filling and new paint coating application. It is believed M&amp;B already have a contractor onsite carrying out these works.</p> |

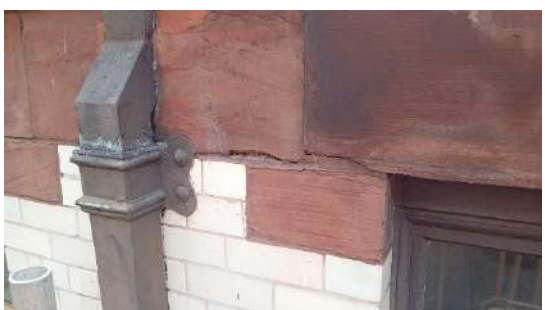
| 14 | | <p>Defective mortar joints potentially caused by expansion of internal ironwork. Compound repairs and pointing works required to defective areas.</p> |

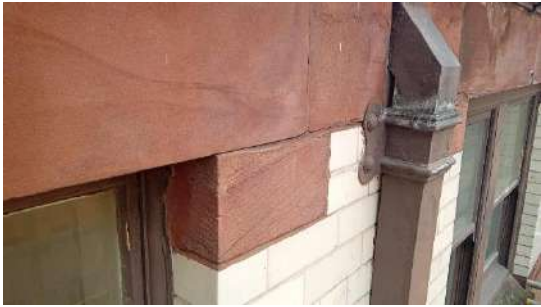
| 15 | | <p>Failed defective mortar joint would benefit from being raked out and repointed using lime based mortar.</p> |

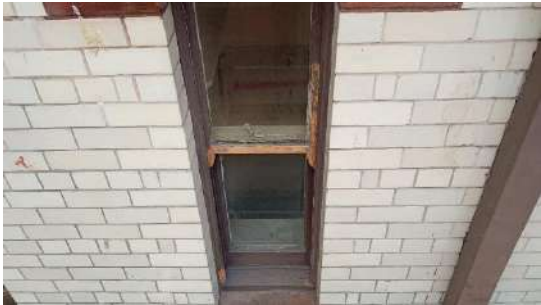
| 16 | | <p>Timber window frames would benefit from being overhauled by sanding, filling and new paint coating application. It is believed M&amp;B already have a contractor onsite carrying out these works.</p> |

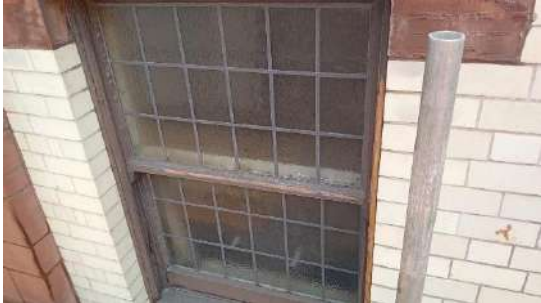
| 17 | | <p>Timber window frames would benefit from being overhauled by sanding, filling and new paint coating application. It is believed M&amp;B already have a contractor onsite carrying out these works.</p> |

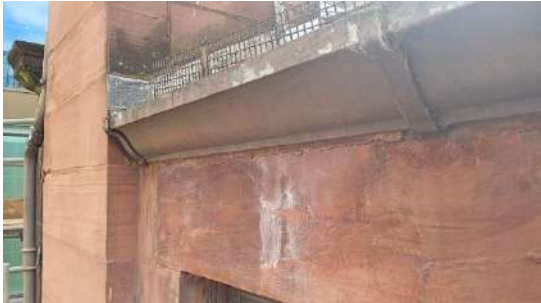
| 18 | | <p>Failed mortar joints to underside of guttering require raking out and repointing.</p> |

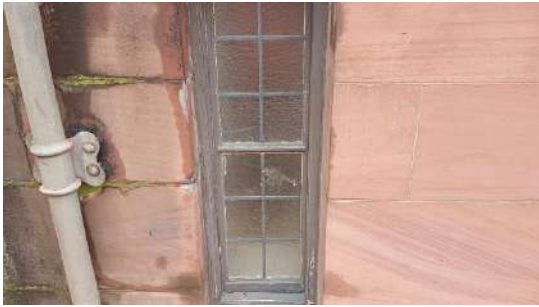
| 19 | | <p>Timber window frames would benefit from being overhauled by sanding, filling and new paint coating application. It is believed M&amp;B already have a contractor onsite carrying out these works.</p> |

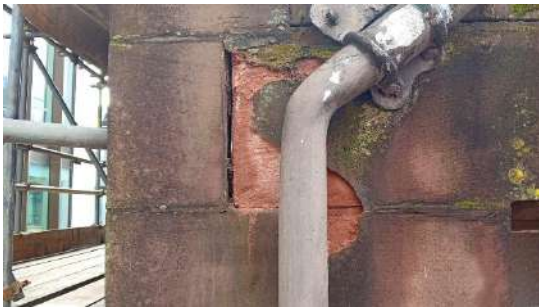
| 20 | | <p>Defective open mortar joints and laminated stone faces require repointing and lime-based compound repair application.</p> |

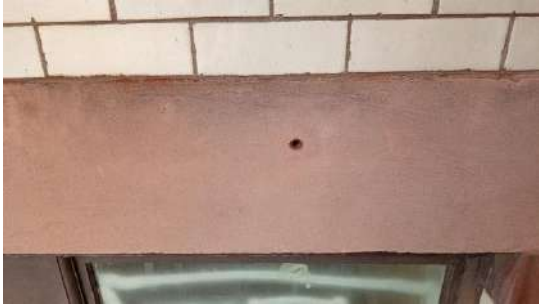
| 21 | | <p>Historic scaffold tie would benefit from removal to prevent expansion and damage to surrounding masonry.</p> |

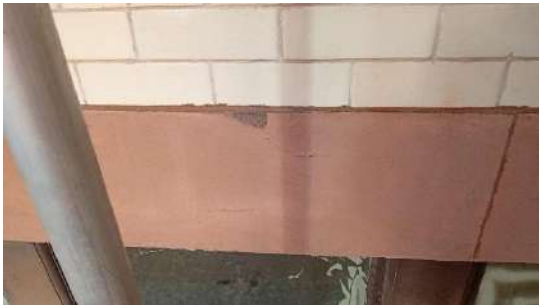
| 22 | | <p>Minor defect to stonework would benefit from filling using lime-based compound repair mortar.</p> |

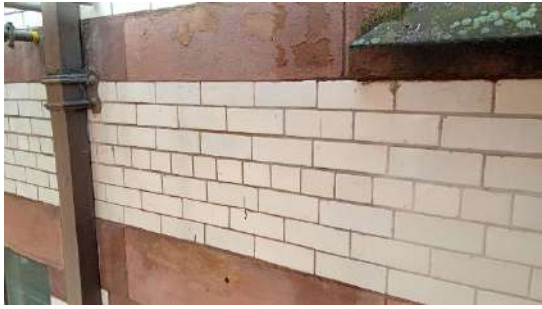
| 23 | | <p>Historic scaffold tie would benefit from removal to prevent expansion and damage to surrounding masonry.</p> |

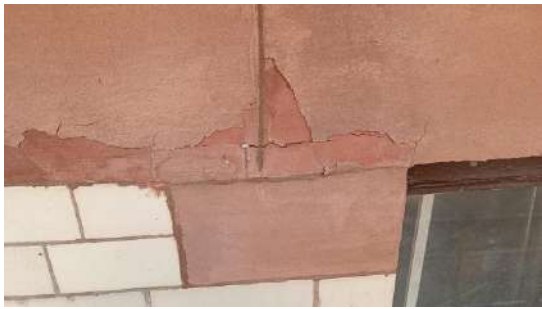
| 24 | | <p>Defective open mortar joints and laminated stone faces require repointing and lime-based compound repair application.</p> |

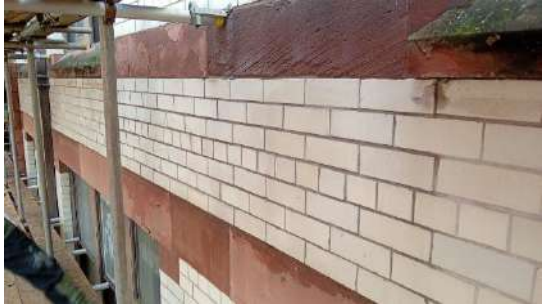
| 25 | | <p>Friable masonry would benefit from being de-frassed.</p> |

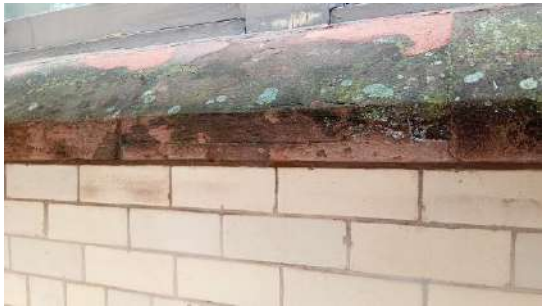
| 26 | | <p>Fissure to masonry unit would benefit from being raked out and filled.</p> |

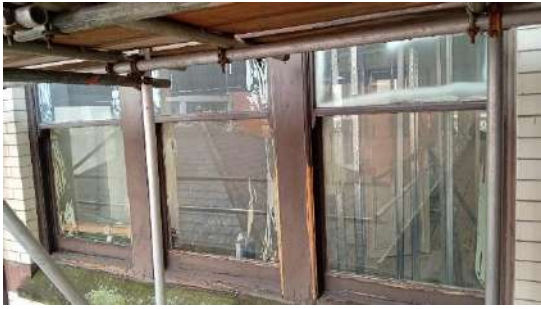
| 27 | | <p>Timber window frames would benefit from being overhauled by sanding, filling and new paint coating application. It is believed M&amp;B already have a contractor onsite carrying out these works.</p> |

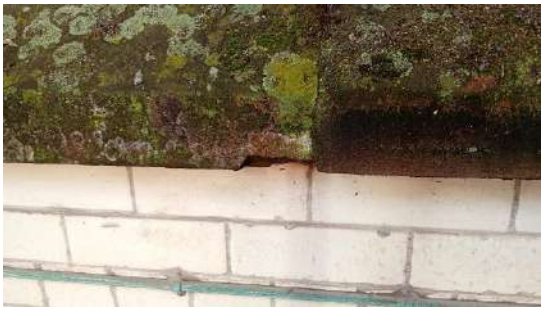
| 28 | | <p>Defective masonry area would benefit from compound repair application to reform and colour match surrounding masonry.</p> |

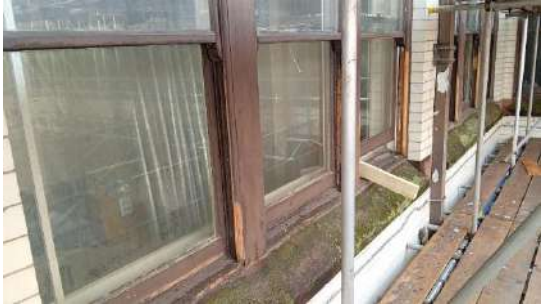
| 29 | | <p>Timber window frames would benefit from being overhauled by sanding, filling and new paint coating application. It is believed M&amp;B already have a contractor onsite carrying out these works.</p> |

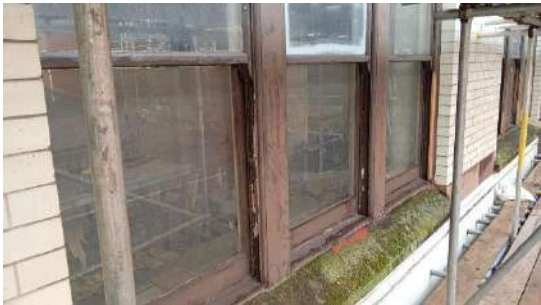
| 30 | | <p>Timber window frames would benefit from being overhauled by sanding, filling and new paint coating application. It is believed M&amp;B already have a contractor onsite carrying out these works.</p> |

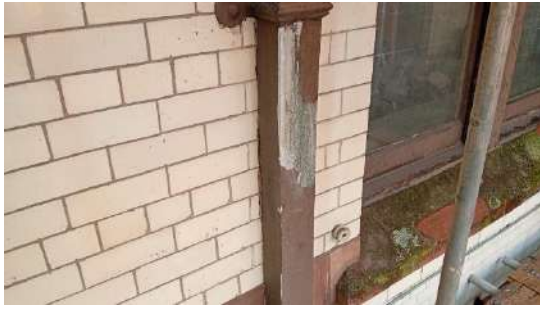
| 31 | | <p>Flaking paint coating system to downpipe would benefit from preparation and re-application of suitable paint system.</p> |

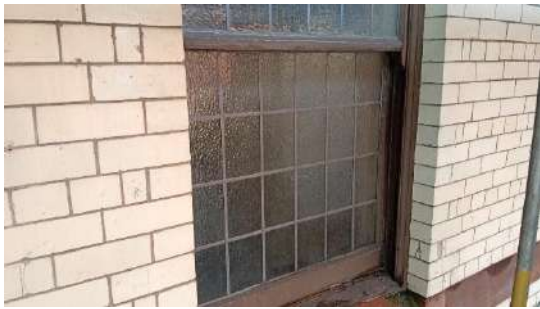
| 33 | | <p>Timber window frames would benefit from being overhauled by sanding, filling and new paint coating application. It is believed M&amp;B already have a contractor onsite carrying out these works.</p> |

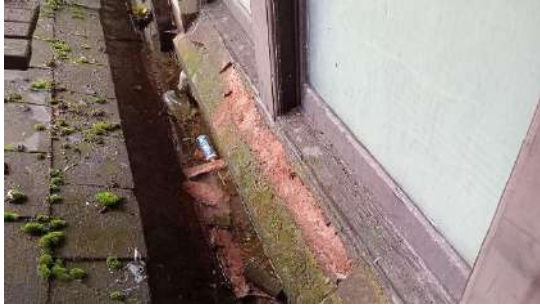
| 34 | | <p>Defective laminated stonework would benefit from being reformed using appropriate lime-based compound repair mortar.</p> |

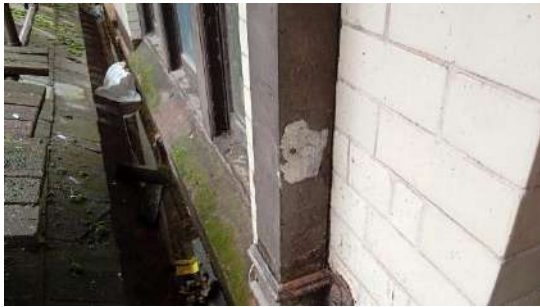
| 35 | | <p>Flaking paint coating system to downpipe would benefit from preparation and re-application of suitable paint system.</p> |

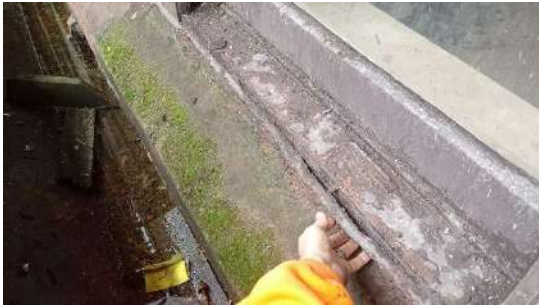
| 36 | | Failed flexible seal requires removing and replacing. |

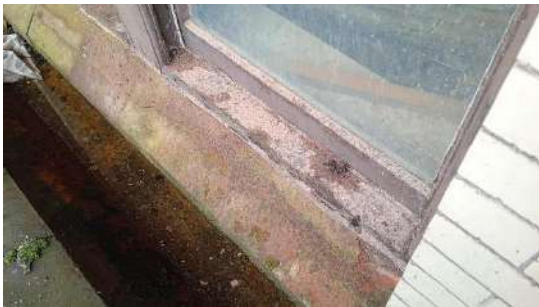
| 37 | | Failed flexible seal requires removing and replacing. |

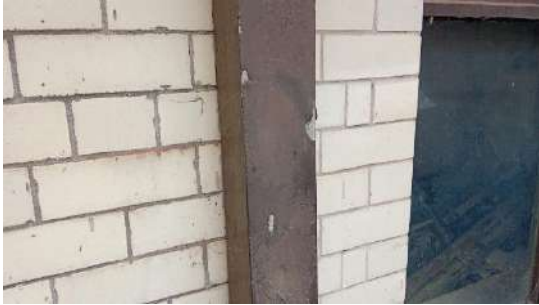
| 38 | | Flaking paint coating system to downpipe would benefit from preparation and re-application of suitable paint system. |

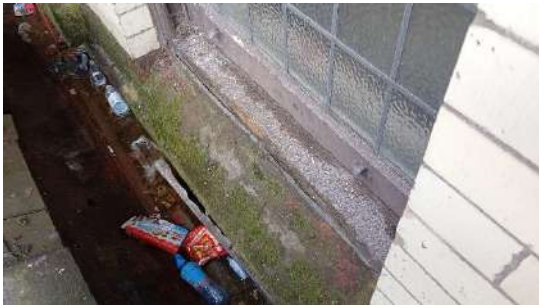
| 39 | | Failed sealant to junction between timber sill and stone detail that would benefit from removal and replacement. |
