Project
SCIENCE & INDUSTRY MUSEUM MANCHESTER

Title
POWER HALL ROOF REPAIRS
REPAIRS PLAN (EAST)

Drawing No
180426-CON-PH-RF-DR-S-1028

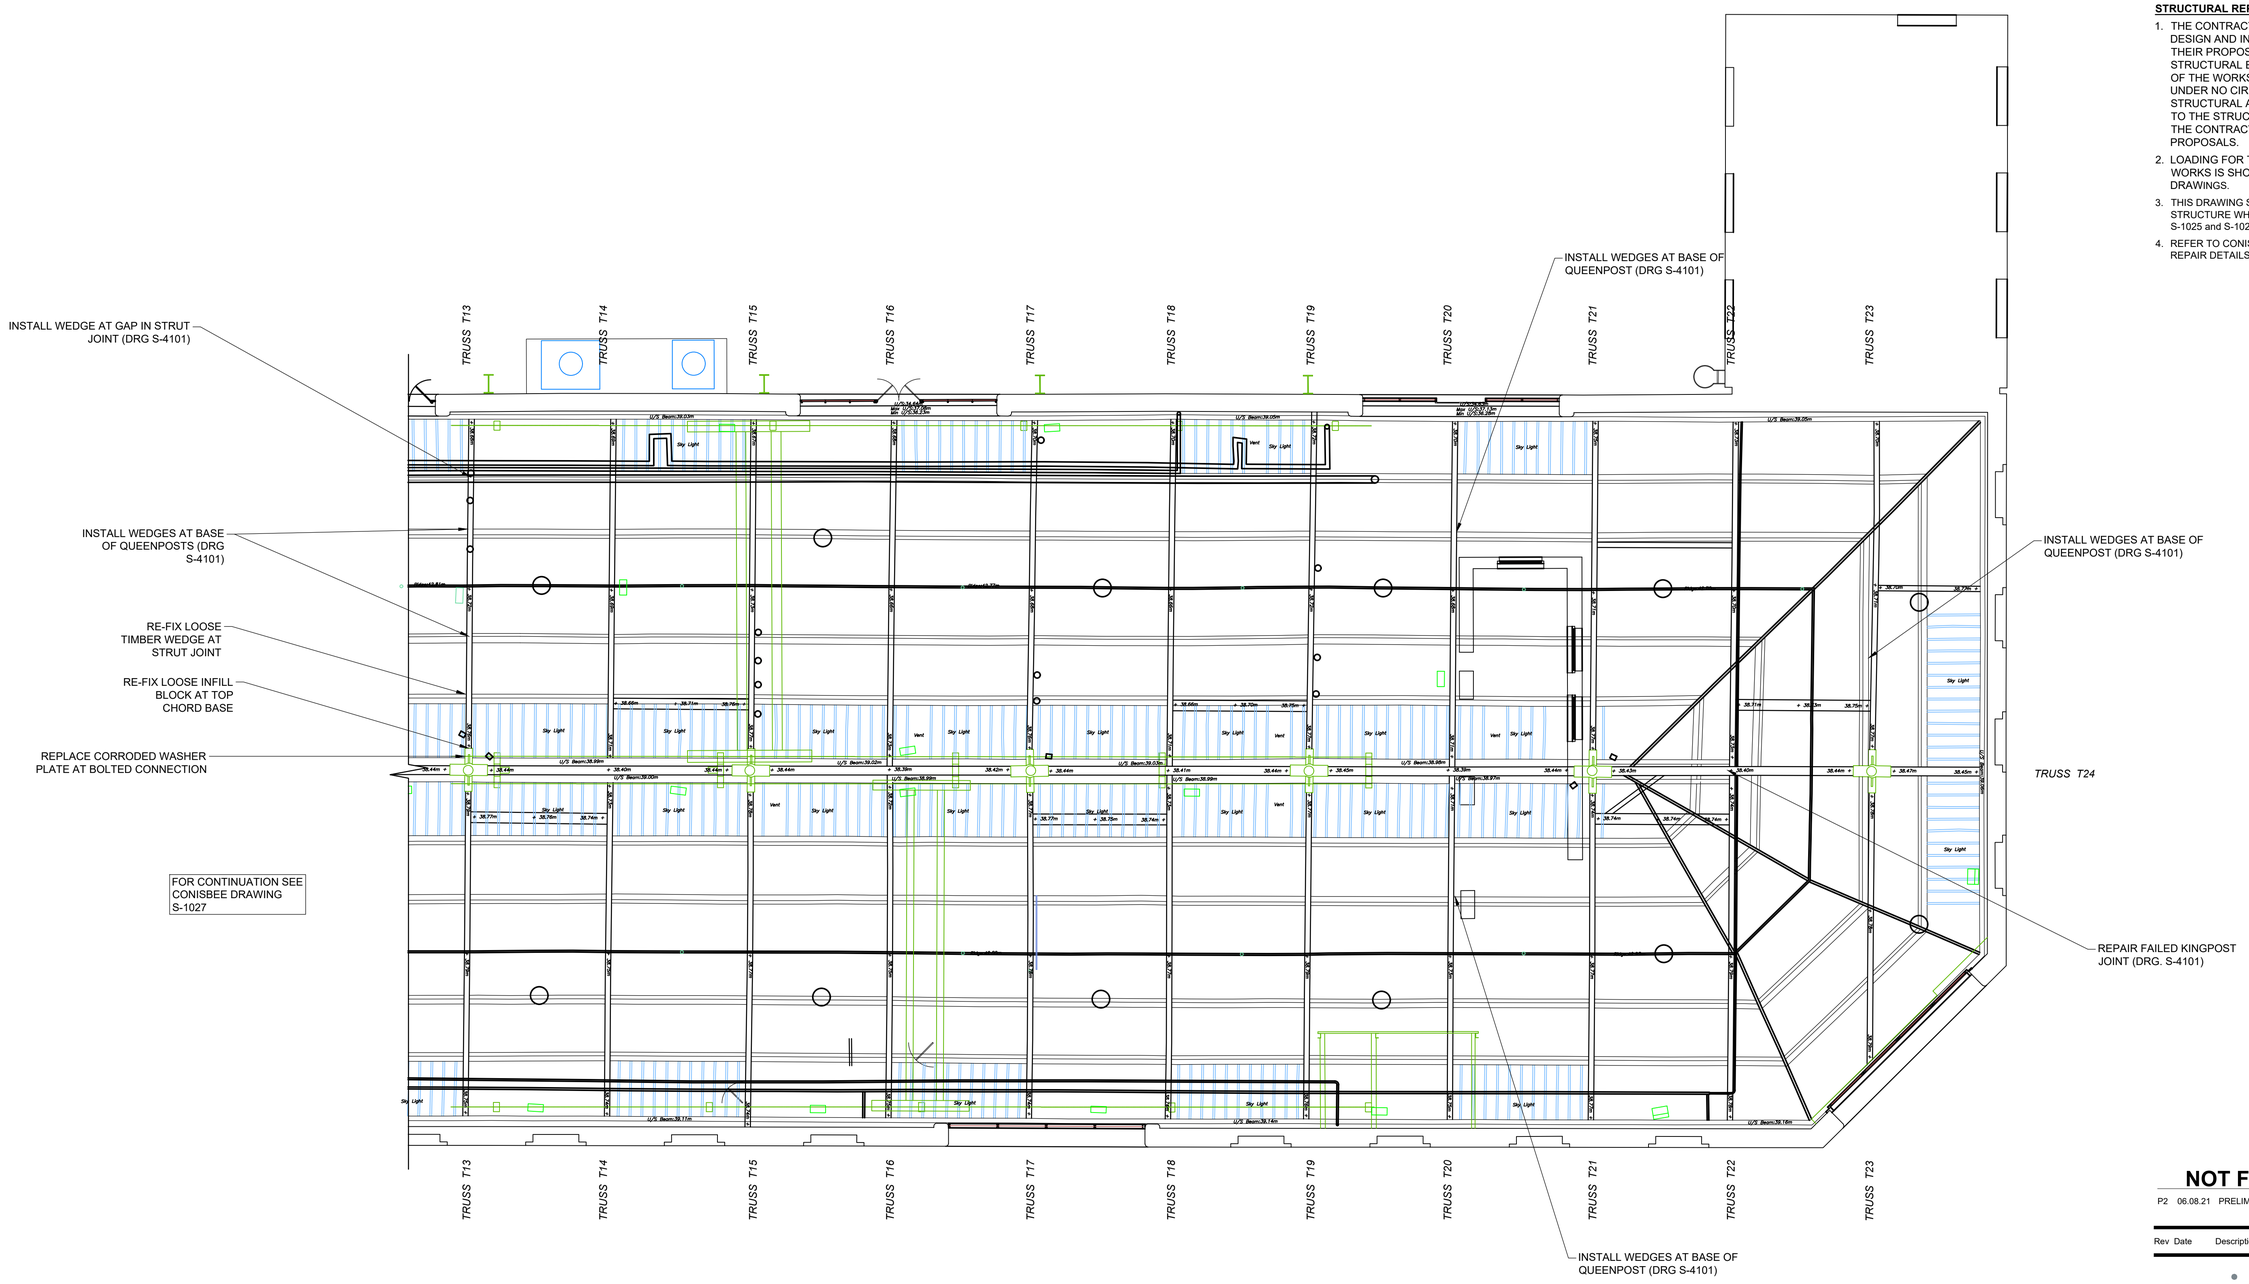
GENERAL NOTE: CHECK ALL EXISTING PACKERS/WEDGES ARE SECURE
