# HERITAGE STATEMENT

Rear extension and refurbishment of 10 Rushford Avenue, Levenshulme

August 2021

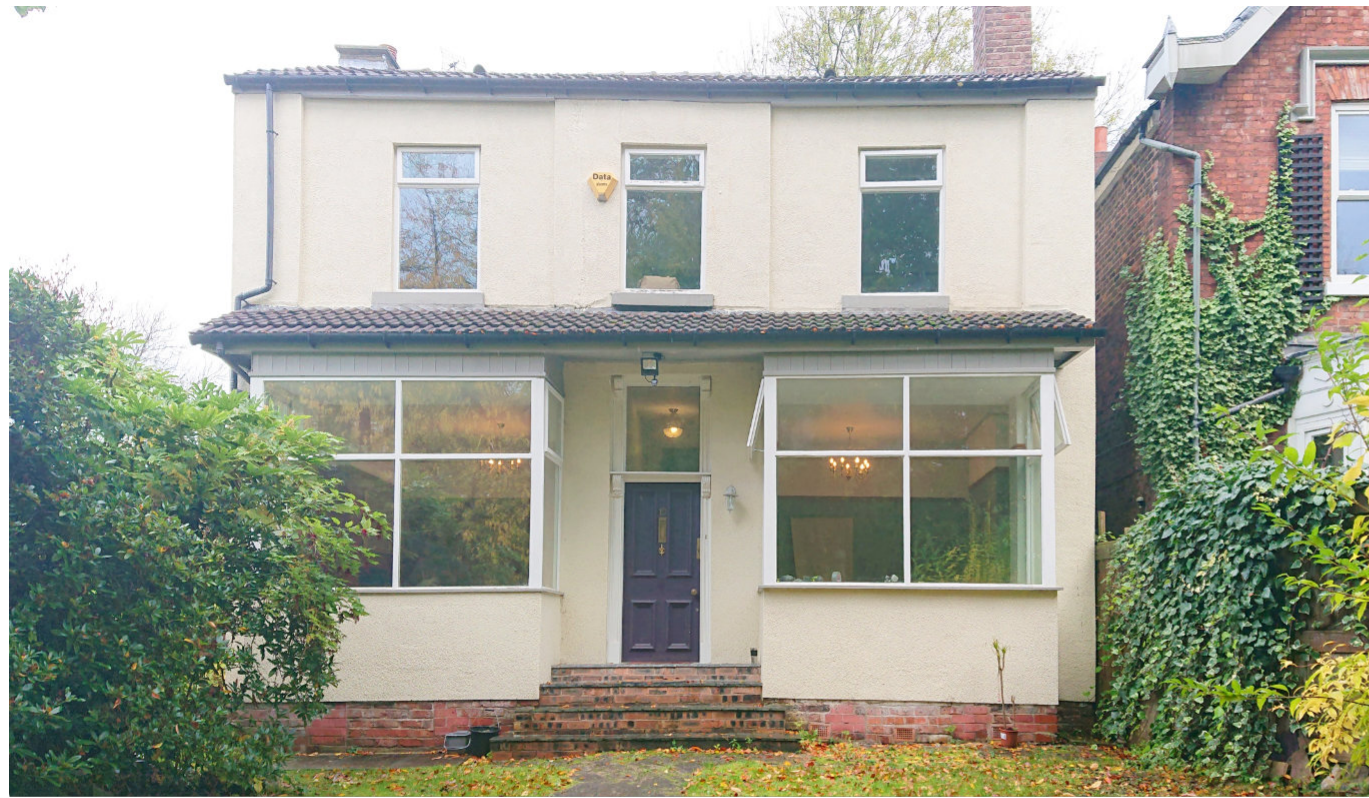
FIGURE 1: existing front elevation and internal spaces to 10 Rushford Avenue.

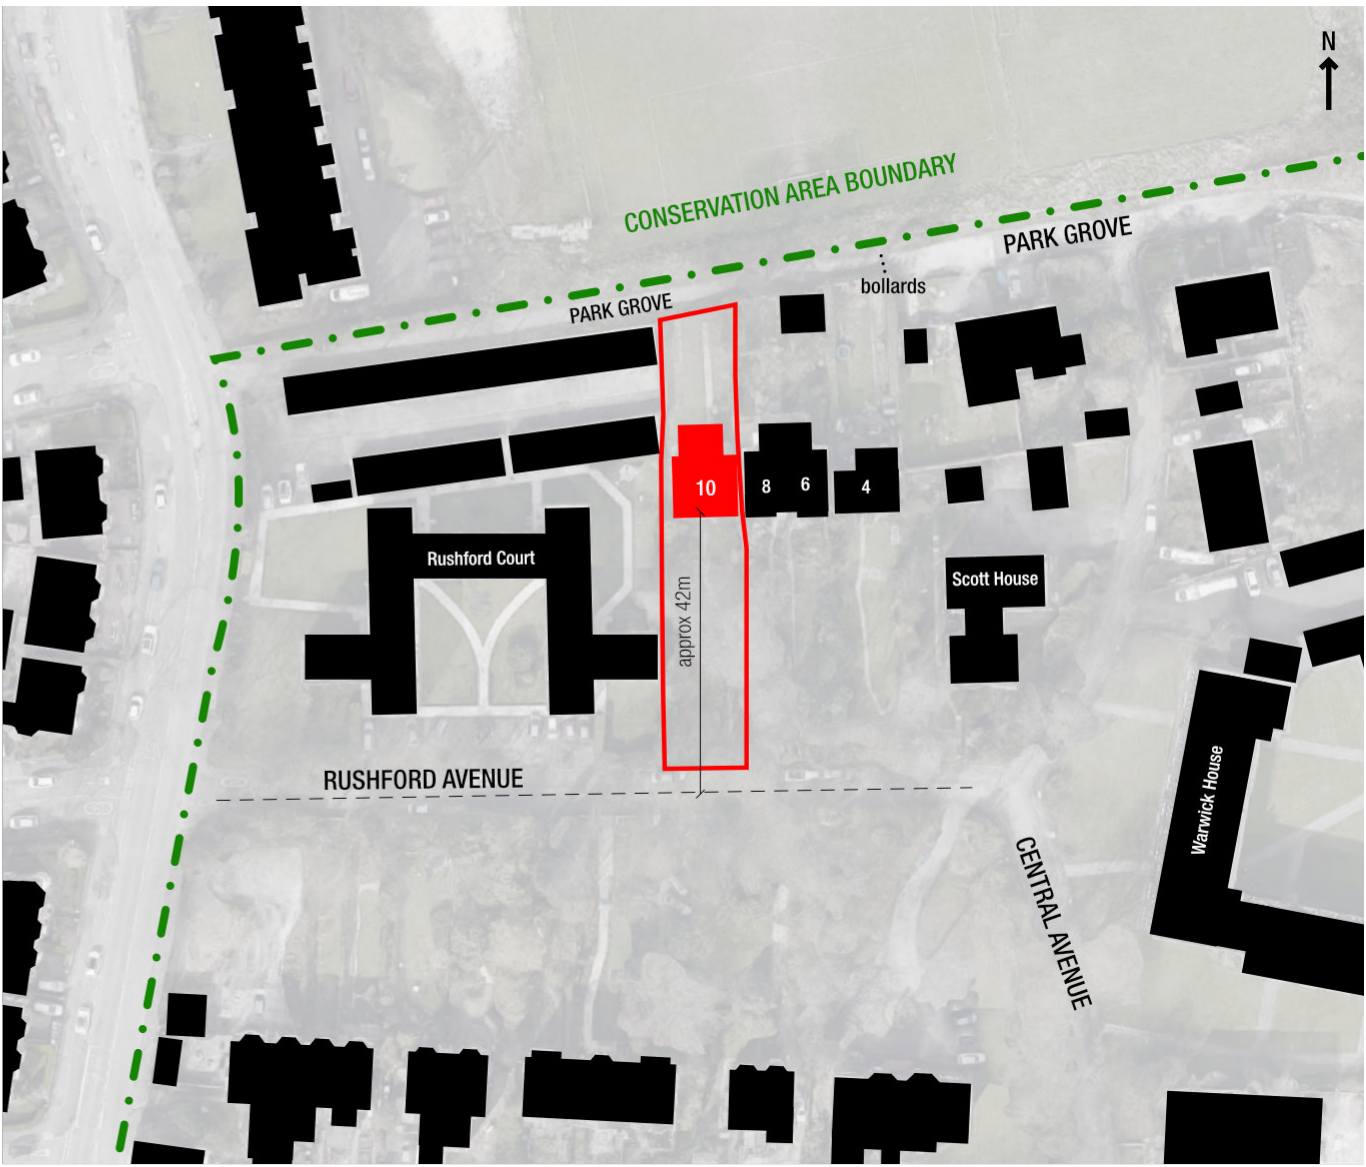
FIGURE 2: figure ground showing extents of conservation area

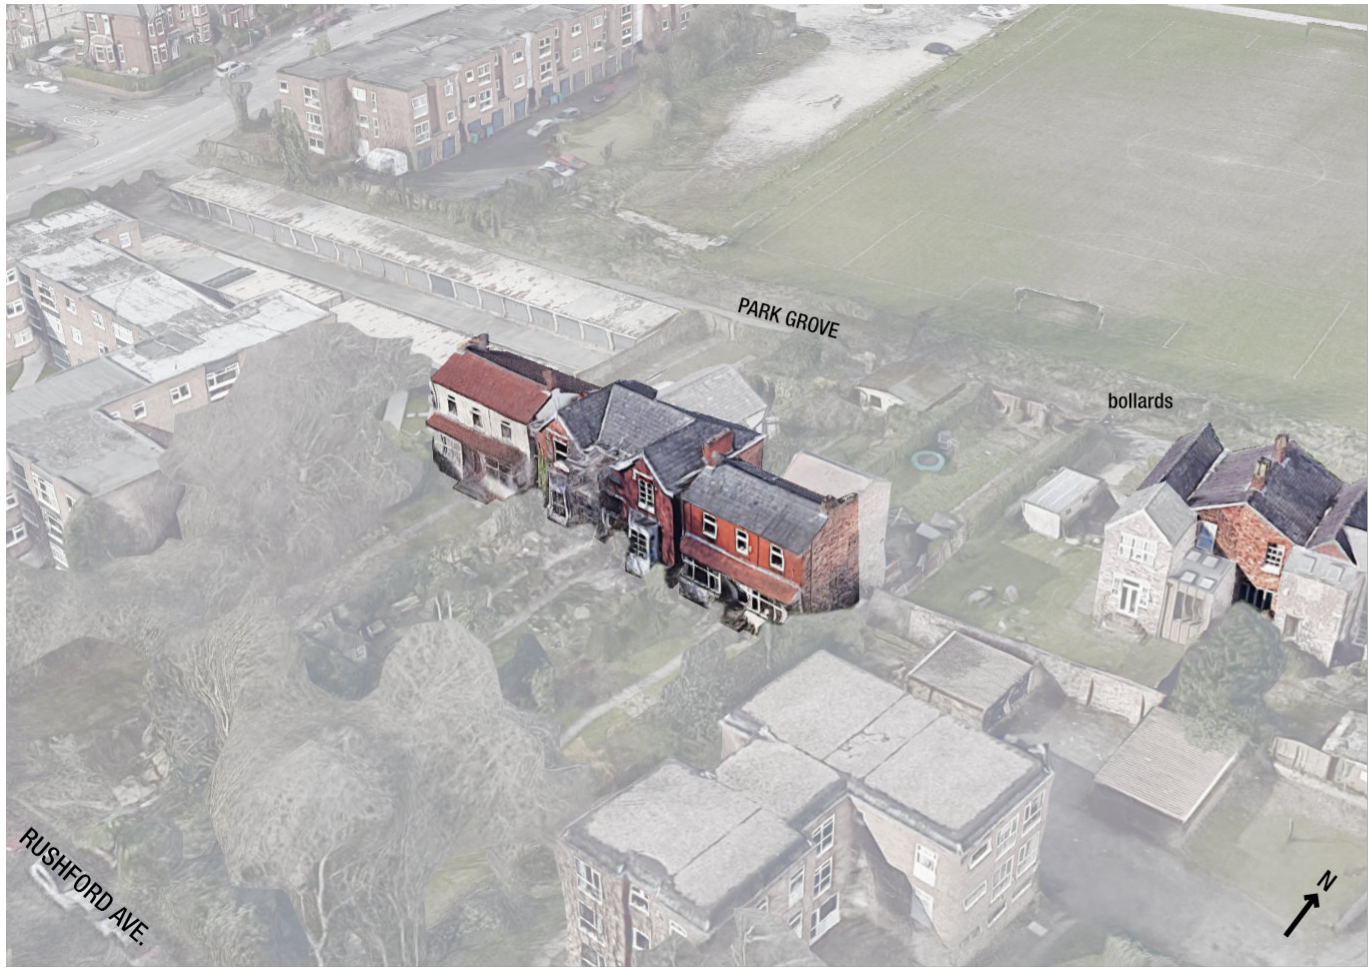
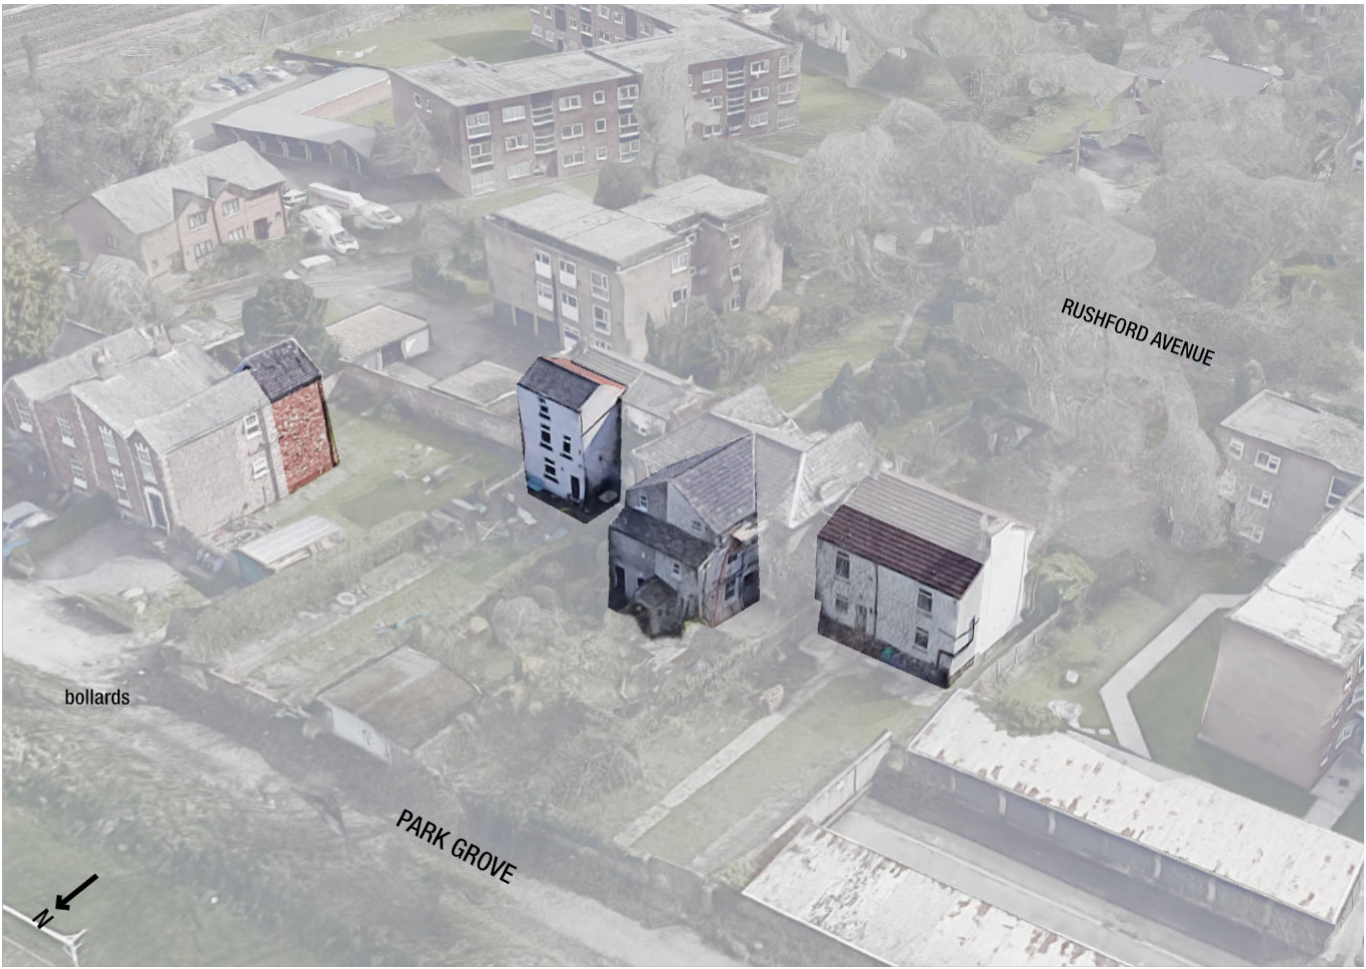
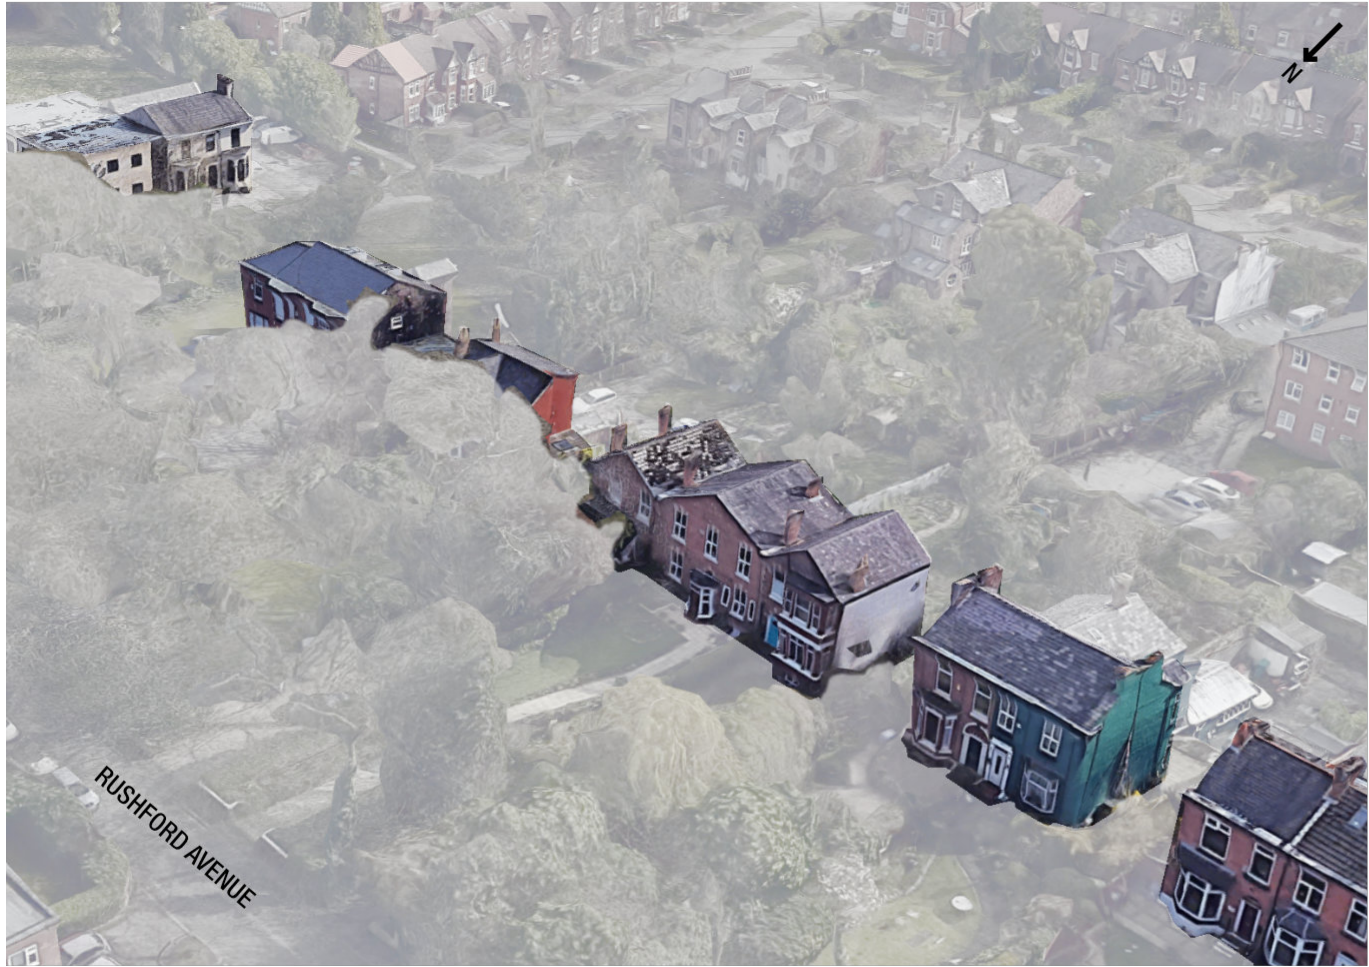
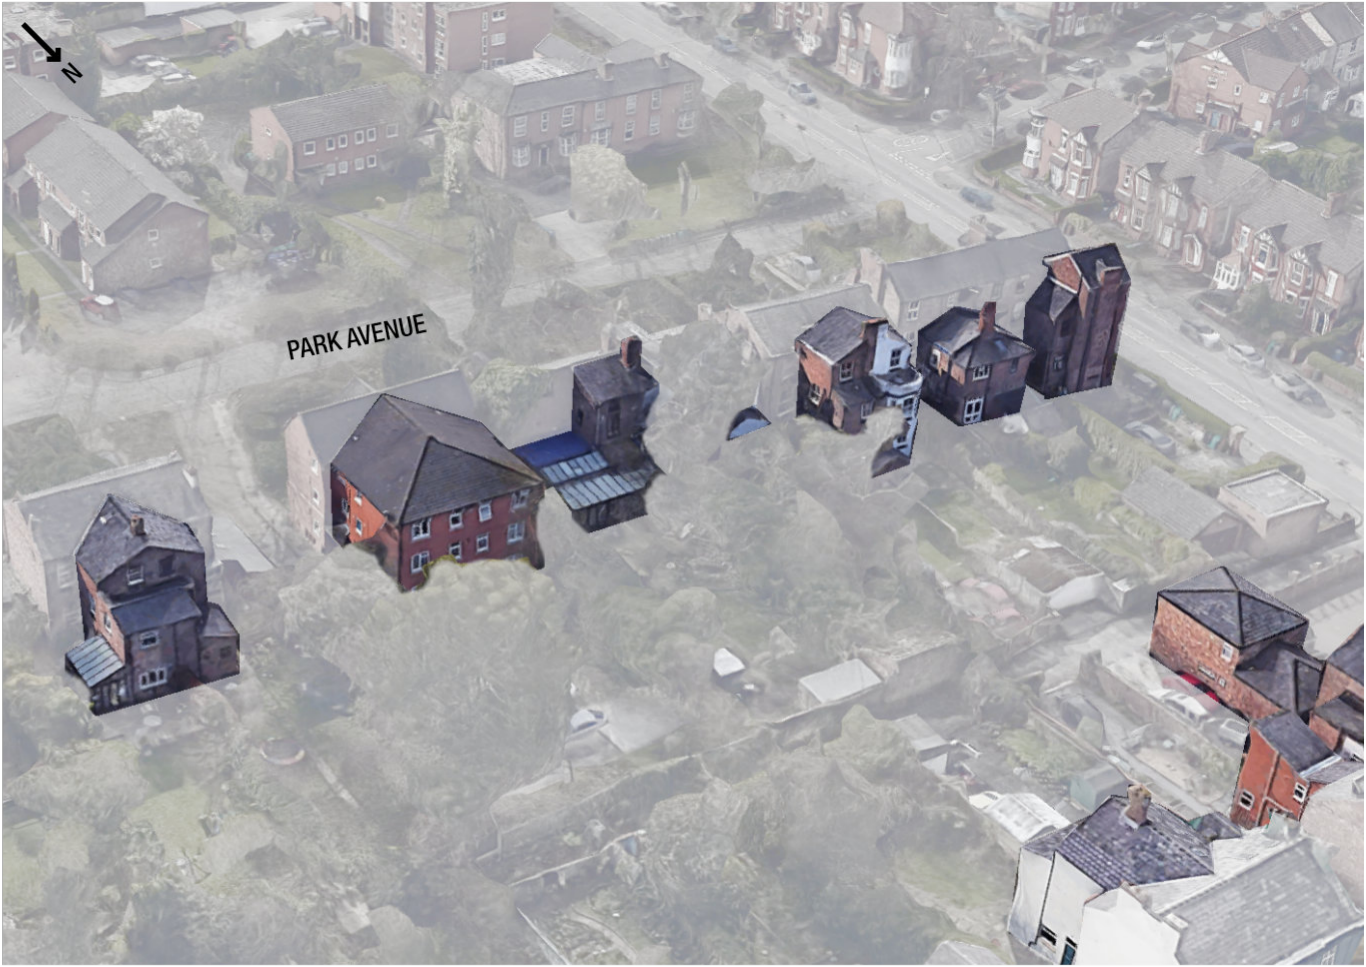
FIGURE 3.1: examples of frontage elevation conditions throughout Rushford Park (based on Google Maps imagery)

FIGURE 3.2: examples of rear elevation conditions throughout Rushford Park (based on Google Maps imagery)

The rear urban grain is less formal, with a variety of rear outriggers, extensions and out-buildings of different depths, heights and construction evident throughout the estate (see Figure 3.2). Park Grove acts as a rear service track to 10 Rushford Avenue and it's immediate neighbours. The application site is immediately adjoined by incongruous low level communal garages for the neighbouring apartment block to the West, while further along Park Grove the road becomes an informal frontage for a pair of slightly later semi-detached houses with articulated front gable facing across the playing fields. Vehicular access for these dwellings is from Central Avenue past another incongruous 3 storey apartment block at Warwick House. It is considered that there is no clearly defined building line facing Park Grove at this point, although the neighbour at 6-8 Rushford Avenue features a prominent 2-3 storey outrigger whose gable acts as point of reference within the rear gardens.

Rear elevations are generally informal in Rushford Park. The immediately neighbouring buildings appear to retain more or less original outriggers but they have generally been modified and amended such that the material and styling varies from plot to plot. Throughout the estate a range of rear installations provide a variety of precedents, including large 3 storey outriggers, expansive glazed extensions, linear extensions strung between the rear elevation and the end of the garden and a variety of alternative roof forms ranging from flat roof, hipped, parapets, gable and cat-slide (see Figure 3.2).

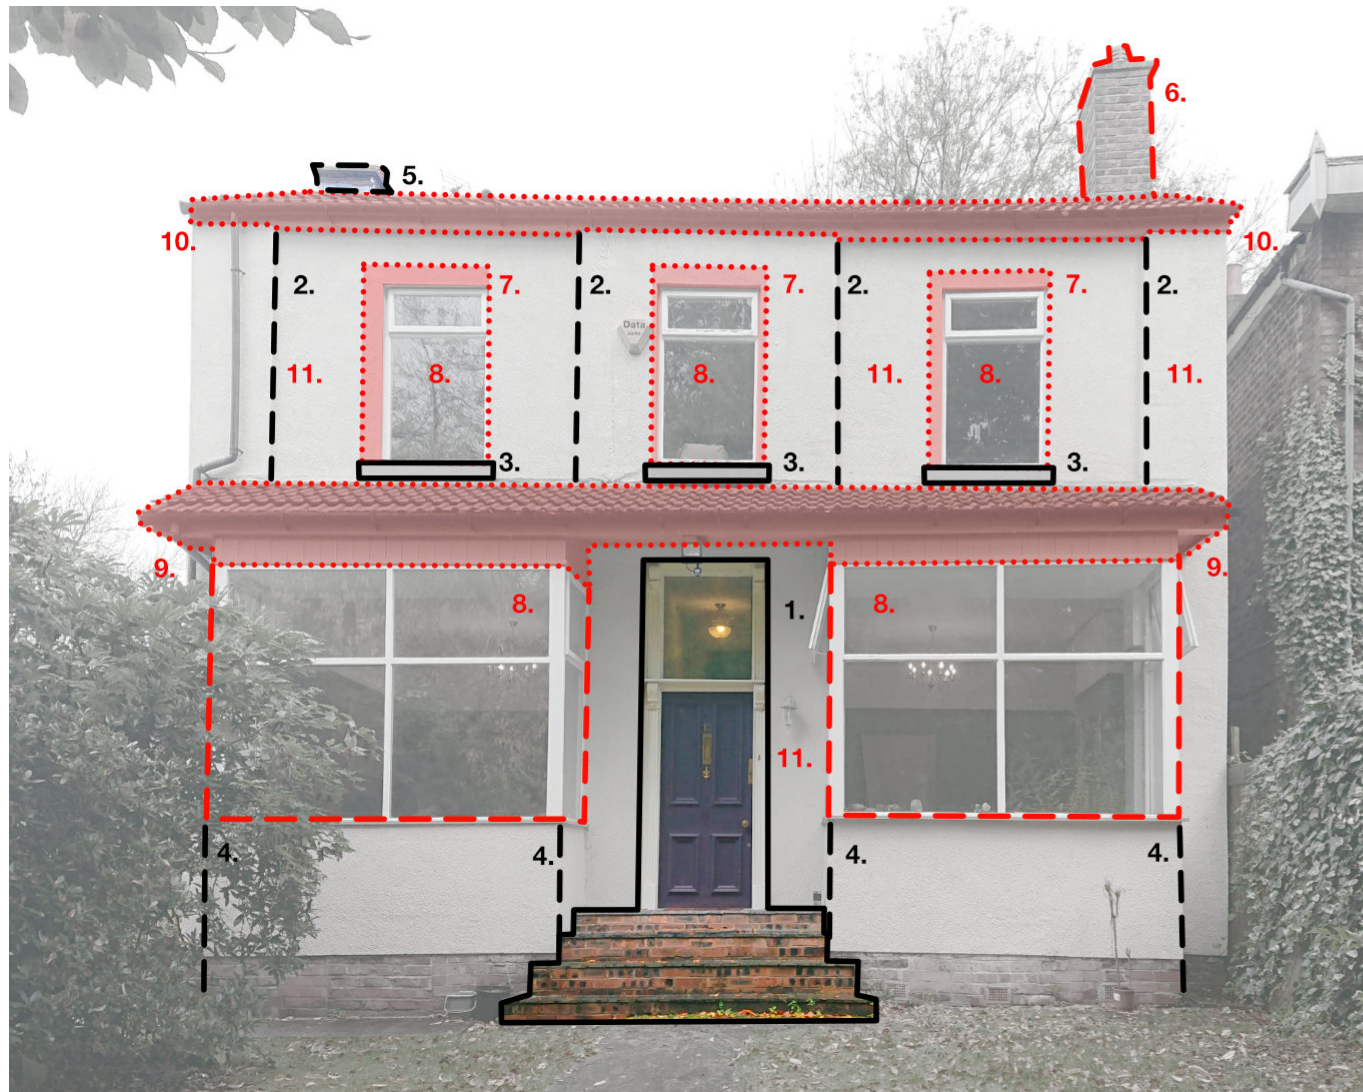
FIGURE 4: breakdown of front elevation details: “Original Detail” Vs “Lost / Additional Detail”

1. Pilastered door reveal, with appropriate front steps apparently having been rebuilt in a different brick.
2. Prominent brick reveal detailing to frame bay windows, now rendered.

3. Painted stone cills, now appear offset due to windows having been apparently rebuilt.
4. Bay window structure appears original at low level, now rendered - as are others in context.

5. LH chimney appears original scale according to neighbours.
6. RH chimney appears to have been made taller and appears out of context.
7. Windows have been rebuilt with lower heads and reveals adapted in relation to original cills.

8. Windows have been replaced throughout with modern style timber frame windows with opening top lights.
9. Bay window / canopy roof was rebuilt apparently higher than neighbours resulting in boarded bay head detail.

10. Roof has been rebuilt with altered materiality and eaves detail that does not match neighbours.
11. Original brickwork has been covered by Tyrolean cement render painted white throughout. Patching and eaves level damage results in generally uneven arris lines and poor surface finish generally.

The key remaining elements of the original design are the original vertical delineation and segmented elevation around and over the bay windows, and also the decorative reveal around the front door and light, which contains inset neoclassical pilasters, scrolls below an architrave header below a large square transom light. It is evident that both the main roof and the lean-to roof above the bay windows have been rebuilt, with the latter having apparently been constructed at a higher level than the original (evident when compared to the neighbour at number 4). The later roofs were finished in interlocking concrete pan-tiles, which replaced former slate roof, which are still evident on the majority of neighbouring buildings. The main roof eaves do not match neighbouring details, being flush to the uneven render finish of the prominent centre bay and cheeks. The bay windows and all other windows were replaced with modern timber frame windows with opening top lights, that lack the elegant proportions of the neighbours. It is evident by the location of the cills at first floor level, when compared with the neighbours, that the windows have been reduced in size and offset to one side, which explains the clumsy proportions in the elevation. The window heads have also been lowered, which likely results from the clumsy replacement of original brick flat arches that had failed.

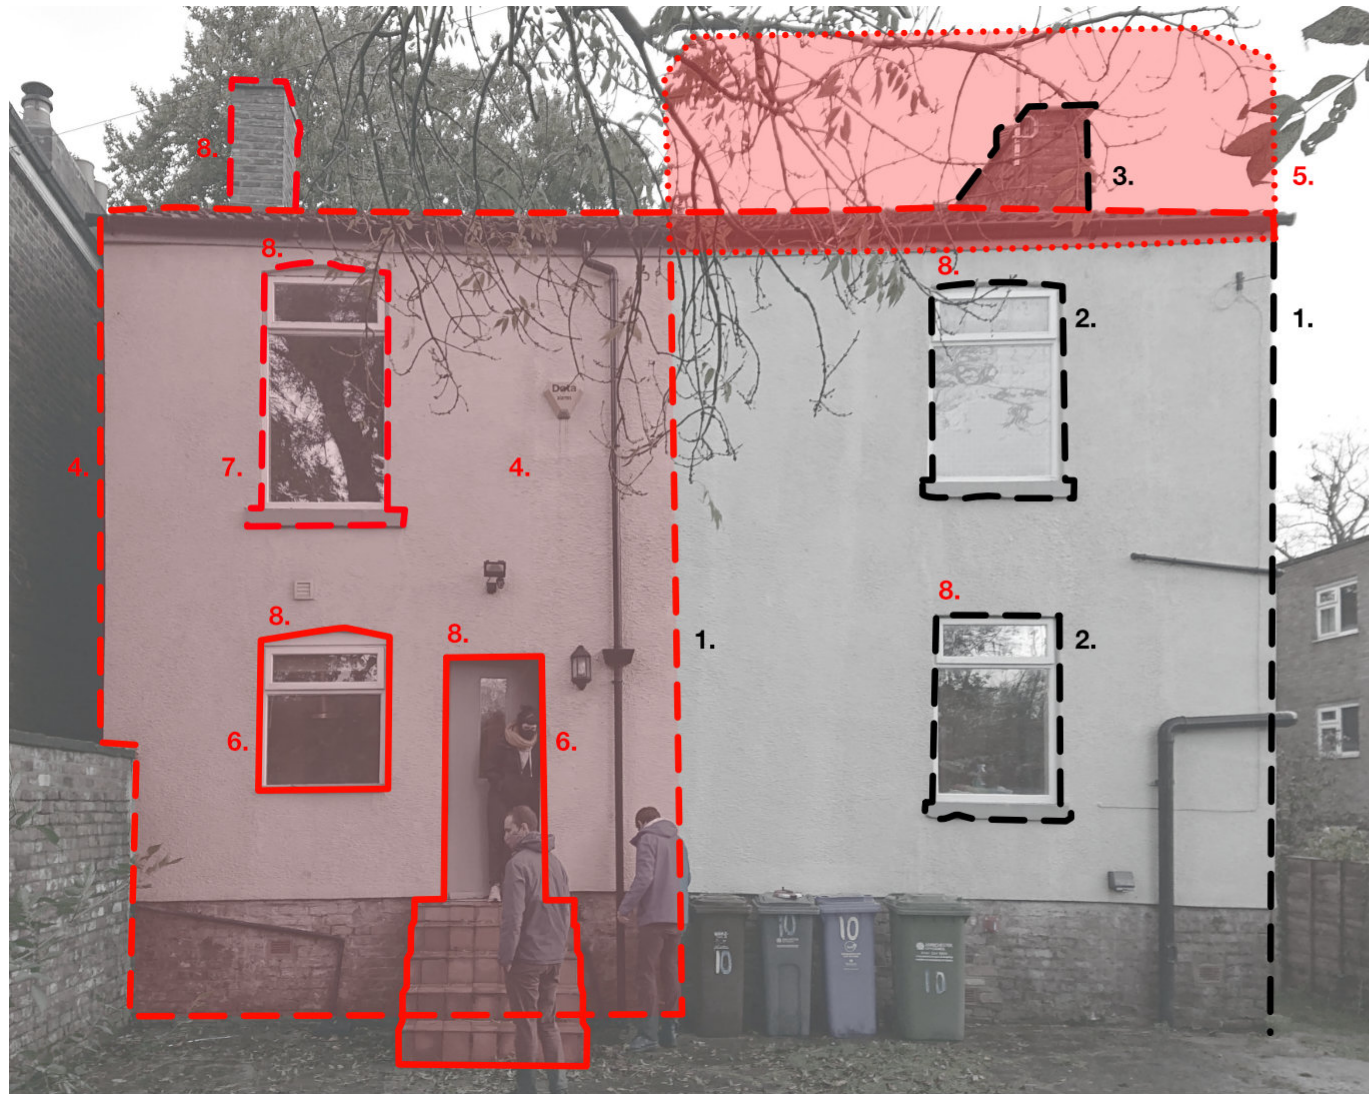
FIGURE 6: breakdown of rear elevation details: “Original Detail” Vs “Lost / Additional Detail”

1. Line of original 3 storey outrigger evident on neighbour at number 4.
2. Window reveals and cills apparently original placement, although windows are modern.
3. Chimney stack retains original height, apparent size increase compared to number 4.
4. C20th extension with reduced eaves line compared to neighbours and internal floor levels
5. Loss of 3<sup>rd</sup> storey with valley roof structure.
6. Mismatched kitchen window and door lack detail or proportions of earlier building. Steps are poorly detailed and not suitable for location.
7. Window cill non aligned and window width does not match windows elsewhere.
8. Low arch window heads are inconsistent, in poor condition and do not relate to context.
9. Chimney is increased in height in relation to existing.

Even considering the informality of the context, the existing rear elevation of number 10 stands out as particularly poorly detailed, incoherent and out of proportion. It is apparent that during the major works in the 1970s, an original 3 storey outrigger (evident in the reflected neighbour at number 4) was reduced in height and resolved within the same reduced flush eaves line as a 2 storey extension to infill the remainder of the rear elevation. The result is an apparently lower scale building compared to its neighbour, despite having more or less matching eaves at the front. Moreover, the additional rooms have resulting windows and a rear door that are quite disorderly with differing head heights, cill heights and widths than the existing and ignoring the proportions of the existing building. The internal resolution results in large blank spaces in the elevation and distinctively uneven appearance.

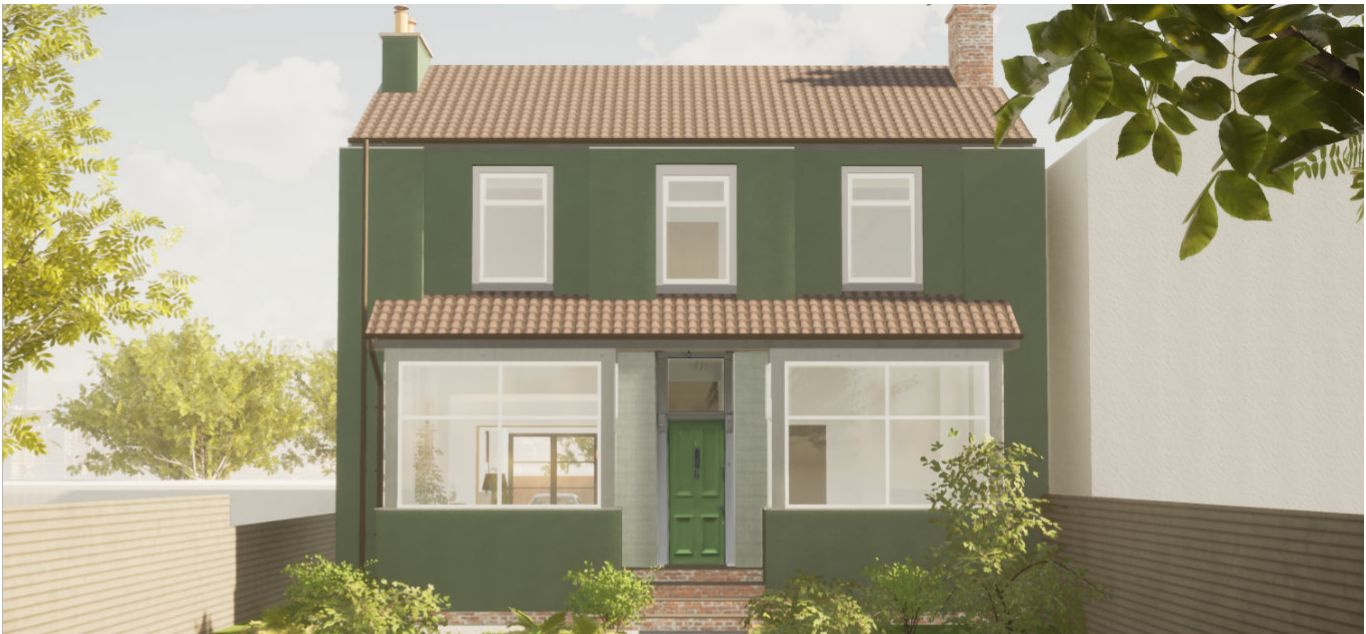
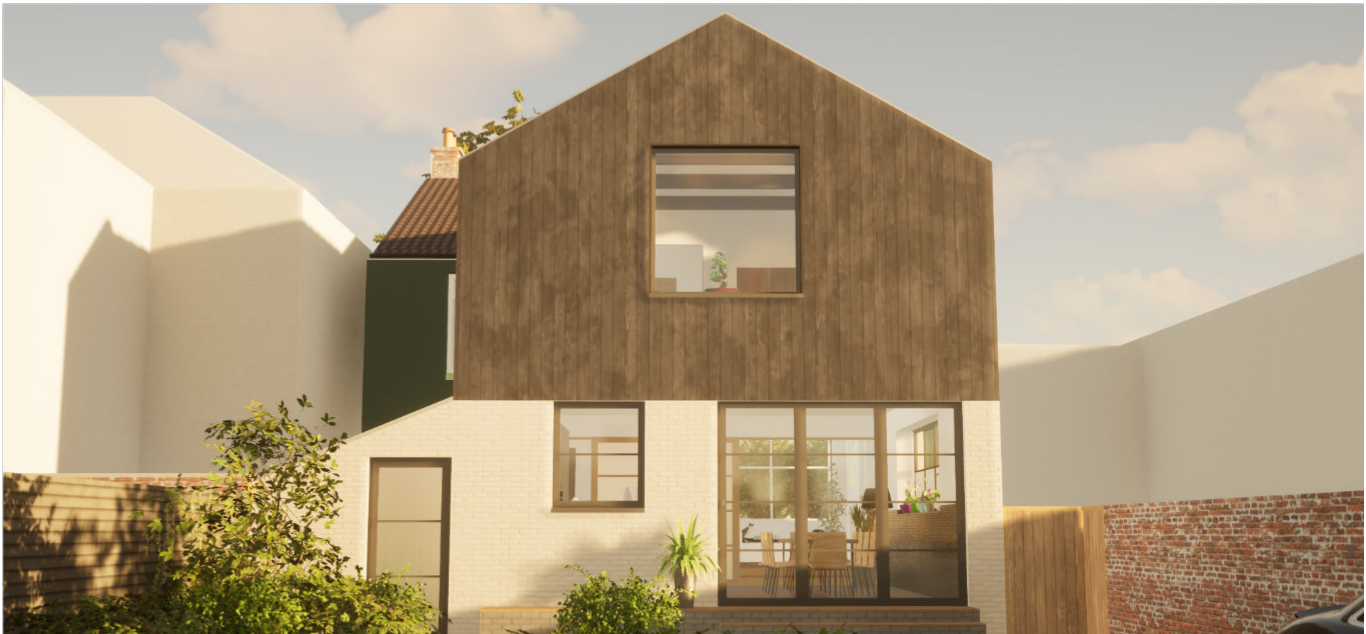
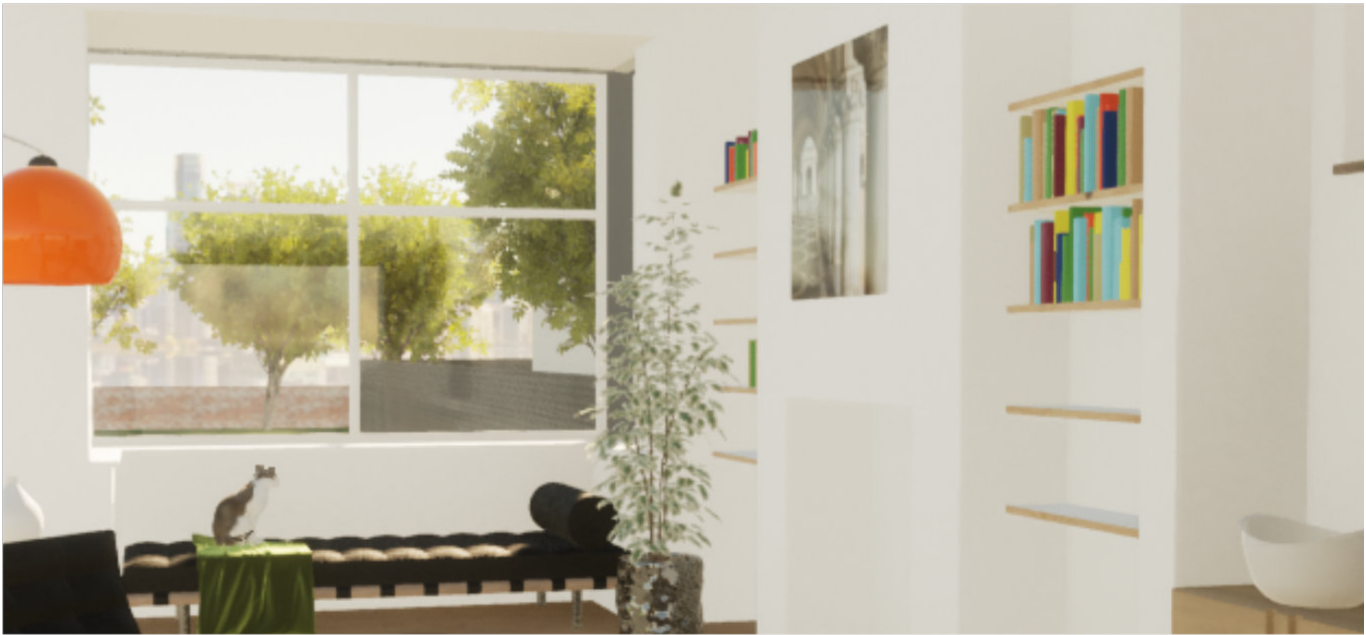
FIGURE 9: Proposed impressions of the front, rear and internal views of number 10 Rushford Avenue.
