4144.10.04 - SSB/1/A

FIRE PRECAUTION WORKS TO:

Sackville Street Building

THE UNIVERSITY OF MANCHESTER

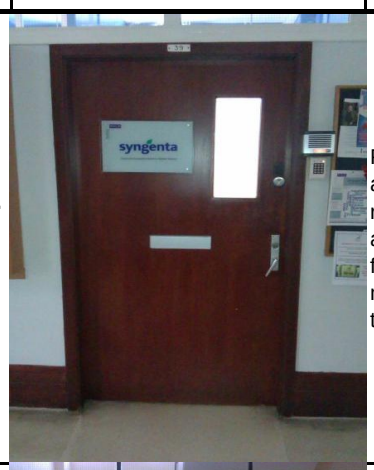
1.03	D - Fire Doors	K	**K7 Desk Store / C1 Corridor**	**4144-SSB-(P3)-(S-) 111 & door detail 4144-SSB-(P3)-(32-) 01 Door Type 1**		The door should be replaced by a door, frame and associated screen that will provide a minimum of 30 minutes fire resistance. The door should be kept locked shut being fitted with intumescent strips and seals and fitted with a sign stating "Fire Door Keep Locked Shut"	New FD30S oak veneer door with combined seals, small vison panel with clear, film obscured glass. Brass hinges, 150mm kick plate & lever EP cylinder lock set.Splice repair to redundant lock keeps. 'FDKL' brass disk sign. Stain & varnish finish on site to match tone of frame & remaining adjacent doors.

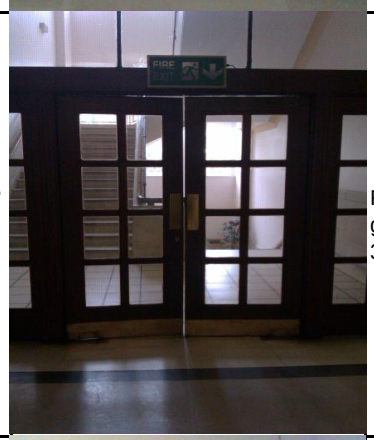
1.04	D - Fire Doors	J	**C1 Corridor / C2 Corridor**	**4144-SSB-(P3)-(S-) 110**		Provide both intumescent strips and cold smoke seals to the fire resisting doorset (Double)	Rout door leaves & fit combined seals (intumescent only to one meeting stile). Sand & re-varnish door leaves. Replace 4 No. 'FDKS' signs with brass disktype.

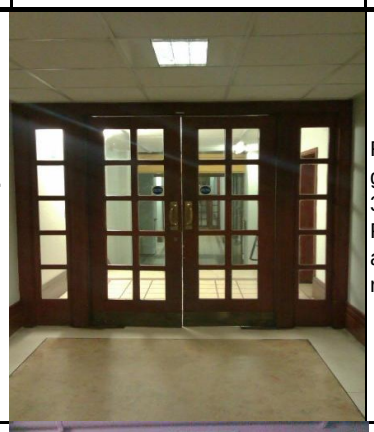
1.07	D - Fire Doors	J	**J18 Office / C2 Corridor**	**4144-SSB-(P3)-(S-) 110 & door detail 4144-SSB-(P3)-(32-) 01 Door Type 1**		Replace the existing construction specified with a door and associated screen that will provide a minimum of 30 minutes fire resistance. The door should be positively self closing fitted with intumescent seals and cold smoke brushes.	New FD30S oak veneer door with combined seals, small vison panel with clear, film obscured glass. Brass hinges, 150mm kick plate & lever EP cylinder lock set. Splice repair to redundant lock keeps. 'FDKS' brass disk signs & overhead closer. Stain & varnish finish dorr & repaired frame on site to match tone of frame & remaining adjacent doors.

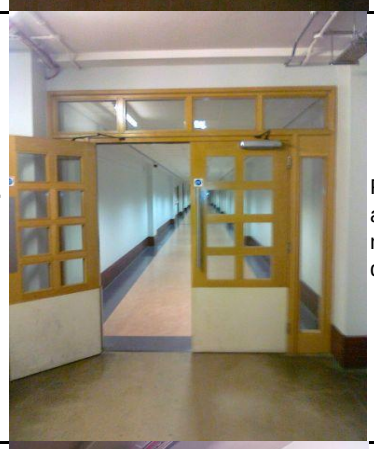
1.08	D - Fire Doors	H	**Office H32 / C2 Corridor**	**4144-SSB-(P3)-(S-) 109 & door detail 4144-SSB-(P3)-(32-) 01 Door Type 1**		The door should be replaced by a door, frame and associated screen that will provide a minimum of 30 minutes fire resistance. The door should be made and maintained positively self closing onto its rebated frame being fitted with intumescent strips and smoke seals.	New FD30S oak veneer door with combined seals, small vison panel with clear, film obscured glass. Brass hinges, 150mm kick plate & lever EP cylinder lock set. Splice repair to redundant lock keeps. 'FDKL' brass disk sign. Stain & varnish finish on site to match tone of frame & remaining adjacent doors.

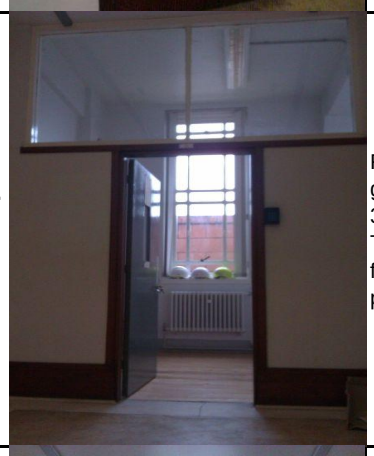
1.11A	D - Fire Doors	H	**C1 Corridor / C2 Corridor**	**4144-SSB-(P3)-(S-) 109**		Provide both intumescent strips and cold smoke seals to the fire resisting doorset (Double)	Rout door leaves & fit combined seals (intumescent only to one meeting stile). Sand & re-varnish door leaves. Replace 4 No. 'FDKS' signs with brass disktype.

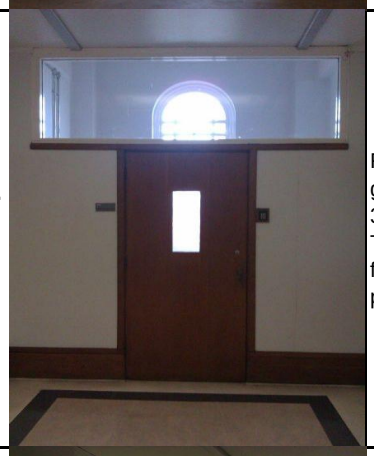
1.12	D - Fire Doors	H	**Office H4 / C1 Corridor**	**4144-SSB-(P3)-(S-) 109 & door detail 4144-SSB-(P3)-(32-) 01 Door Type 1**		The door should be replaced by a door, frame and associated screen that will provide a minimum of 30 minutes fire resistance. The door should be kept locked shut being fitted with intumescent strips and seals and fitted with a sign stating "Fire Door Keep Locked Shut".	New FD30S oak veneer door with combined seals, small vison panel with clear, film obscured glass. Brass hinges, 150mm kick plate & lever EP cylinder lock set. Splice repair to redundant lock keeps. 'FDKL' brass disk sign. Stain & varnish finish on site to match tone of frame & remaining adjacent doors.

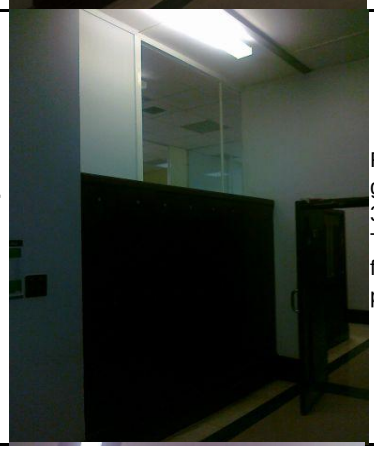
1.13	D - Fire Doors	H	**Office H3 / C1 Corridor**	**4144-SSB-(P3)-(S-) 109 & door detail 4144-SSB-(P3)-(32-) 01 Door Type 1**		The door should be replaced by a door, frame and associated screen that will provide a minimum of 30 minutes fire resistance. The door should be kept locked shut being fitted with intumescent strips and seals and fitted with a sign stating "Fire Door Keep Locked Shut".	New FD30S oak veneer door with combined seals, small vison panel with clear, film obscured glass. Brass hinges, 150mm kick plate & lever EP cylinder lock set. Splice repair to redundant lock keeps. 'FDKL' brass disk sign. Stain & varnish finish on site to match tone of frame & remaining adjacent doors.

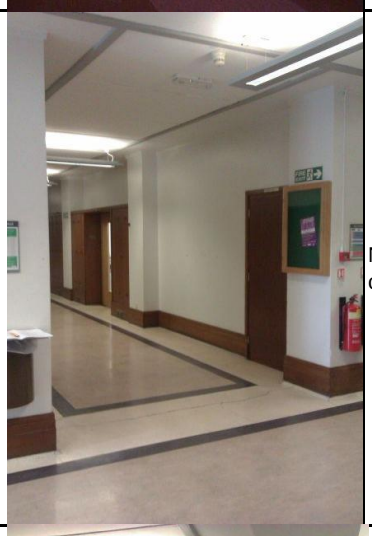
1.17	D - Fire Doors	G	**Workshop G34 / C5 Corridor**	**4144-SSB-(P3)-(S-) 109 & door detail 4144-SSB-(P3)-(32-) 01 Door Type 1 (as double variant)**		The door should be replaced by a door, frame and associated screen that will provide a minimum of 30 minutes fire resistance. The door should be made and maintained positively self closing onto its rebated frame being fitted with intumescent strips and smoke seals.	New FD30S oak veneer door pair with combined seals, small vison panels with clear, film obscured glass. Re-use existing ironmongery & maintain/replace floor closer mechanisms. Replace lock set & flush bolts. 'FDKS' brass disk sign. Stain & varnish finish on site to match tone of frame & remaining adjacent doors.

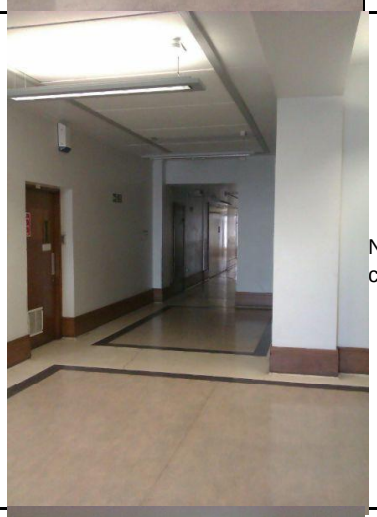
1.17A	D - Fire Doors	G	**Stair S4 / C5 Corridor**	**4144-SSB-(P3)-(S-) 108**		Fire door pair not closing effectively	Adjust door pair on floor closers & replace combined seals for better fit. Clean off glass. Replace blue stickers with brass 'FDKS' signs. Sand & re-varnish door leaves.

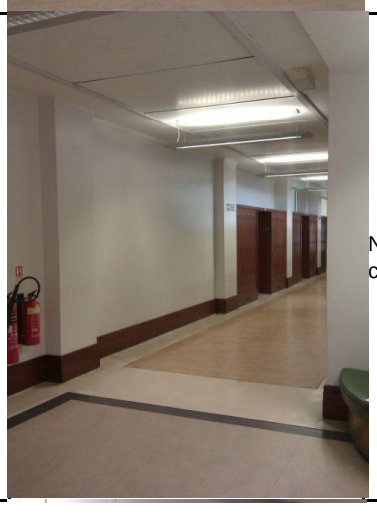
1.18	D - Fire Doors	G	**Office G36 / C5 Corridor**	**4144-SSB-(P3)-(S-) 108 & door detail 4144-SSB-(P3)-(32-) 01 Door Type 1**		The door should be replaced by a door, frame and associated screen that will provide a minimum of 30 minutes fire resistance. The door should be kept locked shut being fitted with intumescent strips and seals and fitted with a sign stating "Fire Door Keep Locked Shut".	New FD30S oak veneer door with combined seals, small vison panel with clear, film obscured glass. Brass hinges, 150mm kick plate & lever EP cylinder lock set. Splice repair to redundant lock keeps. 'FDKL' brass disk sign. Stain & varnish finish on site to match tone of frame & remaining adjacent doors. NEED FOR DOOR VENT REINSTATEMENT TBC WITH FACULTY ESTATES

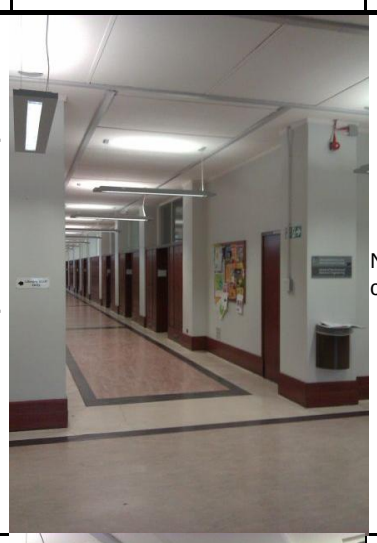
1.21	D - Fire Doors	D	**C3 Corridor**	**4144-SSB-(P3)-(S-) 105**		Replace non FR glazing with glazing affording a minimum of 30 minutes Fire Resistance.	Replace exisitng combined seals to reduce gaps around doors. Re-glaze 16 No. vision panels with clear FR glass. Sand & re-varnish doors.

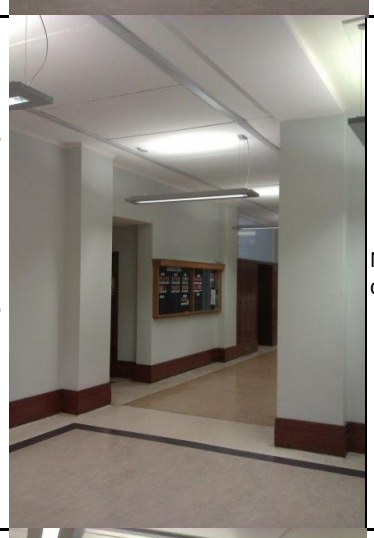
1.21A	D - Fire Doors	D	**C3 Corridor/ S4 Stairwell**	**4144-SSB-(P3)-(S-) 105**		Fire door pair not closing effectively	Repair/replace floor box closer mechanisms, retaining brass cover plates. Replace combined seals. Clean off glass. Replace blue stickers with brass 'FDKS' signs. Sand & re-varnish door leaves.

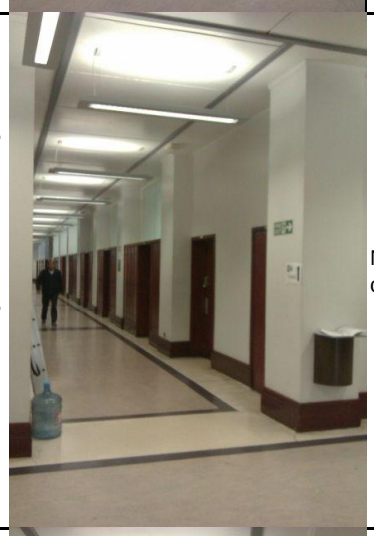
1.22	D - Fire Doors	D	**Lecture Room D39 / C3 Corridor**	**4144-SSB-(P3)-(S-) 105**		The door should be replaced by a door, frame and associated screen that will provide a minimum of 30 minutes fire resistance. The door should be made and maintained positively self closing onto its rebated frame being fitted with intumescent strips and seals.	Preferably: repair split door at top flush bolt & glazing beading. Maintain floor box closers & reglaze 16 No. panels. Rout for combined seals (intumescent only on one meeting stile). Fit 4 No. brass 'FDKS' disks. If door repairs not possible replace pair with matching design & refit all ironmongery. (lock arrangement TBC).

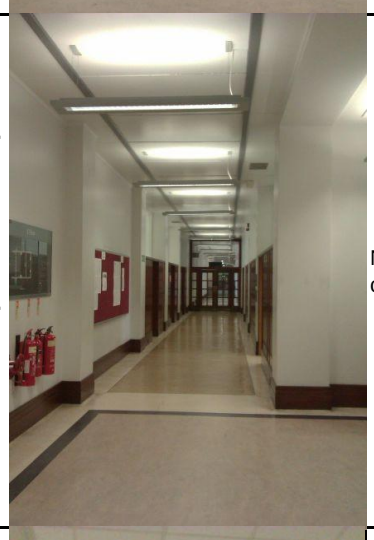
1.23	D - Fire Doors	D	**C3 Corridor**	**4144-SSB-(P3)-(S-) 105**		Provide both intumescent strips and cold smoke seals to the fire resisting doorset. Replace non FR glazing with glazing affording a minimum of 30 minutes Fire Resistance.	Re-glaze all glass panels witihin corridor door screen with clear FR rated glass. Maintain floor box closers. Repair beads, sand & re-varnish. Fit 4No. Brass disk 'FDKS' signs

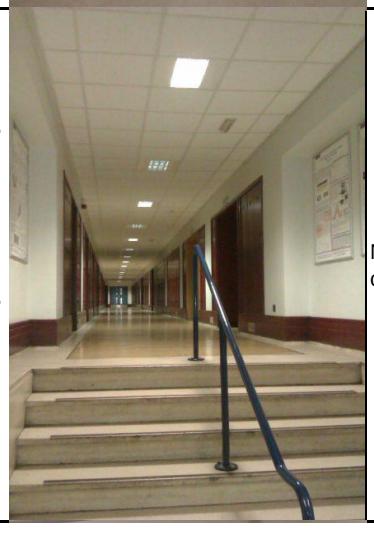
1.24	D - Fire Doors	C	**Lift Machinery 309 / C3 Corridor**	**4144-SSB-(P3)-(S-) 104 & door detail 4144-SSB-(P3)-(32-) 01 Door Type 2**		The door should be replaced by a door, frame and associated screen that will provide a minimum of 30 minutes fire resistance. The door should be kept locked shut being fitted with intumescent strips and seals and fitted with a sign stating 'Fire Door Keep Locked Shut'.	New FD30S oak frame door with combined seals. 12 No. small vison panel with clear, film obscured glass in arrangement of exisitng door. Brass hinges, 150mm kick plate & lever EP cylinder lock set. Splice repair to redundant lock keeps. 'FDKL' brass disk sign. Stain & varnish finish on site to match tone of frame & remaining adjacent doors. Refit/replace all other safety signage.

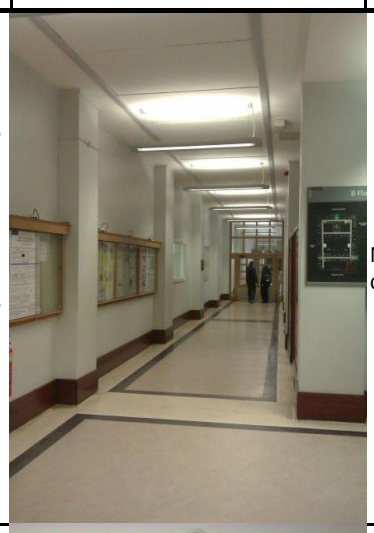
1.25	D - Fire Doors	C	**C3 Corridor / C2 Corridor**	**4144-SSB-(P3)-(S-) 104**		Provide both intumescent strips and cold smoke seals to the fire resisting doorset .	Rout door for combined seals (intumescent only to one meeting stile). Stop door binding on floor on rehang. Re-decorate door as existing. Fit 4No. 'FDKS' brass disk signs.

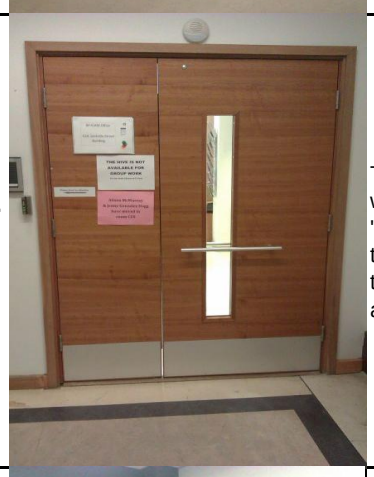
1.26	D - Fire Doors	C	**C39 / C3 Corridor**	**4144-SSB-(P3)-(S-) 104**		Provide both intumescent strips and cold smoke seals to the fire resisting doorset. Infill hole with a materials providing 30 minutes fire resistance or a suitable metal enclosure on the inside of the door.	Rout door for combined seals. Re-decorate door as existing. Fit 2No. 'FDKS' brass disk signs.

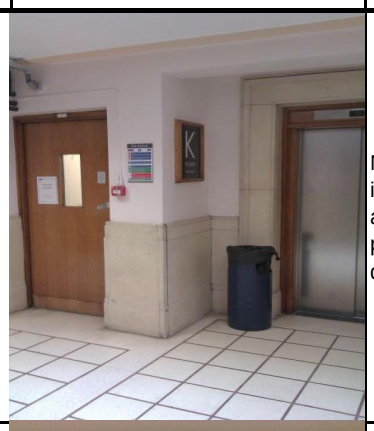
1.28A	D - Fire Doors	B	**C6 Corridor/ S4 Stairwell**	**4144-SSB-(P3)-(S-) 103**		Fire door pair not closing effectively	Repair/replace floor box closer mechanisms, retaining brass cover plates. Replace combined seals. Clean off glass. Replace blue stickers with brass 'FDKS' signs. Sand & re-varnish door leaves.

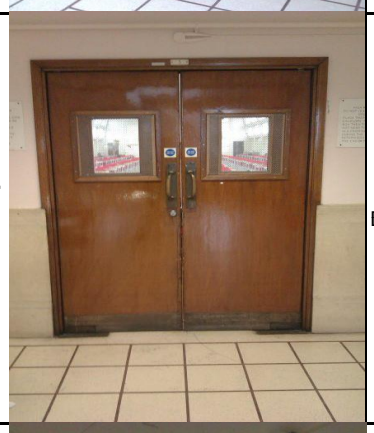
1.29	D - Fire Doors	B	**B38 / C6 Corridor**	**4144-SSB-(P3)-(S-) 103**		Provide both intumescent strips and cold smoke seals to the fire resisting doorset	Rout door for combined seals. Re-decorate door as existing. Fit 2No. 'FDKS' brass disk signs.

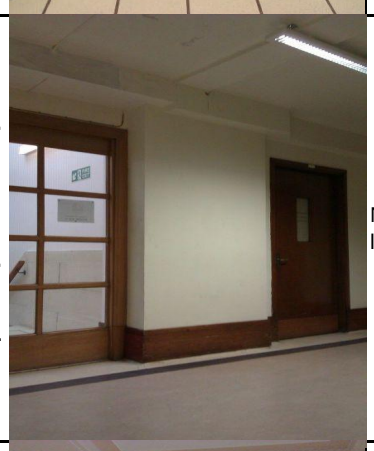
1.30	D - Fire Doors	B	**C6 Corridor / C8 Corridor**	**4144-SSB-(P3)-(S-) 103**		Replace non FR glazing with glazing affording a minimum of 30 minutes Fire Resistance. Provide both intumescent strips and cold smoke seals to the fire resisting doorset .	Rout door for combined seals (intumescent only to one meeting stile). Re-glaze screen side panles in GWG to match doors. Maintain overhead closers. Re-decorate door as existing. Replace signs for 4No. 'FDKS' brass disk signs.

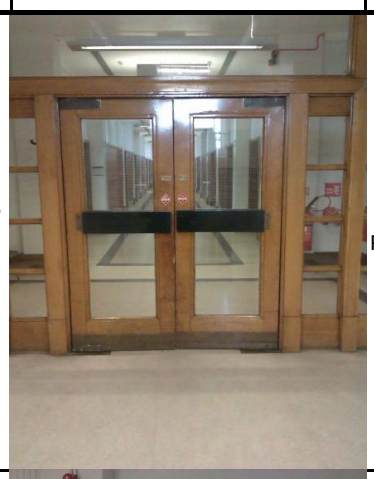
1.33	D - Fire Doors	H	**H21 / C2 Corridor**	**4144-SSB-(P3)-(S-) 109 & door detail 4144-SSB-(P3)-(32-) 01 Door Type 1**		The door should be replaced by a door, frame and associated screen that will provide a minimum of 30 minutes fire resistance. The door should be kept locked shut being fitted with intumescent strips and seals and fitted with a sign stating 'Fire Door Keep Locked Shut'.	New FD30S oak veneer door with combined seals, small vison panel with clear, film obscured glass. Brass hinges, 150mm kick plate & lever EP cylinder lock set. Splice repair to redundant lock keeps. 'FDKL' brass disk sign. Stain & varnish finish on site to match tone of frame & remaining adjacent doors.

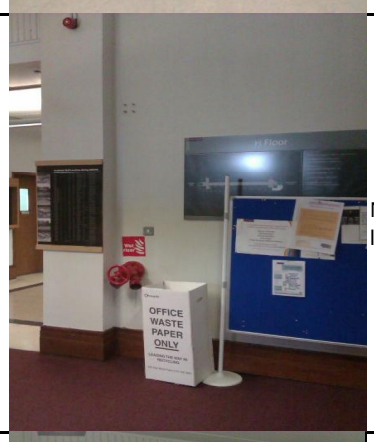
1.34	D - Fire Doors	A	**S4 Stairwell / Store 164**	**4144-SSB-(P3)-(S-) 101 & door detail 4144-SSB-(P3)-(32-) 01 Door Type 1**		The door should be replaced by a door, frame and associated screen that will provide a minimum of 30 minutes fire resistance. The door should be kept locked shut being fitted with intumescent strips and seals and fitted with a sign stating 'Fire Door Keep Locked Shut'.	New FD30S oak veneer door with combined seals, small vison panel with clear, film obscured glass. Brass hinges, 150mm kick plate & lever EP cylinder lock set. Splice repair to redundant lock keeps. 'FDKL' brass disk sign. Stain & varnish finish on site to match tone of frame & remaining adjacent doors.

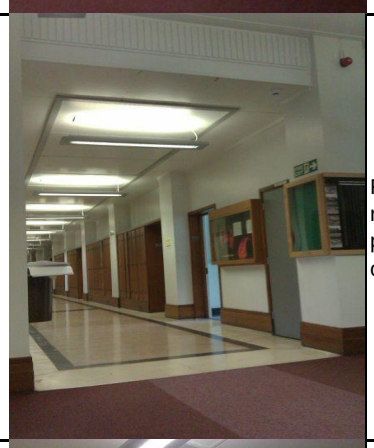
1.34A	D - Fire Doors	A	**C 8 Corridor / Stairwell 4**	**4144-SSB-(P3)-(S-) 101**		Fire doors not closing	Repair/replace floor box closer mechanisms, retaining brass cover plates. Replace combined seals. Clean off glass. Replace blue stickers with brass 'FDKS' signs. Sand & re-varnish door leaves.

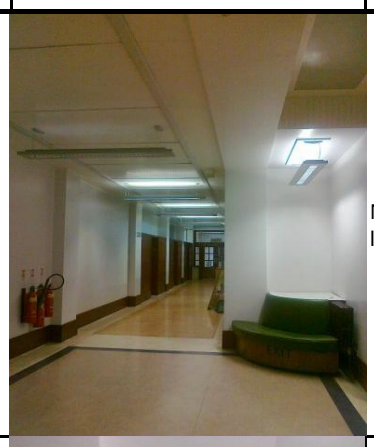
3.03	D - Fire Doors	D	**C3 Corridor / D39 Lecture Room**	**4144-SSB-(P3)-(S-) 105**		Replace non FR glazing with glazing affording a minimum of 30 minutes Fire Resistance. The glazing should be fitted in a frame fixed in the closed position.	Reglaze 5 No. screen panels above door with clear 30 minute FR glass in intumecent mastic. Refite/replace hardwood bead, make good frames & paint decorate.

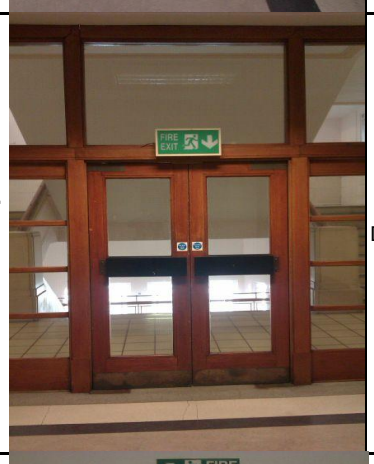
3.04	D - Fire Doors	C	**C3 Corridor**	**4144-SSB-(P3)-(S-) 104**		Replace non FR glazing with glazing affording a minimum of 30 minutes Fire Resistance. The glazing should be fitted in a frame fixed in the closed position.	Reglaze all panels above lockers in screen either side of door 1.27 with clear 30 minute FR glass in intumecent mastic. Refite/replace hardwood bead, make good frames & paint decorate.

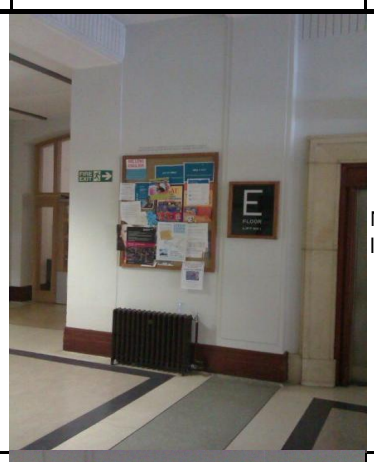
4.01	D - Fire Doors	H	**C1 Corridor**	**4144-SSB-(P3)-(S-)109 & door detail 4144-SSB-(P3)-(32-)01 Screen Type 1**		New fire screen required to create refuge lobby	Remove bin, glass cabinet & fire signage on columns. Install new oak screen between columns & plaster soffit with single swing door pair & ironmongery as per detail drawing. (SO 2620 wide x 3030 high) New 300x100 running man/arrow up photoilluminescent sign to door frame head on corridor side. Make good wall & soffit decoration. SEE ITEM 6.07 FOR ASSOCIATED FIRE DETECTOR ALTERATIONS

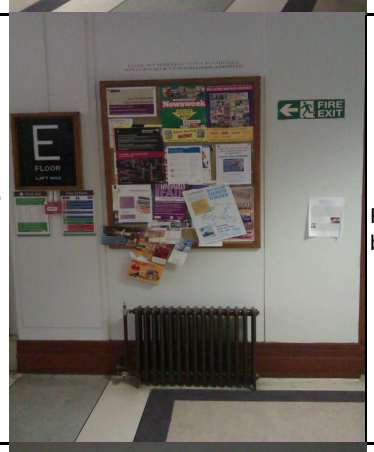
4.03A	D - Fire Doors	G	**C1 Corridor/ S3 Stairwell**	**4144-SSB-(P3)-(S-)108**		Fire doors not closing	Repair/replace floor box closer mechanisms, retaining brass cover plates. Replace combined seals. Clean off glass. Fit 4 No. brass 'FDKS' signs. Sand & re-varnish door leaves. Re-face peeling black laminated pull panel.

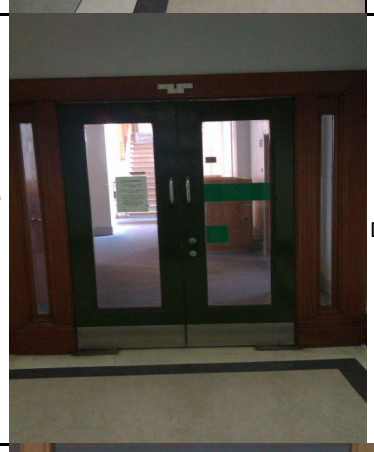
4.04	D - Fire Doors	F	**C4 Corridor**	**4144-SSB-(P3)-(S-)107 & door detail 4144-SSB-(P3)-(32-)01 Screen Type 1**		New fire screen required to create refuge lobby	Install new oak screen with return panel between columns & ceiling with single swing door pair & ironmongery as per detail drawing. (SO 2650 wide x 3000 high) New 300x100 running man/arrow up photoilluminescent sign to door frame head on corridor side. Fire barrier installed above screen in ceiling void. Board ceiling made good & new surface battens matching profiles of existing fitted to either side of screen. Refer to mechanical design for new damper to existing ductwork if found to be passing above screen.

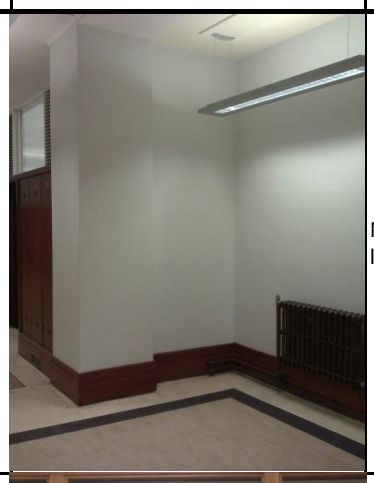
4.05	D - Fire Doors	D	**C2 Corridor**	**4144-SSB-(P3)-(S-)105 & door detail 4144-SSB-(P3)-(32-)01 Screen Type 1**		New fire screen required to create refuge lobby	Install new oak screen between columns & ceiling with single swing door pair & ironmongery as per detail drawing. (SO 2610 wide x 3300 high) New 300x100 running man/arrow up photoilluminescent sign to door frame head on corridor side. Fire barrier installed above screen in ceiling void. Board ceiling made good & new surface battens matching profiles of existing fitted to either side of screen. Refer to mechanical design for new damper to existing ductwork if found to be passing above screen.

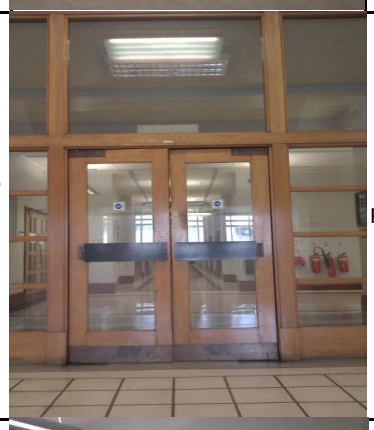
4.08	D - Fire Doors	C	**C1 Corridor**	**4144-SSB-(P3)-(S-)104 & door detail 4144-SSB-(P3)-(32-)01 Screen Type 1**		New fire screen required to create refuge lobby	Install new oak screen between columns & ceiling with single swing door pair & ironmongery as per detail drawing. (SO 2420 wide x 3650 high) New 300x100 running man/arrow up photoilluminescent sign to door frame head on corridor side. Fire barrier installed above screen in ceiling void. Board ceiling made good & new surface battens matching profiles of existing fitted to either side of screen. Refer to mechanical design for new damper to existing ductwork if found to be passing above screen.

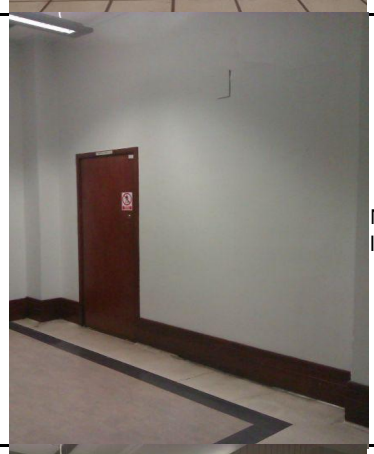
4.09	D - Fire Doors	B	**Corridor C5**	**4144-SSB-(P3)-(S-)103 & door detail 4144-SSB-(P3)-(32-)01 Screen Type 2**		New fire screen required to create refuge lobby	Install new oak door set within new plasterboard partition as per that existing at the other end of the corridor between columns & ceiling with single swing door pair & ironmongery as per detail drawing. (SO 2445 wide x 2490 high) New 300x100 running man/arrow up photoilluminescent sign to door frame head on corridor side. Partition carried through ceiling as fire barrier. Ceiling made good with new tinber edge battens against screen as existing profiles. Refer to mechanical design for new damper to existing ductwork if found to be passing above screen.

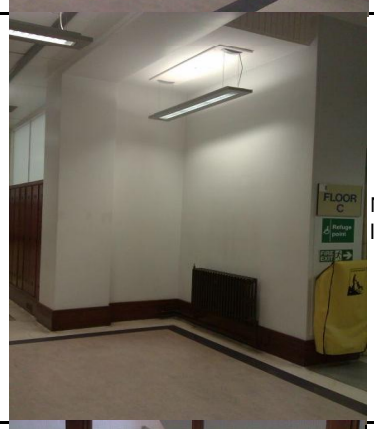
4.10	D - Fire Doors	B	**Corridor C5**	**4144-SSB-(P3)-(S-) 103 & door detail 4144-SSB-(P3)-(32-) 01 Screen Type 1**		New fire screen required to create refuge lobby	Install new oak screen between columns & ceiling with single swing door pair & ironmongery as per detail drawing. (SO 2405 wide x 3625 high) New 300x100 running man/arrow up photoilluminescent sign to door frame head on corridor side. Fire barrier installed above screen in ceiling void. Board ceiling made good & new surface battens matching profiles of existing fitted to either side of screen. Refer to mechanical design for new damper to existing ductwork if found to be passing above screen.
